**Research Report**  
**KTC-03-14/SPR193-98-1F**

**ASSESSMENT AND MODELING OF  
STREAM MITIGATION PROCEDURES**

May 2003

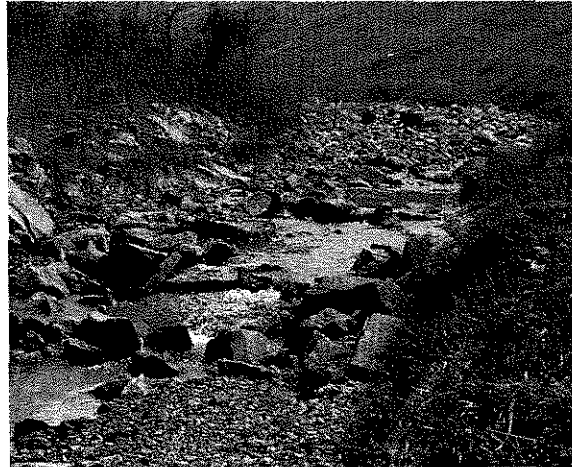
Figure 17 Shallow unnamed stream flows into Cedar Creek.

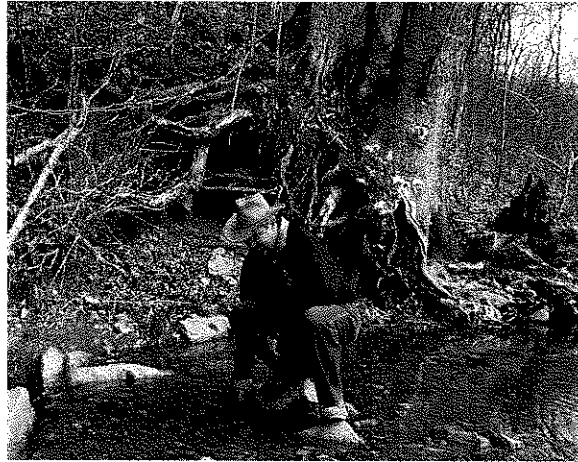
**Figure 19 Bank erosion results from undercutting. This picture taken at Cedar Creek2.**

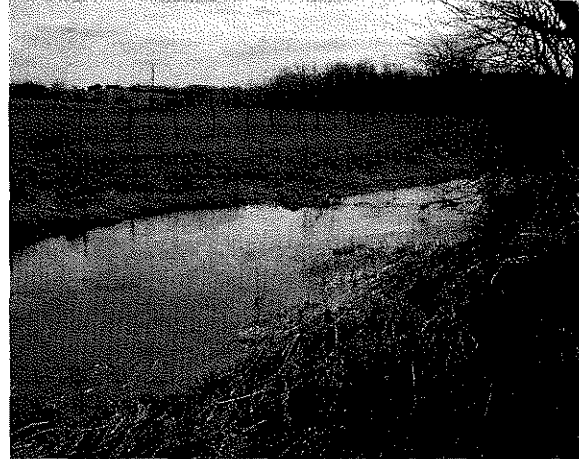
Doctor's Fork runs parallel to US 68. It is bordered on the southeast (right bank) by farmland. The creek itself is very shallow and is about six inches at the thalweg line. This stream is quite shallow in the summer but must flood occasionally as there is evidence of undercutting and erosion.

**Figure 20** Doctor's Fork is bordered by farmland on one side and US 68 on the other side.

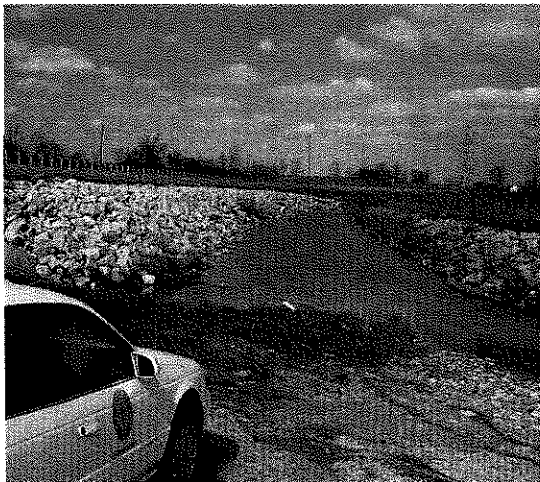
significant part of the mitigation is 350 feet of 30-foot wide channel change south of relocated US 68 beginning at Station 190+50 (Figure 22). The project is bordered by farmland on the southeast side. Runoff from the farmland is deposited in the stream.

**Figure 22** Doctor's Fork has 350 feet of 30 foot channel change.

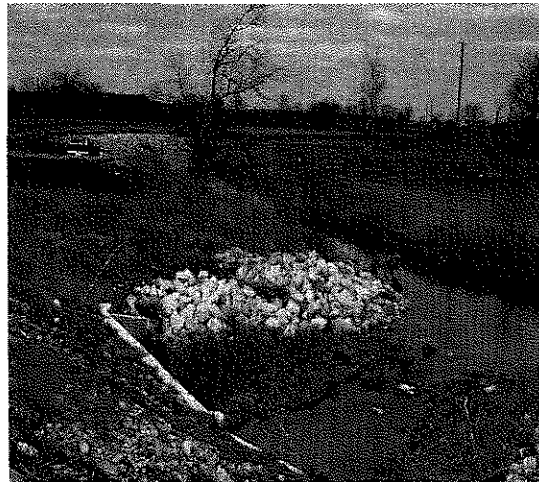
**Figure 23** Riprap is used around box culvert to prevent erosion. The 30-foot channel change is shown in the background.

The stream runs west to east and travels through a wooded area. Culvert bottoms were constructed flush with the streambed and outlets were stabilized with stone (Figure 23).

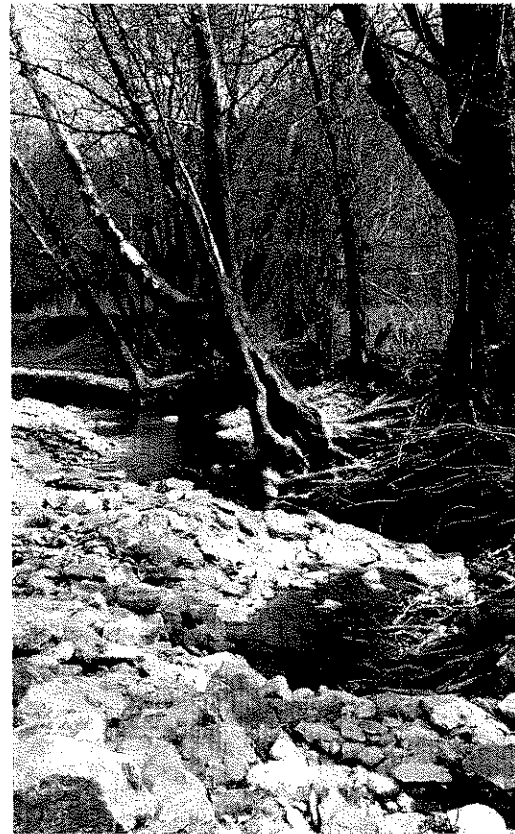
Figure 25 Combined streams go underground. Undercutting has taken place at Holts Creek.

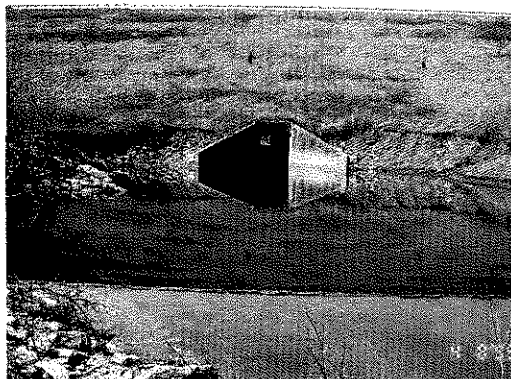
**Figure 28** Expansive pool development. Severe erosion on both sides of box culvert at West Holts Creek.
