**Research Report
KTC-03-20/SPR107-01-1I**

THE USE AND PERFORMANCE OF GEOGRIDS IN KENTUCKY

August 2003

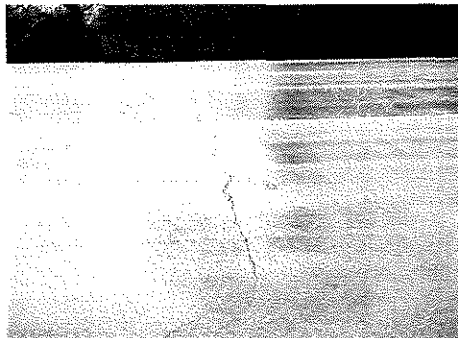
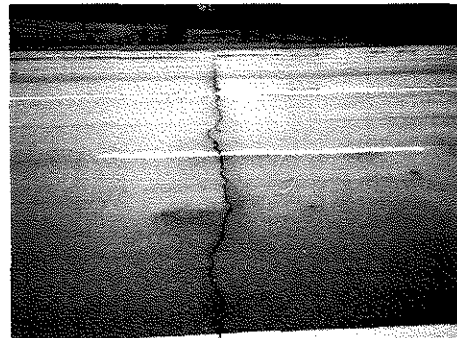
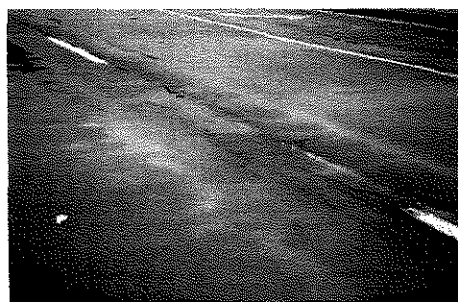
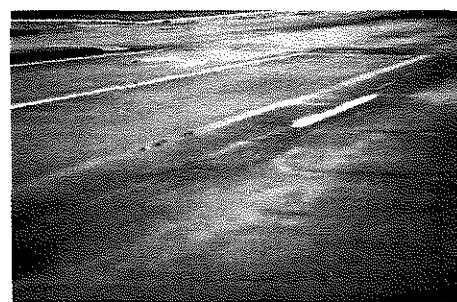
2. **Site Description** – The pavement appears to be in good condition. There are no longitudinal or map cracks. There also are no base failures. However, there are many transverse cracks. Of the section of road that exists beyond the geogrid section, the road is in much worse condition. The pictures below support this.

4. **Conclusions about site** – This 1.7 mile section of geogrid appears to be in good condition. Considering that the road is in a low, swampy region, and that the rest of the road (nongeogrid) is in worse condition, it appears that the geogrid has helped the road maintain a longer life. There are, however, transverse and one longitudinal crack that need to be repaired. There are no apparent base failures to report.

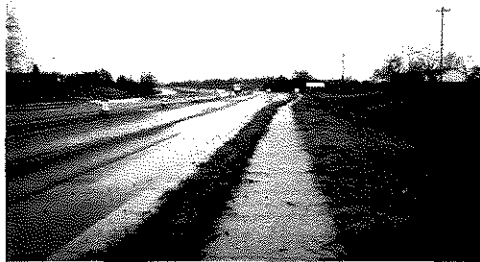
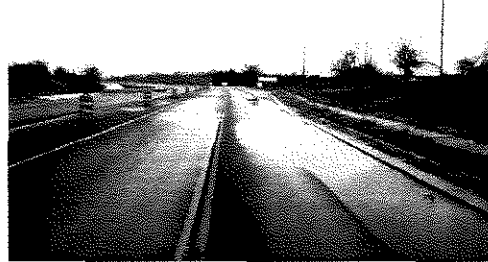
2. Site Description – There is a large sinkhole alongside US 231. When the road was built, a sinkhole formed under the subgrade. The sinkhole under the road was repaired and geogrid fabric was placed on top of the subgrade below the rock. At the time of the pictures, this part of US 231 has a base but does not have a surface and has not been opened to traffic.

4. Conclusions About Site – The road appears to be in good structural condition. However, water has collected in the right lane and further drainage may be necessary. A follow-up survey should be performed to see how the road handles repeated loading once it is opened to traffic.

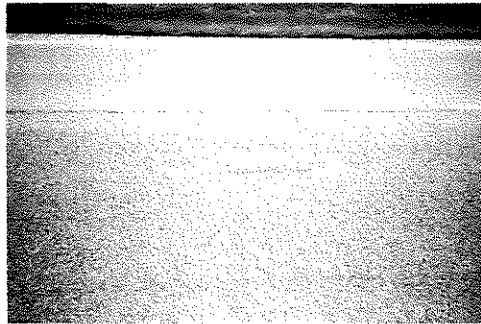
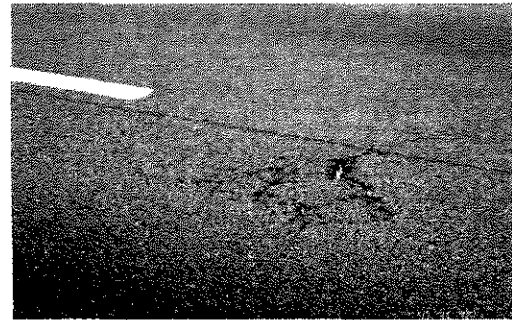
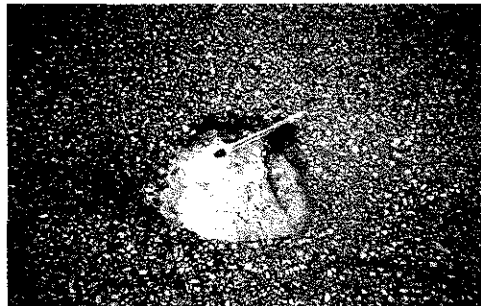
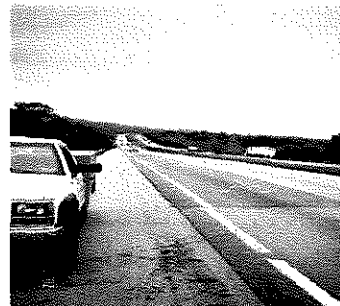
2. Site Description – There are many, around 15, small holes in I-65 (Pictures 3 and 4). There are also many areas, around 20, that exhibit minor bleeding. The pavement appears to be in excellent condition, however, except for the area around milepoint 61.0.

4. Conclusions About Site – Besides the small holes in the road, the 4.2 mile stretch of I-65 appears to be in good condition. Further analysis should be conducted in the future to monitor the road's condition.

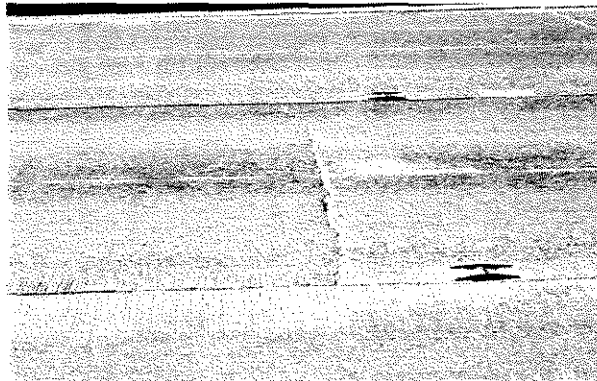
4. Conclusions About Site – Overall the pavement looks to be in good condition. There are a few cracks and many places where the pavement is breaking apart around areas where the pavement markers are missing. There are many bridges or overpasses on this section and consequently much of the pavement is on a bridge or ramp. A lack of shoulder space limits the ability to get more pictures for this site. Recommendation for the future would be to have right lane closed and more pictures taken.

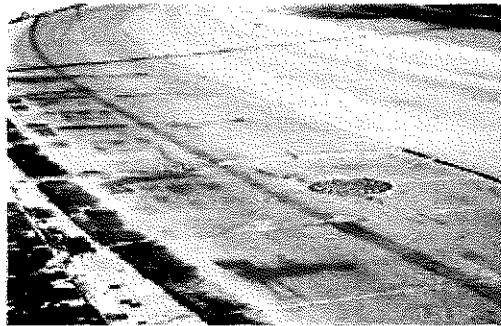
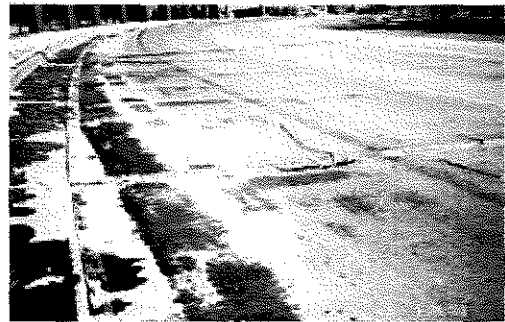
4. Conclusions About Site – Overall this section of Grade Lane appears to be in good condition, except for one problem area presented in the above pictures. There is a slab of concrete around a utility manhole that has recessed badly. This section needs to be fixed.

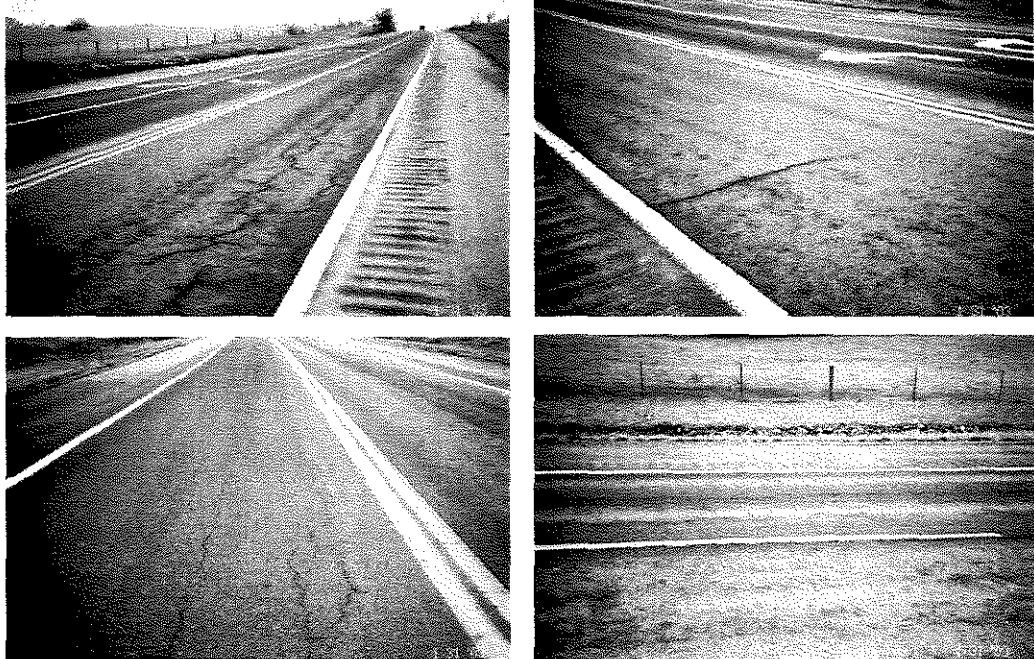
4. Conclusions About Site – Overall the road looks good, but there are many longitudinal cracks over the entire length of the project. These cracks should be patched and the road monitored for future stress problems.

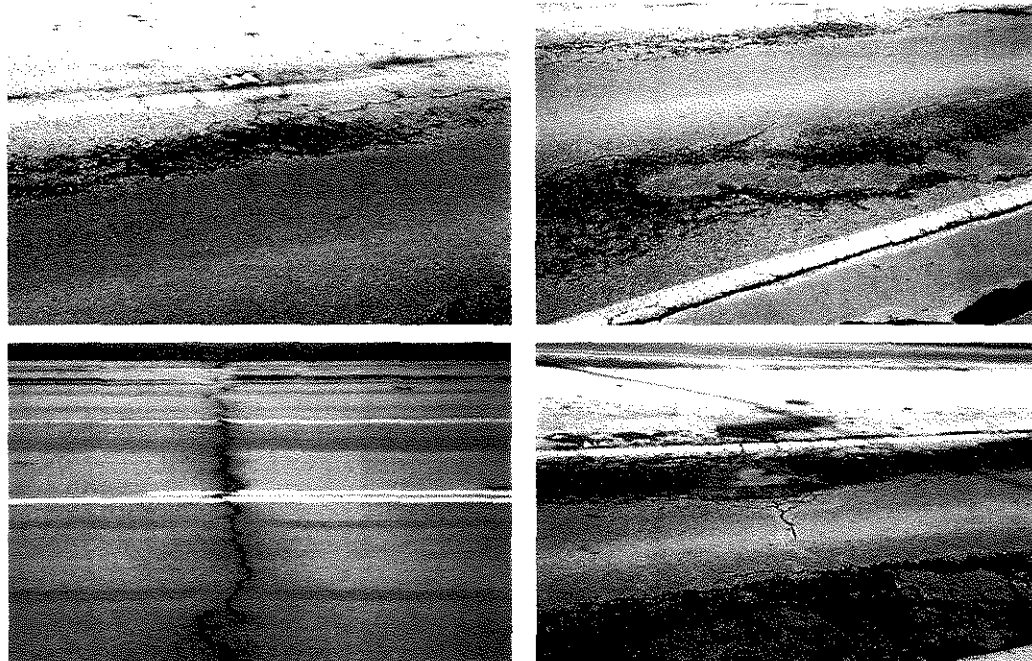
2. Site Description – Geogrid was used between #2's and dense grade. This pavement stretch has many problems: longitudinal cracks, map cracking, and patches.

4. Conclusions About Site – From 0-0.29 miles north of US 42, there are many stress fractures of the pavement, although no base failures to report. After this section, the pavement looks better, but there are still many longitudinal and map cracks in a number of areas.

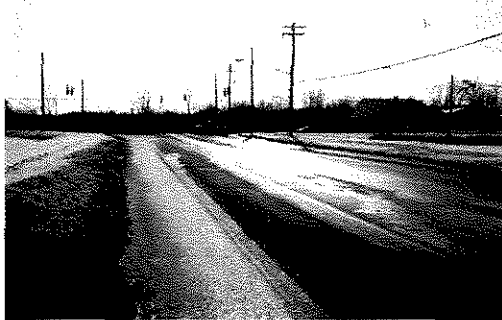
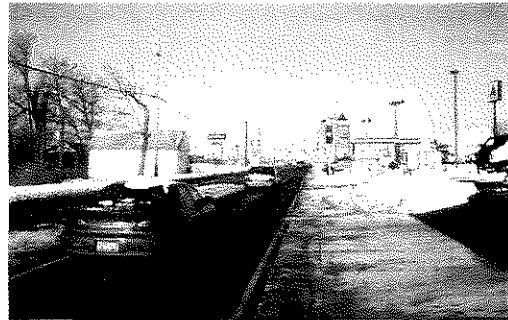
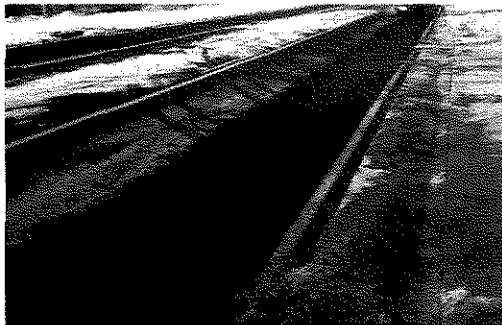
2. Site Description – This section of geogrid runs for about 500-600 feet and was constructed in 2000. Fabric and geogrid were used on top of the subgrade, between subgrade and dense-grade. The fabric was placed on the subgrade and then the geogrid was placed on top of the fabric. There are no exhibits of defects of any form, the pavement looks very good.

4. Conclusions About Site - While this section of pavement is extremely young (three years), the road appears to be in good shape. Further monitoring is recommended.

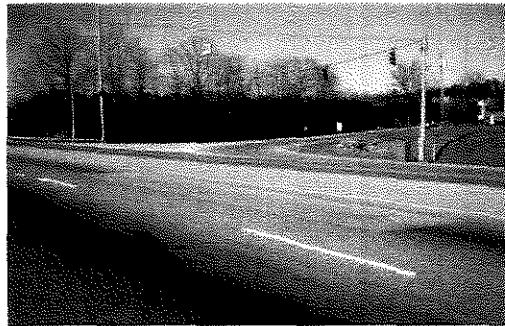
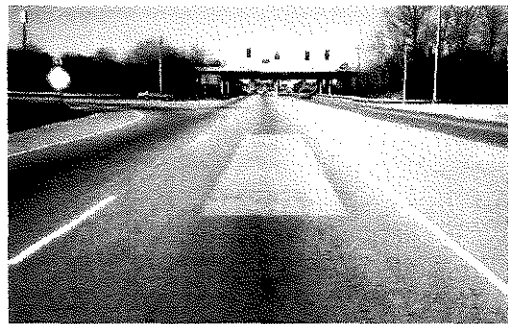
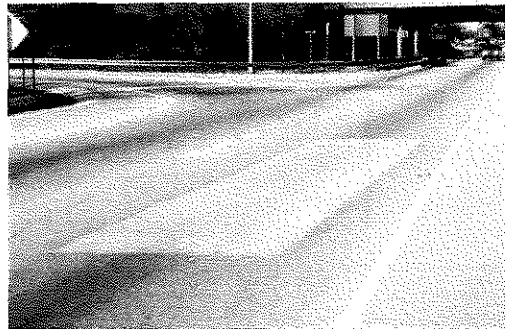
2. Description of Site – Geogrid was used to repair a blow-up in the inside lane on US 25 eastbound.

4. Conclusions About Site – The patch fixed with geogrid appears to be in good condition and it covers only a very small area.

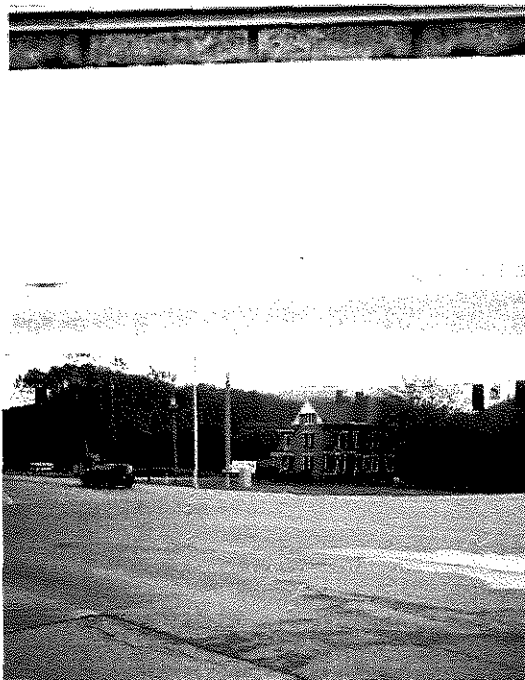
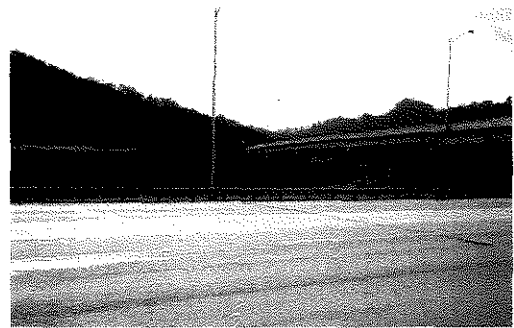
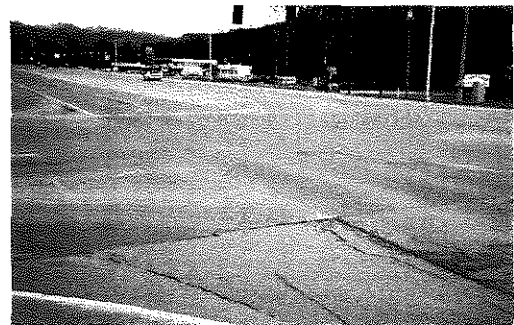
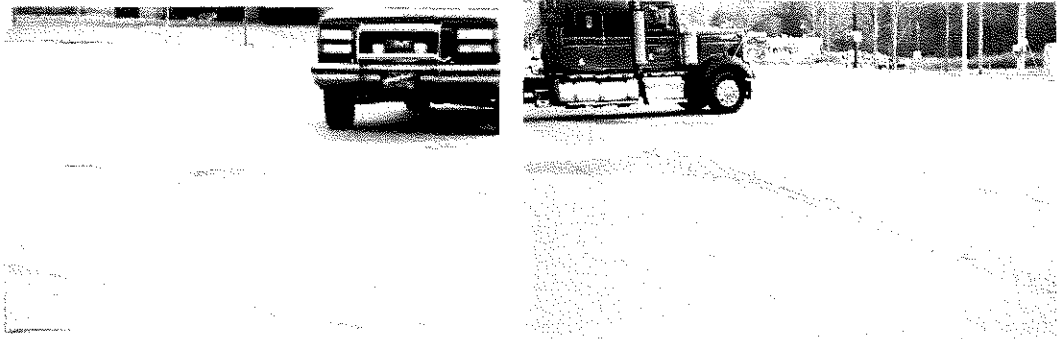
2. Site Description – US 460 intersects US 23 which passes over on a overpass. The pavement at the intersection looks good but has many longitudinal cracks. On the eastbound side the turn lane onto KY 40 and US 23 NB has been replaced with a PCC overlay. The entire intersection is 1825 feet long, and includes a ramp to US 23 SB. A ramp extends from US 23 NB and to a ramp through US 23 NB. However, there is no ramp from US 23 SB at the intersection. On the ramp to US 23 NB there is a large patch over almost the entire intersection. This is also where the PCC lane ends and there is water standing at the end of that lane. There are several large cracks in the PCC lane.

4. Conclusions About Site – This road has many cracks and ruts and needs to be repaired.

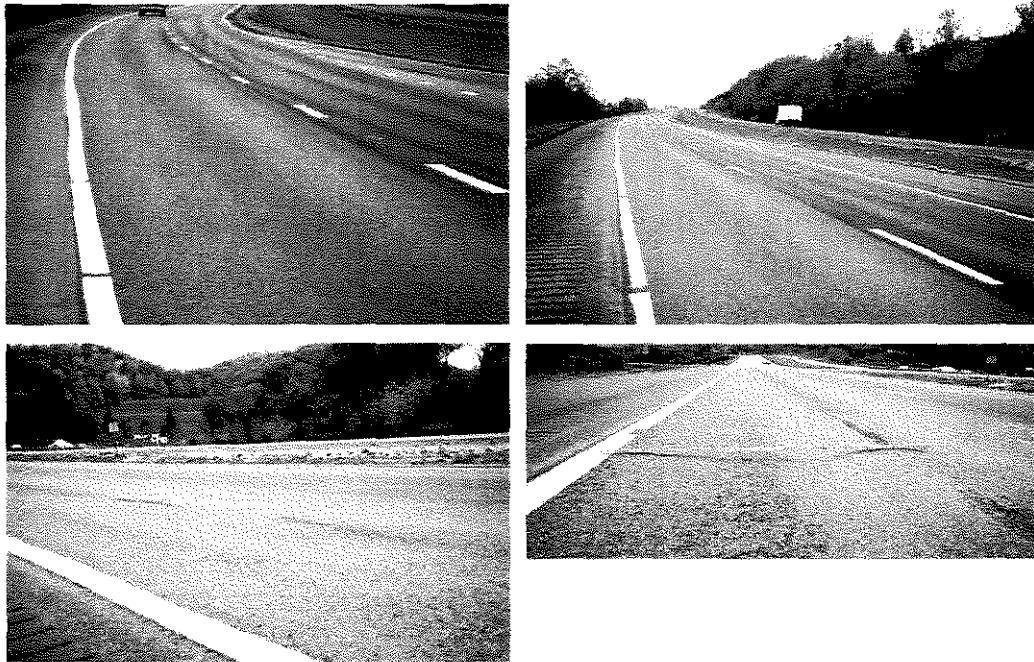
2. Description of Site – At milepoint 0.02, the right lane exhibits an extreme area of sunken pavement about 150 to 200 feet long.

4. Conclusions About Site – Overall, apart from the 150 foot area of sunken pavement, the project looks good. There is a small amount of rutting in the right lane at various locations.

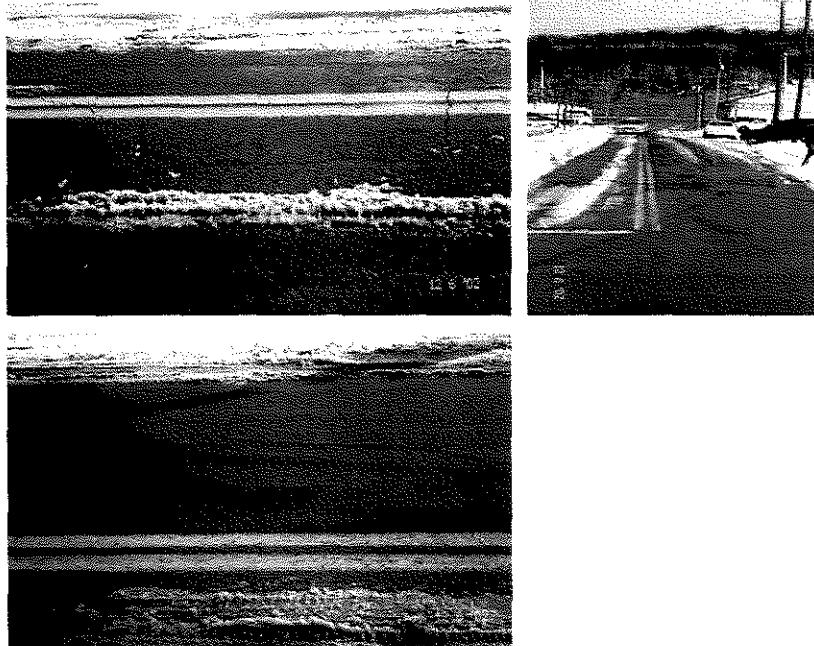
2. Description of Site – At the time of inspection, the road was partially covered with ice. Parts that are showing exhibit many transverse and longitudinal cracks. There also is some map cracking, although not as much. This street is two lanes wide, with one lane in each direction.

4. Conclusions About Site – Further inspection needs to be conducted, but it appears that the existing cracks should be fixed before more damage occurs.

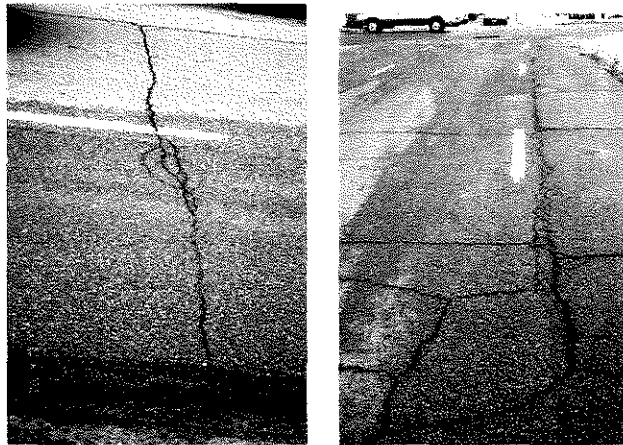
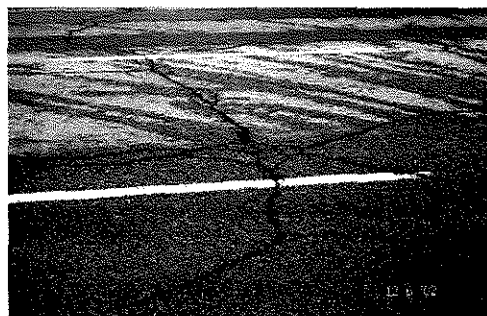
2. Description of Site – MLK Blvd. is between 11th and 13th street. 12th street is cracked in many places. It appears to be in the same condition as 11th street. A lot of transverse and longitudinal cracking, but with very little map cracking in this section. This street is 4 lanes wide and it is a one-way street.

4. Conclusions About Site – Distresses at this site indicate a high volume of traffic. There are many cracks that need to be repaired. There appear to be no structural failures with the road, at this time. Careful monitoring is recommended.

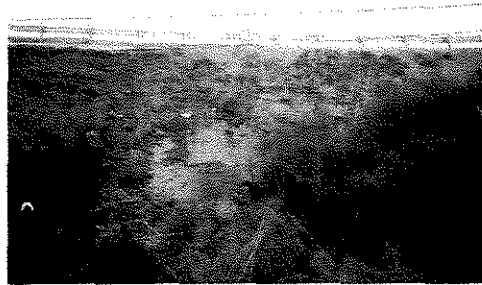
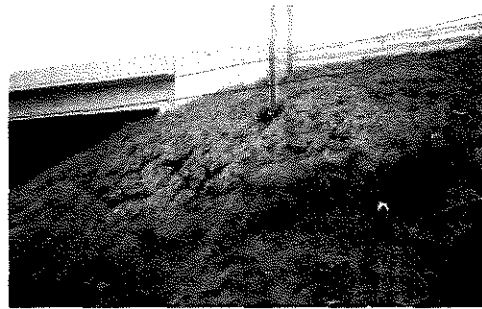
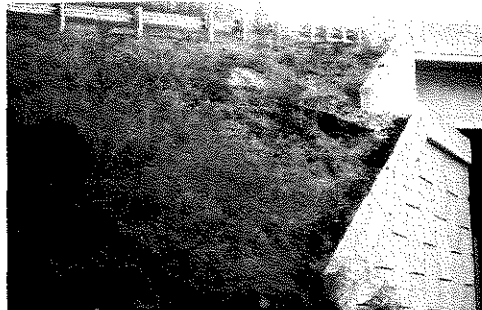
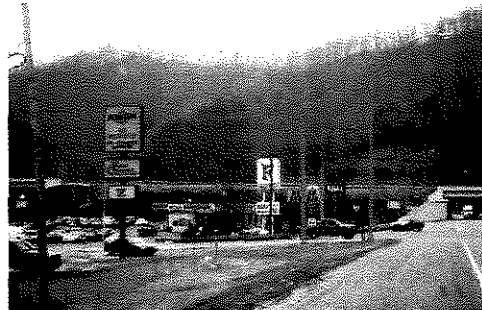
2. Site Description – This geogrid project is a slope stabilization between two bridges on US 23 along side the Glenview Plaza shopping center. This slope is about 10 years old, and overall it looks to be in good condition. In places where the geogrid fabric is visible, the fabric is deteriorating but it looks to have fulfilled its purpose by holding the slope together so that vegetation could take hold. At one end of the slope, which is very steep, there is some slippage. There is also some heavier geogrid showing. In addition, geogrid may have been used in other areas but it could not be determined.

4. Conclusions About Site – This project appears to be in good condition. Further monitoring is recommended.

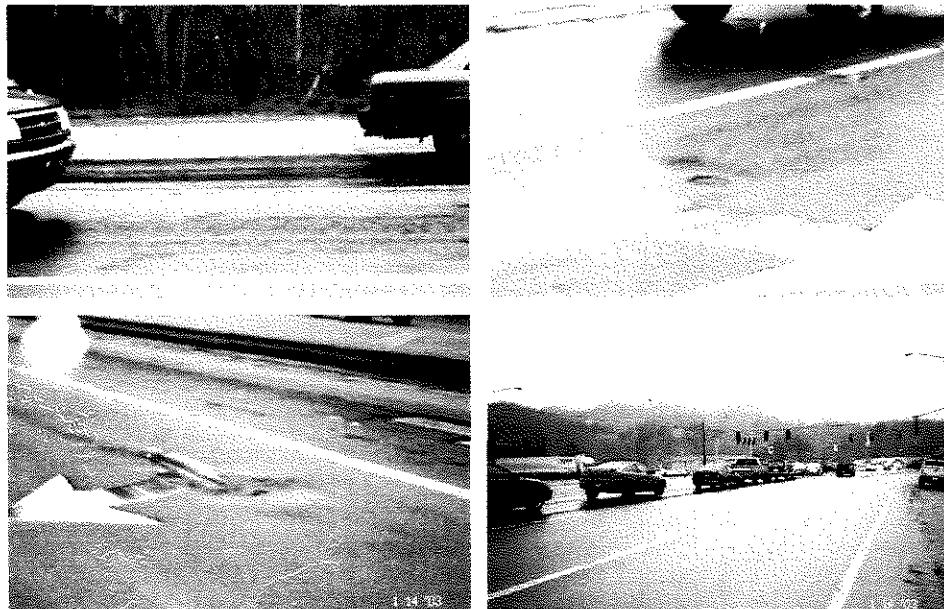
2. Site Description – There is a lot of rutting in this intersection. This probably occurs due to the high volume of coal truck traffic. The left turn lane from US 119 WB onto US 23 SB is severely rutted, in some places more than one inch. The other lanes are rutted but not as badly. There is, however, one distressed location in the right turn lane US 119 EB onto US 23 NB (in the left wheel path). This circular area is about 30 inches in diameter and has sunk about 2 or 3 inches.

4. Conclusions About Site – This project appears to be in good condition, for the most part, considering the routine heavy loading that is applied to the pavement. A number of sunken spots should be fixed.

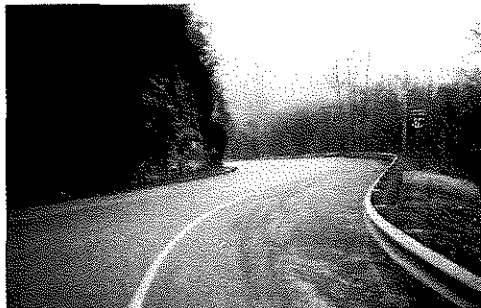
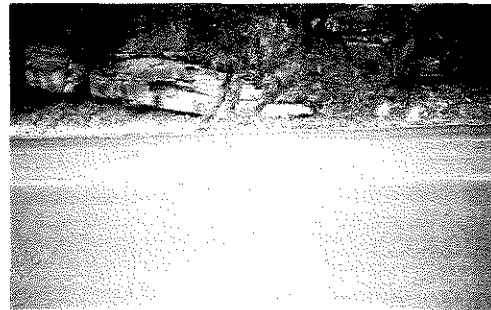
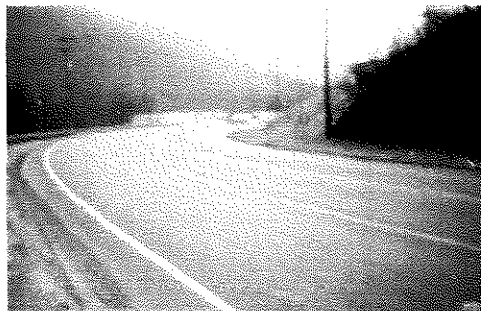
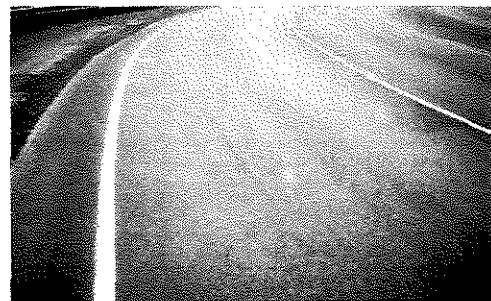
2. Site Description – This site is purported to have geogrid, although that has not been confirmed. There is about 50 feet of road on KY 194 and the intersection between KY 194 and US 119 that has been investigated. Everything looks good, but there are a few areas of longitudinal cracks. The right wheel path in the right lane on US 119 NB, just before KY 194, east bound, has a large number of cracks. This road is a coal haul route.

4. Conclusions About Site – This project is in good condition, considering the heavy loads, however, a definitive word on whether geogrid has or has not been used cannot be made.
