Research Report
KTC-04-21/FRPDeck-1-97-1F

INSPECTION AND EVALUATION OF A BRIDGE DECK PARTIALLY REINFORCED WITH GFRP REBARS

August 2004

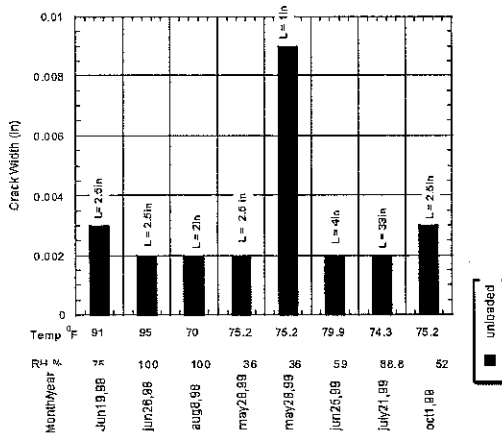
(a) Crack No. 1

Figures 7.1. (a) to (d); Graphical Variation of Cracks Observed in the Top Surface of the Bridge Deck in GFRP Reinforced Area

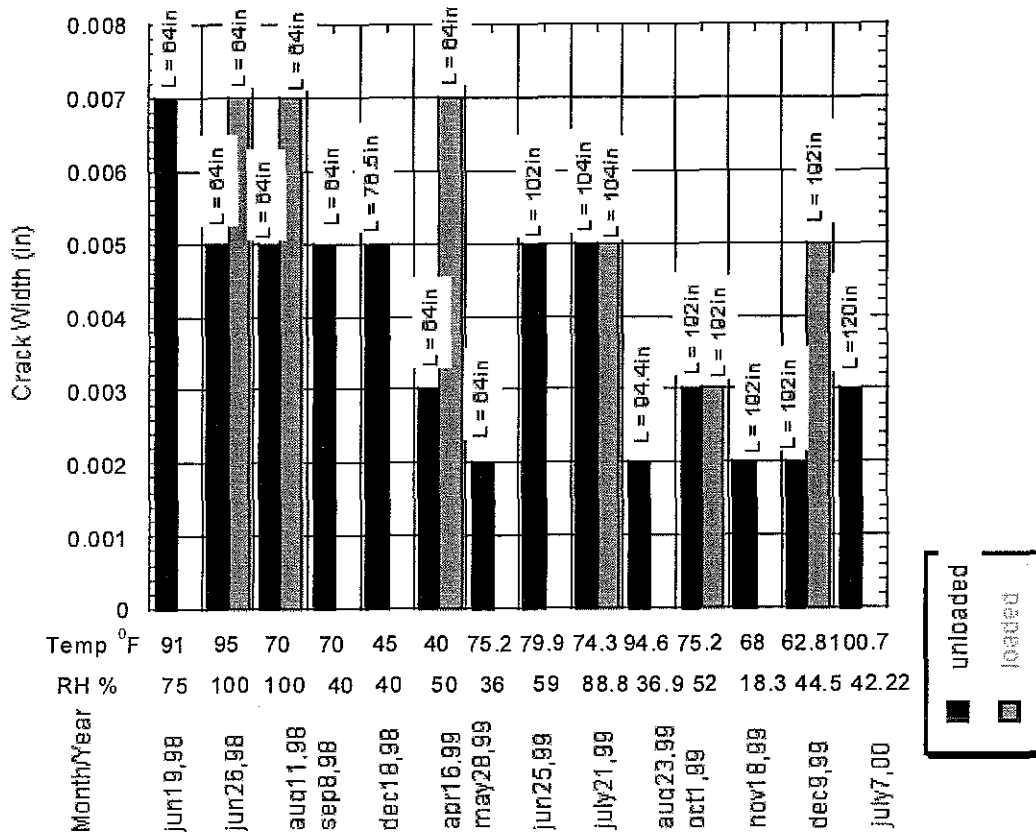
Figure 7.2. Graphical Variation of Crack No. 1 Observed in the Bottom Surface of the Bridge Deck in GFRP Reinforced Area

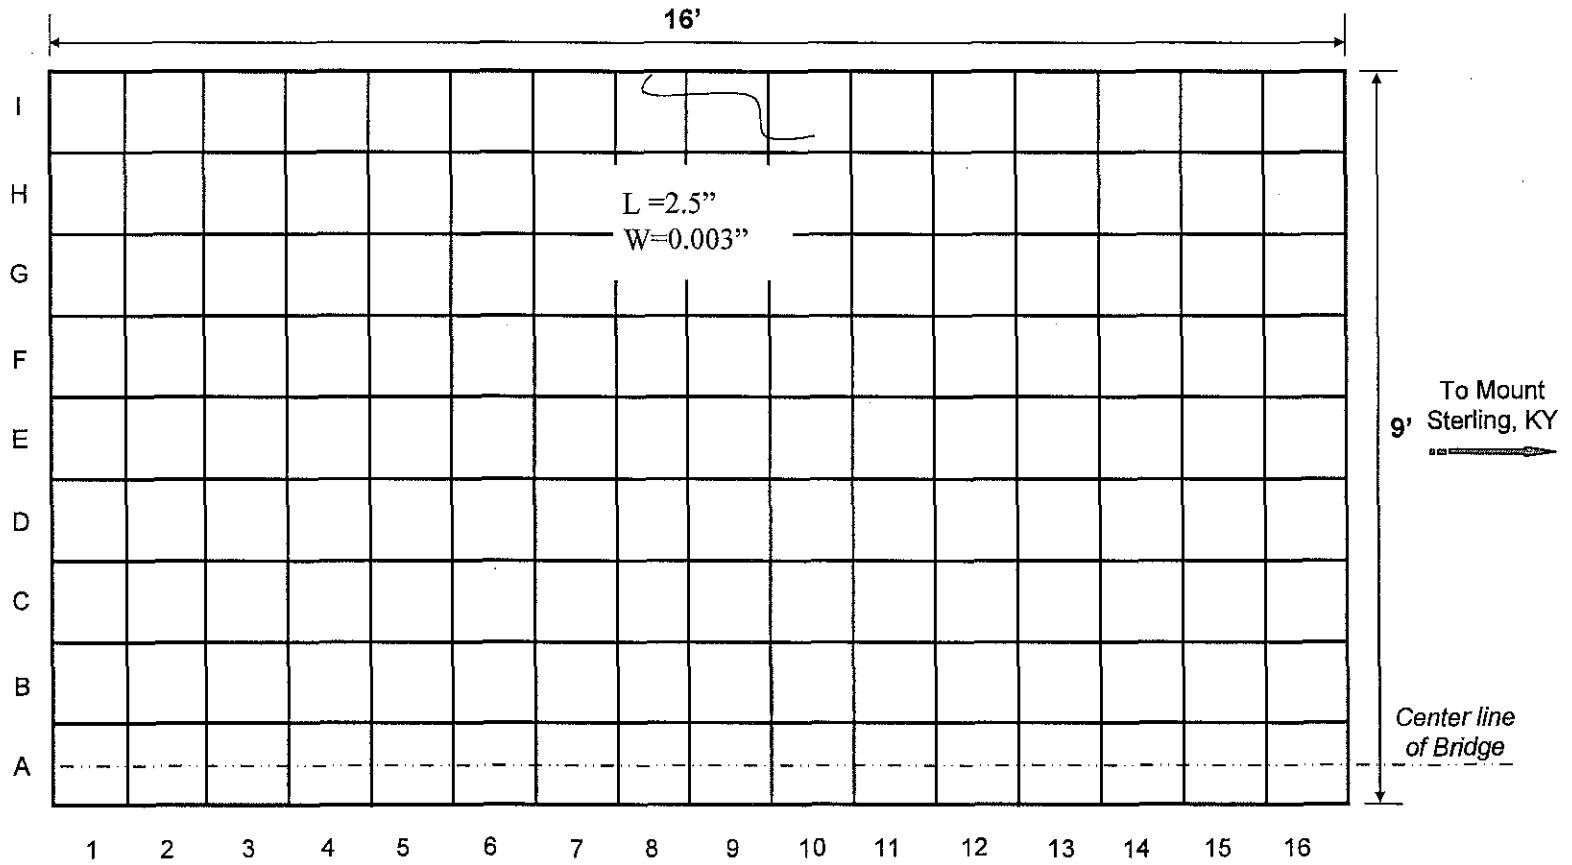
Fig. A1. Cracks observed in the top surface of the bridge deck in the GFRP area under unloaded condition

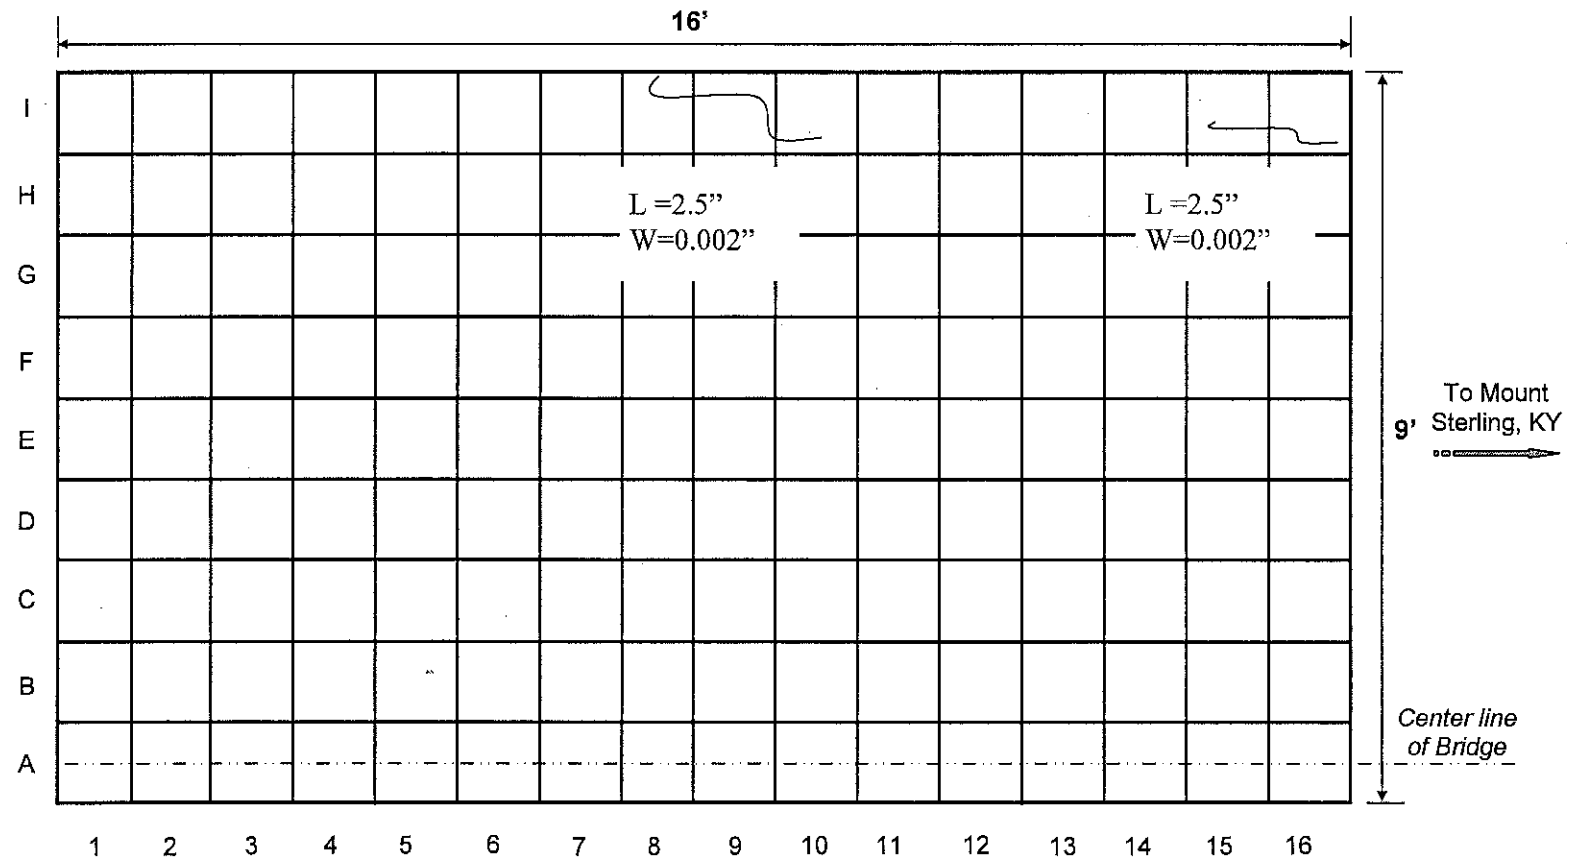
Fig. A2. Cracks observed in the top surface of the bridge deck in the GFRP area under unloaded condition

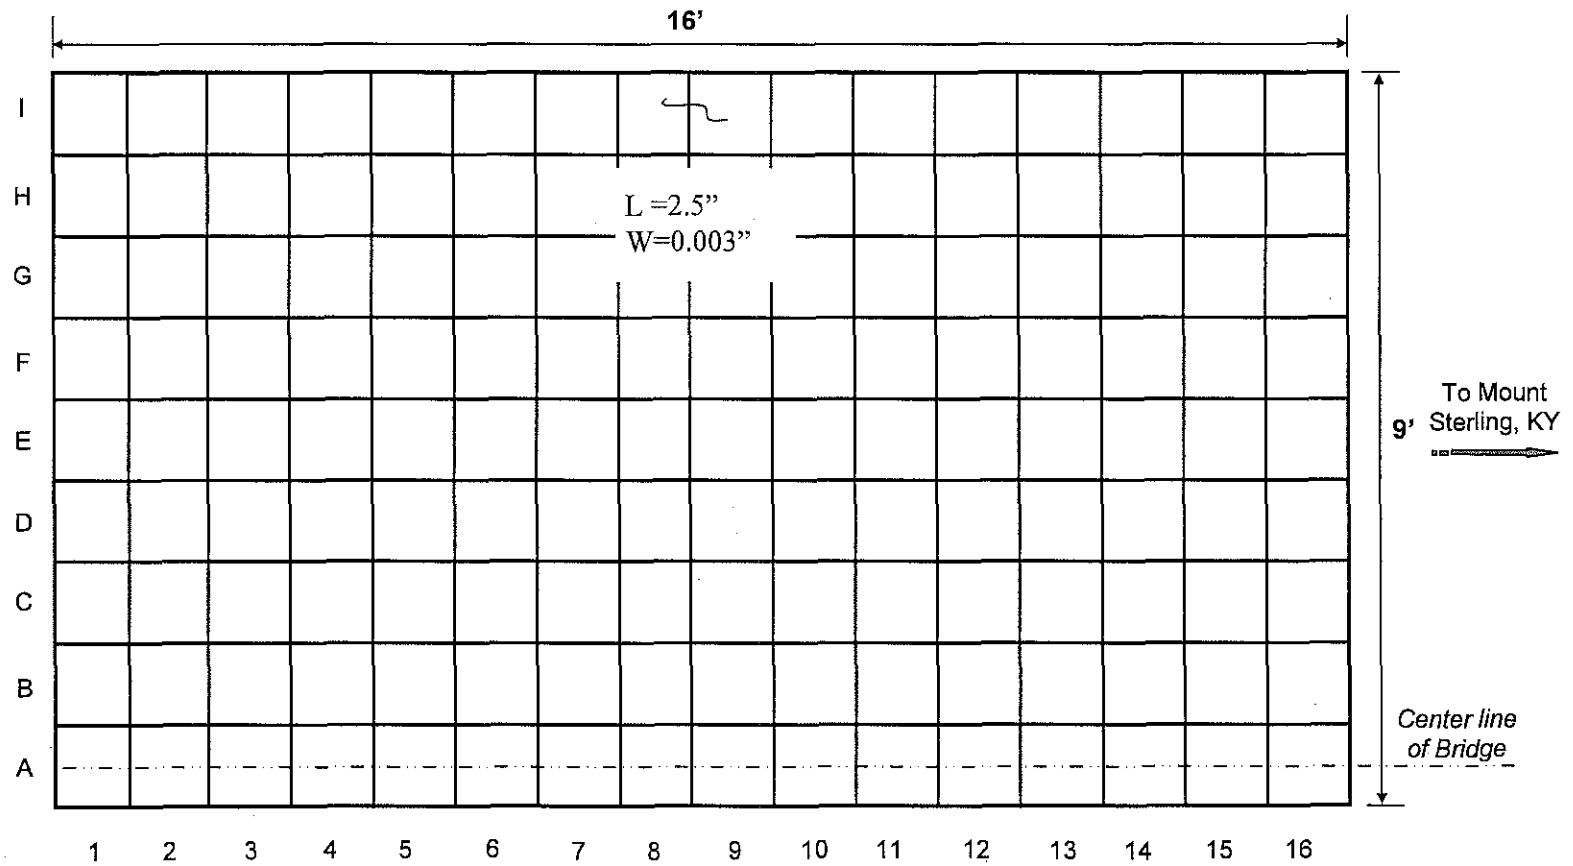
Fig. A3. Cracks observed in the top surface of the bridge deck in the GFRP area under loaded condition

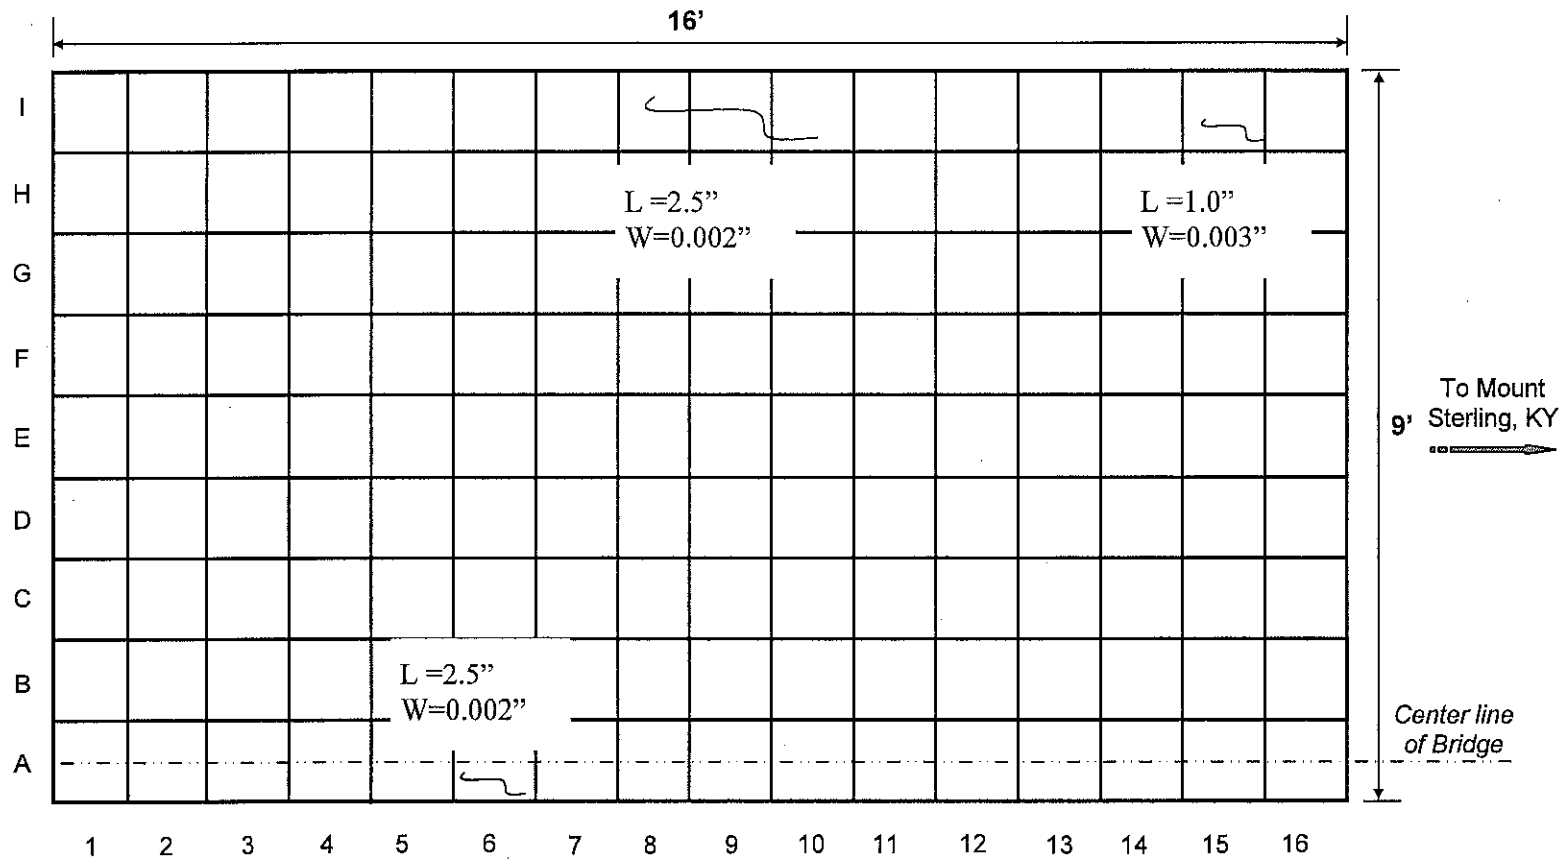
Fig. A4. Cracks observed in the top surface of the bridge deck in the GFRP area under unloaded condition

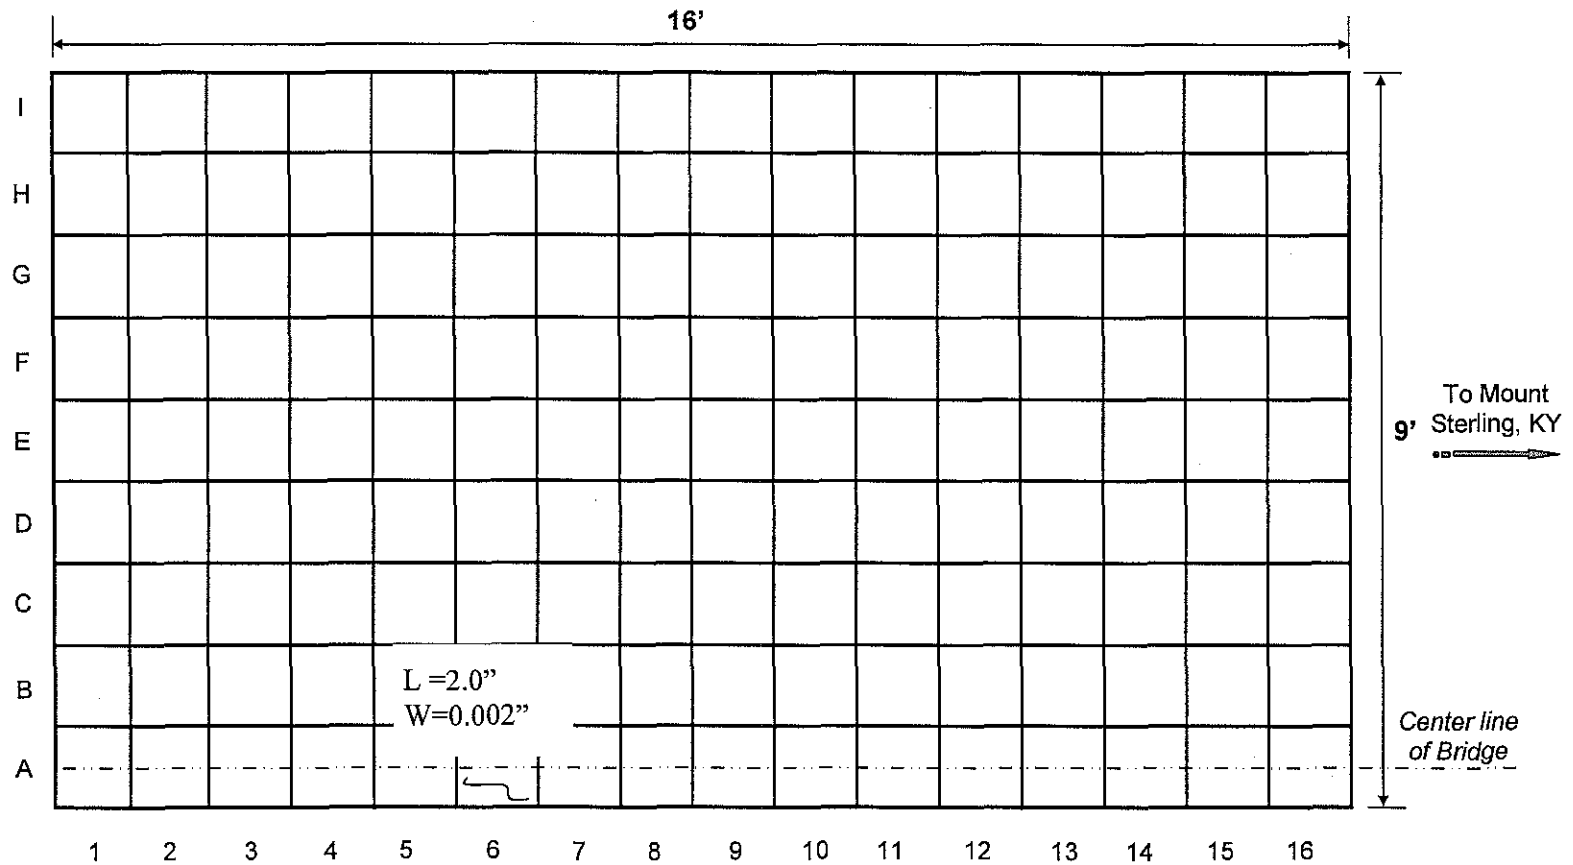
Fig. A5. Cracks observed in the top surface of the bridge deck in the GFRP area under loaded condition

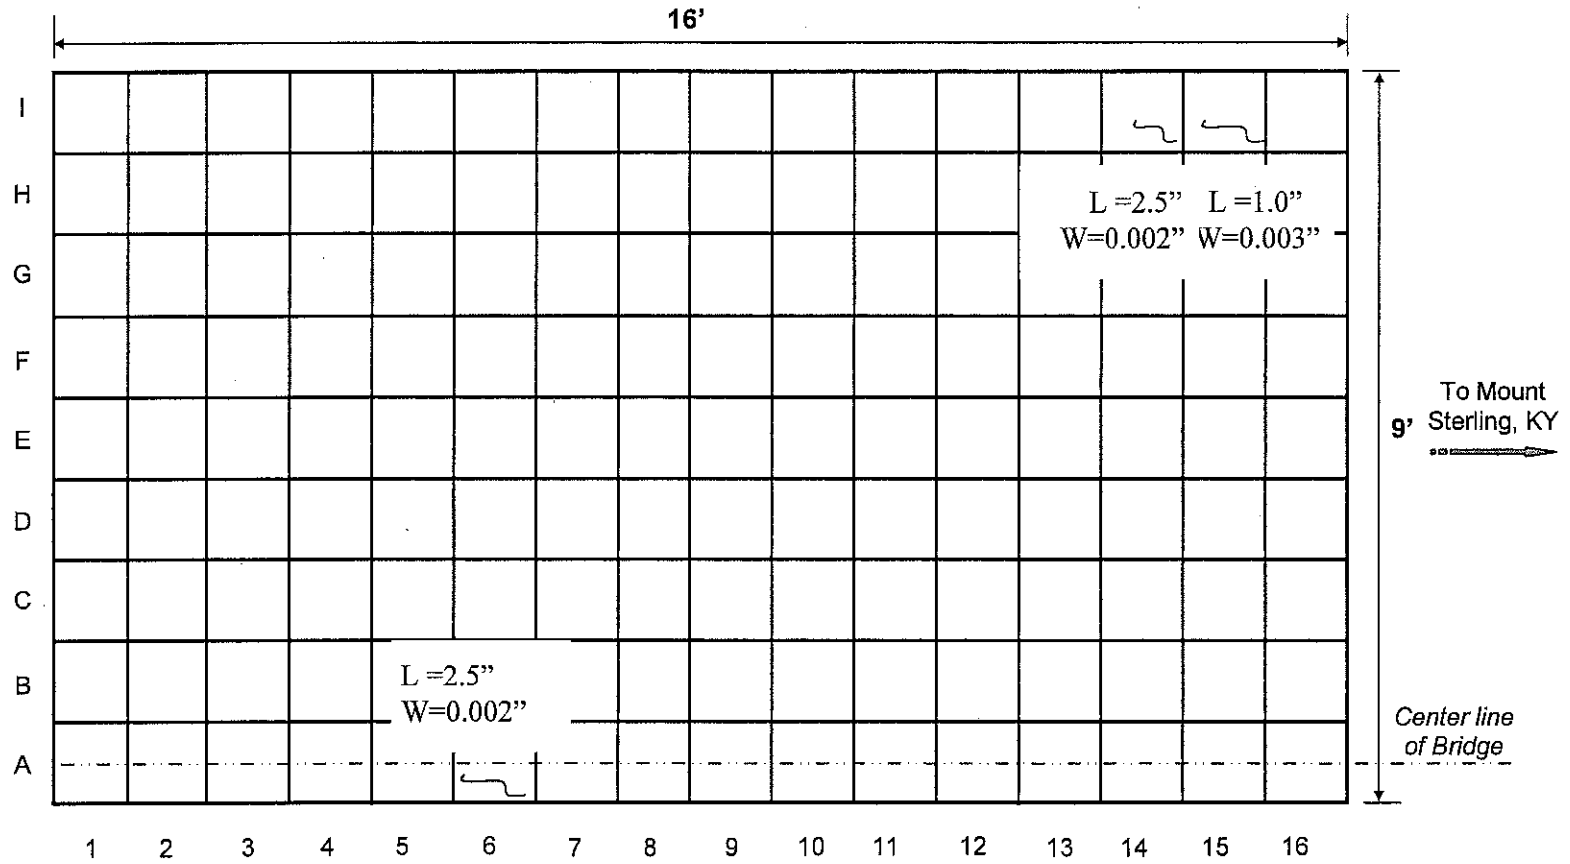
Fig. A6. Cracks observed in the top surface of the bridge deck in the GFRP area under unloaded condition

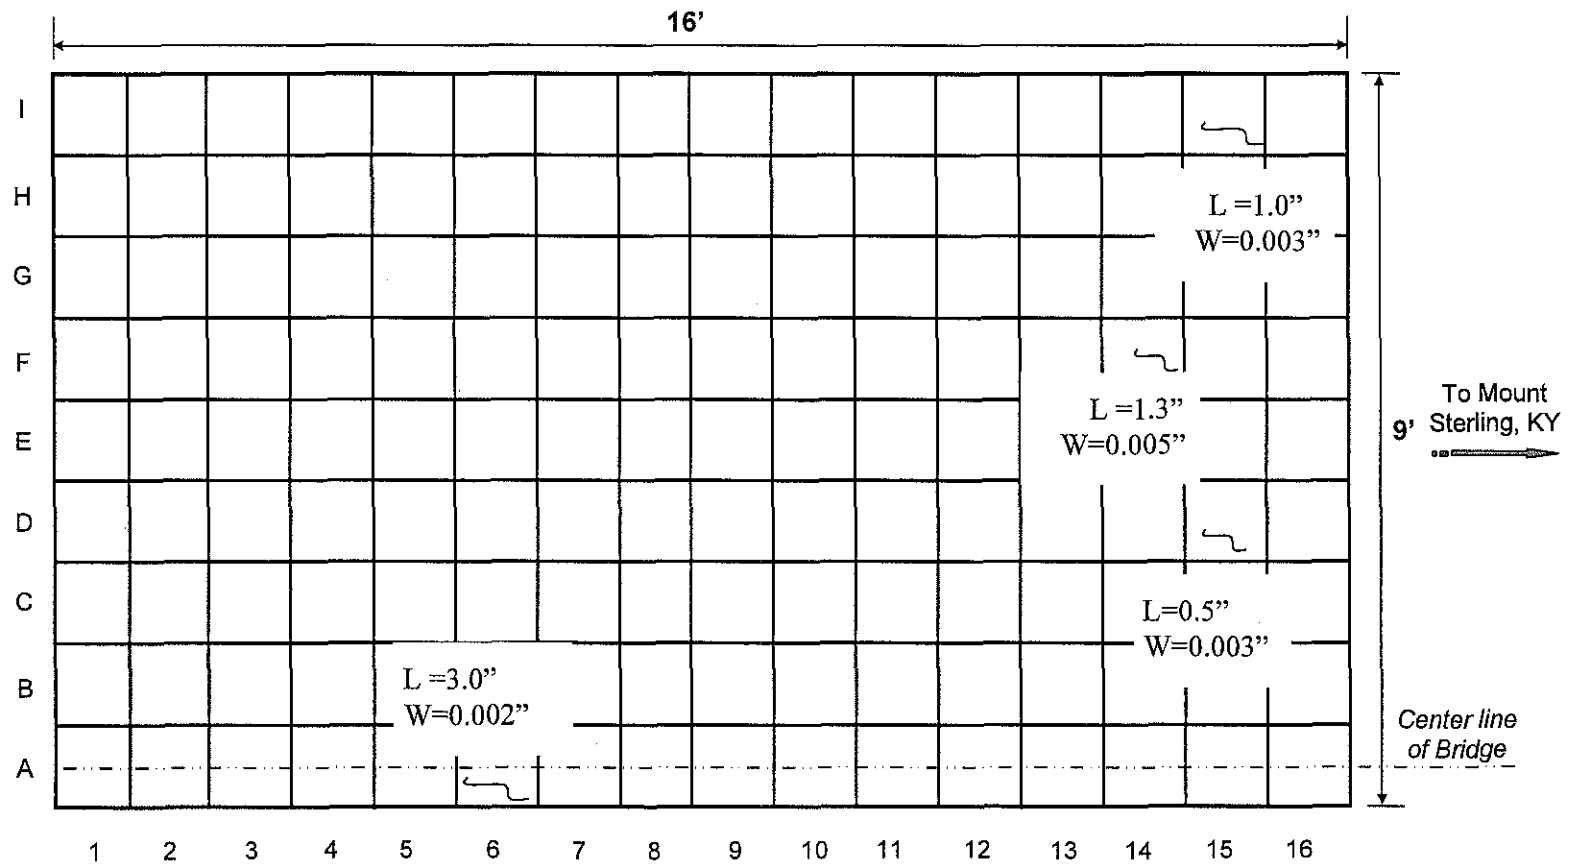
Fig. A7. Cracks observed in the top surface of the bridge deck in the GFRP area under unloaded condition

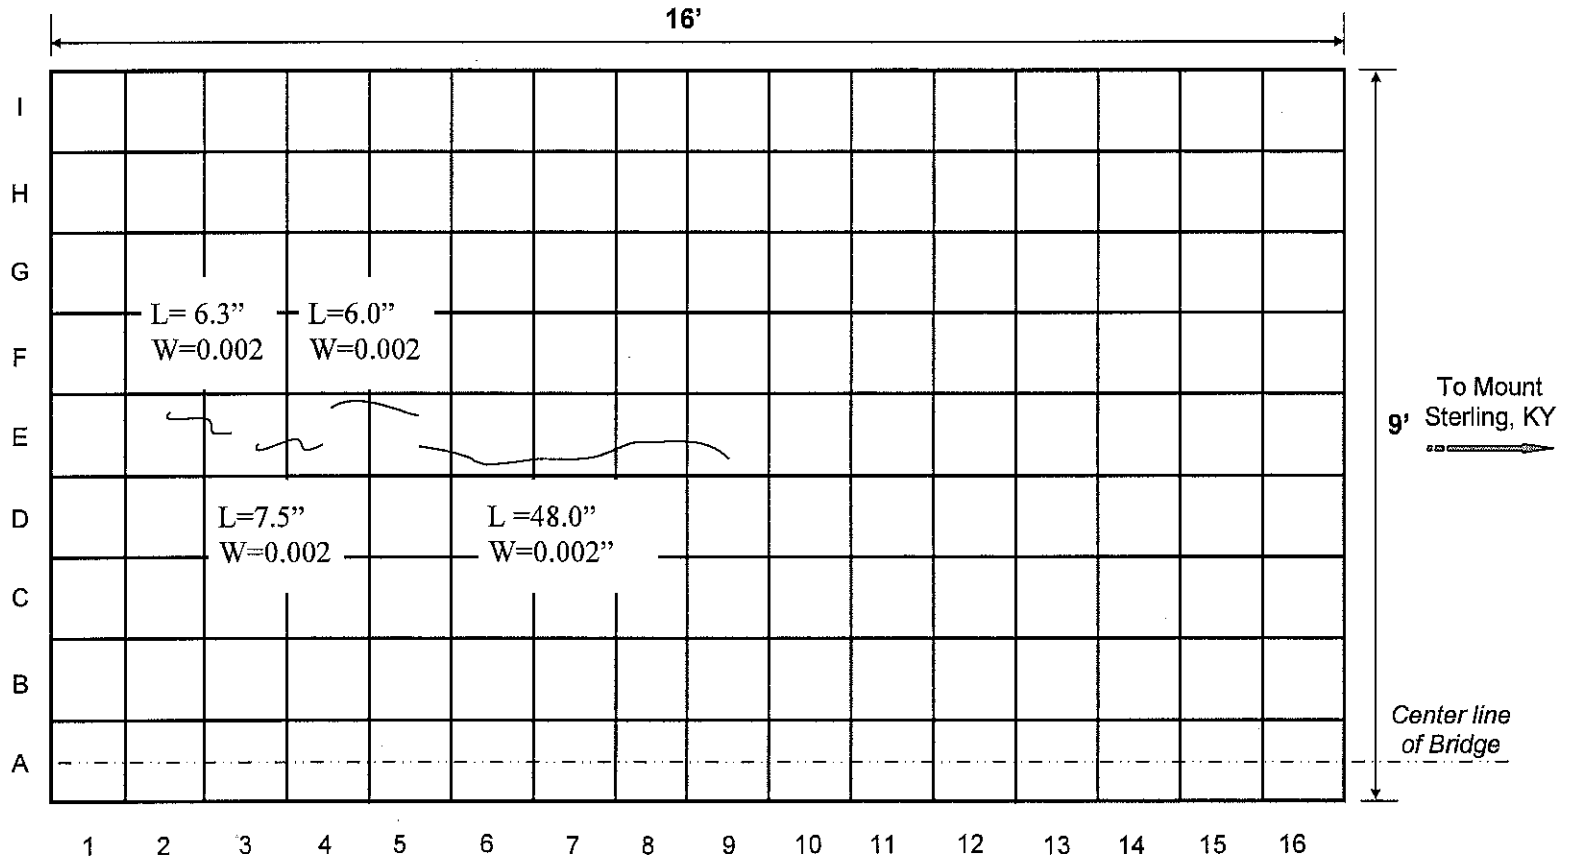
Fig. A8. Cracks observed in the top surface of the bridge deck in the GFRP area under unloaded condition

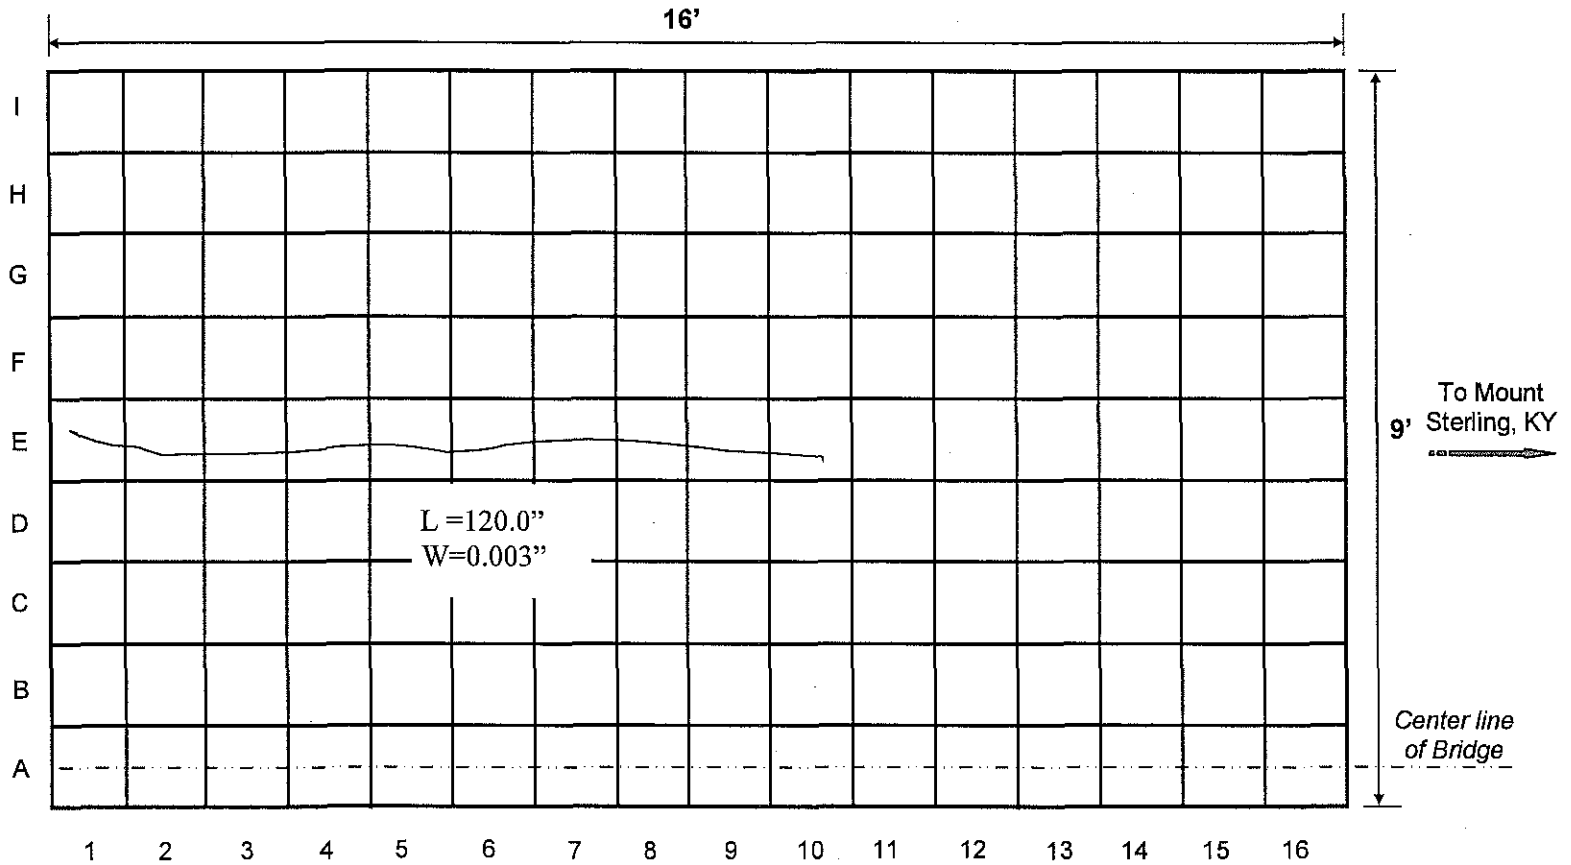
Fig. A9. Cracks observed in the top surface of the bridge deck in the GFRP area under unloaded condition

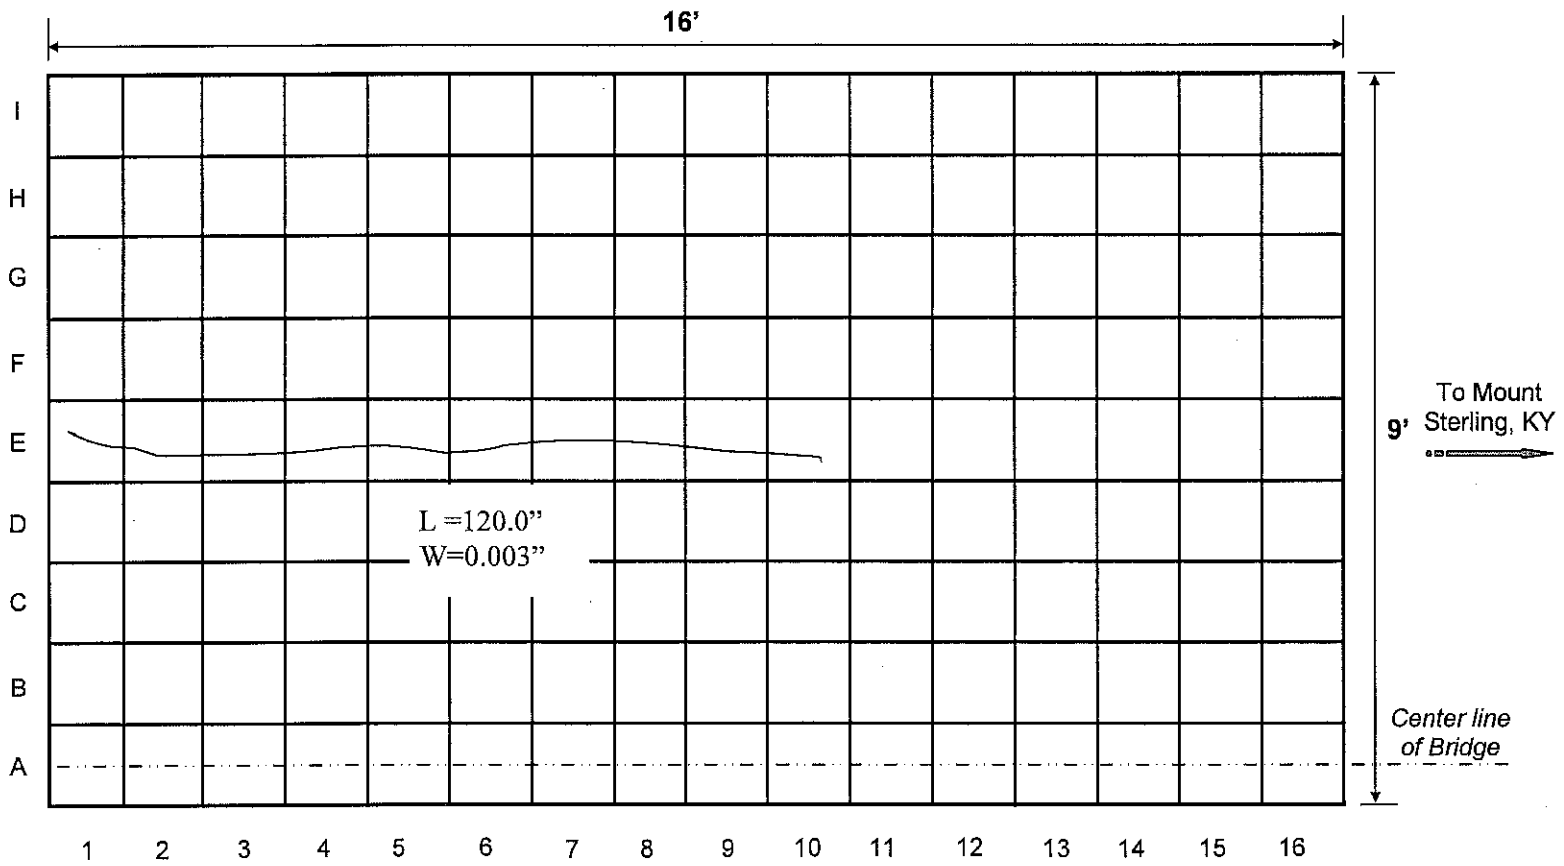
Fig. A10. Cracks observed in the top surface of the bridge deck in the GFRP area under unloaded condition

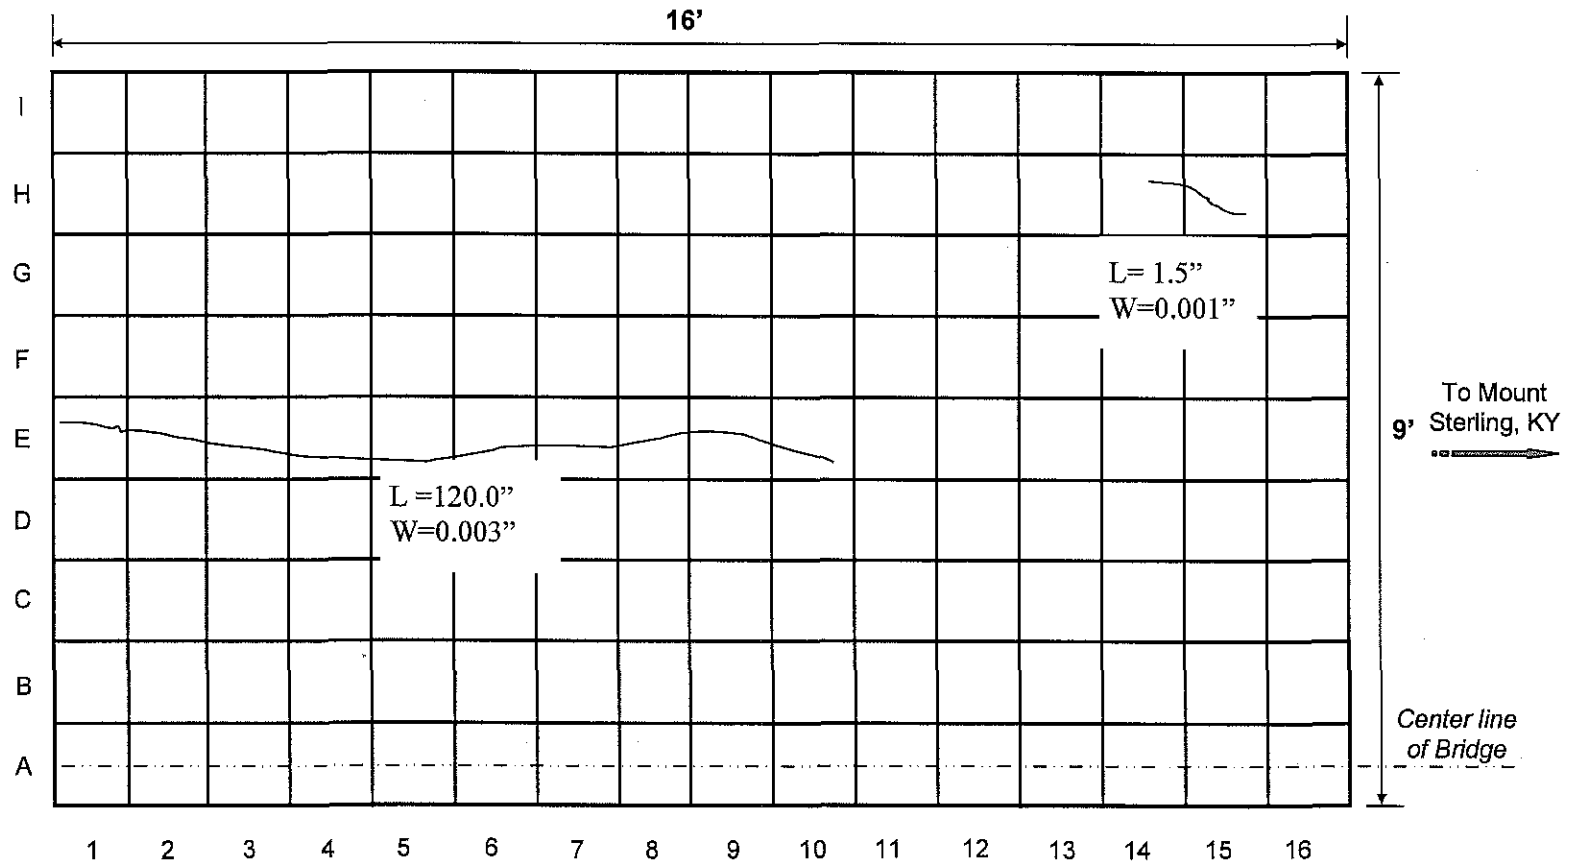
Fig. A11. Cracks observed in the top surface of the bridge deck in the GFRP area under unloaded condition

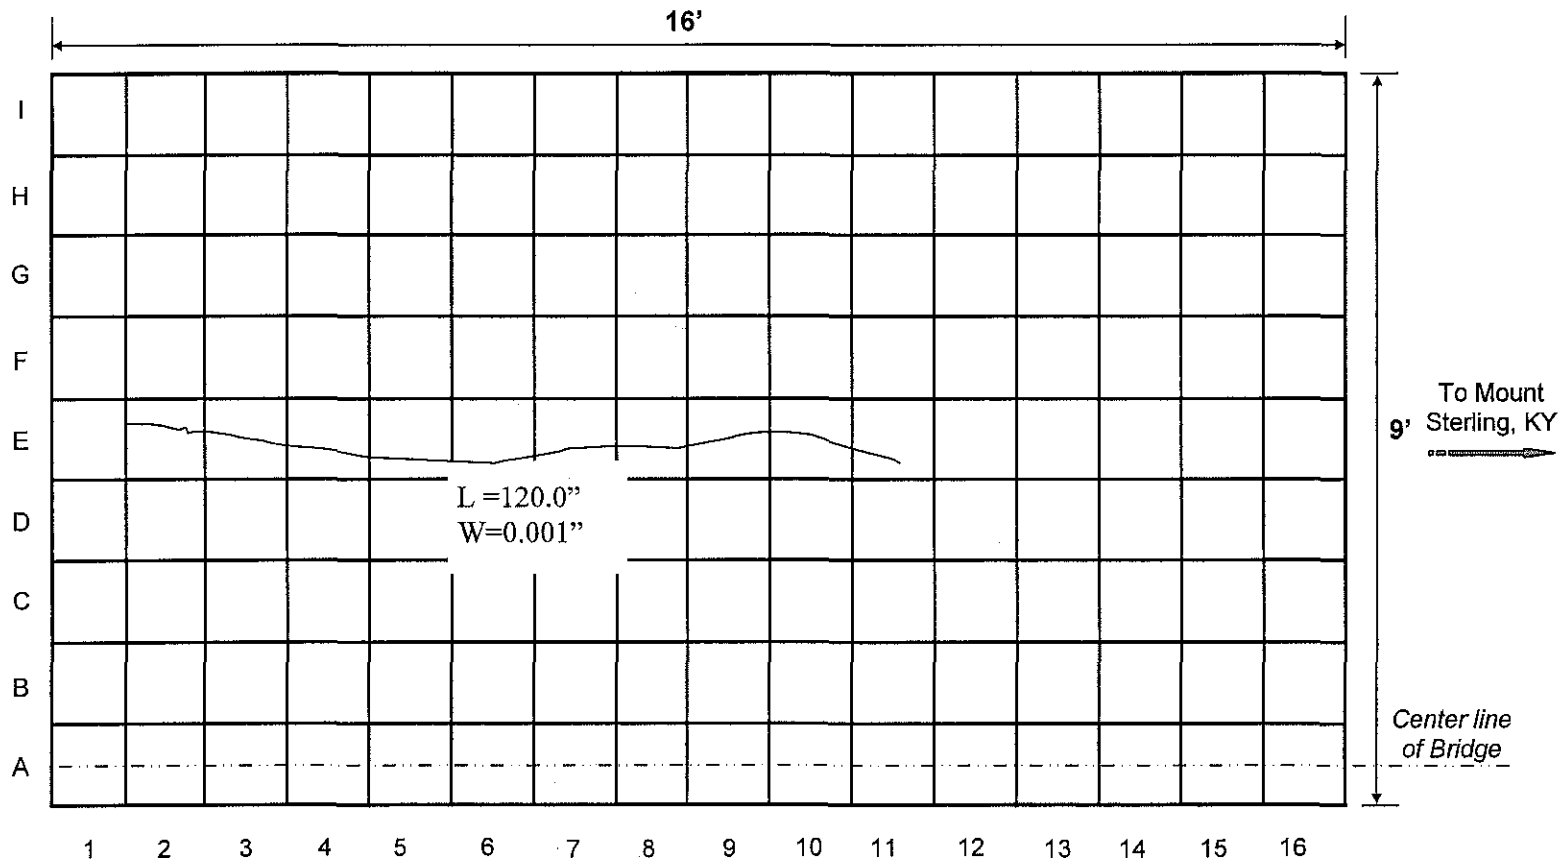
Fig. A12. Cracks observed in the top surface of the bridge deck in the GFRP area under loaded condition

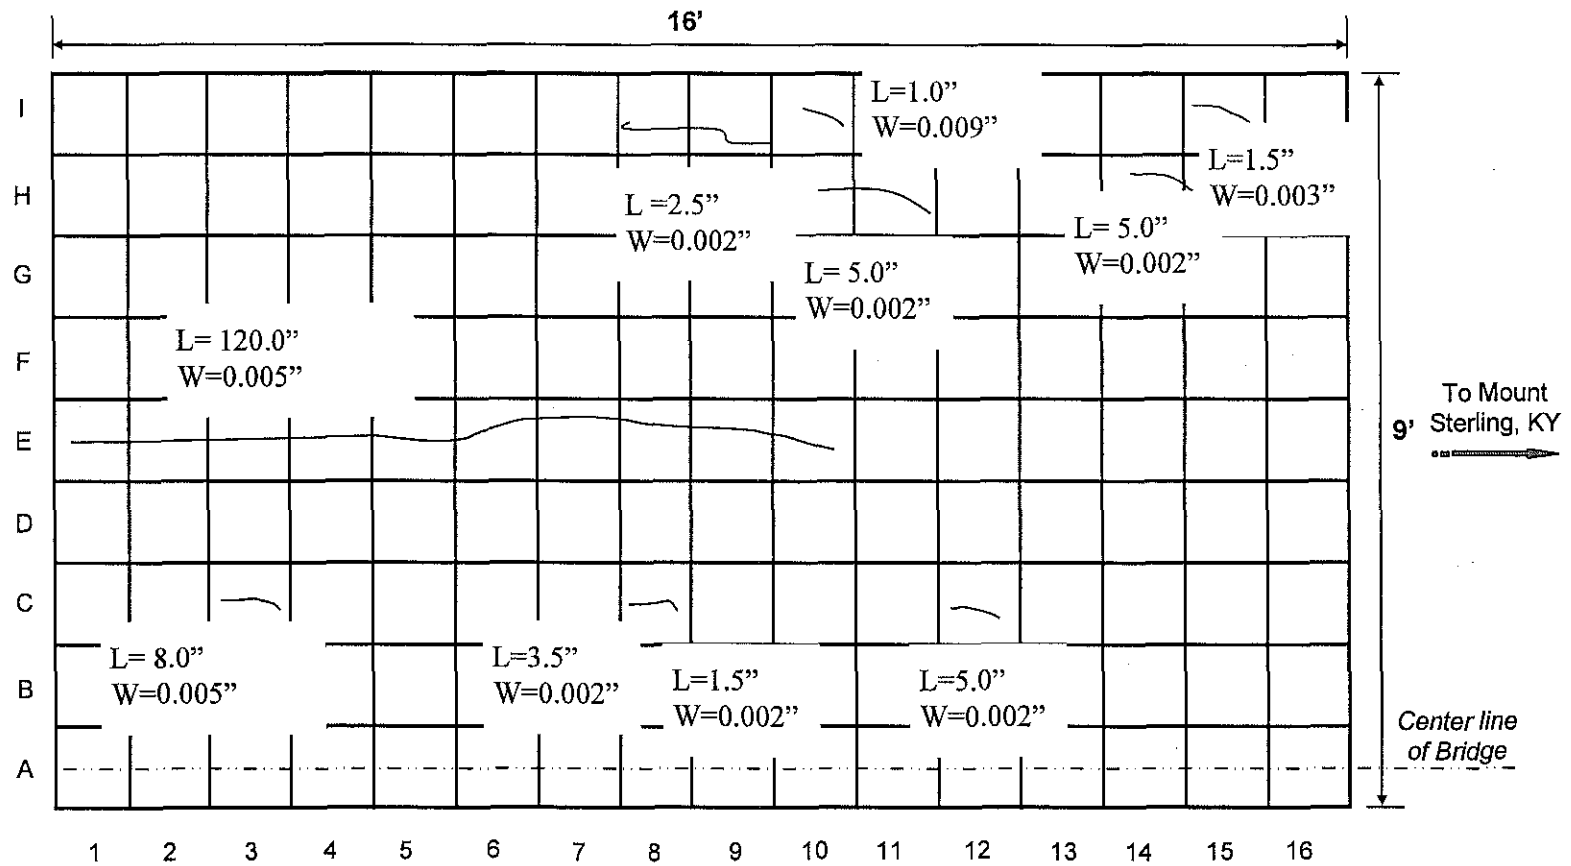
Fig. A13. Cracks observed in the top surface of the bridge deck in the GFRP area under unloaded condition

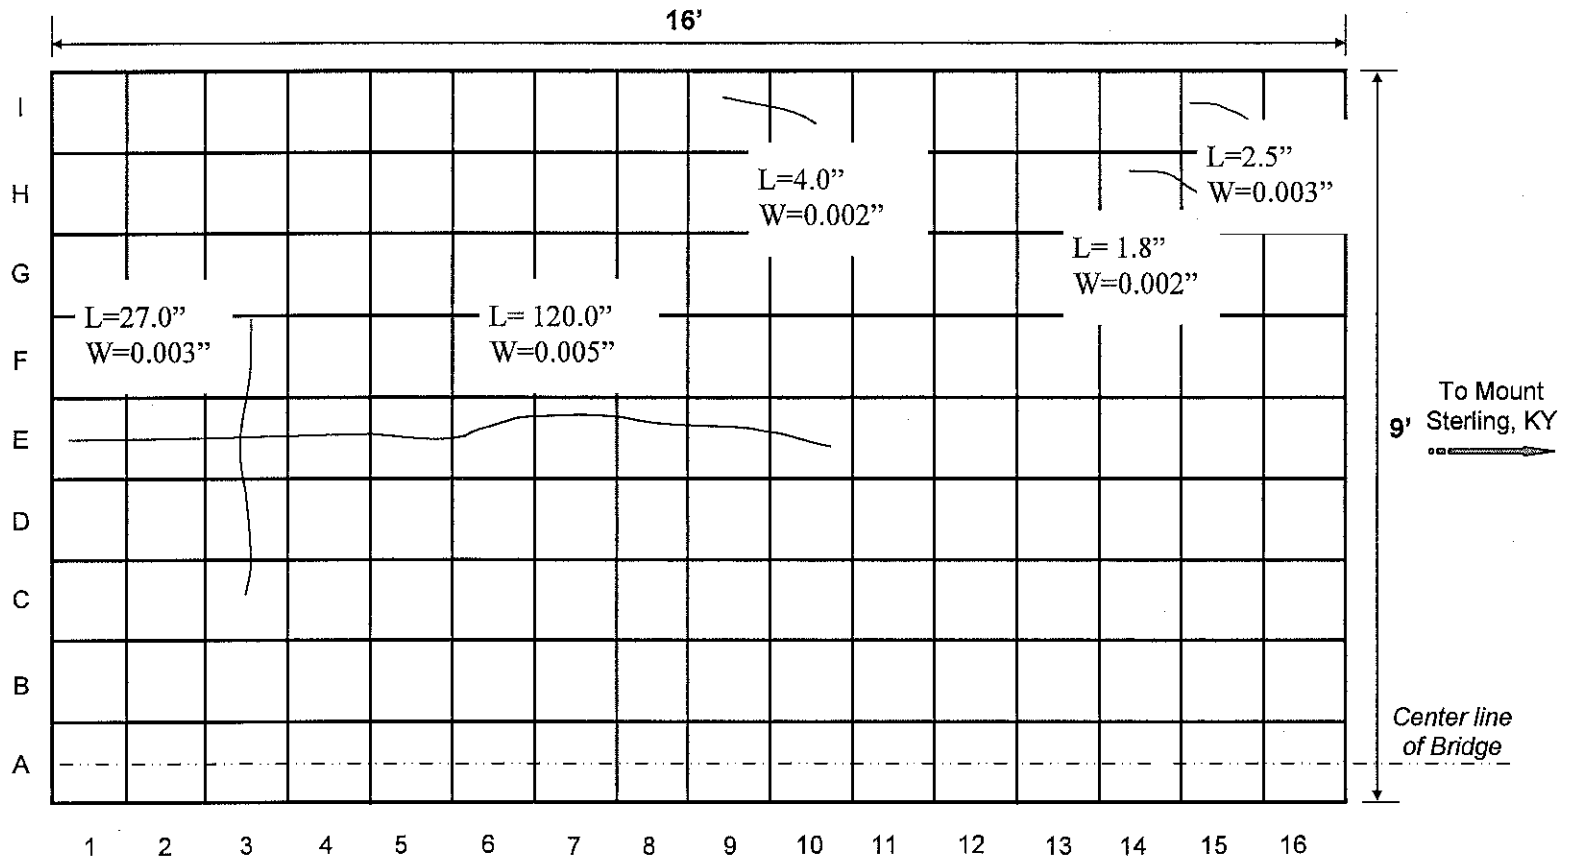
Fig. A14. Cracks observed in the top surface of the bridge deck in the GFRP area under unloaded condition

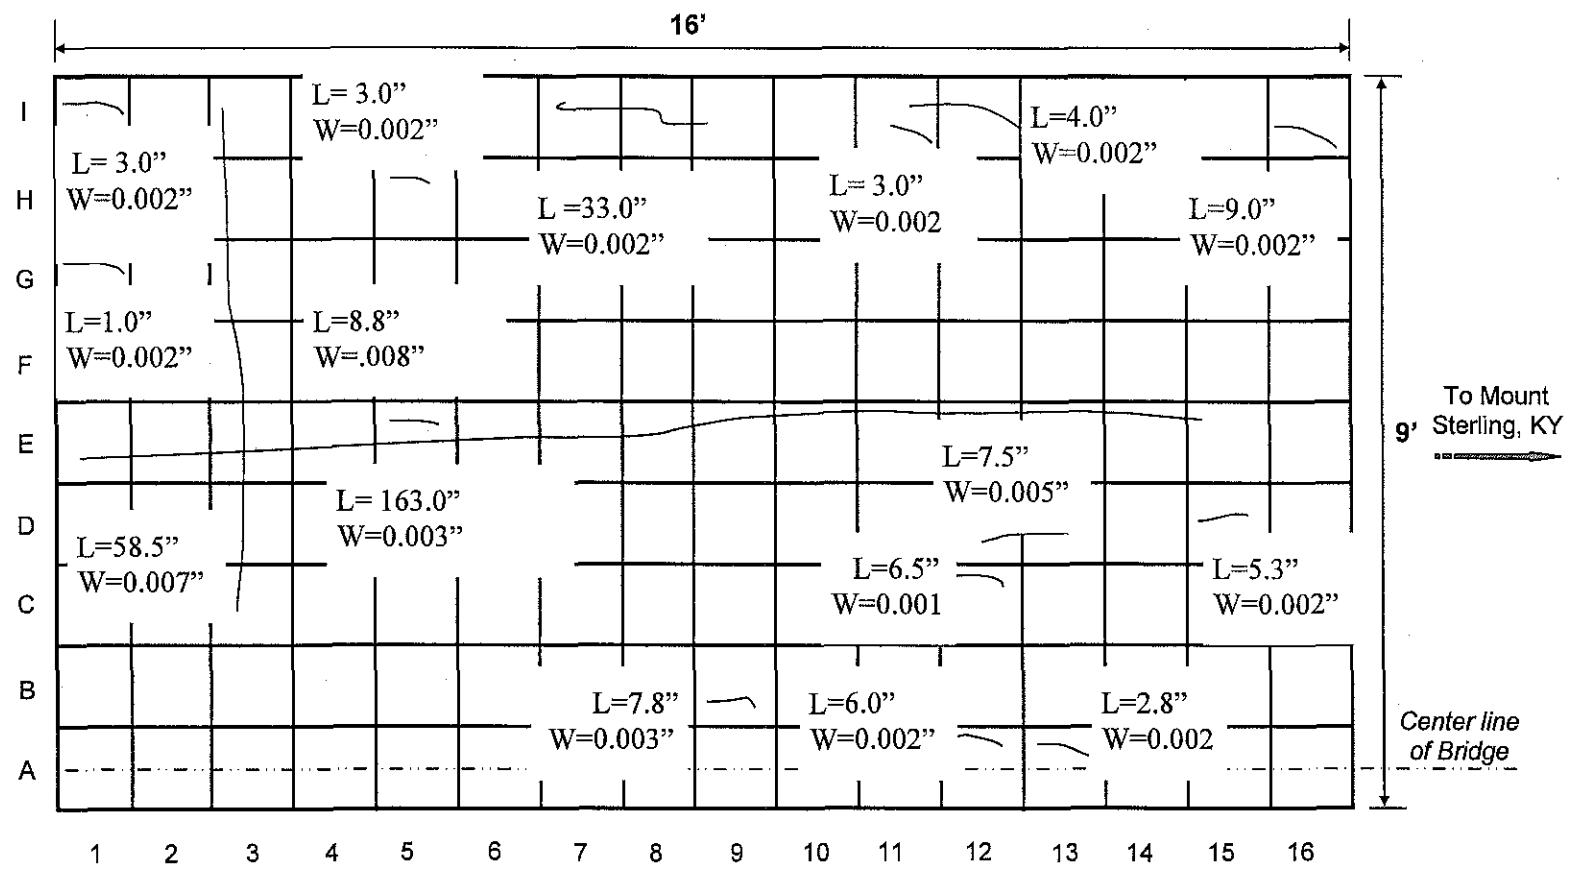
Fig. A15. Cracks observed in the top surface of the bridge deck in the GFRP area under unloaded condition

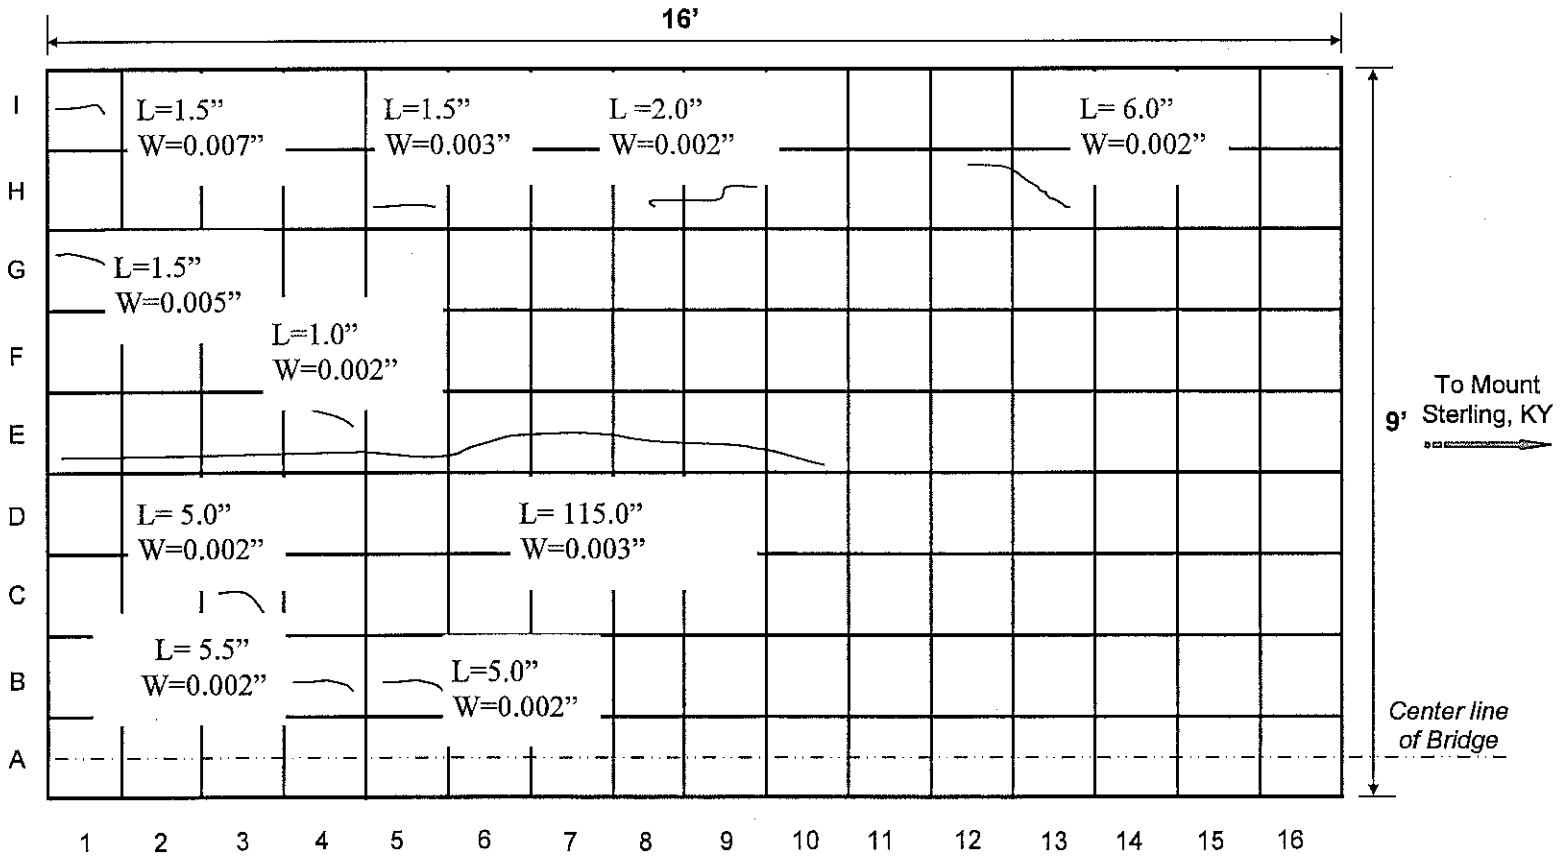
Fig. A16. Cracks observed in the top surface of the bridge deck in the GFRP area under unloaded condition
