Research Report
KTC-04-21/FRPDeck-1-97-1F

INSPECTION AND EVALUATION OF A BRIDGE DECK PARTIALLY REINFORCED WITH GFRP REBARS

August 2004

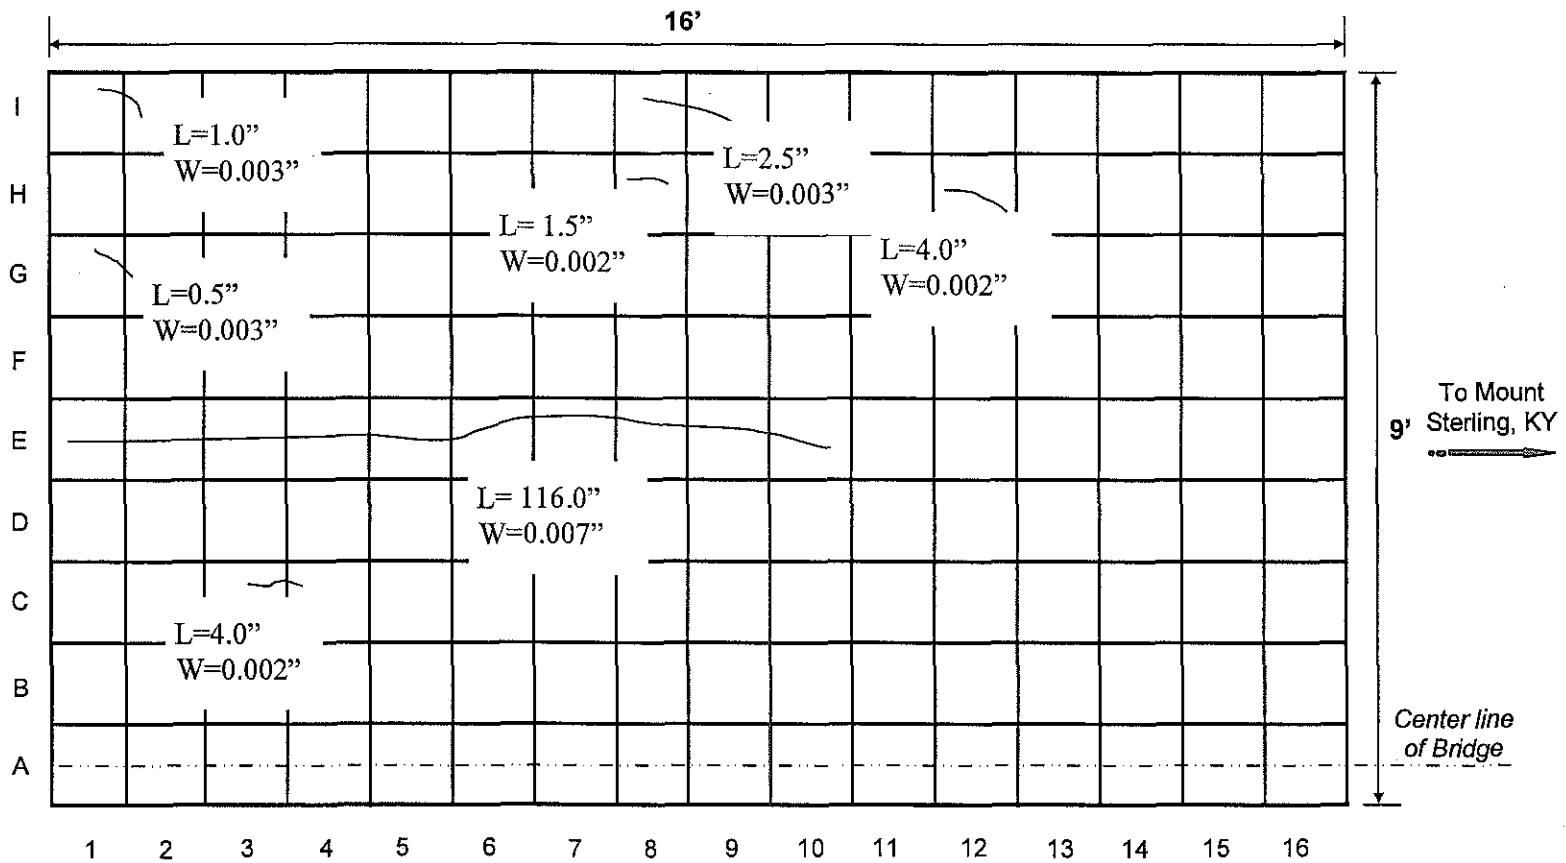
Fig. A17. Cracks observed in the top surface of the bridge deck in the GFRP area under unloaded condition

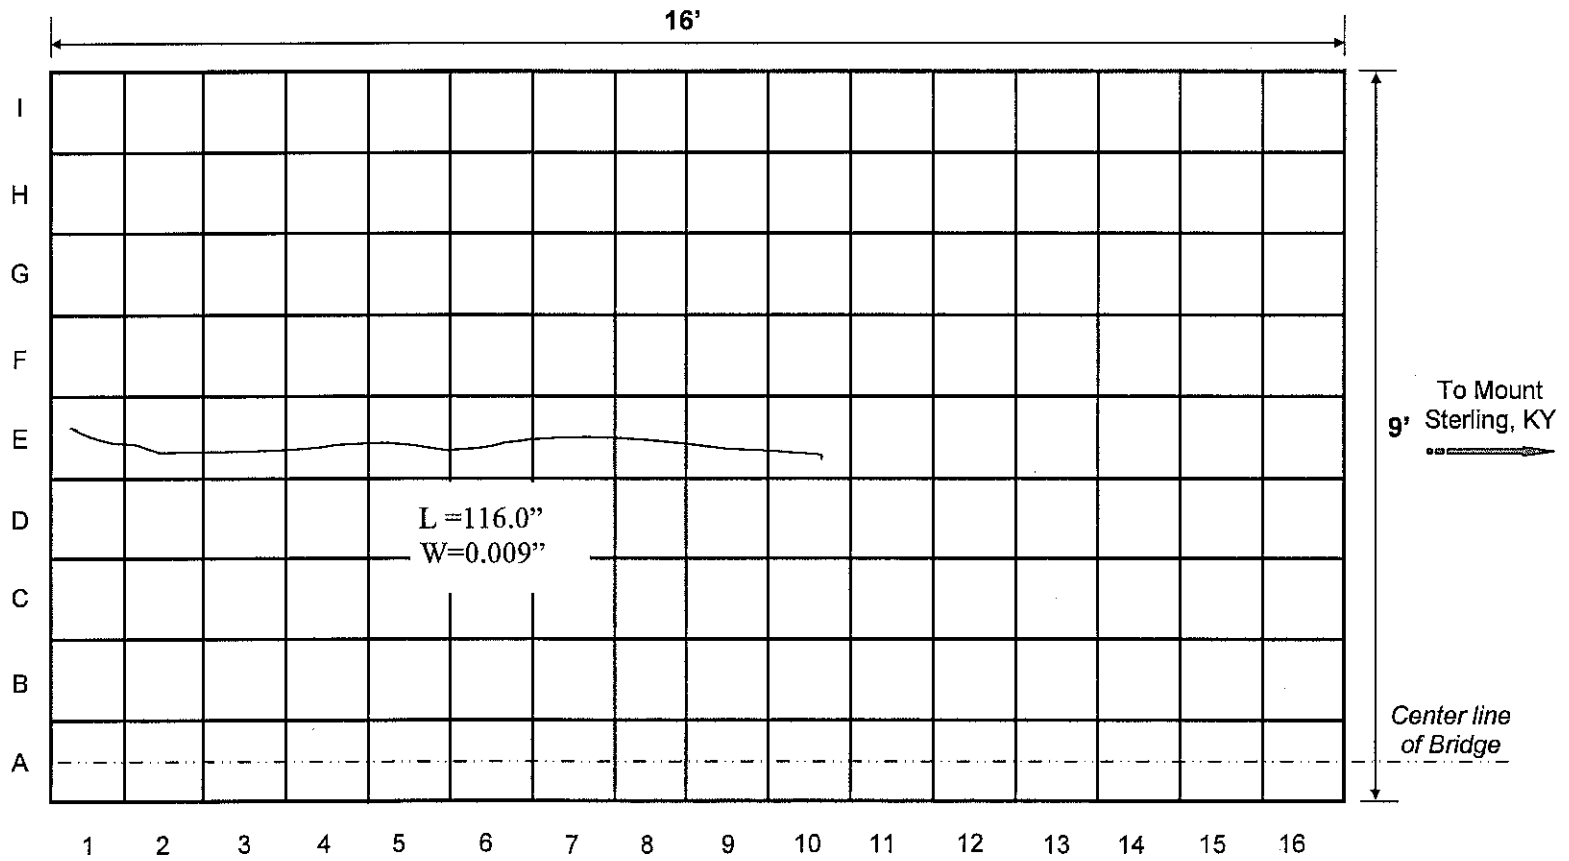
Fig. A18. Cracks observed in the top surface of the bridge deck in the GFRP area under loaded condition

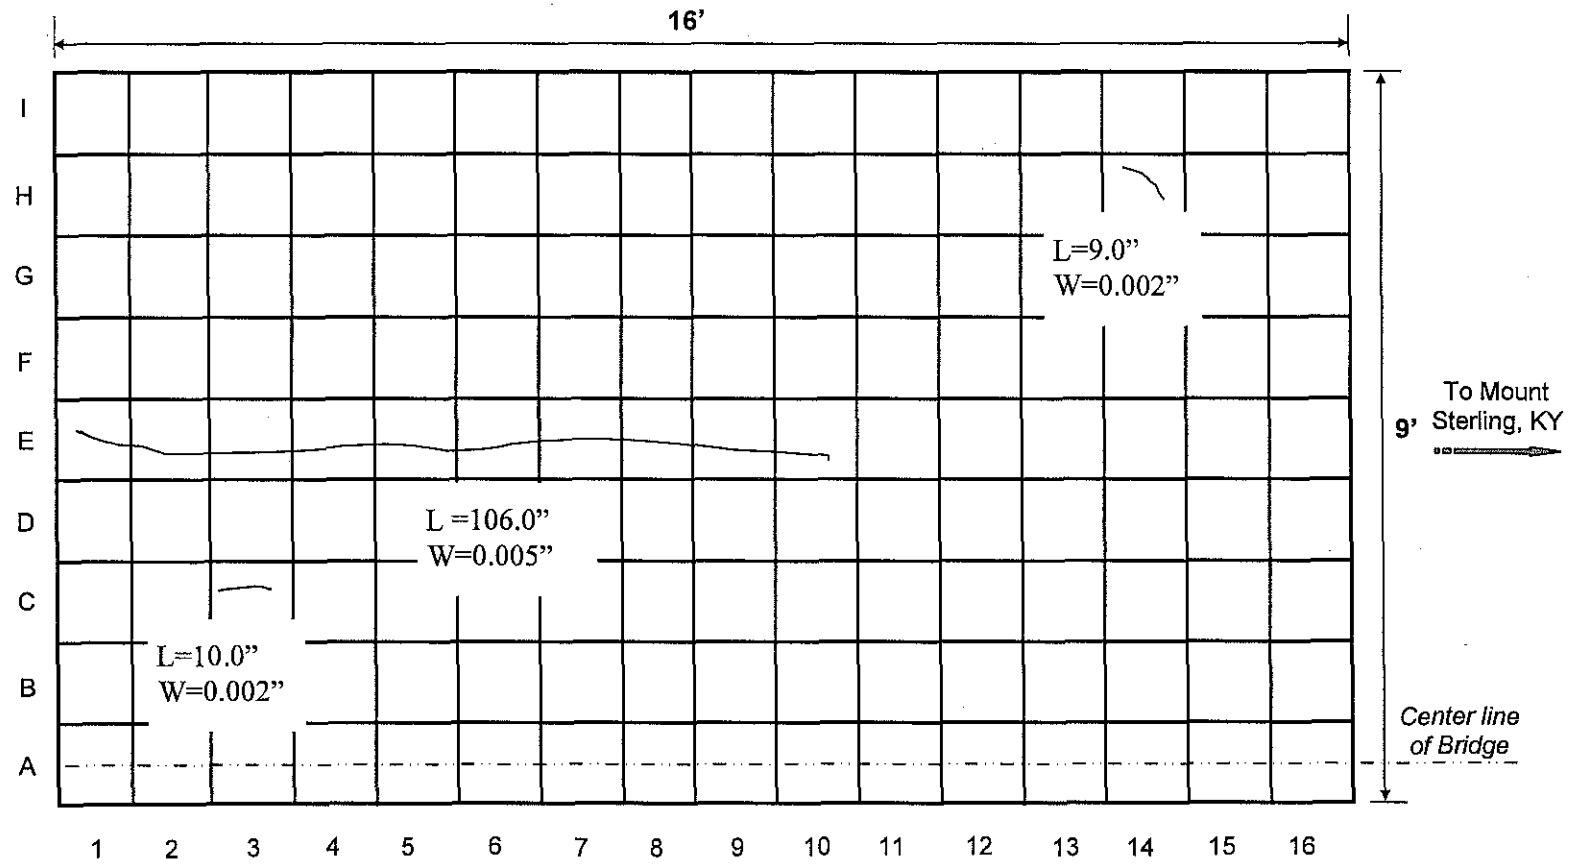
Fig. A19. Cracks observed in the top surface of the bridge deck in the GFRP area under unloaded condition

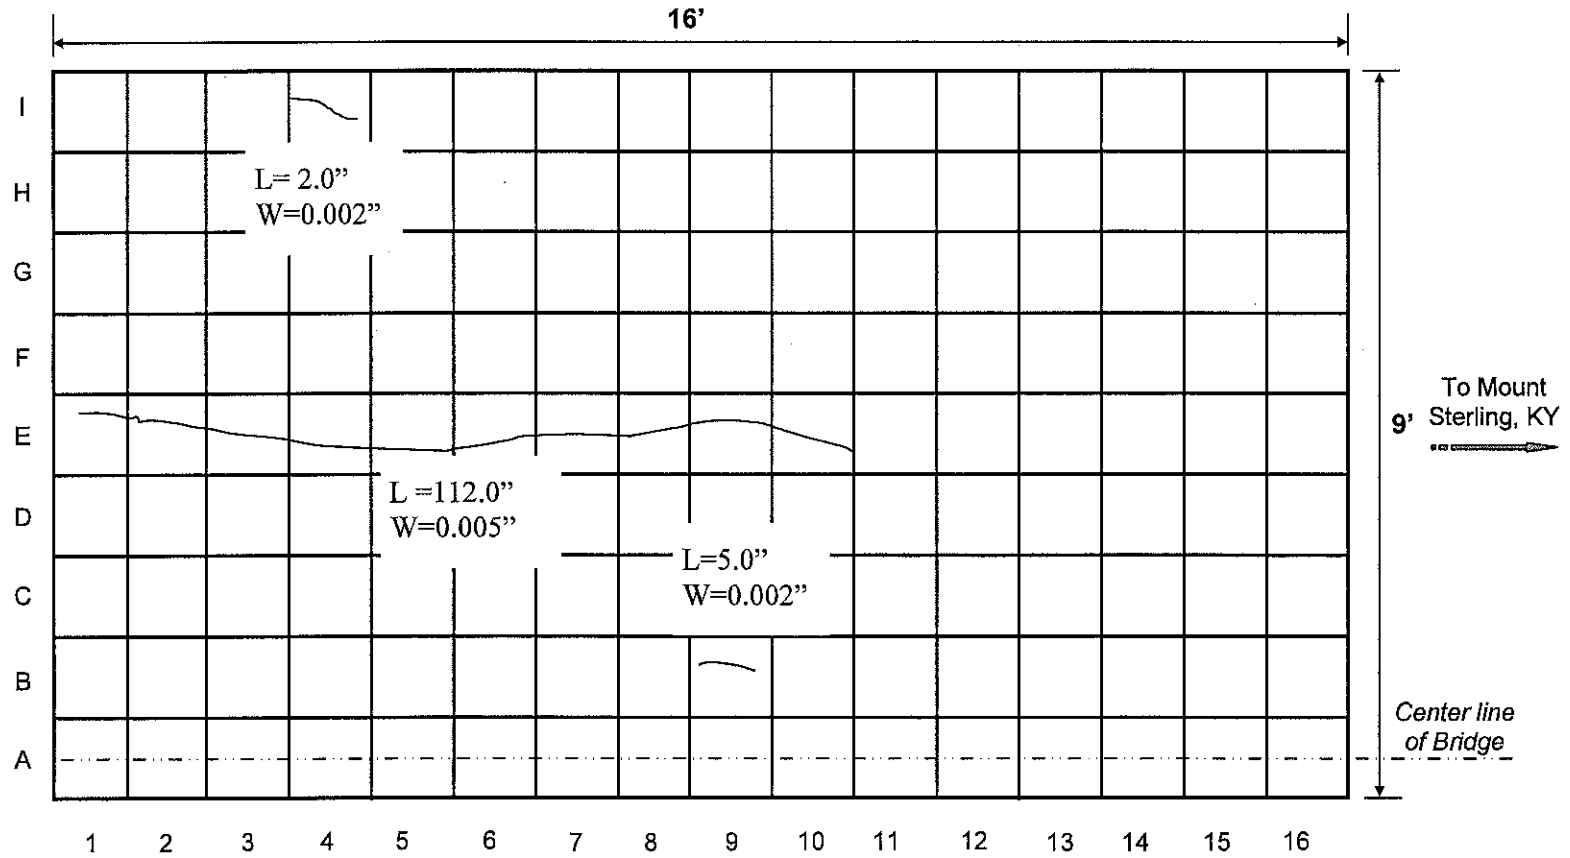
Fig. A20. Cracks observed in the top surface of the bridge deck in the GFRP area under unloaded condition

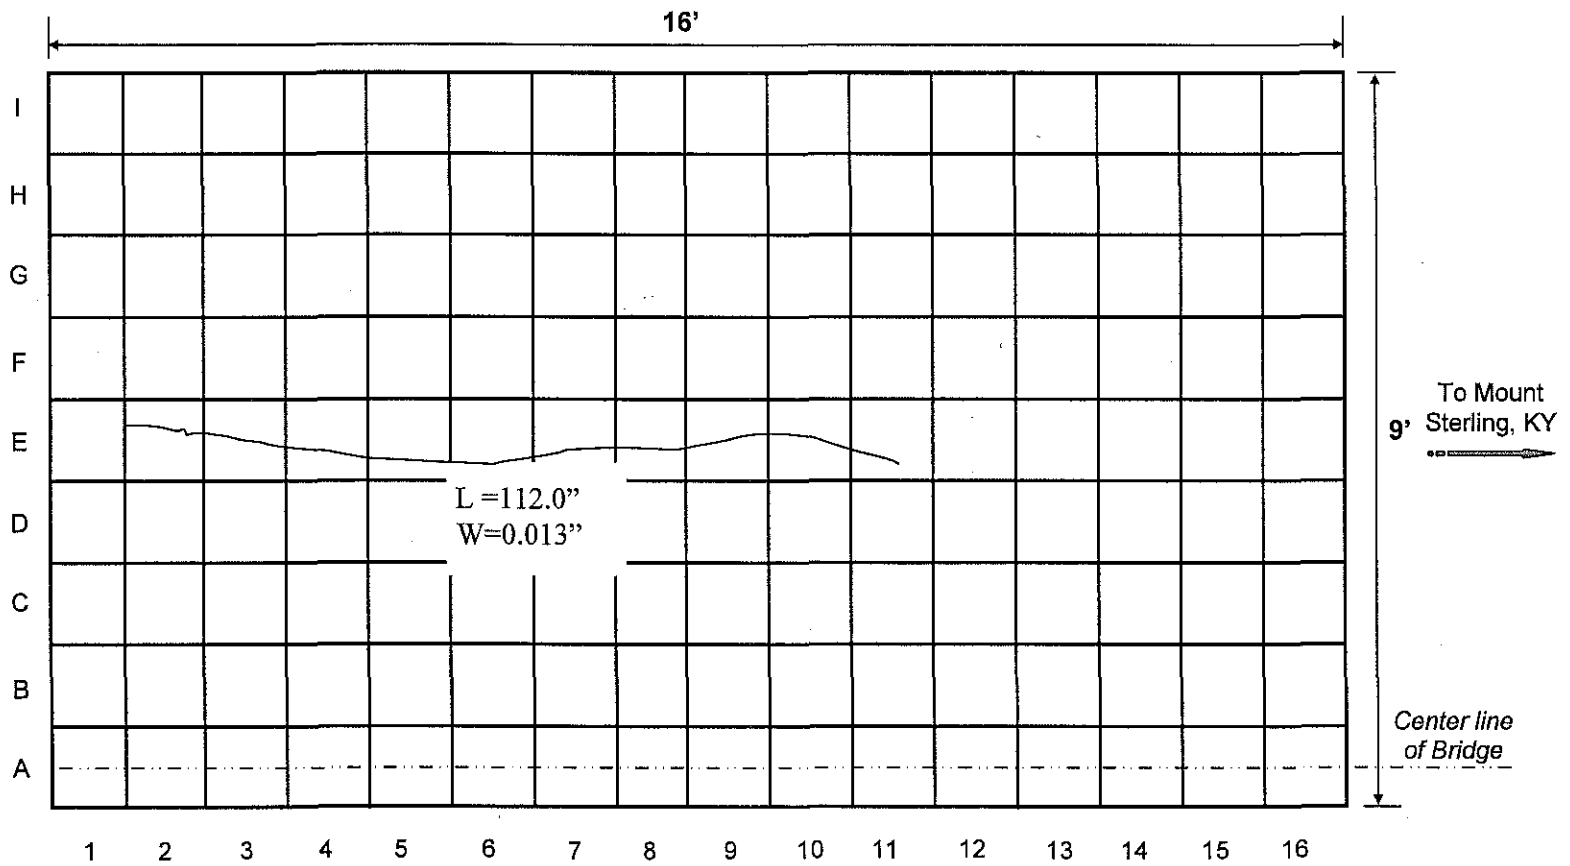
Fig. A21. Cracks observed in the top surface of the bridge deck in the GFRP area under loaded condition

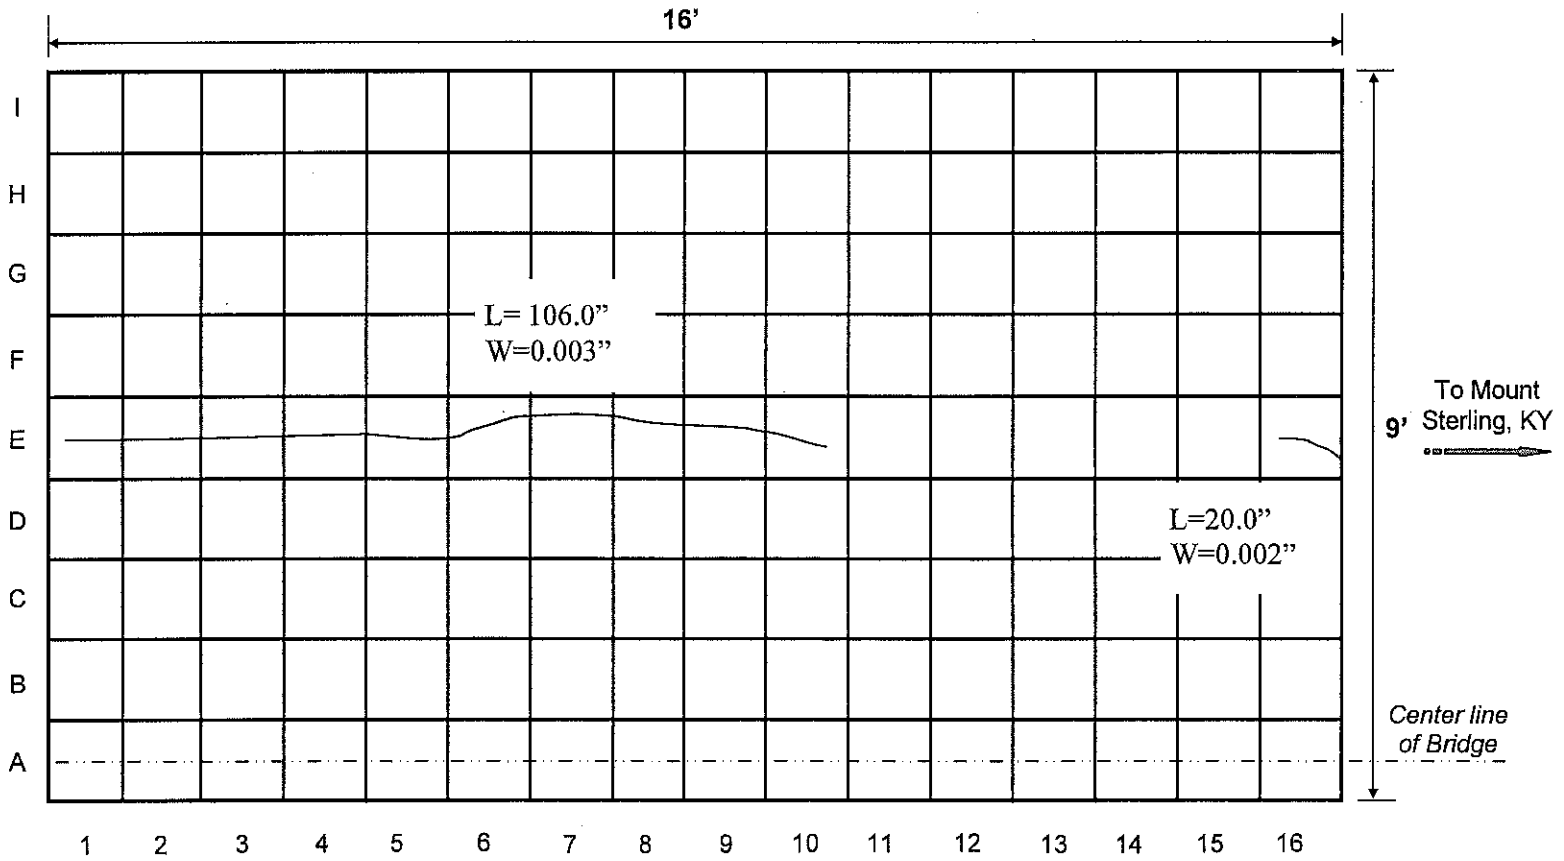
Fig. A22. Cracks observed in the top surface of the bridge deck in the GFRP area under unloaded condition

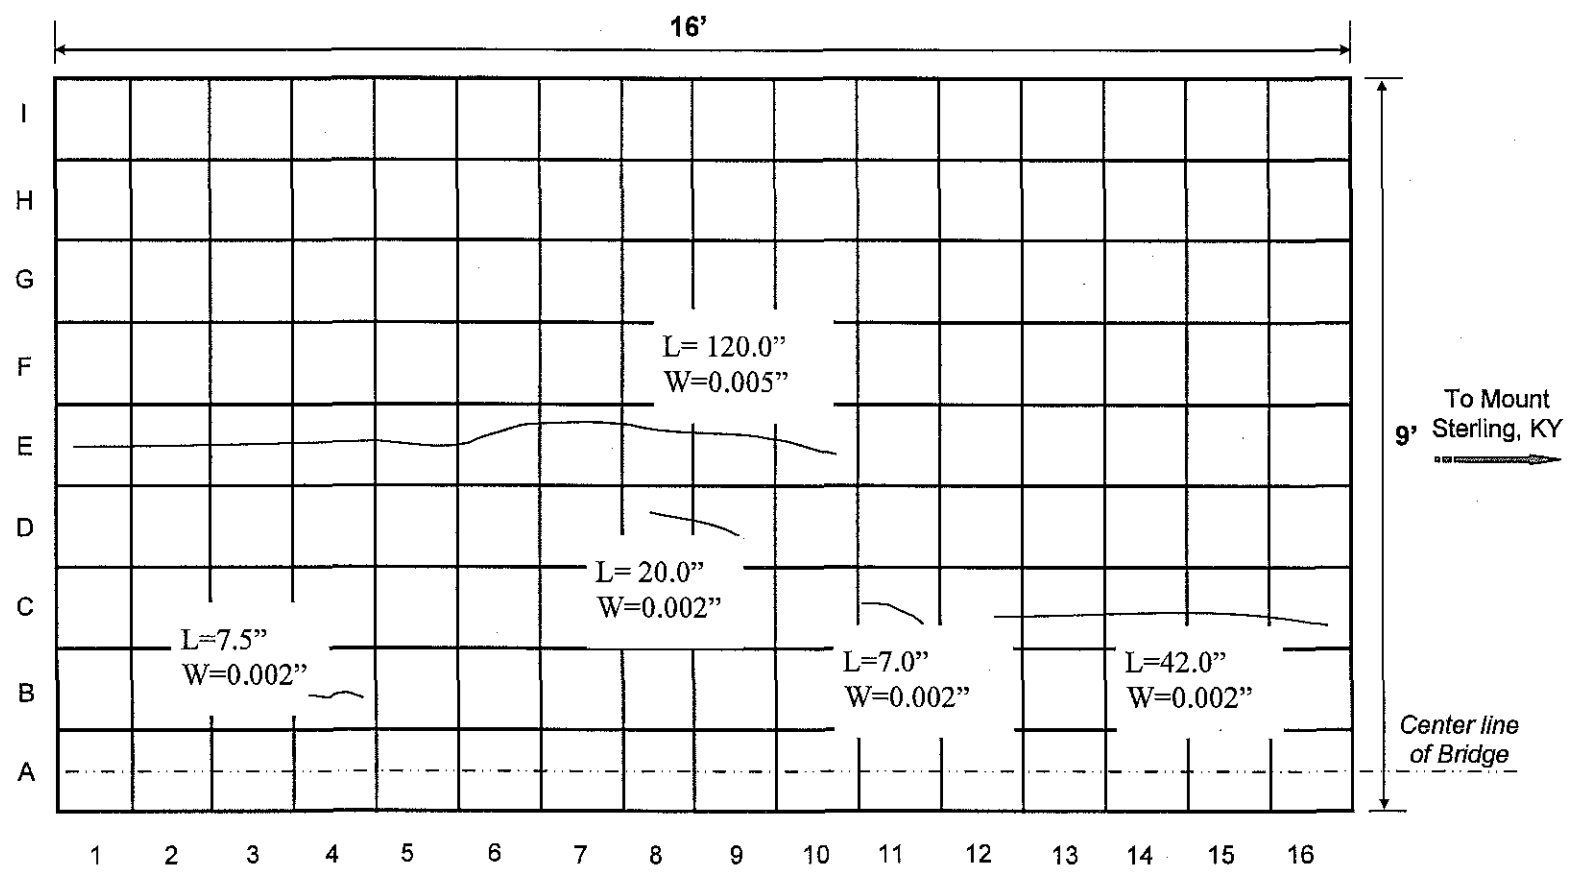
Fig. A23. Cracks observed in the top surface of the bridge deck in the GFRP area under unloaded condition

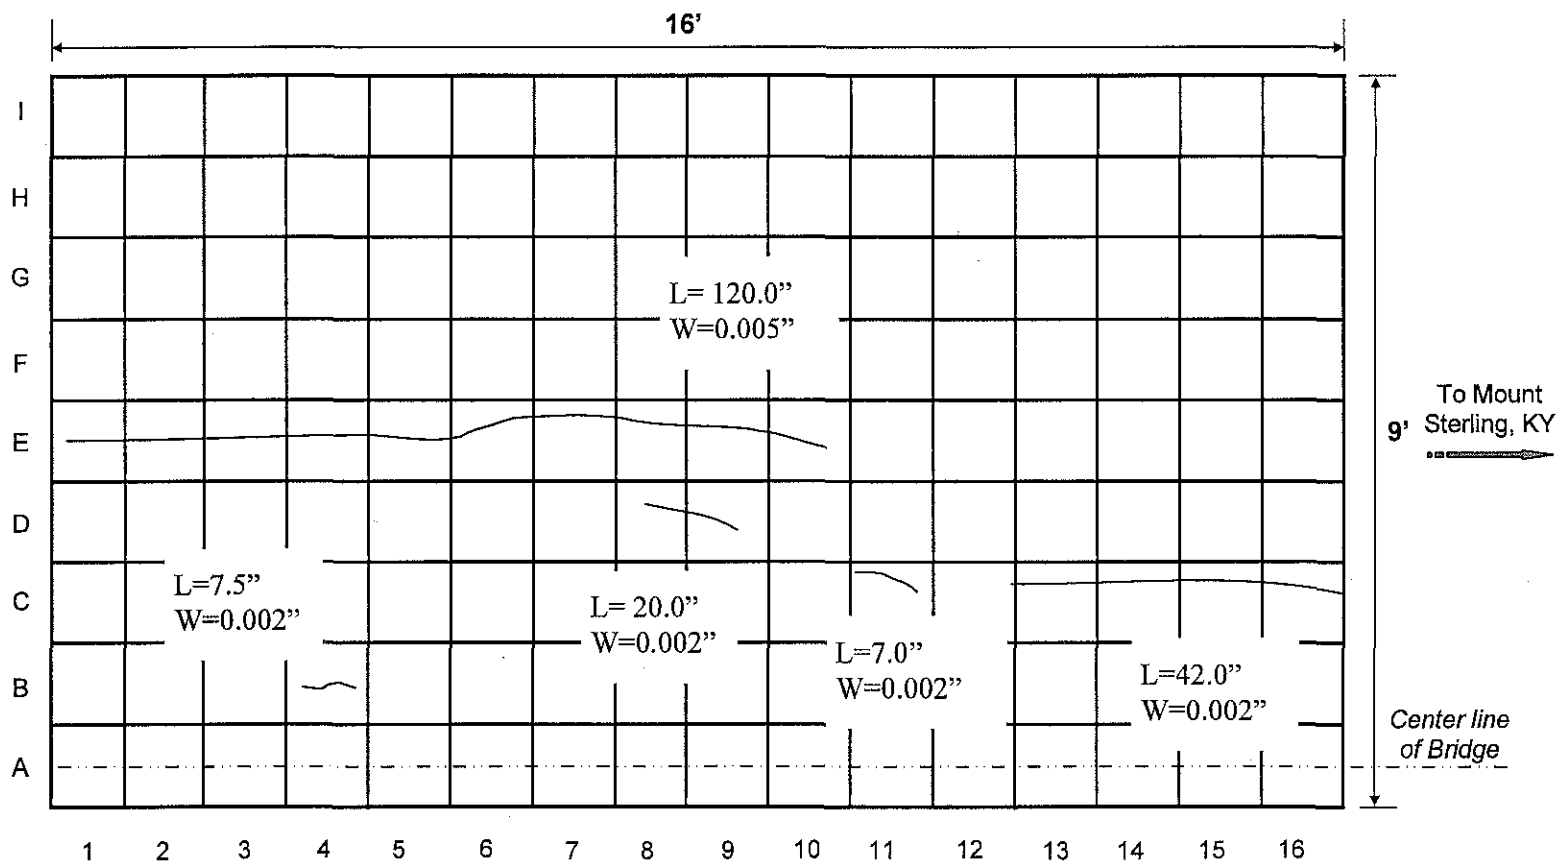
Fig. A24. Cracks observed in the top surface of the bridge deck in the GFRP area under unloaded condition

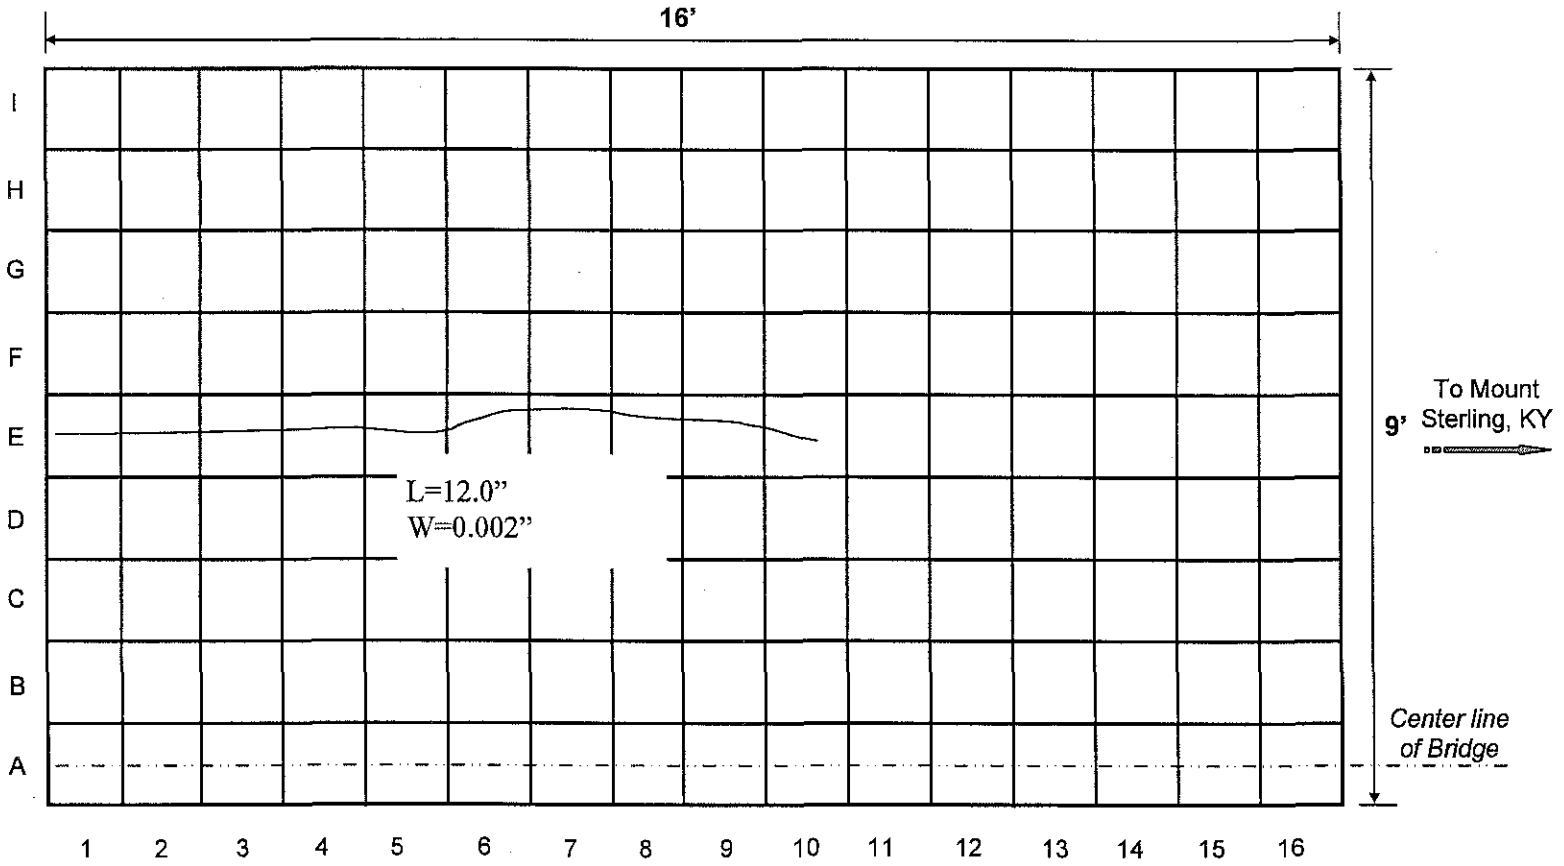
Fig. A25. Cracks observed in the top surface of the bridge deck in the GFRP area under unloaded condition

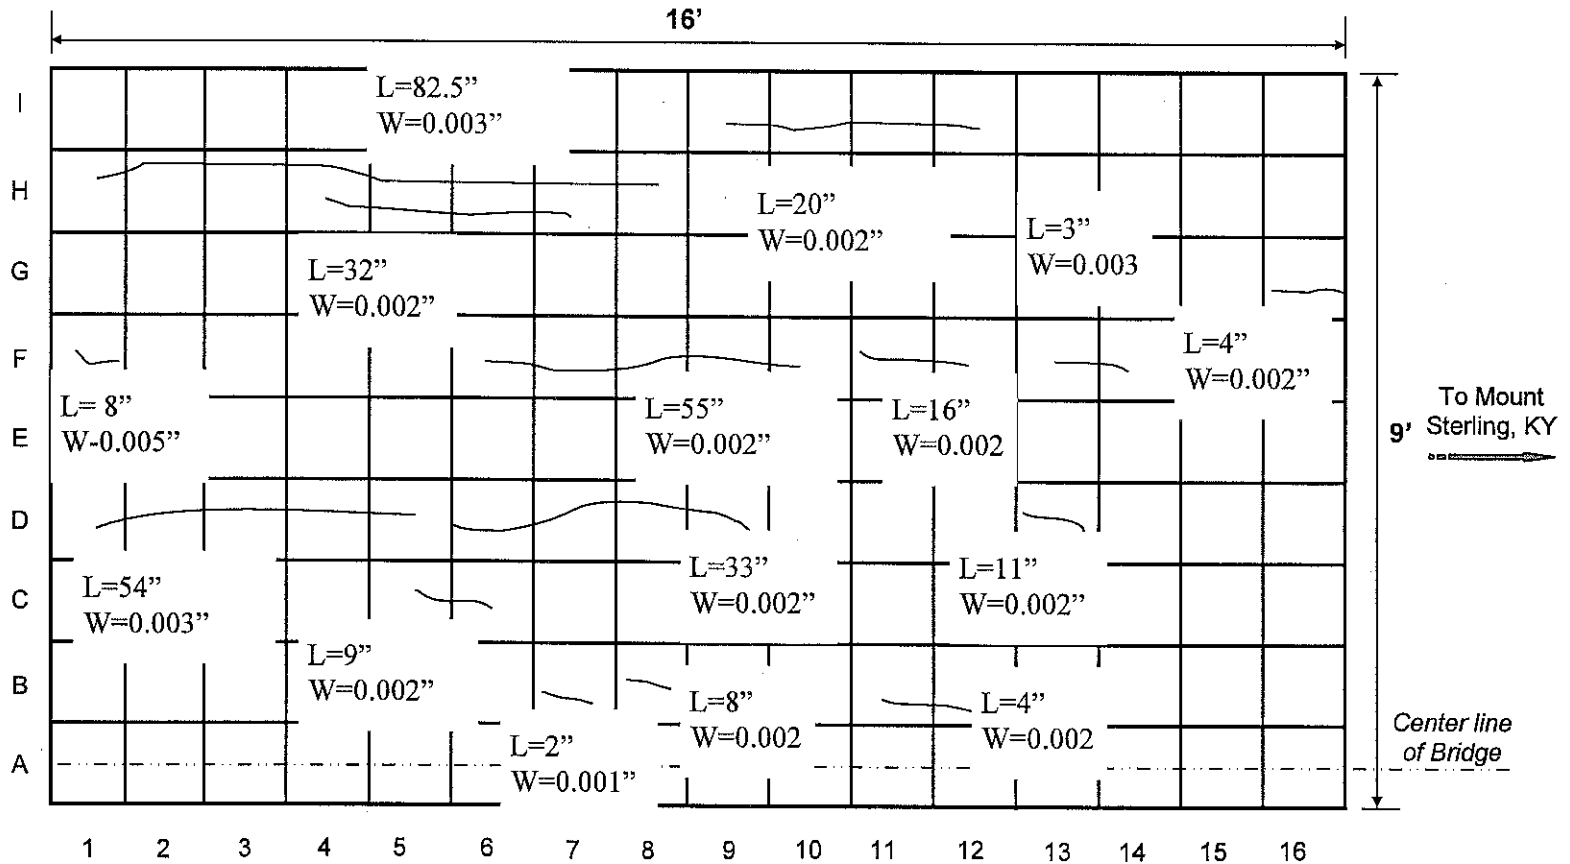
Fig. B1. Cracks observed in the top surface of the bridge deck in the steel area under unloaded conditions

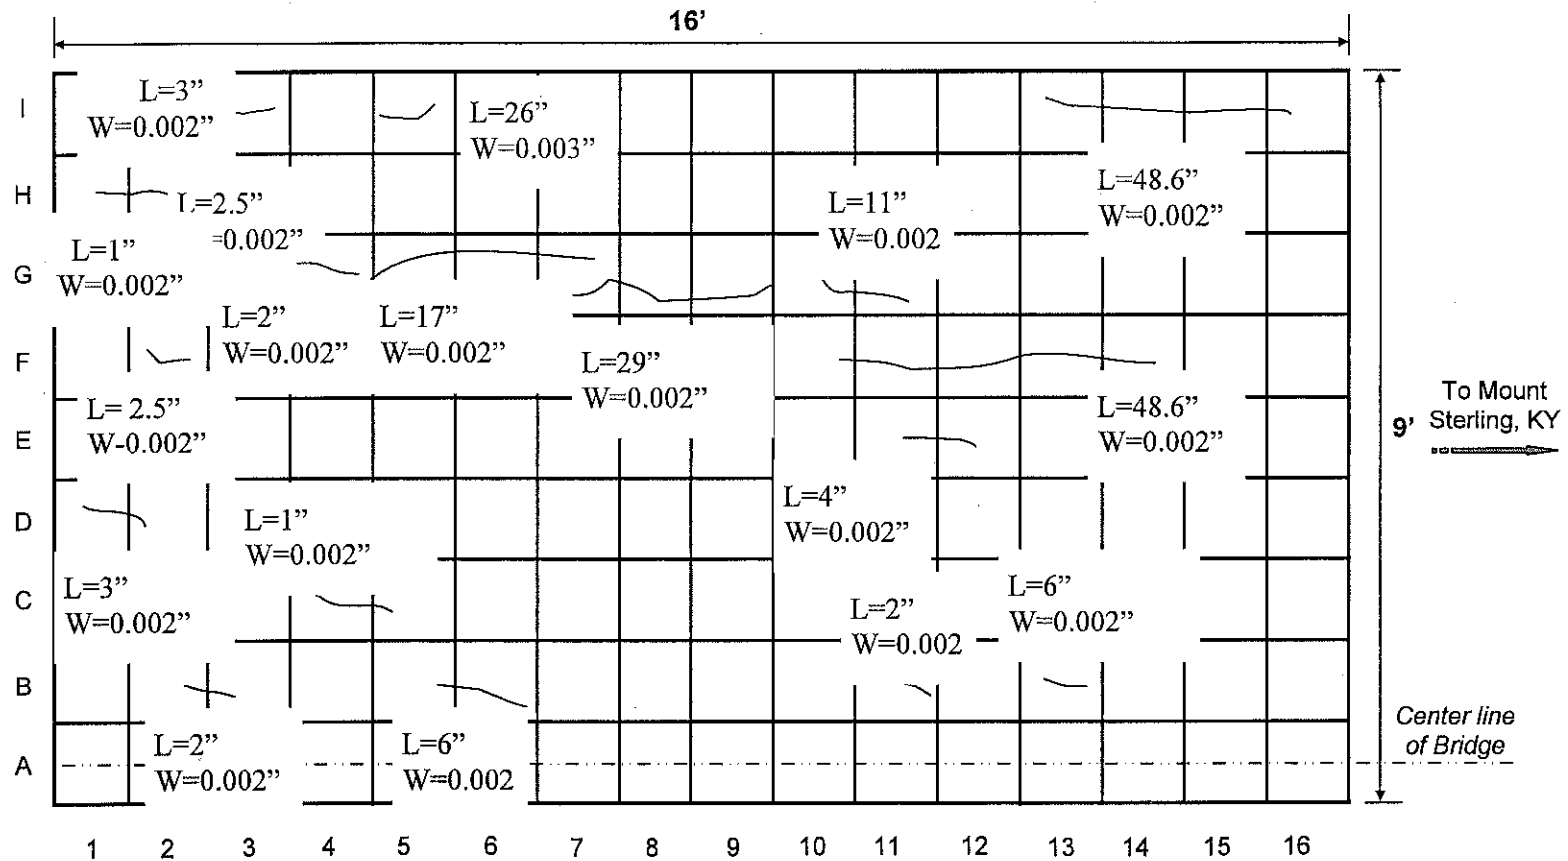
Fig. B2. Cracks observed in the top surface of the bridge deck in the steel area under unloaded conditions

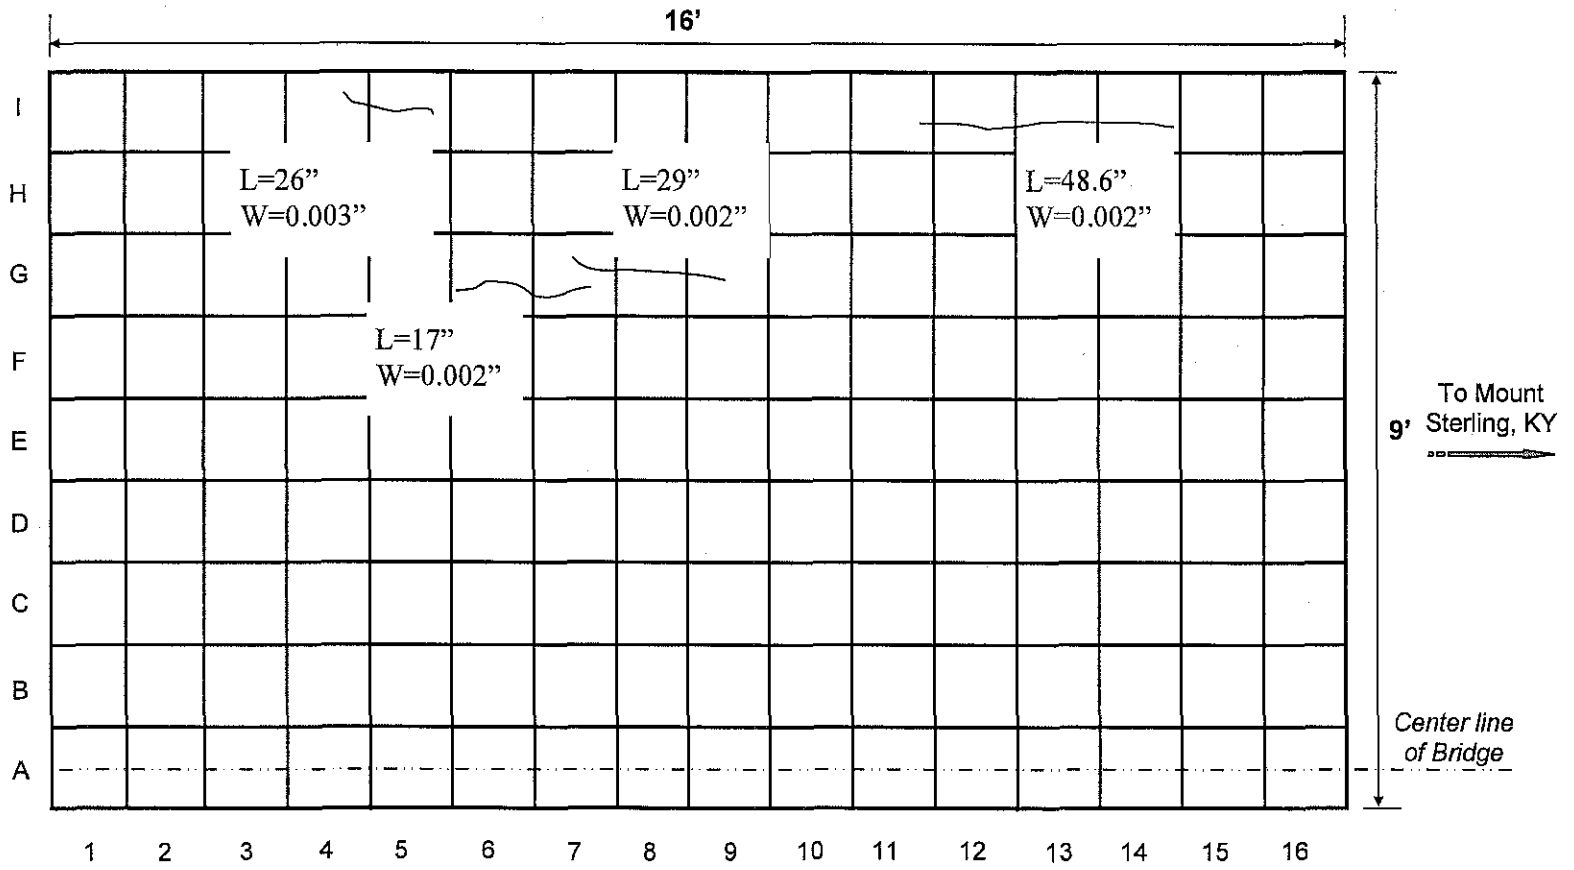
Fig. B.3 Cracks observed in the top surface of the bridge deck in the steel area under loaded conditions

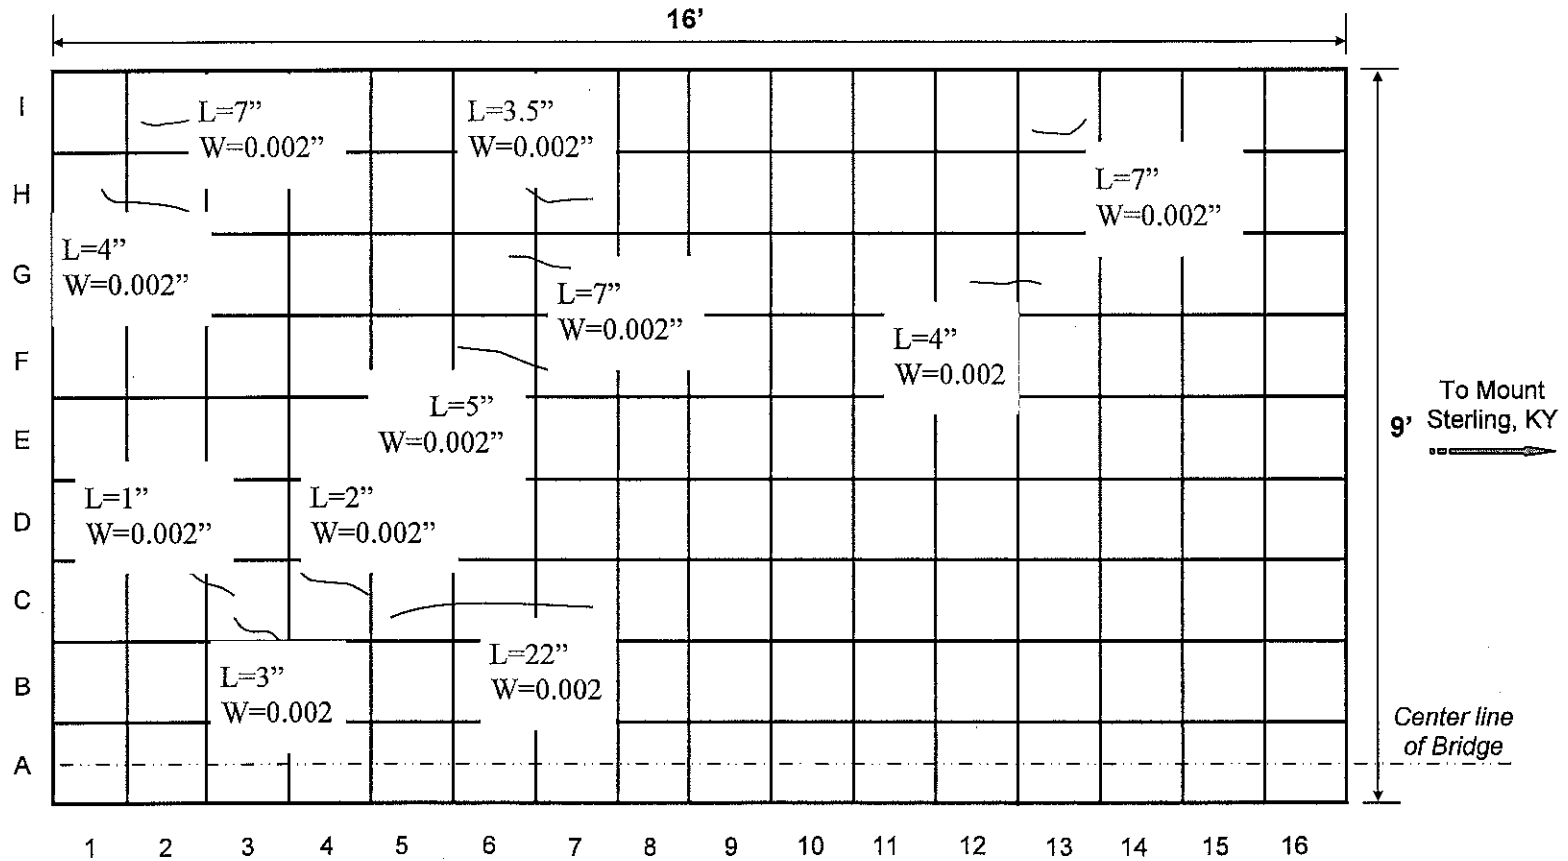
Fig. B4. Cracks observed in the top surface of the bridge deck in the steel area under unloaded conditions

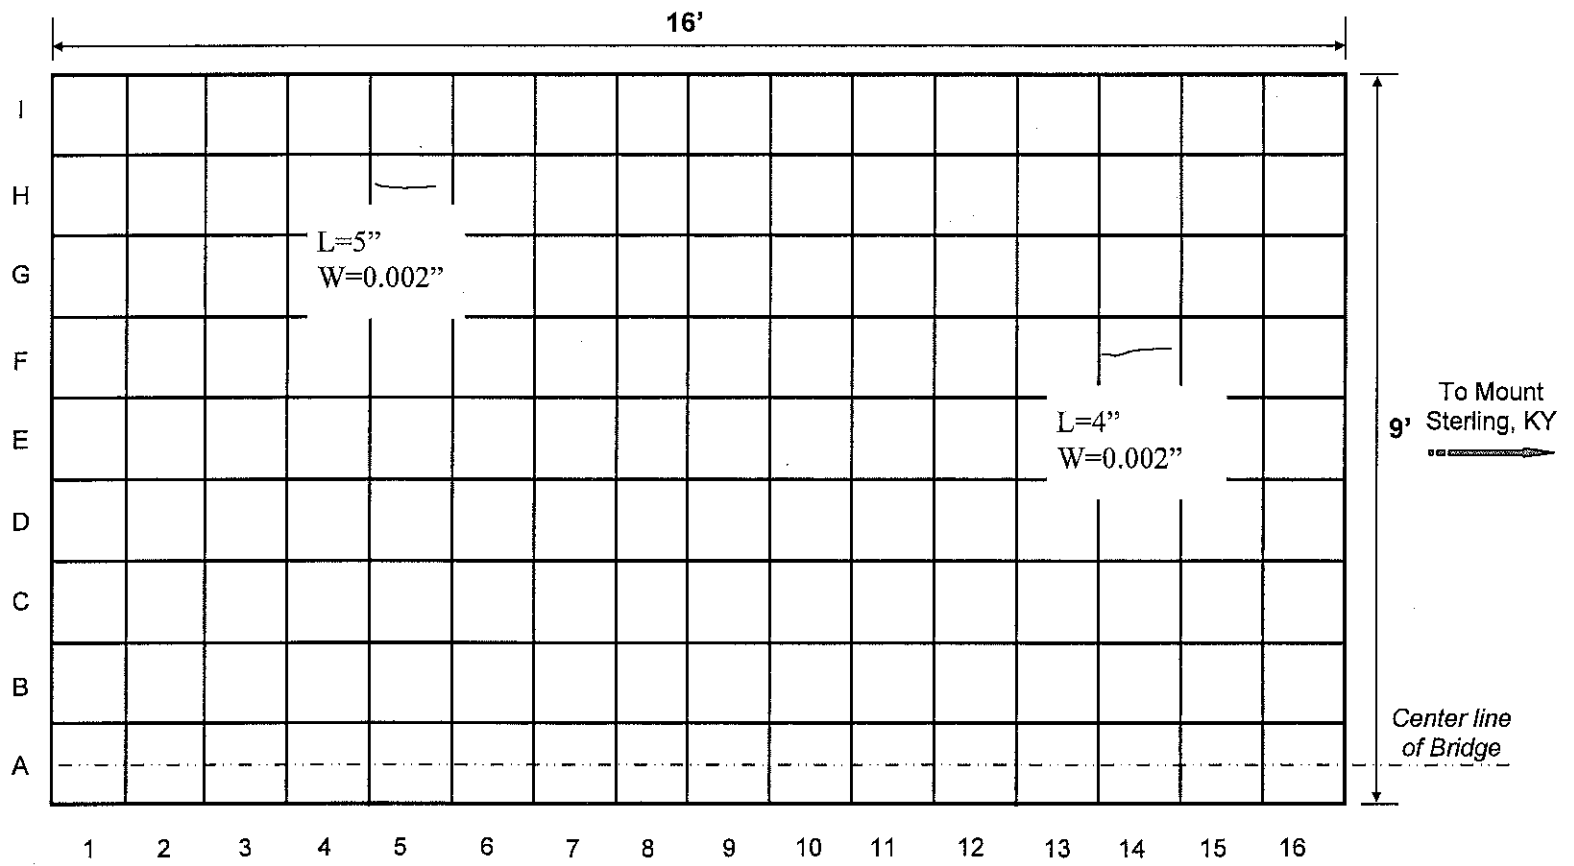
Fig. B6. Cracks observed in the top surface of the bridge deck in the steel area under loaded conditions

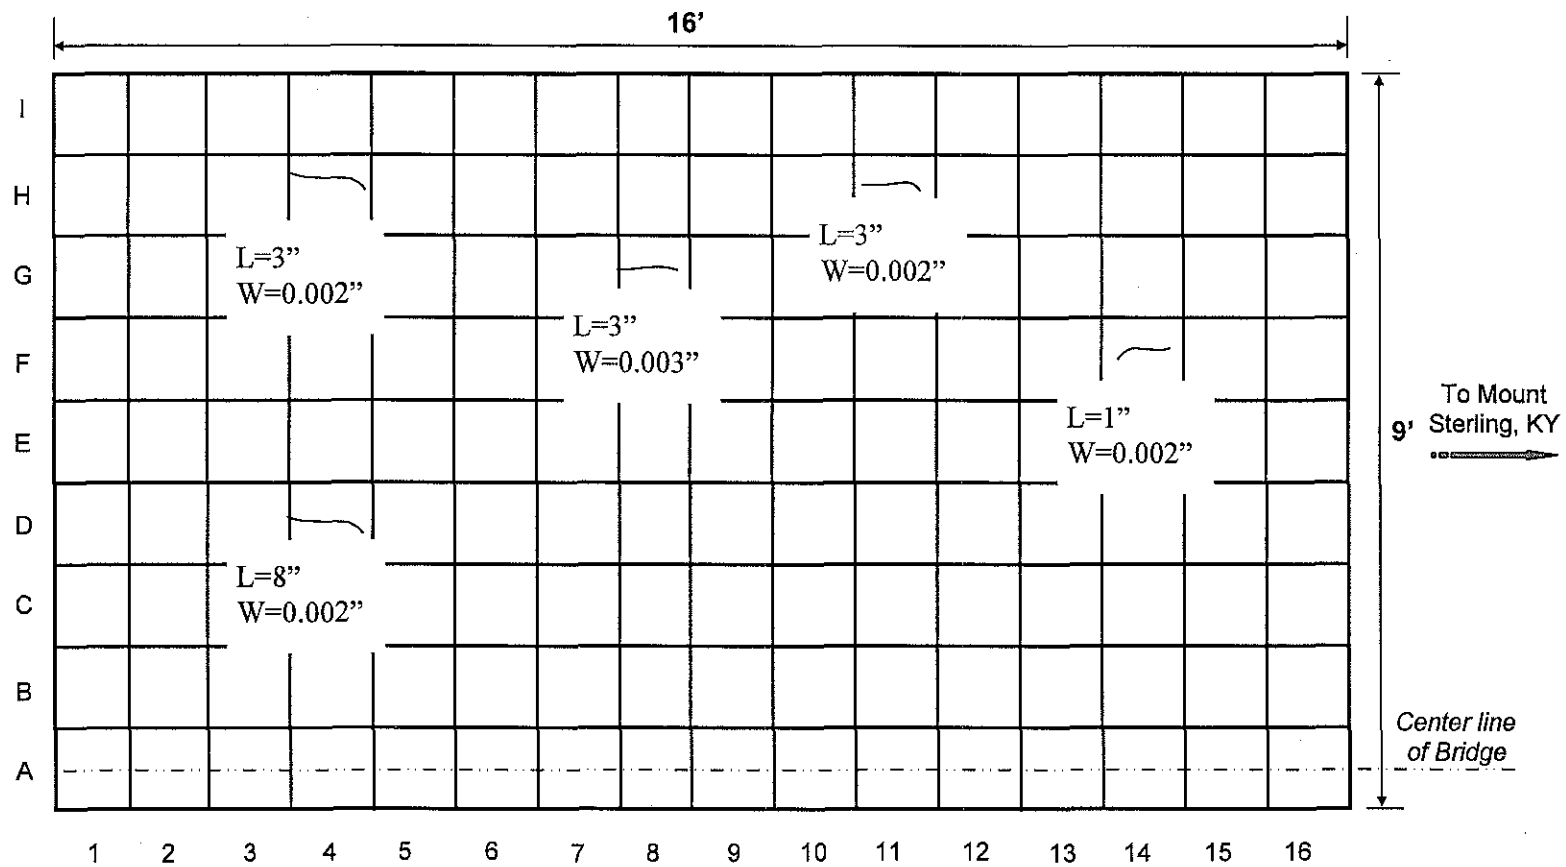
Fig. B7. Cracks observed in the top surface of the bridge deck in the steel area under unloaded conditions

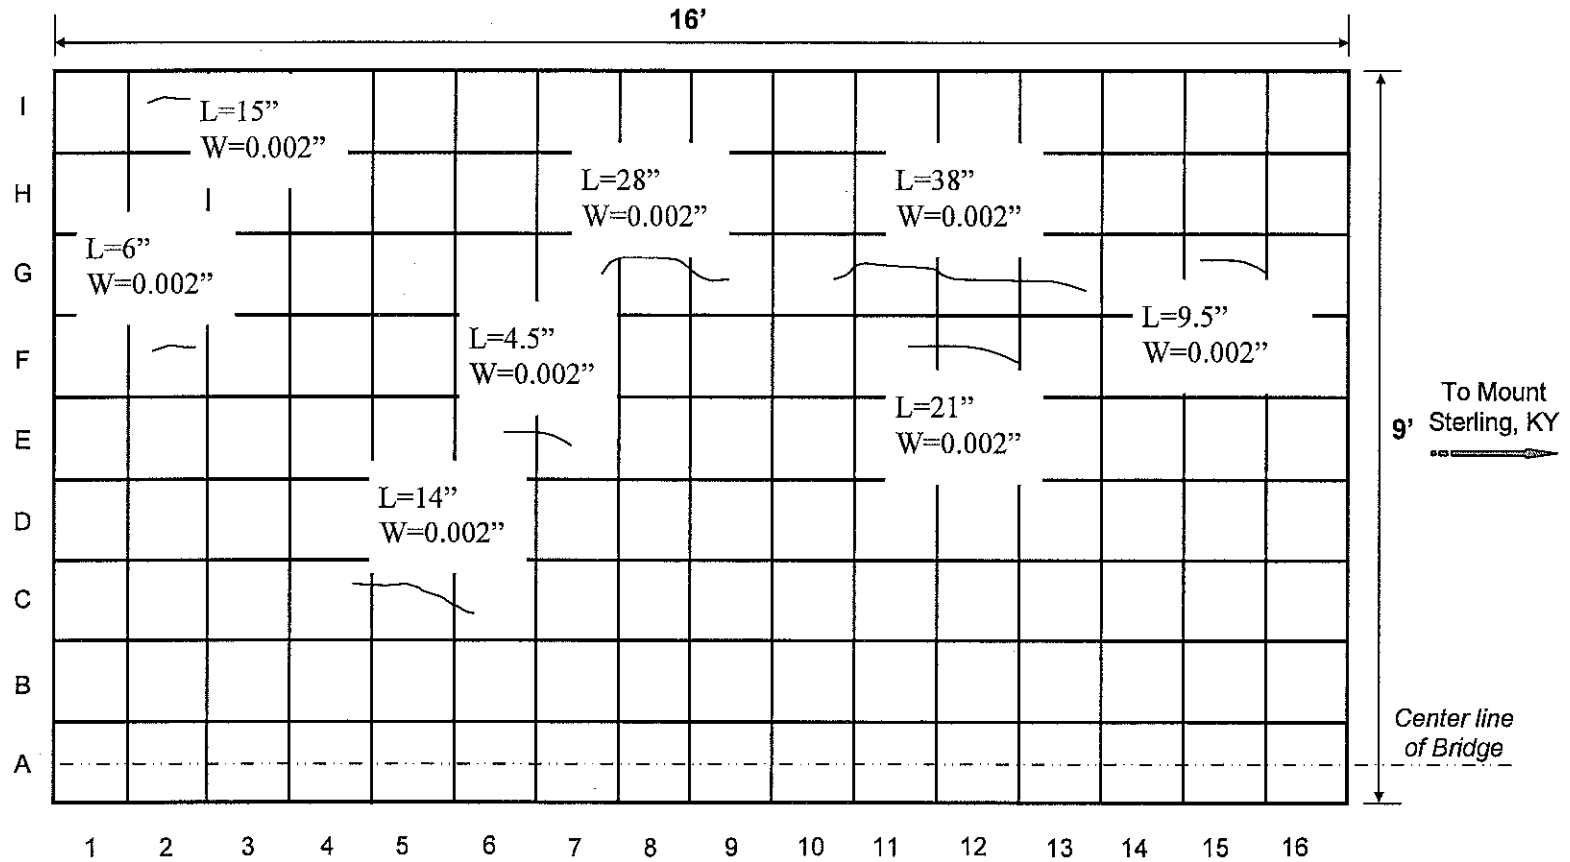
Fig. B8. Cracks observed in the top surface of the bridge deck in the steel area under unloaded conditions
