Research Report
KTC-04-21/FRPDeck-1-97-1F

INSPECTION AND EVALUATION OF A BRIDGE DECK PARTIALLY REINFORCED WITH GFRP REBARS

August 2004

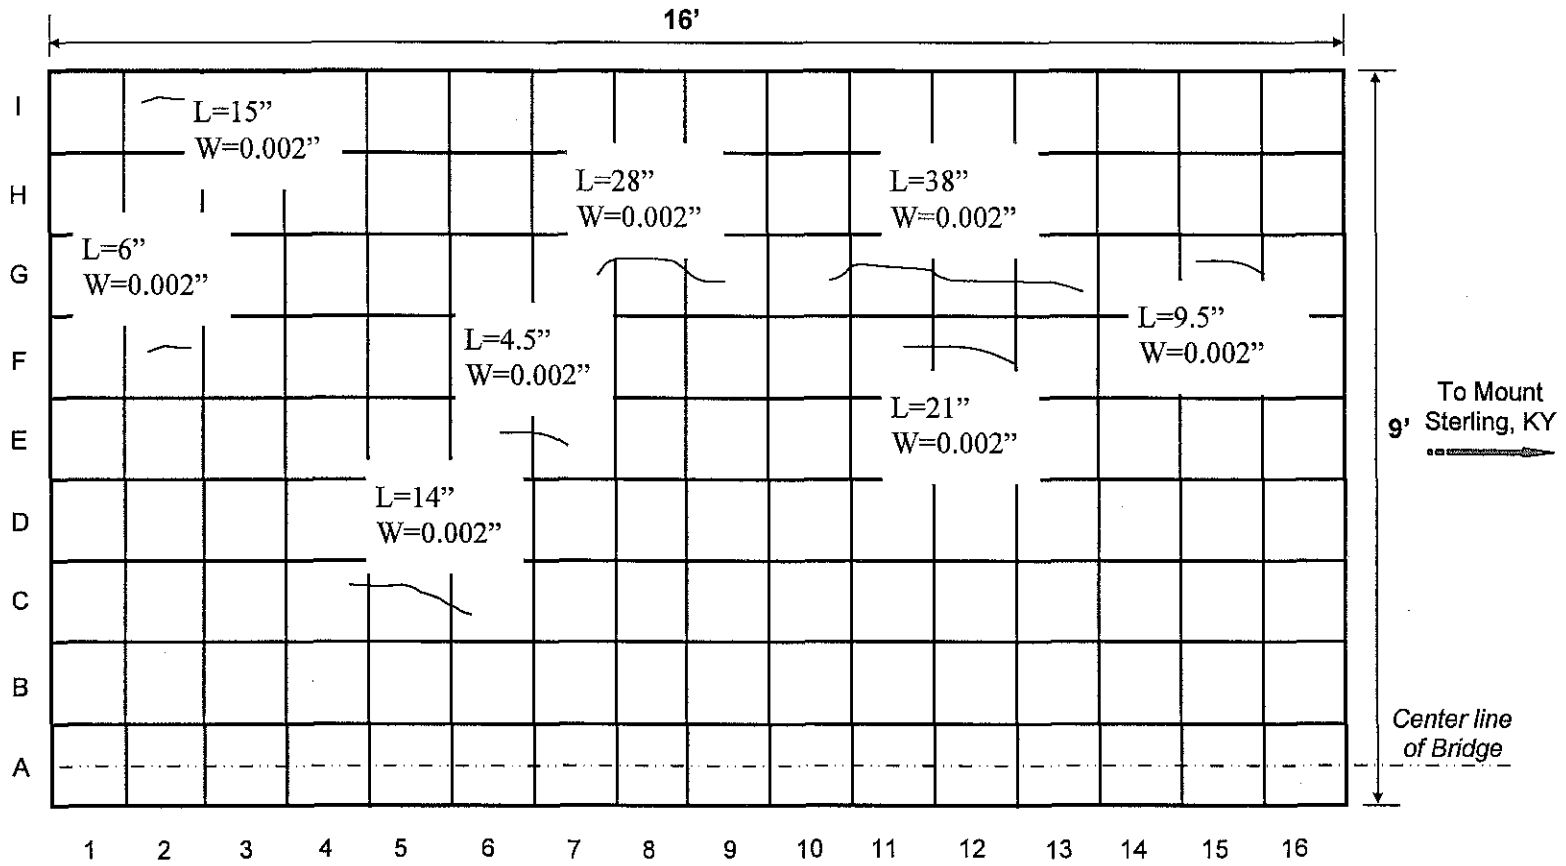
Fig. B9. Cracks observed in the top surface of the bridge deck in the steel area under loaded conditions

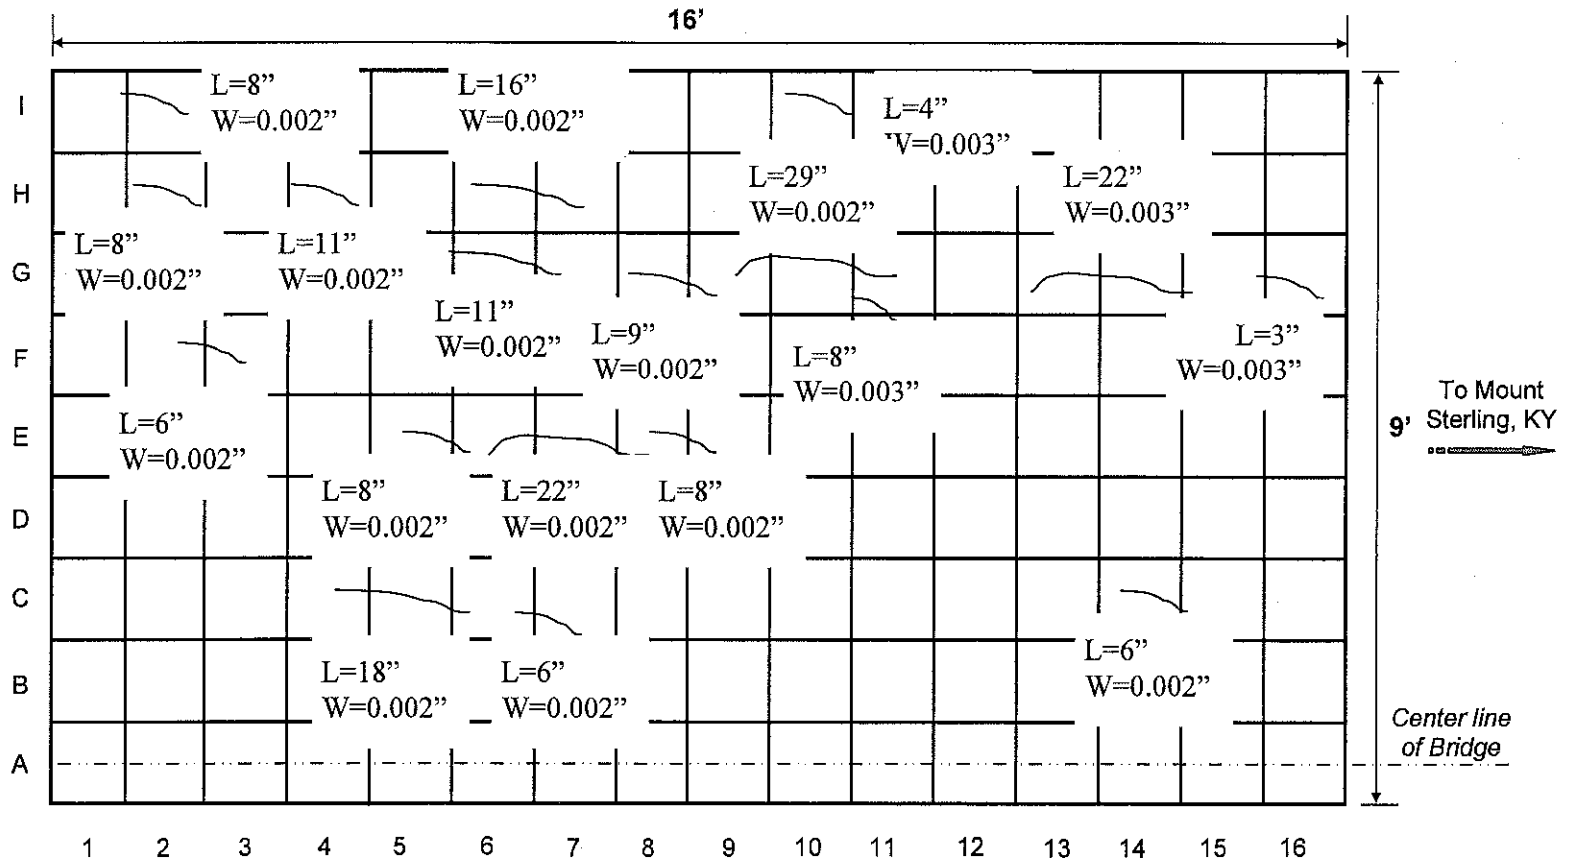
Fig. B10. Cracks observed in the top surface of the bridge deck in the steel area under unloaded conditions
