Edge Drain Performance

Report Number: KTC-19-21/SPR18-557-1F

Research Report
KTC-19-21/SPR18-557-1F

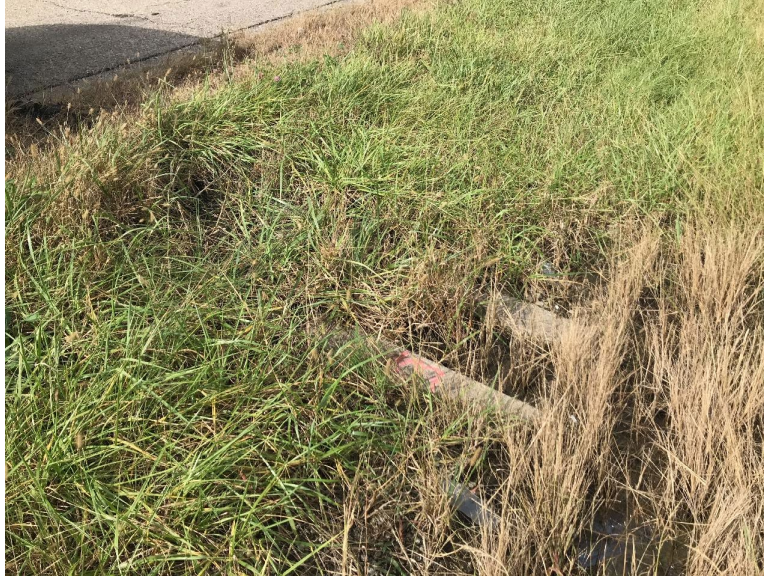
All 126 headwalls inspected by KTC were in good condition and did not have any structural problems (e.g., cracks, damage), nor did they show signs of settlement. 71% of the outfall waterways were clear. The remaining 29% exhibited issues that prohibited the flow of water from the headwall (Figures 1 and 2). 65% of the outlet waterways or the trough of headwalls suffered from blockages. Most blockages were due to grass growing in the trough, but gravel, mud, silt and other debris were observed in outlet waterways as well (Figures 3 to 5). Due to blockages at outfalls and outlet waterways, 61% of the outlet pipes were blocked. These blockages impeded the video inspection of perforated pipes. Due to blockages, of the 126 perforated edge drains, only 57% underwent video inspection. Of the 72 that were inspected 37% were clear, 6% were blocked with mud/gravel/debris, and 14% were crushed/ damaged.

Figure 1 Outfall Waterway Obstructed by Vegetative Growth

- Continue to perform post-installation inspection of edge drains.
- Perform a yearly inspection and cleaning of the headwalls and outlet pipes
- Consider alternative methods to outlet water (e.g., a dry well).
- Limit the use of T-Junctions.

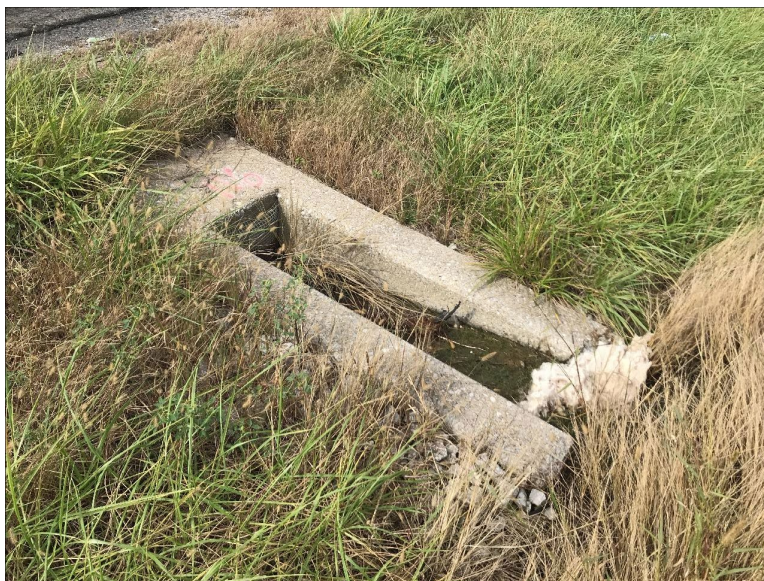
Figure 2 Outfall Waterway Obstructed by Debris

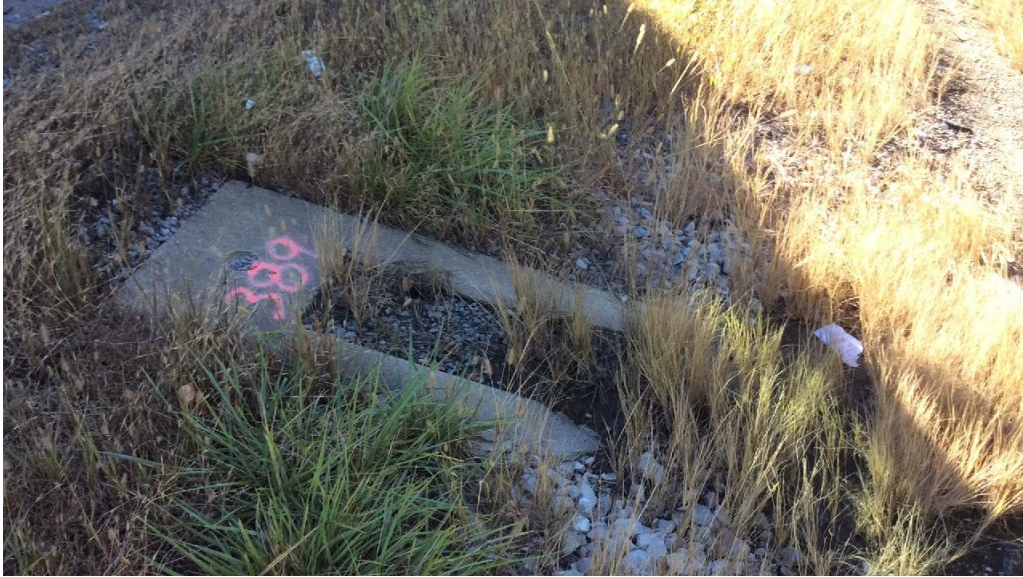
Figure 3 Outlet Waterway Blocked by Gravel

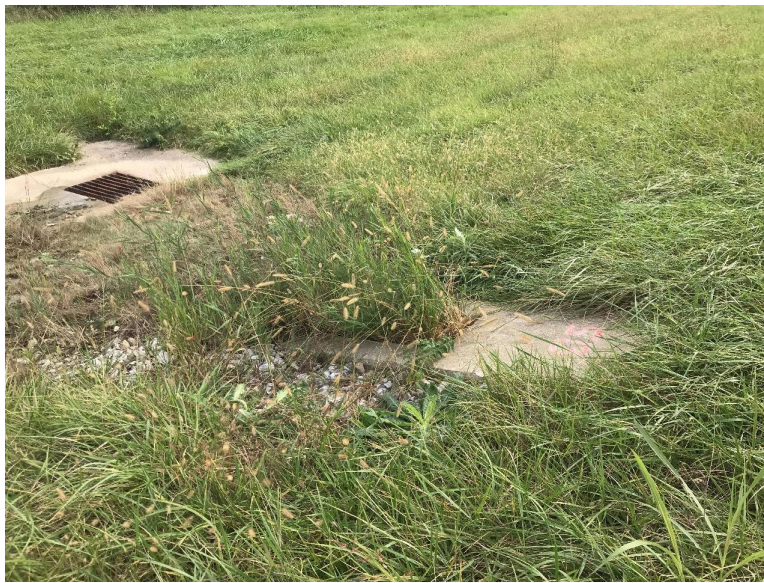
Figure 4 Outlet Waterway Blocked by Vegetative Growth

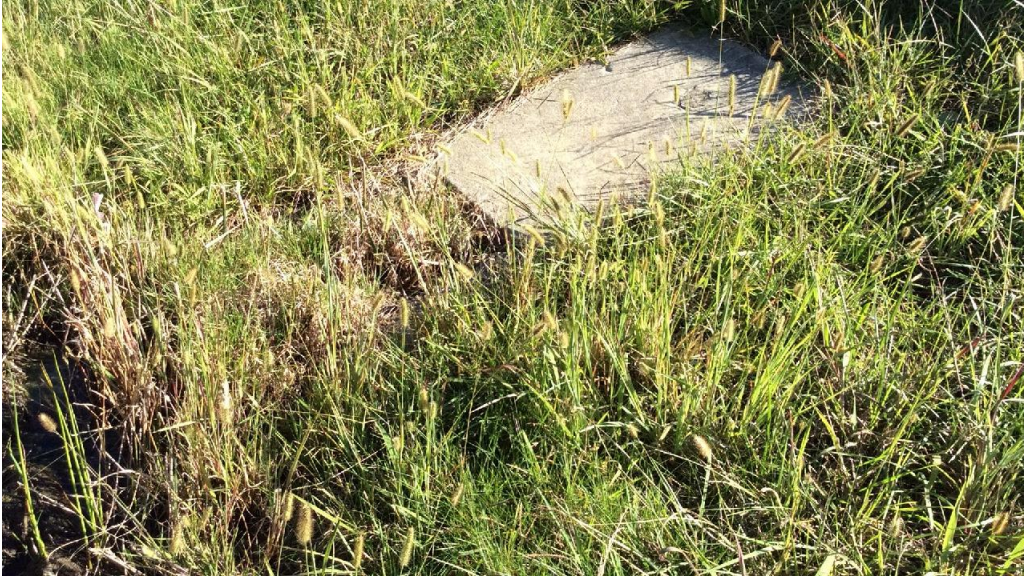
Figure 5 Waterway Completely Inundated

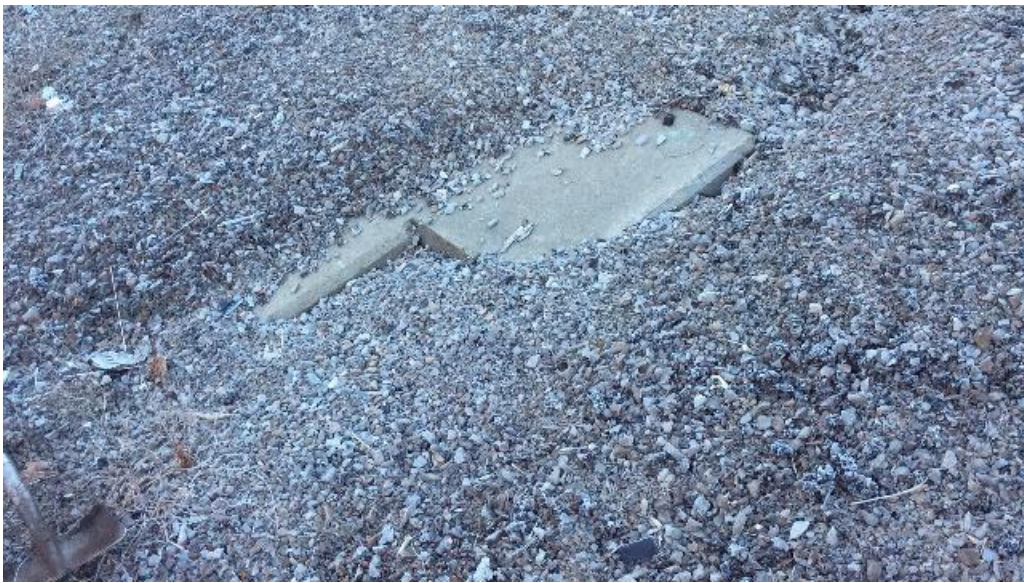
Figure 6 Waterway Completely Inundated

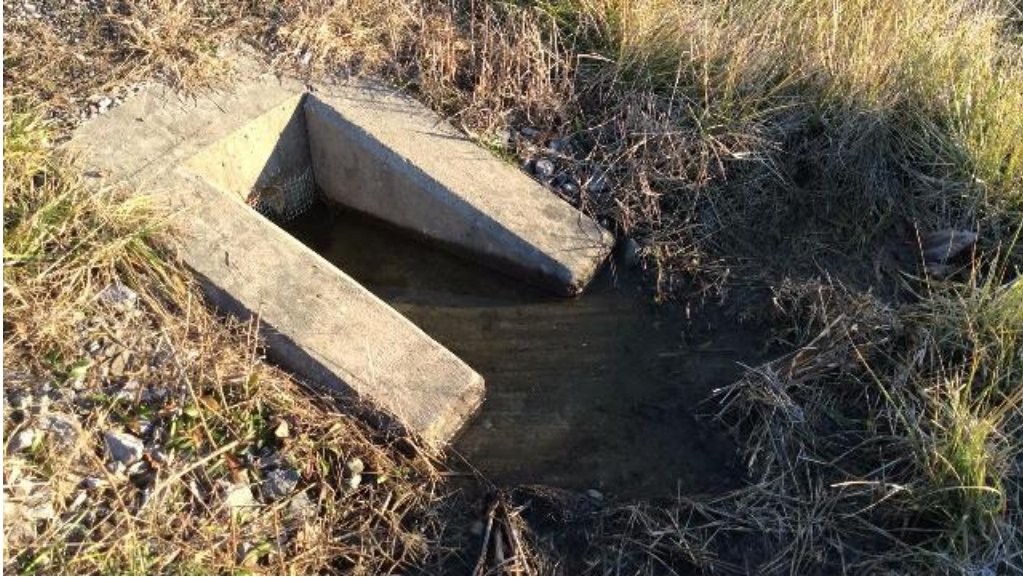
Figure 7 Outlet Waterway and Outfall Waterway Holding Water

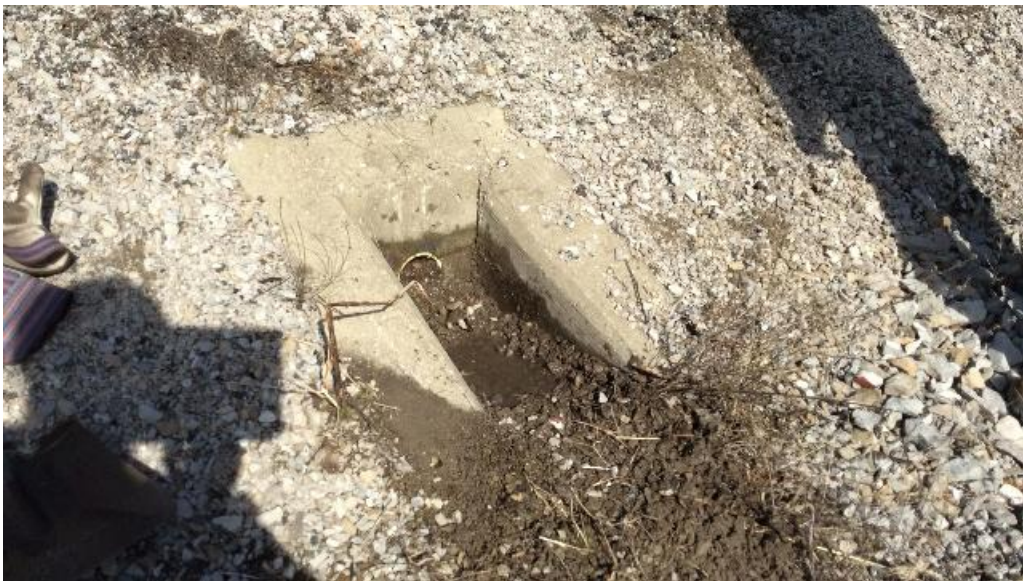
Figure 8 Blocked Outlet Pipe

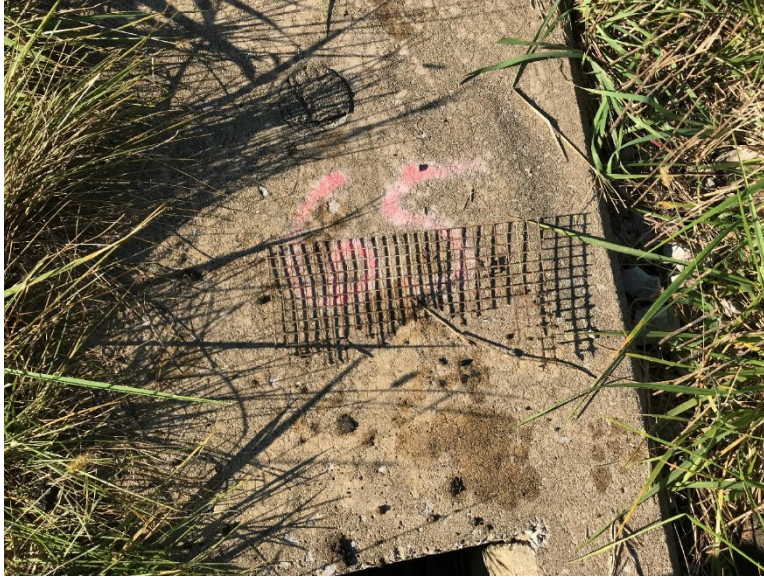
With respect to the presence and condition of rodent screens, 75% of the 126 headwalls had them installed 18% lacked them, while on 6% they were present but not functioning due to the screens being rusted through (Figure 9).

Figure 9 Rodent Screen Rusted Through
