## **Clayburn Creek Watercourse Assessment: Development and Stream Management in an Urban Residential Area.**

**Shawna M. T. Erickson**, U.C.F.V. Geography Undergrad, Abbotsford, B.C., V2S 7M8, E-mail: shawna76@telus.net

### **Abstract:**

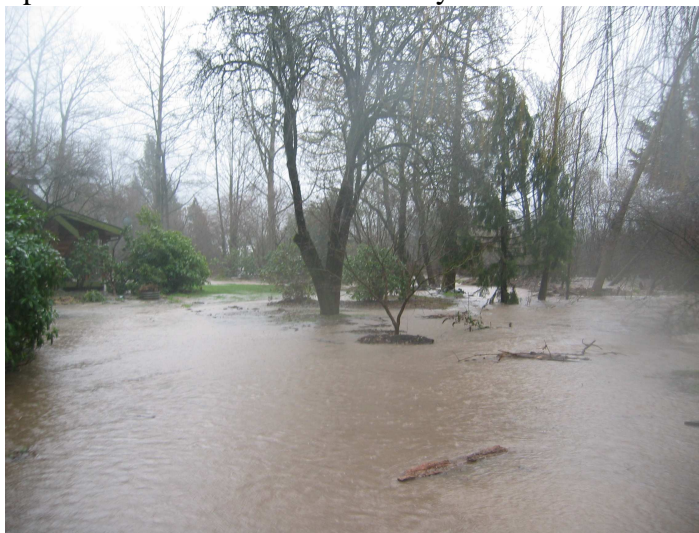
**Figure 1. Clayburn Creek flooding residential area of Clayburn Village on January 10, 2007.**

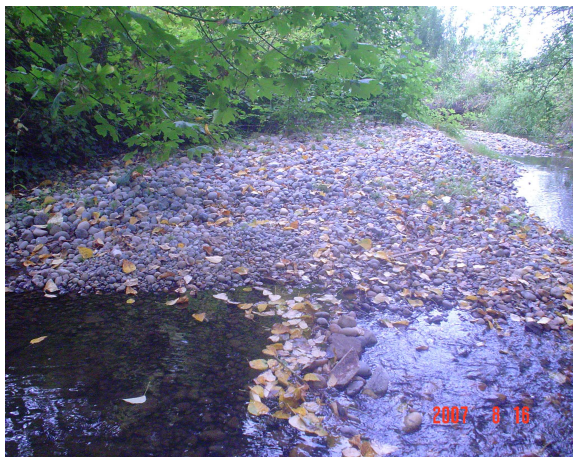
Prior to the city dredging in September 2007 the channel had a substantial amount of cobble sized material that had been deposited from previous high flows. This material raised the channel bed by more than a meter in some areas. Coupled with an increase in water discharge

**Figure 6. In channel deposition of cobble material within the Village reach of Clayburn**

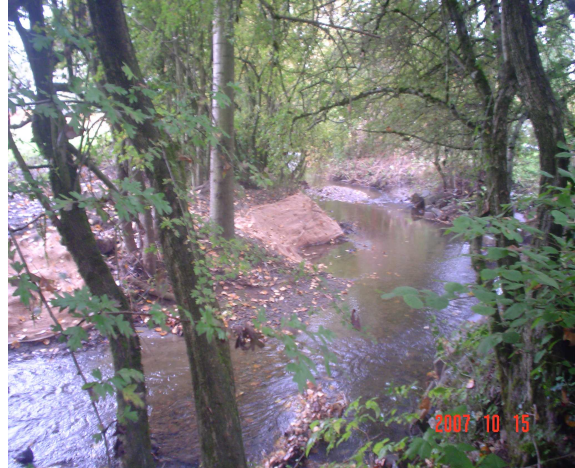
**Figure 5. Usual flow conditions illustrating erosion and mitigation along the channel.**

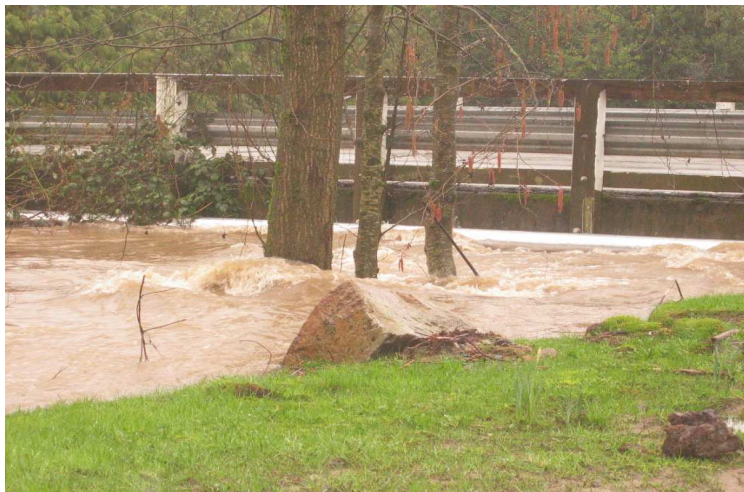
**Figure 8. Debris damaged gas line that crosses the channel at the Wright Street bridge in Clayburn Village.**

Many of the metal casings are dented and damaged from debris that is carried by high flows. Material such as mature trees are easily picked up and carried downstream damaging banks, the channel bed and gas lines adjacent to vehicle bridges crossing the creek. Some residents have water lines and personal bridges that cross the creek that may be in danger of damage from high water flows.

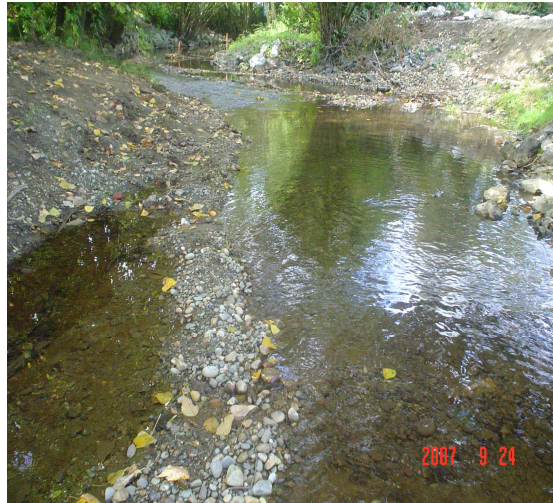
this enabled the creek to flood its banks more frequently. After dredging was completed the channel is deeper and wider allowing for the increased flows to travel through the channel without spilling over its banks onto residential property. Although this is the hope it is still weather dependant as heavy rainfall increases the sediment deposition within the channel. Aiding in the efforts of restoration, the City of Abbotsford is protecting the banks of the creek with burlap, rip rap, sandbags and other modifications. Some areas have been dredged in an attempt to control the flooding experienced within the village core. Unfortunately much of the burlap is already being torn away from the banks by high flows. Turbidity is a key issue as

**Figure 7. Same portion of channel as in Figure 6, illustrating the dredging done by the City of Abbotsford in fall 2007.**

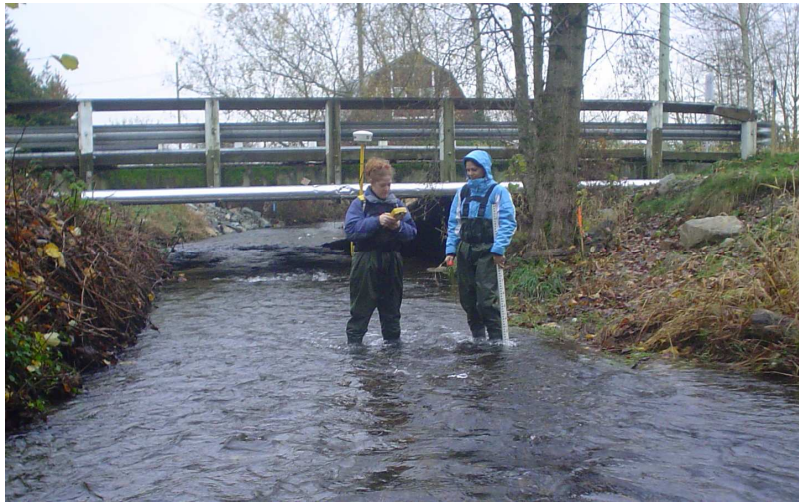
contrast, under the same bridge, to the high flows seen in the previously in Figure 8. The water is clearly brown from suspended sediments. This increased turbidity of Clayburn Creek is due to

Figure 9. Site 1 evaluation and mapping.

a combination of erosion of the upstream banks and from runoff. October 1<sup>st</sup>, 2007 a small overcast break in conditions that had allowed the stream to narrow back to its typical flow volume. Sand deposition was documented within the channel. The water was nearly clear except for near large amounts of fine sand deposition. The stream bed is visible with substrate recognizable to the discerning eye.
