Failure Mechanism of Woven Roving Fabric/Vinyl Ester Composites in Freeze–Thaw Saline Environment

Original Research Article

Failure Mechanism of Woven Roving Fabric/ Vinyl Ester Composites in Freeze-Thaw Saline Environment

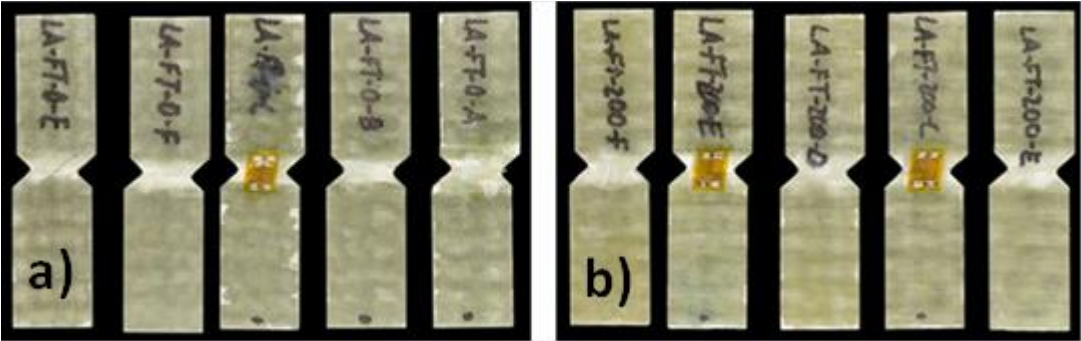
Effect of exposure on shear properties of the laminates was studied in accordance to the v-notched beam test (ASTM D5379-12) [13]. Figure 3 shows typical shear failure mode that occurred at the mid-span of the V-notched beam. The average reduction in shear modulus and strength after 100 days of exposure is 18.5% and 13.5 %, respectively (Figure 4).

Figure 3- Shear failure modes for a) unexposed; and b) exposed specimens

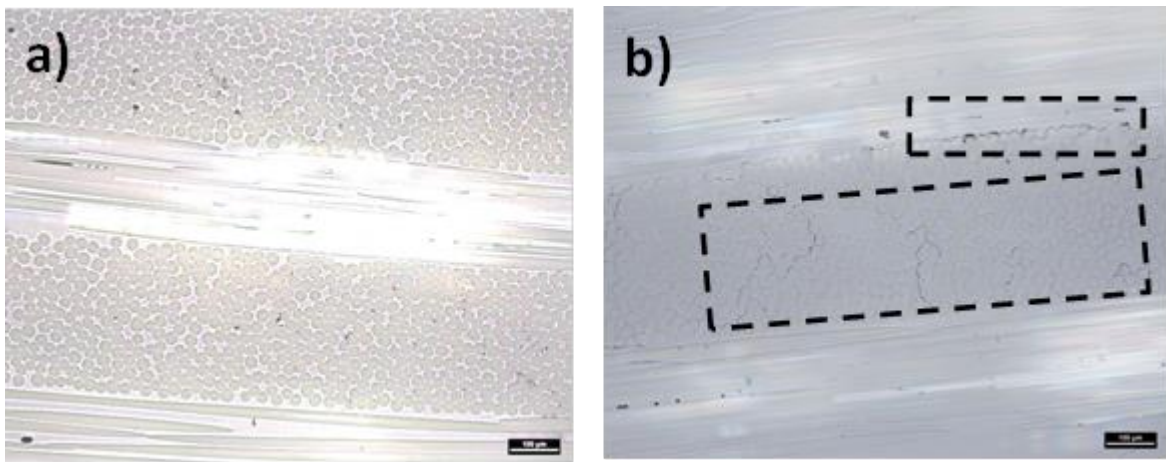
Following the shear test, failed samples were cut in between the V-notch locations (across the length of the sample) and dissected using an optical image technique. Figure 5 shows the final fracture states and internal cracks for the unexposed and exposed specimens. The unexposed failed specimens exhibited interlaminar cracks and separation in between the resin and warp fibers. The cracks were oriented along the warp direction. For the exposed failed samples, a high density of intralaminar cracks occurred along the fill fibers as well as their interfaces (Figure 5). This clearly shows that the resin has been degraded due to the F/T cycling.

Figure 5– Micrograph of the cross section after failure at the V-notch location a)

Unexposed: showing only interlaminar cracks, b) Exposed: showing interlaminar and intralaminar cracks

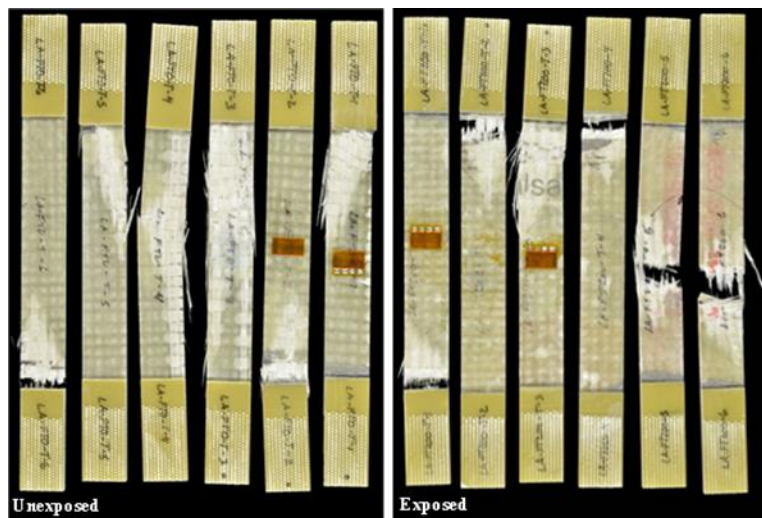
Figure 7– Tensile test failure modes; unexposed and exposed specimens

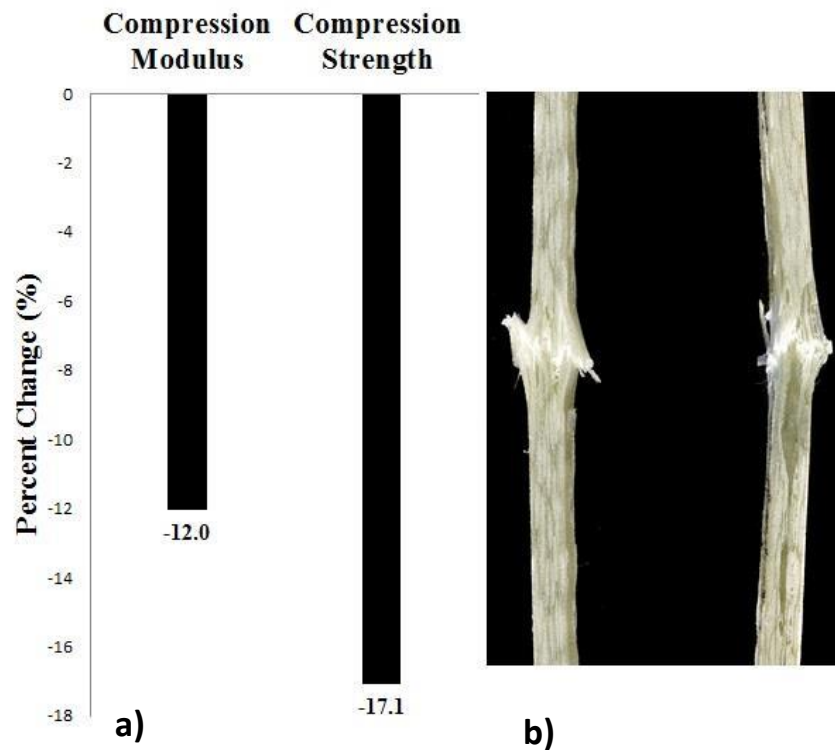
The combined loading compression test fixture was used to study the effect of exposure on the compressive properties of the GFRP laminates. A total of 12 samples were tested in accordance with ASTM D6641 [16]. The exposed samples showed an average reduction of 17.1% in strength and 12% in modulus. One can notice the high dependency of the matrix degradation and interfacial failure on the compression strength versus the shear strength observed in Figure 4. Typical experienced failure modes are shown in Figure 9.

Figure 9 –a) Percent change in modulus and strength, b) Compression failure modes

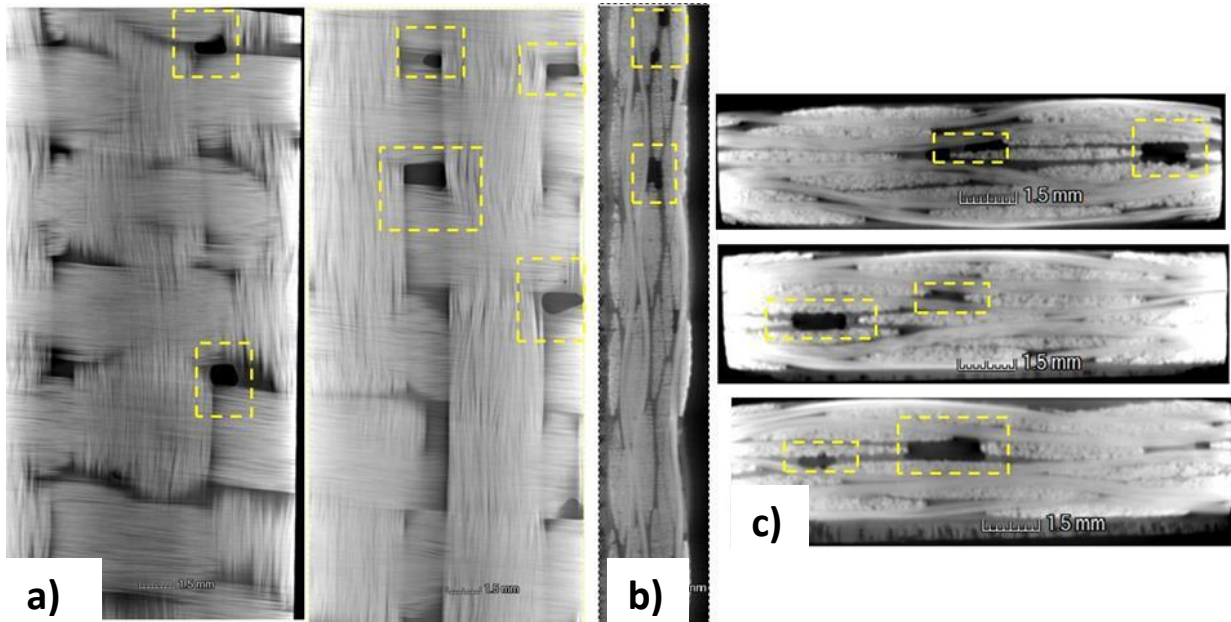
In order to investigate the size and location of the internal defects, a 3D X-Ray CT-Scan test was conducted on the exposed specimens. Figure 11 shows resin cracking at preferred sites. In addition, intralaminar cracks occurred in the mid-section of the FRP laminate, specifically in resin rich areas. The damage shown in Figure 11 (transverse cross section) is approximately 1.2 mm in length and 0.7 mm thick. These defects (cracks and fractures) are source of delamination initiation that further degrades the component strength and eventually lead to local stiffness reduction.

Figure 11- X-Ray computed tomography showing damage in exposed samples a) 2nd and 3rd plies, b) longitudinal cross section, c) transverse cross section

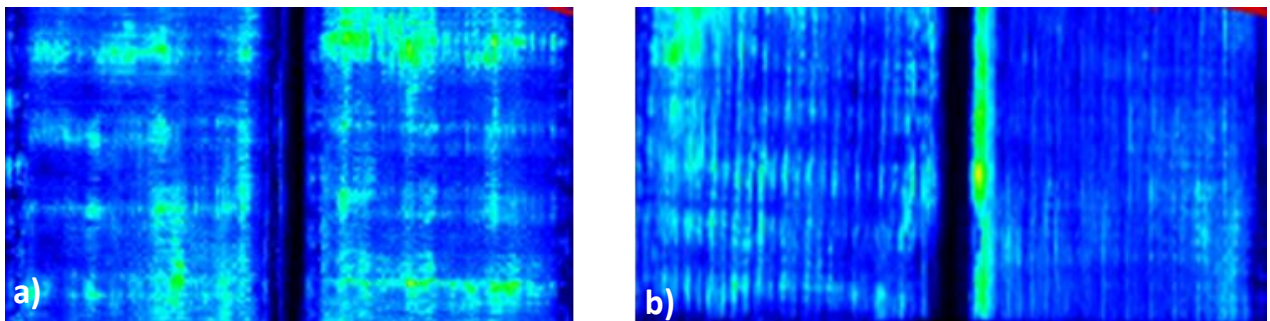
In order to test the structural integrity of the connections between the fill and warp fibers, a pulse ultrasonic C-scan technique was performed on two exposed and unexposed specimens. Figure 12 shows the C-scan images of all tested samples. The grid pattern (signals at nodes) is clearly shown in the unexposed samples (Figure 12a), whereas the linear pattern is clearly visible in the exposed samples. This change in pattern indicates that these connections are impaired and ineffective in transferring the loads, including racking or shear loads. In addition to the shear stiffness loss of the cracked matrix, the deterioration

of these nodes is believed to affect the tensile and shear moduli of the laminate. To interpret this phenomenon, one could envision the laminate structure similar to a picture frame (hinged truss) with some degree of rotational stiffness at the four pins (nodes). Two of these pins could be connected with a horizontal spring simulating the lateral stiffness supplied by the matrix. If a load (tension or shear) is applied to the truss, the capability of the truss to resist load and deformation (axial or racking) is controlled by the rotational stiffness supplied by the nodes (bond at junction of fill and warp fibers) and the axial stiffness of the spring. This simple mechanistic model helps to understand the basic phenomena governing the behavior of these systems.

Figure 12- Ultrasonic C-scan results (102 mm wide specimens); a) unexposed: grid pattern,
b) exposed: linear pattern

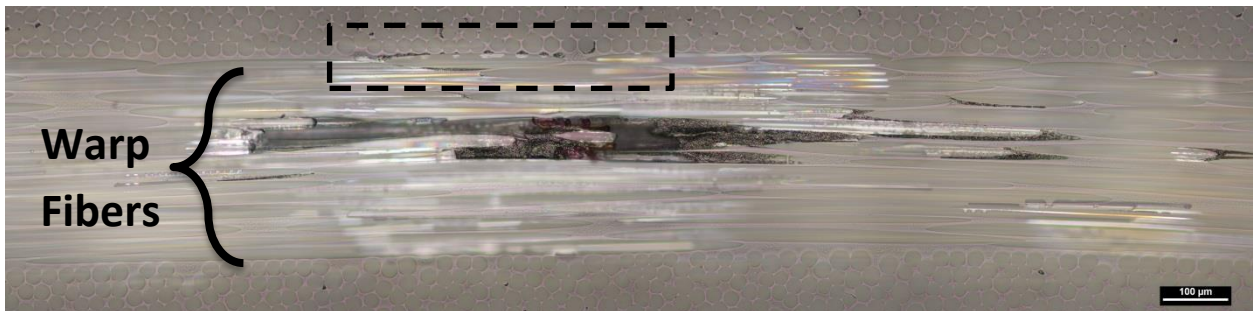
To map out the damage and frequency of defects that occurred in the laminate after exposure, a high resolution optical image technique was used to inspect their locations. Figure 13 shows damaged fibers and matrix bond failure between the fill and warp fibers. This failure pattern commonly occurred at the kink/weave location between the roving. It seems that the volume change due to the thermal cycling initiated a high non-uniform residual stresses at the sharpest curvature location and significantly degraded this node/junction between the fibers. The authors believe that this damage will be recurrent for any plain weave type no matter what type of reinforcement is used.

Figure 13- Local magnified optical image at weave junction showing matrix failure between damaged warp fibers and fill fibers after exposure

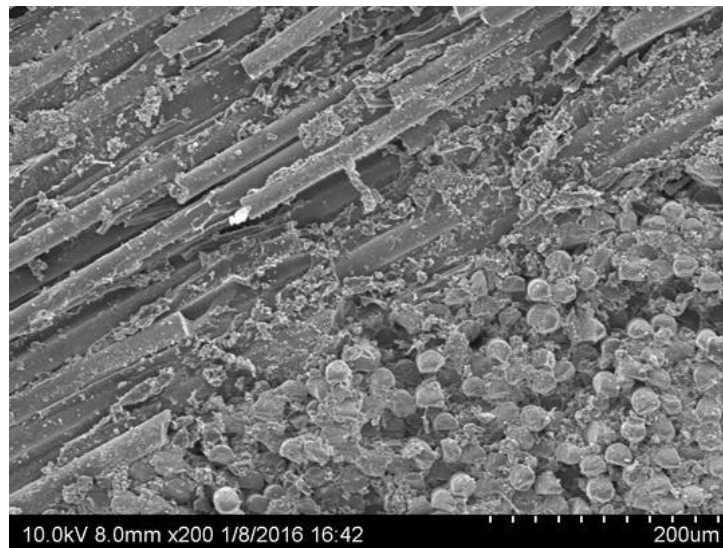
Figure 14 shows the microstructure of an exposed specimen with a high resolution Scanning Electron Microscopy (SEM). Significant amount of fiber/matrix degradation is observed. This justifies the DMA result discussed in section 3.4. The mismatch in the coefficient of thermal expansion between the resin and the E-glass fiber is believed to cause this interfacial failure mode. In addition, fiber fractures are clearly shown in Figure 14.

Figure 14– SEM micrograph showing degradation of fiber/matrix interface and fiber fracture

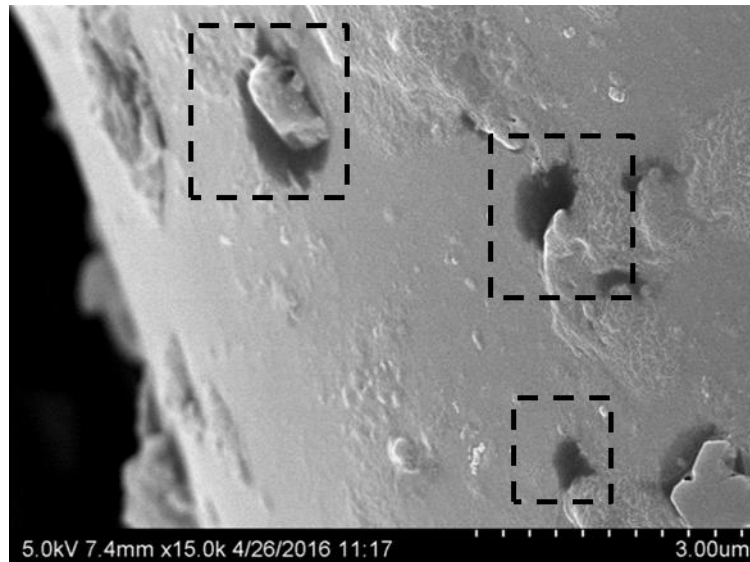
Karbahari et. al. [11] reported that aqueous solution in contact with glass fiber surface produced free-alkali hydroxide groups that degraded the silica structure of the glass fiber

when exposed to an alkaline media. The effect is through breaking of Si-O bonds in the glass network and was believed that surface loss and pitting occurred in areas of high pH solution. In general, alkali solution such as cement environment is known to degrade the glass fiber through several processes such as pitting, etching, leaching, and embrittlement [17-19]. Figure 15 shows a surface of a filament of glass fiber in an exposed sample. Several defects (black spots) are observed, including localized areas around these spots, which might be related to coupling agent or polymer swelling

Figure 15- SEM picture of damaged E-glass fiber after exposure
