The causes and prevention of human error contributing to maritime accidents in Tanzania

Gerson Japhet Fumbuka
WMU

**THE CAUSES, AND PREVENTION OF HUMAN
ERROR CONTRIBUTING TO MARITIME
ACCIDENTS IN TANZANIA.**

MARITIME SAFETY AND ENVIRONMENTAL PROTECTION

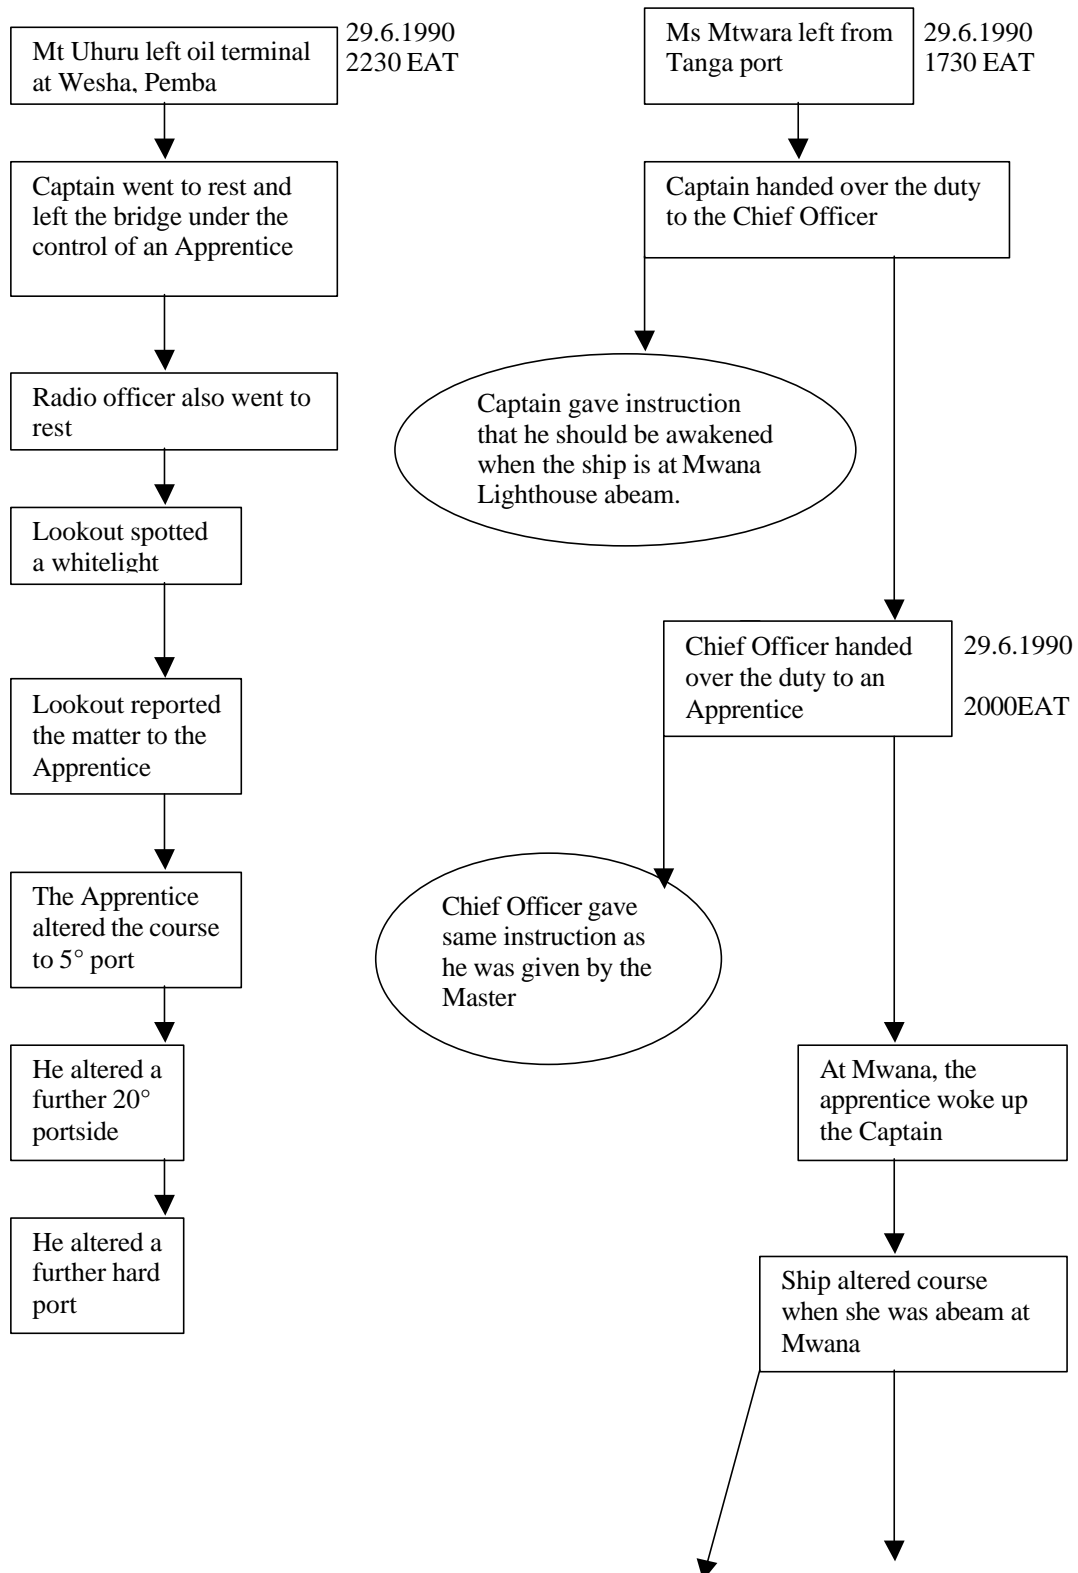
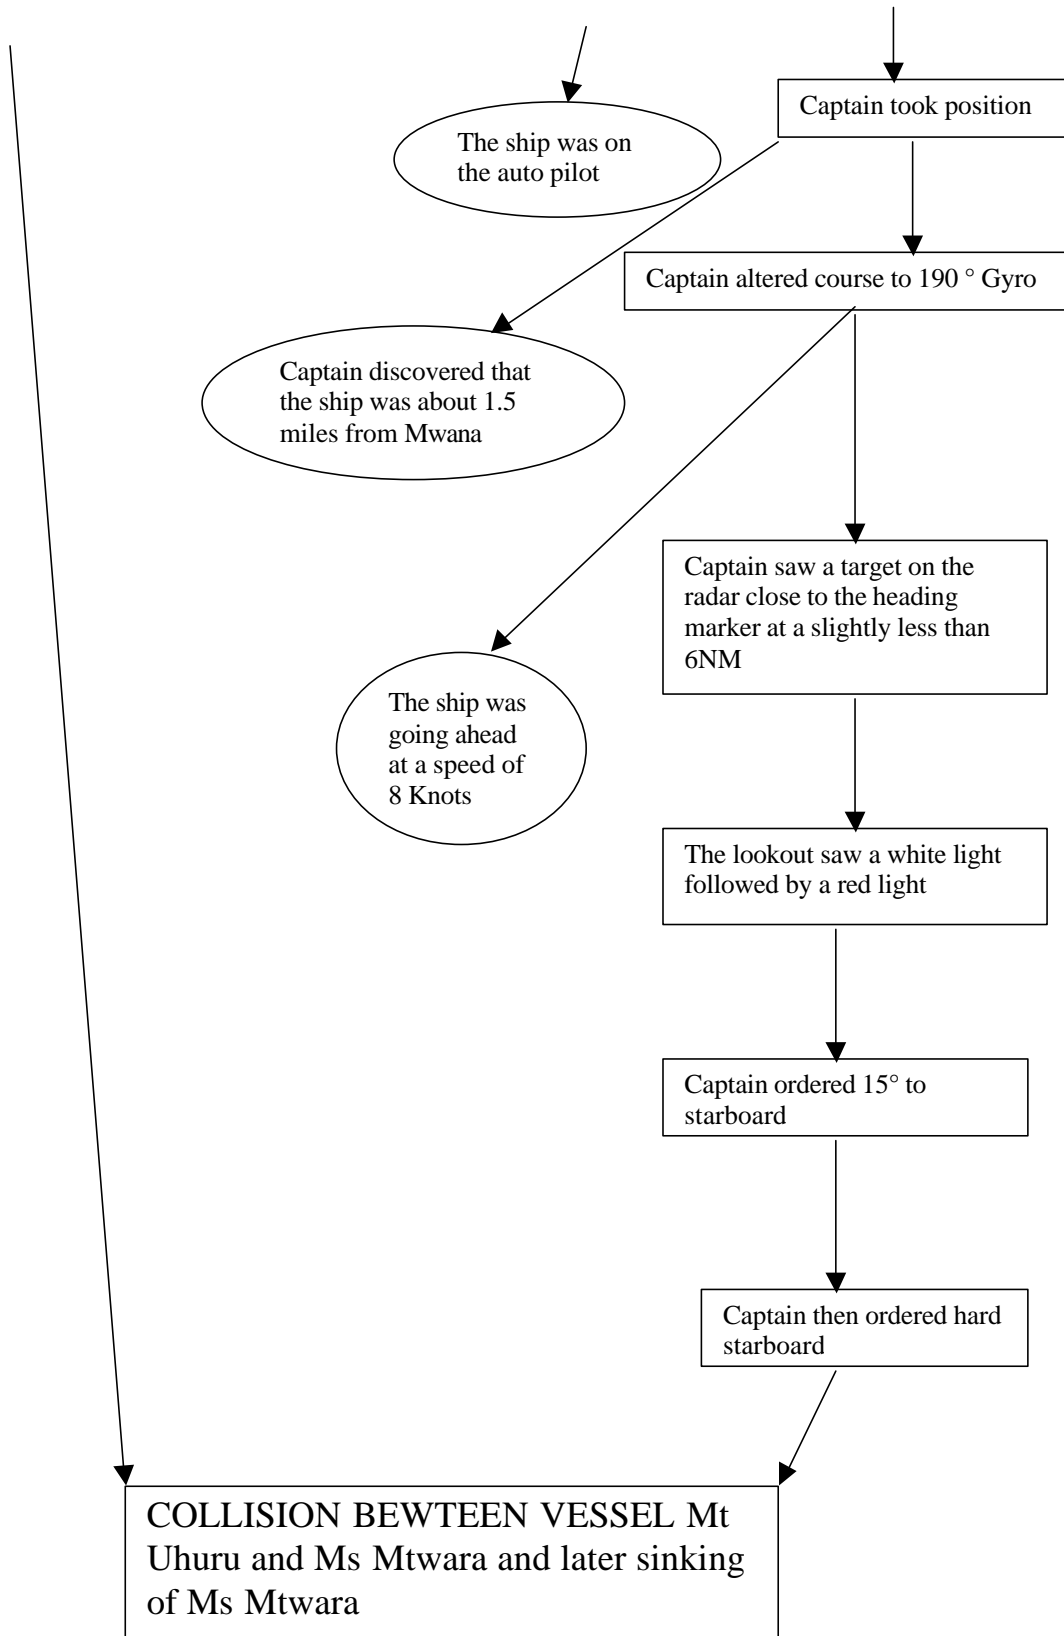
(Chart 1.0) Events and Causal Factors Analysis of the collision between tanker vessel Mt Uhuru and Passenger vessel Ms Mtwara

The signal station failed to mention that MT Uhuru had left Zanzibar. The apprentice was unable to determine the location of the vessel MS Mtwara just before the collision. His lack of knowledge, training, and experience in commanding a vessel prevented him from making proper judgement in altering to port instead to starboard in accordance to COLREG 1972.

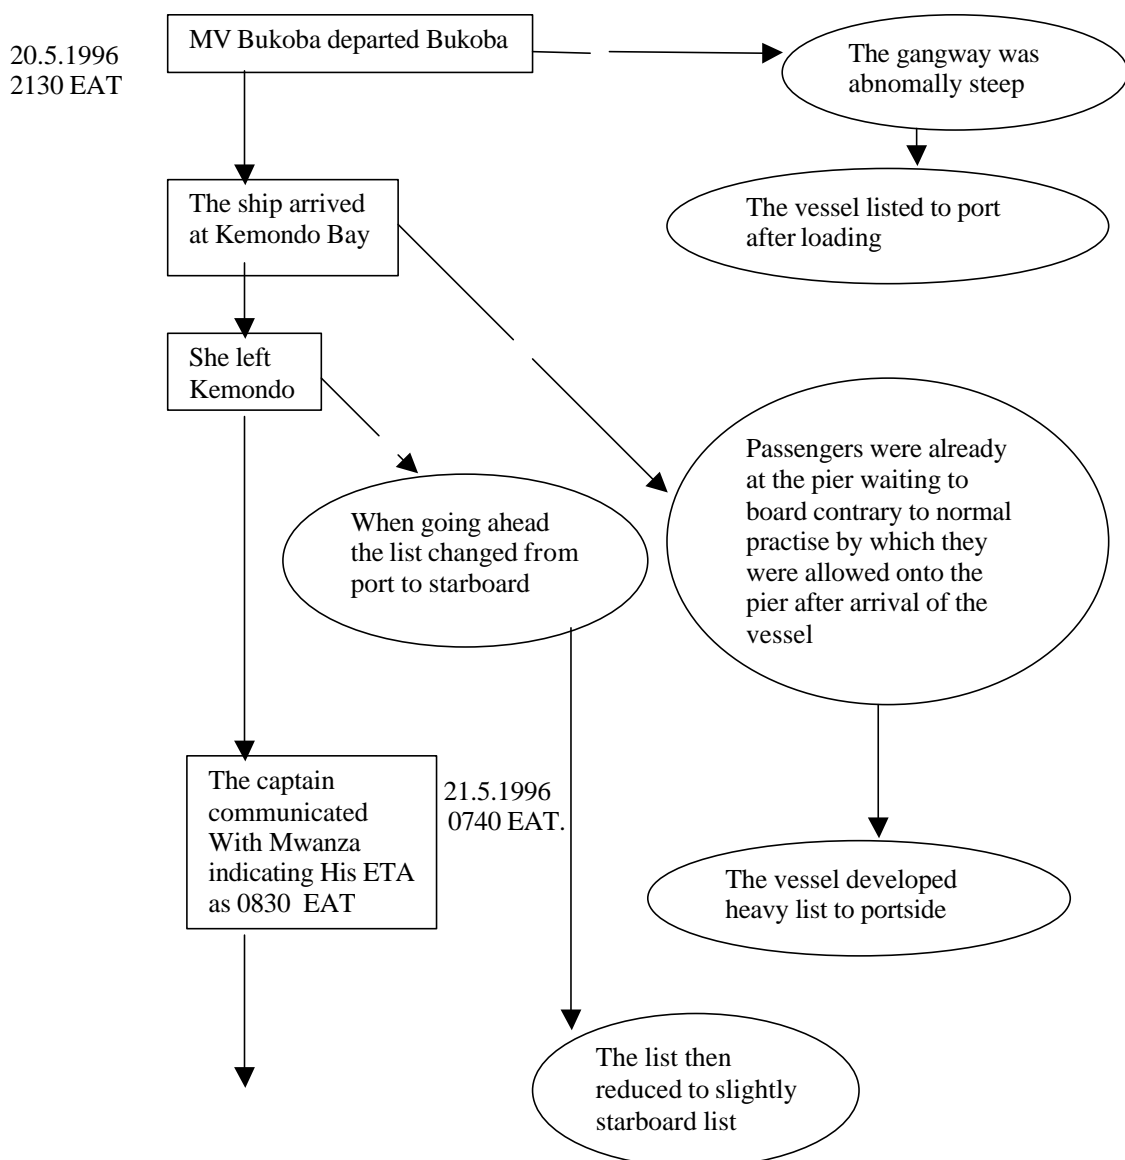
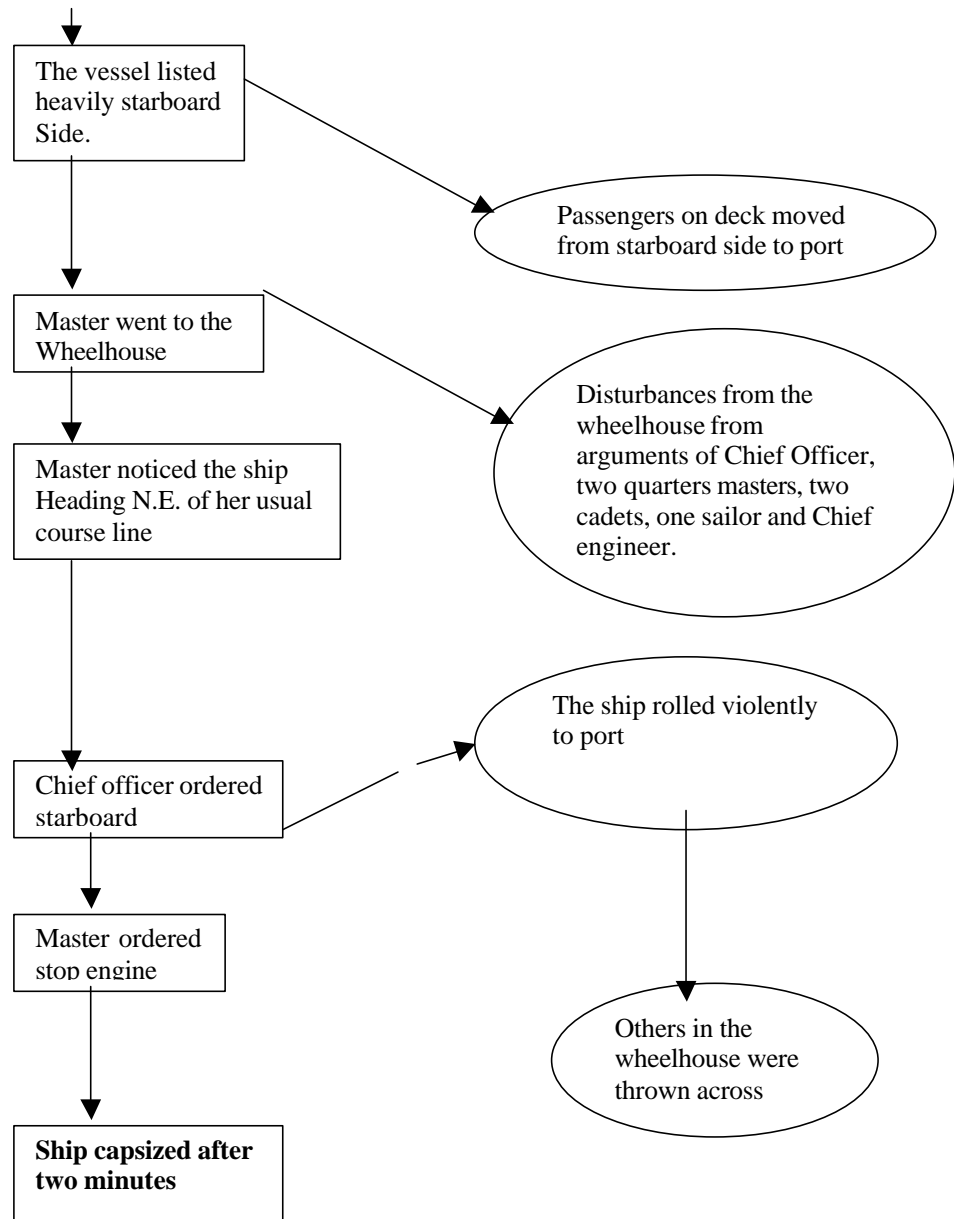
(Chart 2.0) Events and causal Factors Analysis of the Capsize of MV Bukoba

It was generally observed that MV Bukoba was listing slightly to port or starboard during her lifetime. Although the cause of list was not investigated on board the vessel, it is evident that it was either due to poor design or construction or both. Basically, TRC acquired a faulty ship from Belgium Shipbuilders Corporation (BSC) whose defects could not be detected for sometime until Danish expert came on the scene three years later. This problem originated from the contract itself which was drawn by the ship builders, and was heavily skewed in favour of the shipbuilders. The belgian party was adamantly reluctant to vary any of the terms in the contract inspite of numerous appeals from the Government of Tanzania. Due to the special circumstances prevailing at the time, especially the transportation crisis with the Government's financial weakness, the Tanzania Government apparently felt itself to have no option but to accept the unequal terms of the contract. Here are some of the contract articles which had serious anomalies:

1. MV Bukoba had a common tendency of listing to the portside or the starboard side.
2. The vessel had two shore communication systems both in good condition but internal communication between engine room and bridge was defective.

3. It was common practise to overload the vessel.
4. There was no stability booklet onboard.
5. Most of the senior officers onboard had no knowledge of ballasting conditions requiring permanent ballasting.

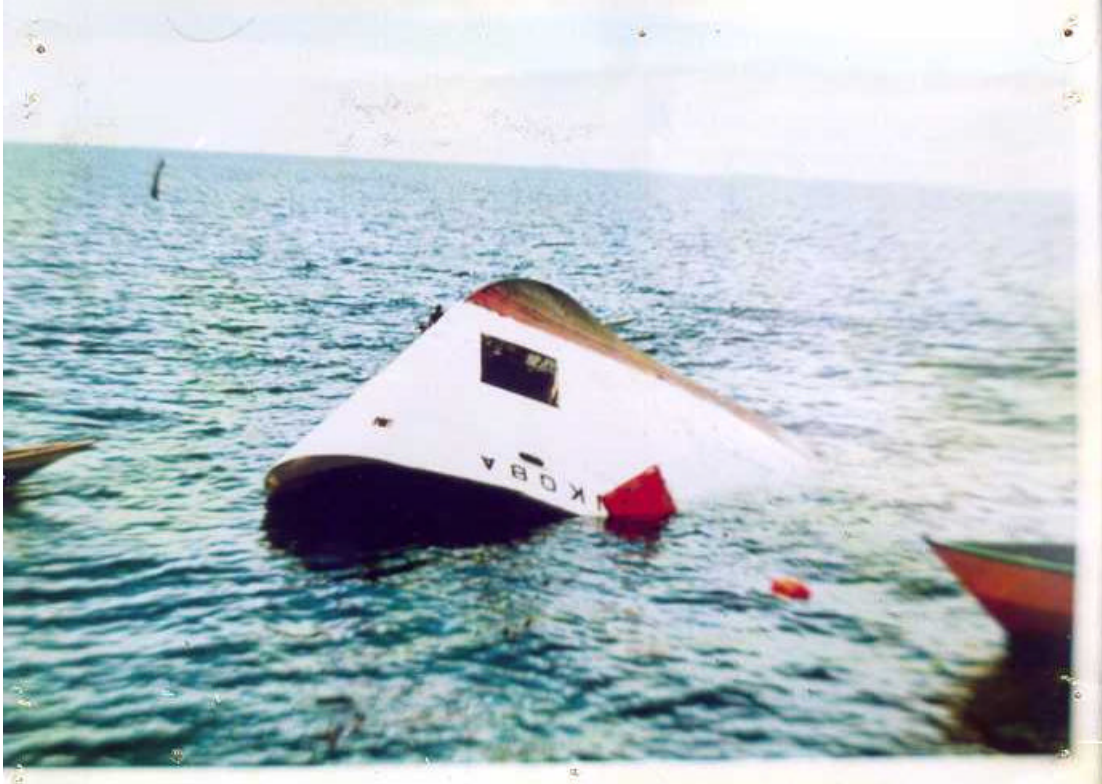
Picture 1.0: A hole cut by the TRC rescuers at the starboard bow

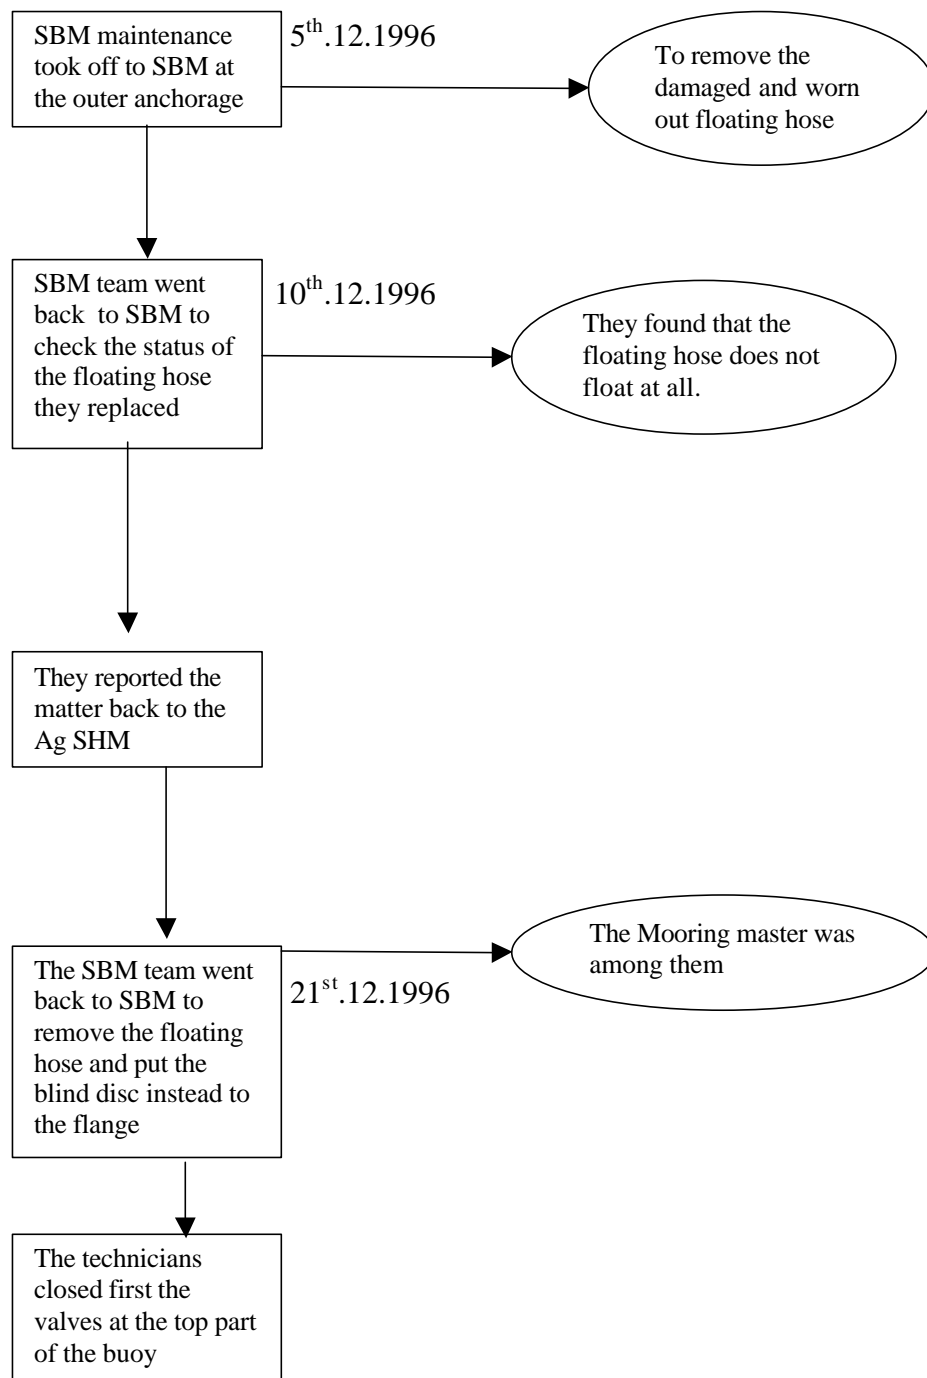
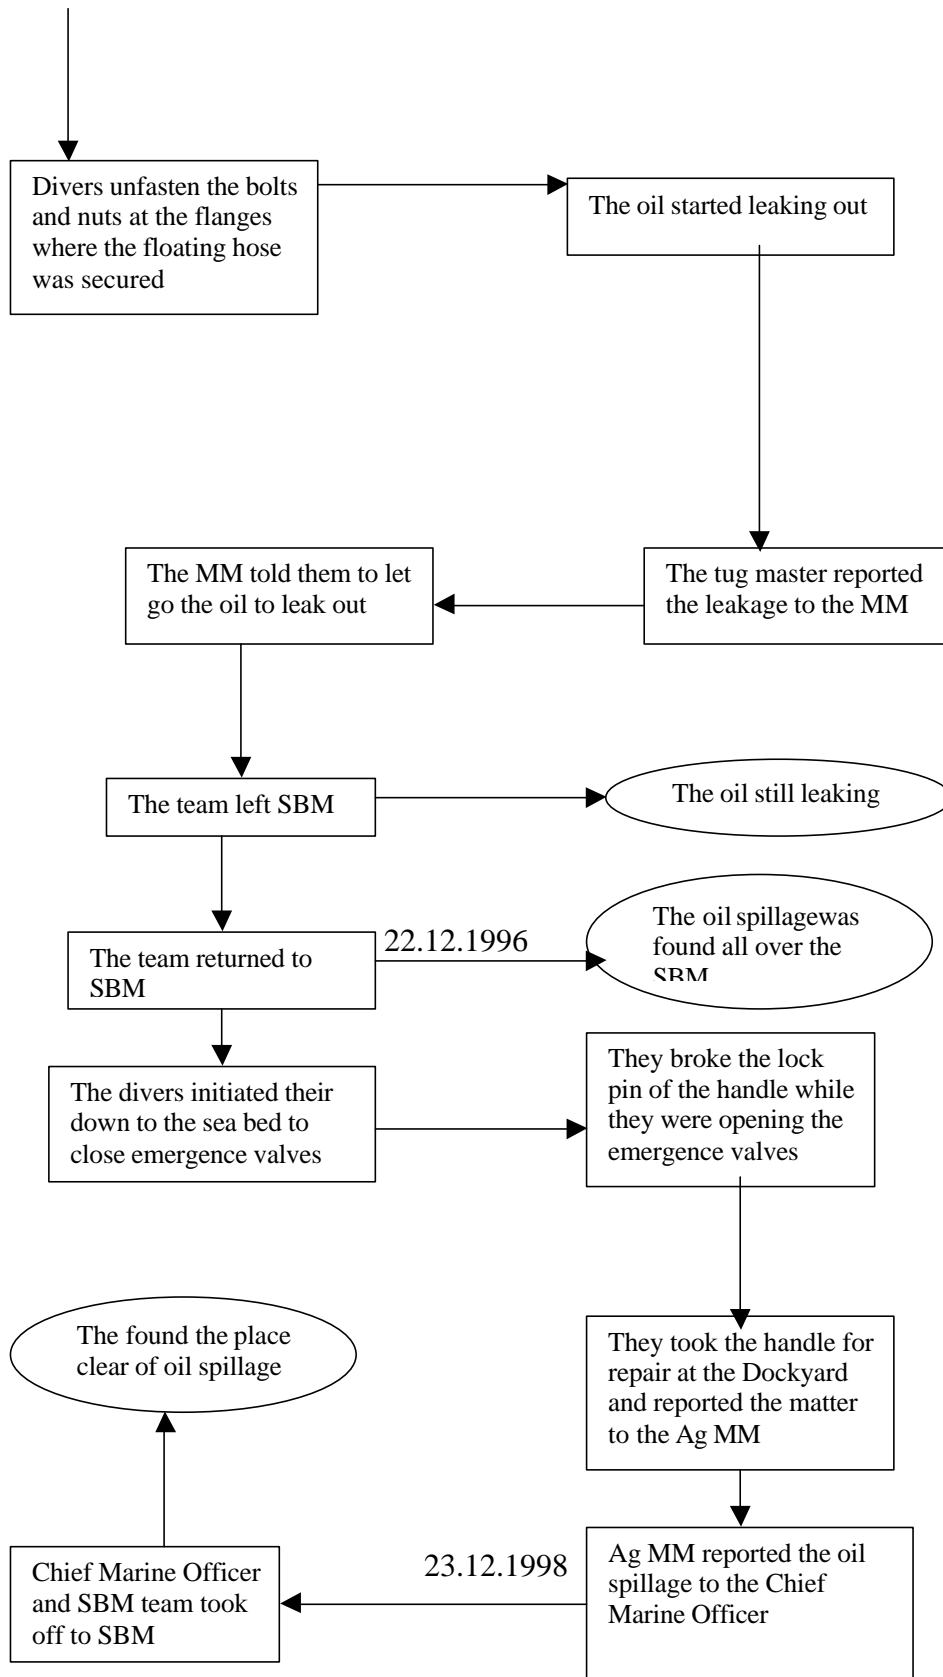
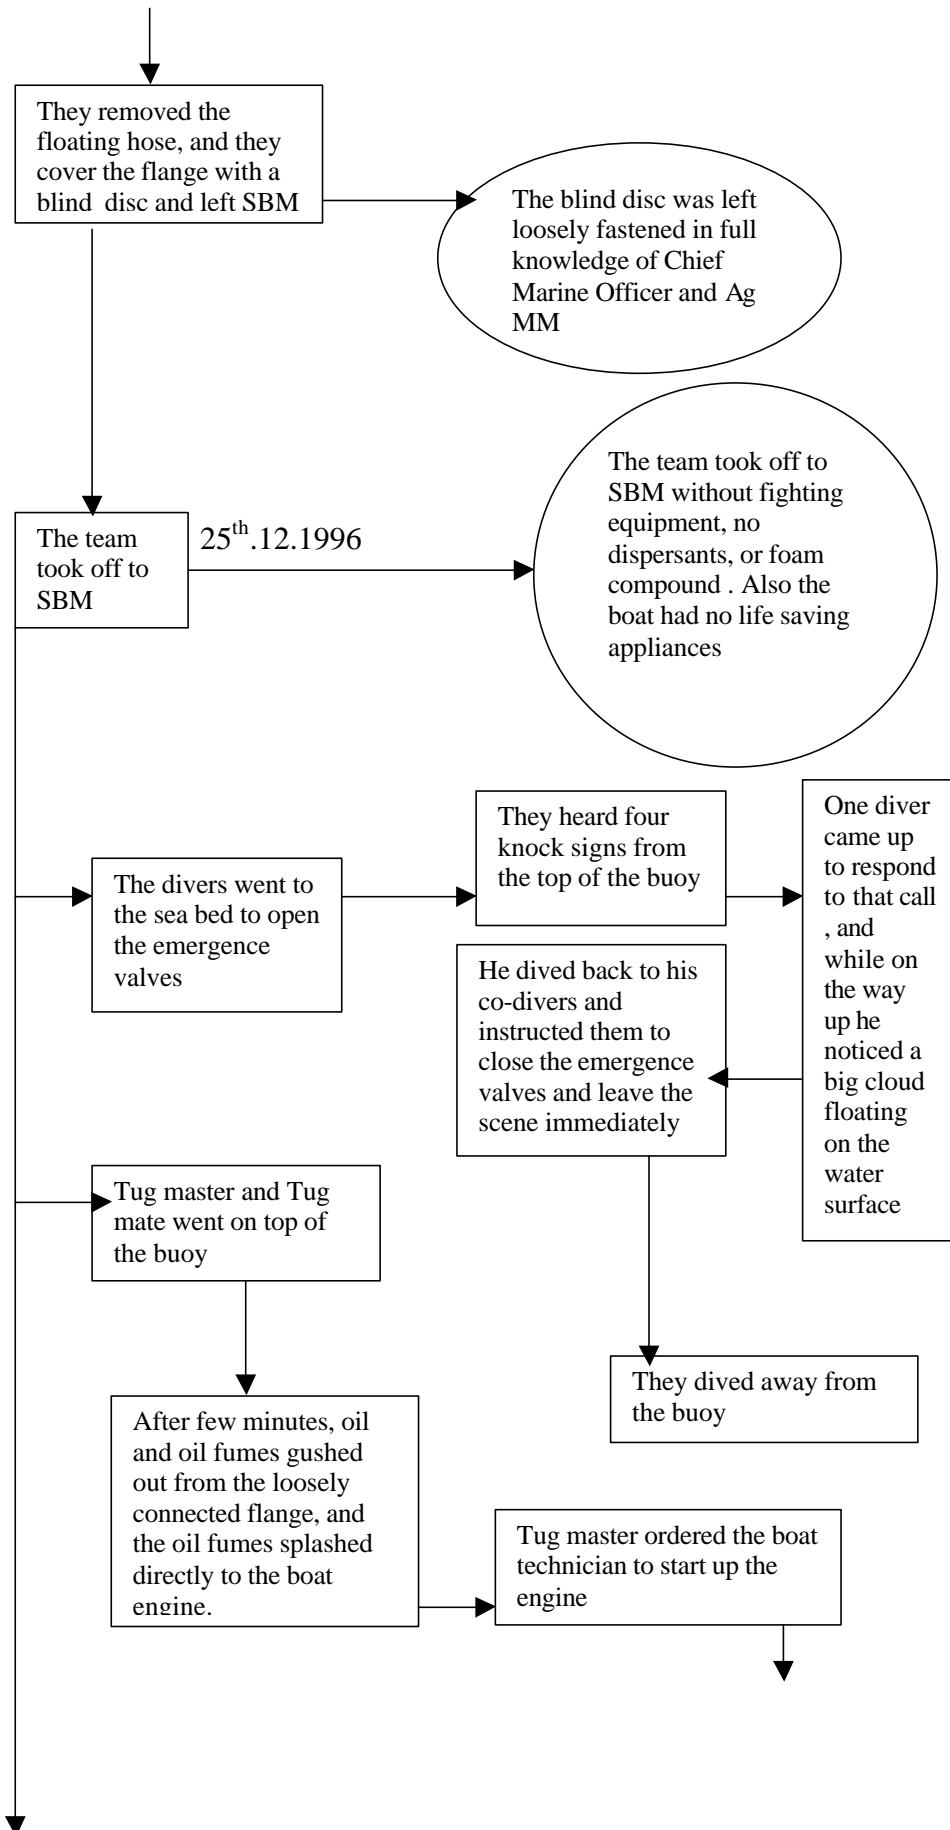
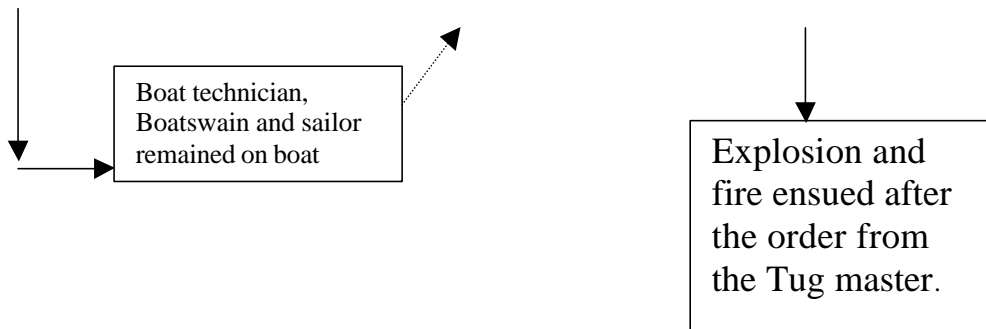
(Chart 3) Events and Causal Factors Analysis of the Fire/Explosion involving Mv INZI and SBM (Single Buoy Mooring)

The boat herself was not fit for that kind of job and not even recommended by the IOCMF which deals with oil safety precautions at oil terminals and was operating the SBM without complying IOCMF regulations for about more than 10 years. The Tanzania Harbours Authority (THA) management is largely accountable for what has happened and contributed a lot to this fire accident.

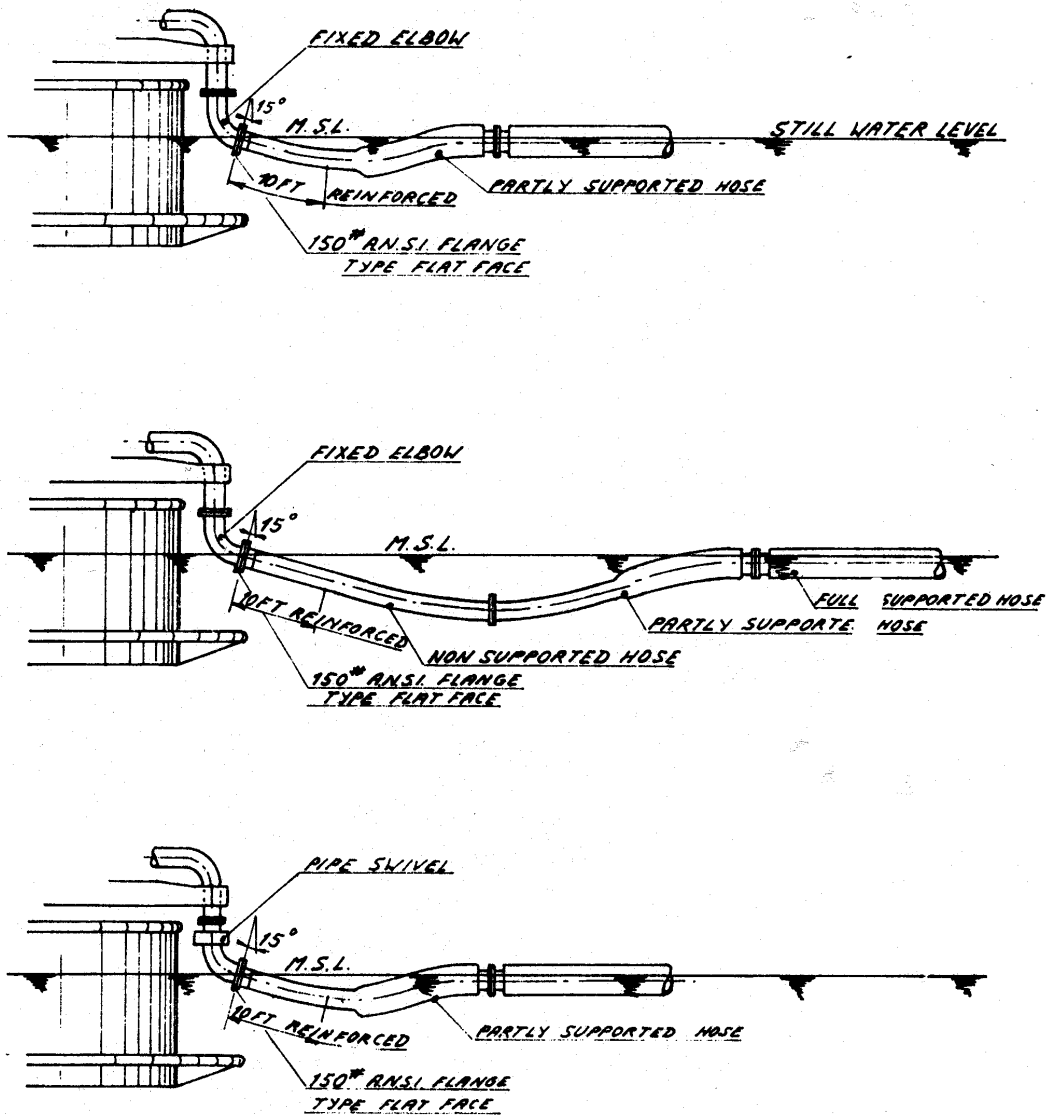
Mooring Master went on leave from 1st December 1996 until 30th December 1996. On 1st December 1996 he handed over his duties verbally to the Assistant Mooring Master on front of Harbour Master and Senior Harbour Master. The Mooring Master left the following assignment to be done on the SBM that is to repair the damaged and worn out floating hose, which was losing ability to float (Figure 3.0).

Figure 3.0 Different arrangements of floating hose

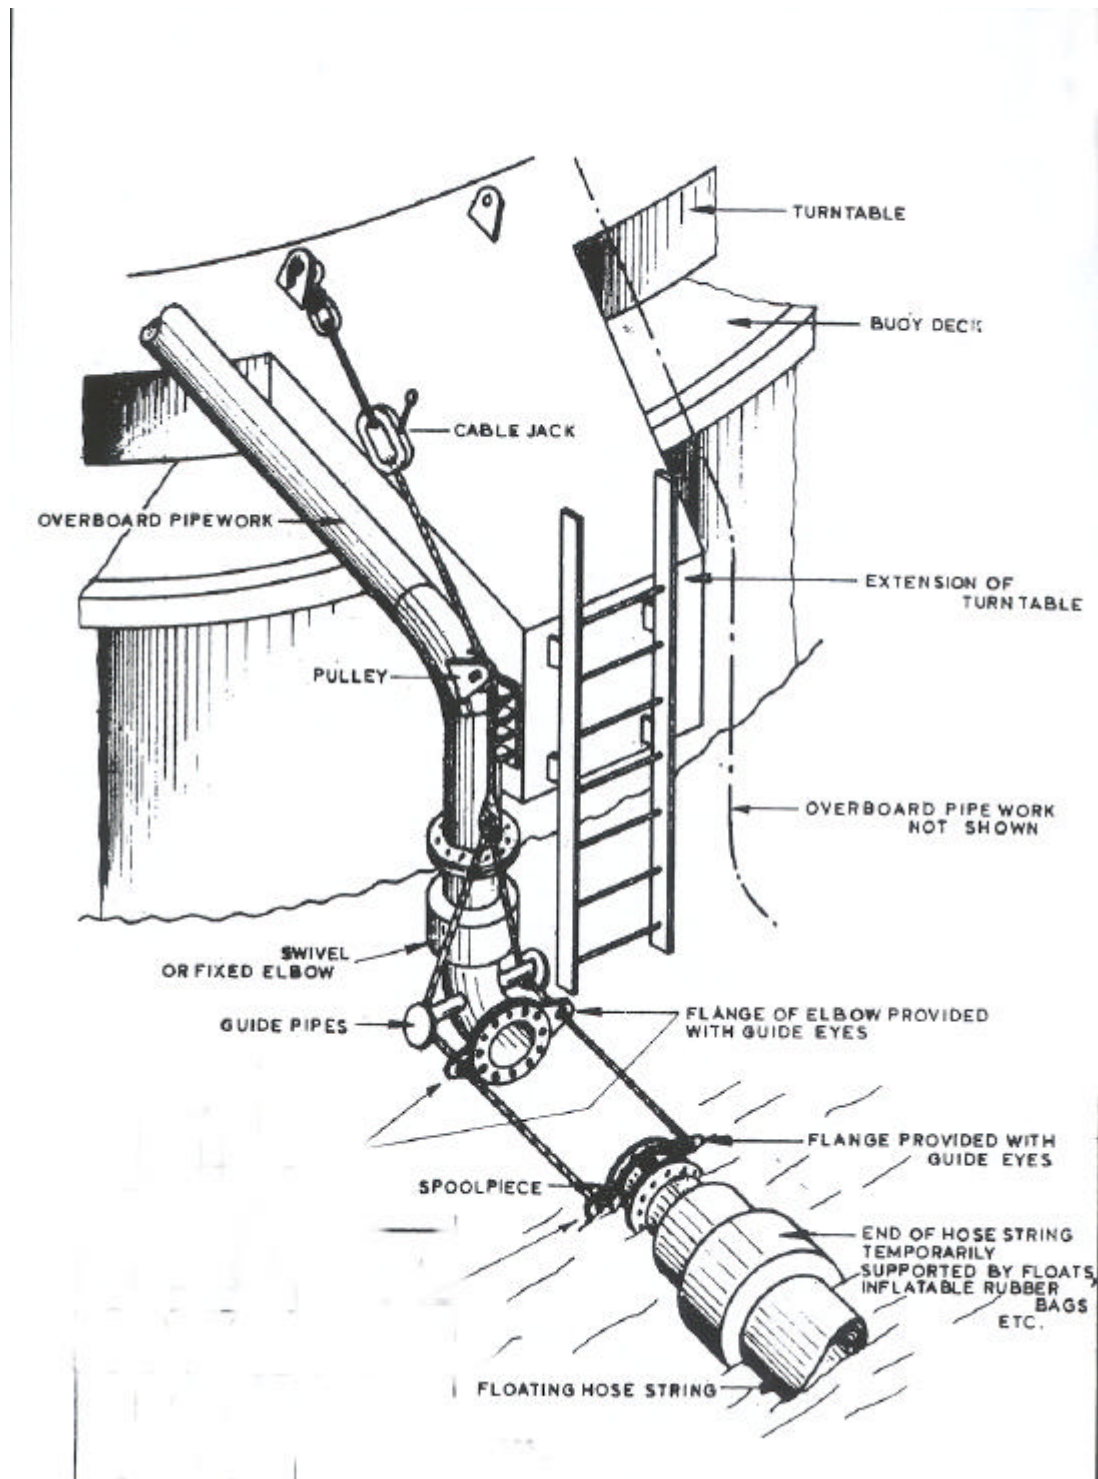
Figure 3.1 Flange where oil started leaking out
