Failure investigation of a protective epoxy coating by means of crosscheck between infrared spectroscopy and thermal analysis

Abstract

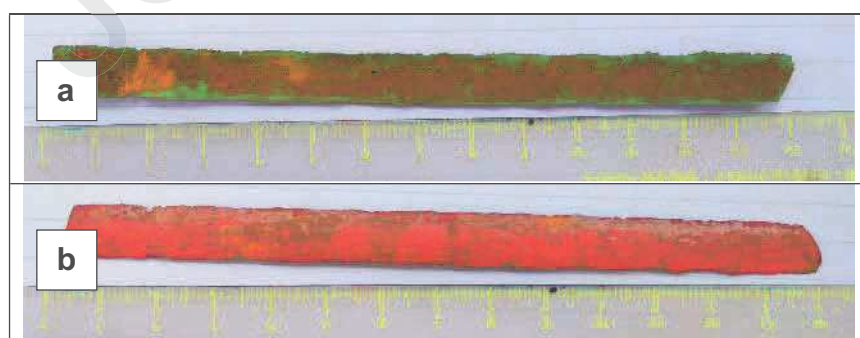
Visual inspection of green coating on sample A shows some surface sediments and pores all over sample surface (Figure 2). At optical microscope observation (Figure 4a), many cracks can be seen; cracks are spread all over sample surface.

Figure 2. Visual survey of sample A: (a) inner surface of the coating, facing conveyed fluid; (b) outer surface of the coating, facing the pipe wall.

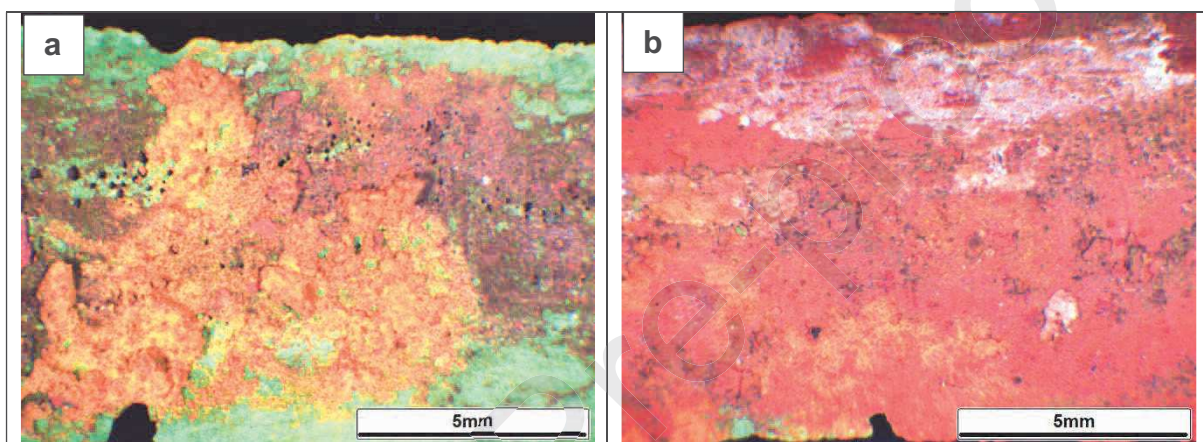
On red coating there are no evident porosities, but some sediments can be seen (Figure 4b), with colors ranging from ochre (lower part), to brown (central part) up to white (upper part). These deposits, probably already attached on pipe walls before coating application, were embedded inside the red coating.

Figure 4. Optical microscopy of sample A: (a) inner surface of the coating, facing conveyed fluid; (b) outer surface of the coating, facing the pipe wall (right).

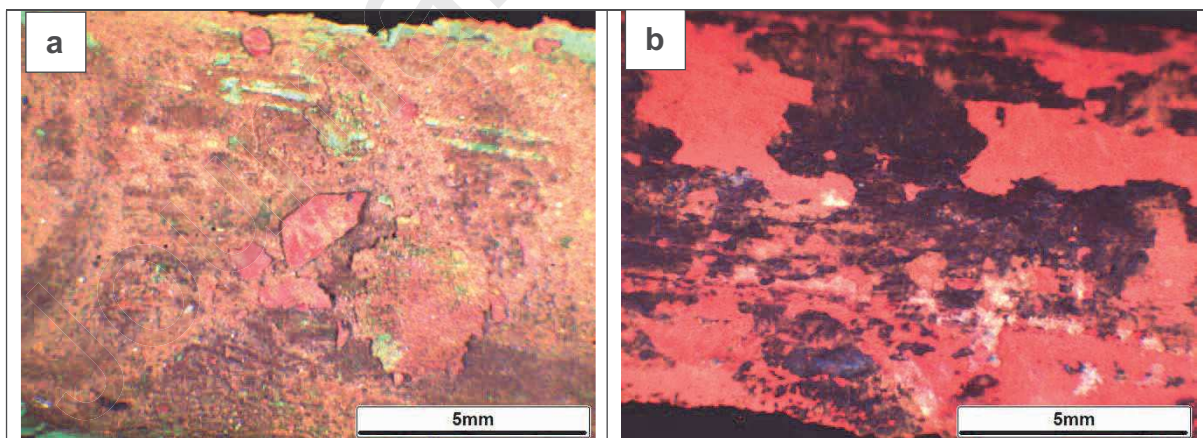
Green coating on sample B (Figure 3a, Figure 5a) appears brown-tarnished and it is characterized by many surface sediments. Some small pores are noticeable, even if less abundant than in sample 1. Red coating on sample 2 (Figure 3b, Figure 5b) is characterized by large dark areas; in other areas the red coating does not show deposits or cracks. Figure 6 shows a visual comparison of color change induced by simulated thermal aging on coatings: all samples were kept at the respective temperatures for 2 hours, except for samples at 120°C (which were left in the oven for 2 and 16 hours). Samples up to 120°C - 2h do not show significant color change, whereas for higher temperatures (or longer time at 120°C), an overall darkening effect is noticeable.

Figure 5 – optical microscopy of sample B: (a) inner surface of the coating, facing conveyed fluid; (b) outer surface of the coating, facing the pipe wall.

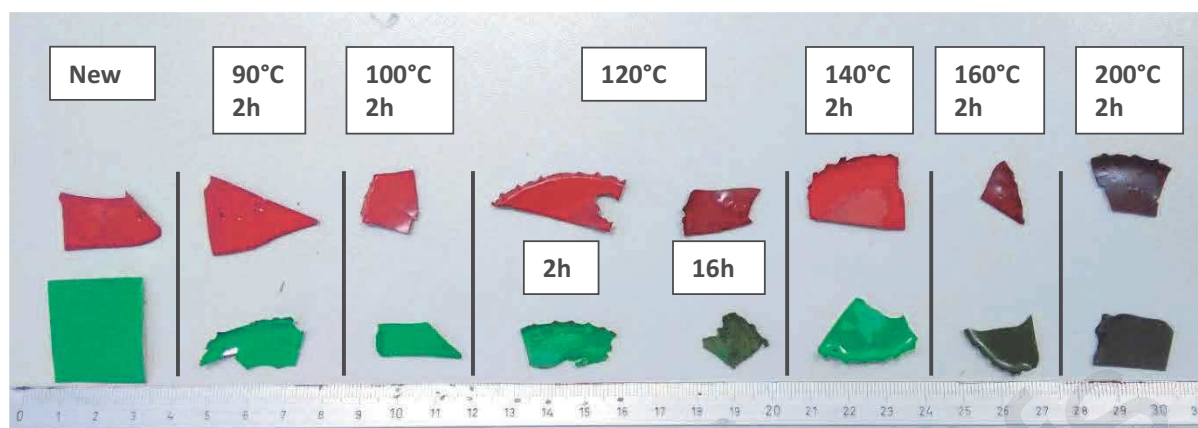
Figure 6 – Color change in samples subjected to thermal treatments.

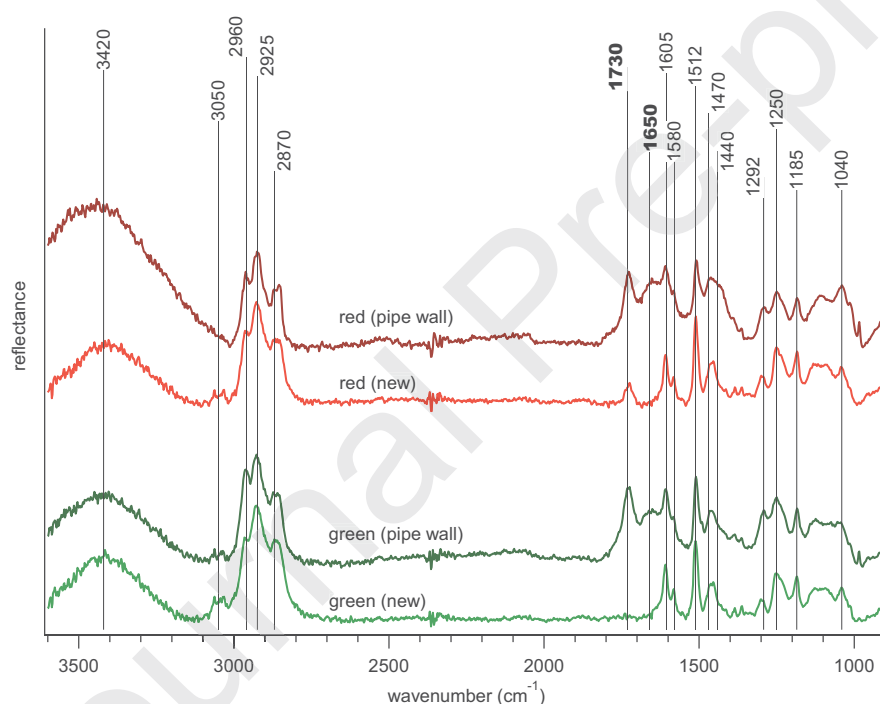
From the comparison (Figure 7) between the spectra of fresh green coating and detached green sample two additional peaks (at 1730 cm⁻¹ and 1650 cm⁻¹) can be noticed in the latter one. The first peak, related to carbonyl stretch, is usually associated with generic thermo-

oxidative degradation of polymers, while the second band is related to an “amide-I” vibration (carbonyl and C-N vibration overlap), typically linked to amine group oxidation [7–9]. Fresh red coating shows the same vibrational bands already seen for green paint; the only difference consists in a small peak linked to carbonyl group, most likely due to the presence of a filler or a dye. Spectra comparison (Figure 7) between new and detached red samples shows an extra peak at 1650 cm^{-1} (amide-I) and an increase in intensity of 1730 cm^{-1} peak (carbonyl stretch). These peaks, already examined in the previous case (green coating), are linked to thermo-oxidative degradation phenomena of epoxy resins [8–10].

Figure 7. FT-IR spectra of new coatings and coatings detached from the pipe wall, from bottom to top: fresh green paint, detached green sample, fresh red paint and detached red sample.

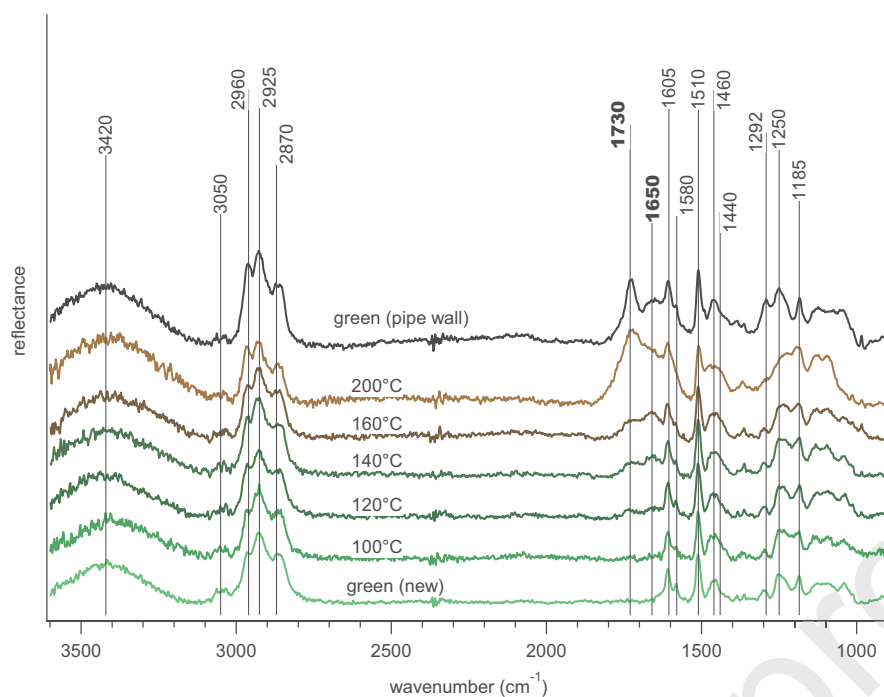
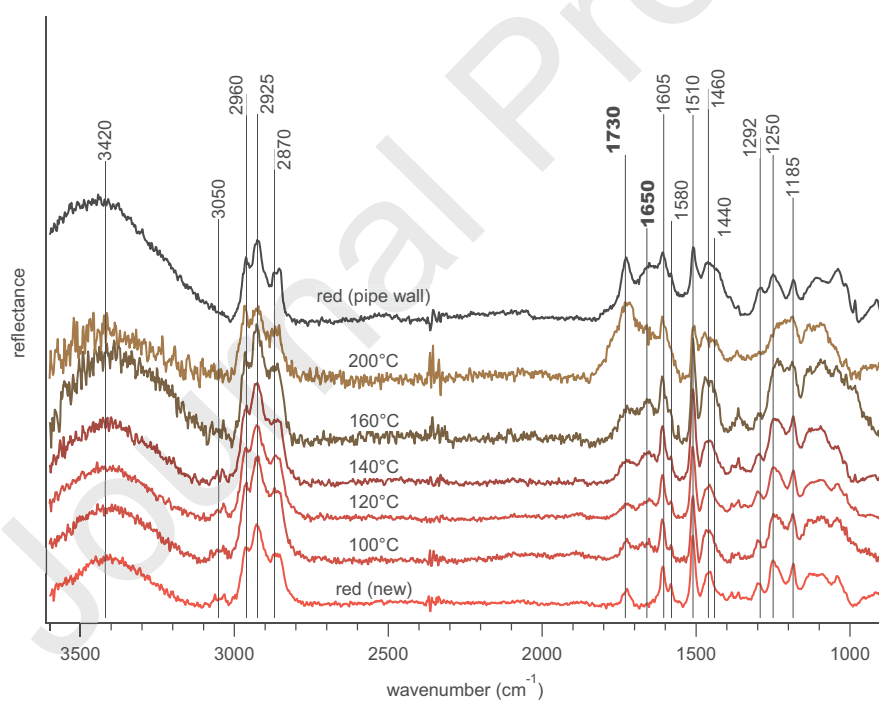
Aged coating spectra, if compared to new coating ones (Figure 8 and Figure 9), show the already mentioned extra peaks (1730 cm^{-1} and 1650 cm^{-1}). These peaks start emerging around $100\text{--}120^\circ\text{C}$. Intensities of degradation-related peaks rise with the aging temperature. The same peaks are visible in the spectrum acquired from coating detached from pipe walls, although the relative intensity ratio is different. The comparison between spectra of coatings aged for 2 hours at 120°C with those belonging to coatings aged for 16 hours at the same temperature (Figure 9, Figure 10 and Figure 11) shows how the degradation-related peaks (1730 cm^{-1} and 1650 cm^{-1}) intensities increase for longer aging times.

Figure 8. FT-IR spectra comparison of laboratory aged green sample with fresh green coating and detached green coating, from bottom to top: new green coating, aged green coatings (aging temperature above the curves) and green coating detached from the pipe wall.

Figure 9. FT-IR spectra of aged red coating compared with new and detached red coatings, from the bottom: new red coating, aged red coatings (aging temperature above the curve) and red coating detached from the pipe wall.

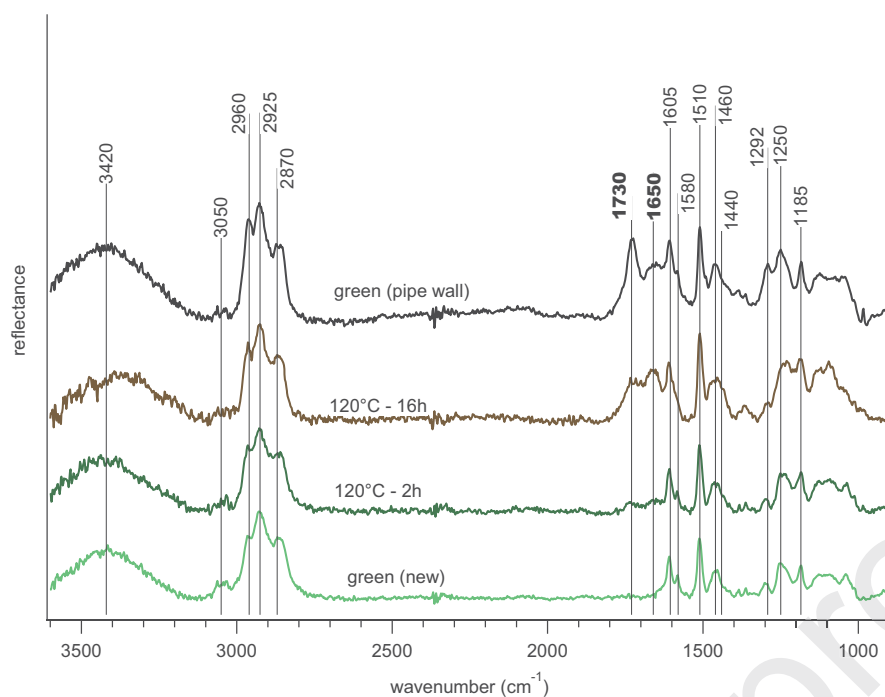
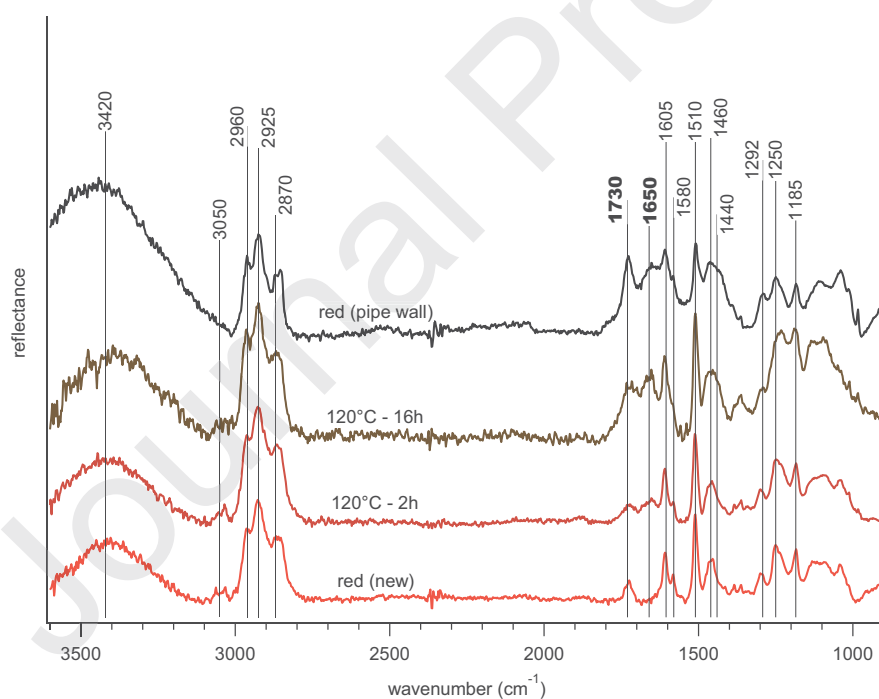
Figure 10. FT-IR spectra of aged green coatings at 120°C 2h (dark green curve) and 16h (brown curve), new green coating (bottom green curve) and green coating detached from the pipe wall (black curve).

Figure 11. FT-IR spectra of new red coating (bottom curve), red coatings aged at 120°C for 2h (dark red curve) and for 16h (brown curve) and red coating detached from the pipe wall (black curve).

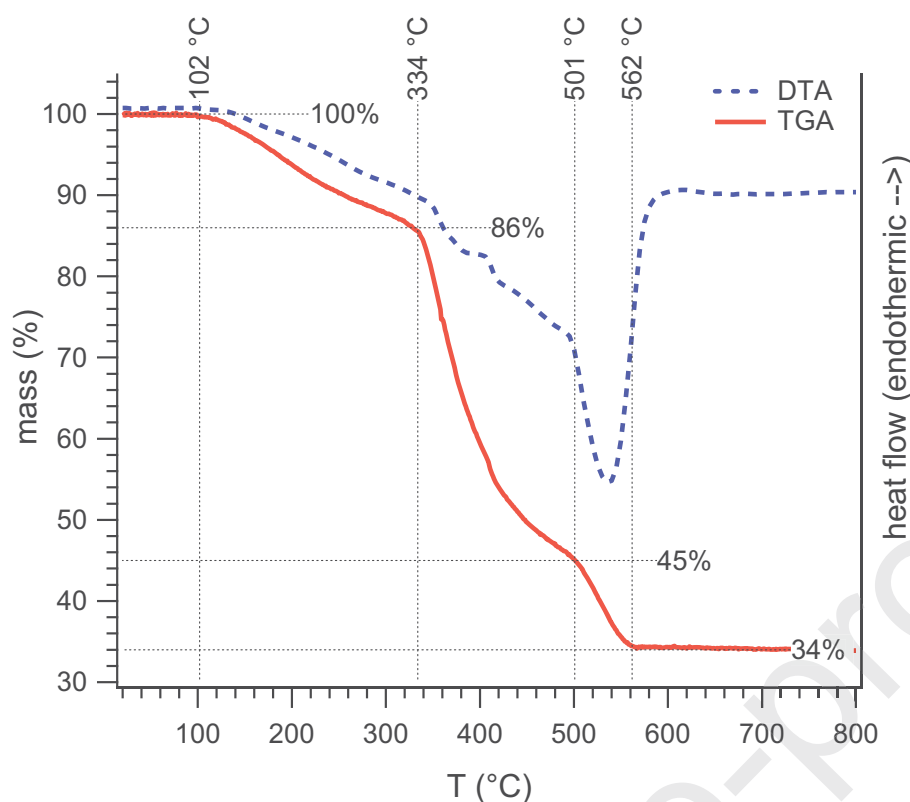
Figure 12. TGA and DTA curves of coating produced in laboratory.

DSC measurements on the coating detached from the pipe wall and on fresh prepared coating did not show any exothermic peaks in the 20°C-200°C range, pointing out a complete cross-linking [11,12]. The fresh coating showed a glass transition temperature around 165°C, in line with previously reported data for similar compounds [13]. We performed simultaneous thermal analysis (TGA and DTA curves) on the fresh coating, to study mass change and heat evolution as a function of temperature. TGA and DTA are reported in Figure 12. Coating starts losing mass above 100 °C; a first degradation step (102-334°C) correspond to a loss of 14% original sample mass; a second, faster degradation step (335-501°C) – residual mass 45%; and the final step concluding around 560°C. Residual inorganic mass is about 33% of the original sample mass. The starting temperature of the first degradation step (102°C) complies with the starting of the thermo-oxidative degradation detected after aging simulation in oven. DTA show evolution of heat between 110°C and 600°C, with two exothermic feature between 102-300°C, 330-500°C, and one exothermic peaks around 540°C, corresponding to the mass decreasing steps seen in TGA.
