# The San Francisco Earthquake and Fire April 18, 1906 and Their Effects on Structures and Structural Materials

US Department of the Interior

THE  
SAN FRANCISCO EARTHQUAKE AND FIRE  
OF  
APRIL 18, 1906  
AND THEIR EFFECTS ON STRUCTURES AND  
STRUCTURAL MATERIALS

REPORTS BY  
GROVE KARL GILBERT, RICHARD LEWIS HUMPHREY,  
JOHN STEPHEN SEWELL, AND FRANK SOULÉ

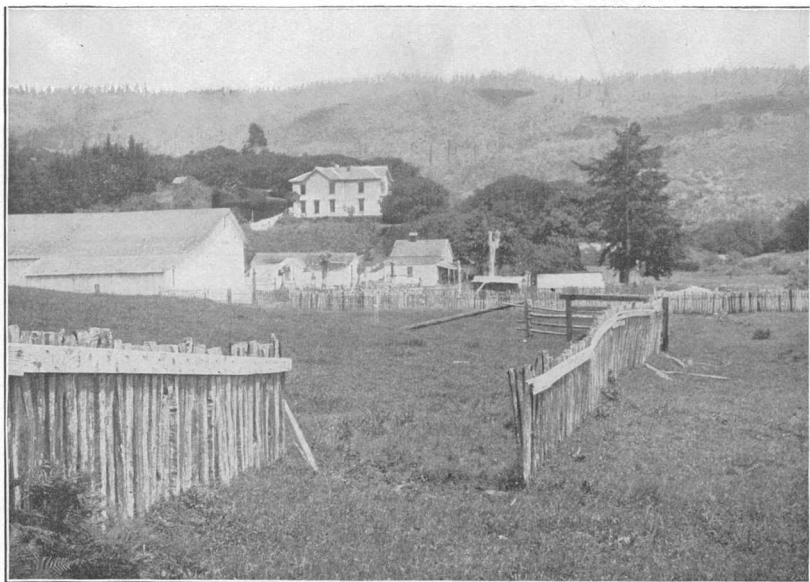
B. FENCE PARTED BY EARTHQUAKE FAULT.

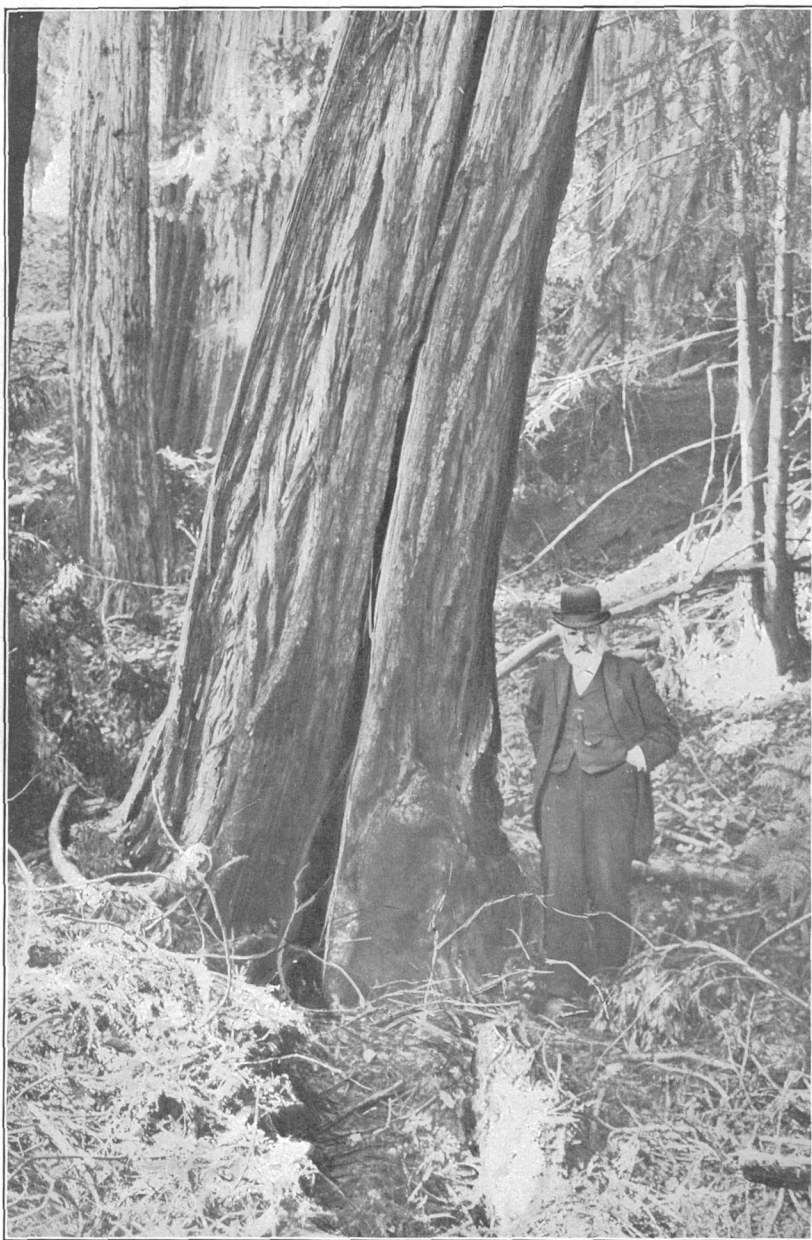
REDWOOD TREE 6 FEET IN DIAMETER ON LINE OF FAULT SOUTH OF FORT ROSS.

The tree was split to a height of 35 feet, although the horizontal displacement was slight. The opening is wedge-shaped at the base, running from a width of 8 inches on the side shown to a fine crack on the farther side. Photograph by Richard L. Humphrey.

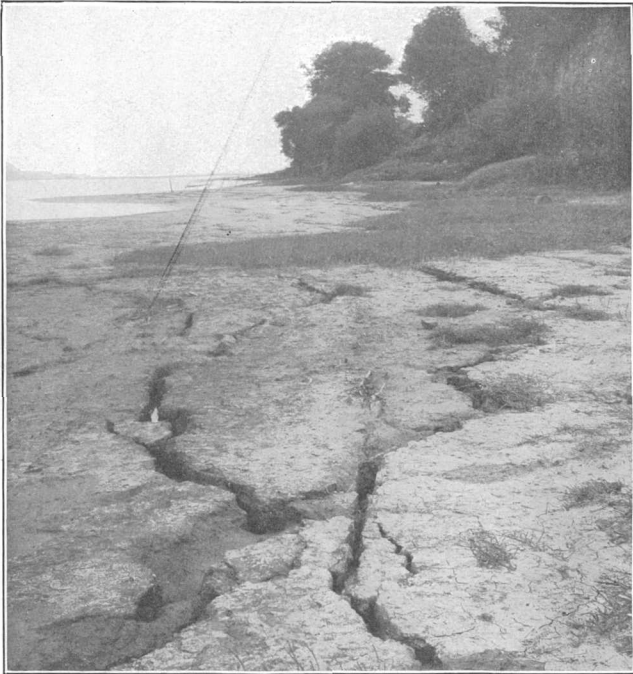
A. SECONDARY CRACKS, SHORE OF BOLINAS LAGOON.

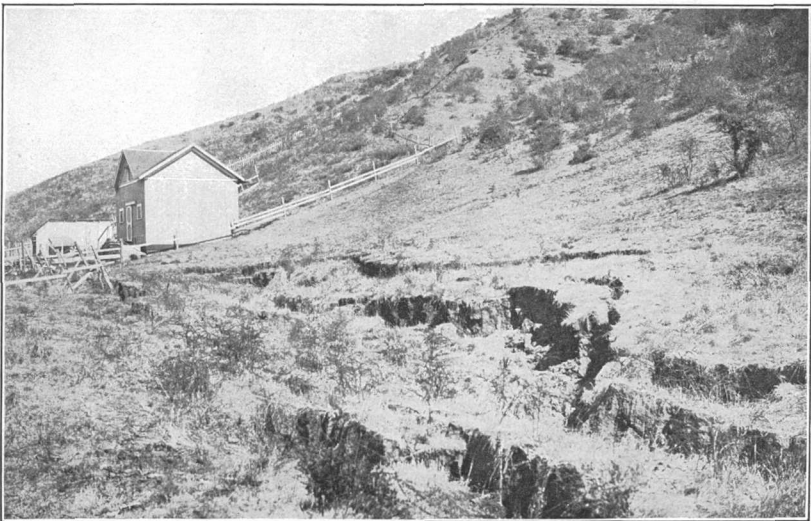
B. SECONDARY CRACKS, WITH SETTLING, BOLINAS.

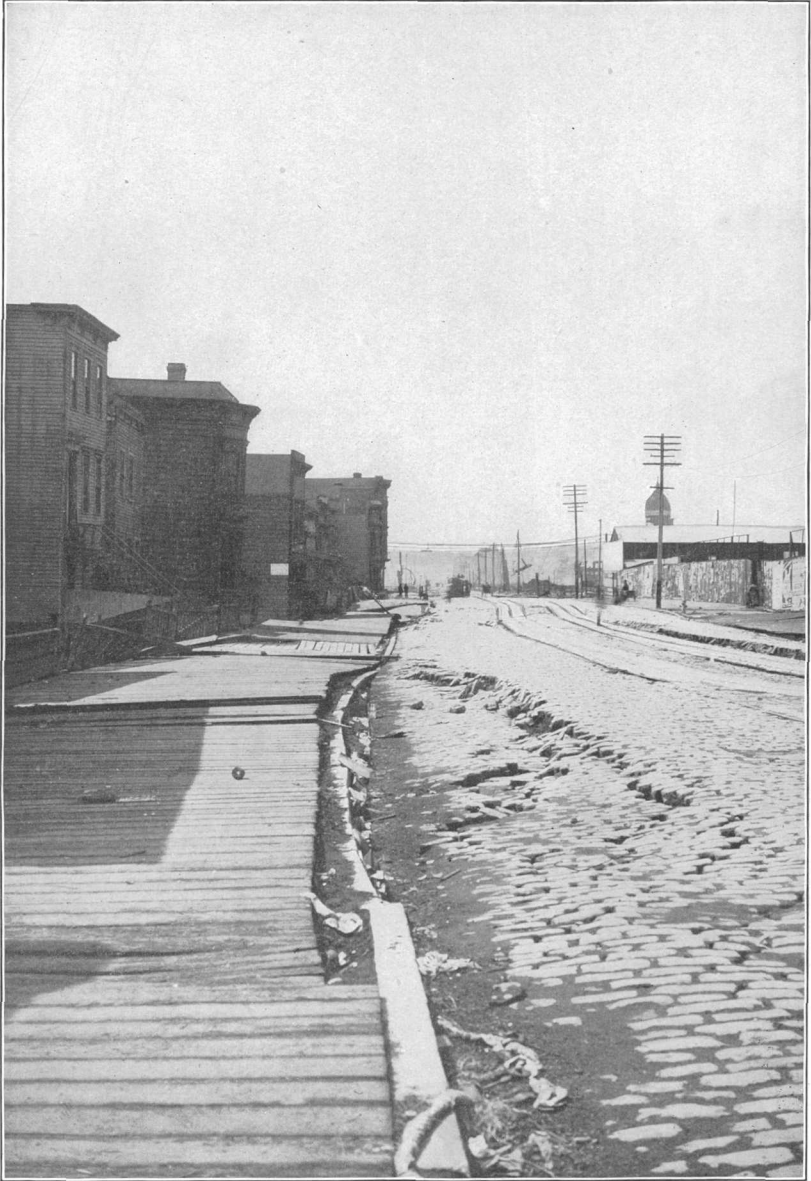
RESULTS OF EARTH FLOW, NINTH STREET, SAN FRANCISCO.

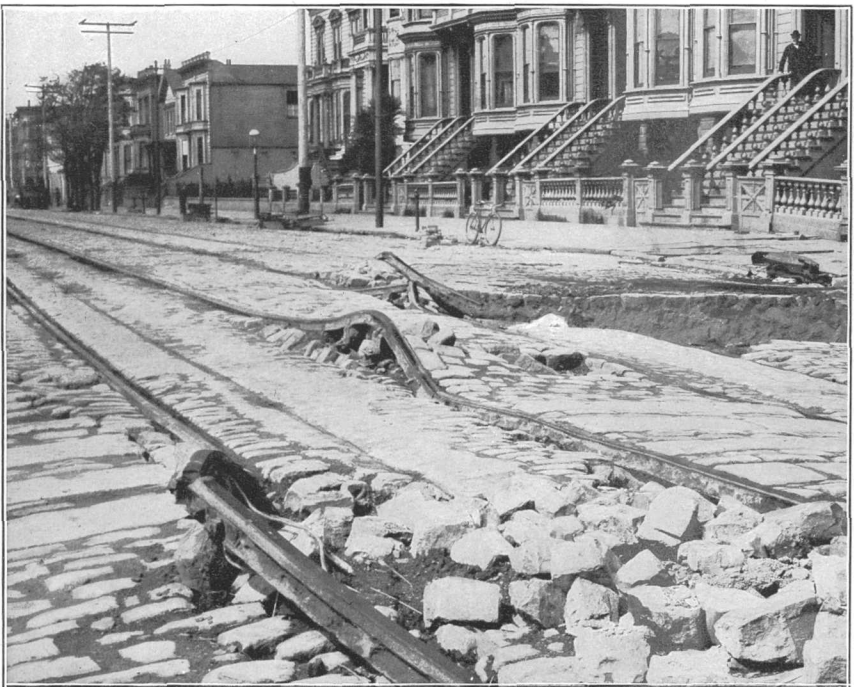
B. BUCKLING CAUSED BY EARTH FLOW, HOWARD STREET, SAN FRANCISCO.

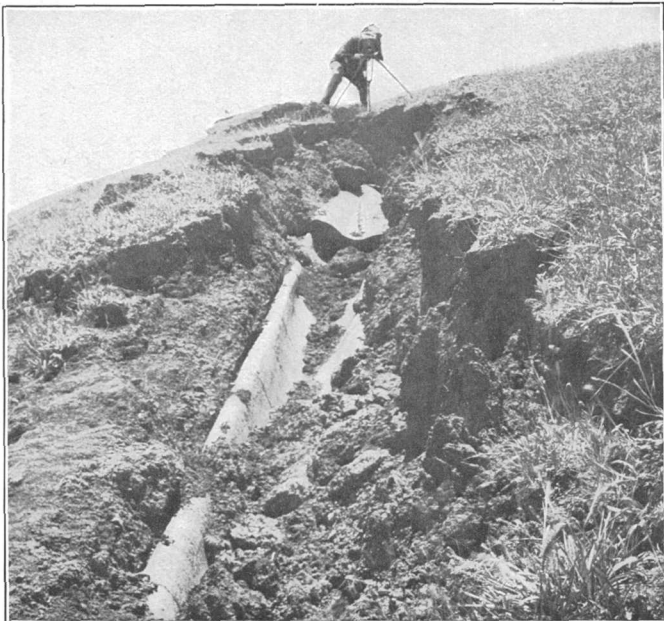
A. COLLAPSED PILARCITOS 30-INCH WROUGHT-IRON PIPE LINE, NEAR TRESTLE CROSSING THE FAULT.

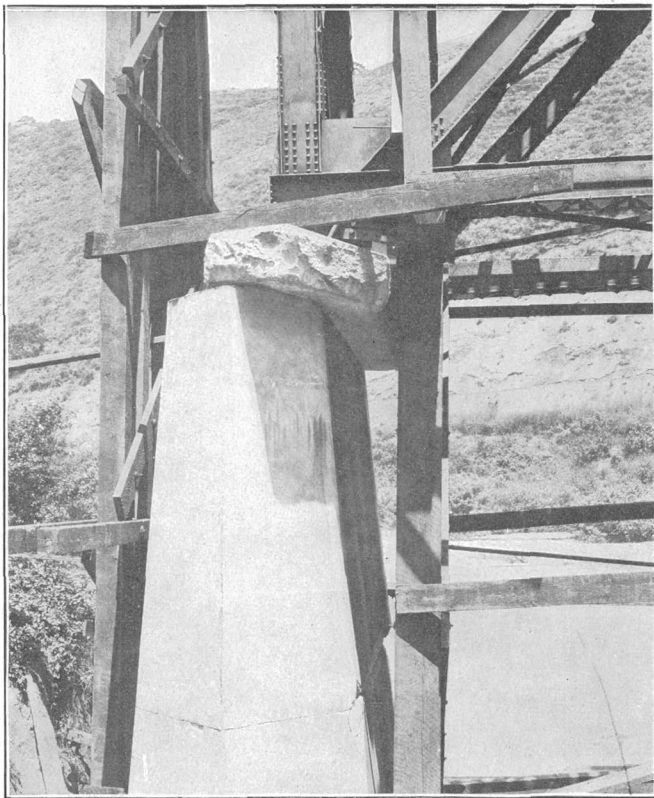
A. RACKING AND SPALLING OF CONCRETE PIER DUE TO EARTHQUAKE.

Near south abutment of Southern Pacific Railroad bridge over Pajaro River. Photograph by Richard L. Humphrey.

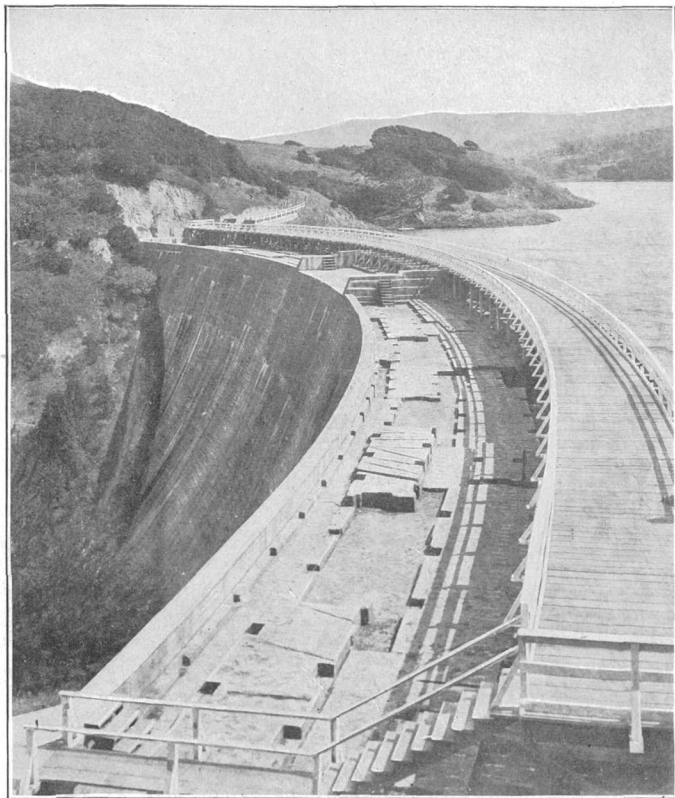
B. ENDURANCE OF CONCRETE DAM NEAR FAULT TRACE, AT CRYSTAL SPRINGS LAKE, SAN MATEO:

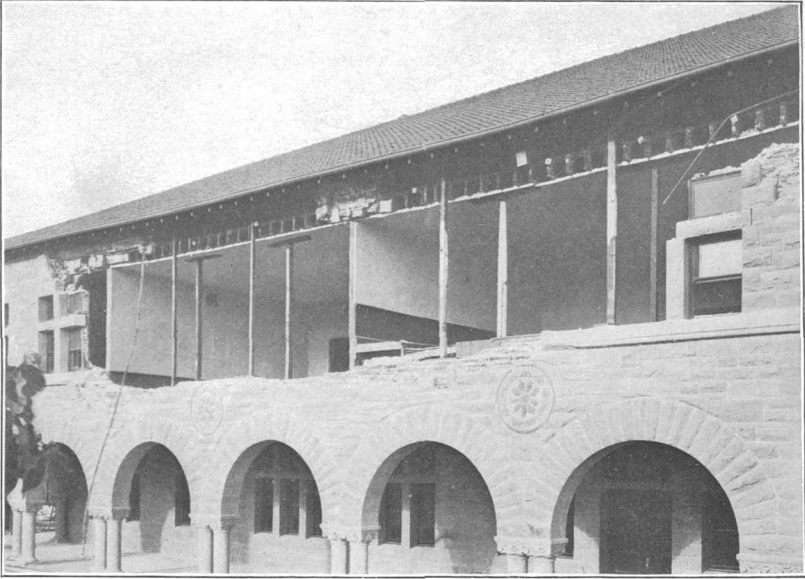
A. EARTHQUAKE DAMAGE DUE TO LACK OF TIE AND BRACING, GEOLOGICAL DEPARTMENT, LELAND STANFORD JUNIOR UNIVERSITY.

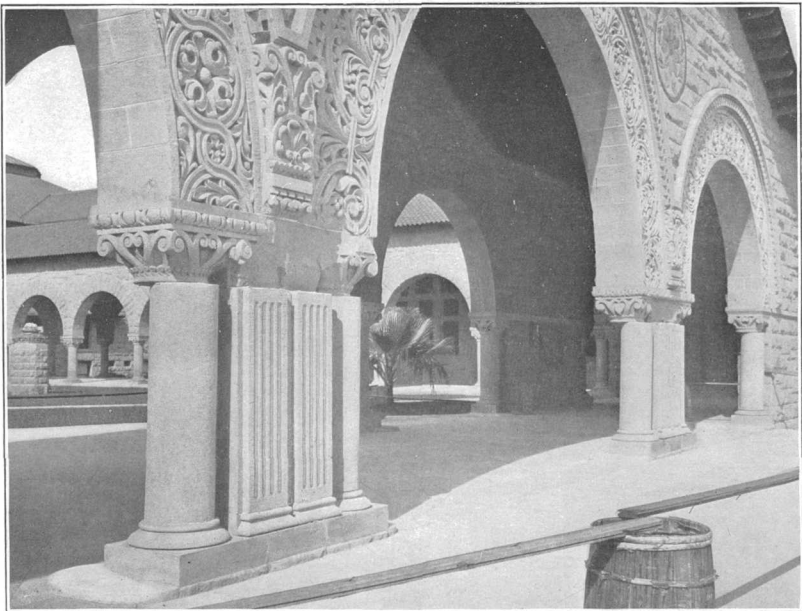
B. EARTHQUAKE EFFECT ON ARCHES, LELAND STANFORD JUNIOR UNIVERSITY.

Spalling of caps and movement of upper part of columns. Photograph by Richard L. Humphrey.

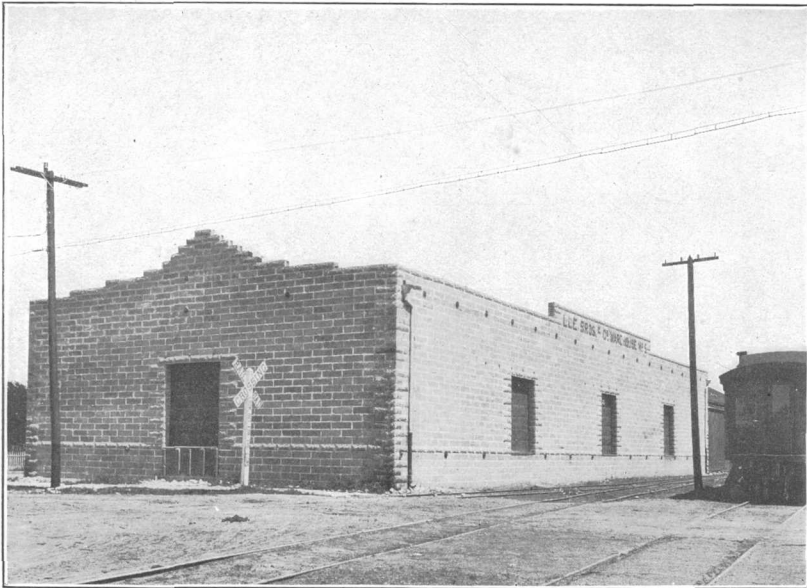
A. ENDURANCE OF WALLS TIED TOGETHER WITH STEEL RODS, LEE BROTHERS' WAREHOUSE, SANTA ROSA.

Slightly damaged at cornice. The few blocks which were thrown down by the earthquake were replaced previous to the taking of the photograph.

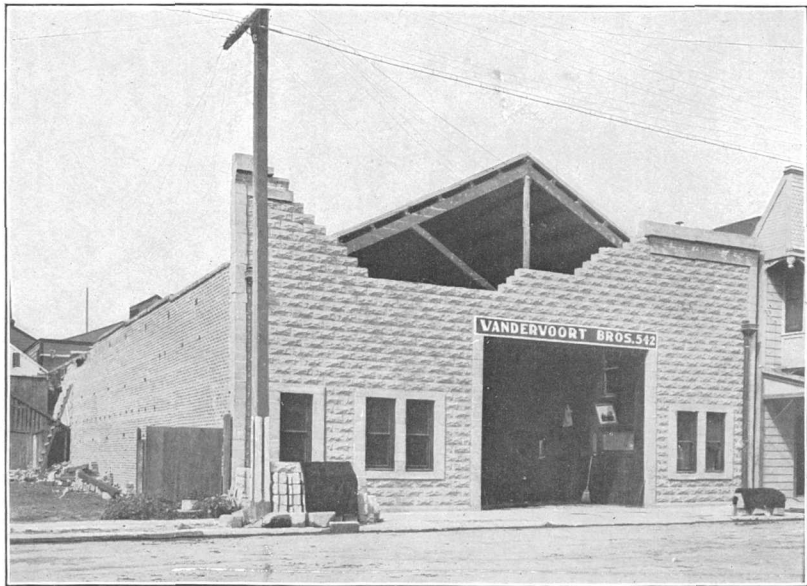
B. WALL THROWN DOWN BY EARTHQUAKE VIBRATIONS OF ROOF TRUSSES WHICH WERE NOT TIED TO WALL, VANDERVOORT BROTHERS' LIVERY, PALO ALTO.

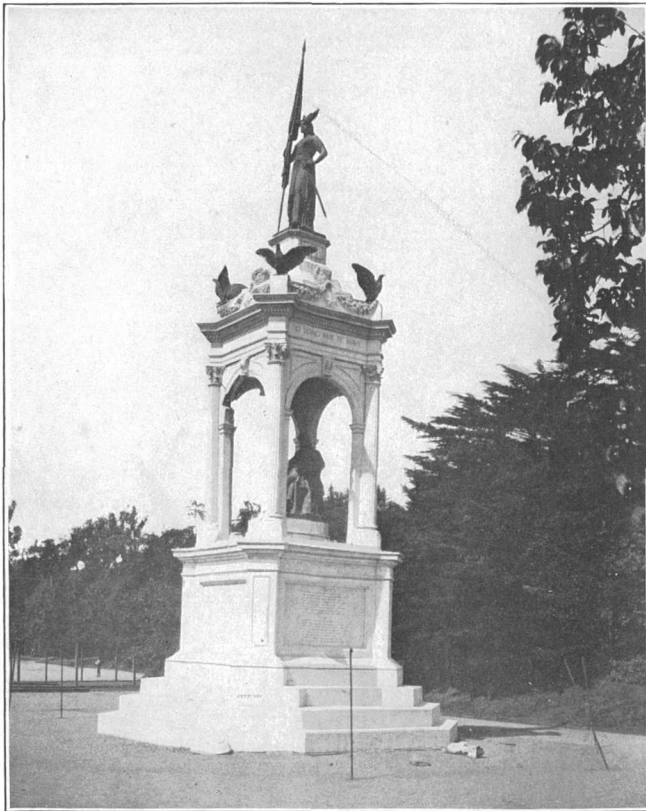
A. LOOSENING OF ARCH STONES AND SPALLING OF COLUMNS BY EARTHQUAKE, FRANCIS SCOTT KEY MONUMENT, GOLDEN GATE PARK, SAN FRANCISCO.

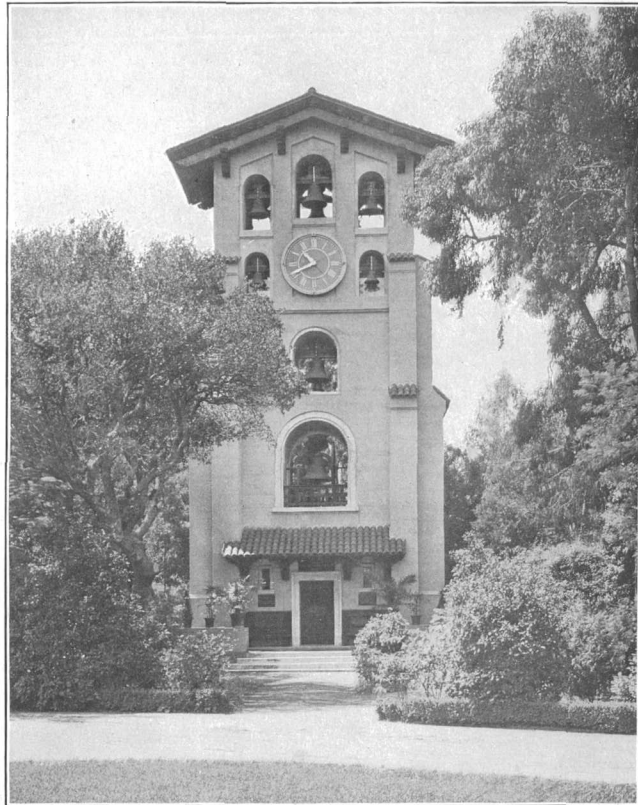
B. UNDAMAGED REINFORCED-CONCRETE STRUCTURE AT MILLS COLLEGE, NEAR OAKLAND.

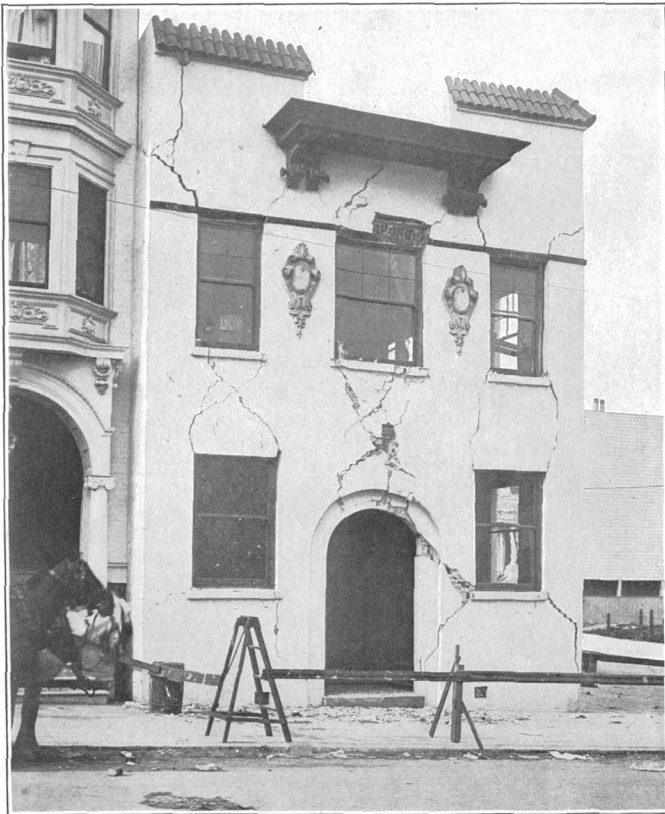
A. X CRACKS IN BRICKWORK, CAUSED BY ROCKING, HOUSE IN SAN FRANCISCO.

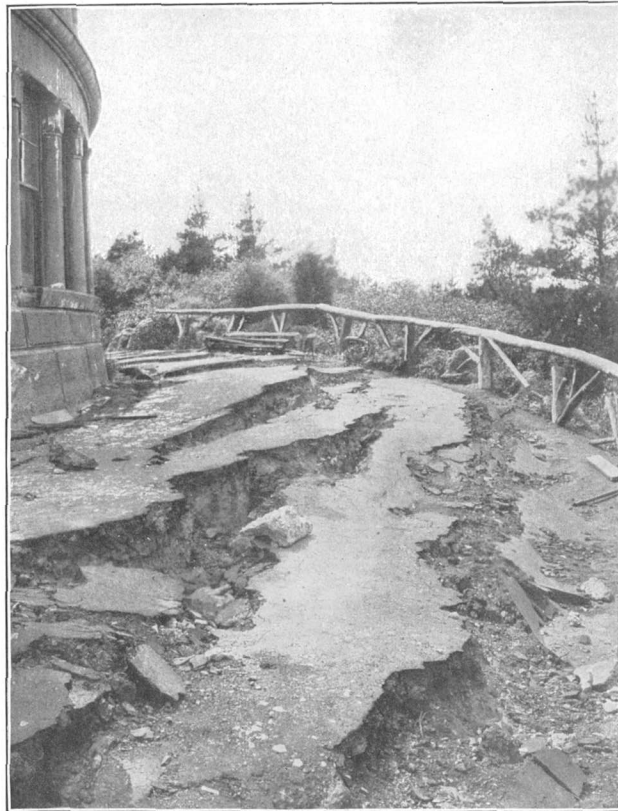
B. SLIP OF FOUNDATION OF CYCLORAMA, STRAWBERRY HILL, GOLDEN GATE PARK, SAN FRANCISCO, CAUSING COLLAPSE OF THE STRUCTURE.

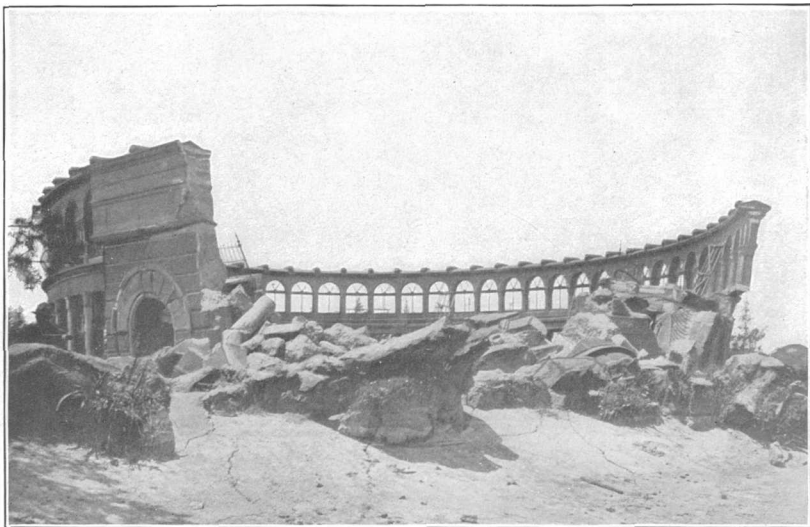
A. EARTHQUAKE EFFECT ON STRUCTURE OF REINFORCED CONCRETE OF POOR QUALITY.  
Cyclorama, Strawberry Hill, Golden Gate Park, San Francisco. Photograph by Richard L. Humphrey.

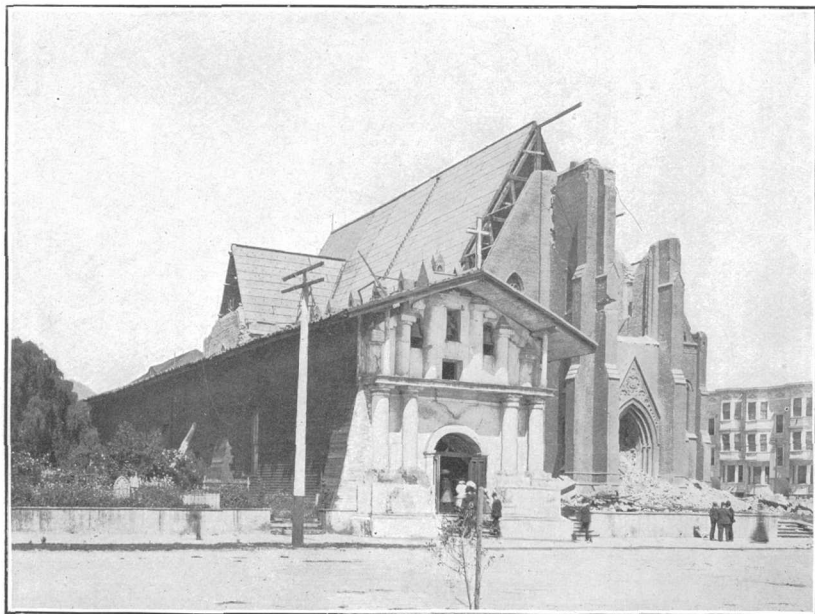
B. EFFECT OF EARTHQUAKE ON ADJACENT BUILDINGS OF DISSIMILAR TYPE AND CONSTRUCTION.

Old Mission Dolores, San Francisco, undamaged. Tower of new church adjoining was so badly damaged that it had to be taken down. Photograph by Richard L. Humphrey.

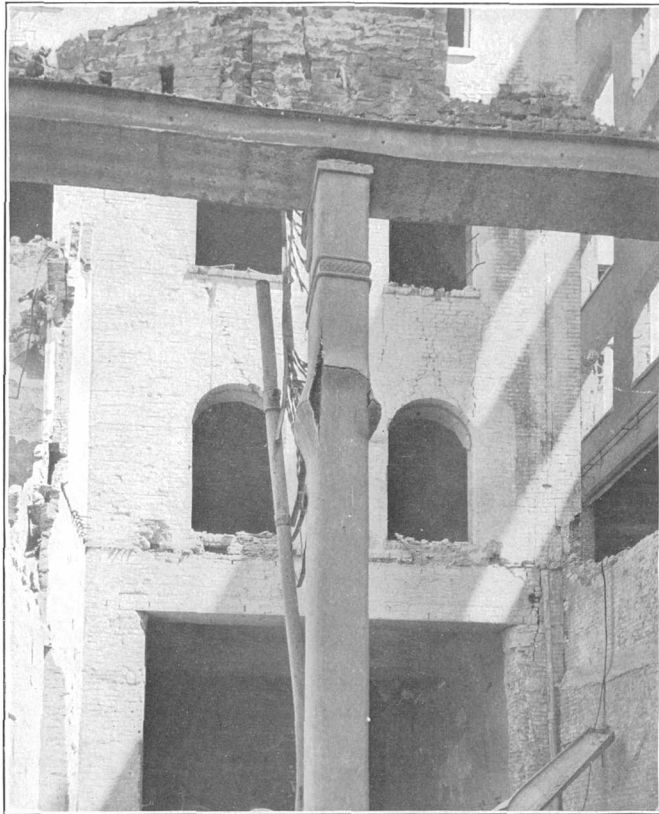
A. FAILURE OF CAST-IRON SHELL OF CONCRETE-FILLED CAST-IRON COLUMN BY FIRE, ACADEMY OF SCIENCES BUILDING, SAN FRANCISCO.

The concrete core supports the load. Note also the effect of the earthquake on the brick wall in the rear. Photograph by Richard L. Humphrey.

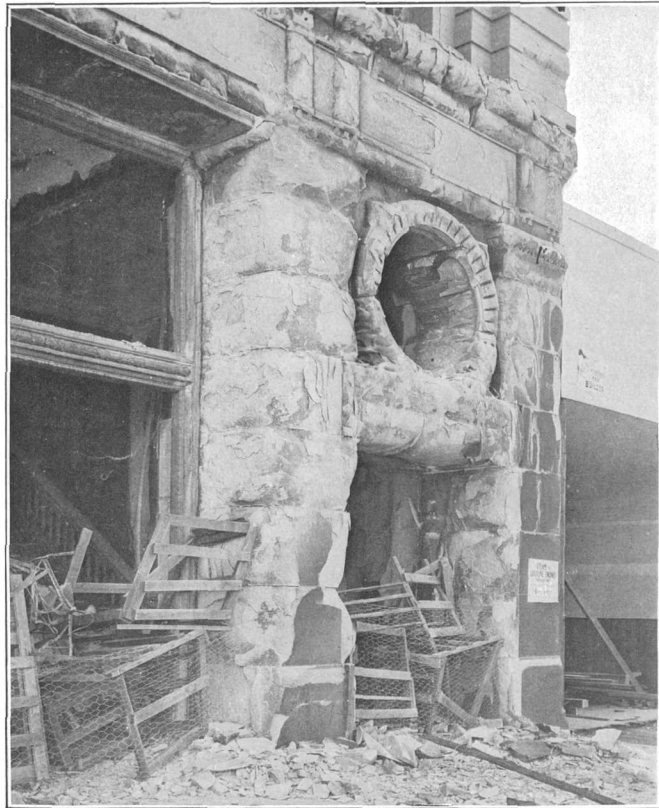
B. SPALLED GRANITE, MARKET STREET ENTRANCE OF ÆTNA BUILDING, SAN FRANCISCO.

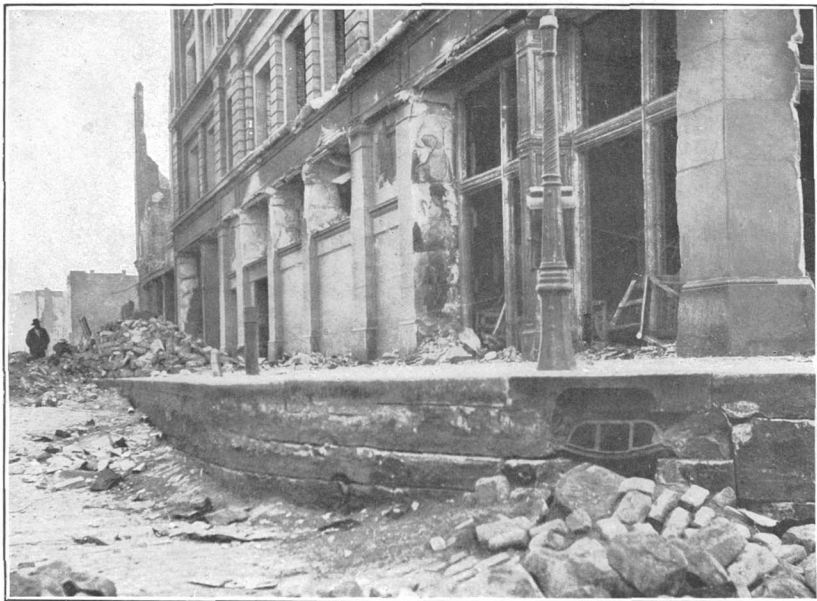
.1. SUBSIDENCE OF STREET IN FRONT OF ÆTNA BUILDING, SAN FRANCISCO.

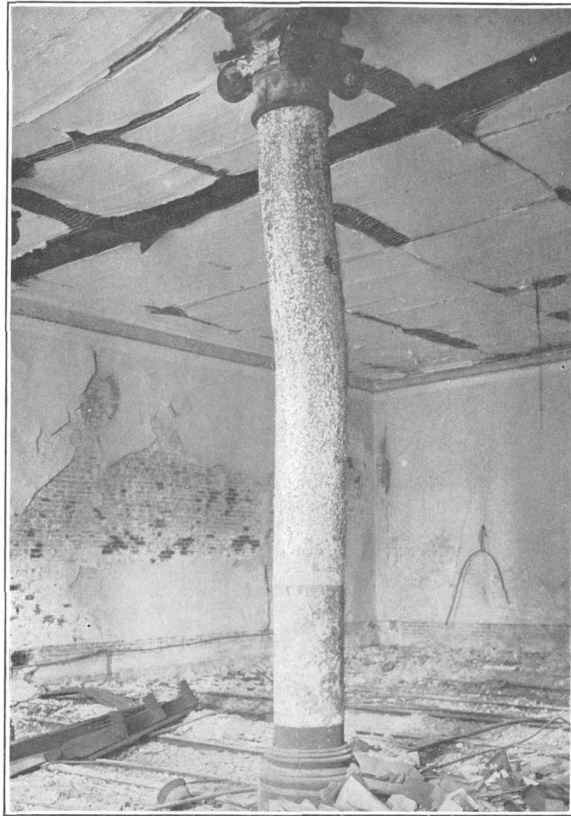
B. INCIPIENT FAILURE OF NAKED CAST-IRON COLUMN IN CITY  
HALL, SAN FRANCISCO.

Ceiling on the point of falling. Photograph by John Stephen Sewell.

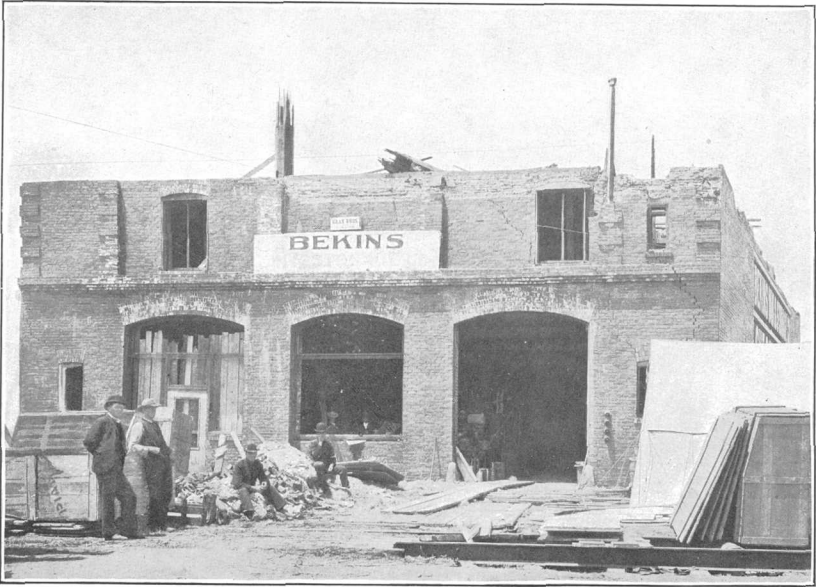
A. EARTHQUAKE ENDURANCE OF REENFORCED-CONCRETE BUILDING, BEKINS VAN AND STORAGE COMPANY'S WAREHOUSE, SAN FRANCISCO, UNDER CONSTRUCTION.

The only building of pure reinforced-concrete type in the city. The brick walls composing the shell of the building were cracked, but the reinforced-concrete floors and columns were uninjured. Photograph by Richard L. Humphrey.

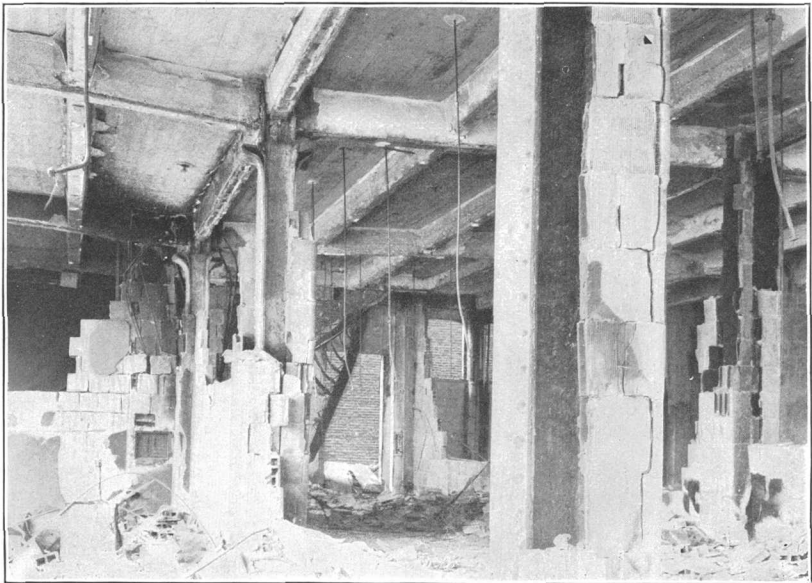
B. FAILURE OF TERRA-COTTA COLUMN COVERINGS, RESULTING IN BUCKLED COLUMNS; ENDURANCE OF CINDER-CONCRETE FLOORS; CENTER OF GROUND FLOOR, ARONSON BUILDING, SAN FRANCISCO.

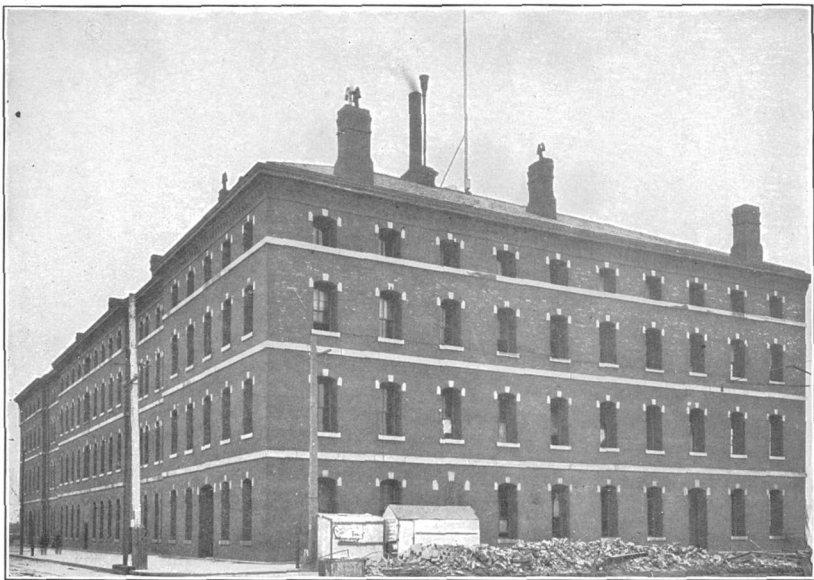
**A. EARTHQUAKE ENDURANCE OF A WELL-CONSTRUCTED BRICK BUILDING: APPRAISERS' WAREHOUSE, SAN FRANCISCO.**

The walls were built with full-header courses and show only a few slight cracks, although the building was located on alluvial soil. Photograph by Richard L. Humphrey.

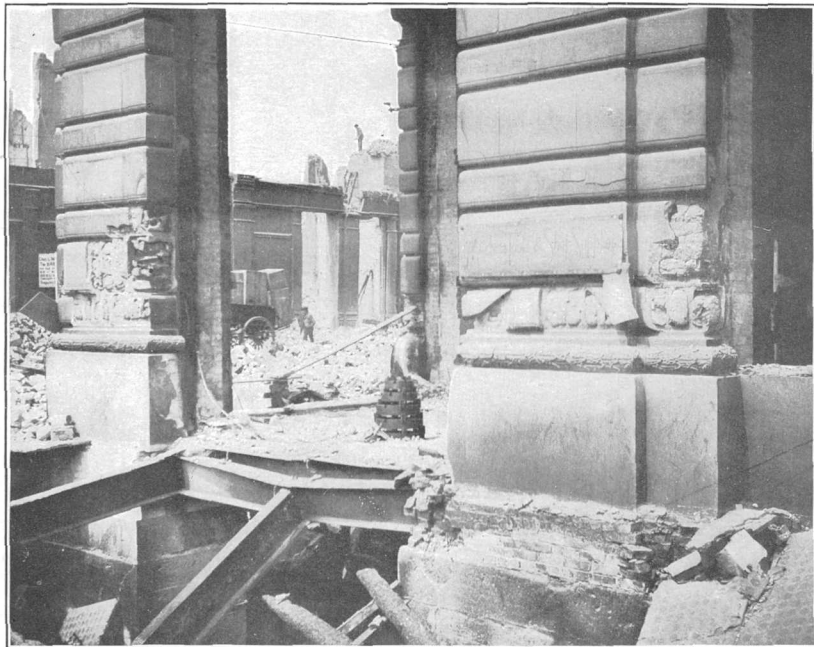
**B. FAILURE OF ORNAMENTAL TERRA COTTA, CROCKER ESTATE BUILDING, SAN FRANCISCO.**

This terra cotta failed, though solidly filled with brick mortar. The damage shown was probably due to fire, although damage of this kind was caused by both earthquake and fire. Photograph by John Stephen Sewell.

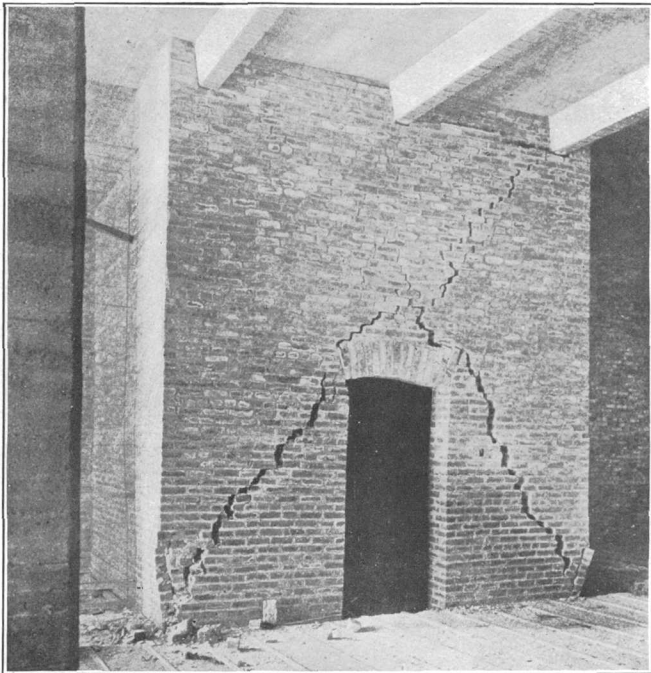
A. EARTHQUAKE CRACKS IN WALL OF VAULT, CALIFORNIA CASKET COMPANY'S BUILDING, SAN FRANCISCO.

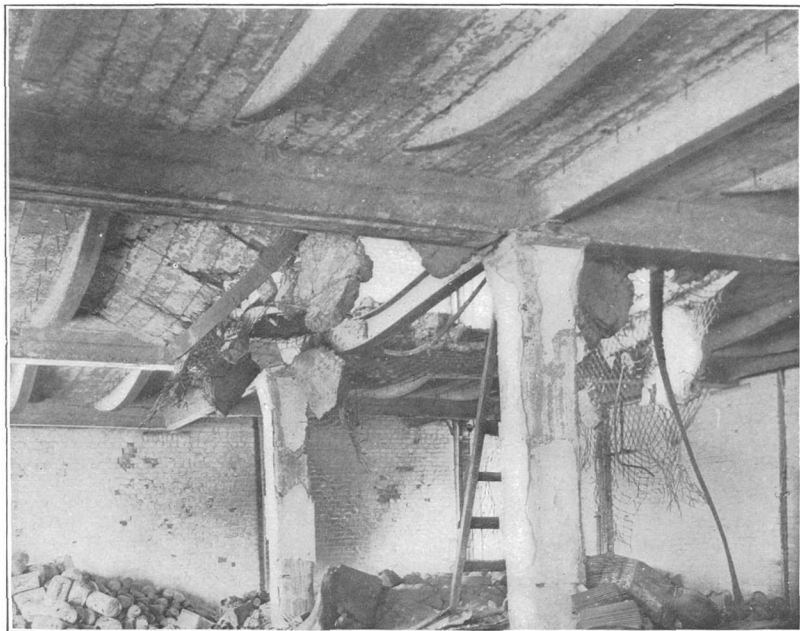
B. COLLAPSE OF FLOOR PANEL, CAUSED BY LOAD FALLING FROM A FLOOR ABOVE, THIRD FLOOR OF ÆTNA BUILDING, SAN FRANCISCO.

The failure of the upper floor was due to the softening by heat of reinforcing steel bands. Photographs by Richard L. Humphrey.

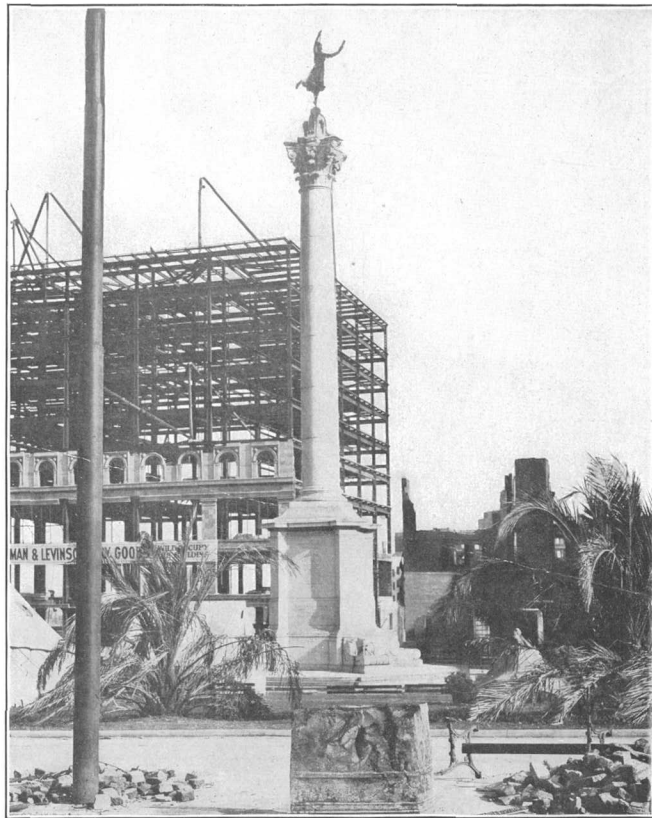
A. EARTHQUAKE DAMAGE MINIMIZED BY SPECIAL CONSTRUCTION, DEWEY MONUMENT, SAN FRANCISCO.

The drums on the shaft were displaced slightly, but were kept from falling by a steel core. Photograph by John Stephen Sewell.

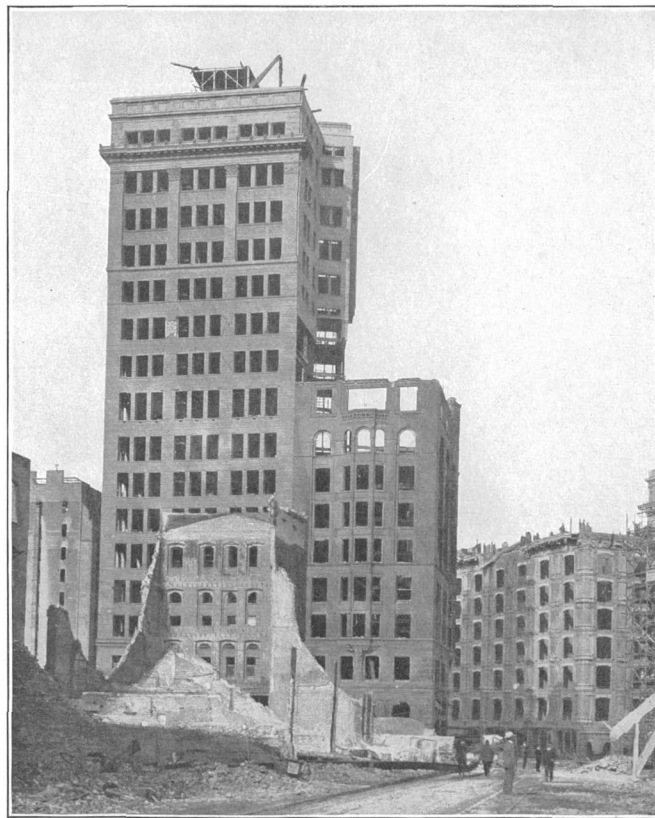
B. X CRACKS IN WALLS, DUE TO ROCKING OF BUILDING BY EARTHQUAKE, CHRONICLE BUILDING AND ANNEX, SAN FRANCISCO, LOOKING EAST.

The Palace Hotel (at the right) was completely gutted by fire, but the walls remained in good condition. Photograph by Richard L. Humphrey.

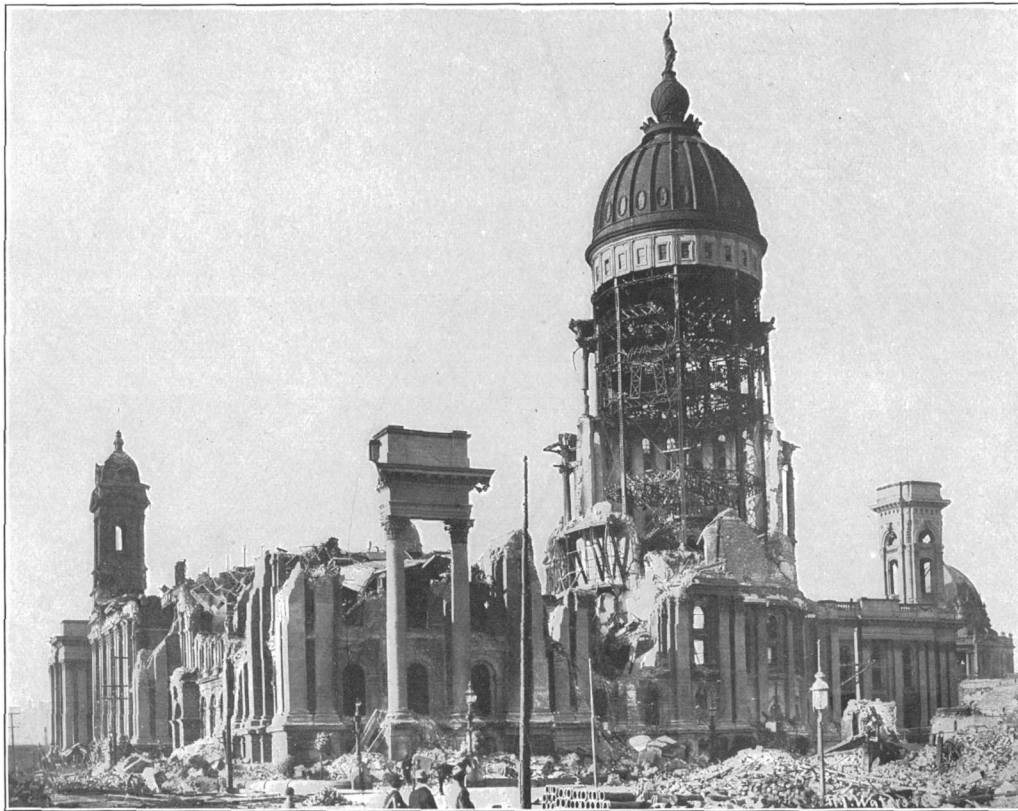
RUIN OF THE \$7,000,000 CITY HALL, SAN FRANCISCO, BY EARTHQUAKE AND FIRE.

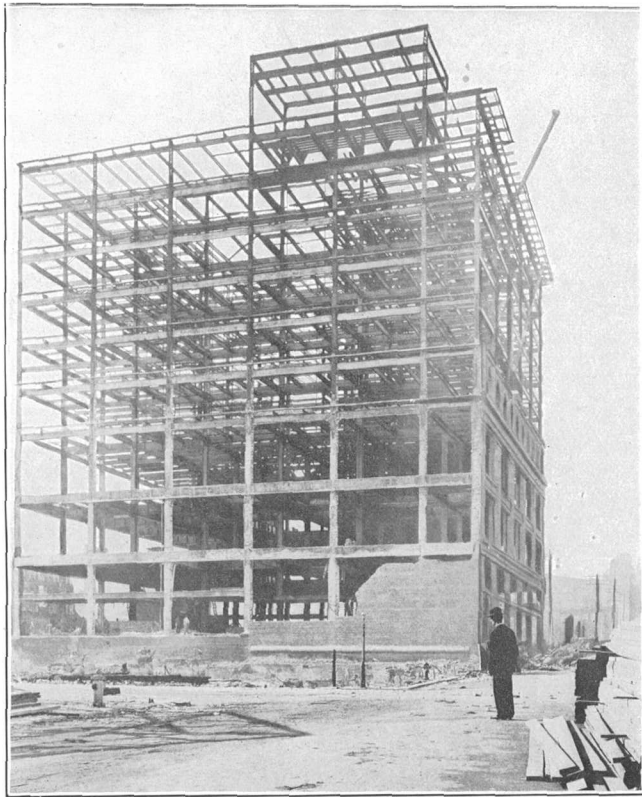
A. BEHAVIOR OF STEEL FRAME, BUTLER BUILDING (INCOMPLETE), AT THE SOUTHWEST CORNER OF GEARY AND STOCKTON STREETS, SAN FRANCISCO.

Walls taken down in places because of earthquake damage, although damage to steel by earthquake and fire was nominal. Photograph by John Stephen Sewell.

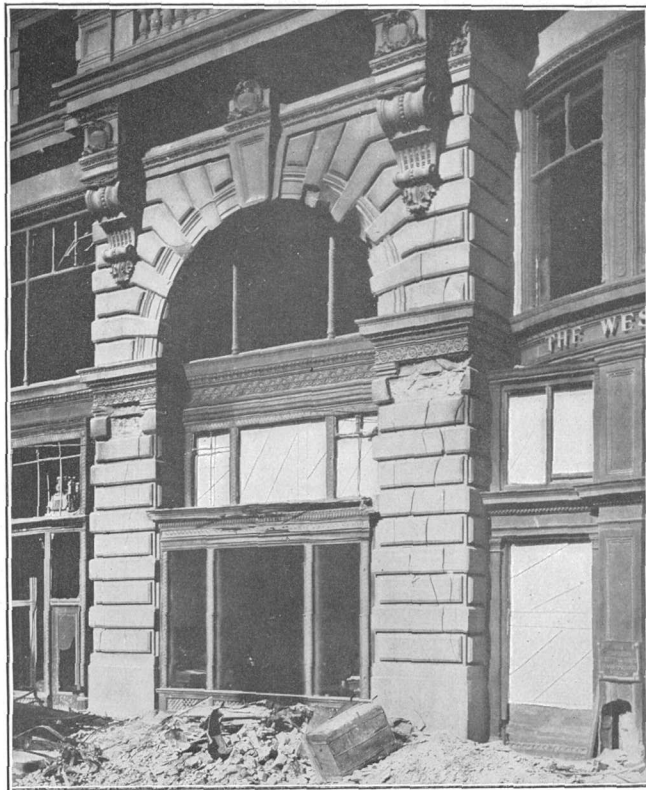
B. EARTHQUAKE DAMAGE TO STONE PIERS, JAMES FLOOD BUILDING, SAN FRANCISCO.

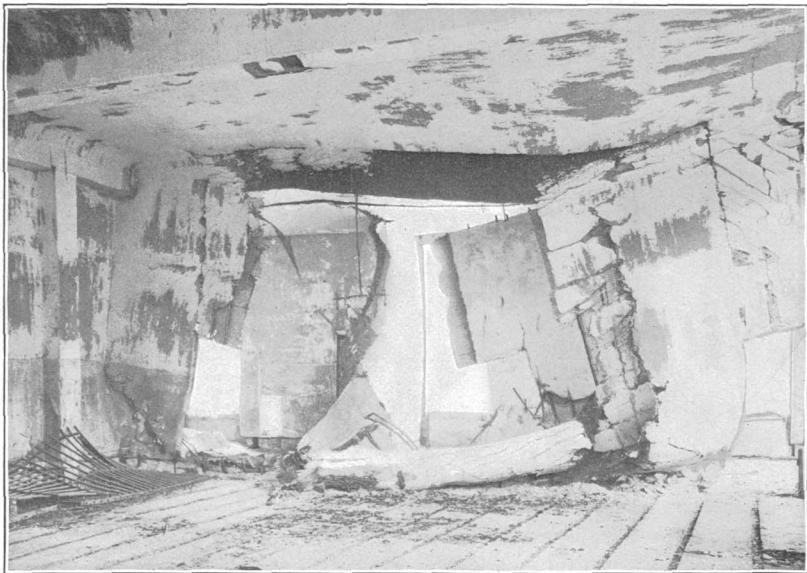
B. FAILURE OF SUSPENDED CEILING, HALL OF JUSTICE, SAN FRANCISCO.

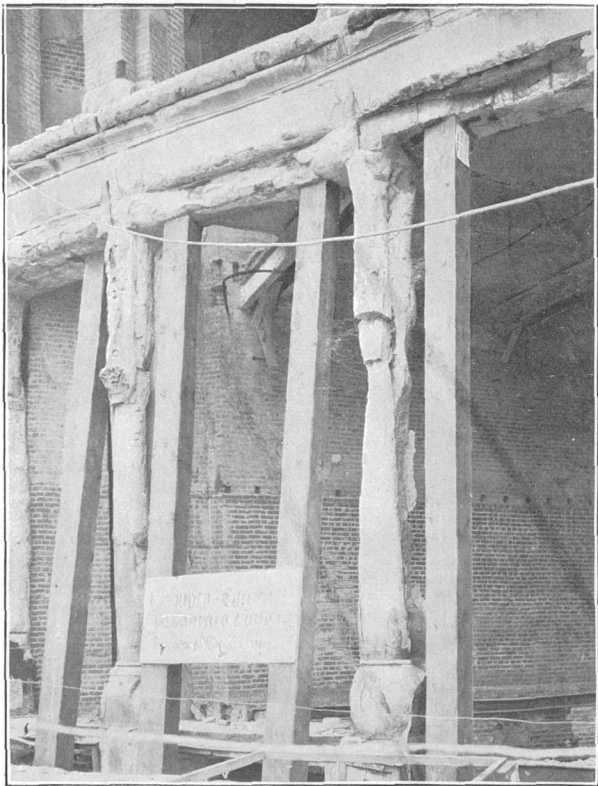
A. GRANITE COLUMNS SPALLED BY FIRE, HOBART BUILDING, SAN FRANCISCO.

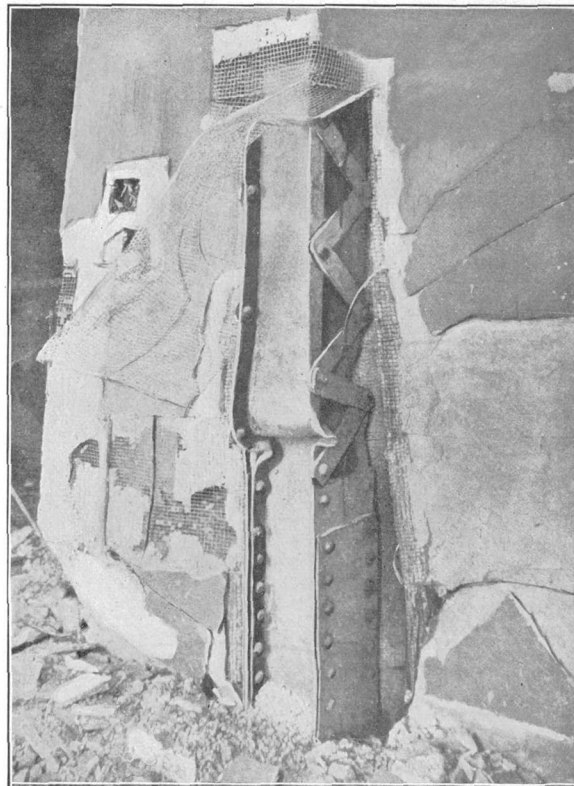
B. BUCKLING OF COLUMNS DUE TO FAILURE OF WIRE-MESH-AND-PLASTER FIREPROOFING, HOTEL HAMILTON, SAN FRANCISCO.

The fireproofing on either side shows the general condition in which it was left by the fire. It was stripped away from the column just before the photograph was taken in order to show the buckling. Photograph by A. L. A. Himmelwright.

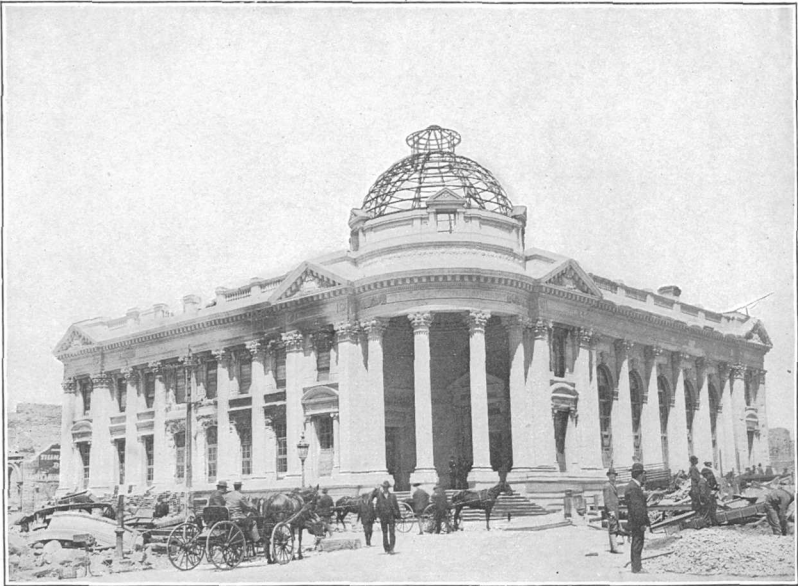
A. STONEMWORK SPALLED BY FIRE, HIBERNIA SAVINGS AND LOAN SOCIETY'S BUILDING, SAN FRANCISCO.

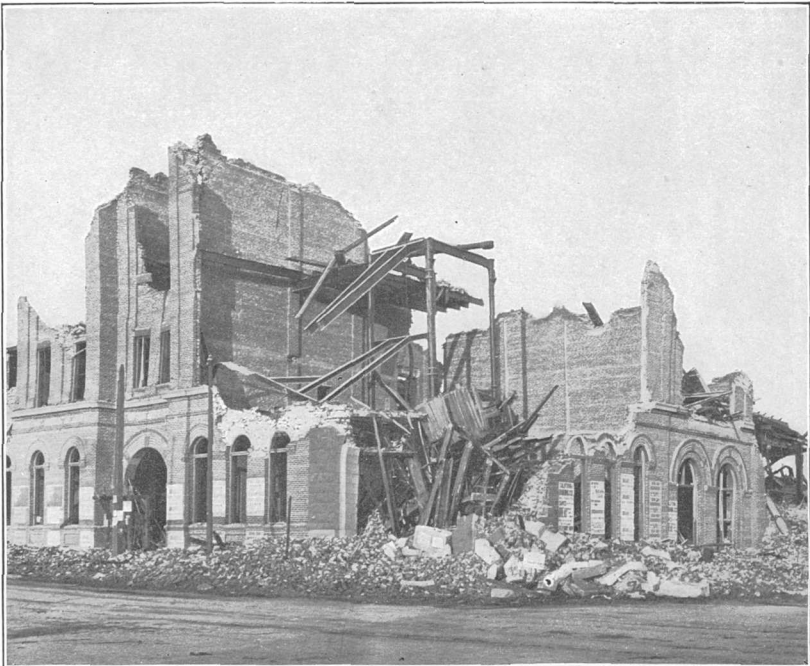
B. EARTHQUAKE DAMAGE, JACKSON BREWING COMPANY'S BUILDING, SAN FRANCISCO.

Light walls, badly bonded and laid up with poor lime mortar, and flimsily constructed steel work. Photograph by Richard L. Humphrey.

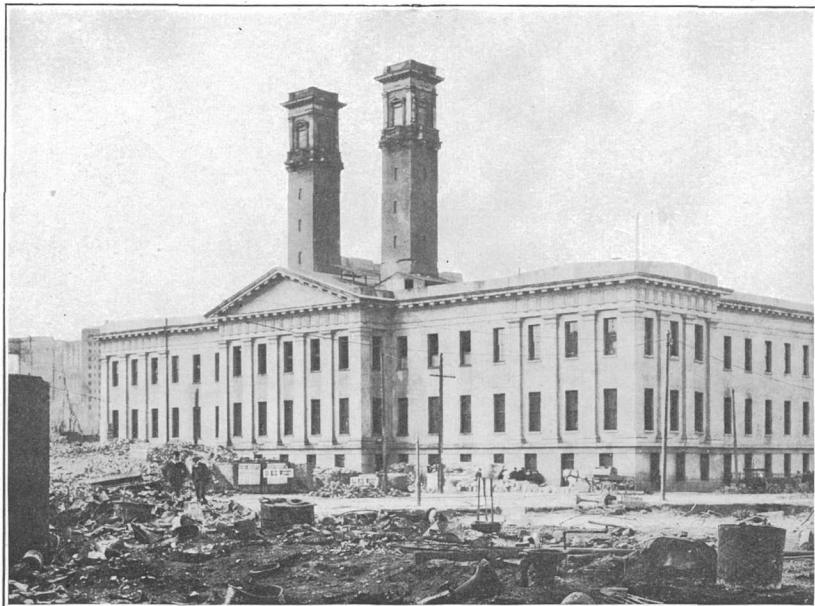
A. GOOD EARTHQUAKE ENDURANCE OF A BUILDING OF THE MONUMENTAL TYPE: UNITED STATES MINT, SAN FRANCISCO.

Showing only slight damage to brick stack, probably due to earthquake. Photograph by John Stephen Sewell.
