# The San Francisco Earthquake and Fire April 18, 1906 and Their Effects on Structures and Structural Materials

US Department of the Interior

THE  
SAN FRANCISCO EARTHQUAKE AND FIRE  
OF  
APRIL 18, 1906  
AND THEIR EFFECTS ON STRUCTURES AND  
STRUCTURAL MATERIALS

REPORTS BY  
GROVE KARL GILBERT, RICHARD LEWIS HUMPHREY,  
JOHN STEPHEN SEWELL, AND FRANK SOULÉ

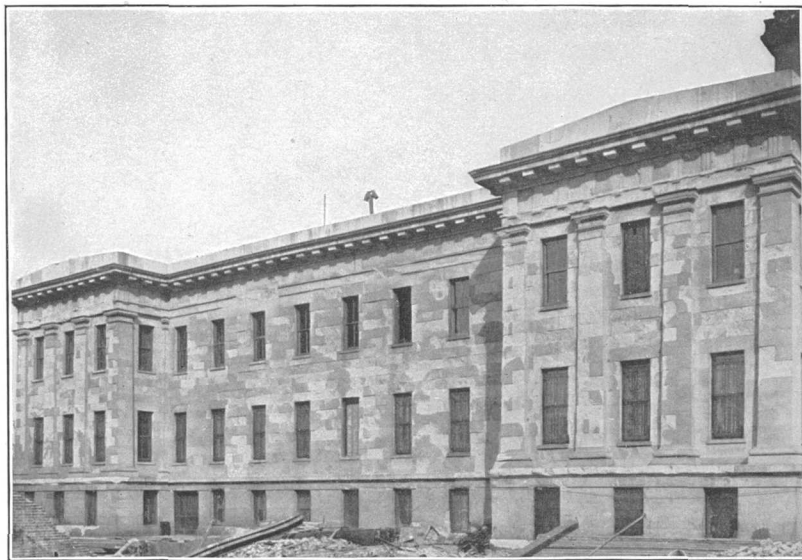
B. SPALLING OF STONework BY FIRE, NORTHWEST FRONT OF UNITED STATES MINT.

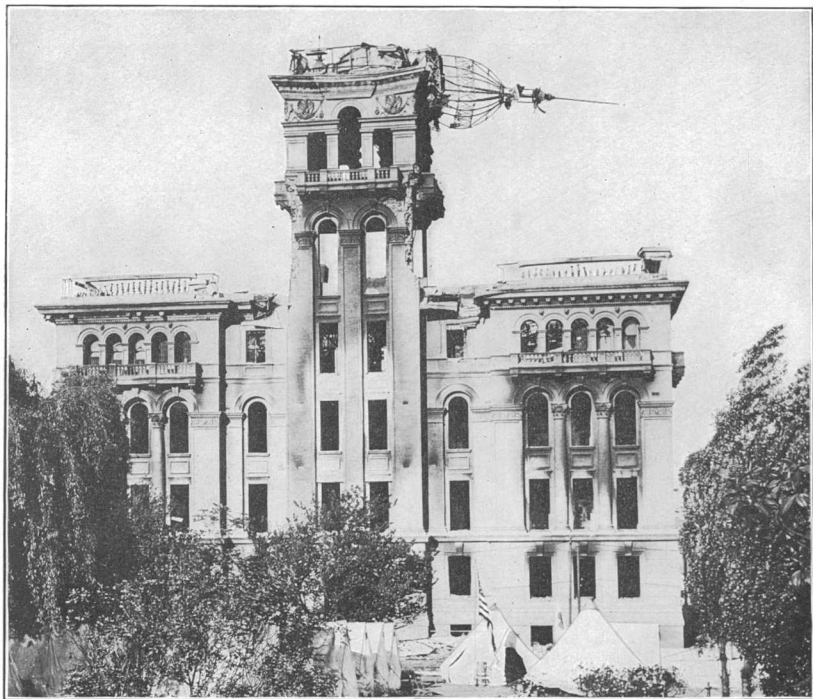
A. WRECKED TOWER AND SPALLED STONEWORK, HALL OF JUSTICE, SAN FRANCISCO.

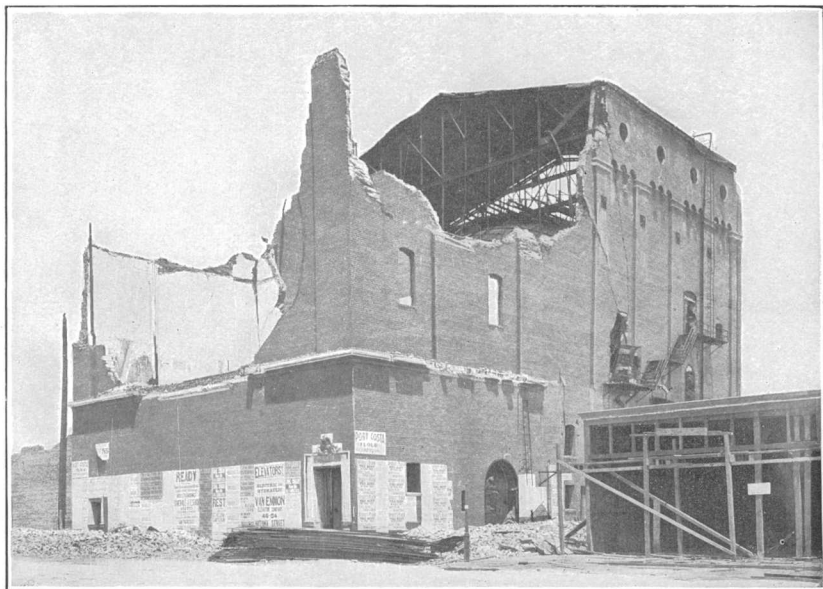
B. COMPLETE WRECK BY EARTHQUAKE, DUE TO POOR DESIGN, MAJESTIC THEATER, SAN FRANCISCO.

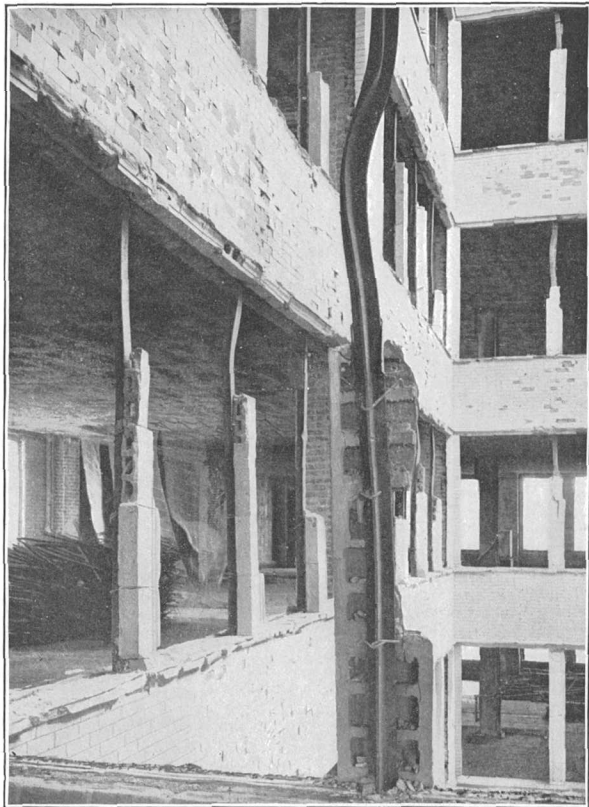
A. SPALLING OF ENAMELED BRICK IN LIGHT WELL, AND FAILURE OF FIREPROOFING OF WINDOW-FRAME SEPARATORS, MERCHANTS' EXCHANGE BUILDING, SAN FRANCISCO.

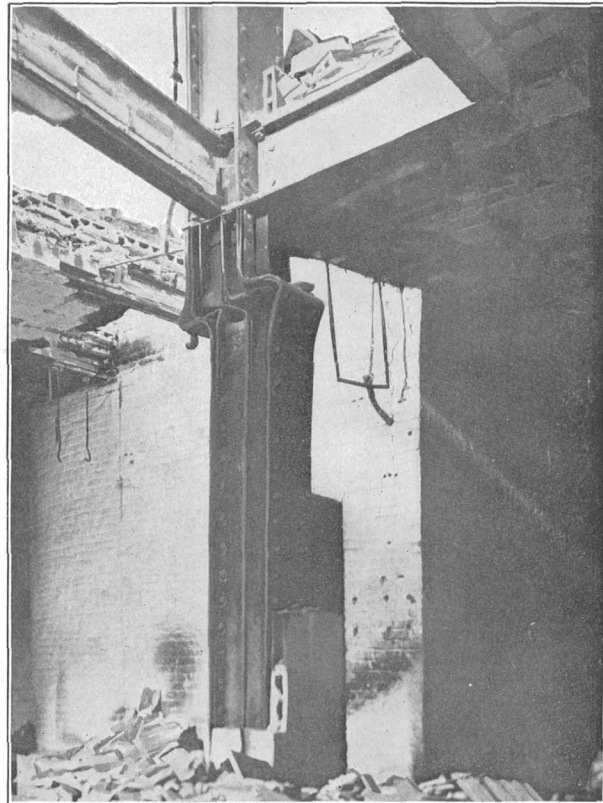
B. BUCKLING OF BASEMENT COLUMN DUE TO FAILURE OF TERRA-COTTA COVERING IN FIRE, MILLS BUILDING, SAN FRANCISCO.

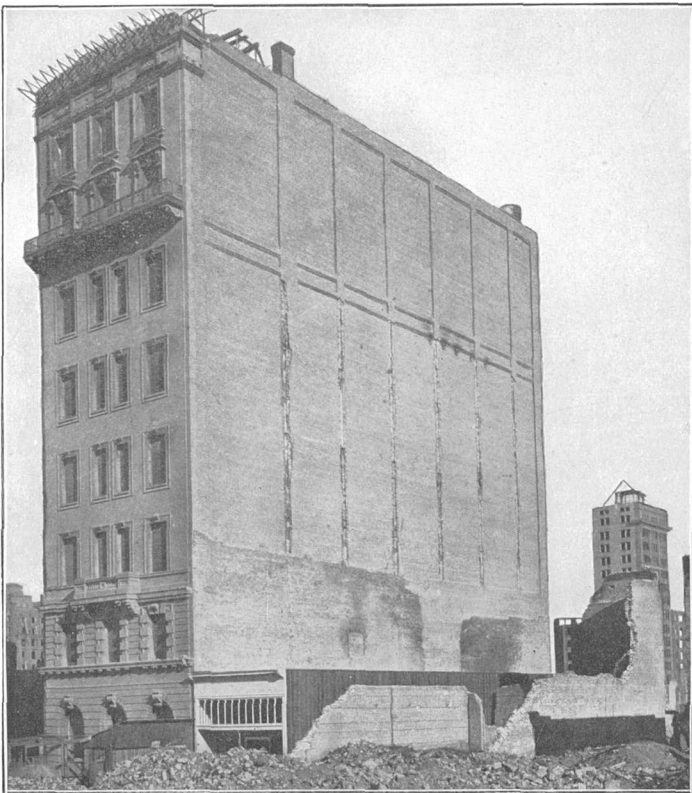
A. ENDURANCE OF A WELL-PROTECTED BUILDING SUBJECTED TO SEVERE HEAT, MAIN EXCHANGE OF PACIFIC STATES TELEPHONE AND TELEGRAPH COMPANY, SAN FRANCISCO.

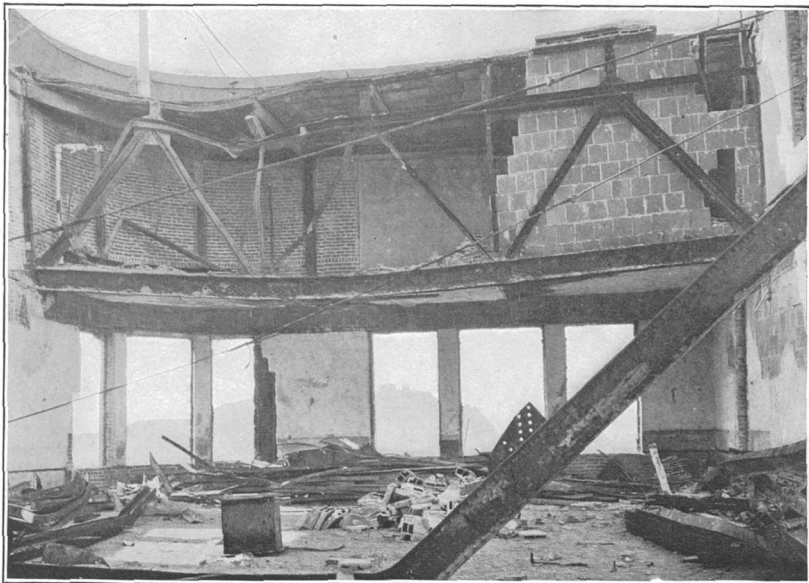
A. ROOF TRUSSES DAMAGED BY HEAT, THROUGH FAILURE OF TERRA-COTTA COVERING, MUTUAL LIFE BUILDING, SAN FRANCISCO.

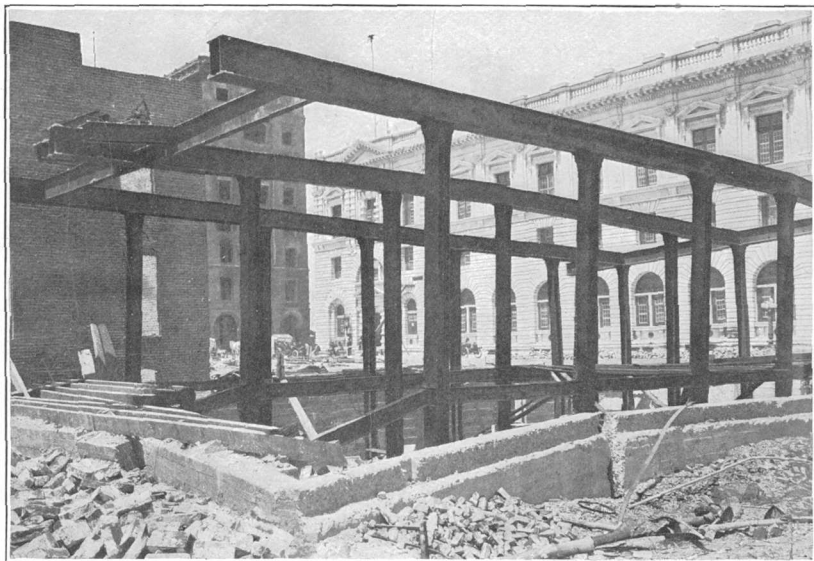
B. EFFECT OF SETTLING OF GROUND SUBJECTED TO EARTHQUAKE VIBRATIONS, STEEL-FRAME BUILDING UNDER CONSTRUCTION.

The concrete basement walls were not reinforced. Post-office in the background. Photograph by Richard L. Humphrey.

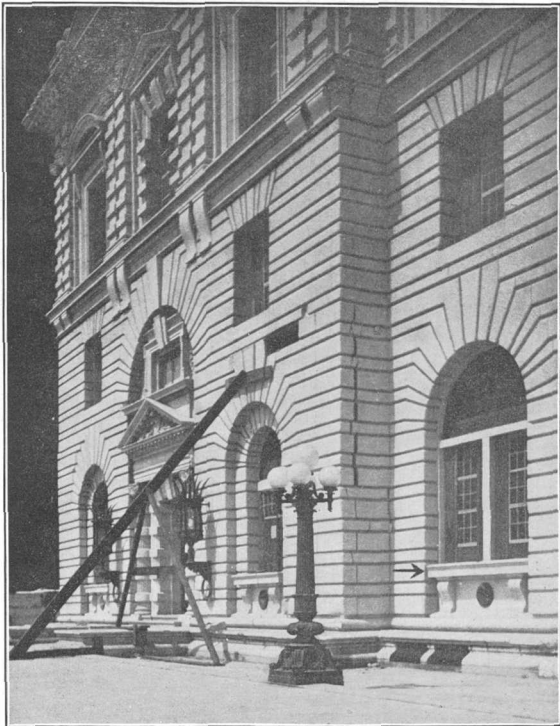
A. CRACKS IN MASONRY, PAVILION OF POST-OFFICE, SAN FRANCISCO.

The window reveal and sill were jostled together by the earthquake at the point indicated by the arrow. Photograph by John Stephen Sewell.

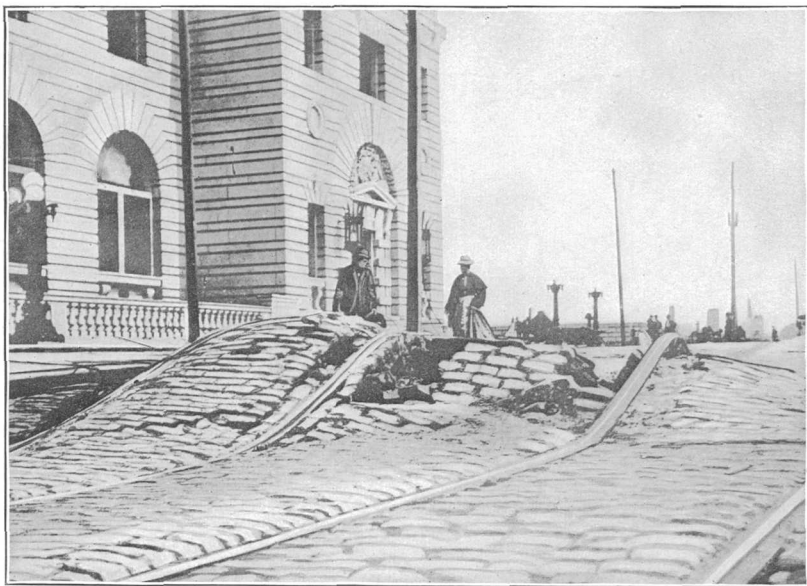
B. EFFECT OF SLIP, MISSION STREET, SAN FRANCISCO.

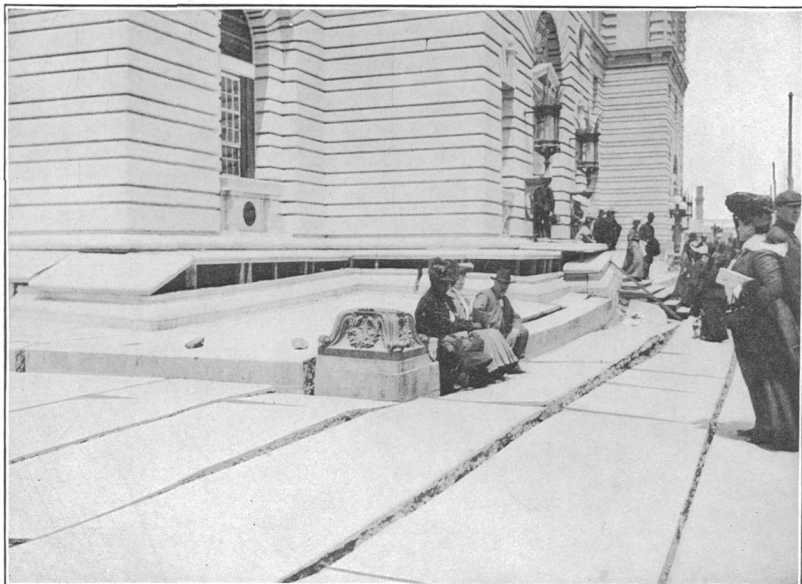
A. CRACKS IN MASONRY AND SETTLING OF OUTER TERRACE, POST-OFFICE BUILDING, SAN FRANCISCO.

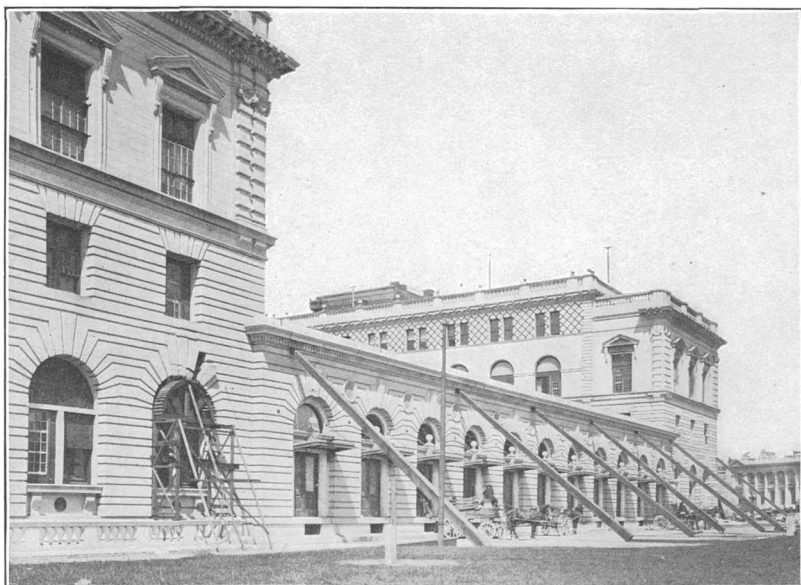
B. EFFECT OF EARTHQUAKE IN LOOSENING STONWORK, NORTHEAST FACE OF POST-OFFICE BUILDING.

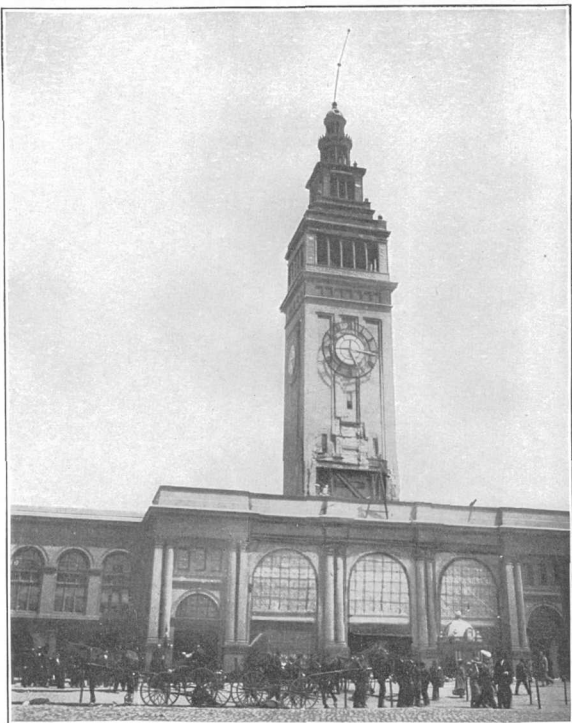
*A.* BRICKWORK THROWN DOWN BY EARTHQUAKE VIBRATION,  
TOWER OF UNION FERRY BUILDING, SAN FRANCISCO.

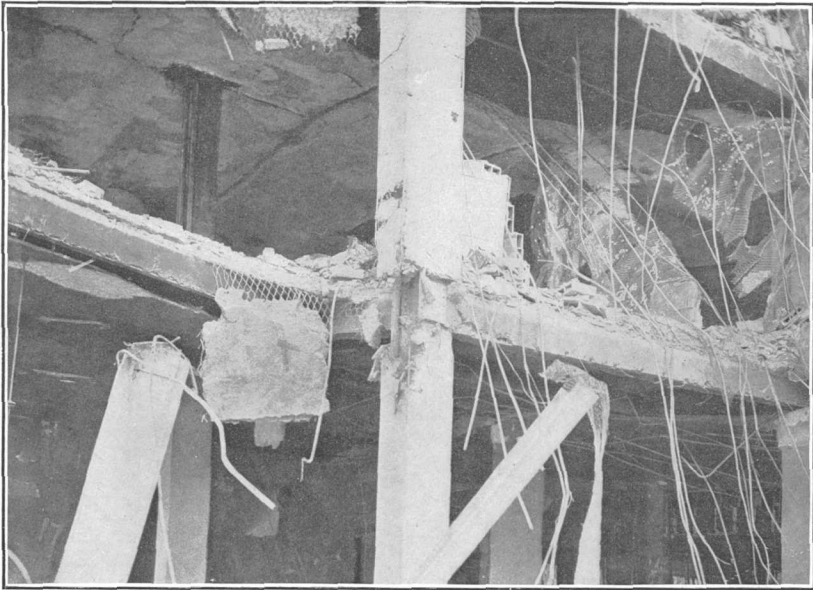
B. DAMAGE SAID TO HAVE BEEN CAUSED BY DYNAMITE, RIALTO BUILDING.

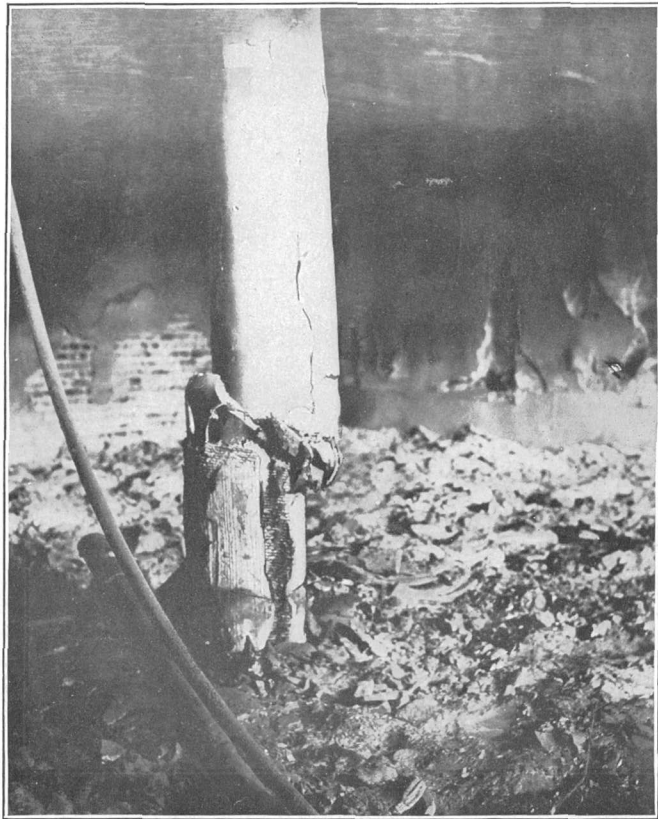
A. FAILURE OF BASEMENT COLUMN DUE TO FIRE, SLOANE BUILDING, SAN FRANCISCO.

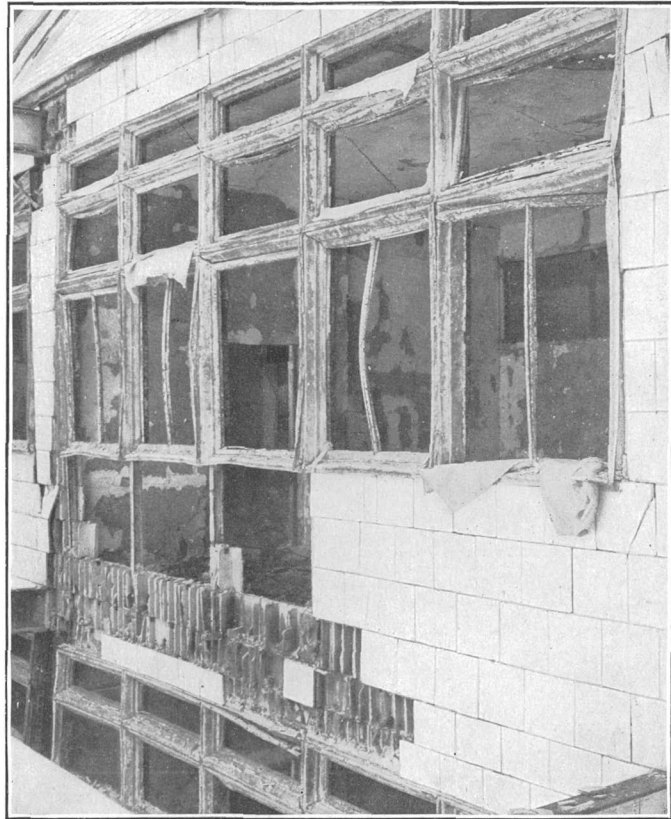
B. FAILURE OF TERRA-COTTA TILING AND METAL-FRAME WIRE-GLASS WINDOWS BY FIRE, LIGHT-WELL COLUMN, WELLS-FARGO BUILDING, SAN FRANCISCO.

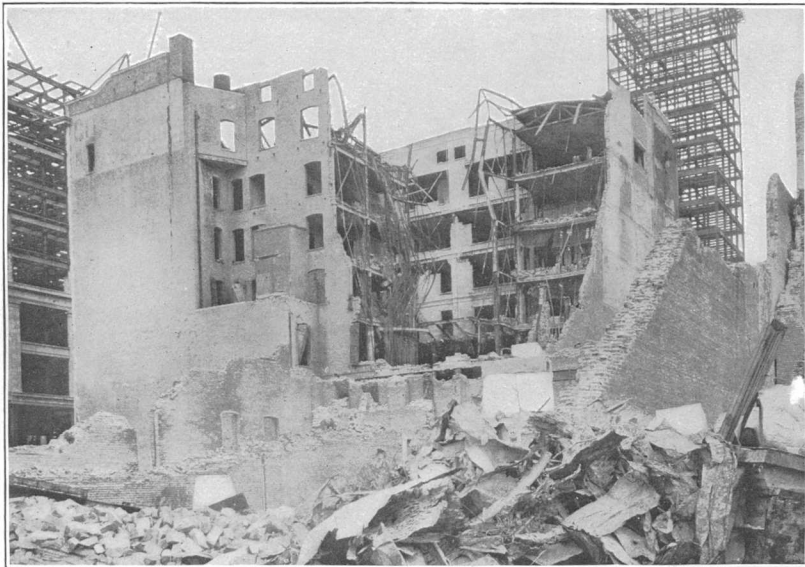
A. COLLAPSE OF BUILDING DUE TO BUCKLING OF COLUMNS, SPRING VALLEY WATER COMPANY'S BUILDING, SAN FRANCISCO.

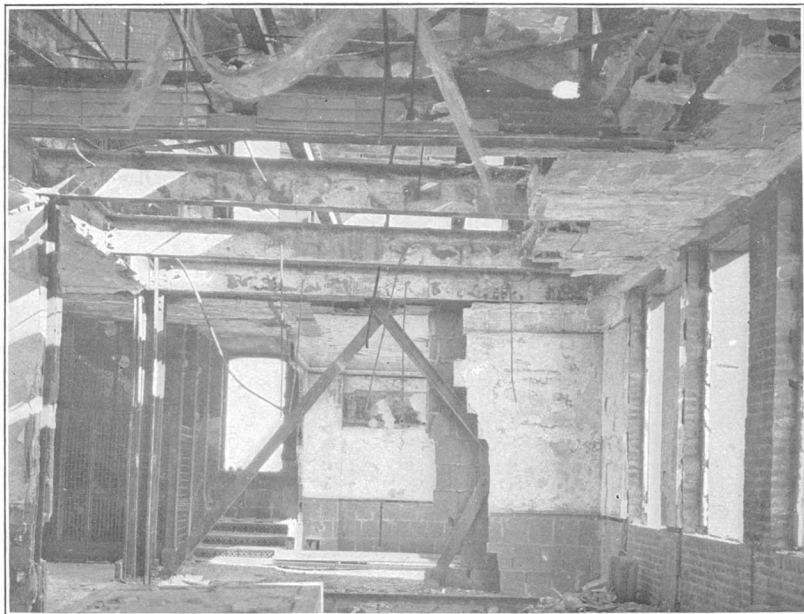
B. FAILURE OF TERRA-COTTA TILE COVERING IN FIRE, UNION TRUST COMPANY'S BUILDING, SAN FRANCISCO.

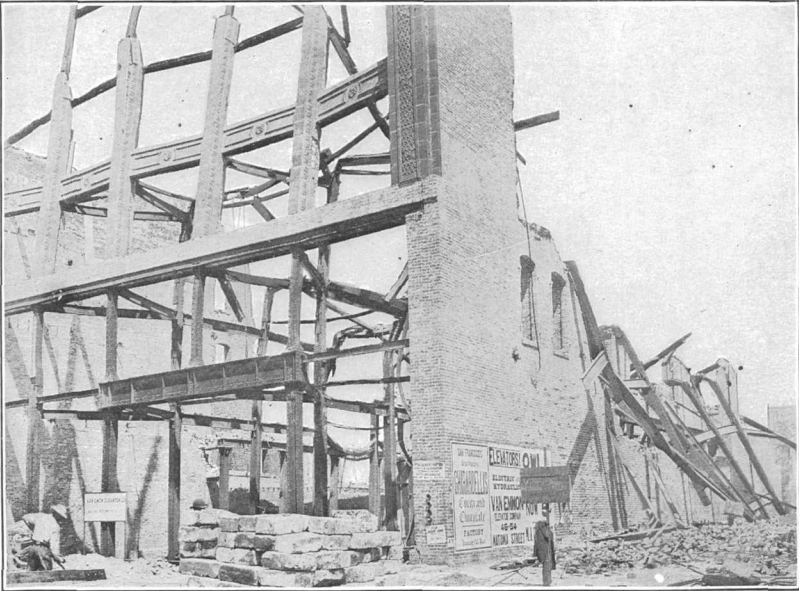
A. AN UNFINISHED STEEL SKELETON, WITH NONFIREPROOFED STEEL WORK.

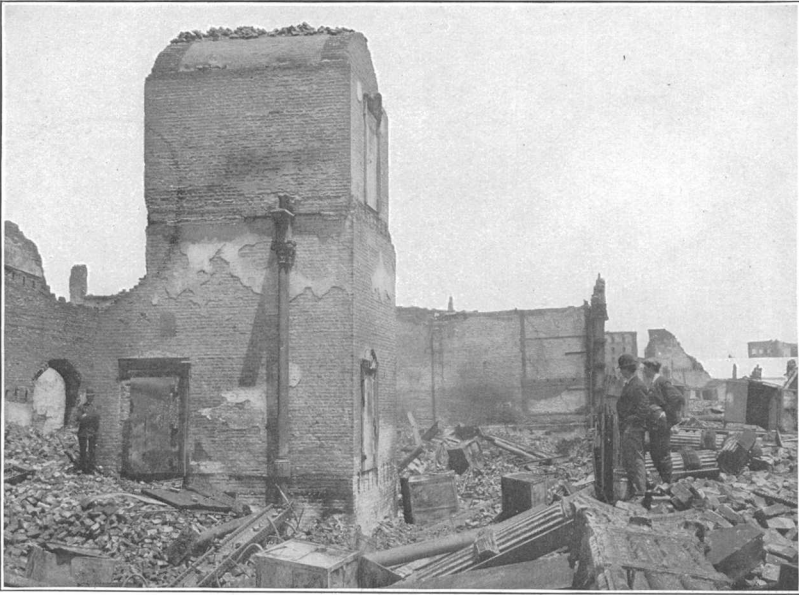
A. ENDURANCE OF BRICK VAULT.

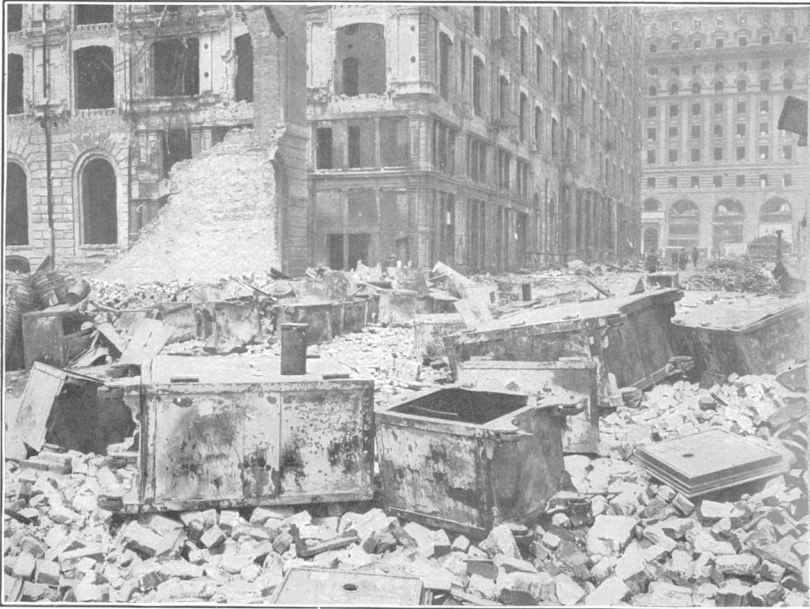
B. ABSOLUTE FAILURE OF SO-CALLED "FIREPROOF" SAFES.

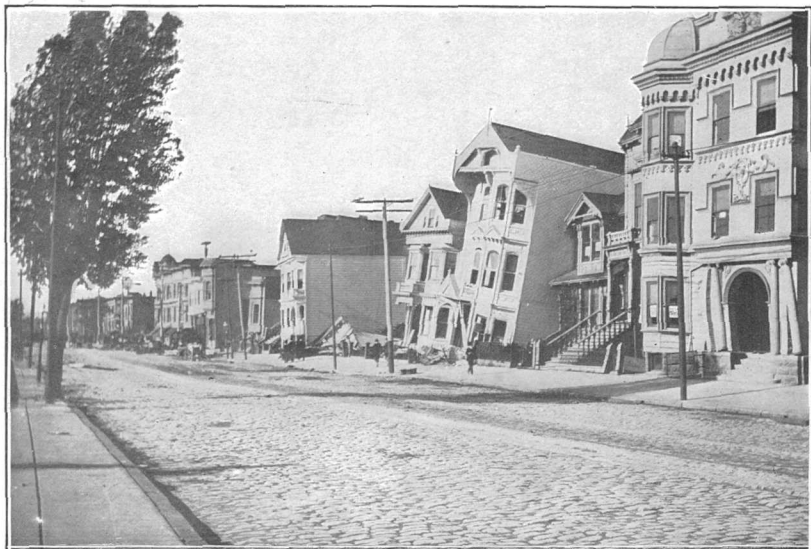
B. GENERAL EARTHQUAKE EFFECT ON FRAME BUILDINGS SITUATED ON ALLUVIAL SOIL, HOWARD STREET, SAN FRANCISCO.
