Frederick Farm Well Contamination: Borehole Camera Analysis of Bedrock Structure

Borehole Camera Analysis of Bedrock Structure

The College at Brockport - State University of New York

Michael D. Rodgers and Paul L. Richards

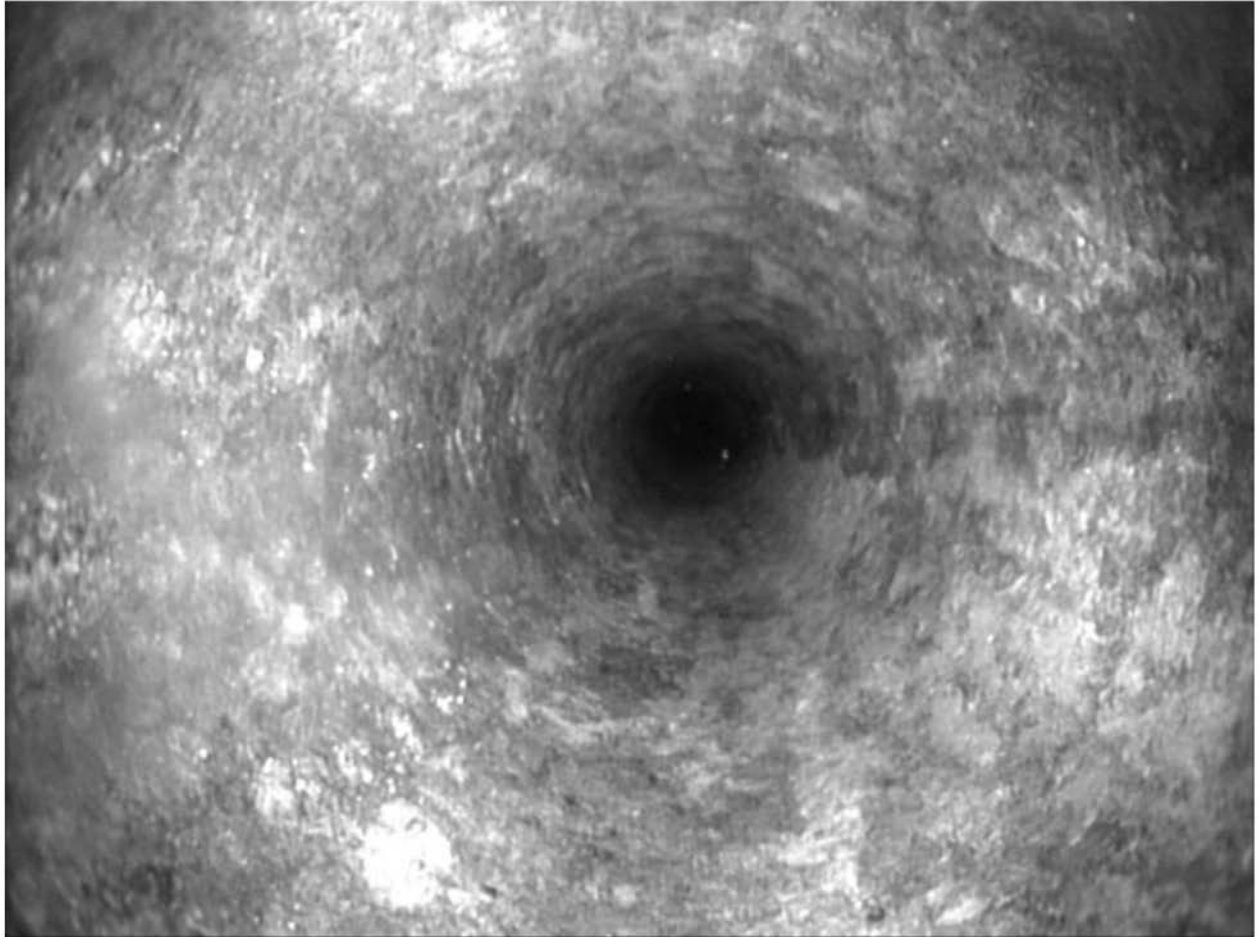
Feature ID #00: 1ft depth, beginning descent into well.

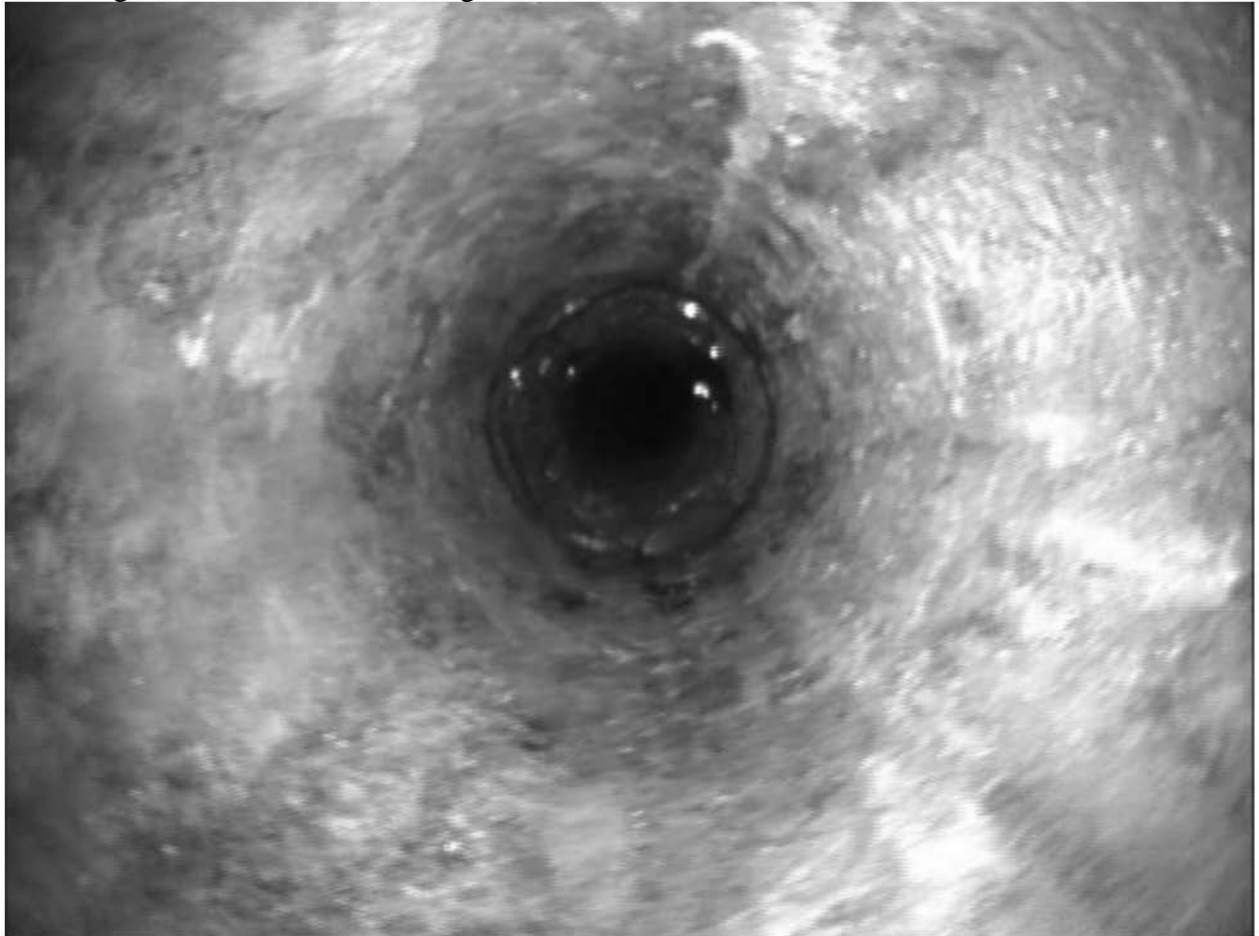
The analysis borehole camera footage showed that the well casing is intact. The well casing extended from the top of the well (ID #00) with rust scale in places (ID #01) -- likely due to the oxidation of the pump as it sat within the casing --down to a depth of 5 ft (ID #02). Visibility is quite good due to the lack of water and debris. No leakage was observed within the well casing, and the base of the casing was determined to be within bedrock.

Feature ID #01: Halfway through the well casing at 3 ft depth. Some rust scale on the sides of the casing. Bottom of the well casing is within view.

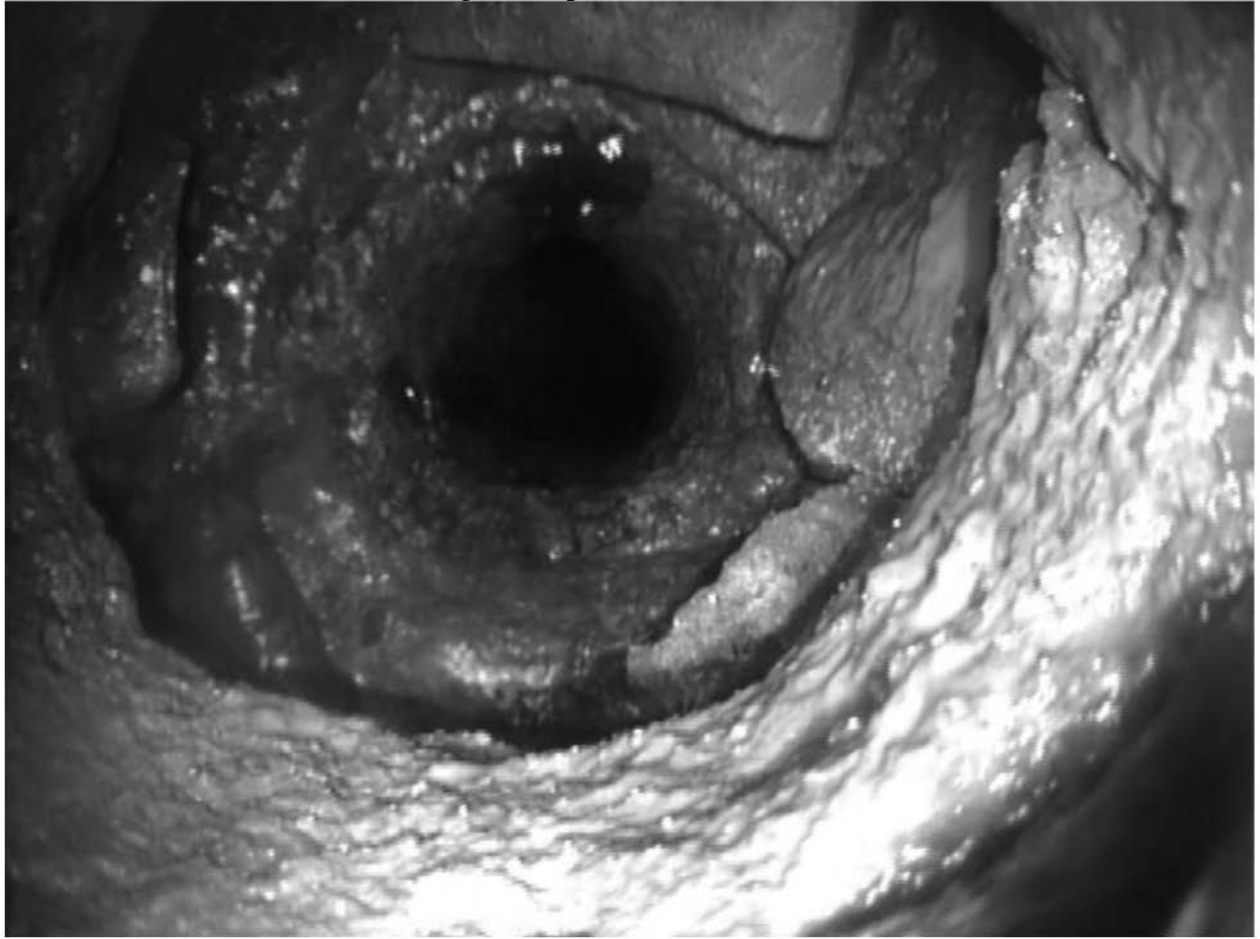
Feature ID #02: Base of well casing at a depth of 5 ft. First notable fracture is in view

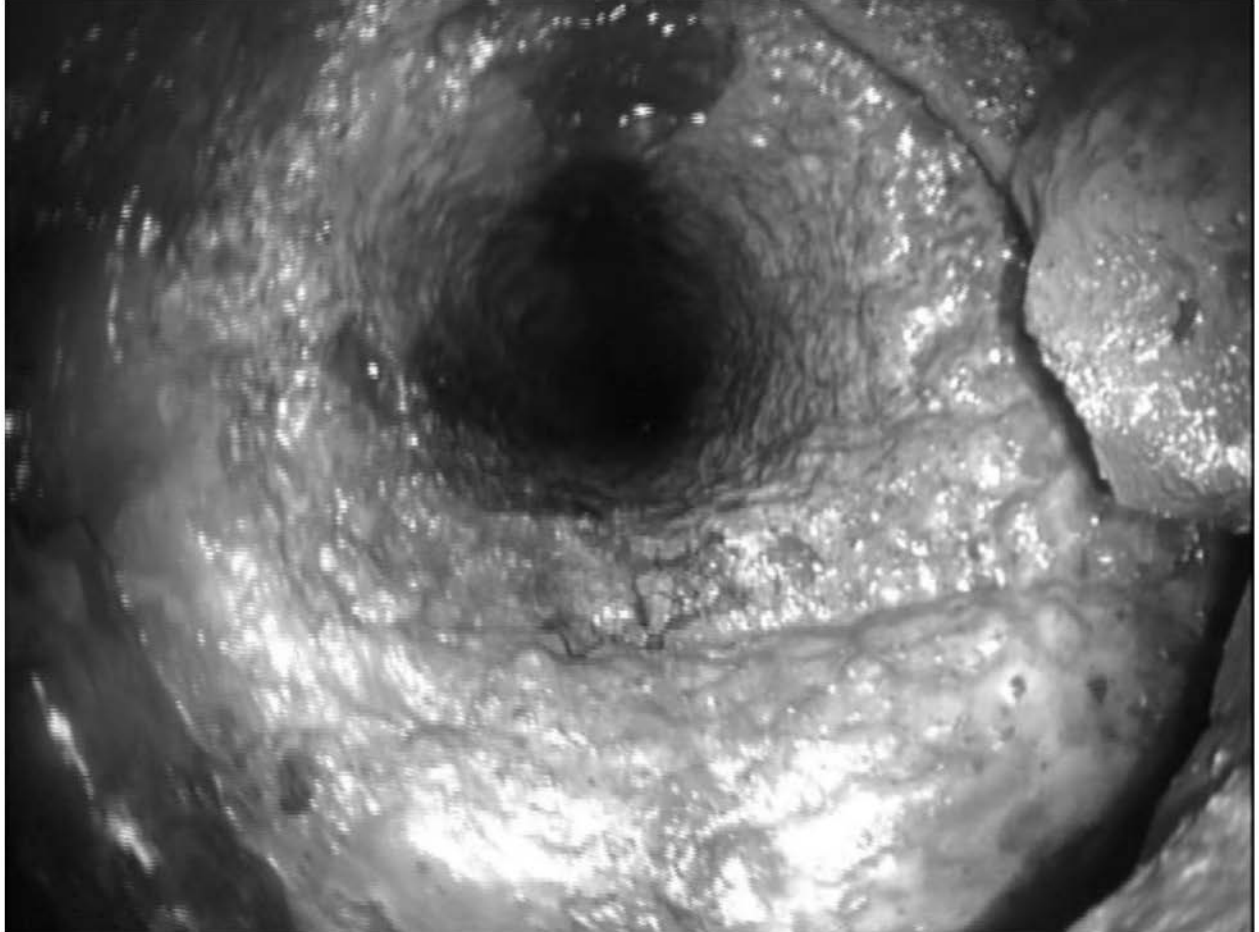
Feature ID #03: Fracture just below well casing at depth just past 5 ft. This feature encompasses nearly the entire perimeter of the well.

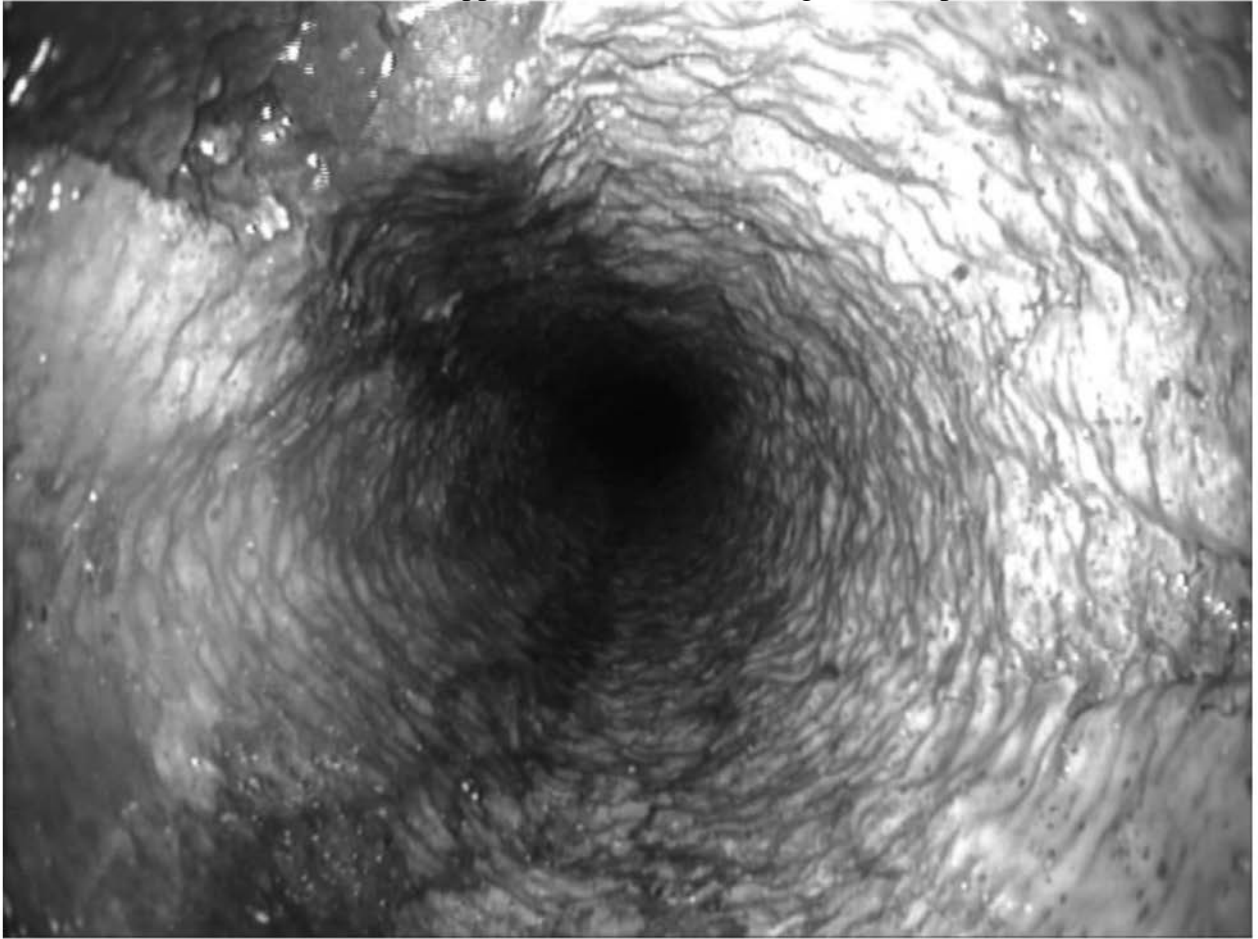
The well casing was completely intact for this well and appeared to have no leakage within it. The casing was also built properly within bedrock. There was a cascading fracture located just below it at 5.5 ft depth. This fracture, located on the south side of the wall, allows for the flow of water and any contaminants within shallow bedrock to flow directly into the well. Similarly, a fracture at 13.5 ft depth on the south-western wall is also allowing water to flow directly into the well. The unsaturated zone had few fractures other than the two main ones that had flowing water. This zone also had evidence of chemical weathering. The saturated zone had far more/ and more frequent fractures, including large fractures which were as wide as ~1 ft of thickness. There was a lot of chemical weathering in the deeper part of the well, below 62.5 ft. Flow direction was unable to be measured because the water movement was low. In summary, the well appears to be built within heavily fractured and weathered karstic limestone. Some of these fractures appear to be hydrologically active.

Feature ID #04: Small fracture in upper left with water leaking in at a depth of 5.5 ft.

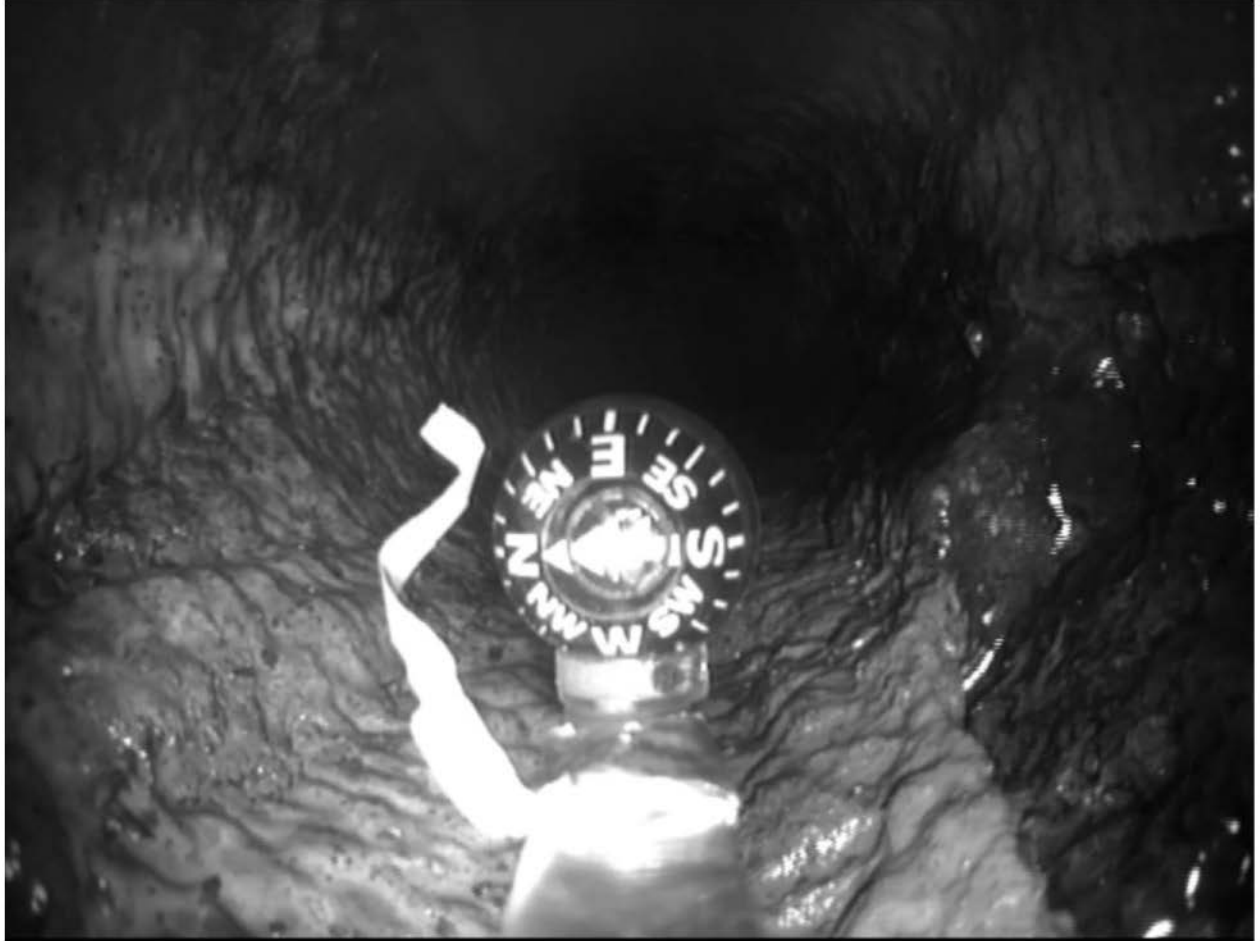
Feature ID #04: Water leaking in through fracture at 5.5 ft depth; compass shows feature on south side of the well.

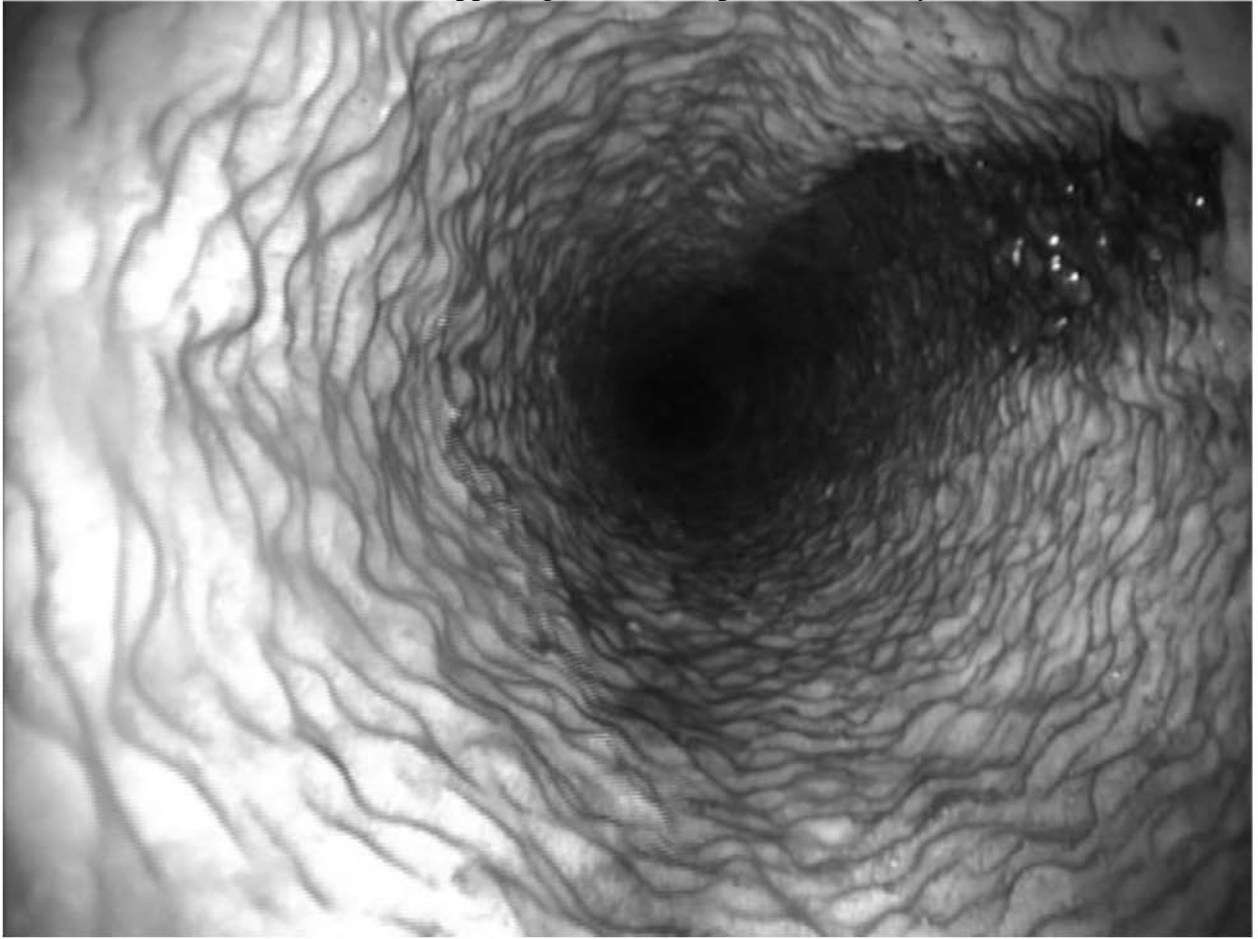
Feature ID #05: Small fracture in upper right at 11 ft depth, darkened by moisture.

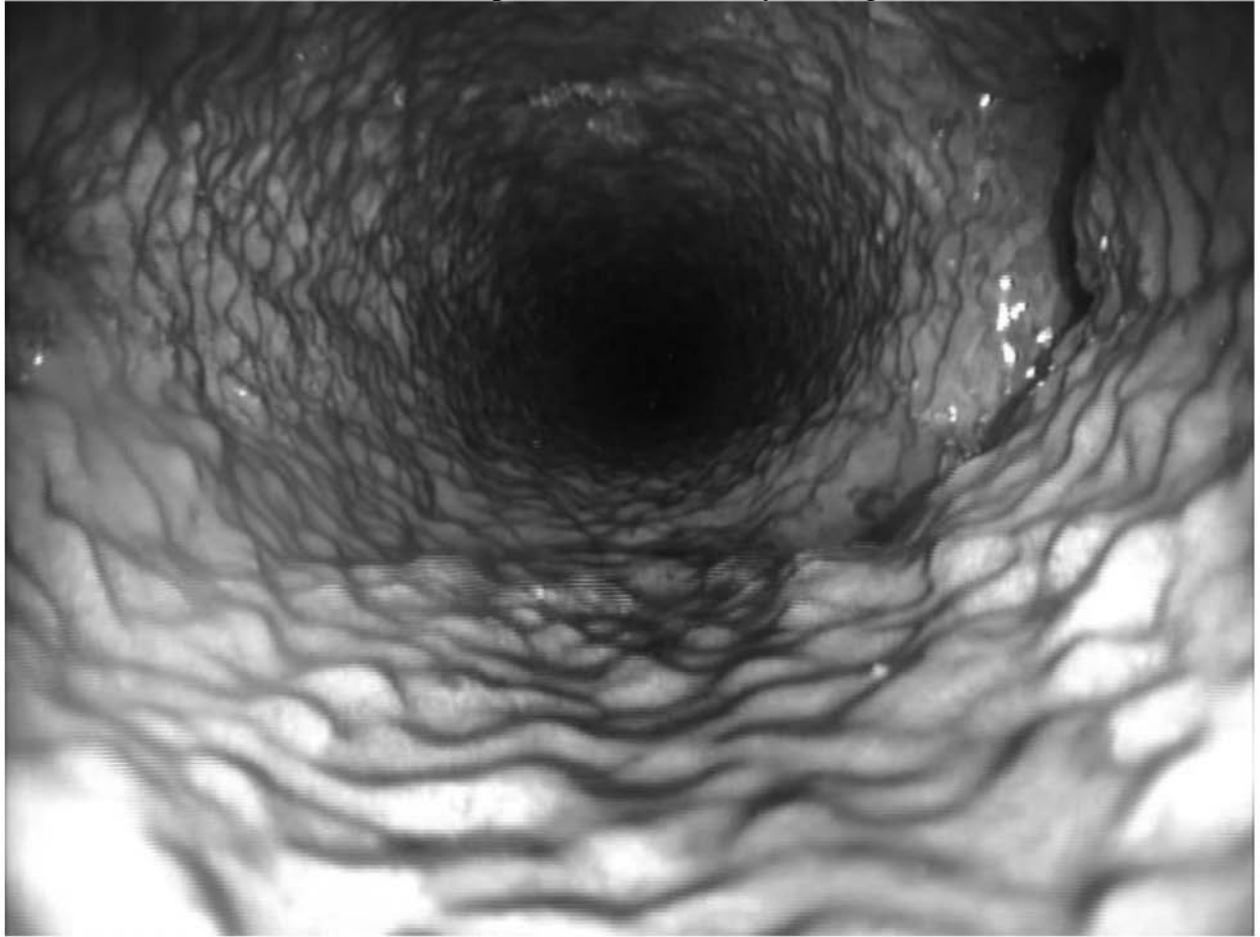
Feature ID #06: Fracture at 13.5 ft depth with water visably leaking in.

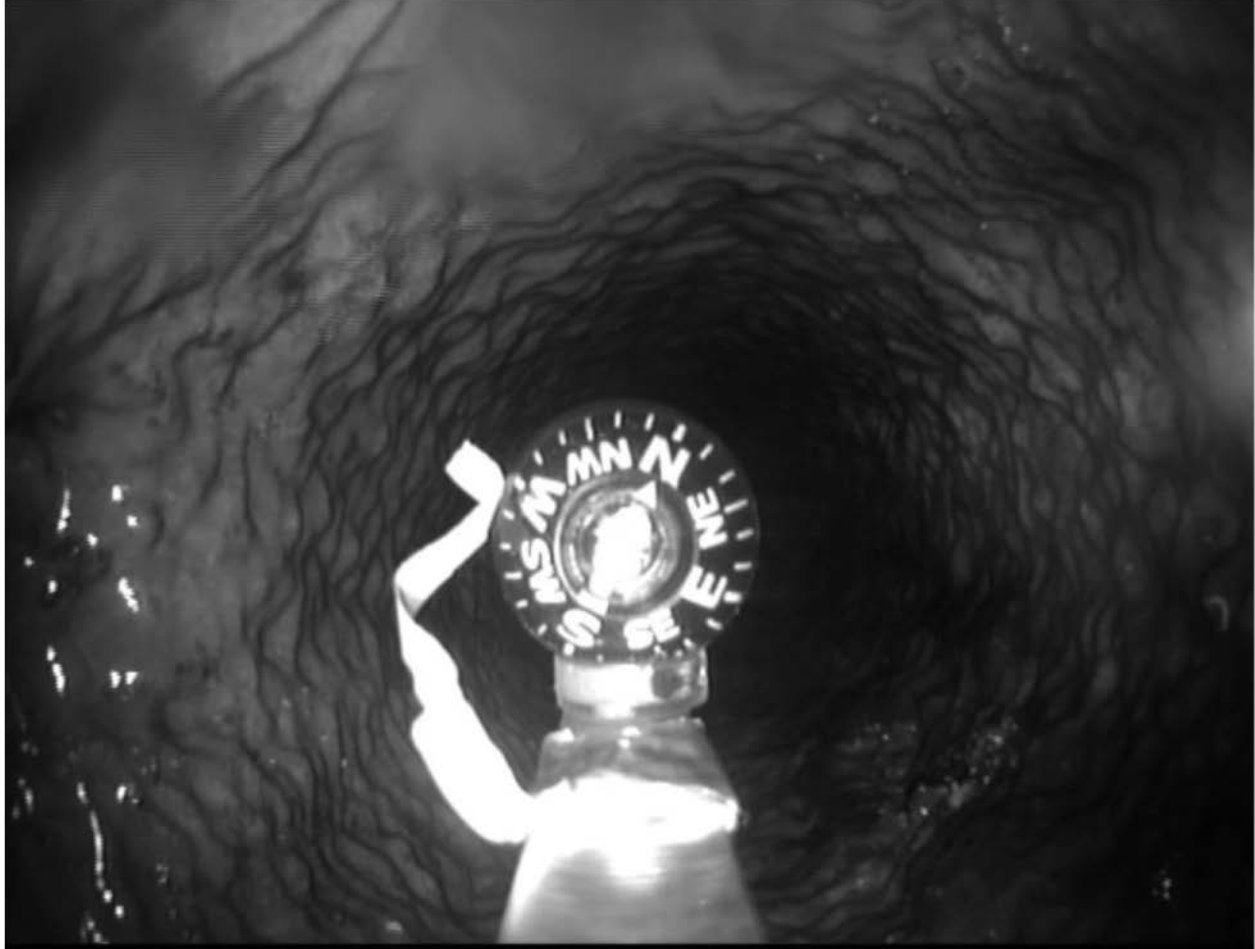
Feature ID #06: Water leaking in through fracture at 13.5 ft depth; compass shows feature on south-west side of the well

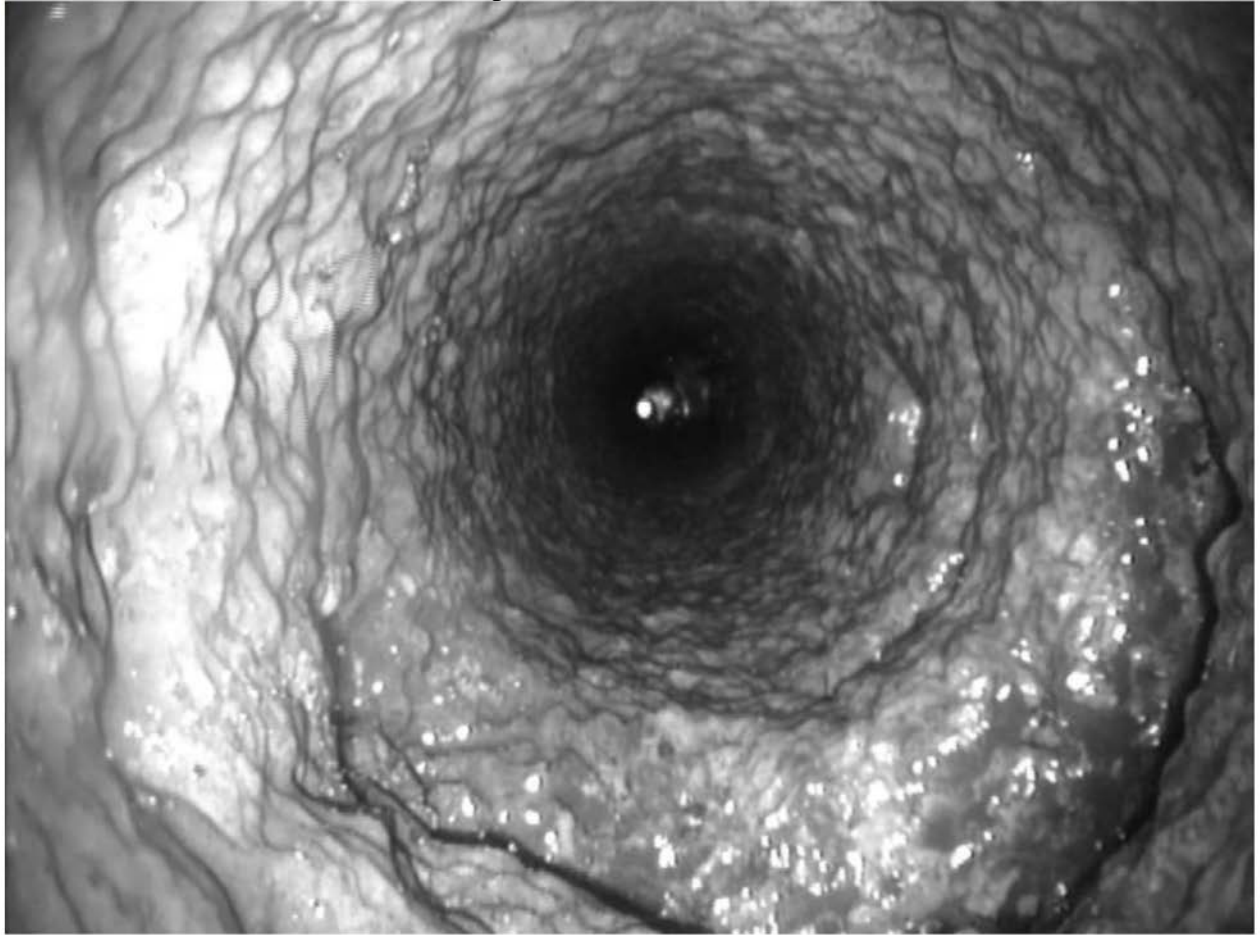
Feature ID #07: Fracture at 25.5 ft depth.

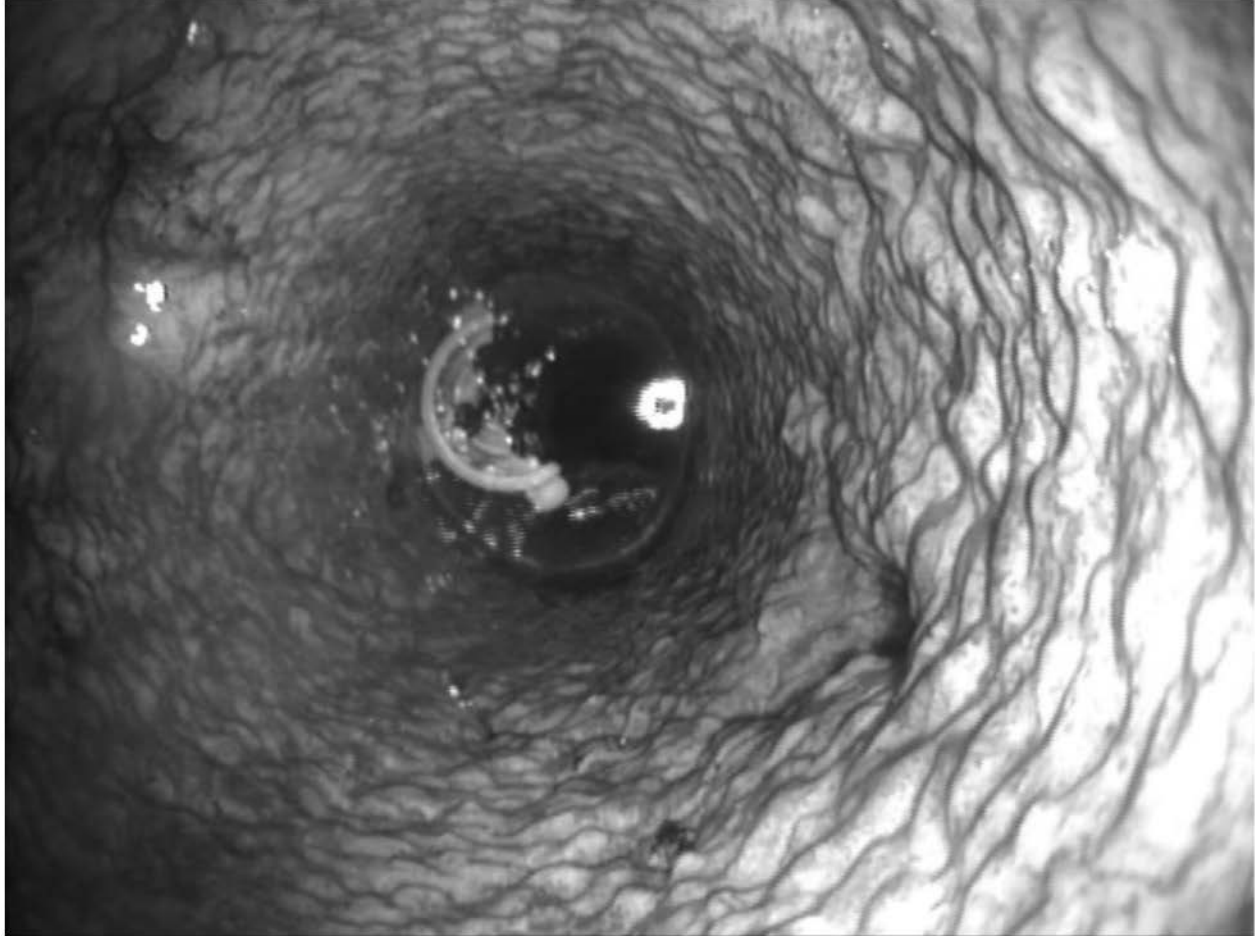
Feature ID #08: Two small, circular voids (upper left and middle-right) at 31.75 ft depth (called horizontal fractures in video). Water table interface is visible.

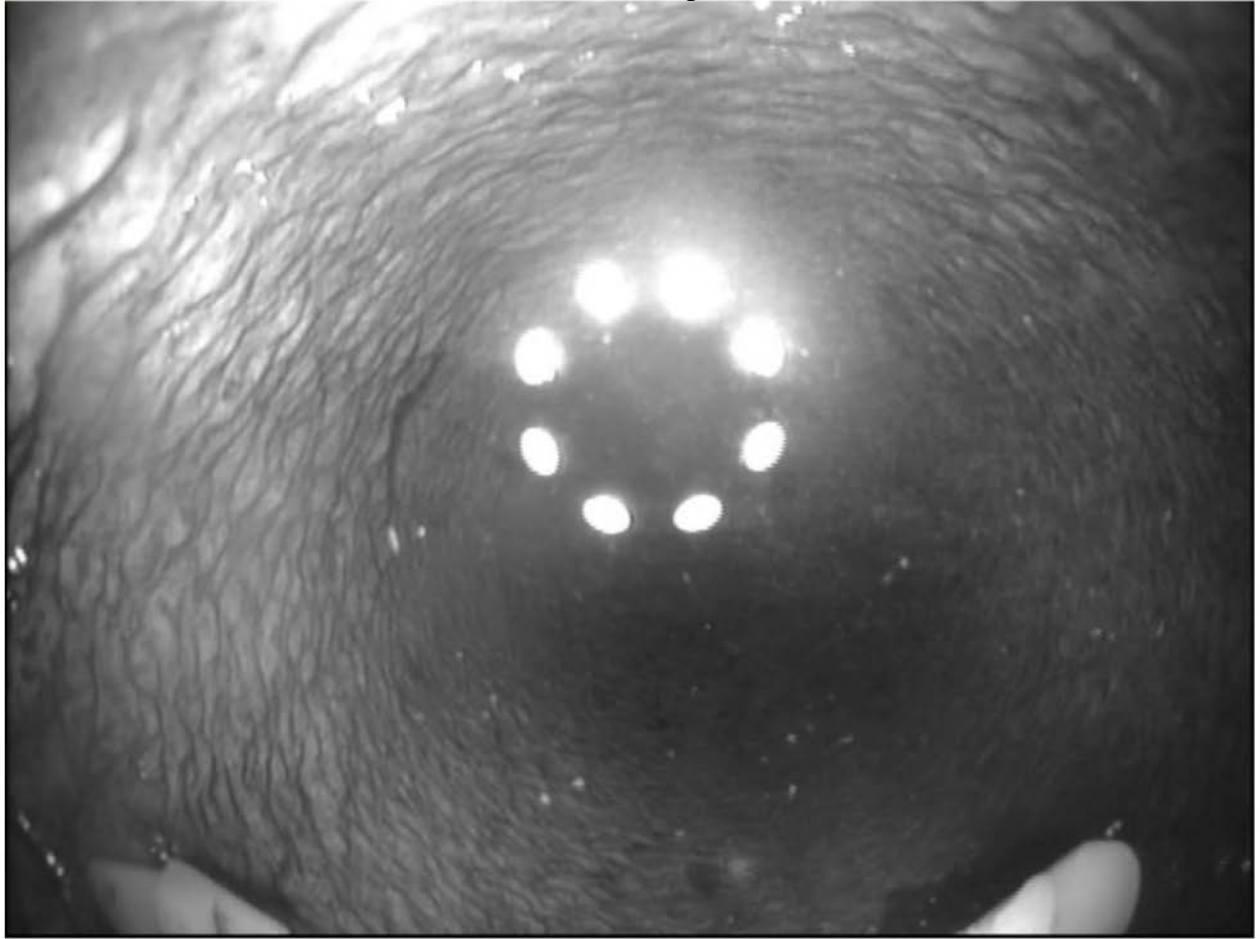
Feature ID #09: Water table interface at 33.125 ft depth.

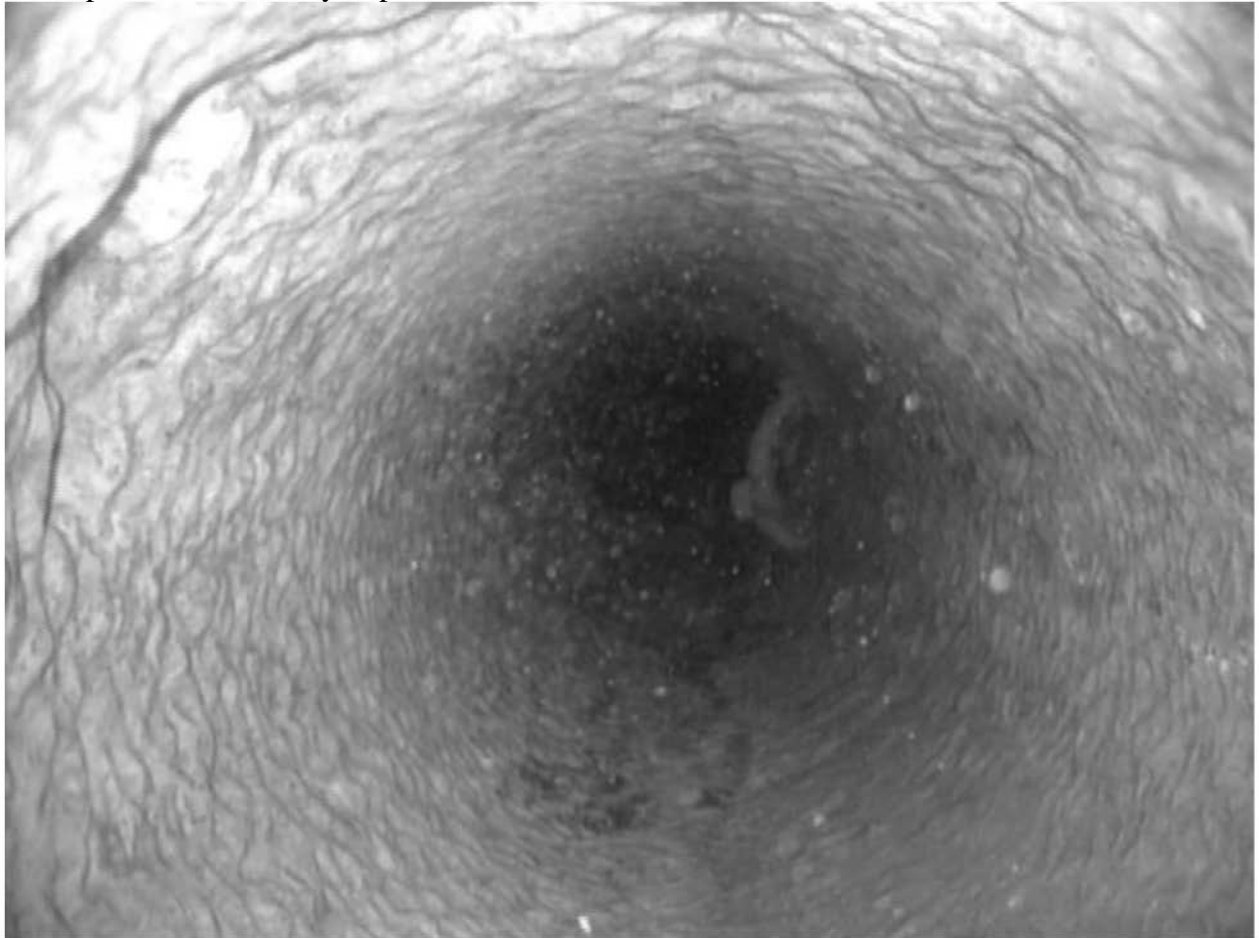
Feature ID #10: Small fracture in upper left at 34 ft depth. This feature was not noted in voice over, spotted in data analysis phase.

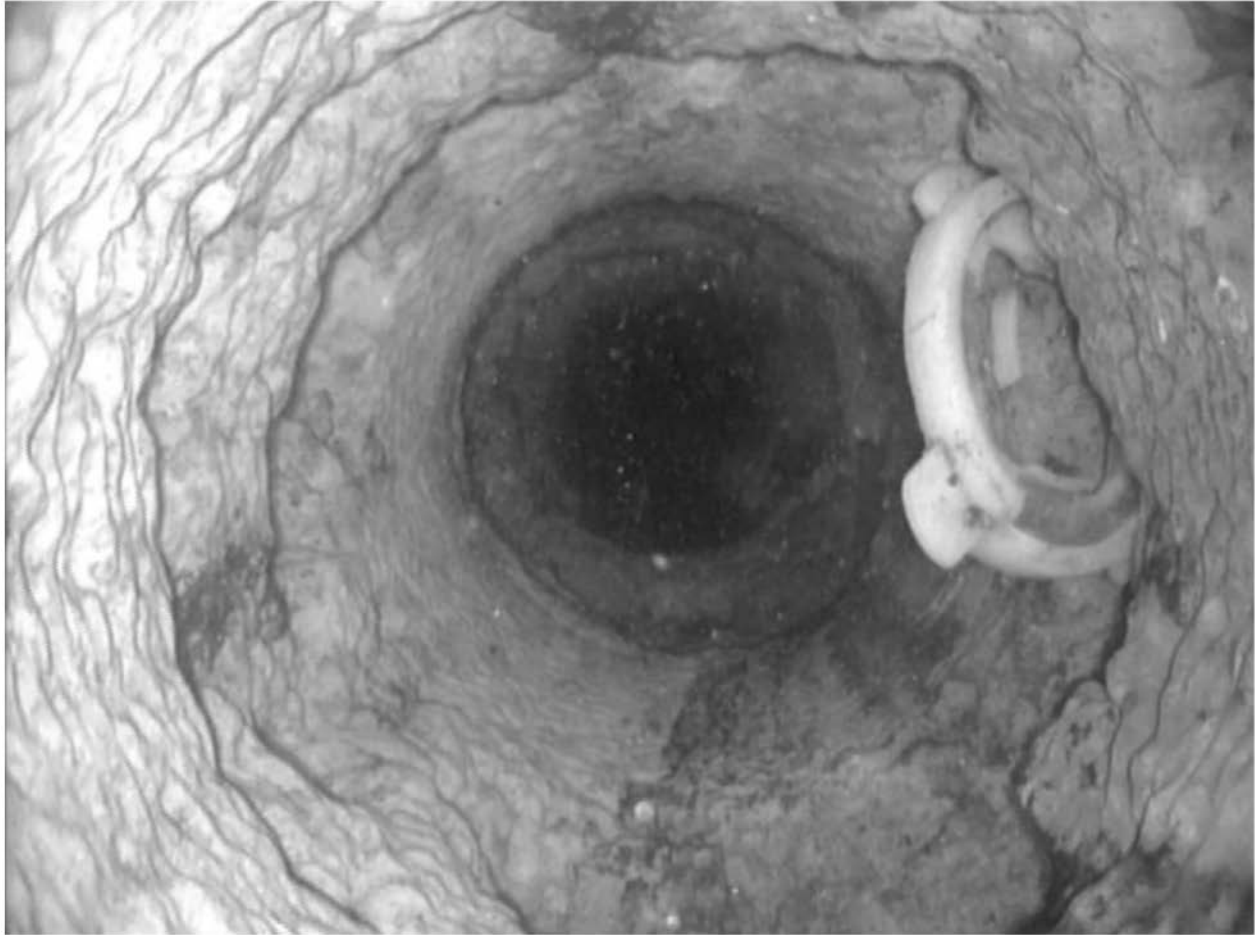
Feature ID #11: Thick fracture (main feature in lower right) at 34.75 ft depth. Thickness between 0.5 and 1.0 ft. Plastic pipe fixture visible at right. Additional fractures visible farther into well.

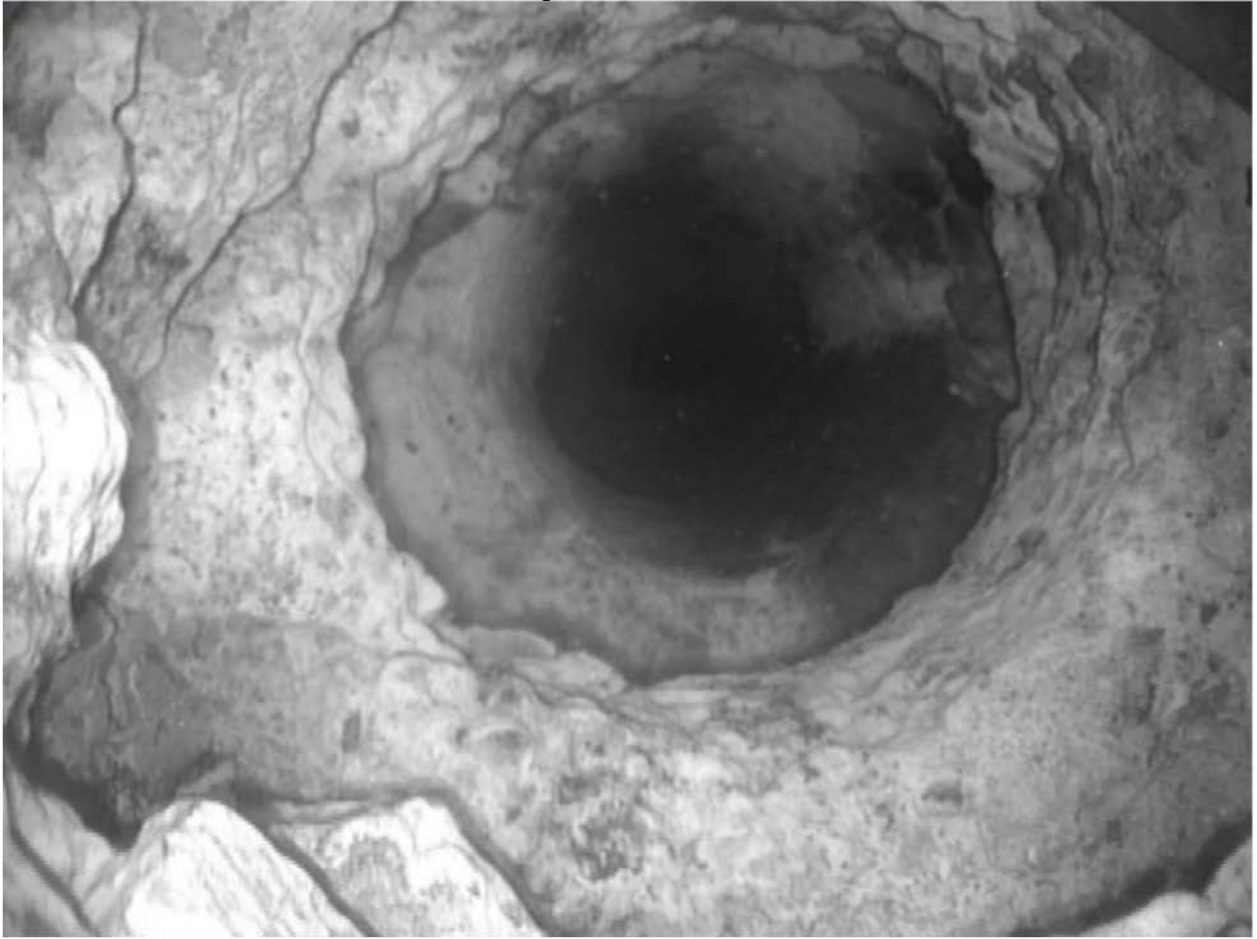
Feature ID #12: Thick fracture at 36 ft depth. Thickness between 0.5 and 1.0 ft.

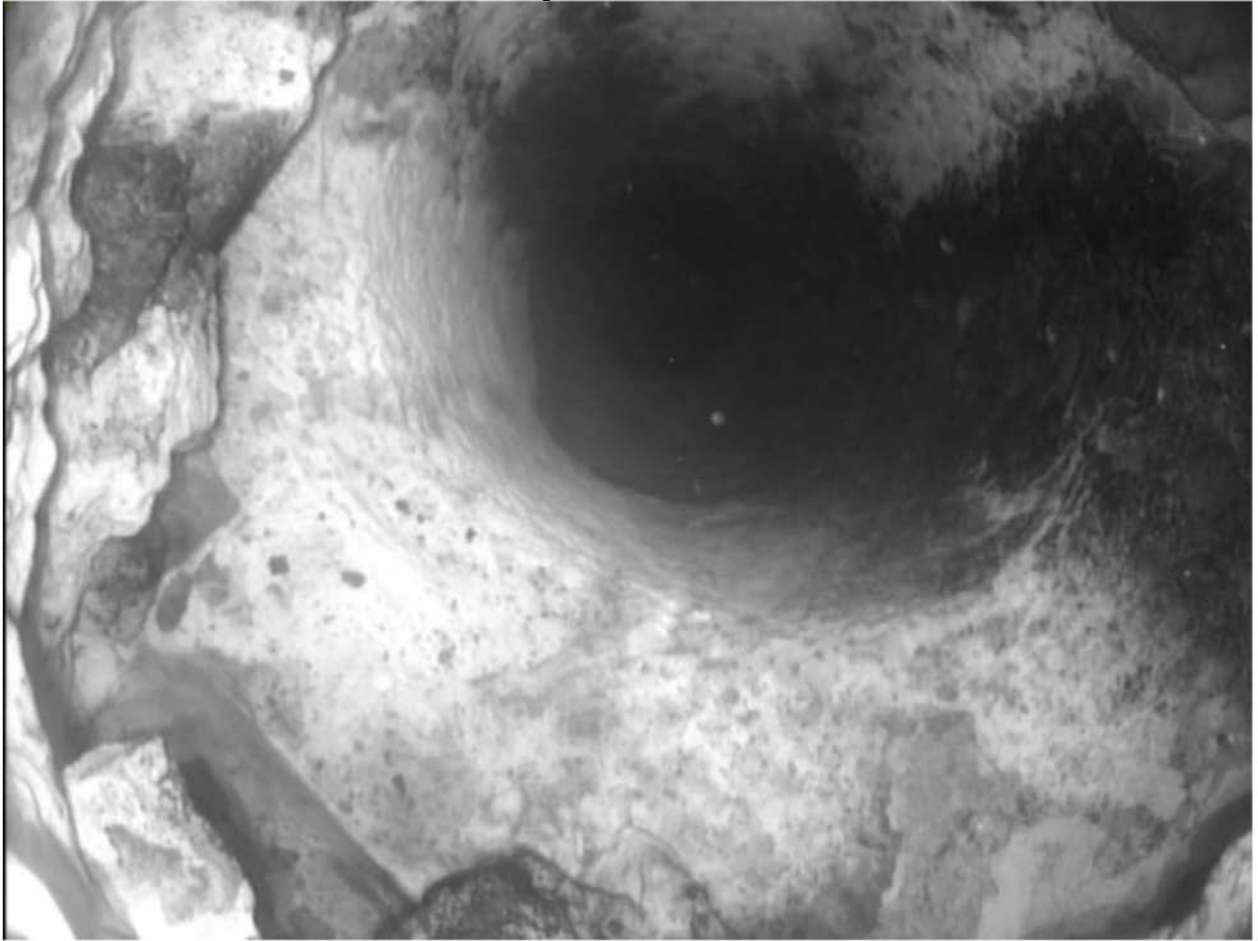
Feature ID #13: Thick fracture at 37 ft depth. Thickness between 0.5 and 1.0 ft.

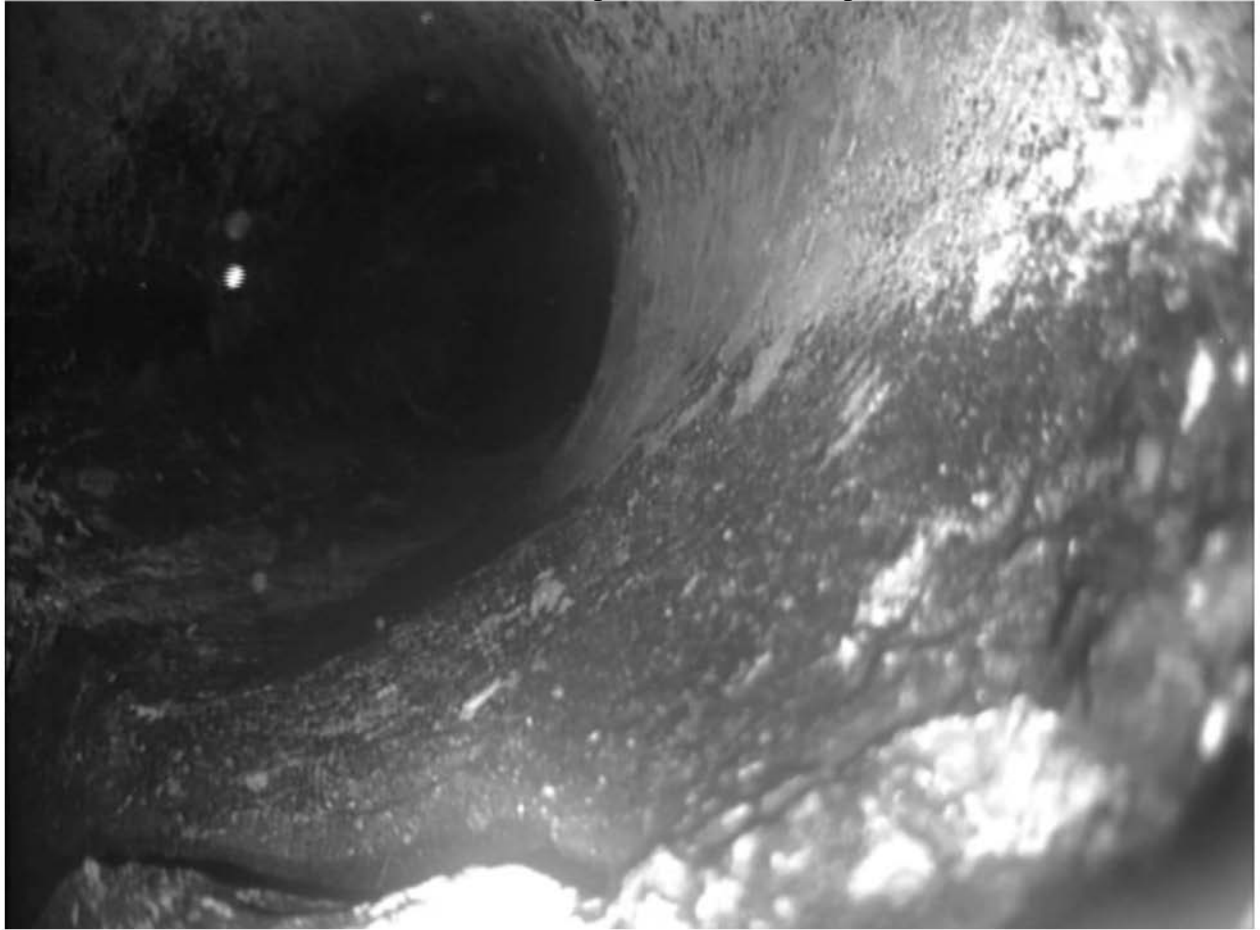
Feature ID #14: Small fracture at bottome of photo at 38.75 ft depth.

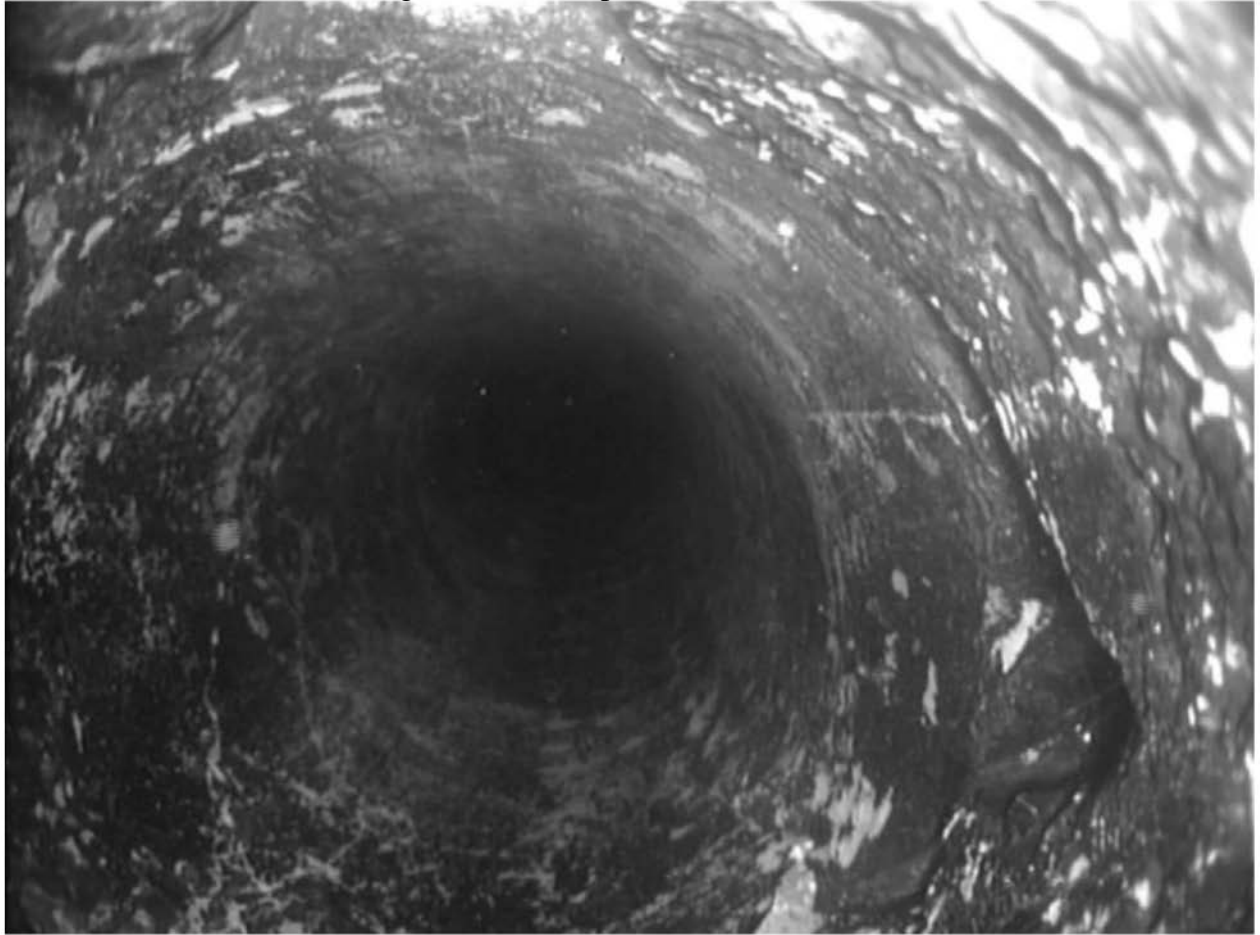
Feature ID #15: Fracture on right at 40.5 ft depth.
