Frederick Farm Well Contamination: Borehole Camera Analysis of Bedrock Structure

Borehole Camera Analysis of Bedrock Structure

The College at Brockport - State University of New York

Michael D. Rodgers and Paul L. Richards

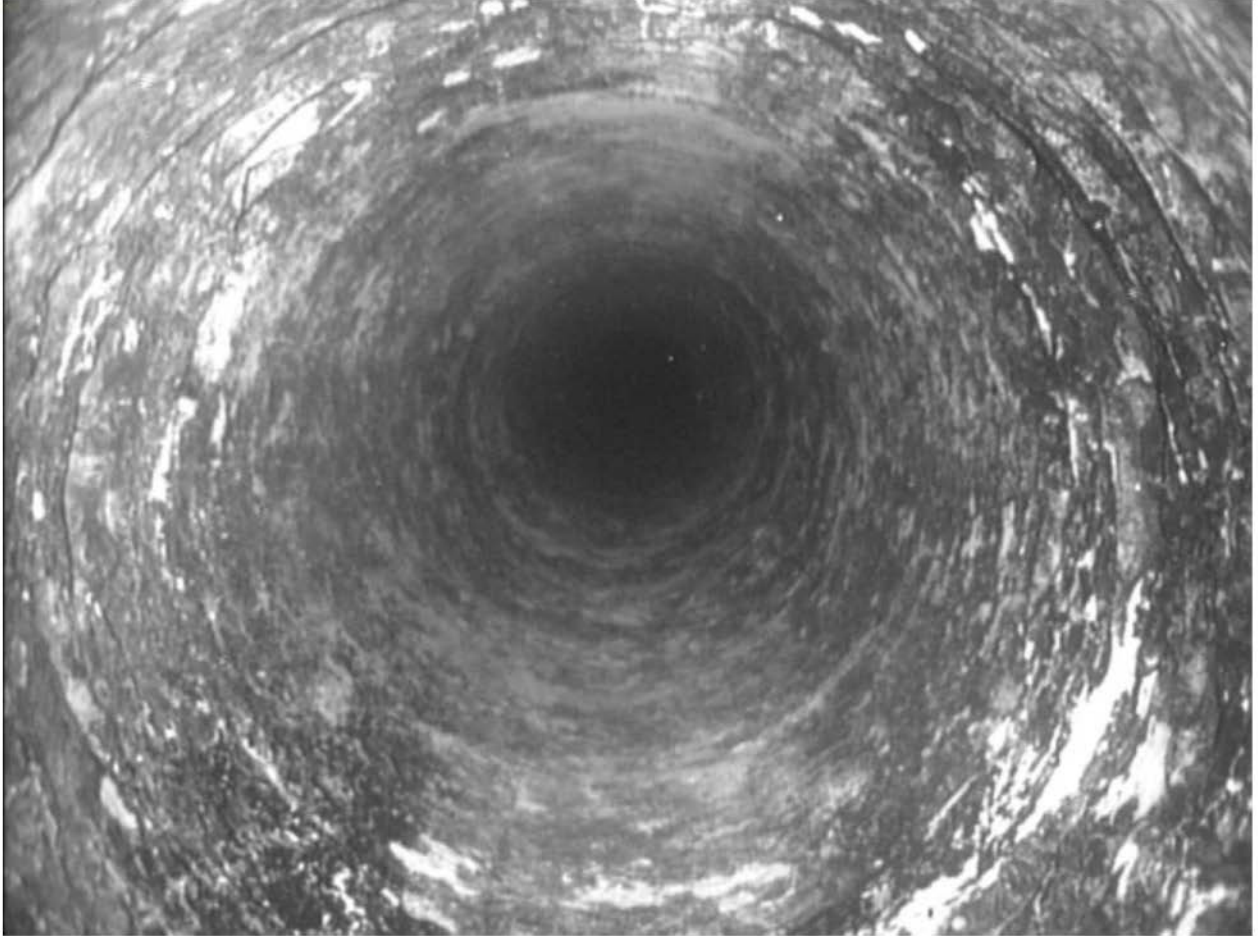
Feature ID #16: Very small fracture on right of photo at 43 ft depth. Not mentioned in the voiceover footage, noticed during data analysis.

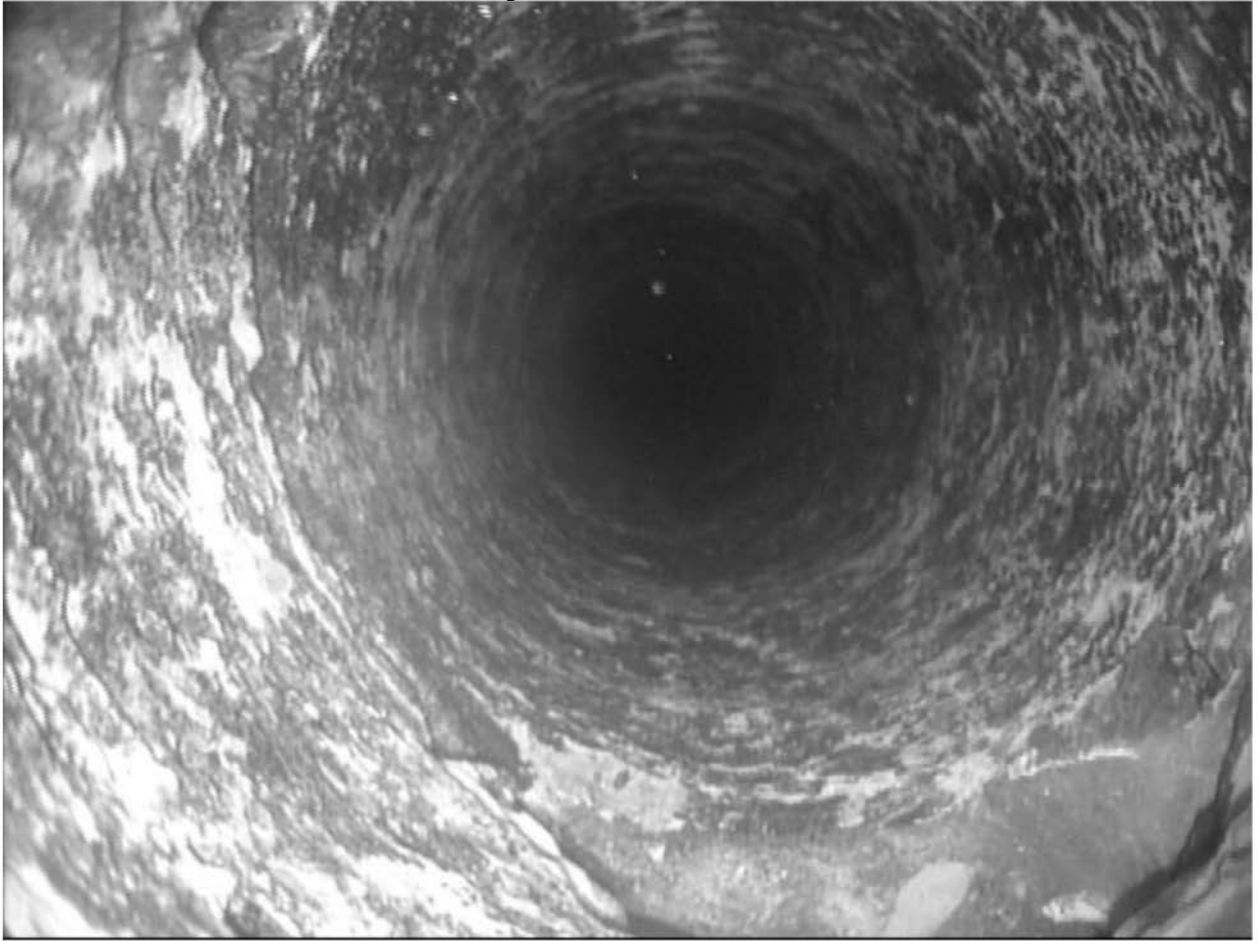
Feature ID #17: Fracture at 45.25 ft depth.

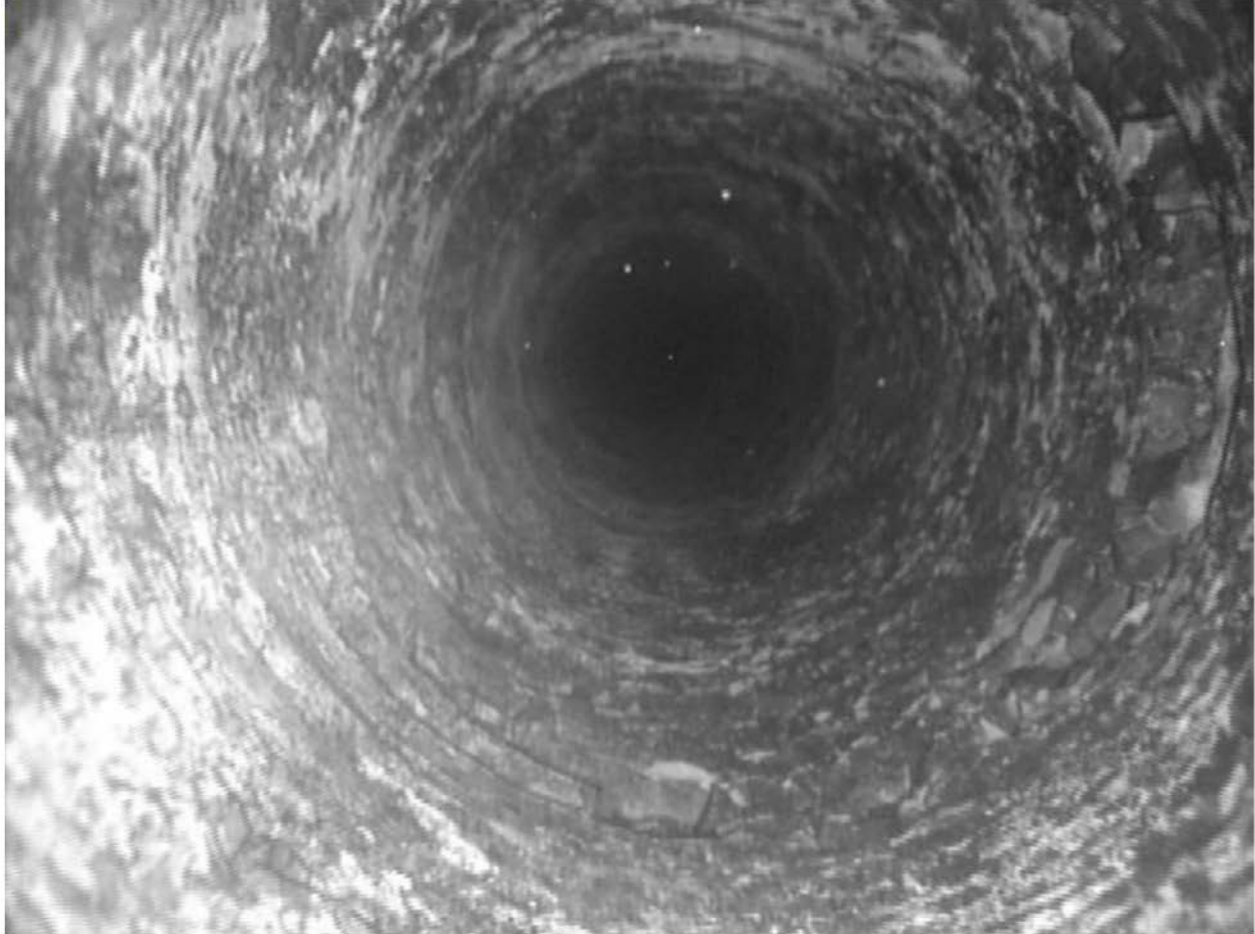
Feature ID #18: Small fracture on right of image at 46 ft depth. Not mentioned in voiceover, noticed in data analysis.

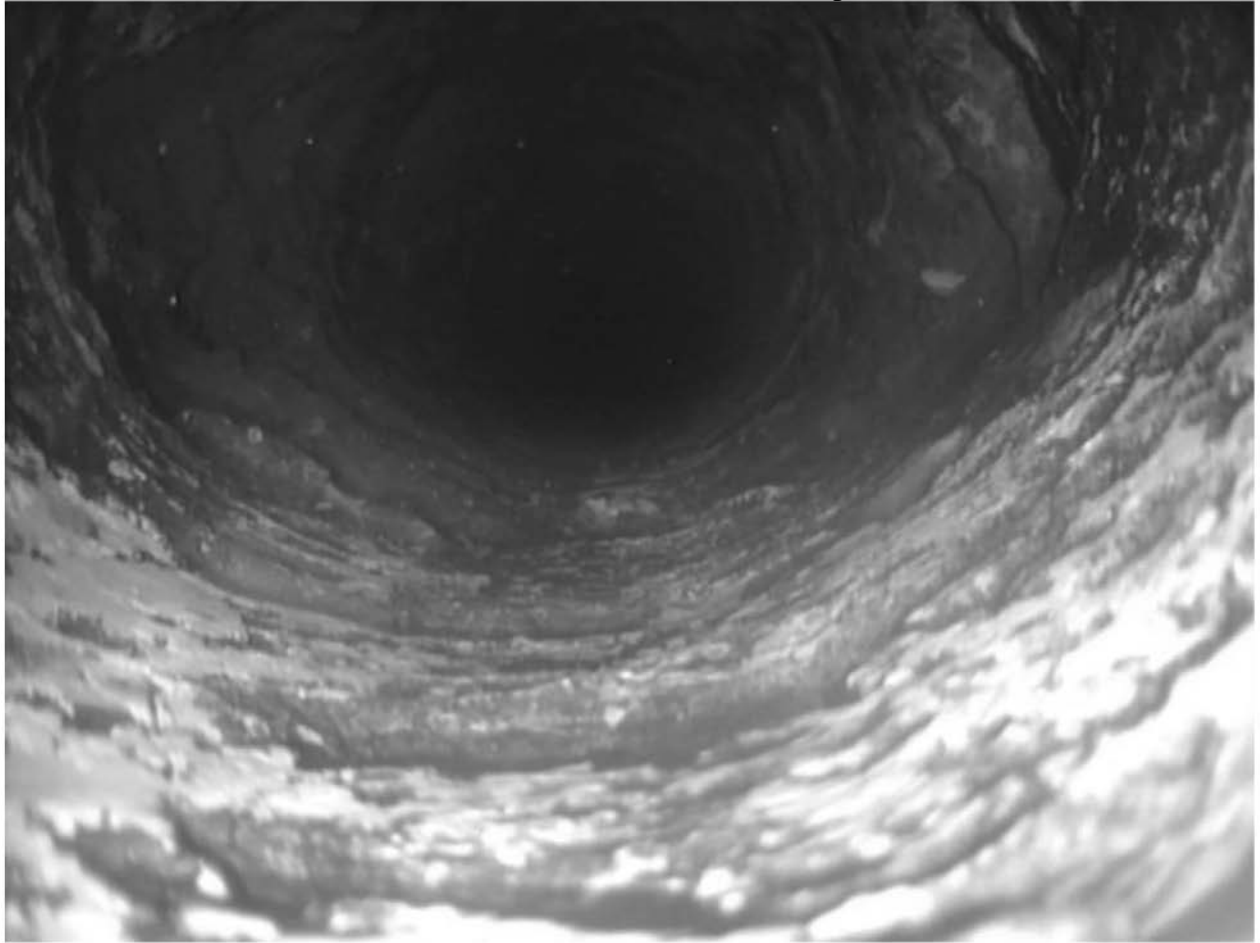
Feature ID #19: Several small fractures between 48 and 49 ft depth.

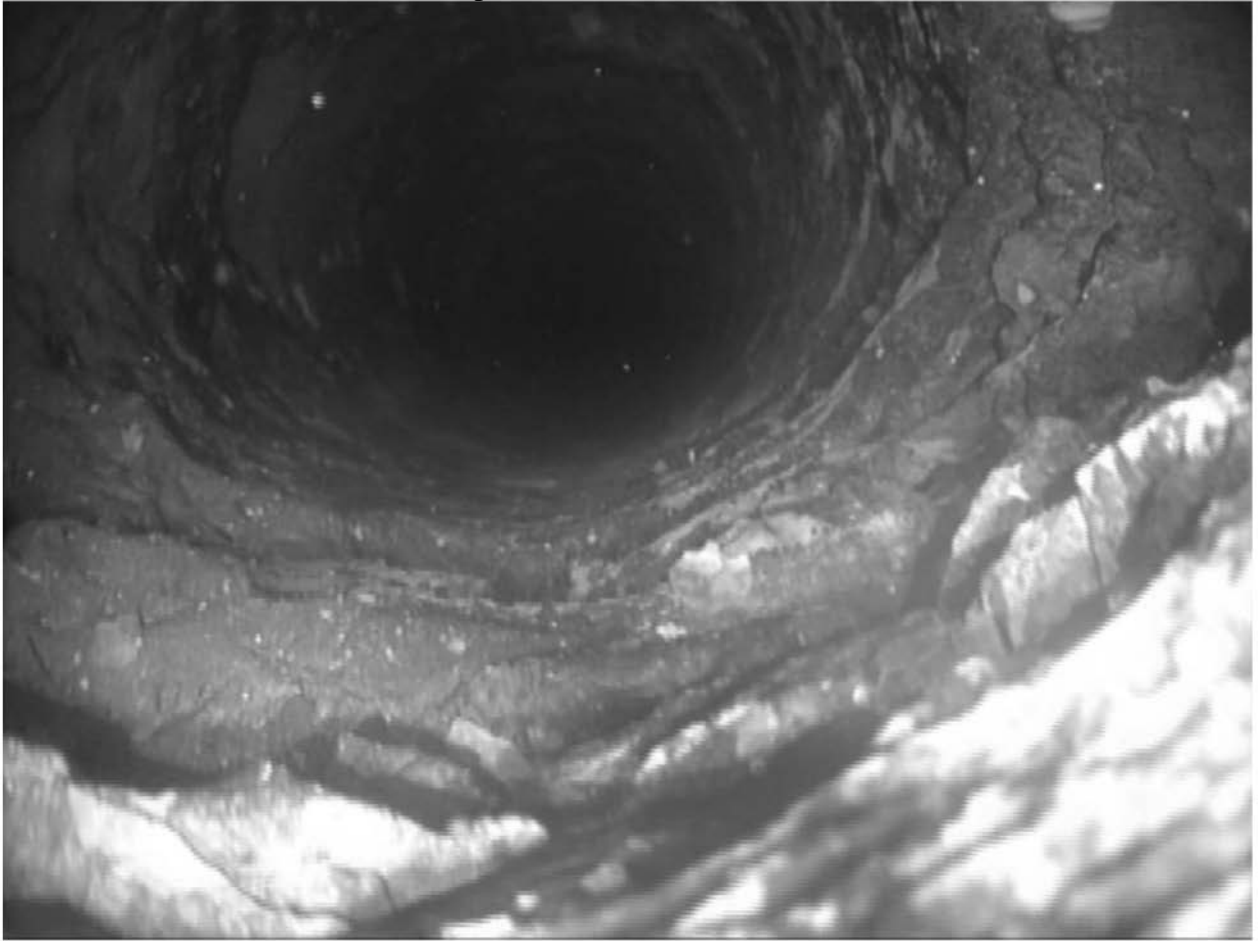
Feature ID #20: Fracture at 49 ft depth.

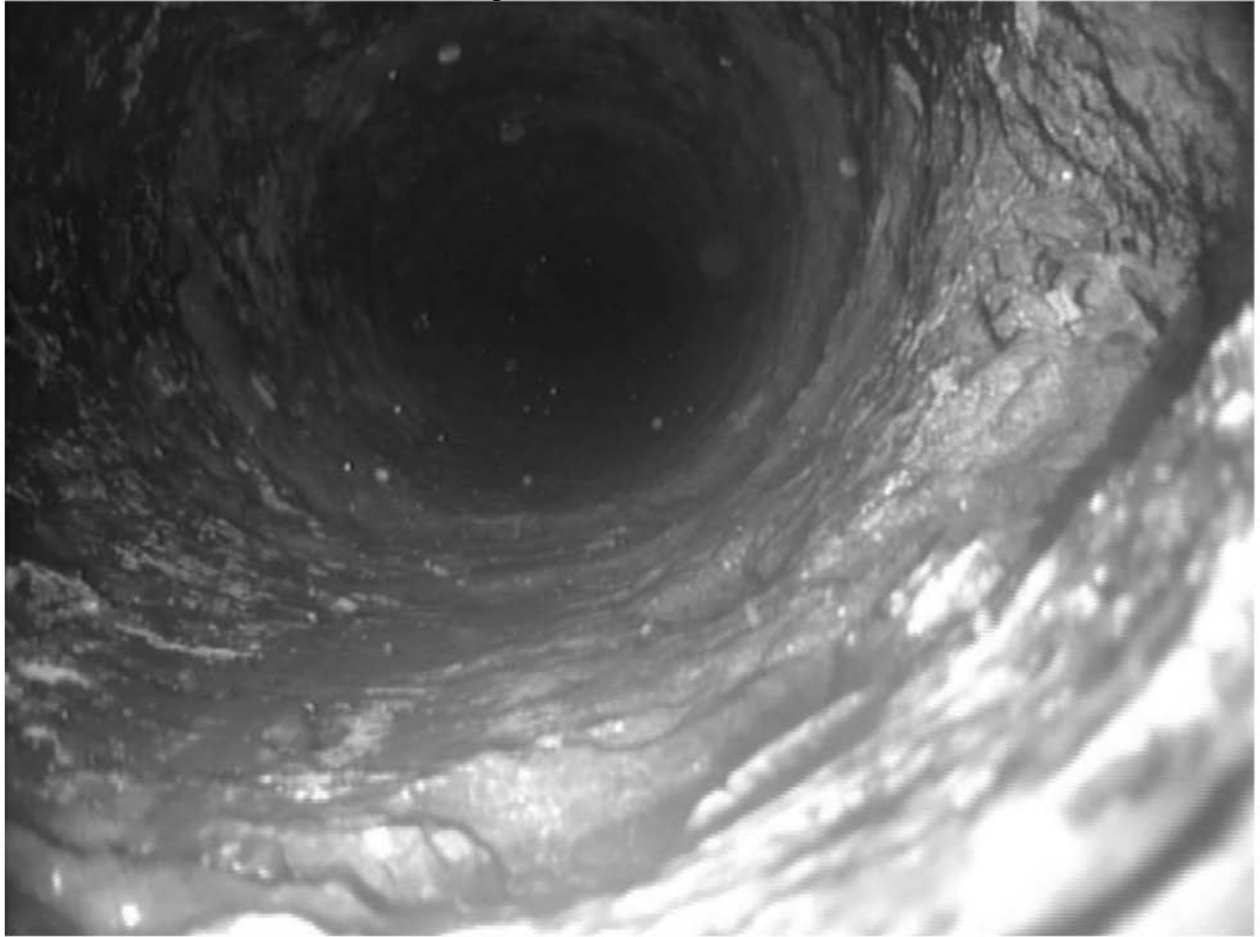
Feature ID #21: Fracture at 50.5 ft depth.

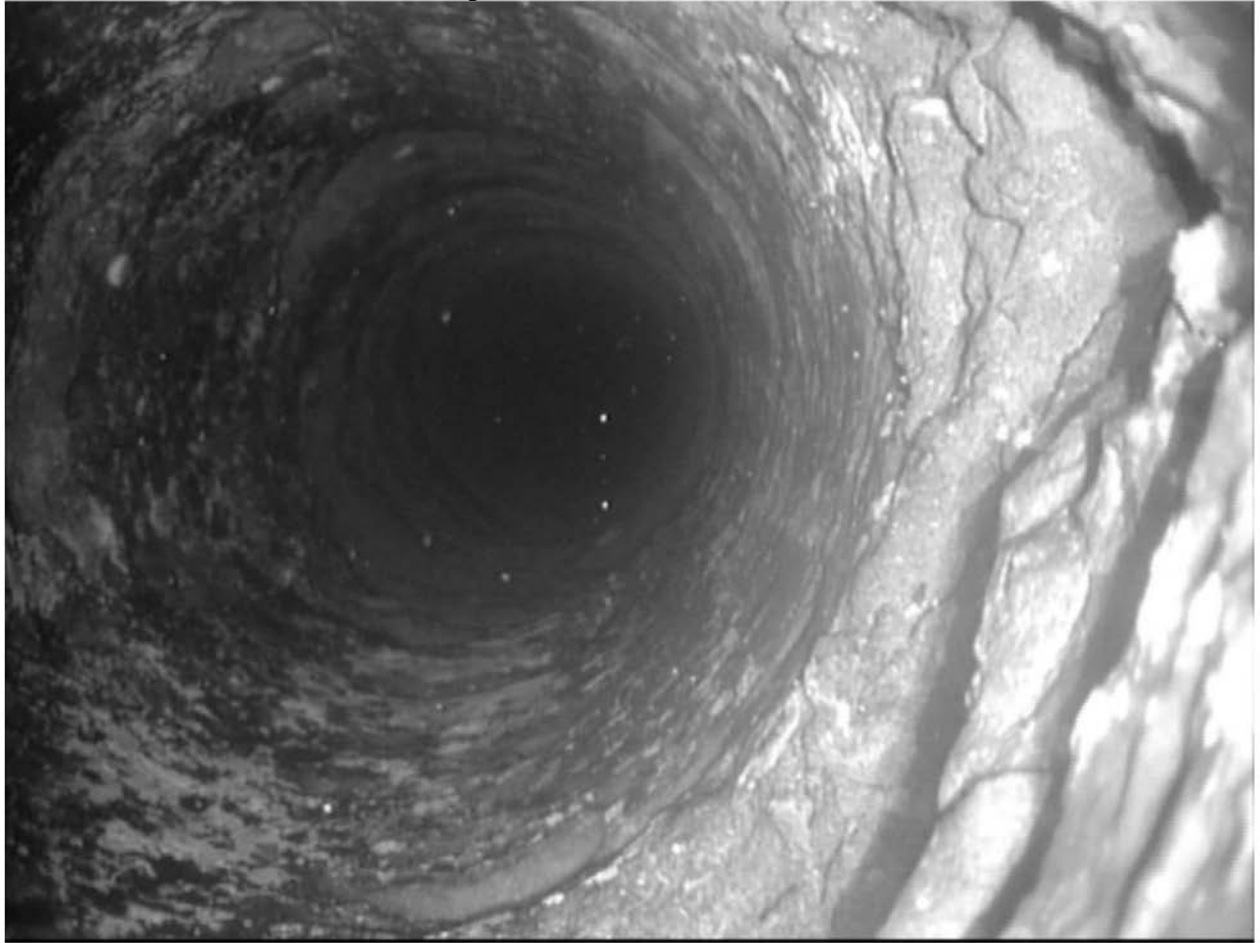
Feature ID #22: Fracture at 51 ft depth.

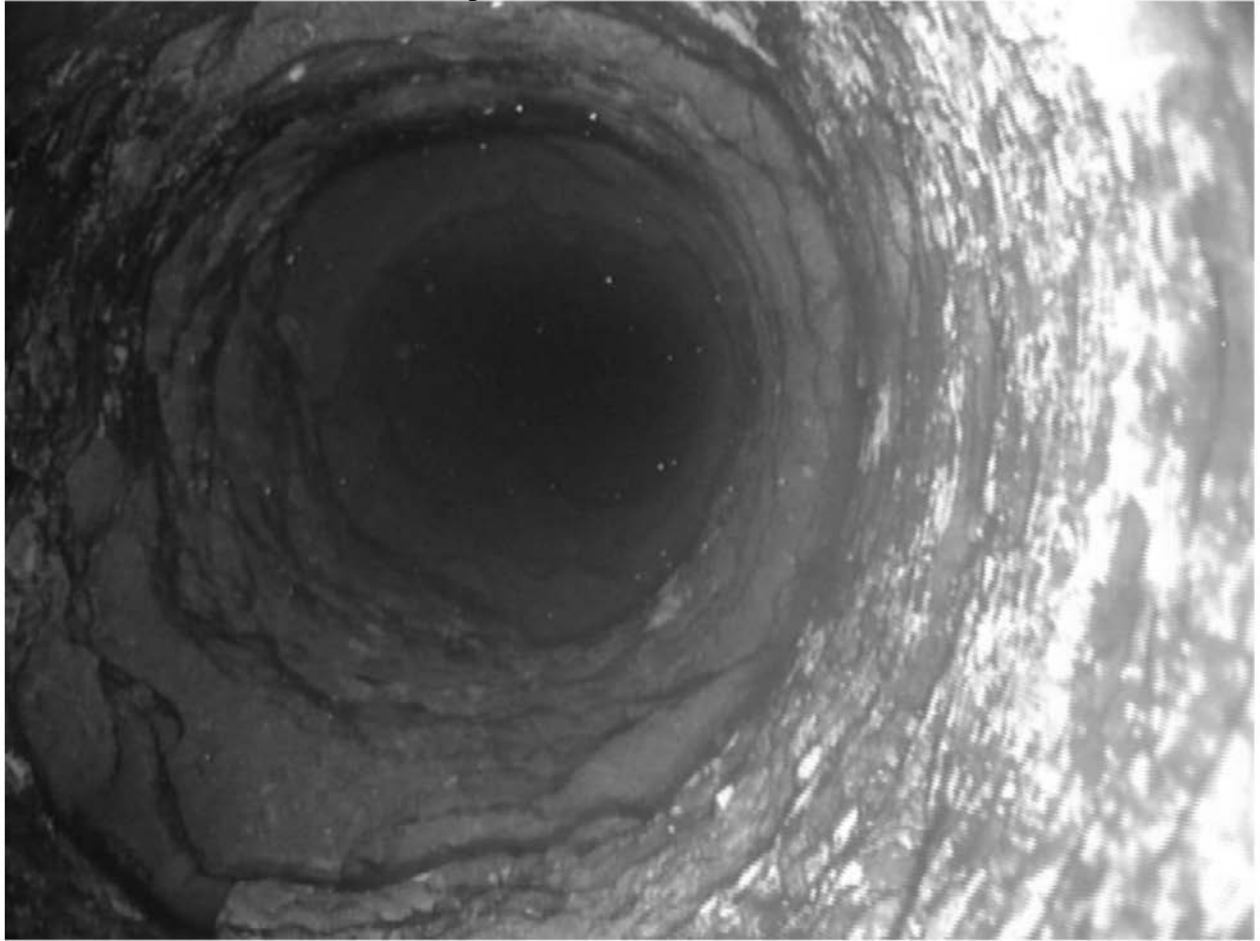
Feature ID #23: Fracture at 52 ft depth. Thickness is ~0.5 ft.

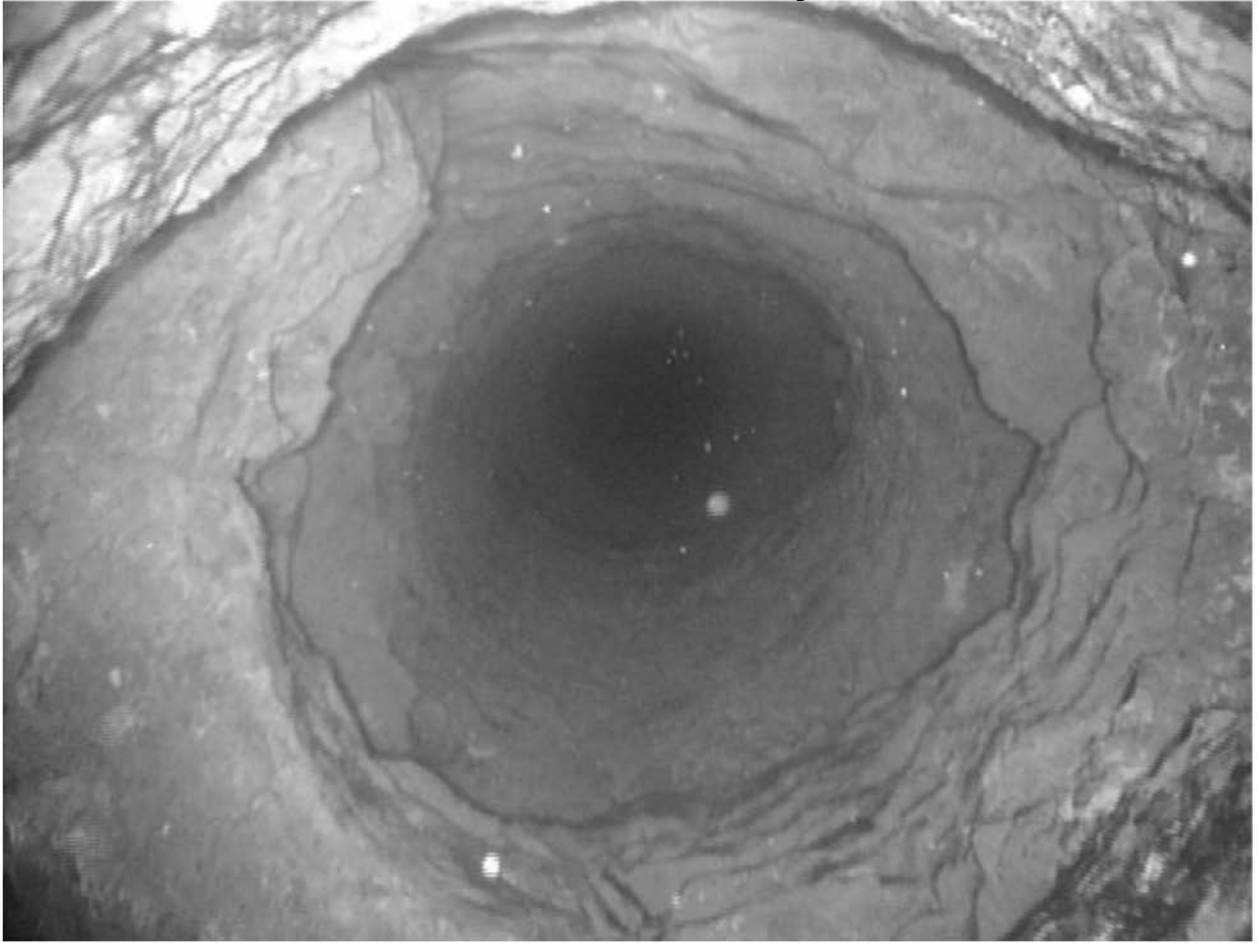
Feature ID #24: Several fractures; main fracture at 53.5 ft depth.

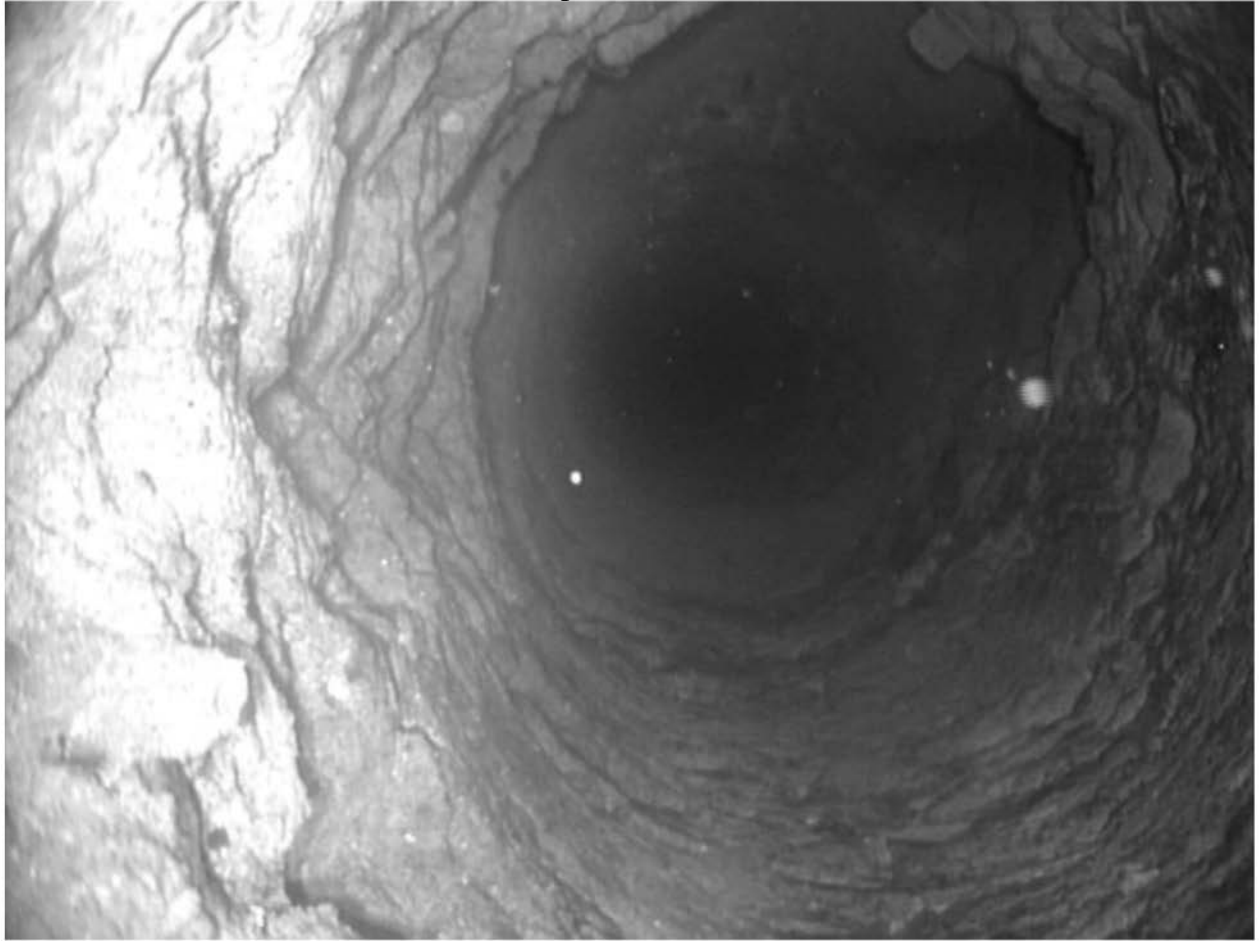
Feature ID #25: Main fracture at 54.5 ft depth; continuation of features seen in Feature ID #24.

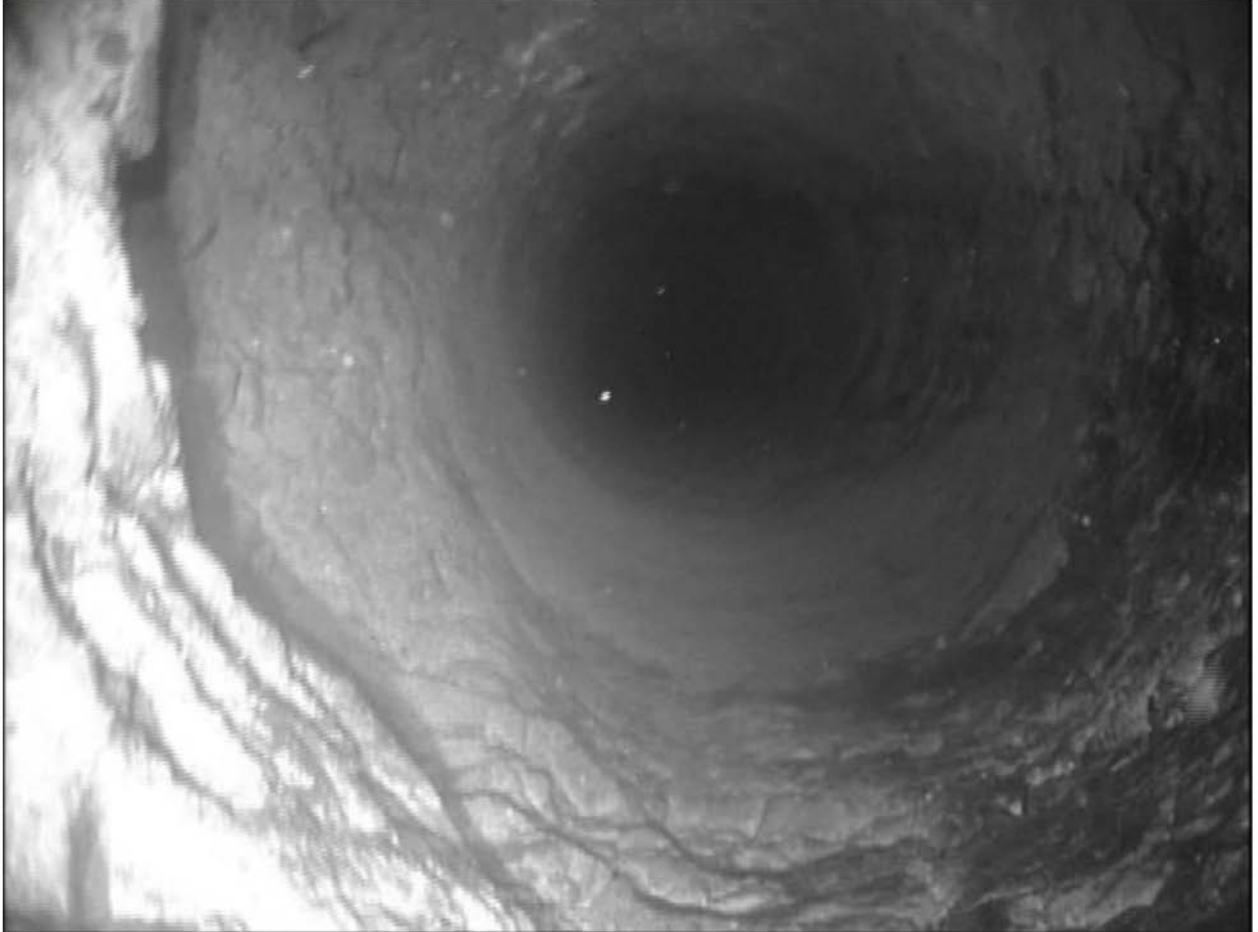
Feature ID #26: Fracture at 55.5 ft depth. Continuation of features from Feature IDs #24 and #25.

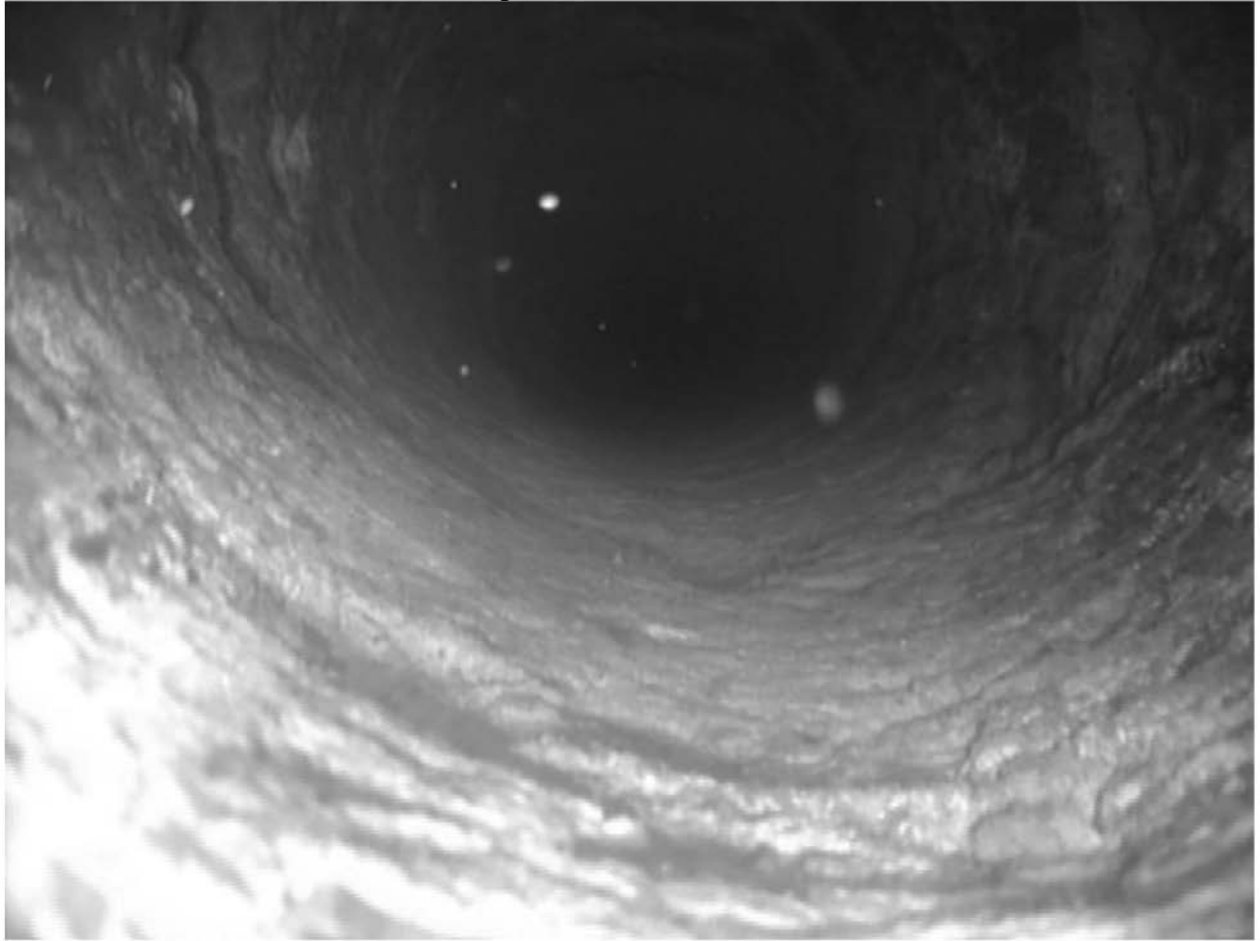
Feature ID #27: Fracture at 57.8 ft depth.

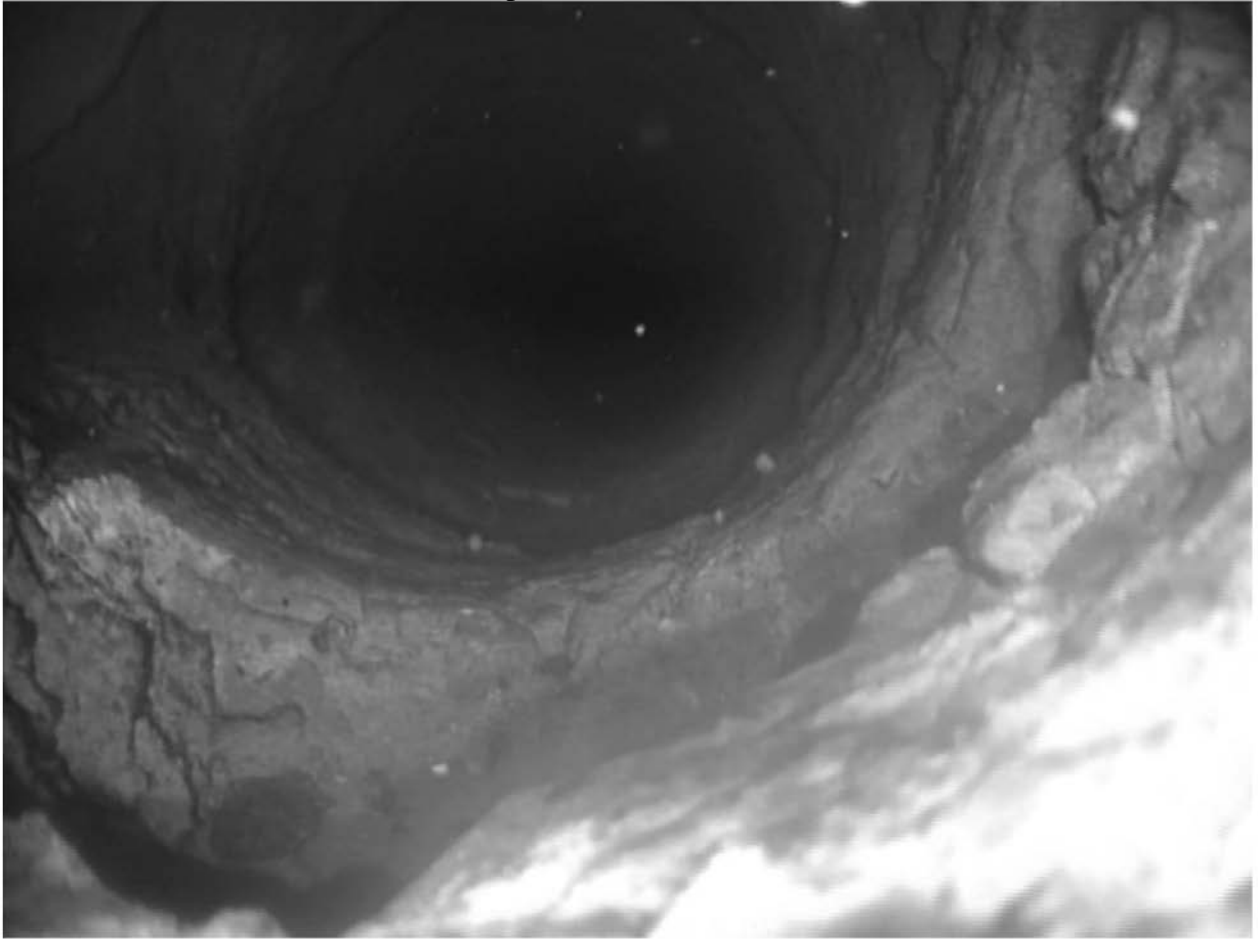
Feature ID #28: Fracture at 59.25 ft depth.

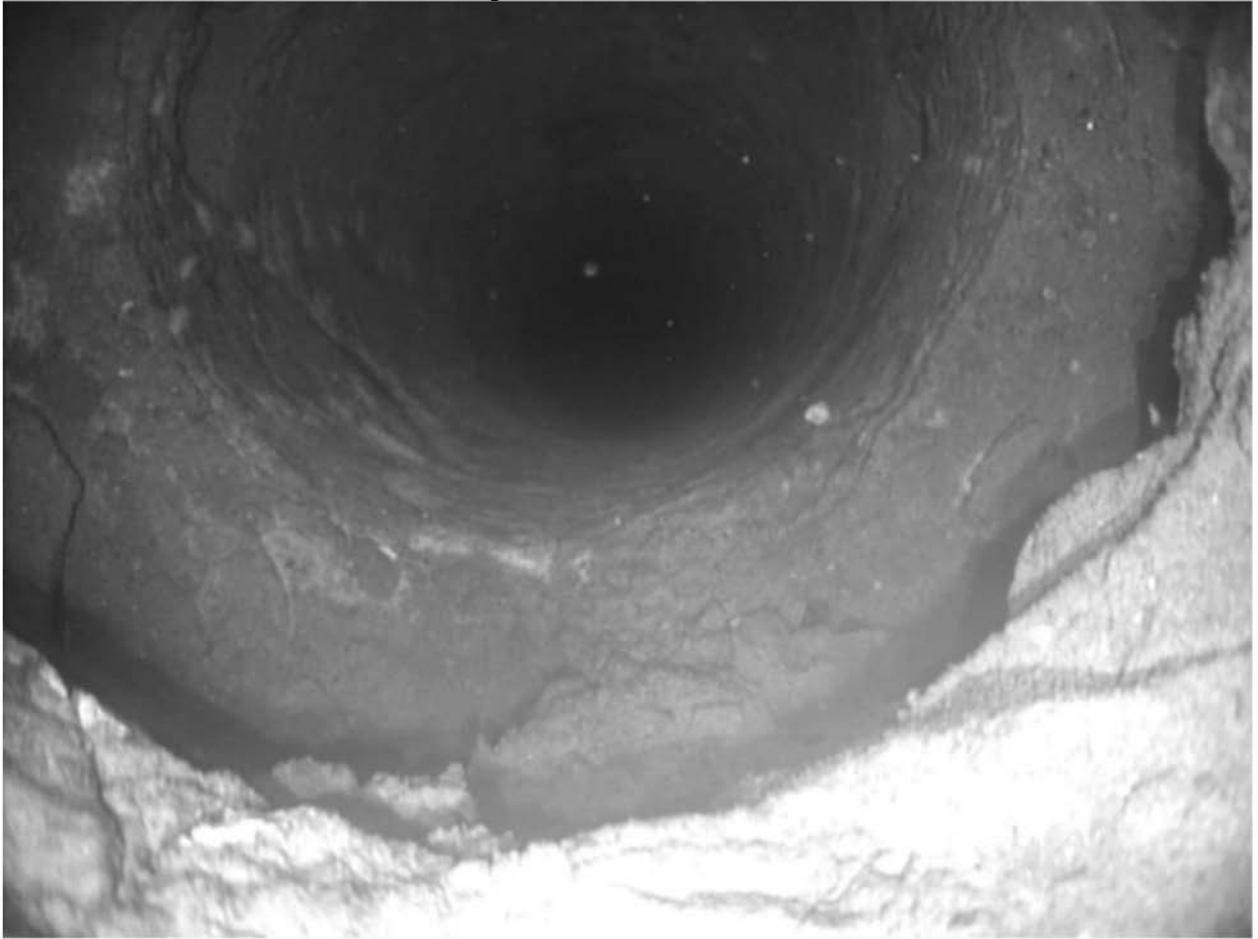
Feature ID #29: Fracture at 59.8 ft depth.

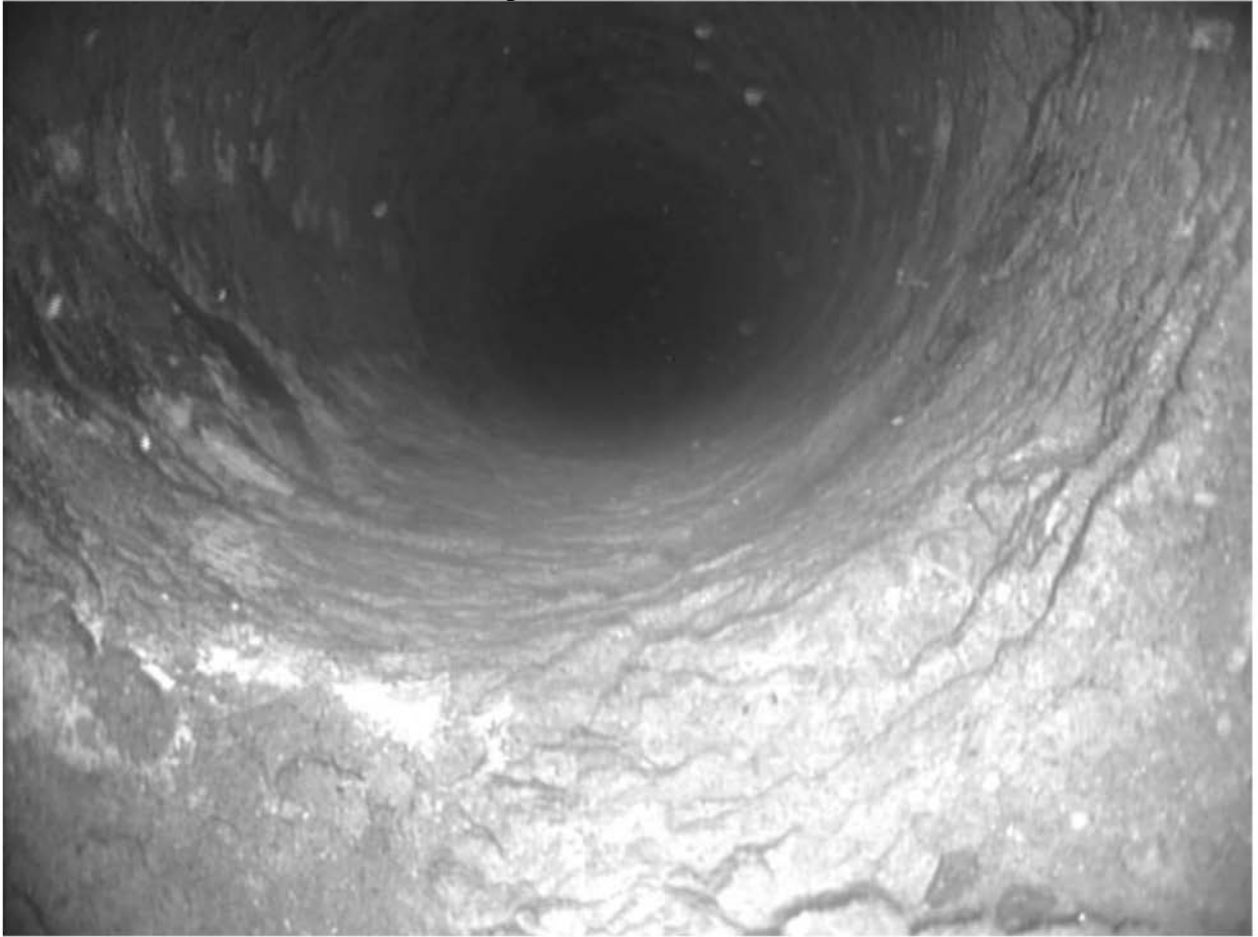
Feature ID #30: Fracture at 60.25 ft depth.

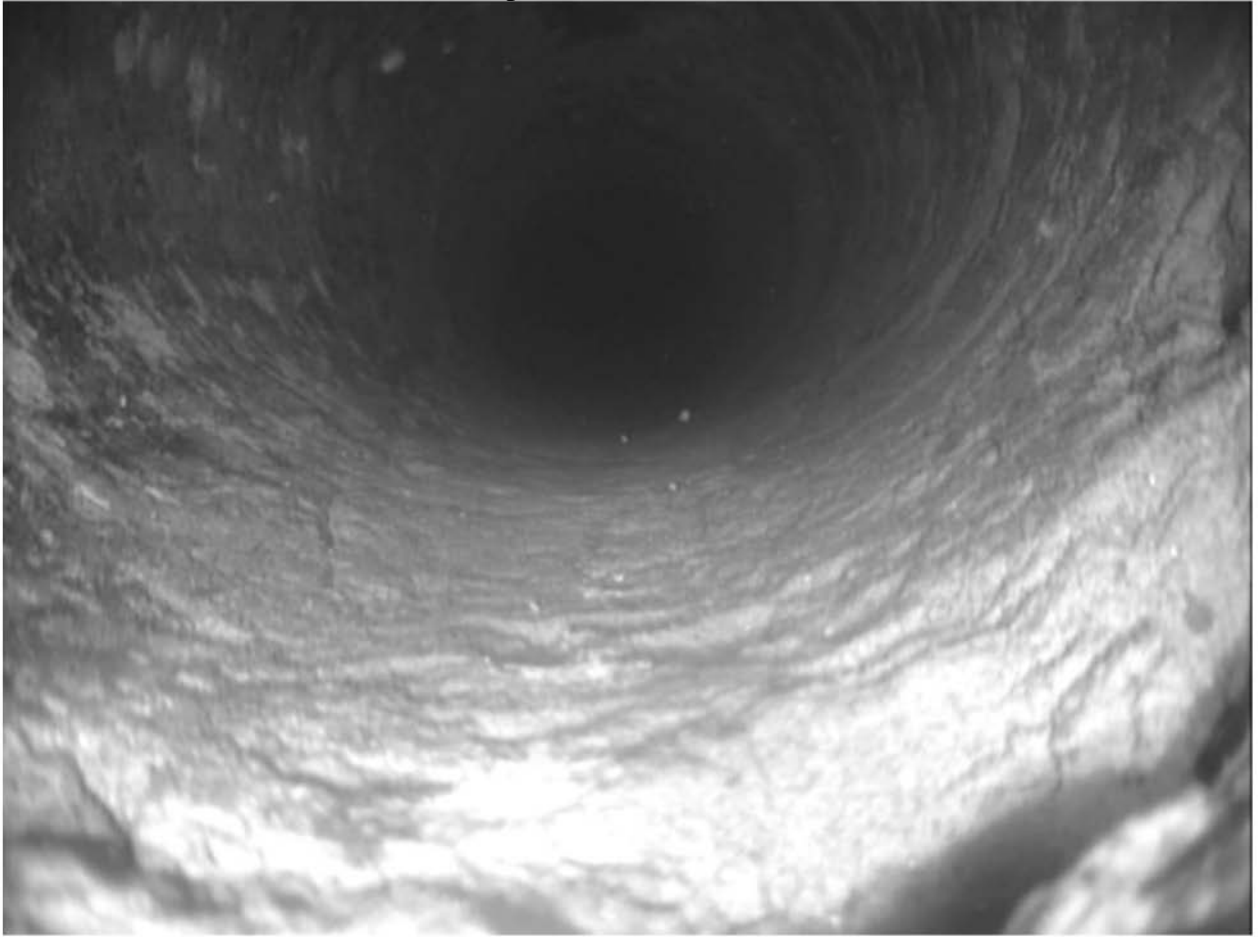
Feature ID #31: Fracture at 60.75 ft depth.

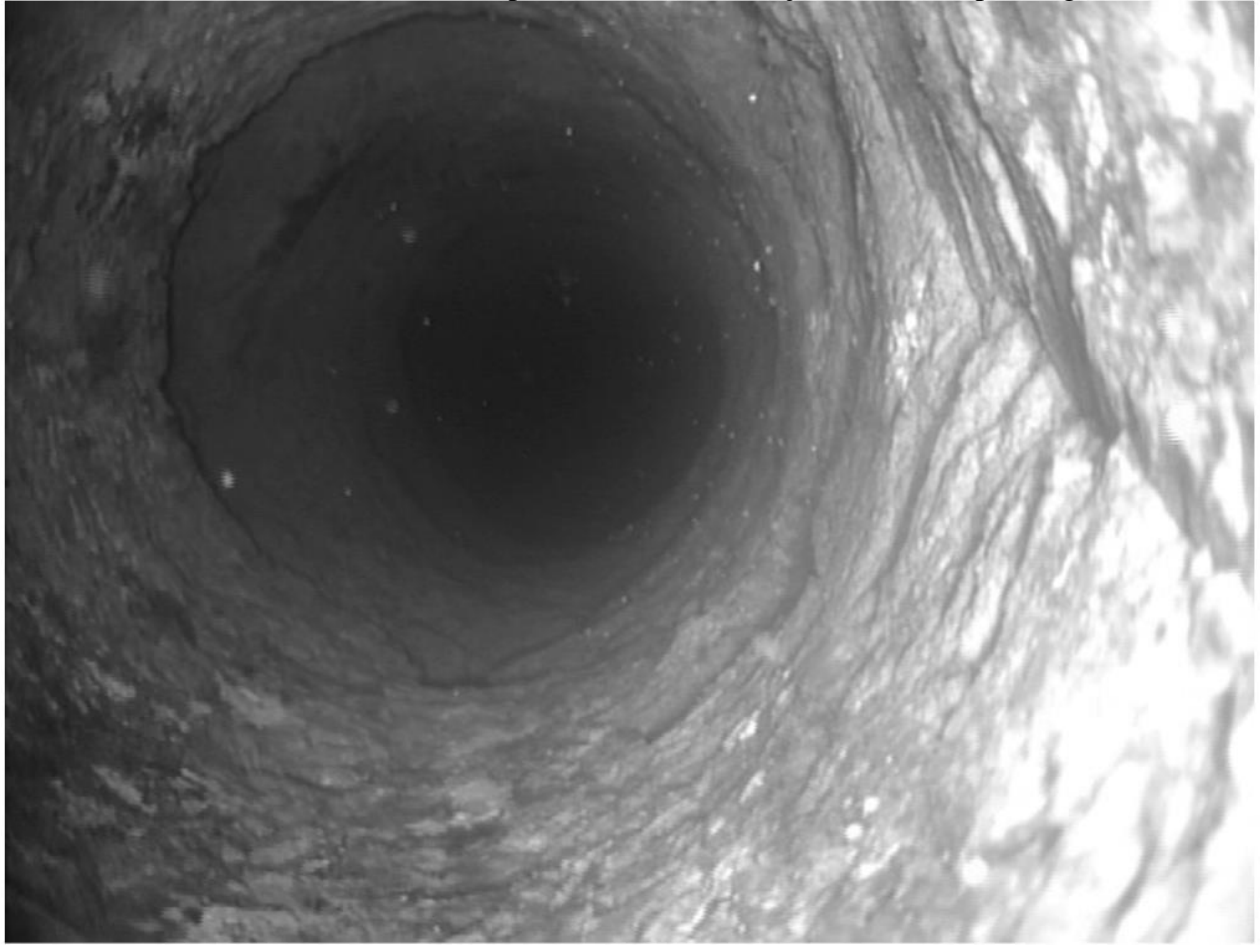
Feature ID #32: Fracture at 61.75 ft depth. This is a vertical-joint fracture spanning ~0.5 ft.

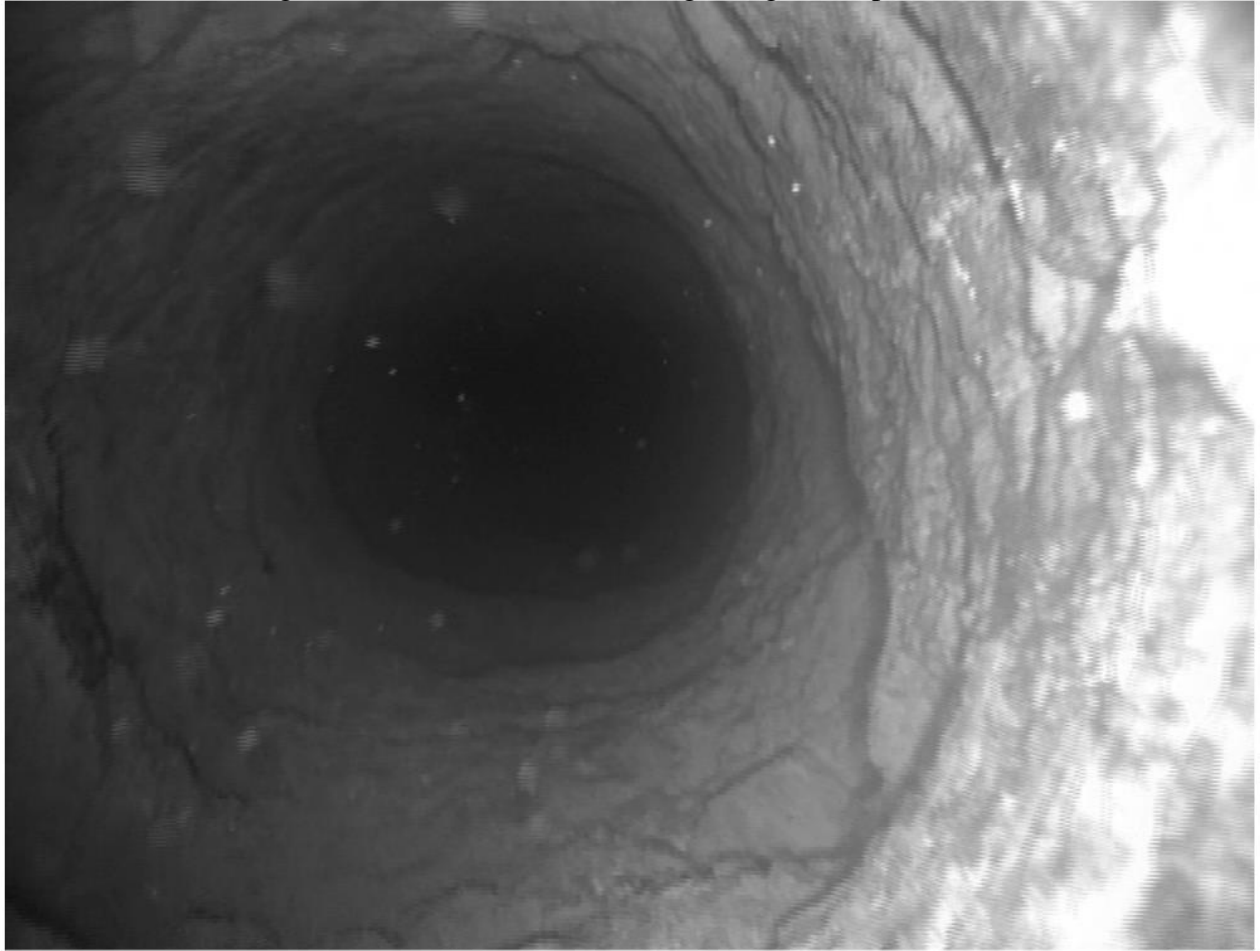
Feature ID #33: Rough weathered, fractured wall beginning at a depth of 62.5 ft.

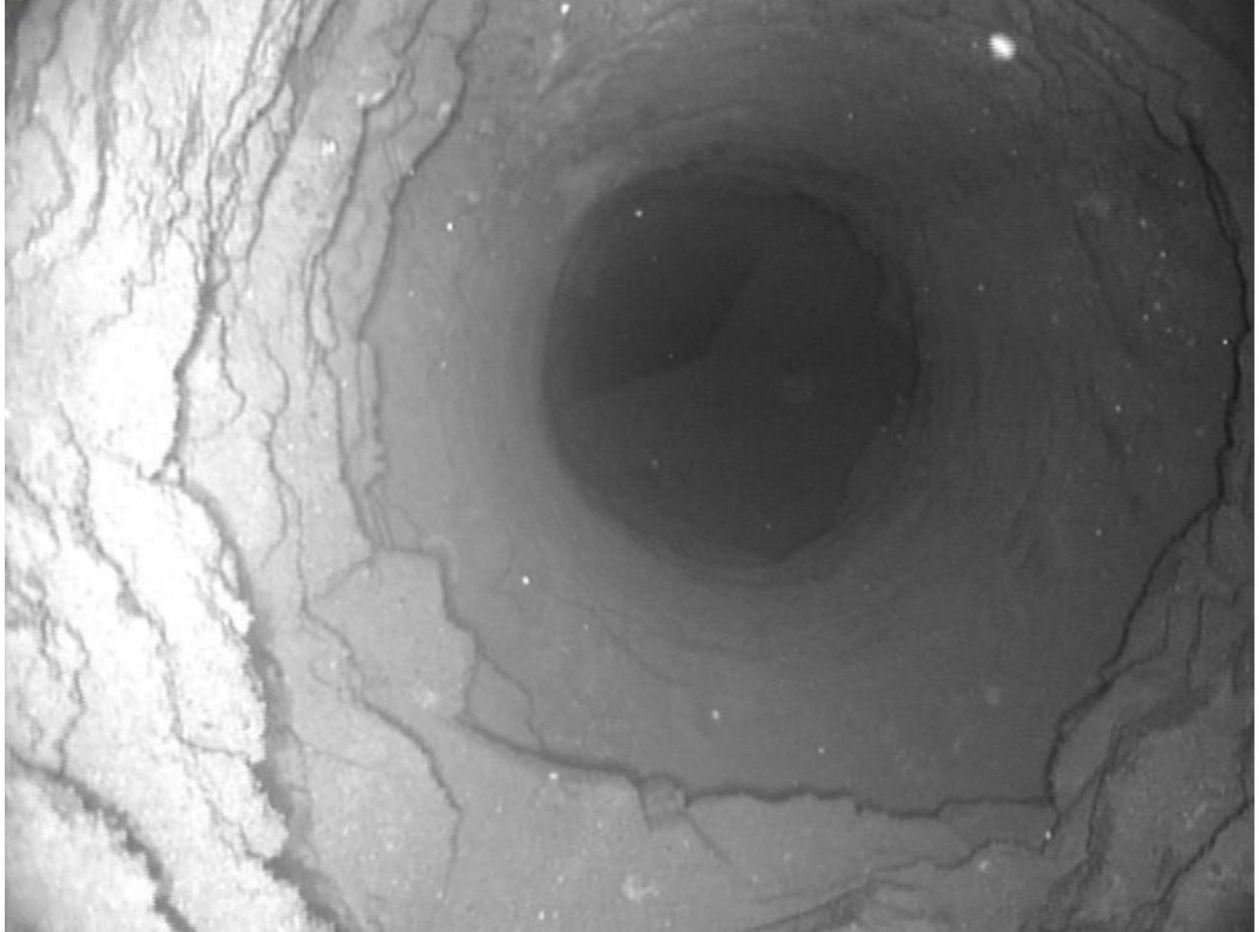
Feature ID #34: Part of the rough fractured wall at a depth of 64 ft. Continuation of Feature ID #33.
