Frederick Farm Well Contamination: Borehole Camera Analysis of Bedrock Structure

Borehole Camera Analysis of Bedrock Structure

The College at Brockport - State University of New York

Michael D. Rodgers and Paul L. Richards

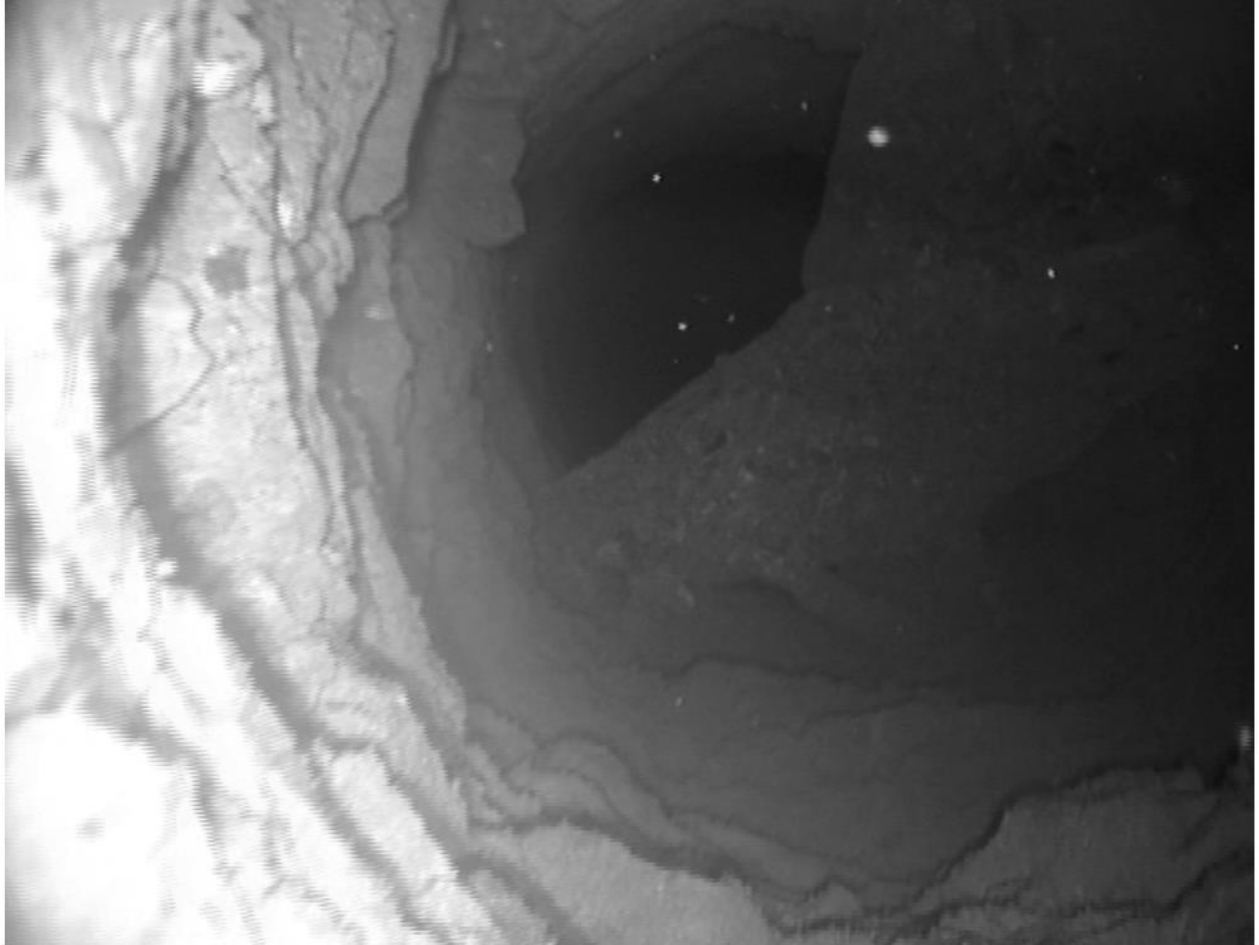
Feature ID #35: Continued fracturing from Feature IDs #33 and #34 at a depth of 67.5 ft. Note a bedrock intrusion lower into the well.

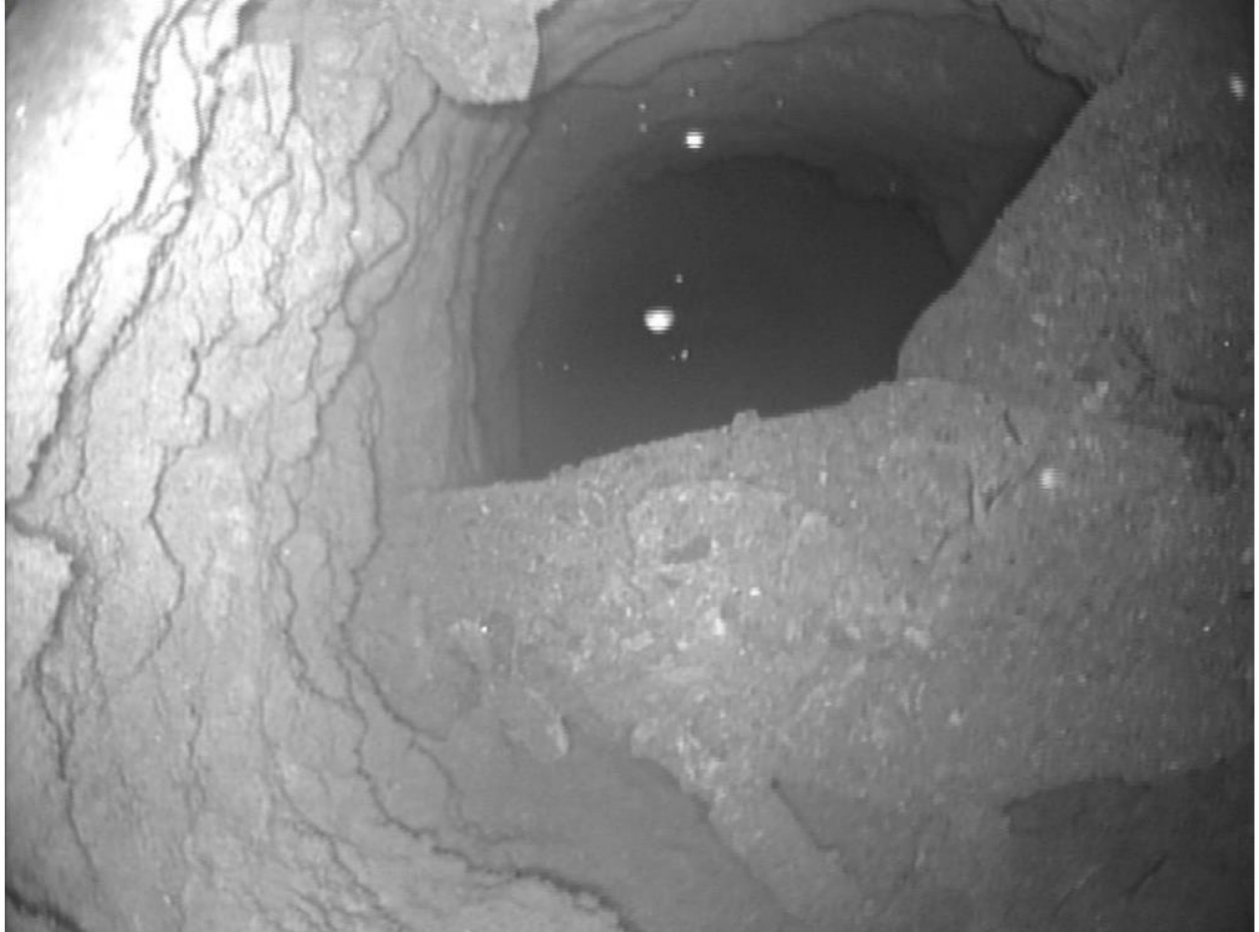
Feature ID #36: Close up of rock intrusion at 68.75 ft. Intrusion appears to be connected to wall, as opposed to fallen debris. Also note the continuation of the rough, weathered well wall.

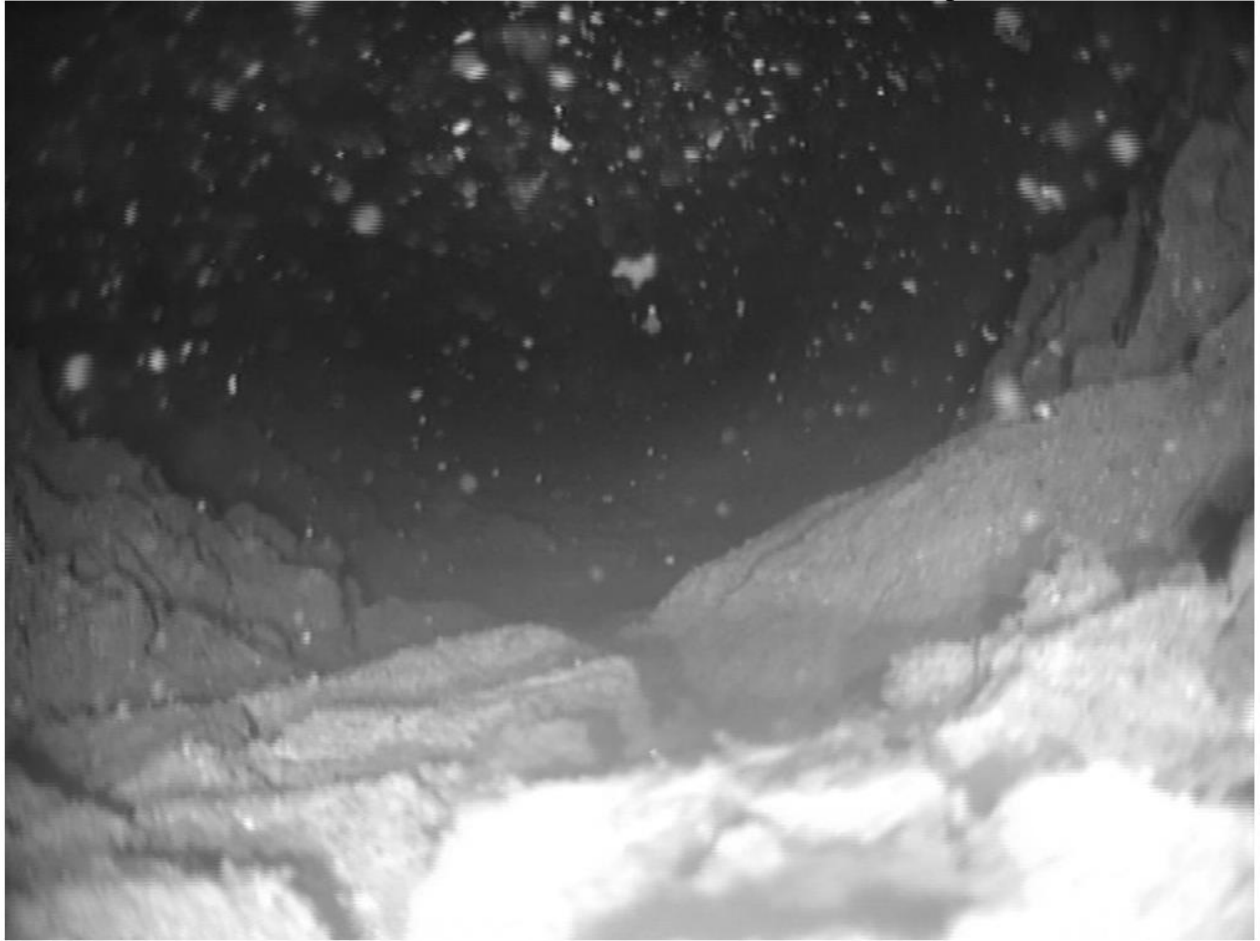
Feature ID #37: Series of small fractures below bedrock intrusion at a depth of 69.5 ft.

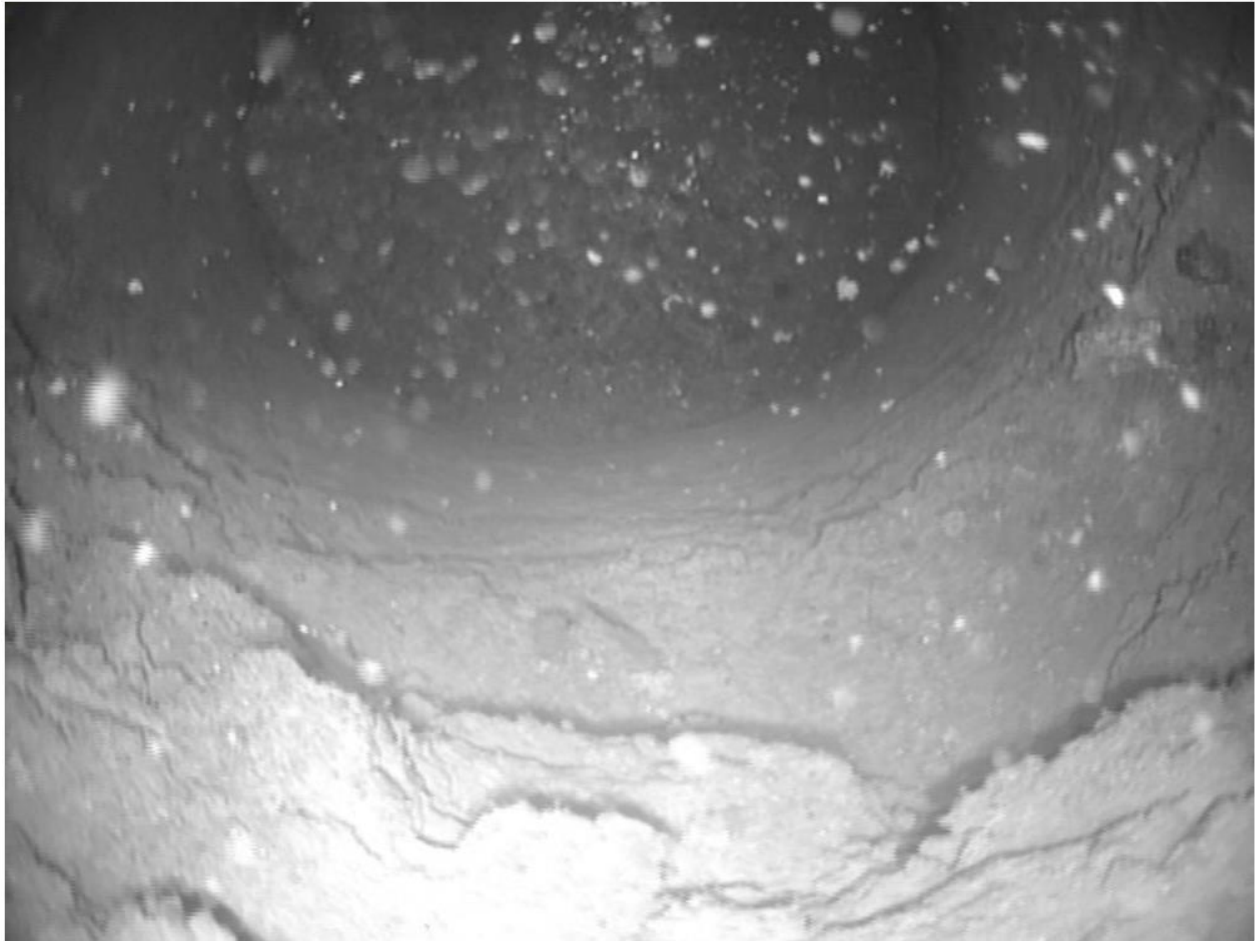
Feature ID #38: Series of small fractures at a depth of 70 ft. Continuation of Feature ID #37. Base of well visible lower in well.
