Investigation of Environmental Factors Influencing the Deterioration of Nikka Stone in Koshien Hall

Tomoko Uno¹ and Kana Noguchi¹

¹ Department of Architecture, Mukogawa Women's University, Nishinomiya, Japan

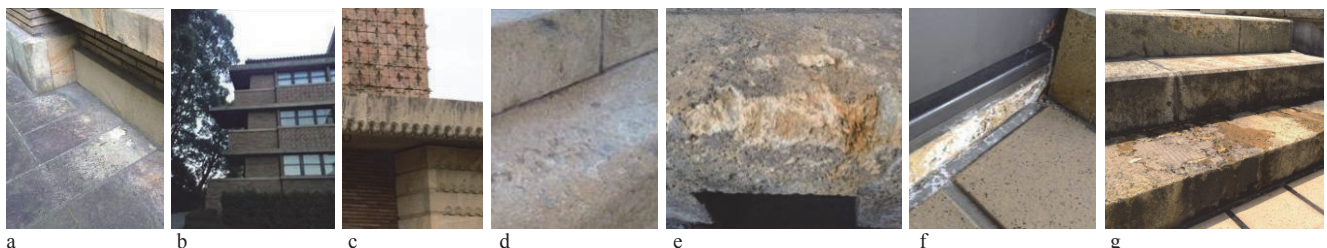
Figure 3. Deterioration conditions

Marked algal growth was observed on the floor stones on the surrounding of West Hall (Figure 3a). Here, most of the Nikka Stone was covered by moss. The ends of the eaves on the west side exterior wall of the West Wing and east side exterior wall of the East Wing were darkened by algae, while the crest tables of the barony wall under the eaves were not darkened (Figure 3b). There are a number of water trace lines caused by algae and dust on the eaves on each south side (Figure 3c).

Several types of detachment were observed. Large detachment tends to occur on horizontal surfaces, such as the stairs of the 2F roof terrace (point B, Table 1) and the crest table on the north side of the 3F roof terrace (point C, Table 1). Fine detachment, such as flaking, was observed on the surface of the outside floor on the east and west sides of the West Hall (Figure 3a), on the exterior steps at the front entrance, on the stairway of the terrace at the south side in front of the lobby in 1F (point A, Table 1 and Figure 3d), and in other locations. Algae were not observed on these flaking areas. Detachment with salt efflorescence was observed on the lower side of the pillars on the south side terrace of the 1F lobby (Figure 3a) and in other

Salt efflorescence appeared in small limited areas, such as on the lower parts of pillars on the south terrace of 1F (Figure 3e) and on baseboards under the entrance doors of 3F (Figure 3f). The causes of salt efflorescence include repeated cycling of dry and wet conditions, i.e., changes in moisture content of materials and temperature changes in the presence of salt.

Steps: Algal contamination and detachment of several sizes were observed. Nikka Stone was significantly darkened by thick algal growth (Figure 3g). Compared to the top stairs in area I of point B in Figure 4, there was much more algal growth on the second, third, and lower stairs. In addition, large detachment was observed in area II; one instance was about 15 cm wide and more than 5 mm thick.

a) Algal contamination and detachment at the floor stone, b) Algal growth in the west side of West Hall, c) darken trace of the eaves, d) flaking on the stairway of the terrace at the south side in front of the lobby in 1F, e) detachment with salt efflorescence on the lower side of the pillars, f) salt efflorescence on the baseboards under the entrance doors, g) detachment and algal growth at the center stairs on the 2F roof terrace, point B.

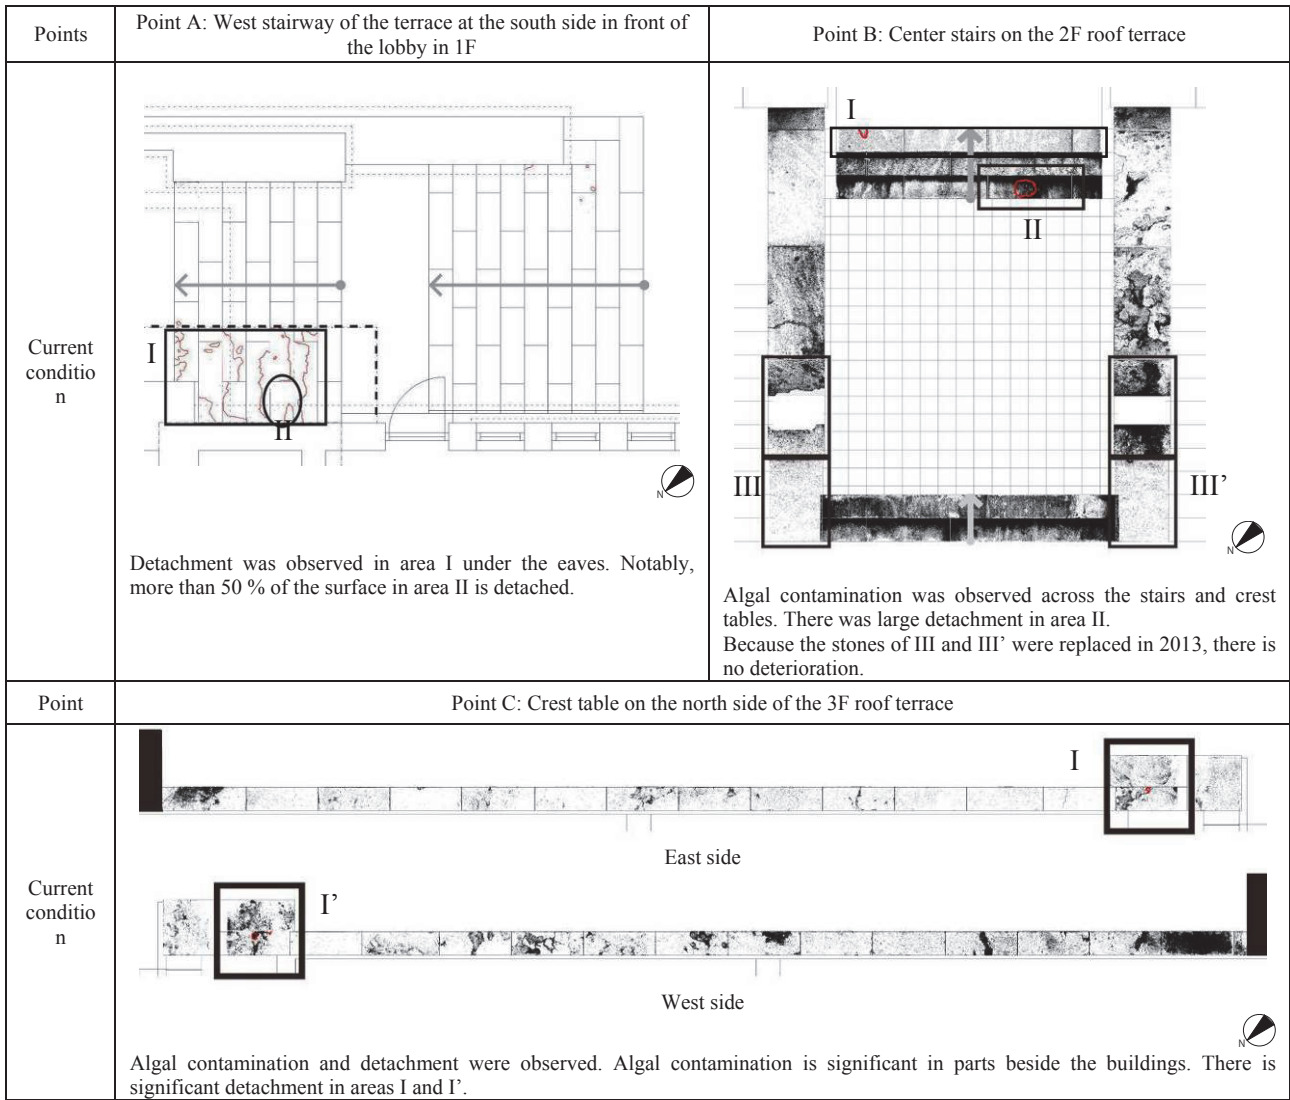
Figure 4. Current conditions in areas of typical deterioration at points A, B, and C

Fine detachment flaking was observed only on the north side of the upper stairs (Figure 3d, Figure 4: the inner side of the dotted line at area I of point A). The flaking area comprised approximately 1/3 of total area. Other areas were in good condition. Water repellent materials had been applied to the surface of the Nikka Stone here in 2009¹. Even now, water films are observed during rain; the effect of the water repellent thus remains. Visual observations confirmed that there is no salt efflorescence.

Crest table: Algal contamination and detachment were observed. Algal growth was less extensive than on the steps. There were several instances of small detachment compared to the steps, some of which had been repaired with mortar. The crest tables of III and III' in Figure 4 were replaced with new materials in 2013 because of serious deterioration.

Algal contamination was observed. This was extensive in the area near the west and east buildings and was less extensive at the center. Although detachment is now rarely observed, many spots had been repaired with mortar and resin. Algal growth was observed in the chinks between the original stone and mortar.

Areas with detachment damage at area I in point A in Figure 4 were shadowed from rain. It is therefore thought that the water supply from the surface is small and that water may originate from neighboring rain-exposed stones. Although these areas have low sky view factors compared to other areas of B or C, the south side is open and the area is influenced by direct solar radiation at noon. When there is a water source, which should be from the back side of the stone, constant evaporation from the surface of the stone under the eave should occur. Additionally, water repellent would prevent evaporation from the surface, while evaporation would be concentrated and would continue in deteriorated areas without water repellent.

Factors contributing to detachment damage at point A should therefore be increasing temperature, drying caused by solar radiation, concentrating evaporation on the surface along with water supplied from nearby stones, and wetting/drying cycles. The effect of water repellent on salt efflorescence requires more detailed investigation and experimentation.

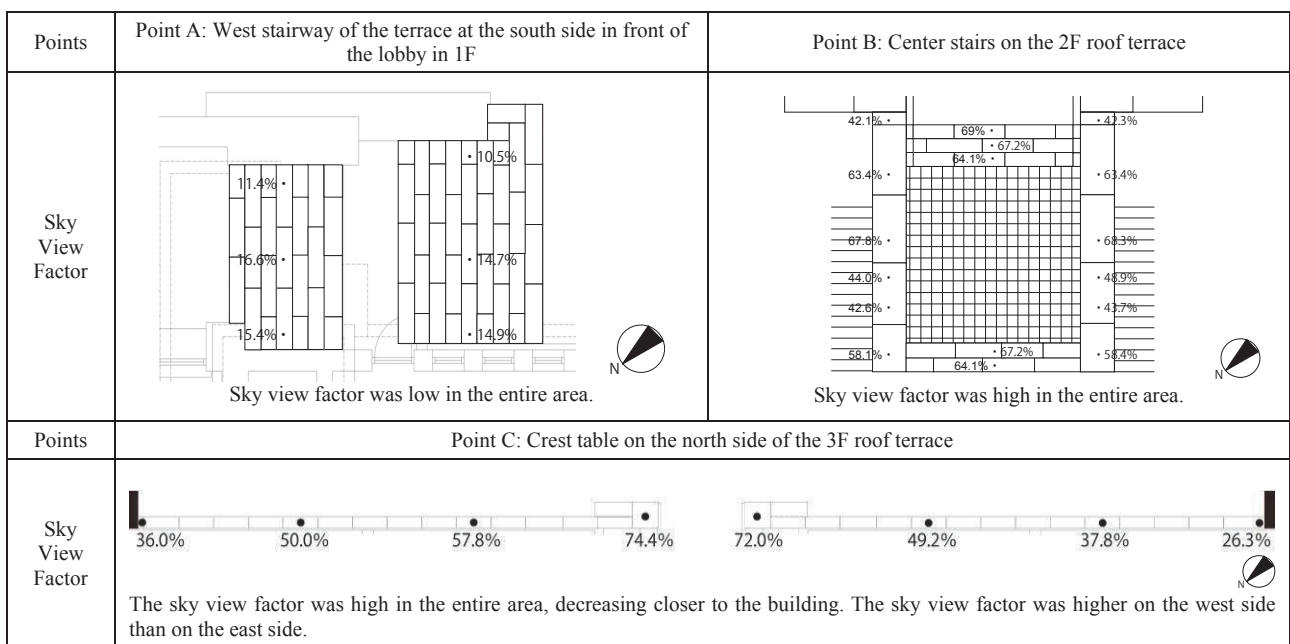
Figure 5. Sky view factor in areas of typical deterioration at points A, B, and C

Sky view factors were low (between 10–17 %) and part of the zenith was covered by an eave. Rain therefore rarely fell on the steps and there was less solar and nocturnal radiation.

The sky view factor was high (between 42–69 %). Rainfall, solar radiation, and nocturnal radiation were therefore high.

The sky view factor was high (between 72–74 % at the center and between 26–36 % at the west and east sides). A lot of rain therefore fell here, and solar radiation and nocturnal radiation were high. Closer to the sides of the west and east buildings, the sky view factor was lower because of the presence of a large tree on the north side of the west part of the building.

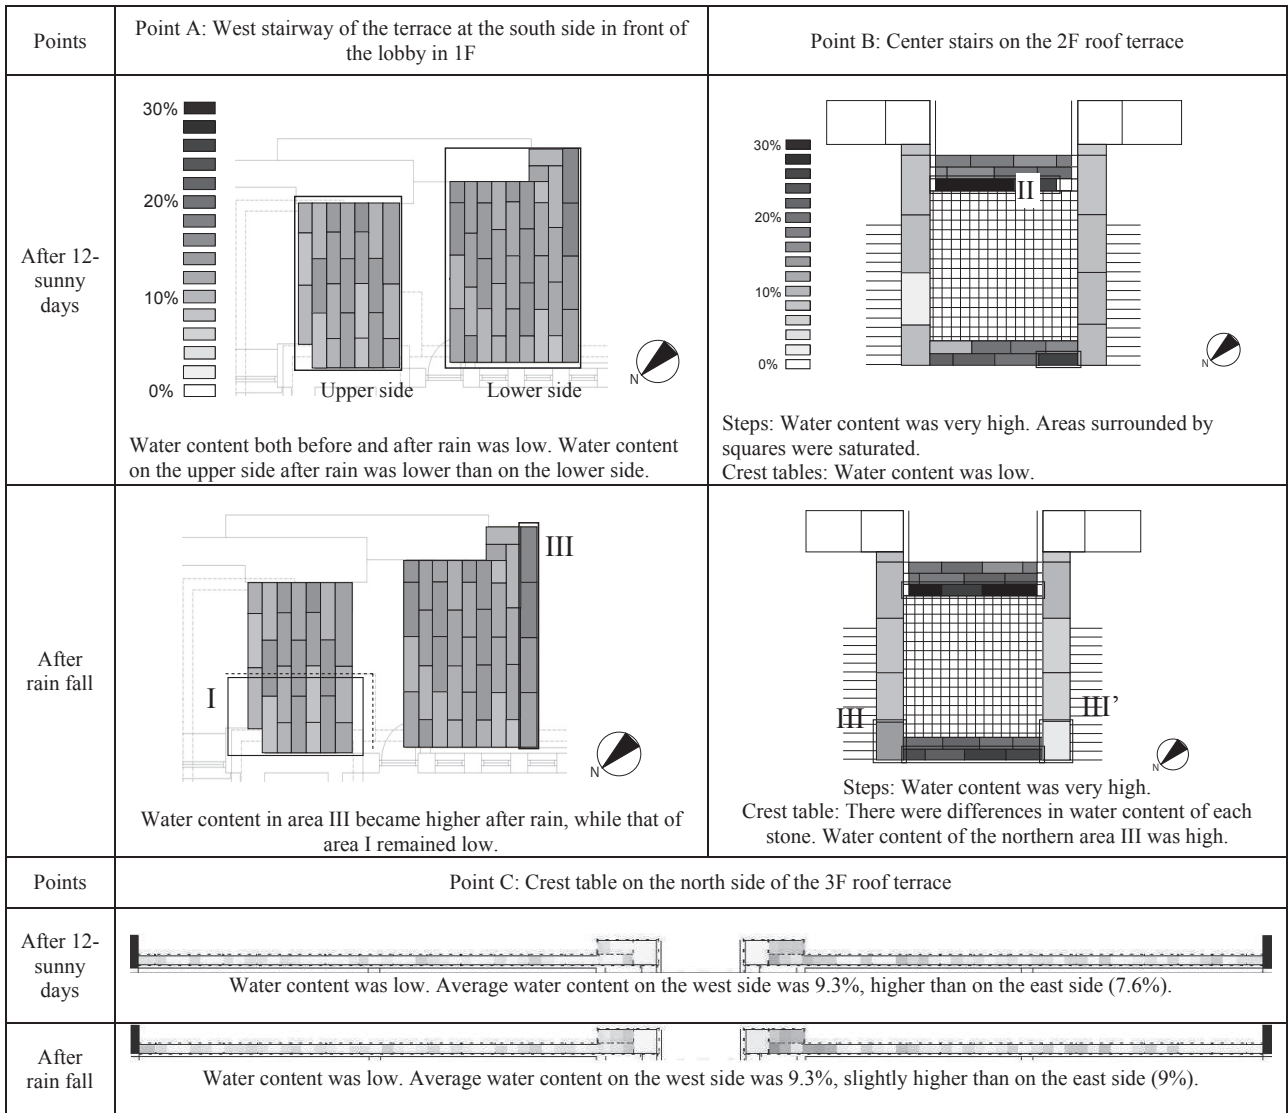
Figure 6. Water content in cases of typical deterioration at points A, B, and C

Water content was low (around 8–15 % before rain and around 10–18 % after rain) everywhere; in particular, the water content of places under eaves was relatively lower, even after rain.

The water content was around 15–18 % (before rain) and 15–21 % (after rain) at the top stair, while that of steps below the second step was 15–30 % (before rain) and 19–32 % (after rain). The water content of the lower side is obviously high, and in area II was over 23% (saturated conditions). These points were thus wet all the time.

Water content was low everywhere, at 2–12 % before rain and 3–14 % after rain. It should be noted that, even when there was significant rain, this location dried out quickly.

Only places under the eaves do not receive much rain and their water content was slightly lower than that in other areas.

Steps: The areas of color change induced by water increased a few days after rain at the lower part of the steps. On the third step from the bottom, the area of color change induced by water did not disappear by ten days after a rain event.

Steps: Detachment and algal contamination were mainly observed. Water content was high and area II in Figure 6 was always wet. Because wetness appears and spreads a few days after a rain event and continues for several days, water supply is too excessive to be explained by rainfall onto the surface. Since there are wide 3F roof terraces without roofs on the upper side of point B, the rain water falling to the 3F terrace can seep through the mortar joints to the lower steps. After the surface of the terrace has dried, water might remain under the tiled floor of the 3F roof terrace and flow to the back side of the stone on the steps. This may be the source of water leading to the high water content of the steps. Water supply is substantial and persists for days.
