The Ozarks Environmental and Water Resources Institute (OEWRi)

PRE-CONSTRUCTION REPORT FOR THE WARD BRANCH STREAM RESTORATION PROJECT

November 14, 2007

OEWRi EDR-07-004

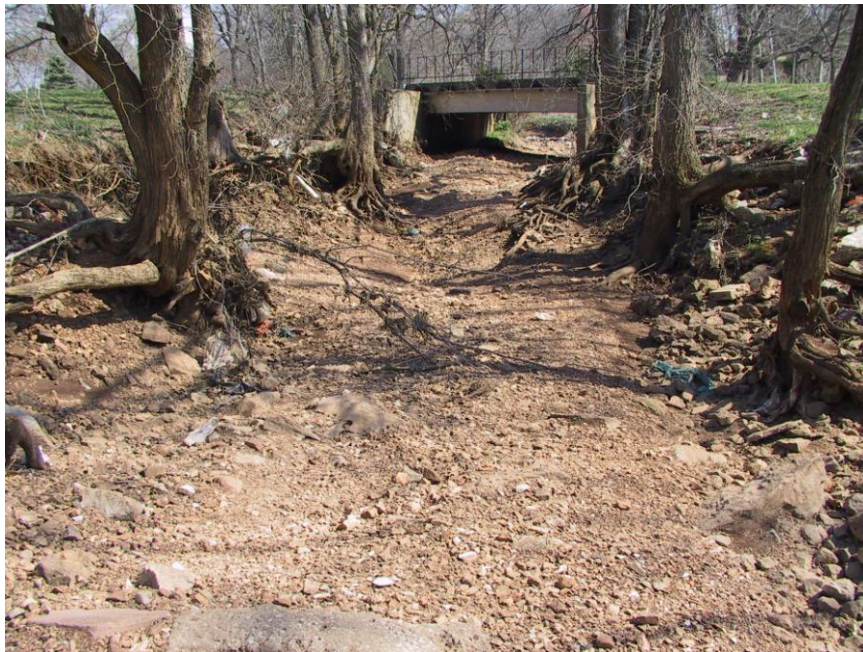
Photo 4. Scour hole at station 2,100 feet
