**The Ozarks Environmental and Water Resources Institute (OEWRI)  
Missouri State University (MSU)**

**Channel Stability and Riparian Corridor Assessment  
to Identify Nonpoint Source Pollution, Wilson Creek,  
Springfield, Missouri**

*Field work completed July 20, 2012*

OEWRI EDR-12-003

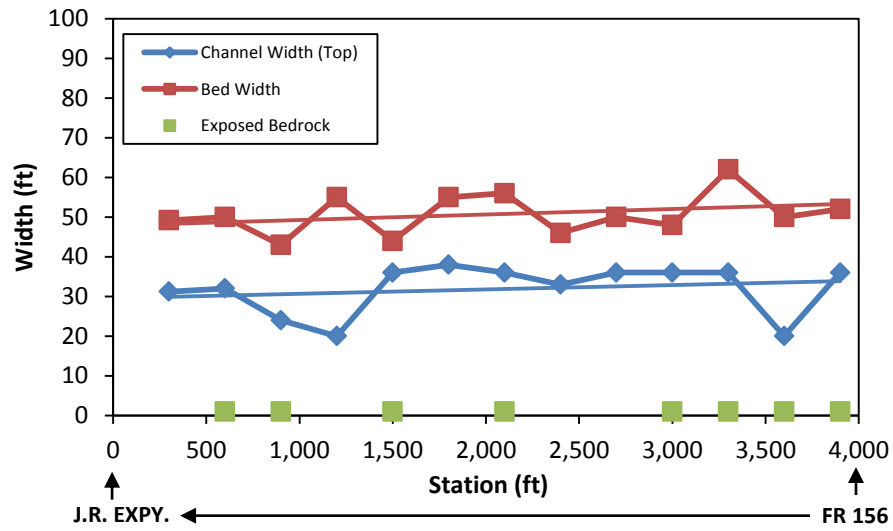
Figure 4. North Segment – Channel Width and Bedrock

Channel and bed width decreased downstream and bedrock was exposed along the bed throughout the majority of the reach (Figure 4). Bed width ranged from 20-38 ft and channel width ranged from 43-62 ft wide. While channel width should be expected to increase downstream, bedrock can control bed elevation and slope locally to disrupt that downstream pattern. The banks through this segment ranged from 4.6-16.4 ft high. The majority of the banks through this reach would be considered moderate to moderately high (4-8 ft) (Figure 5). Bank in the upper 500 ft and near station 1,200 ft would be considered high and susceptible to erosion (> 8ft). Bank heights were highest in the upper 500 ft of the site, with banks exceeding 12 ft near the knickpoint at 3,600 ft where the bed drops 8 ft . Bank angles that exceed 70° are common all along the north segment reach. High banks with steep angles should be considered an erosion risk.

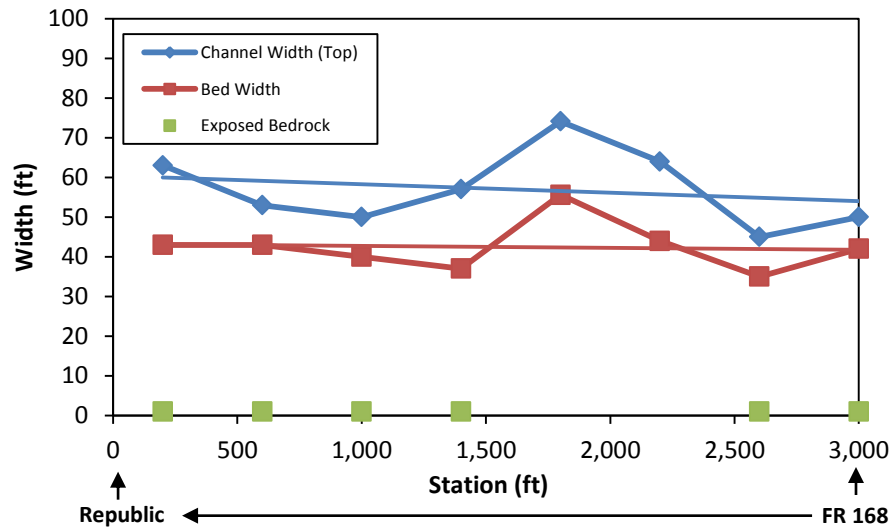
Figure 7. South Segment – Channel Width and Exposed Bedrock

Channel width and bed width increase slightly downstream and bedrock is exposed at the surface along most of the reach (Figure 7). Bed width ranged from 35-55.6 ft and channel width ranged from 45-74.1 ft. Bed and channel widths were higher in the areas of the channel where no bedrock was present in the channel (Stations 1,900-2,300 ft). Banks along the south segment range from 3.3-6.9 ft and appear to be relatively less susceptible to erosion than the north segment with lower bank heights and angles. Bank heights through the south segment would be classified moderate (<6 ft) with the exception of the moderately high bank at station 600 ft (Figure 8). High bank angles were mostly along the right bank though this reach. The highest erosion risk is along the right bank near 600 ft where the height is >6 ft with a steep angle.

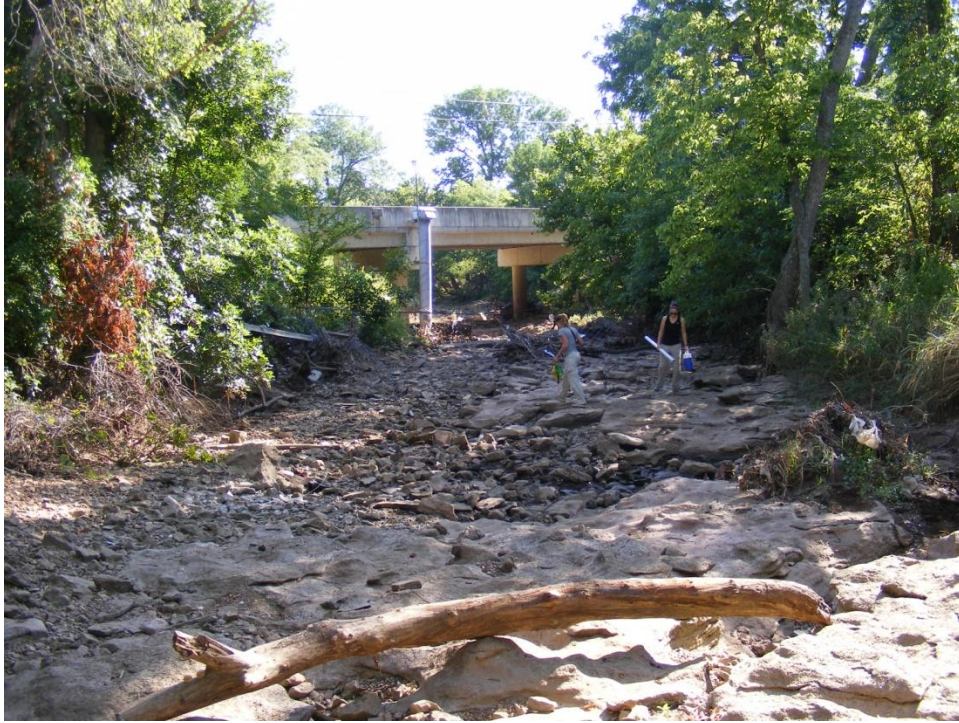
1. *Bridge Reach (3,950-3,850 ft)* – This reach is immediately downstream of the FR 156 Bridge (Photo 1). The wire cable with cattle panels stretched across the channel at the right-of-way collects trash and debris just below of the bridge. The bed is about 50% bedrock with the remainder large gravel and cobble. Banks show slight to moderate erosion with an adequate riparian corridor. Local erosion is typical downstream of bridges where the alignment can deflect flow toward the bank.
2. *Bedrock Bed Reach (3,850-3,650 ft)* – The entire bed along this reach is a bedrock slab or large boulders where pieces of the bed have broken off (Photo 2). The banks along this reach

Photo 1. Bridge Reach (3,850 ft) looking upstream at USGS gage at FR 156.

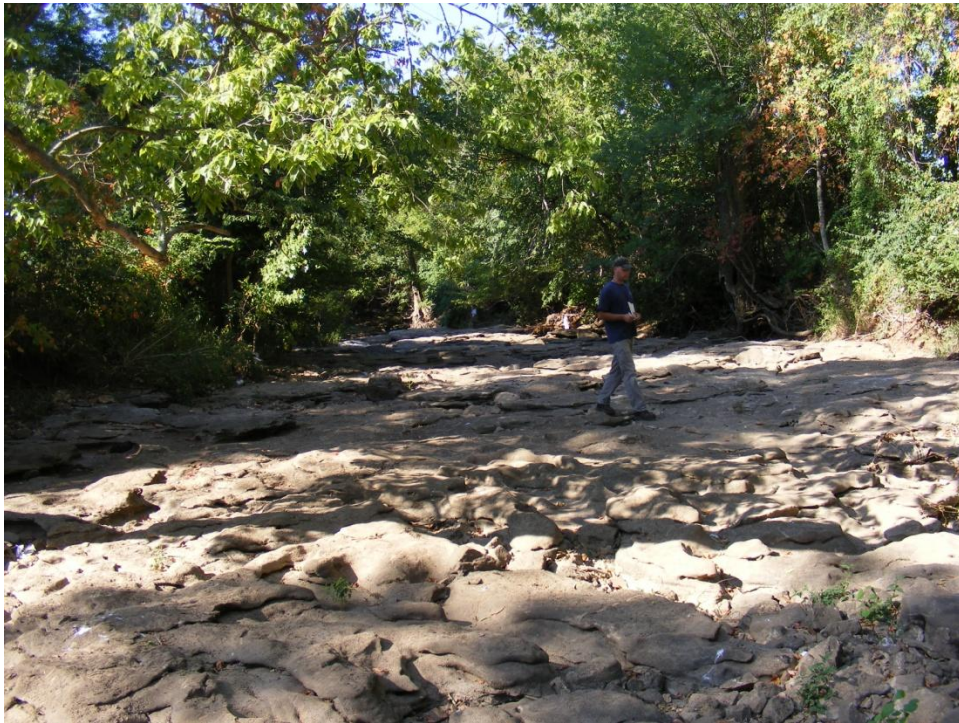
Photo 2. Bedrock Bed Reach (3,800 ft) looking downstream.

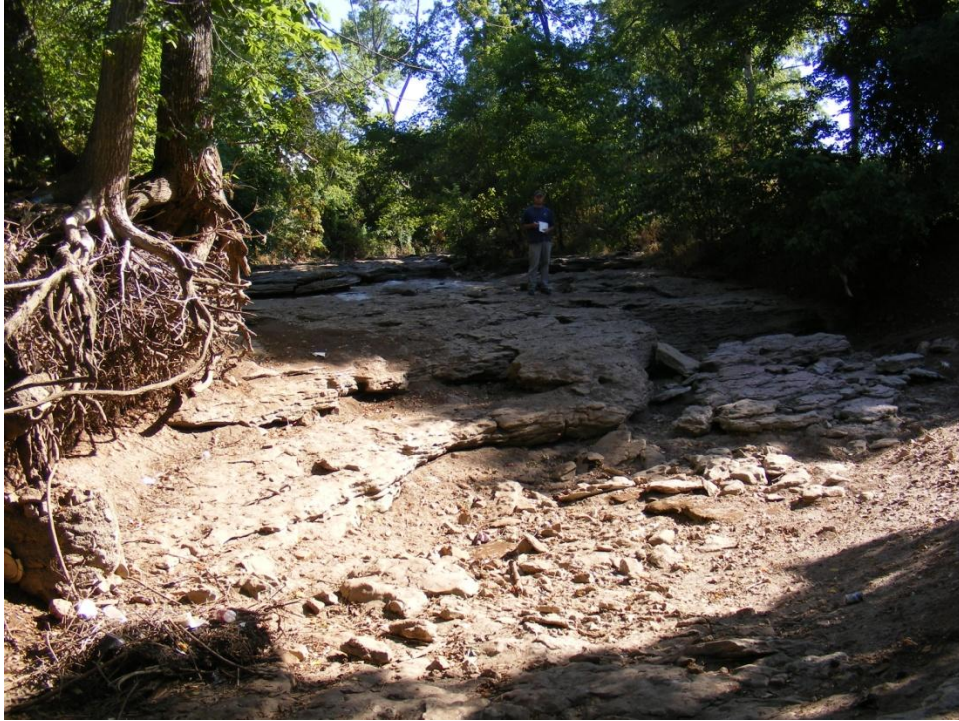
3. *Knickpoint Reach #1 (3,650-3,600 ft)* – A knickpoint is a drop off, or step, cut into the bedrock along the bed of the stream over geologic time. Locations of the knickpoints described in this report are probable locations that would have to be determined by a more thorough survey of the stream. The knickpoint in this reach appears to be caused by a fracture/swallowhole within the bedrock creating a 7-8 foot drop in the bed at this location (Photo 3). Additionally, flow deflection during large floods is causing left bank erosion locally (Photo 4).

Photo 3. Knickpoint Reach (3,600 ft) looking upstream from the bottom of the knick/reverse sinkhole?

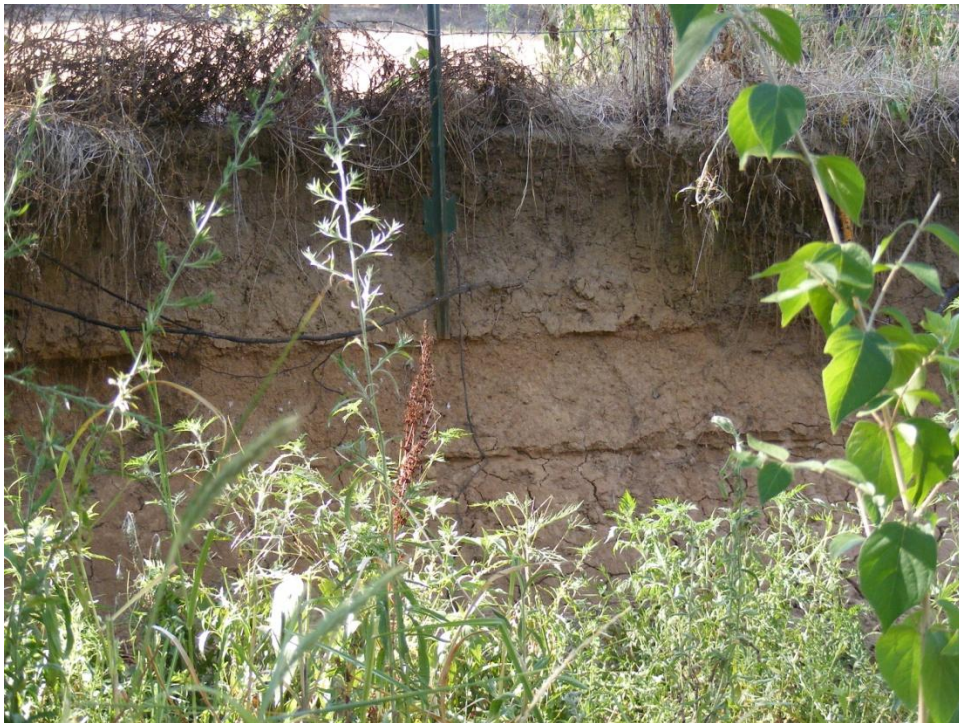
Photo 4. Knickpoint Reach (3,600 ft) left bank erosion.

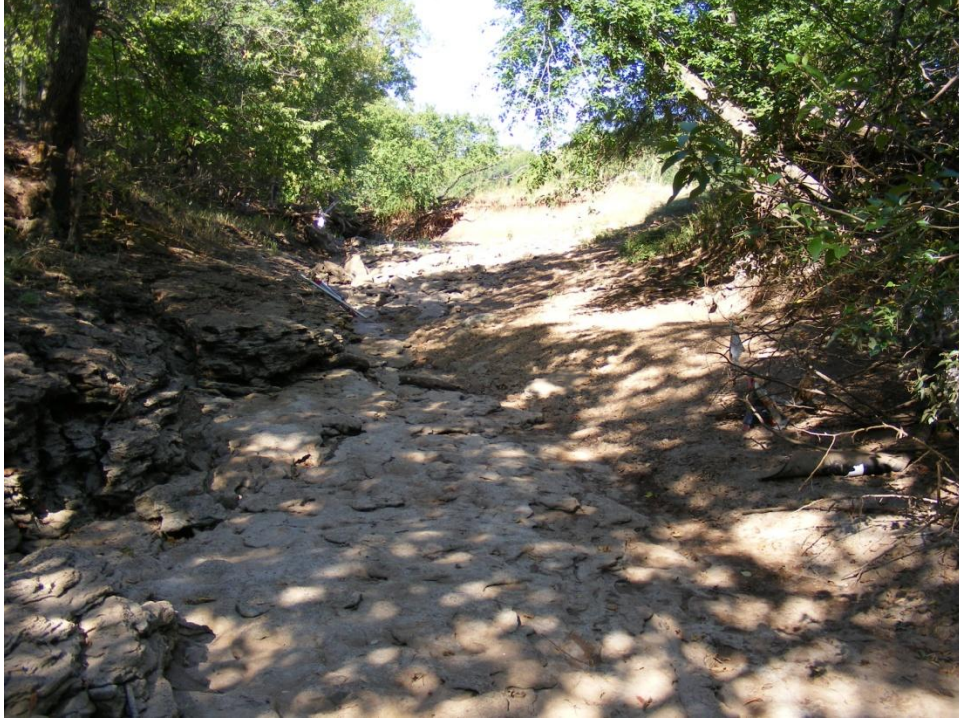
4. *Bedrock Bluff Reach (3,600-3,400 ft)* – The channel through this reach is adjacent to a bedrock bluff along the left bank (Photo 5). Approximately 50% of the bed is bedrock or large boulders with gravel deposits along the right margin of the channel. The right bank has moderate erosion with a thin line of mature trees protecting the bank.

Photo 5. Bedrock Bluff Reach (3,500 ft) looking downstream.

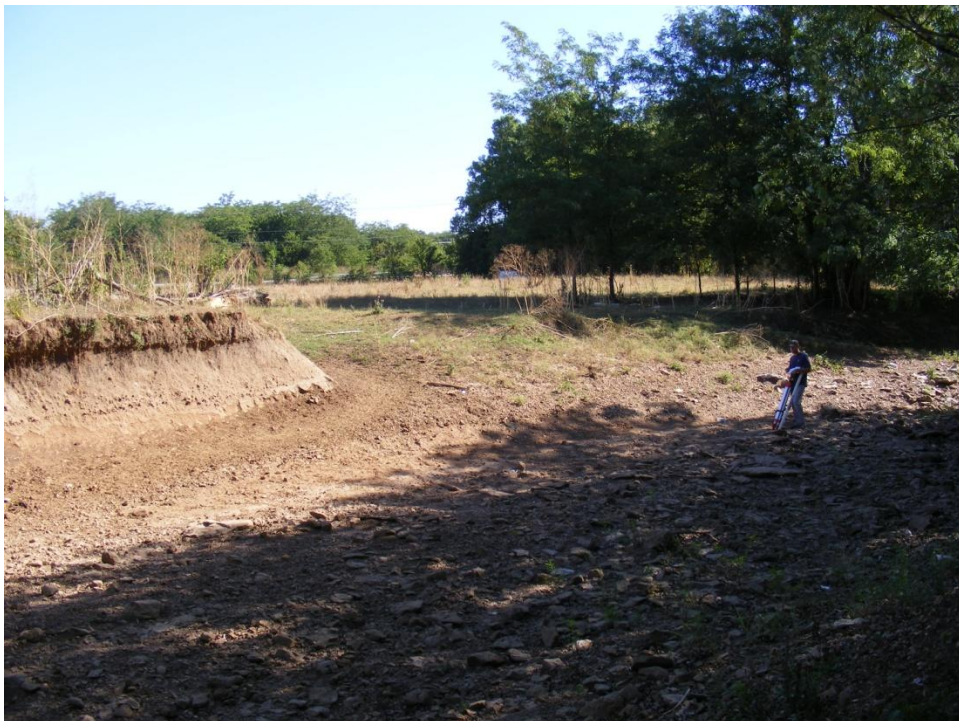
5. *Cattle Entrance and Cutbank Reach (3,400-3,200 ft)* – The right bank along this reach has little to no riparian cover creating a cutbank that is approximately 7-8 ft high (Photo 6). Additionally, cattle have been entering the stream at this location causing further bank instability. A new floodplain is forming along the left bank of the stream adjacent to the bedrock bluff suggesting the channel has been moving at this location. The bed is mostly bedrock here as well.

Photo 6. Cattle Entrance and Cutbank Reach (3,300 ft) looking at the right bank.

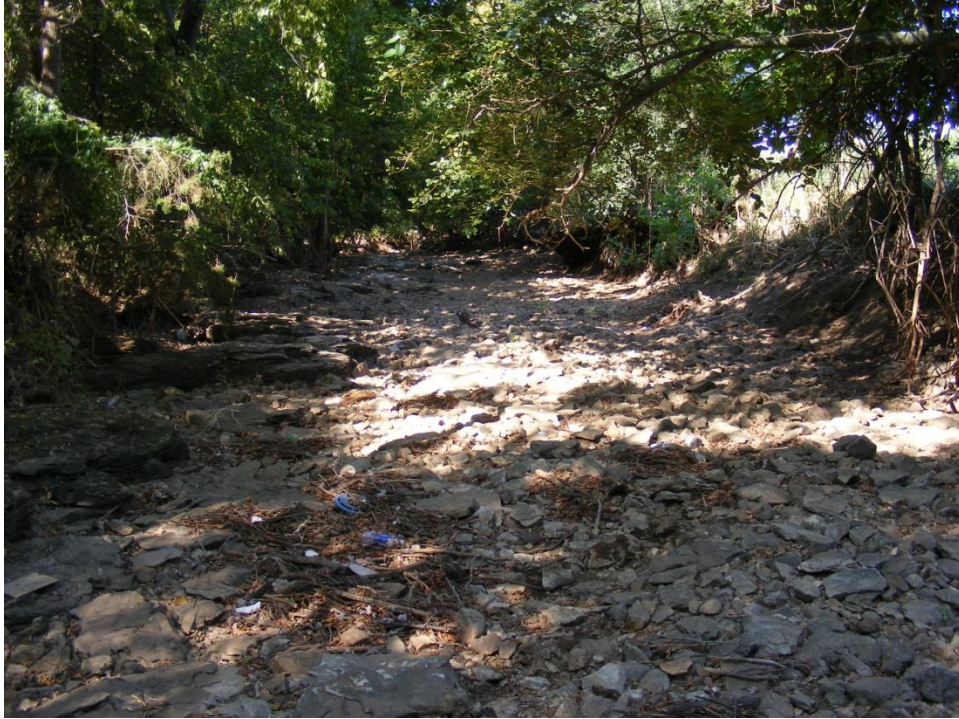
6. *Bedrock/Cattle Entrance Reach (3,200-2,900 ft)* – The bedrock bed continues through this reach with bedrock also along the toe of the left bank (Photo 7). The right bank shows signs of erosion but is weakly protected by a thin line of mature trees. However, cattle have been entering the stream at two locations in this reach creating localized erosion.

Photo 7. Bedrock/Cattle Entrance Reach (3,200 ft) looking downstream.

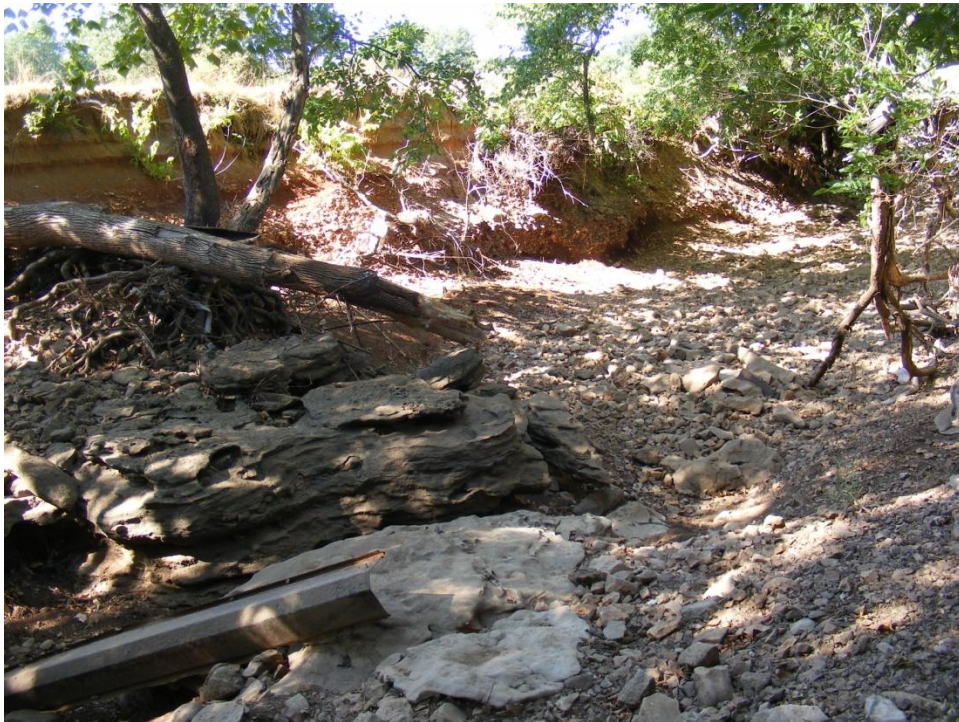
7. *Knickpoint Reach #2 (2,900-2,850 ft)* – Similar to the knickpoint at station 3,600, but at a smaller scale, a fracture/swallowhole has created a knickpoint in the bedrock at this location that is approximately 5 feet deep (Photo 8). Also, flow deflection has caused erosion along the left bank where cattle are entering the stream.

Photo 8. Bedrock Knickpoint #2 (2,900 ft) looking at the left bank erosion near the second knickpoint on the north property.

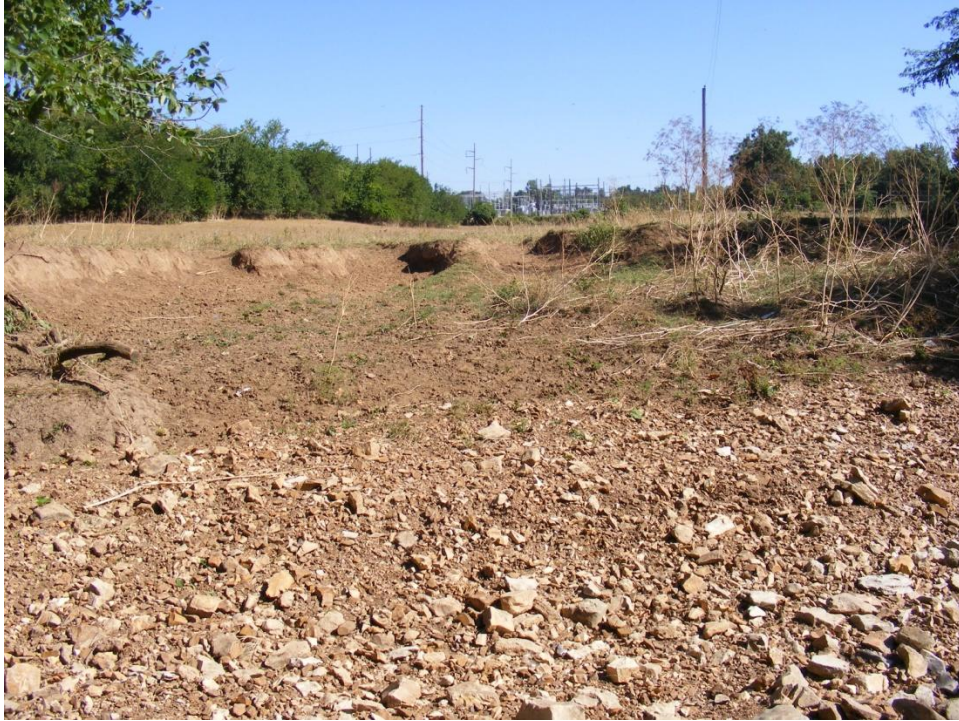
Photo 9. Gravel Bed Reach #1 (2,700 ft) cattle entrance on right bank.

2. *Fence Cattle Out of Stream* - Unlimited access for cattle to the stream at the north segment is a significant nonpoint source for pollution to the stream. Hoof action has caused floodplain scour gullies and erosion near several cattle entrance points along the channel. Additionally, cattle allowed to loaf in the riparian corridor further destabilizes banks, damages vegetation, and concentrates manure near the channel with no buffer to filter sediment and pollutants during storm events. Fencing 100 ft on either side of the stream will allow the banks and vegetation to recover over time and reduce nonpoint sediment and nutrients from entering the stream during storms. This will also allow for the removal of the cables on each end of the property that are currently trash and large woody debris traps. Debris collected here can cause flows to deflect, creating local erosion problems. This property can still be used to pasture cattle and provides an opportunity to demonstrate best management practices for cattle operations near stream corridors. The Missouri Department of Conservation and the Natural Resources Conservation Service private land specialists can provide technical assistance for installing alternative water sources, limiting access to stabilized cattle crossings, and providing shaded areas away from the stream.

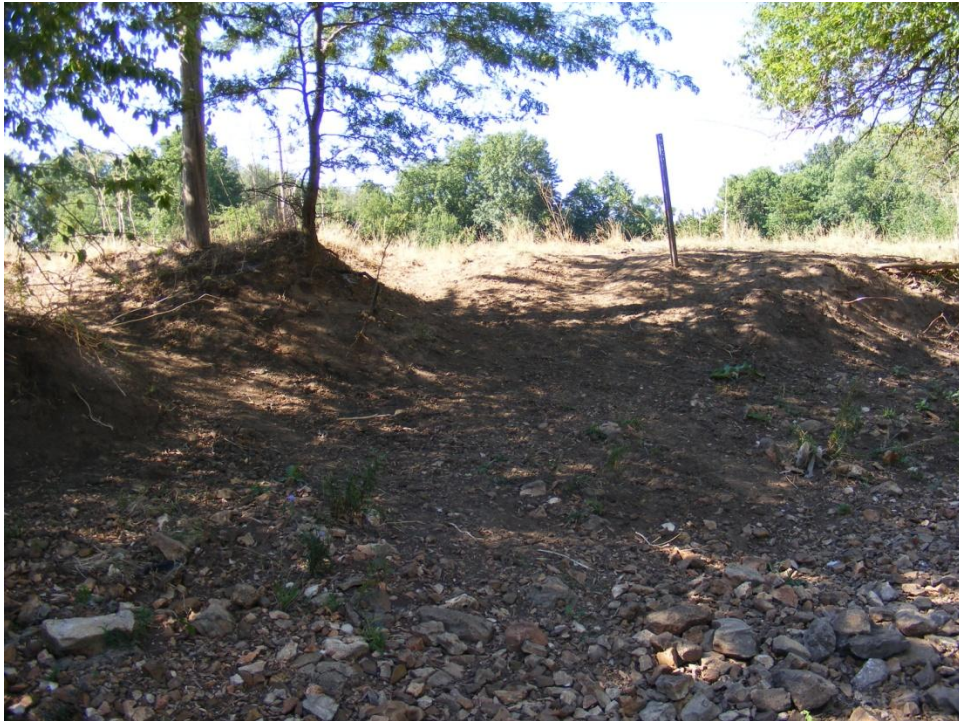
Photo 10. Cattle damaged banks (2,600 ft).

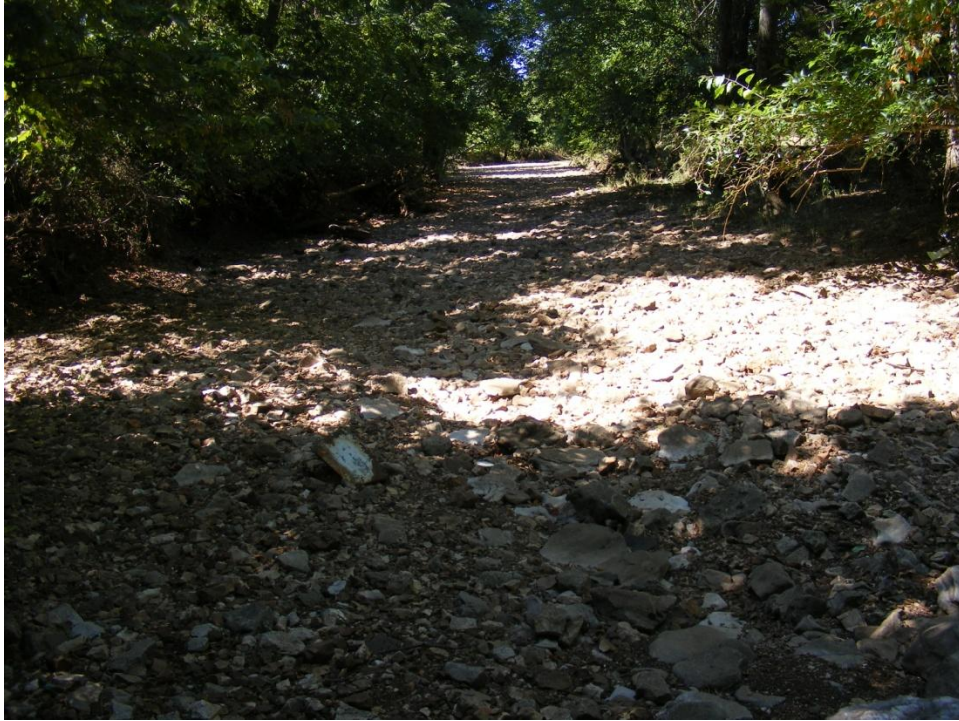
9. *Bedrock Pinnacles (2,200-2,100 ft)* – Localized bed obstruction
10. *Gravel Bed Reach #2 (2,100-1,700 ft)* – The stream bed in this reach is a gravel and cobble bed (Photo 11). The thin riparian corridor is interrupted by several cattle entrance points and loafing areas that cause localized erosion. However, a 6-7 ft diameter “legacy” tree at 1,800 ft on the left bank suggests the channel has not moved much at this location, but may have been widening (Photo 12). A road/cattle crossing is located at station 1,700 ft.

Photo 11. Gravel Bed Reach #2 (2,100 ft) looking downstream.

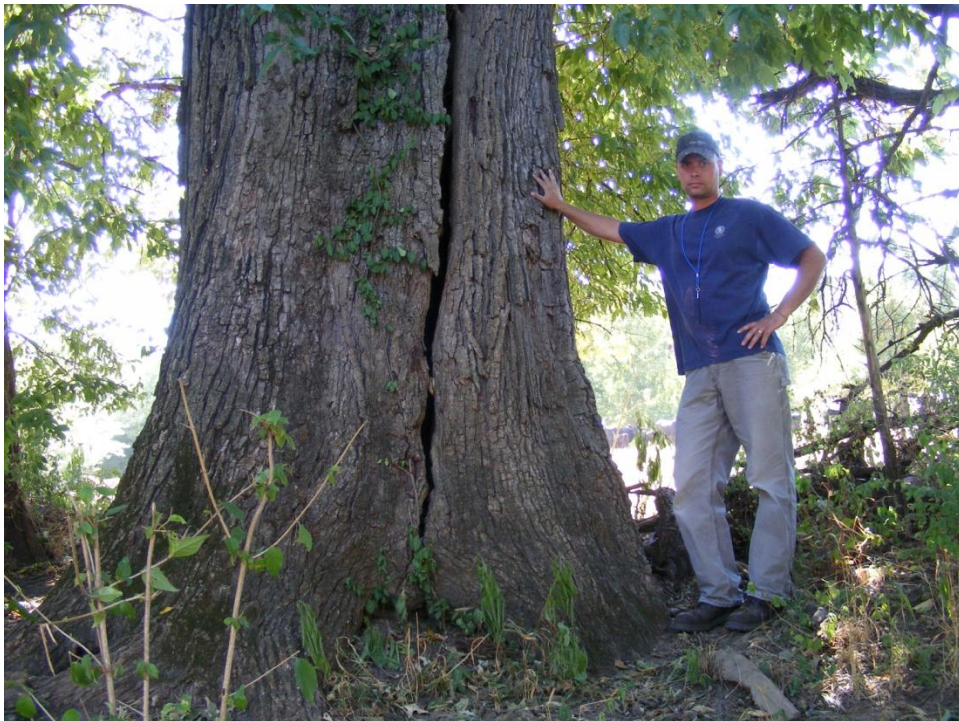
Photo 12. Legacy tree at station 1,800 ft.

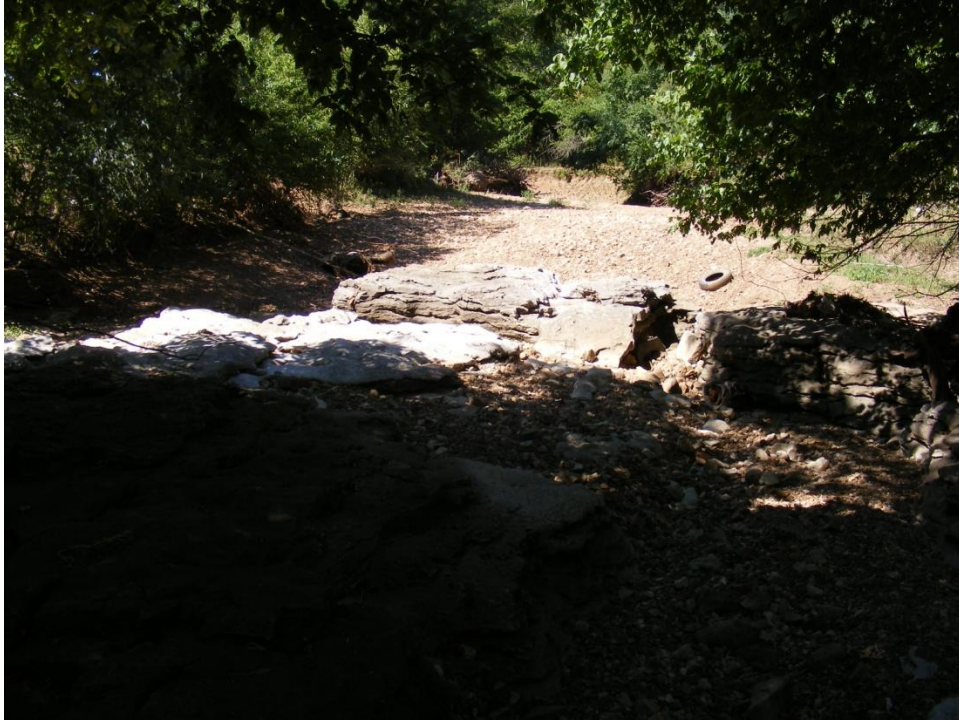
11. *Bedrock/Knickpoint Reach #3 (1,700-1,400 ft)* – Bedrock appears at the surface along the bed in this reach and ends with a 5 ft knickpoint at station 1,450 ft (Photo 13).

Photo 13. Bedrock Knickpoint Reach #3 (1,450 ft) looking downstream.

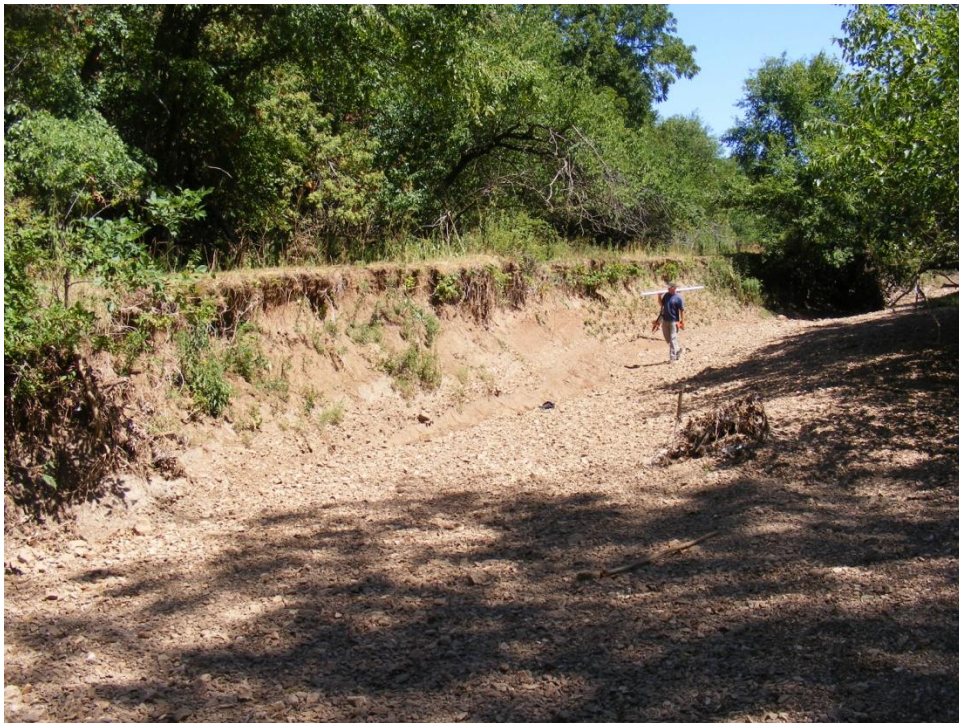
12. *Bank Erosion Reach (1,400-1,000 ft)* – This gravel bed reach is located just upstream of where the channel meets a bluff. Erosion is occurring along the 6-8 ft high, 200 ft long, right bank where there is no riparian vegetation (Photo 14). Additionally, localized erosion is occurring at a cattle crossing at 1,350 ft and cattle loafing areas near 1,050 ft.

Photo 14. Bank Erosion Reach (1,300 ft) looking at the right bank.

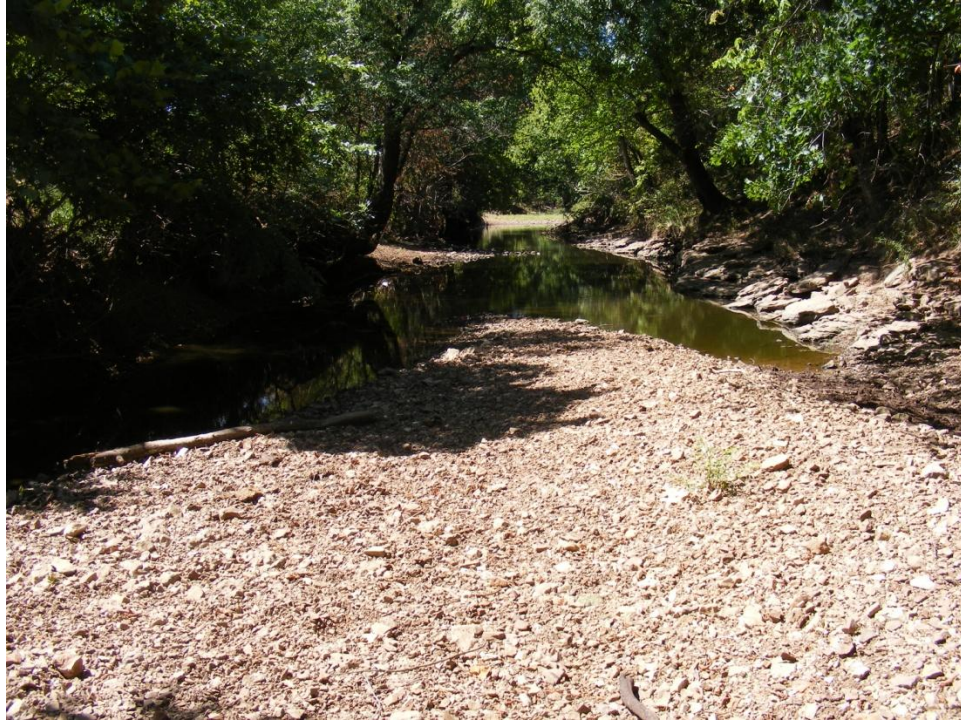
13. *Bedrock/Bluff Pool Reach (1,000-700 ft)* – The right side of the channel in this reach is adjacent to a bedrock bluff and is currently holding water (Photo 15). This is the largest of three pools of water on this site and cattle have been entering the stream here at several locations causing local erosion (Photo 16).

Photo 15. Bedrock/Bluff Pool Reach (700 ft) looking upstream.

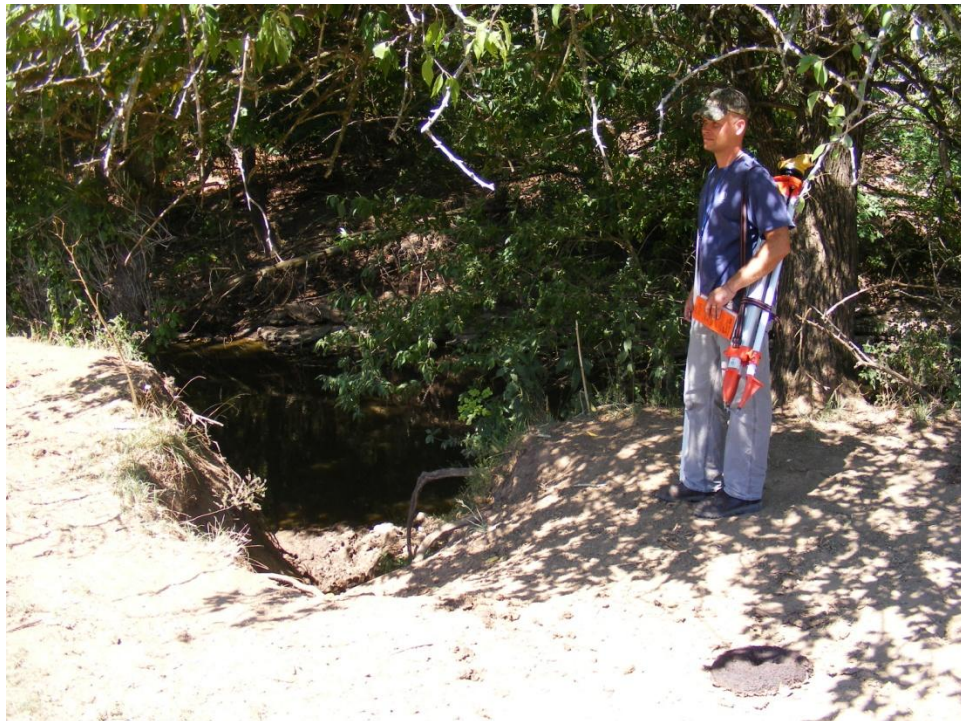
Photo 16. Erosion caused by a cattle entrance to water along the bluff pool.

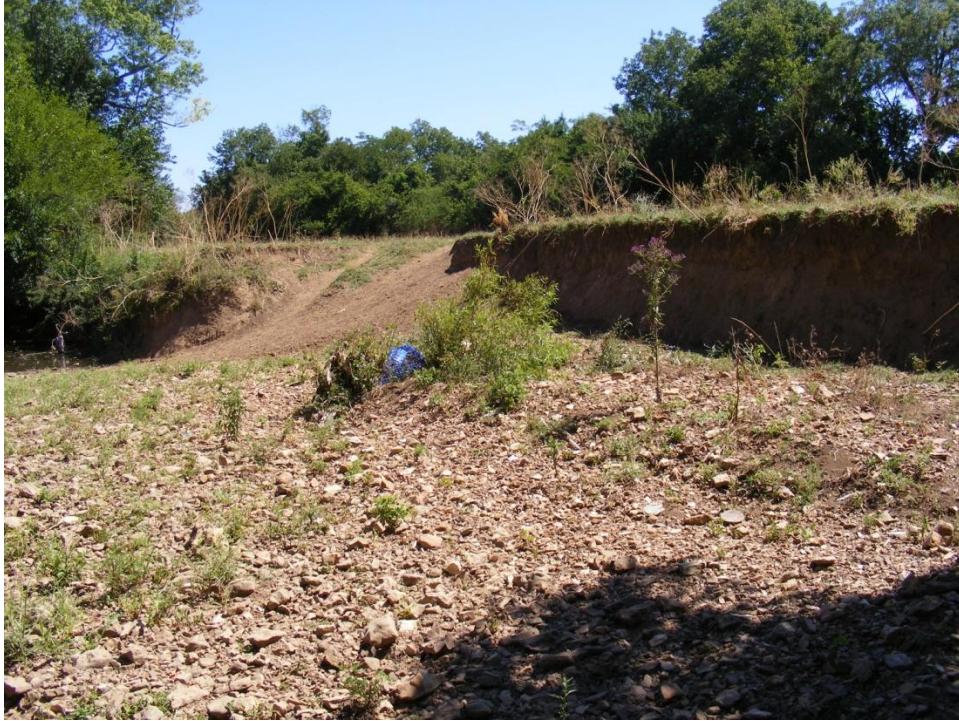
14. *Utility Easement and Cattle Entrance Reach (700-600 ft)* – In this reach a utility easement crosses the channel with overhead powerlines coming down from the bluff on the right. Here the bluff has been cleared of mature vegetation. The left bank is eroding due to a cattle entrance ramp and no riparian vegetation present on the bank (Photo 17).

Photo 17. Utility Easement and Cattle Entrance Reach (600 ft) looking at the cattle entrance and left bank erosion.

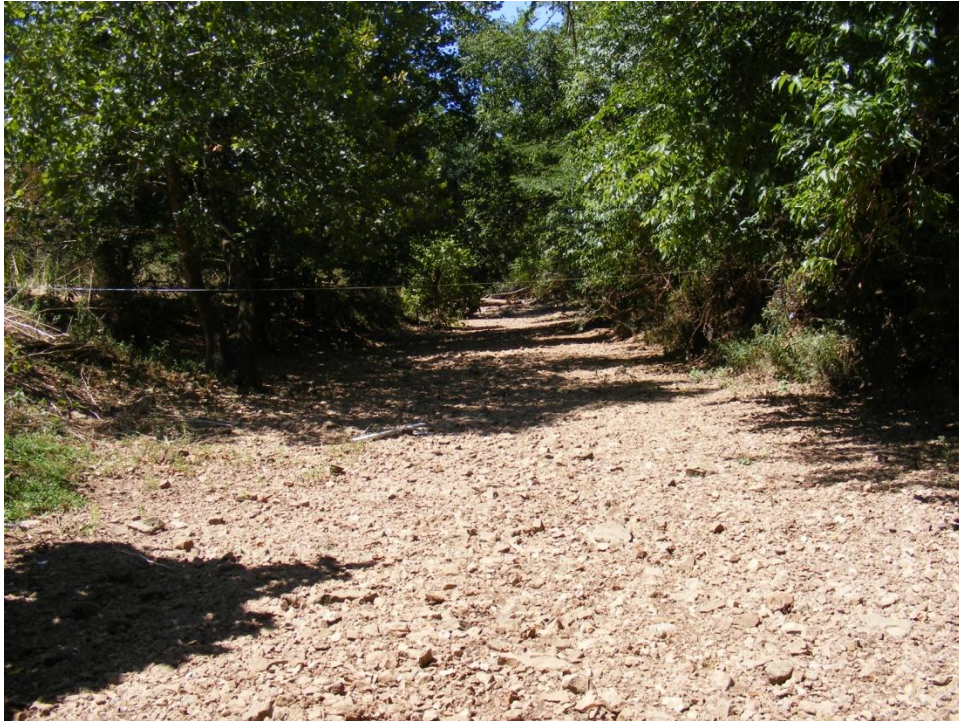
15. *Gravel Bed Reach #4 (600-200 ft)* – This reach has a gravel bed with slight-moderate erosion on both banks (Photo 18). Here, the right bank has a relatively narrow floodplain where the channel has left the valley wall and has mature vegetation. The left bank has a thin line of mature trees with cattle entrances at 400 and 500 ft.

Photo 18. Gravel Bed Reach #3 (300 ft) looking downstream.

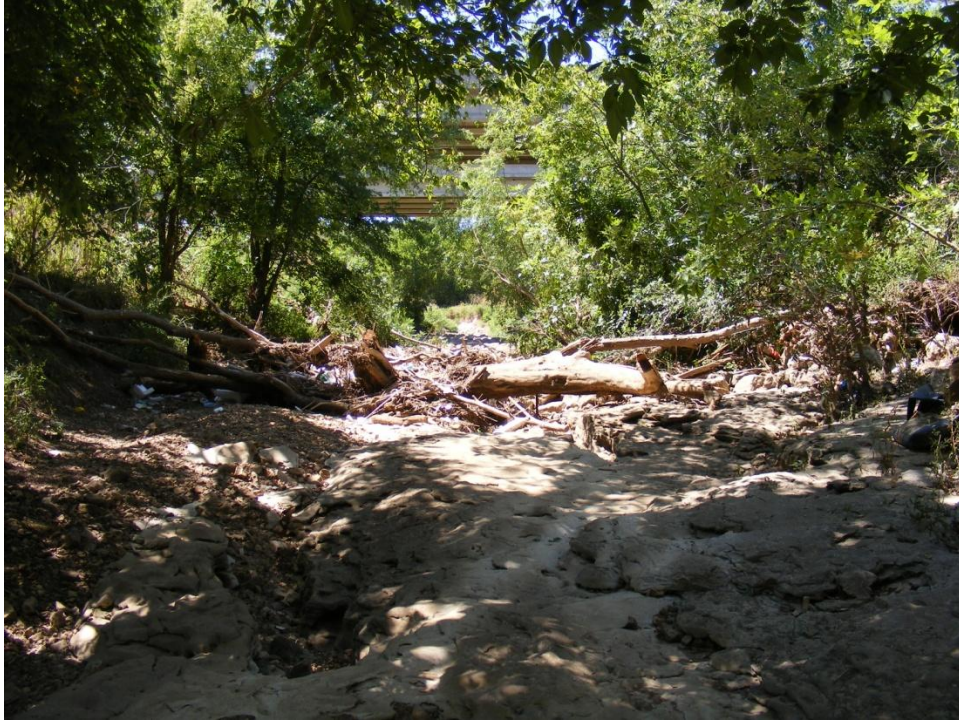
16. *Bedrock/Bridge Reach (200-0 ft)* – This reach has a bedrock bed with banks that have slight-moderate erosion with a thin riparian corridor (Photo 19). A cable across the channel at station 100 ft collects large woody debris and trash at the property line.

Photo 19. Bedrock/Bridge Reach (200 ft) looking downstream.

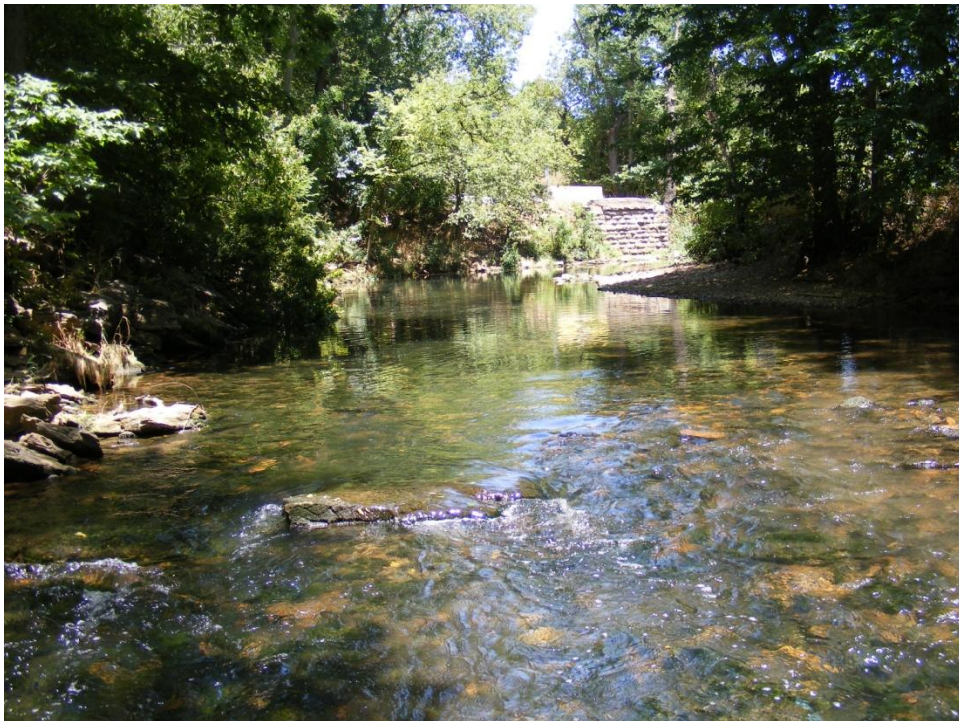
1. *Bedrock Controlled/Bluff Reach (3,200-2,100 ft)* – The channel is adjacent to a bluff along the right bank and there is moderate erosion along the left bank in this reach (Photo 20). Bedrock is exposed in the bed along with deposits of gravel and cobble. A spring seep appears along the right bank at 2,600 ft and a currently dry tributary enters on the left at 2,500 ft.

Photo 20. Bedrock Controlled/Bluff Reach (3,100 ft) looking upstream toward old FR 168 bridge.

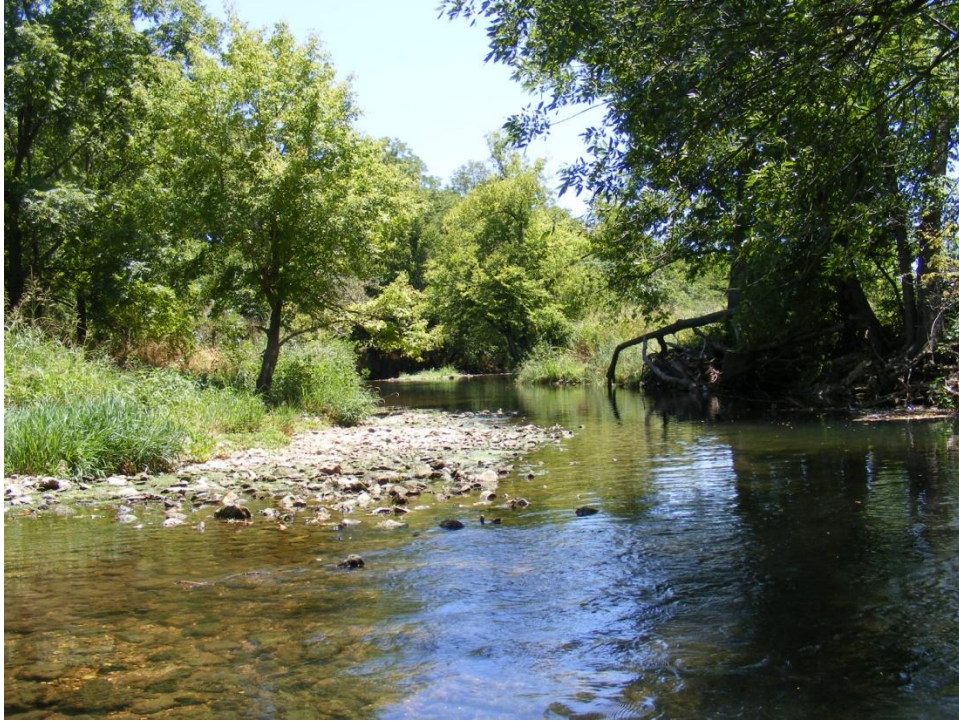
2. *Transition Reach (2,100-1,800 ft)* – Through this reach the channel moves away from the bluff and forms a floodplain on the right bank with a thin riparian buffer consisting of tall grass and small trees (Photo 21). The banks on the both sides have slight-moderate erosion, but the right bank appears to be more susceptible due to less deep-rooted vegetation along the bank. A tributary enters this reach at 1,900 ft.

Photo 21. Transition Reach (2,100 ft) looking downstream.

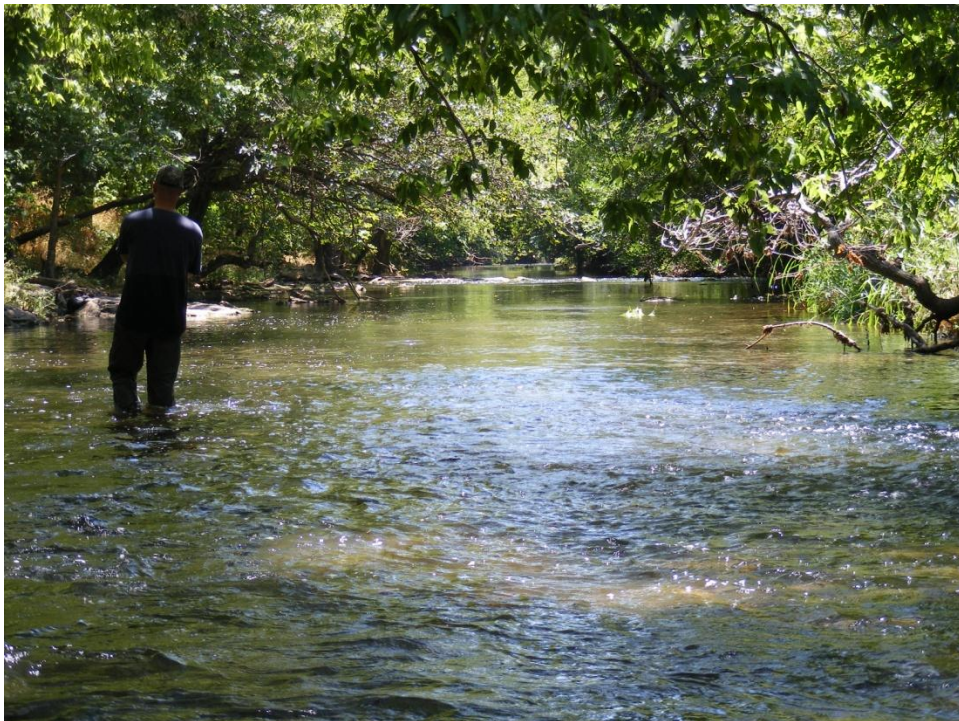
3. *Straight/Bedrock Toe Reach (1,800-1,300 ft)* – Bedrock is prominent along the bed and the toe of the left bank through this reach (Photo 22 and 23). The 500 ft reach is very straight with a bedrock knick/riffle from 1,500-1,400 ft. The right bank has slight-moderate erosion and a thin riparian buffer of mature trees.

Photo 22. Straight/Bedrock Toe Reach (1,800 ft) looking downstream.

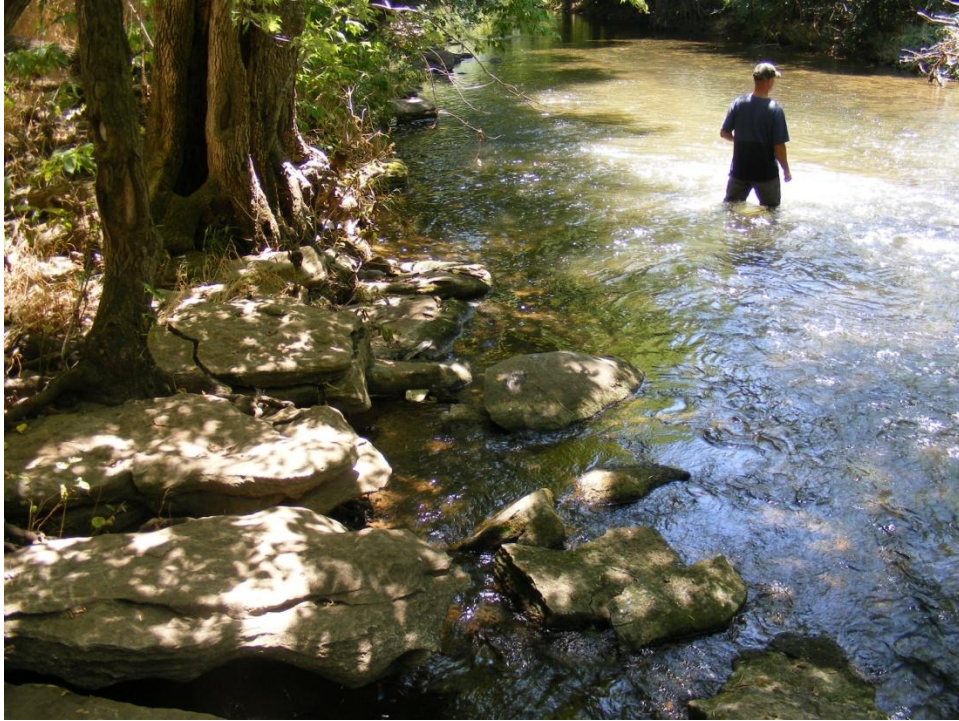
Photo 23. Bedrock exposed along the toe of the left bank at station 1,400 ft.

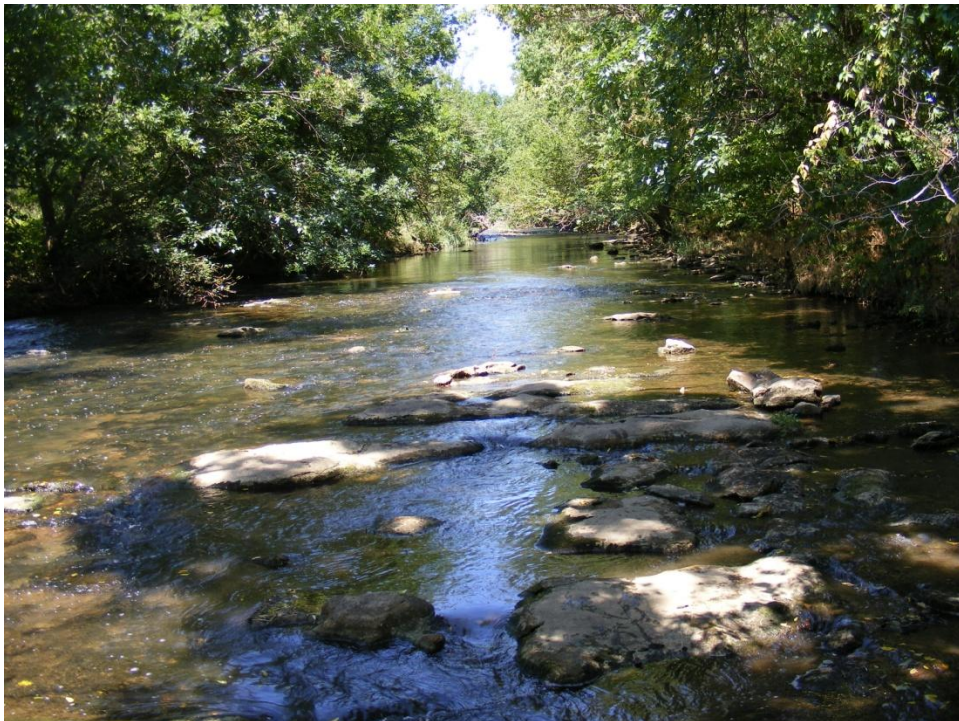
4. *Bedrock Reach (1,300-650 ft)* – This reach is similar to the upstream reach, but there is no bedrock exposed along the bank, only in the bed (Photo 24). Both banks show slight erosion. The right bank has a thin riparian corridor of small trees and is susceptible to more severe erosion than the vegetated left bank (Photo 25). There is a floodplain scour hole at 700 ft (Photo 26).

Photo 24. Slick Bedrock Reach (1,300 ft) looking downstream.

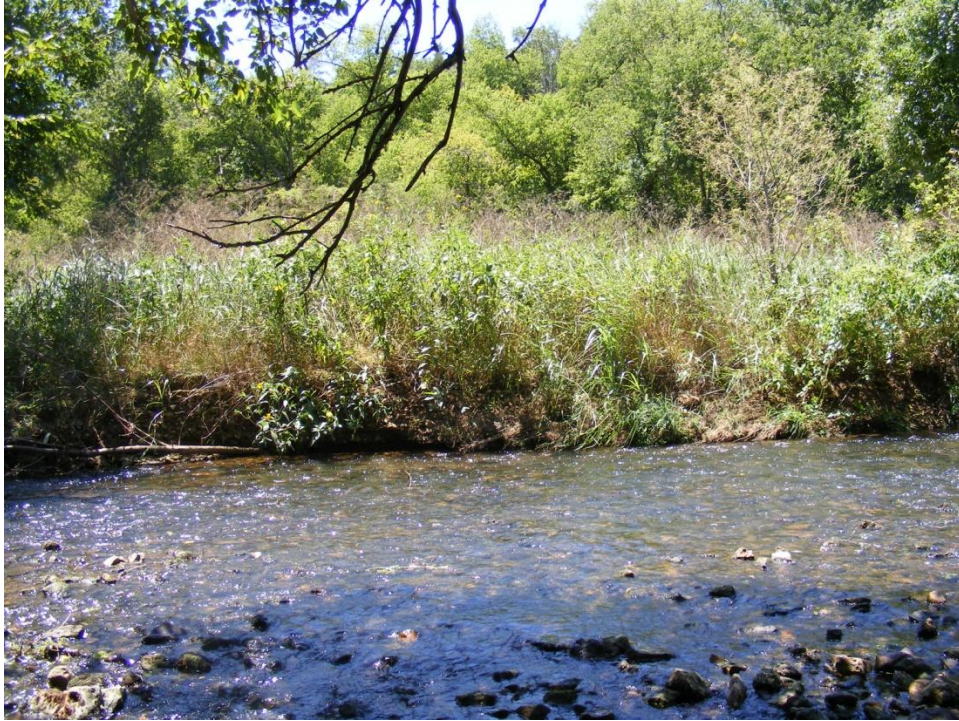
Photo 25. Thin riparian buffer on right bank at station 900 ft.

3. *Establish a Healthy Riparian Buffer* - Currently, the riparian corridor along most of the north segment and the west side of the south segment is too thin. There is 8.7 acres of riparian buffer currently in pasture available for planting in the north segment and 2.3 acres of pasture available along the south segment. Since the stream on the north segment is intermittent, drought tolerant native trees and shrubs appropriate for planting around streams should be used. Trees and shrubs should be planted at a higher density than is currently present that will provide resistance to erosion during flood events, help filter pollutants and sediment washing into the stream, and provide habitat to birds and other non-aquatic species using the stream corridor. The main channel should remain disconnected from urban drainage system now and in future. Runoff from pasture areas and from upstream areas during floods should be forced to go over buffer for filtering and infiltration, not through channels or pipes.

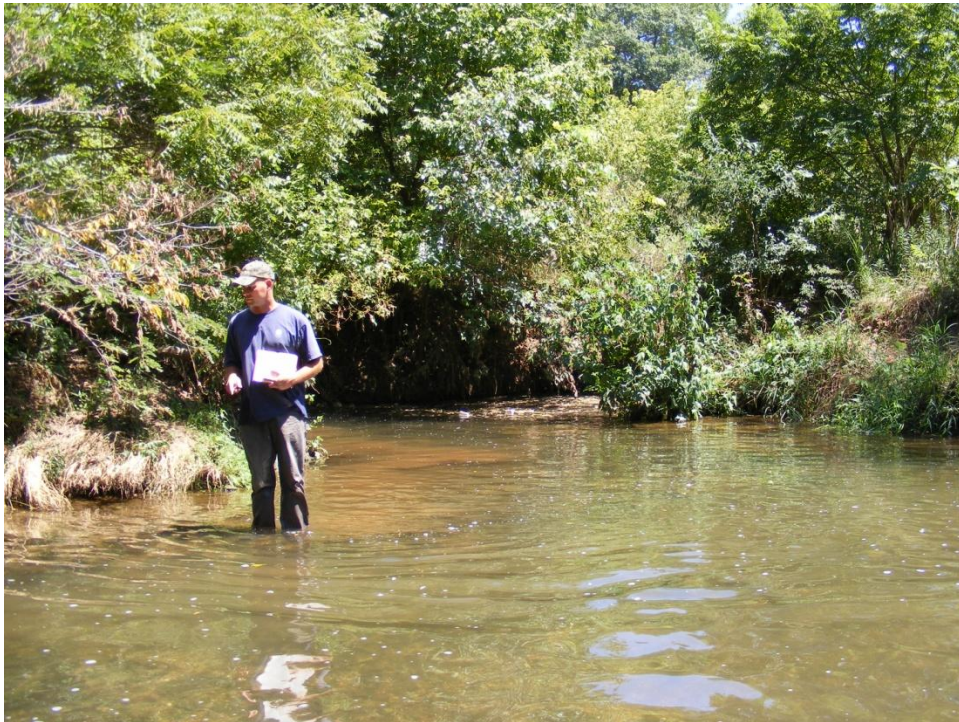
Photo 26. Floodplain scour hole on left bank at station 700 ft.
