**The Ozarks Environmental and Water Resources Institute (OEWRI)  
Missouri State University (MSU)**

**Channel Stability and Riparian Corridor Assessment  
to Identify Nonpoint Source Pollution, Wilson Creek,  
Springfield, Missouri**

*Field work completed July 20, 2012*

OEWRI EDR-12-003

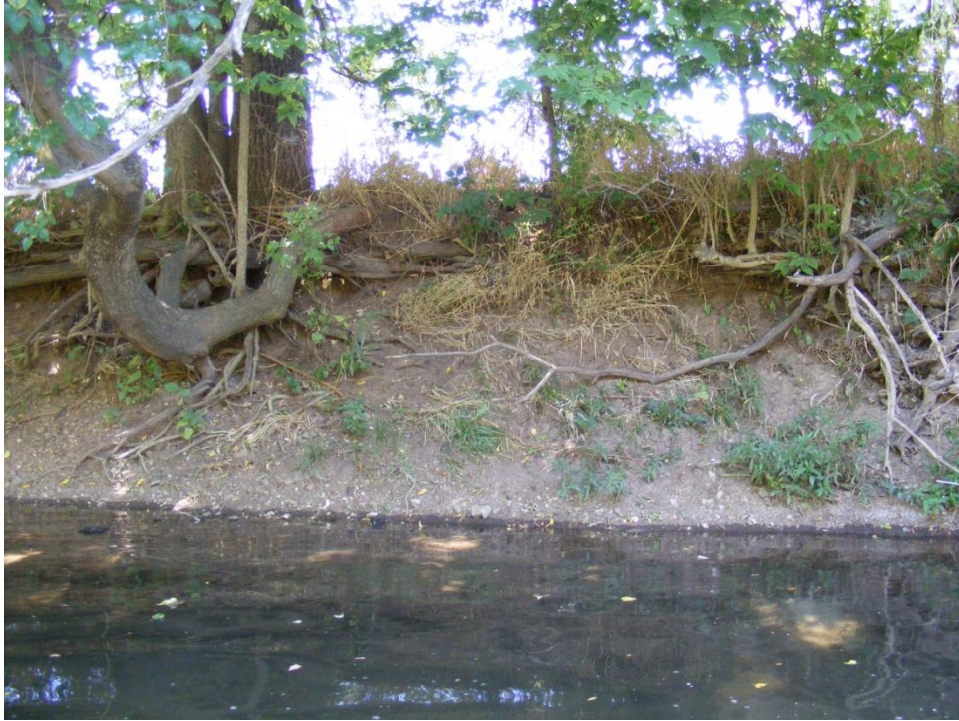
5. *Gravel Bed Reach (650-250 ft)* – The bed through this reach consists of gravel with bedrock exposed only in the bottom of deep pools. There is 200 ft of right bank erosion near the confluence with a tributary coming into the channel from the west at 500 ft (Photo 27). Additional erosion occurs downstream at 400 ft on the left bank.

Photo 27. Gravel Bed Reach (500 ft) looking at the right bank.

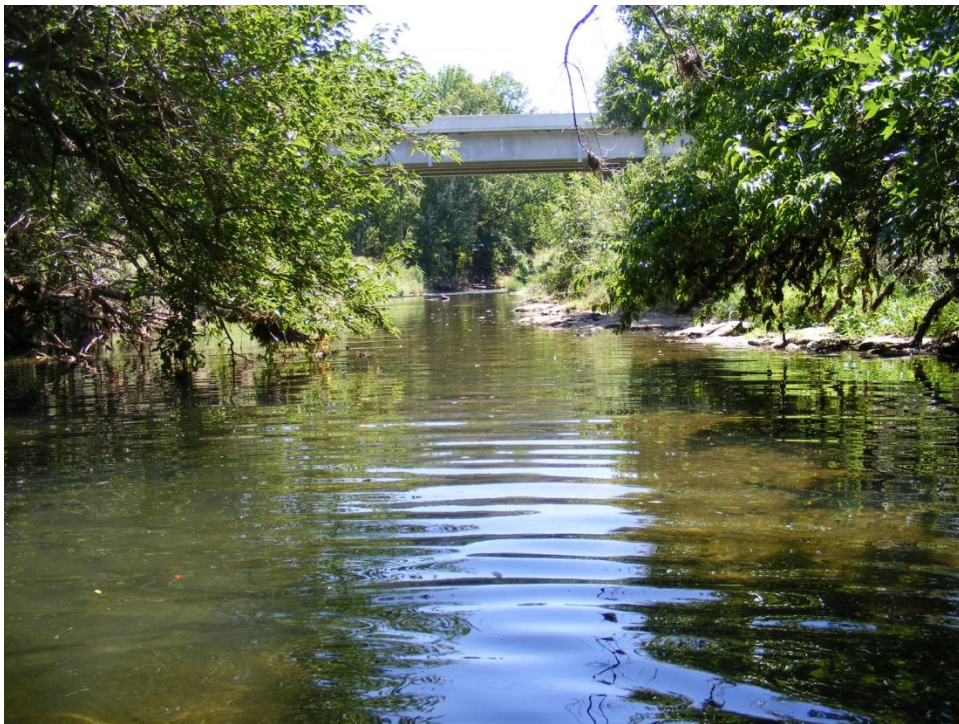
6. *Bedrock Bed/Bridge Reach (250-0 ft)* – Around 250 ft upstream of the Republic Road Bridge, bedrock is exposed along the bed of the stream (Photo 28). Bedrock is also exposed at the toe of the right bank. The riparian buffer stops at the road right-of-way line at station 100 ft.

Photo 28. Bedrock Bed/Bridge Reach (250 ft) looking downstream toward Republic Road Bridge.
