Management of Building Collapse in Nigeria: A Lesson from Earthquake-Triggered Building Collapse in Athens, Greece

In this study, aseismic investigation and retrofits of a collapsed residential building in the Olympic city of Athens is considered. Its aim is to investigate the causes of the collapse and provide mechanism(s) for strengthening the earthquake affected building with the aid of finite element programs-SAP and pi-DESIGN. Figure 1.0 show the ground floor plan produced with pi-DESIGN.

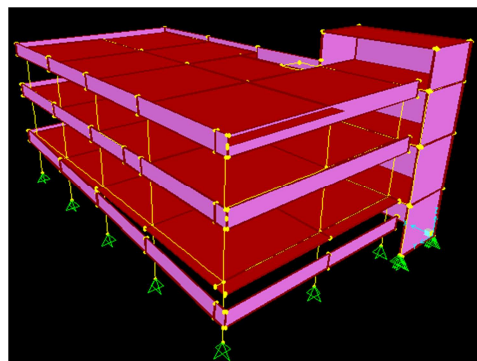
Figure 8. Deformed Shape of the Model

The deformed shape of the model corresponds to the exact mode of failure of the real structure and the deformation is the same as the one observed in the real structure.

The results from Figure 8, 9, and 10 shows that the structural displacements are concentrated at the ground floor with severe damages to the ground floor walls and the slab frame. We observed upward-down displacements of the ground floor slab frame and this shows that the seismic waves (vertical components) were not adequately absorbed by the upper floors. The second floor of the building lying immediately above the damaged floor was excessively reinforced. In other words, the stiffness of the second floor is too high compared to the first floor. Consequently, the seismic waves were reflected back causing high level of impacts and resulted to a decrease in the stiffness of the lower floor slabs and the load bearing columns. This in turn resulted to severe damages of the walls and the slab frame with little or no effects on the upper floors.

The behaviour of the collapsed building before strengthening was unsatisfactory and the failure of the structure can be attributed to its poor design. The distribution of the stiffness in the structure was not well taken care of and this is the basis of the observed damages that the building sustained when the earthquake occurred. The reduction in the stiffness and resulting friction of the ground floor slabs, and the load bearing columns were the main causes of the building collapse.

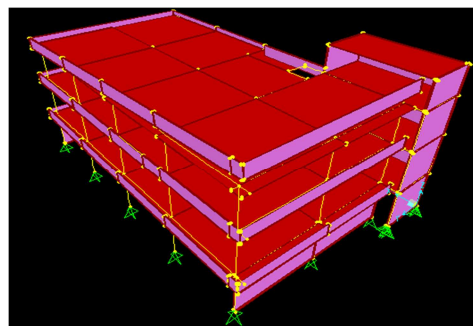
Figure 11. Deformed shape of the model

The results from Figure 11, 12, and 13 shows that the deformed shape of the model are different from the one observed earlier before strengthening. The stiffness of the basement has been increased and the behaviour of the structure is better than the one observed earlier. After strengthening, the ground floor including the basement was more stable than the upper floors and least displacements were observed at the ground floor.
