Cracking of RC School Building Due to Soil Expansion

*Omer S. Mughieda*¹⁾ and *Khaldoon A. Bani-Hani*²⁾

ABSTRACT

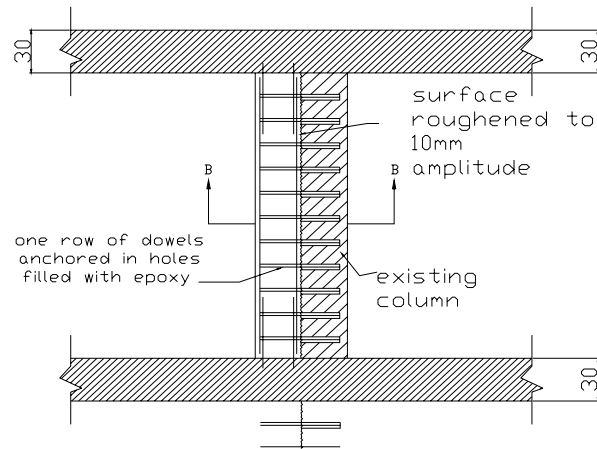
As for the structural elements, they were analyzed using the slope-deflection method and the moments were examined for design requirements. The loads were computed by distributing the slab loads. The analysis results and the steel design for the columns and the beams are shown in Table (1) and Table (2), respectively. The analysis and the required steel showed that some of the columns were over-stressed and require a larger cross-sectional area. Specifically, the results showed that column C8 at axis 2-C was potentially overstressed.

Figure (12): Method of increasing the cross-sectional area of the columns.

Figures (12) and (13) show the remedial work suggested to increase the cross-sectional area of column C8. Although column C1 at axis 7-A, axis 7-E and axis 1-A were not overstressed, a larger cross-sectional area is recommended due to some cracks. On the other hand, some of the beams were under-reinforced and either did not satisfy the minimum steel ratio of 0.004 for concrete compressive strength, f_c' , of 20 MPa and steel yield strength, f_y , of 285 MPa or the anticipated settlements that require more reinforcements.

The shaded column (C8) in Table (1) is recommended to be strengthened by increasing the cross-sectional area of the column as shown in Figures (12) and (13). The same procedure is to be used for strengthening the other columns mentioned earlier.
