Non- destructive characterization of carbon fiber composite/Cu joints for nuclear fusion applications

Non- destructive characterization of carbon fiber composite/Cu joints for nuclear fusion applications / CASALEGNO V; SALVO M.; FERRARIS M; SMEACETTO F; MEROLA M; BETTUZZI M. - In: FUSION ENGINEERING AND DESIGN. - ISSN 0920-3796. - 83(2008), pp. 702-712.

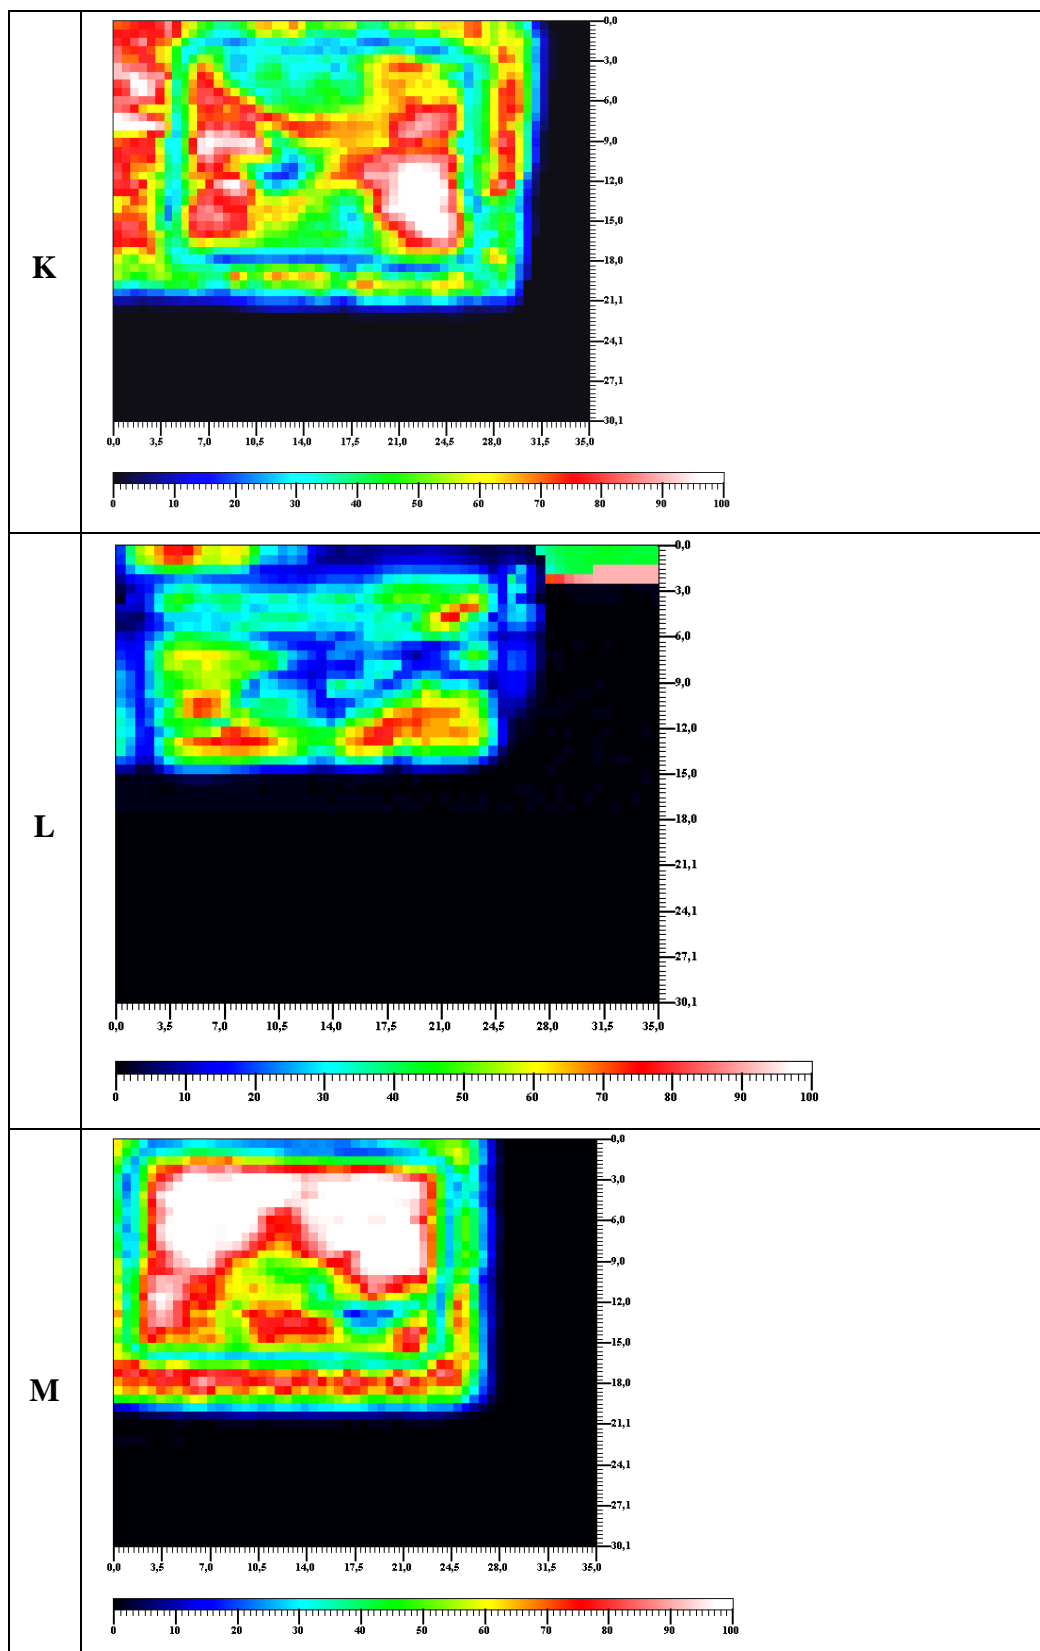
Figure 1 shows C-scans of each sample. Concerning sample K, it is possible to notice a significant echo (any sound from pulse that returns to the transducer) which means that defects through the specimen thickness reflect the sound, back to the transducer. White zones probably indicate a detached interface. A-scan in suspected detached region point out large echo and several reflected echoes; green/blue areas signify good joint interface.

With reference to sample L, one can note that, as for sample K, detected defects are located in the lower region of the samples, probably at interface CFC/Cu (yellow-red areas). Further tests (not reported here) showed an echo most likely due to Cu/CuCrZr interface that hides partly CFC/Cu interface. C-scan of sample M shows possible large defects at interface CFC/Cu, while only lower region (green area) looks not detached.

**Figure 1** C-scan of a CFC NB31/Cu/CuCrZr joined sample

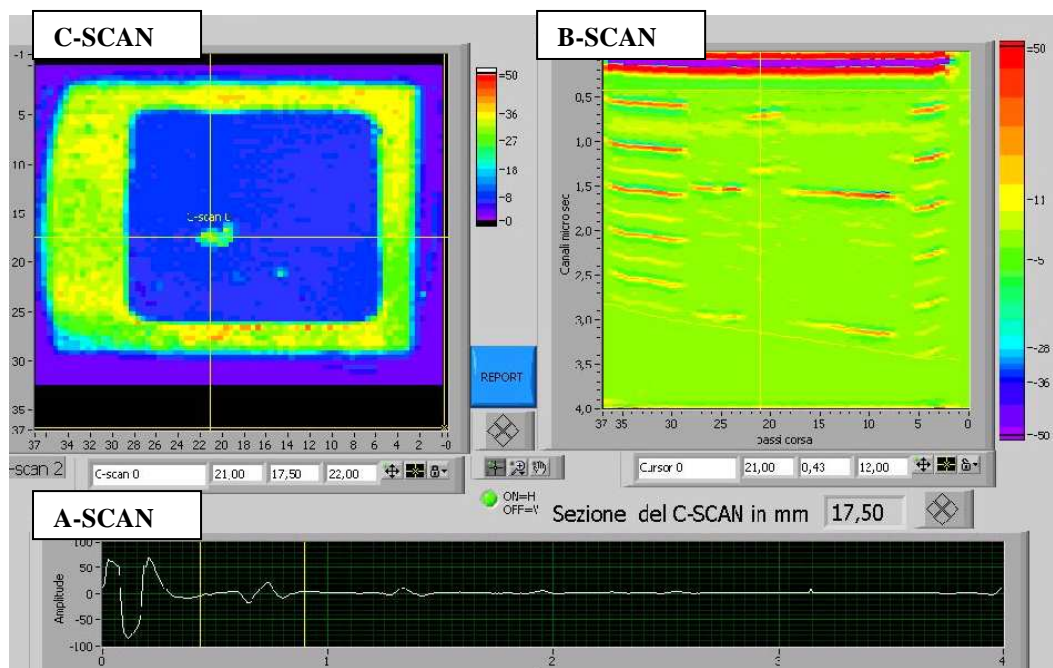
Figure 2

C-scan in area of sample K (figure 2) pointed out a defect at Cu/CuCrZr interface; defect sizes are limited (about  $2\text{ mm}^2$ ); B-scan corroborates defect localization (echo at Cu/CuCrZr interface hides echo at Cu/CFC interface).

**Figure 2** Defect at Cu/CuCrZr interface in sample K

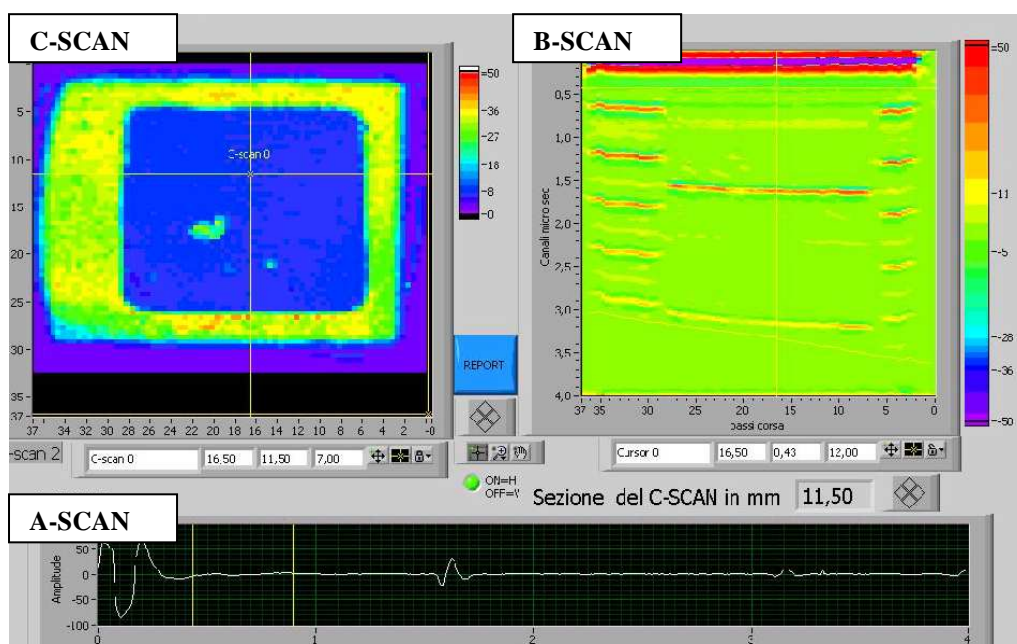
Figure 3

As a comparison, C-scan of a defects free area is shown in figure 3; it can be distinguished the signal at Cu/CFC interface at  $3.5\text{mm}$  (about  $1.5\mu\text{s}$  in the B-scan).

**Figure 3** Maps of ultrasonic investigation on sample K; defect free CuCrZr/Cu interface gets observable CFC/Cu interface

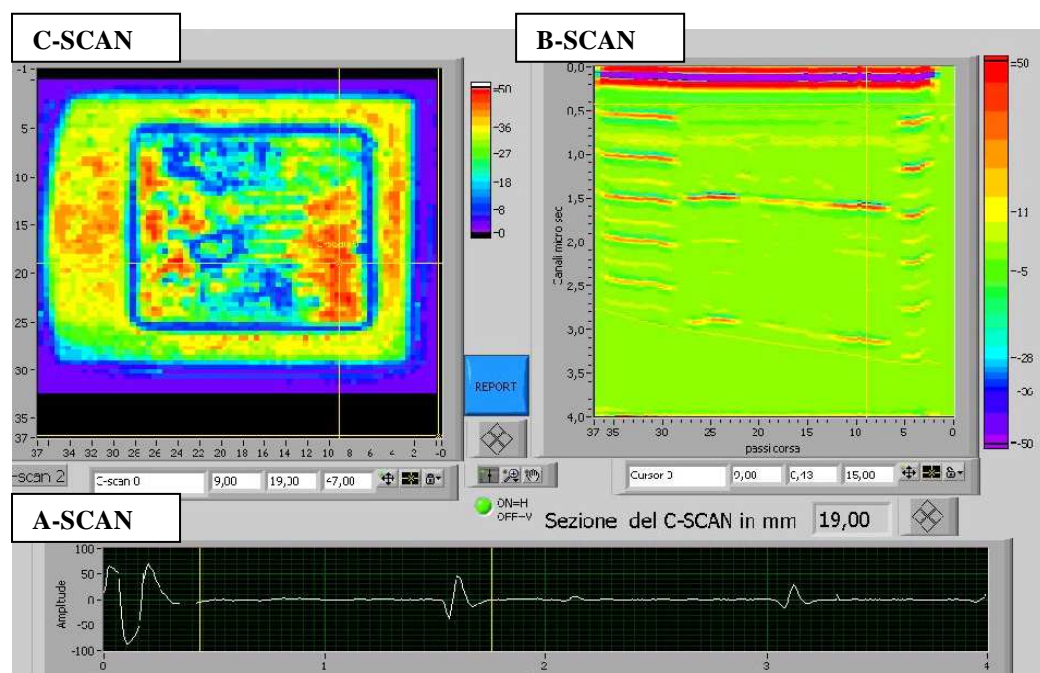
Figure 4

C-scan reported in figure 4 was obtained with an extended window over  $3,5\text{ mm}$  in depth. Defects are localized on the left and on the right side of the sample at CFC/Cu interface (red areas). Blue areas show good joint interface (no defects).

**Figure 4** Defects localization (red color on the C-scan) at Cu/CFC interface for sample K

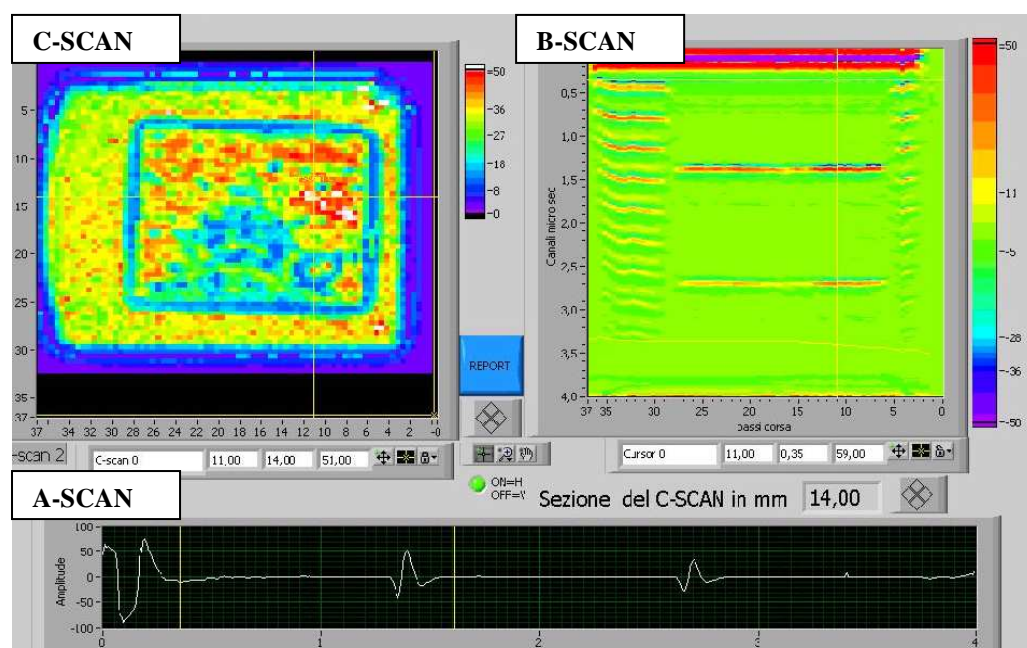
Figure 5

**Figure 5** CFC/Cu interface scan of sample L : defects are located in yellow-red areas

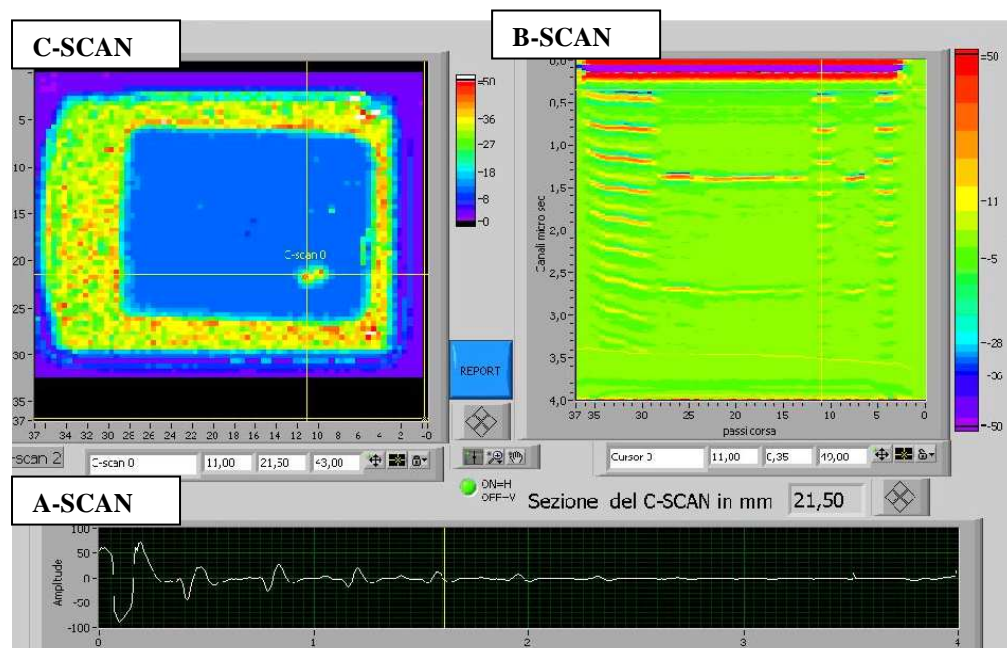
Figure 6

Concerning test on sample L, reference signals have been determined as for sample K (about  $1\text{ mm}$  Cu/CuCrZr interface and about  $3\text{ mm}$  Cu/CFC interface that correspond to  $0.43\text{ }\mu\text{s}$  and  $1.3\text{ }\mu\text{s}$  on time axis respectively). Figure 5 shows discontinuities at CFC/Cu interface. Cu/CuCrZr interface is quite continuous; only limited area (figure 6) indicates a defect.

**Figure 6** Defect at Cu/CuCrZr interface (yellow/red dot in blue area) in sample L

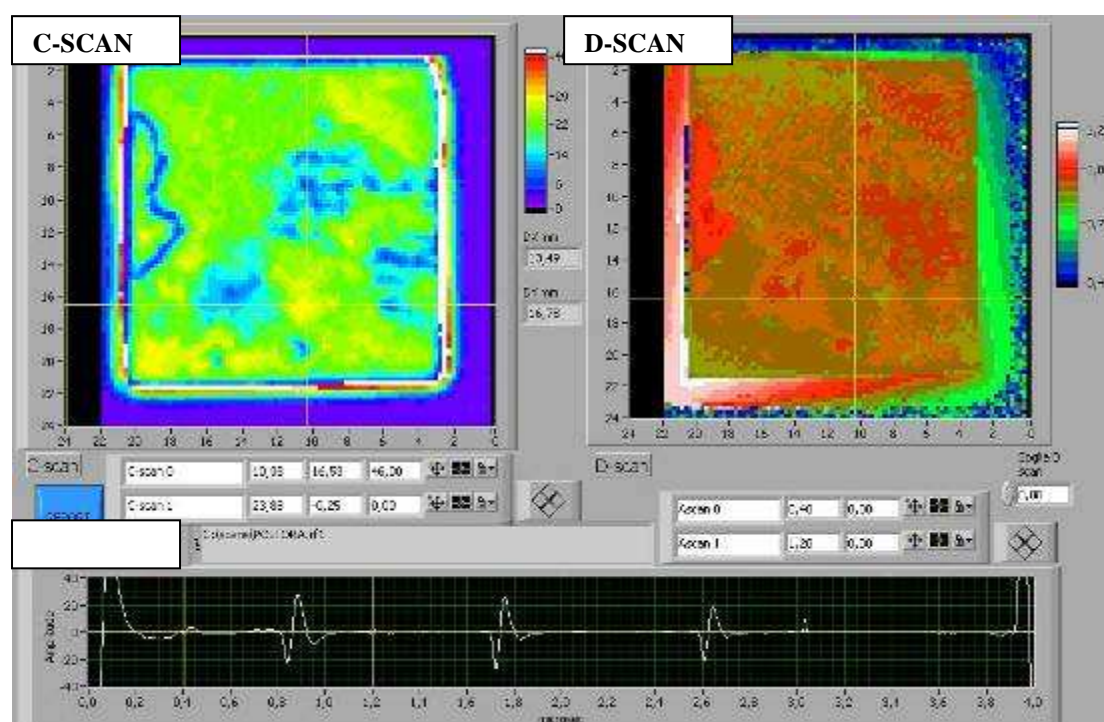
Figure 7 shows a comparison between C- and D-scan for sample D ; if the cursor is directed on yellow area, signal amplitude is more than 20 (relative amplitude); if it's directed on blue area, signal amplitude is significantly lower (less than 10); sample E shows the same behavior.

Typically, good joints show low echo values (relative amplitude below 8, showed in blue). As a consequence, samples D and E seem to be acceptable only in areas corresponding to blue zones on C-scans; since most of the maps are yellow-green, it could be concluded that samples quality is low. On the contrary, red areas are not present on the maps thus indicating that Cu and CFC are not detached.

Actually, the samples quality appears to be poor; this is probably due to weak interface but it cannot be excluded that some porosities in cast Cu are localized at the interface between copper and CFC and they act as a void at interface.

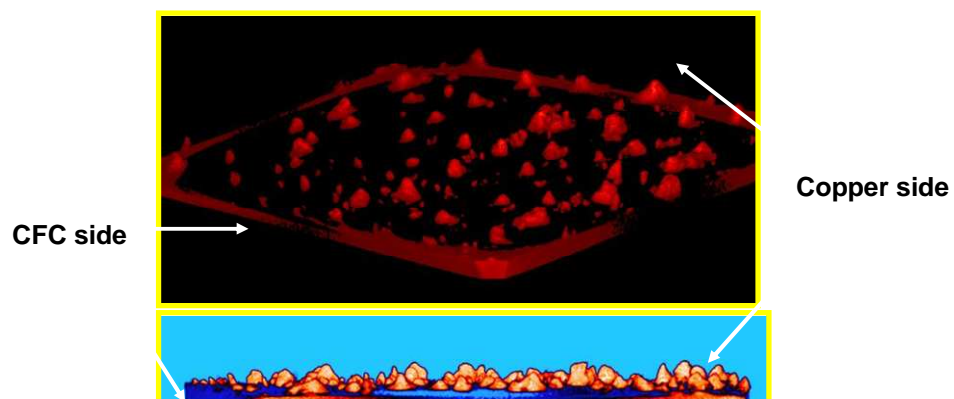
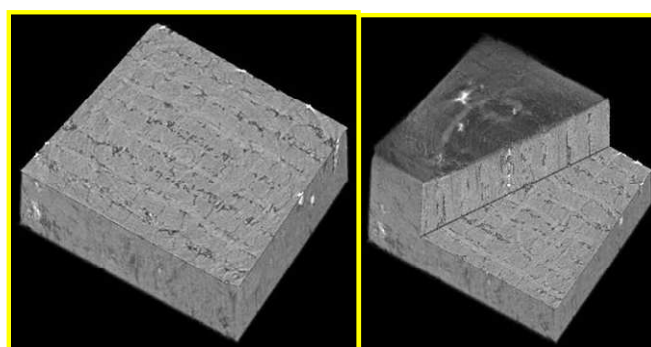
In figures 8 and 9 are shown some tomography of sample M achieved with 85 kV peak energy with 0.8 mm Cu filter and 45 kV without filter respectively. In the first one, the copper layer is clearly observable, where the copper “finger-like” pattern at CFC/Cu interface can be distinguished, while in the second one, the CFC structure is more evident.

The effects of highly absorbing materials on tomographic reconstruction could lead to some “star-artifacts” (white rays radiating away from a spot, a typical star-like pattern also known as metal-artifact.) on the surface of the analyzed sample; they correspond to “lack of information” zones (figure 10). These spots could be explained as voids at CFC/Cu interface but actually they are reconstruction artifacts.

In order to avoid these artifacts, X-ray energy should be enhanced; nevertheless, there will be a lack of information on CFC bulk, since it's less absorbent. In this case, the X-ray beam can penetrate the CFC bulk but there is not enough contrast to detect the CFC/Cu interface.

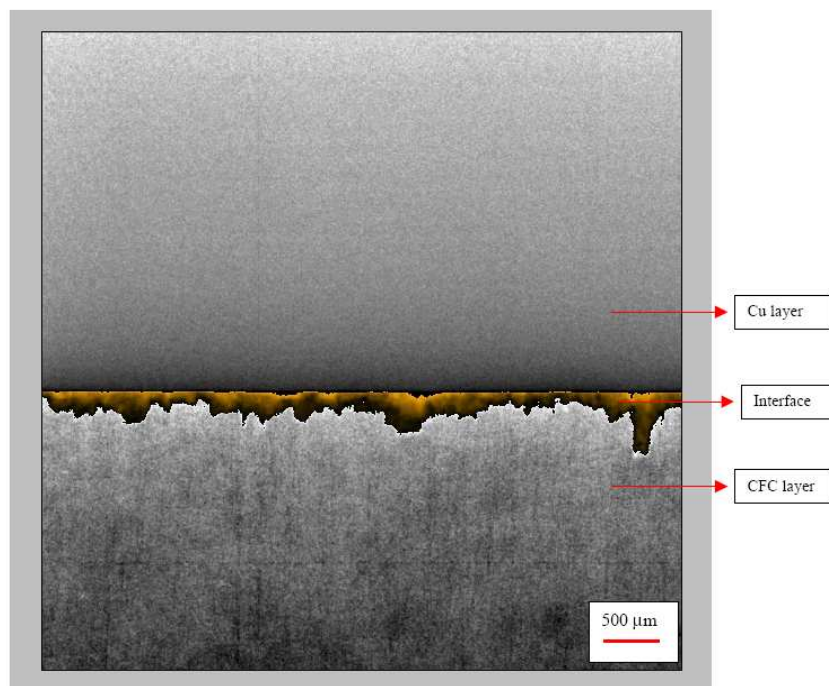
Figure 11

X-ray micro-radiography along the 19 mm side of the examined area ( figure 11) shows the interface between CFC and copper; the structure suggests that molten Cu penetrates into CFC substrate in a “finger-like” pattern.

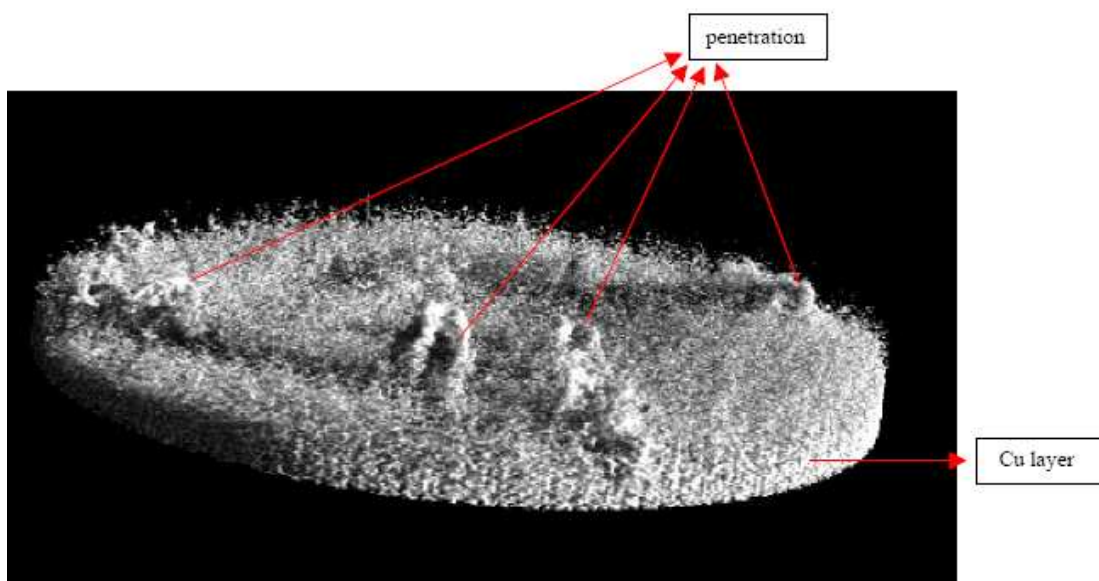
Figure 12 shows a tomographic reconstruction of the interface region, where CFC was intentionally removed by image processing; the “finger-like” penetration of Cu in CFC bulk is outlined.

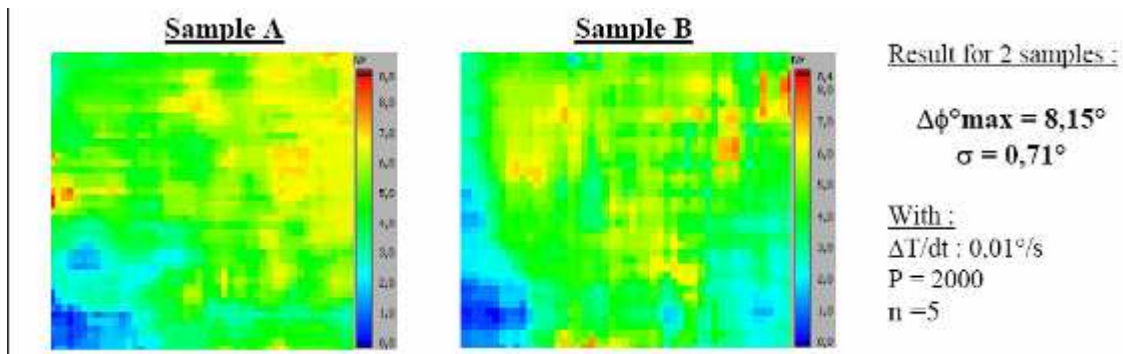
Figure 13

Phase contrast cartography was measured for samples K and L (figure 13); these phase contrast values are in the experimental noise.

The reduced heat transfer capability of some areas of the joined samples, in particular due to the presence of flaws at the interface CFC/Cu can be detected by this technique; not bonded areas indicated by non-homogeneity of the values of the phase contrast cannot be detected in figure 13. As a consequence no defects on K and L samples were detected by means of this technique, in contrast with results of ultrasonic tests.

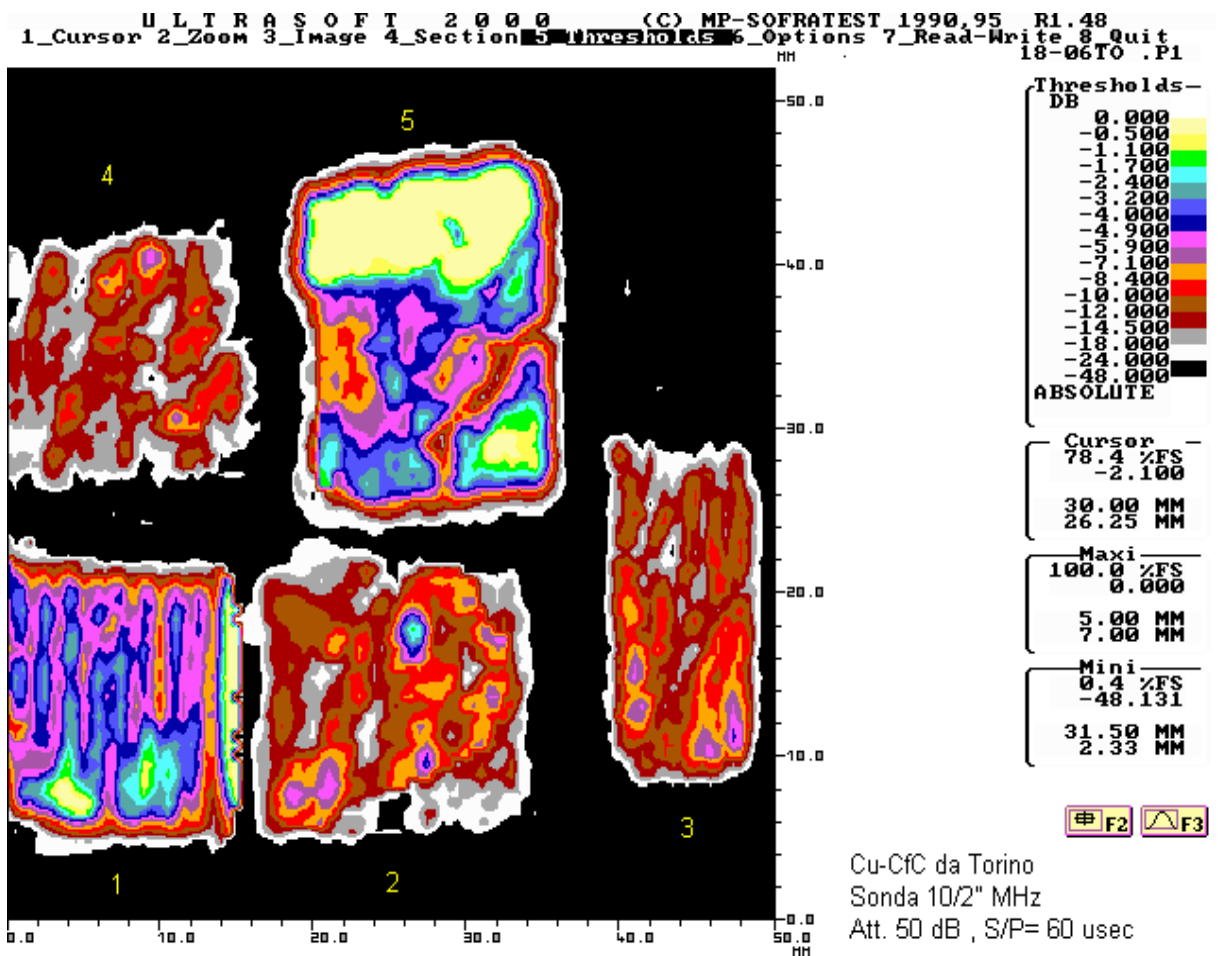
Figure 14

Ultrasonic inspection gave divergent results also for examination of CFC NS31 (silicon doped carbon-carbon) joined to Cu; 5 samples were tested before thermal fatigue test. Sample 1 and 5 (figure 14) showed many defects, especially sample 5 in the upper part (yellow area); these two samples sustained 30 cycles during thermal fatigue test and fracture surface analysis didn't reveal significant detached areas at interface.

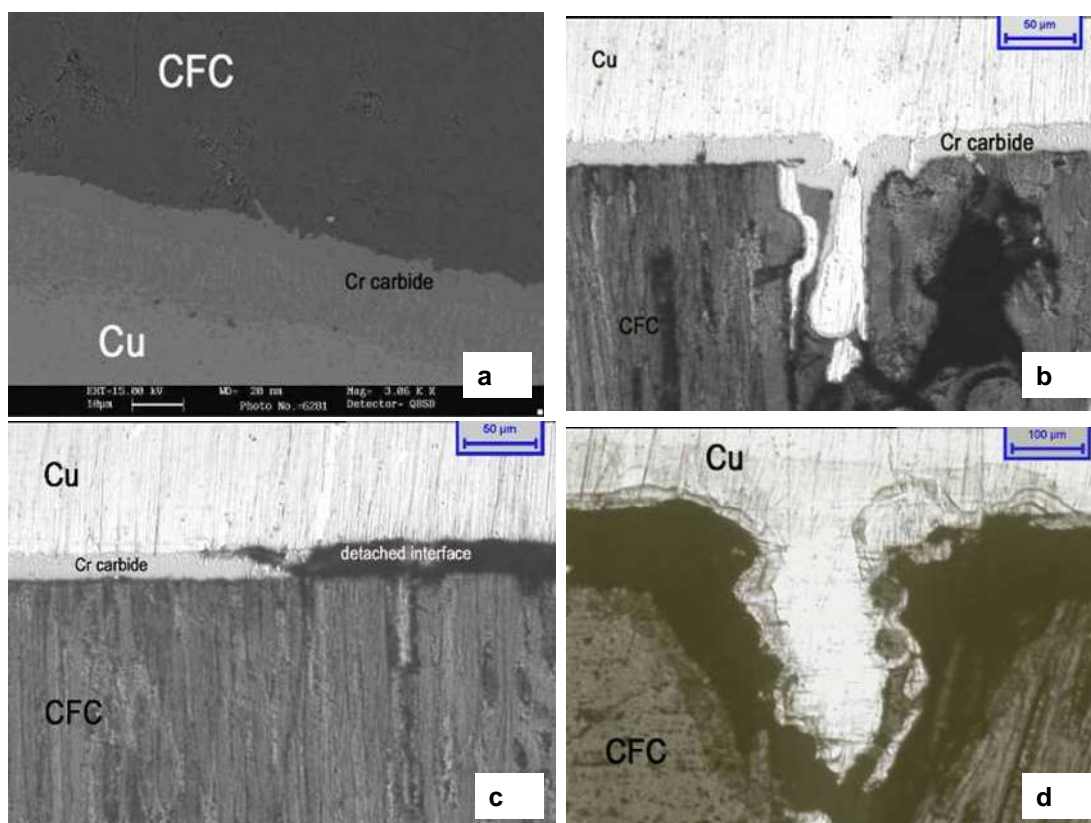
Figure 15

With regard to samples D and E ( prepared with Ar overpressure, not subjected to thermal fatigue tests, tested as prepared) optical analysis of cross sections of the joints (figures 15 b,c,d) shows detached interfaces along some direction where defects were supposed to be, while CFC/Cu interface is continuous in some areas of the joint where the NDT saw large defects.

Results of metallographic inspection on samples D and E agree partially with ultrasonic inspection that foresaw a weak adhesion between CFC and copper; the CFC/Cu interface is partly detached. Conversely, some areas indicated as discontinuous by US analysis look sound (figure 15 b).

**Figure 15** a) SEM magnification of CFC/Cr carbide/Cu interface of sample M; b) Optical micrograph showing defect-free cross section of sample D; on the right, it is possible to identify a pore in the carbon matrix; c) Optical micrograph of sample D showing detached interface between CFC and copper on the right, d) Image from optical microscopy characterization of sample E: there is a significant detach at CFC/Cu interface (about 600  $\mu\text{m}$ )

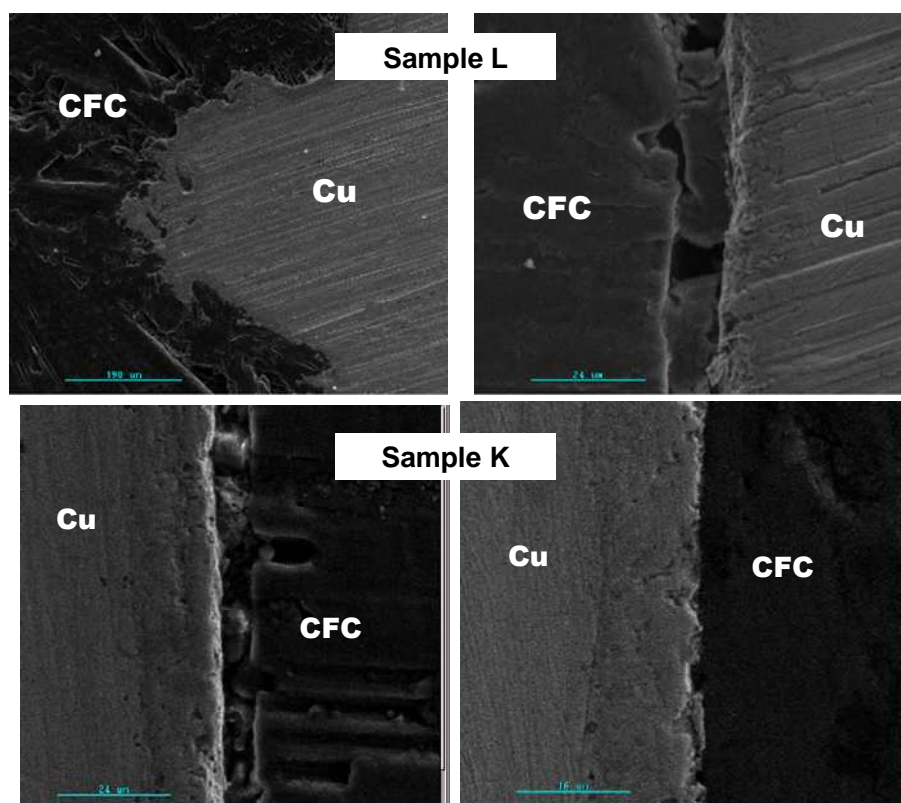
Figure 16

SEM and optical micrographs on samples K and L (figure 16) revealed some voids at CFC/Cu interface, but at the same time supposed detached areas are not confirmed by morphological inspection; as a consequence metallographic analysis doesn't agree completely with results from ultrasonic inspection and ultrasonic analysis disagrees with lock-in thermography.

It can be explained if discontinuities at CFC/Cu interface are small (reduced gap between CFC and Cu surfaces). In that sense, the thermography map can't point out discontinuity at the interface, since thermal response of the joint is quite good; on the contrary mechanical strength should be low.
