Post-seismic effectiveness of the strengthening work carried out with GFRP applied to historical masonry buildings: the case study of the Spoleto Cathedral

Post-seismic Effectiveness of the Strengthening Work Carried Out with GFRP Applied to Historical Masonry Buildings: The Case Study of the Spoleto Cathedral

Alessandro Grazzini¹ (*), Stefano Agnetti²

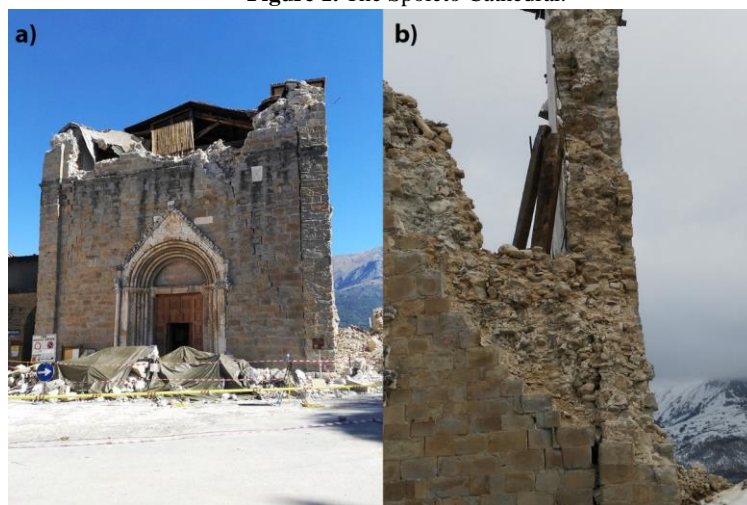
tral Italy highlighted the vulnerabilities present on the historical buildings, and the ineffectiveness of some strengthening techniques that proved useless to protect the buildings during the subsequent earthquakes^[1]. Masonry cracks opened in previous earthquakes and simply sewn by cement injections, reopened and re-exposed the same vulnerabilities during the last 2016 Amatrice-Norcia earthquake (**Figure 2**). In some cases even the buildings strengthened by reinforced cement plasters not connected transversely collapsed to the next powerful earthquake. Seismic damage often regards out of plane mechanisms of the multi-leaf and not effectively connected masonry walls (**Figure 3**).

Figure 2. Collapse of the St. Agostino church in Amatrice (2016 earthquake): **a)** out of plane of the façade after the first seismic shock, which highlights the opening of a sub-vertical crack previously strengthened by cement injections after the 1979 Valnerina earthquake; **b)** opening and collapse of the failure in which it is possible to see the signs of previous cement injections.

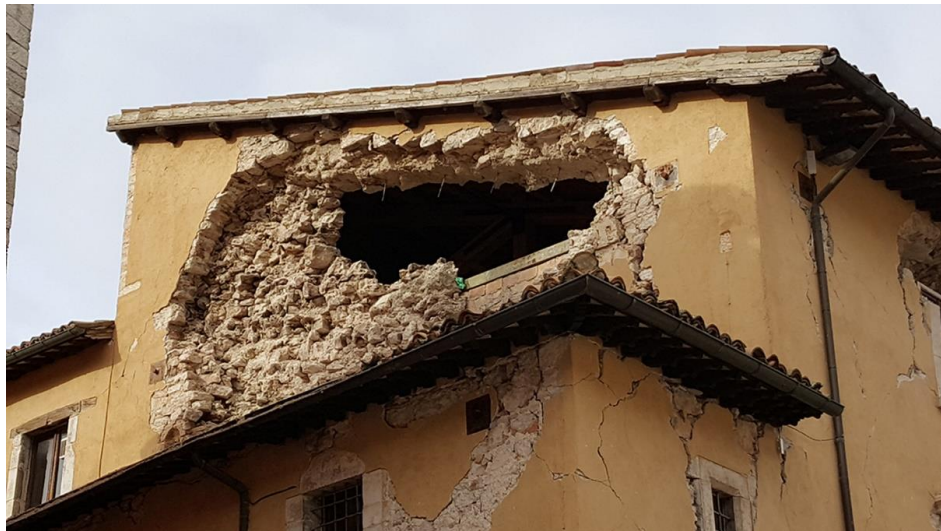
Figure 3. Out of plane collapse of a multi-leaf masonry wall (2016 Amatrice-Norcia earthquake).

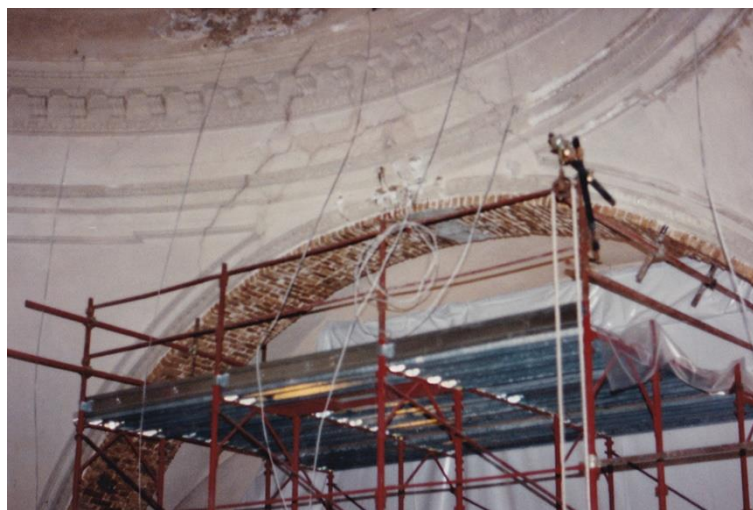
After the 1997 Umbria-Marche earthquake, the Spoleto Cathedral was subjected to a detailed survey carried out in order to know the actual conditions of the monument about the structural and security aspects. The non-homogeneous distribution of the damages present in the various parts of the cathedral showed a different behaviour towards the seismic actions. So the seismic events have highlighted the structural weaknesses, also amplified by the absence of maintenance. The façade showed widespread degradation, mainly due to water infiltration. The main aisle instead suffered cracks on the barrel vault following the seismic action. In the left aisle there were diagonal cracks with respect to the axis of the church in correspondence with the cross-vault centreline. In the area of the high altar there were instead cracks in correspondence of the triumphal arch near the apse (**Figure 8**). In this arc there were produced deep cracks and tilted both in key and in the kidneys which produced a detachment of the central part of the arch up to the dome's turn. In the left transept there was a detachment between the barrel vault and the stiffening arches. The most serious damage occurred in the Chapel

Figure 8. The cracks of the triumphal arch of the main nave.

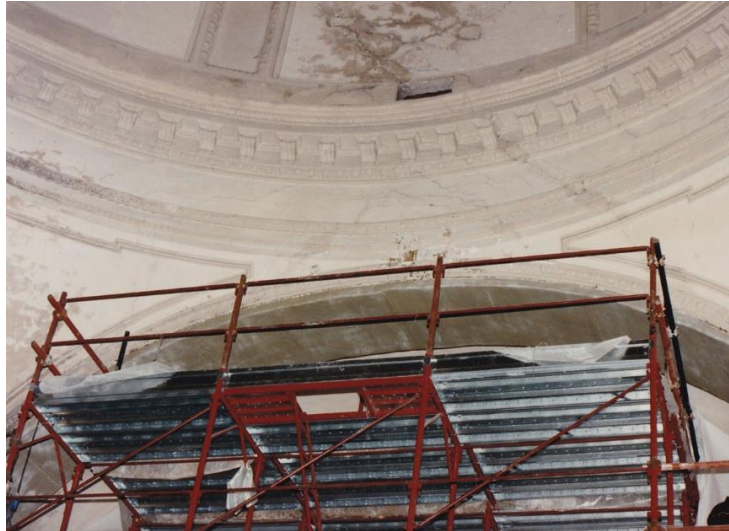
Figure 9. Application of GFRP intrados reinforcement bands on the triumphal arch.

All strengthening materials were supplied by Kimia S.p.A.^[6]. The barrel-vaulted cracks were stitched by means of fiberglass composite material (GFRP) to repair the existing cracks (**Figure 9**). In addition tie rods was put at the level of the top curb to prevent the out of plane phenomena (**Figure 10**). On the dome and on the lantern, strengthening works were carried out by means of injections (**Figure 11**) and reinforcement circle building.

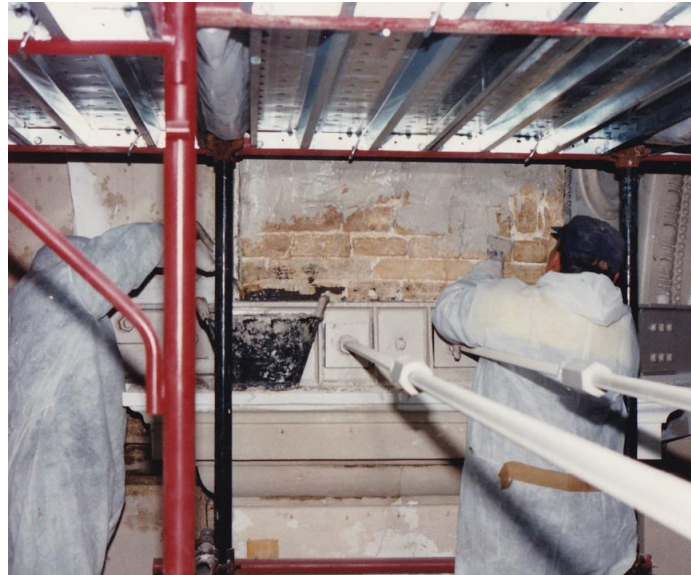
Figure 10. Strengthening work near the insertion of tie rods.

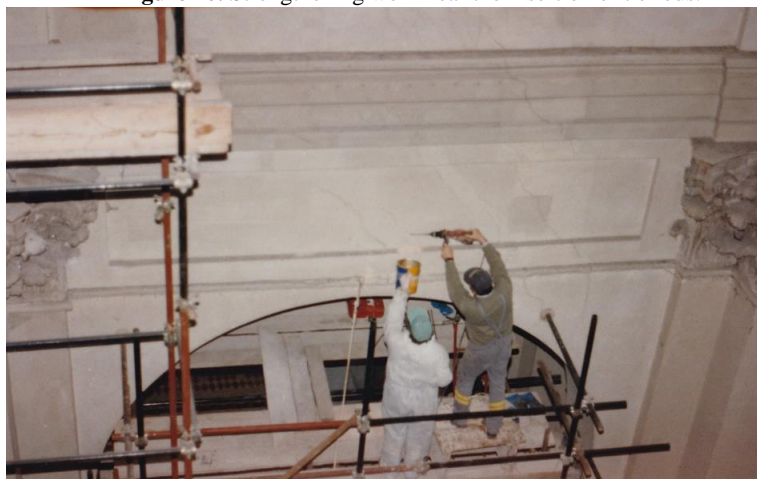
Figure 11. Injections technique for repair of existing cracks.

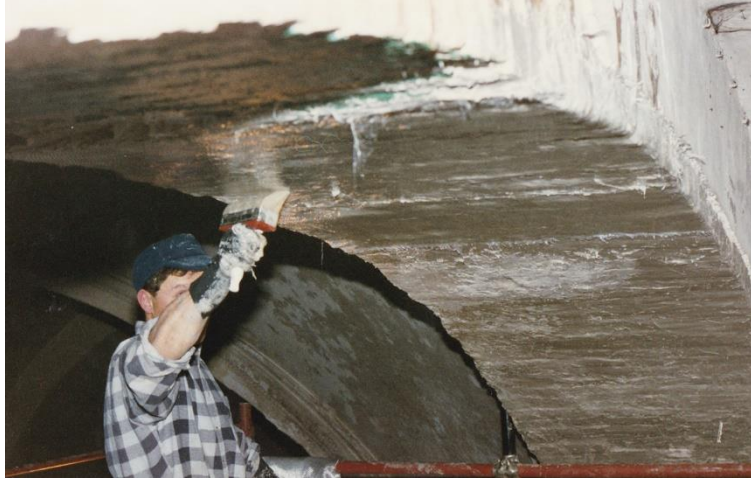
Figure 12. Application on the treated surface of two-component synthetic resin primer in aqueous dispersion.

primer. First of all, application on the treated surface of two-component synthetic resin primer in aqueous dispersion (**Figure 12**). Subsequent application of solvent-free two-component thixotropic epoxy adhesive (**Figure 13**).

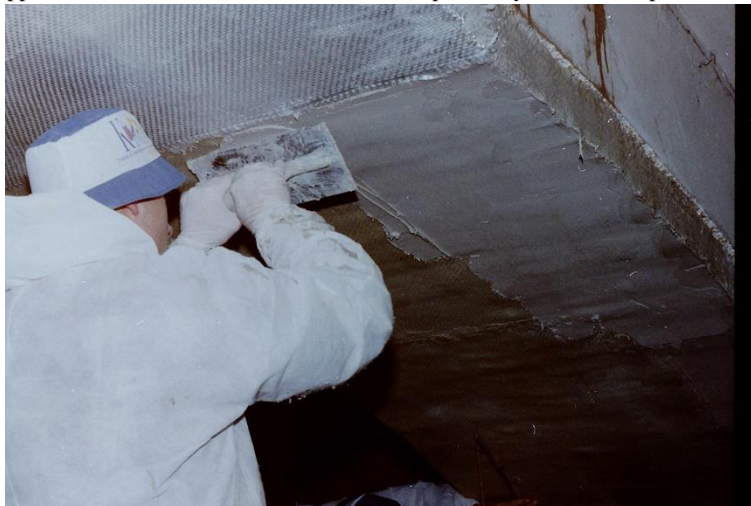
Figure 13. Application of solvent-free two-component thixotropic epoxy adhesive.

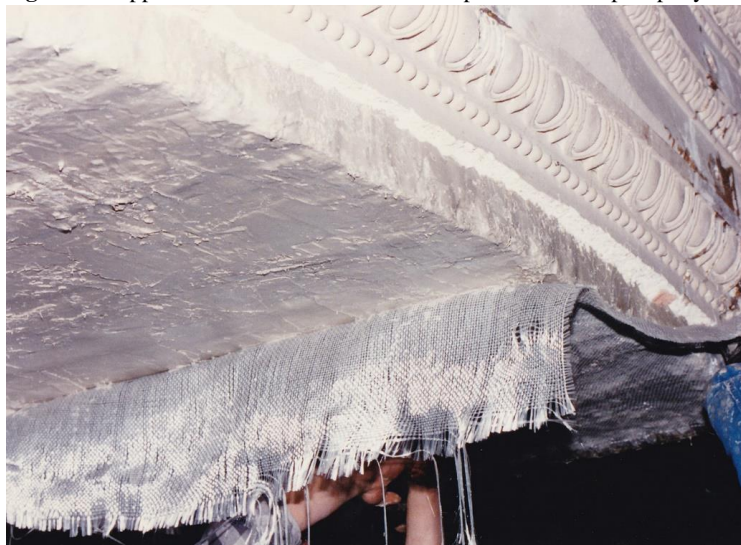
Figure 14. Intrados application of GFRP band for strengthening arch.

The product had the function of levelling the surface to be reinforced and creating an adhesive layer for the subsequent application of the reinforcement. The application of the fabric occurred in the fresh air, applying fibre bands with an iron roller and exert a slight pressure, taking care not to create air bubbles (**Figure 14**). The fabric was pressed in the resin layer, using the roll for composites (always roll in the direction of the fibers, exerting slight pressure paying attention not to move the fabric during this phase). It was necessary to roll until the resin emerges between the fibers and impregnates them completely, forming a uniform layer on the fabric. It was very important to remove any air bubbles that may be trapped between the fabric and the substrate, continuing to roll in the direction of the fibers. Subsequent impregnation with solvent-free, two-component, fluid-containing epoxy resin applied by brush or roller in several coats and slowly so that the impregnation of the fabric was complete. Any further reinforcement layers should be applied fresh on fresh and immediately impregnated with resin.

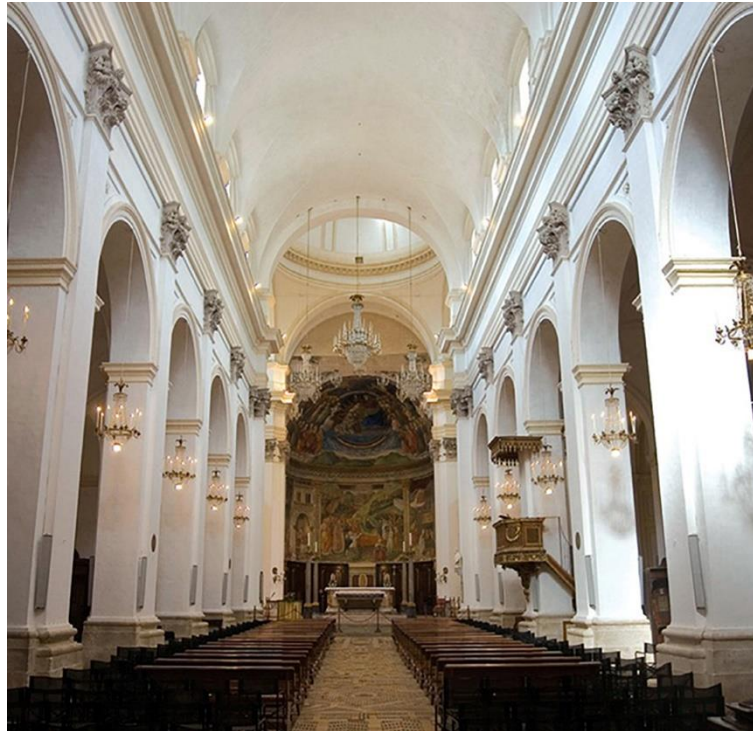
Thanks to this series of structural reinforced work, during the 2016 Amatrice-Norcia earthquake the Spoleto Cathedral has not suffered any damage confirming the seismic improvement achieved (**Figure 15**).

Figure 15. The interior of the Cathedral today after the safety work and after the 2016 Amatrice-Norcia earthquake.

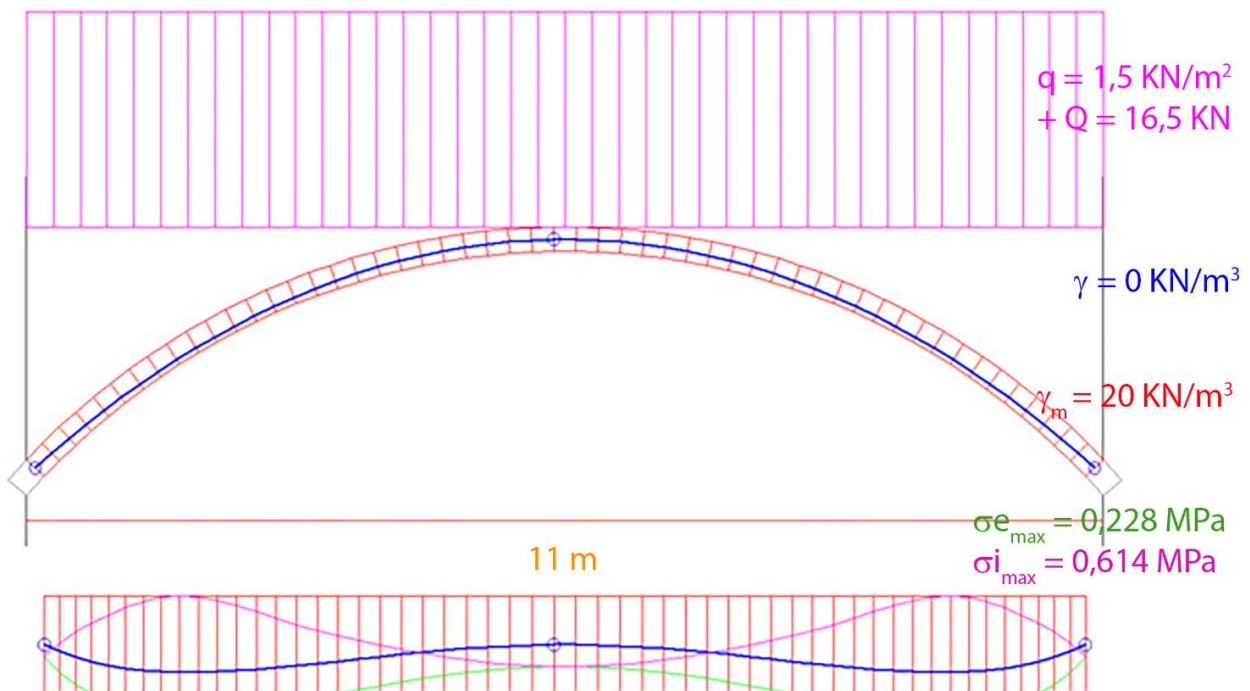
The analysis of the progress of the compression pressures on the vault of the Spoleto Cathedral (**Figure 16**) have been studied by tracing the behavior of the vault to that of an arch with a thickness equal to 25 cm and unit width of 1 meter. The span of the vault was 11 meters and the arrow was 2,5 meters. The mechanical characteristics of the masonry were as follows from the

Circolare 09/02/2009^[9], divided by the confidence coefficient 1,35 relative to a limited level of knowledge of the structure, as suggest by the Italian Technical Codes:

$$f_d = 2,40/1,35 = 1,78 \text{ MPa}$$

$$\tau_{0d} = 0,06 / 1,35 = 0,04 \text{ MPa}$$

Figure 16. Pre-strengthening analysis of the masonry vault in Spoleto Cathedral.

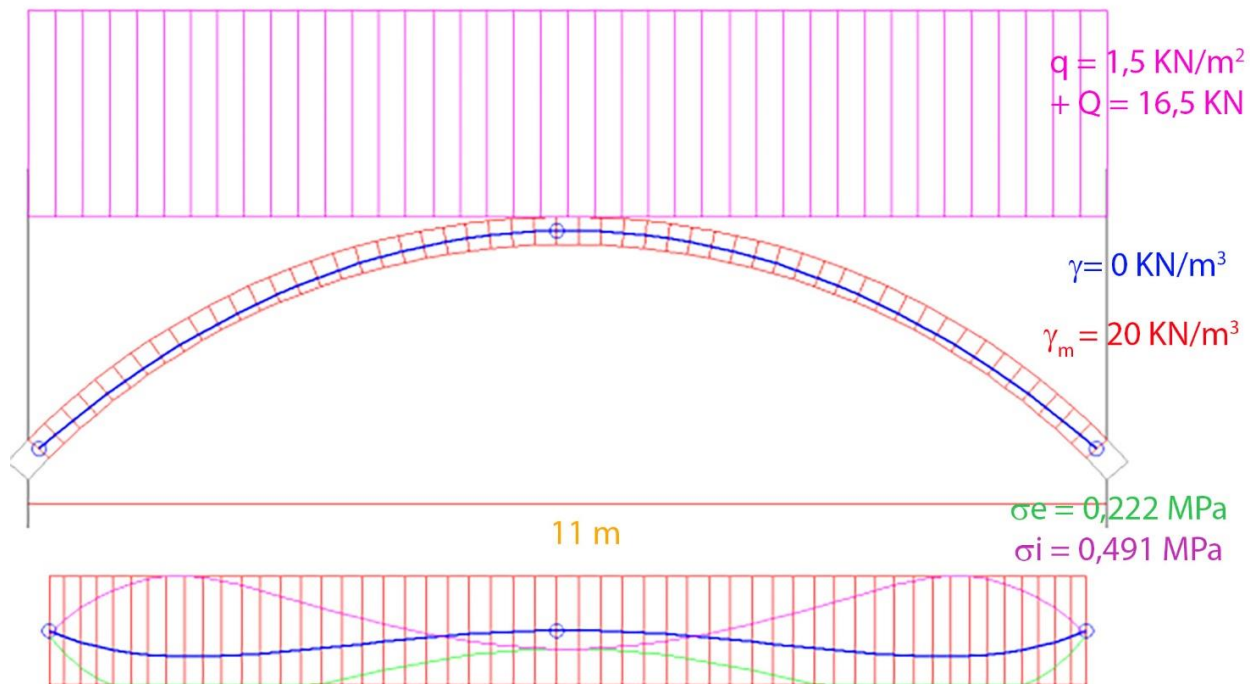
In the case of the reinforced vault, it can be seen that the center of the pressures tended to be more internal to the section and therefore the stresses were more reduced (Figure 17).

Figure 17. Strengthening analysis of the reinforced masonry vault in Spoleto Cathedral.
