Mud House Failures and Mitigation Options in Bauchi, North East Nigeria

¹Emmanuel Ndububa and ²Ahmed Mukaddas

¹Department of Civil Engineering, University of Abuja, P.M.B 117, Abuja, Nigeria

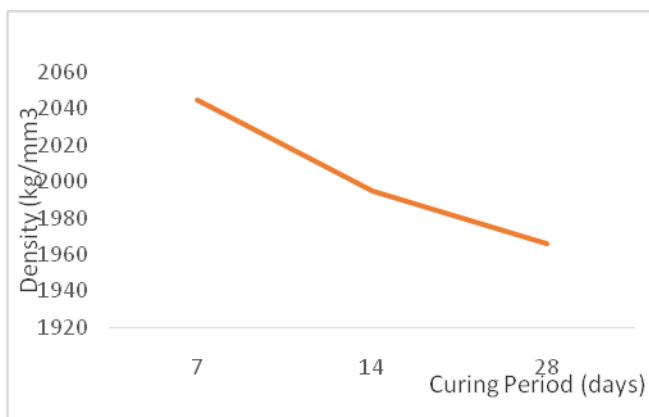
Fig. 1. Density of PMB cubes

Figures 1 and 2 show the results of the density and

compressive strength tests on bricks molded from earth collected from the borrow pits. The 28day density and compressive strengths were 1966 Kg/mm³ and 0.81N/mm² respectively. The result for density shows that the cubes reduced in density by 4% between the 7 and 28days of curing and that made the walls lighter each passing day. The compressive strength as expected increased with age, though the values were inadequate for load bearing. The minimum specified value for sandcrete blocks in Nigeria is 2.5 N/mm² (NSO, 1975).
