## **New Point Comfort Lighthouse Mathews, Virginia Site Assessment Plan**

New Point  
Comfort  
Lighthouse  
Mathews, Virginia

Site Assessment Plan

**February 2008**

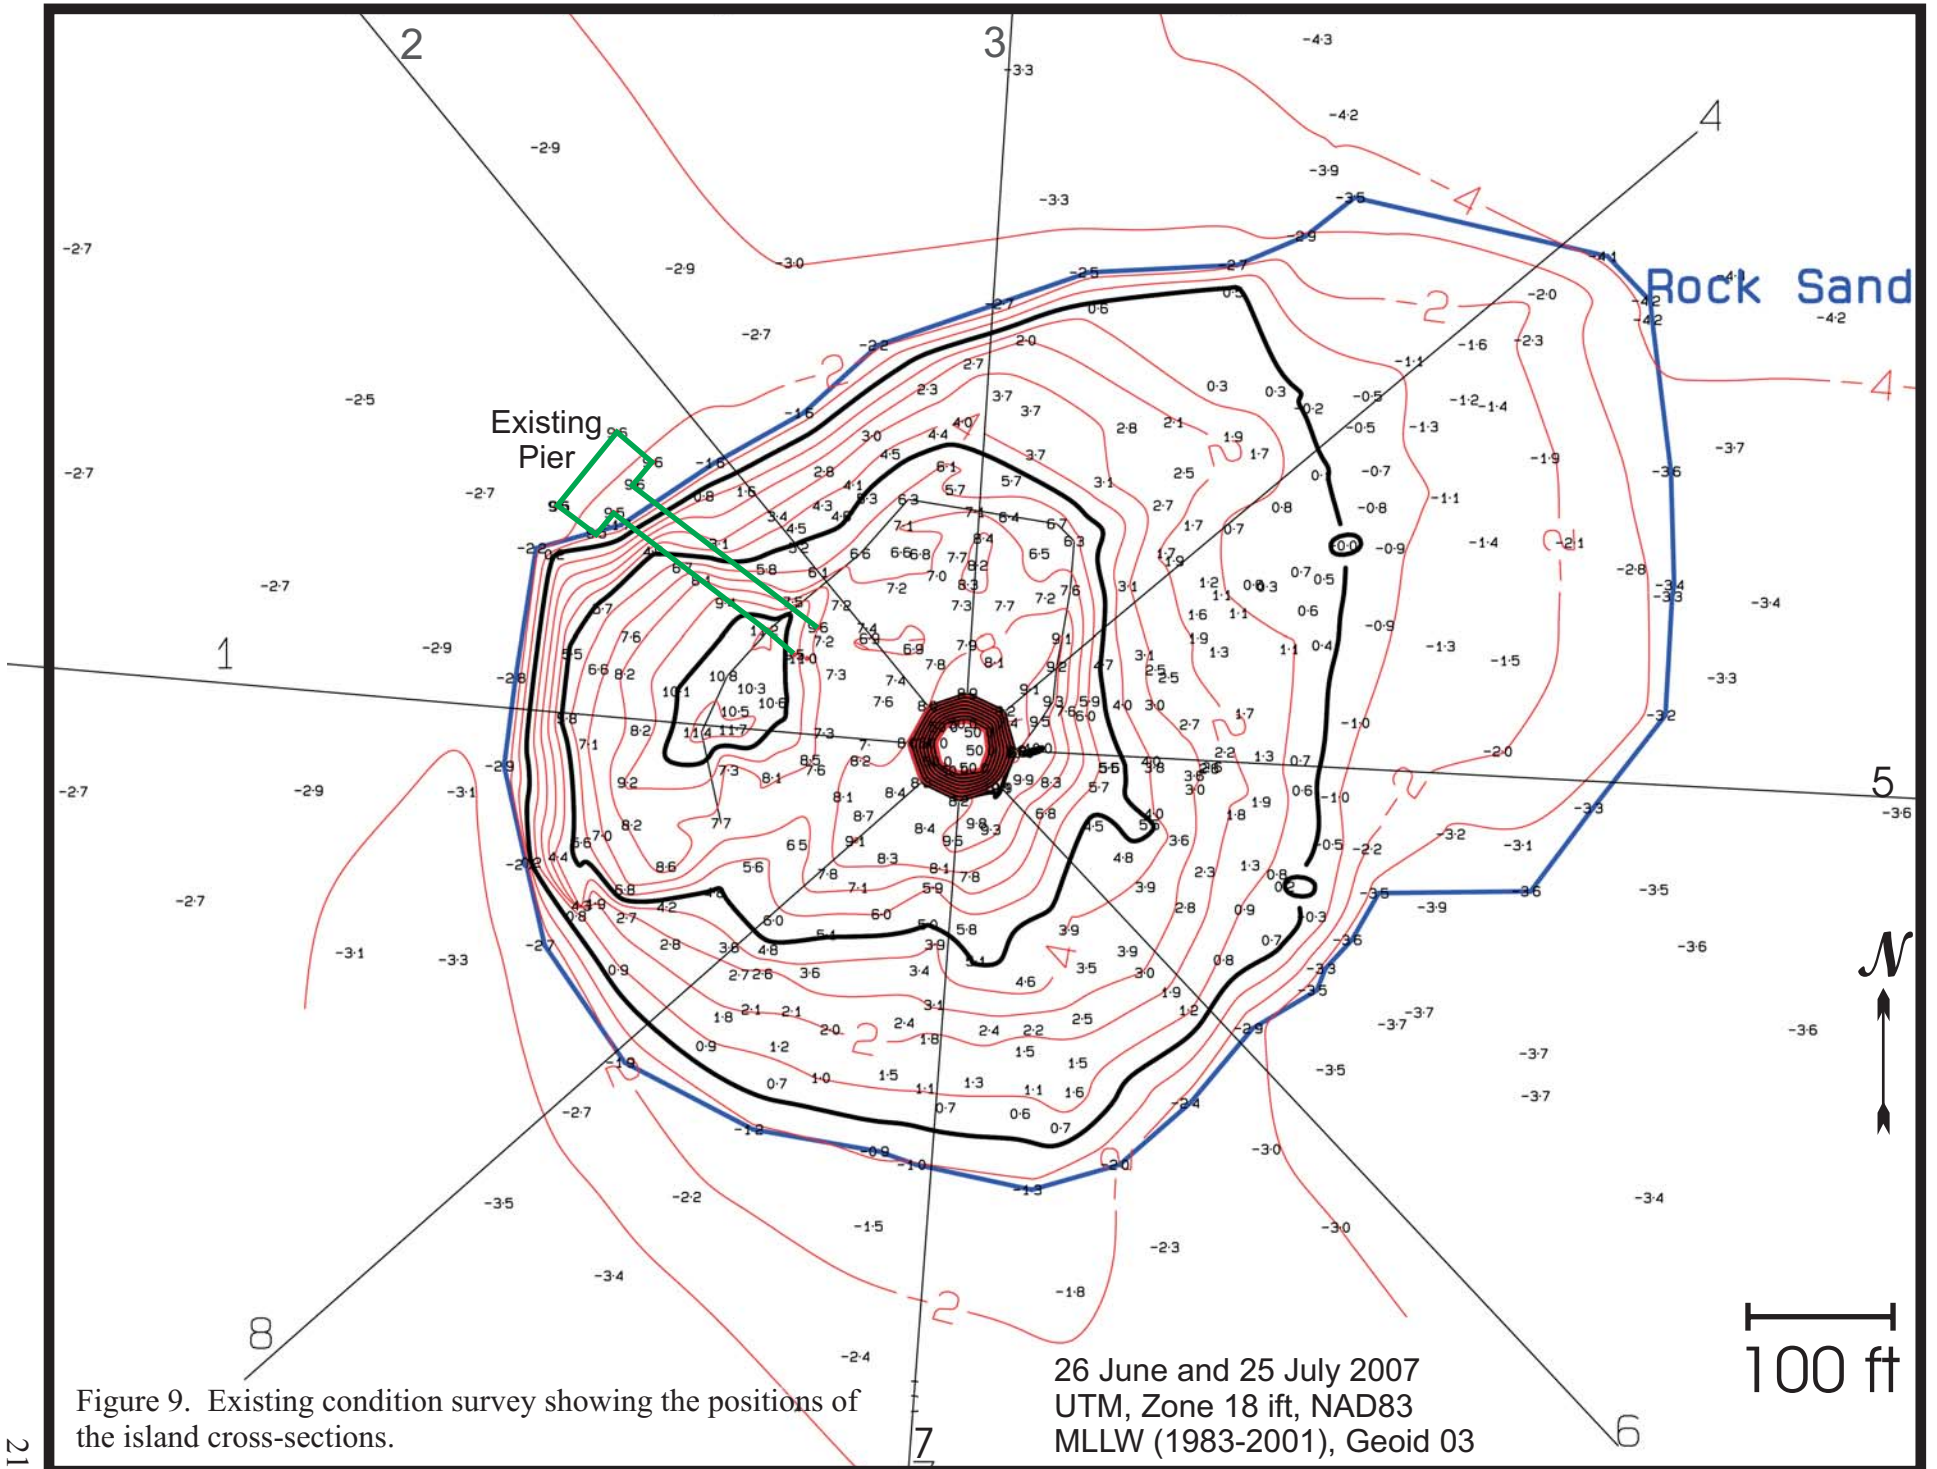
The topographic and nearshore survey showed the scattering of the original revetment's rock around the island as indicated by the blue "Rock Sand" line on the survey (Figure 9). In general, the rock extends to the northeast indicating that larger waves which can move the rock impact this side of the island. The water is shallower on the south and west and deeper on the north and east sides of the island which allows larger waves closer to the shore. Figures 10-12 show cross-sections of the survey data at each corner of the lighthouse. They show the extent of the rock along the profile. Along most of the profiles, the rocks of the old revetment have been rearranged so that they extend from below MLW to the base of the lighthouse. Only profiles 1 and 2 on the west and northwest side of the lighthouse have not had the rocks pushed up against the base of the lighthouse.

Figure 9. Existing condition survey showing the positions of the island cross-sections.

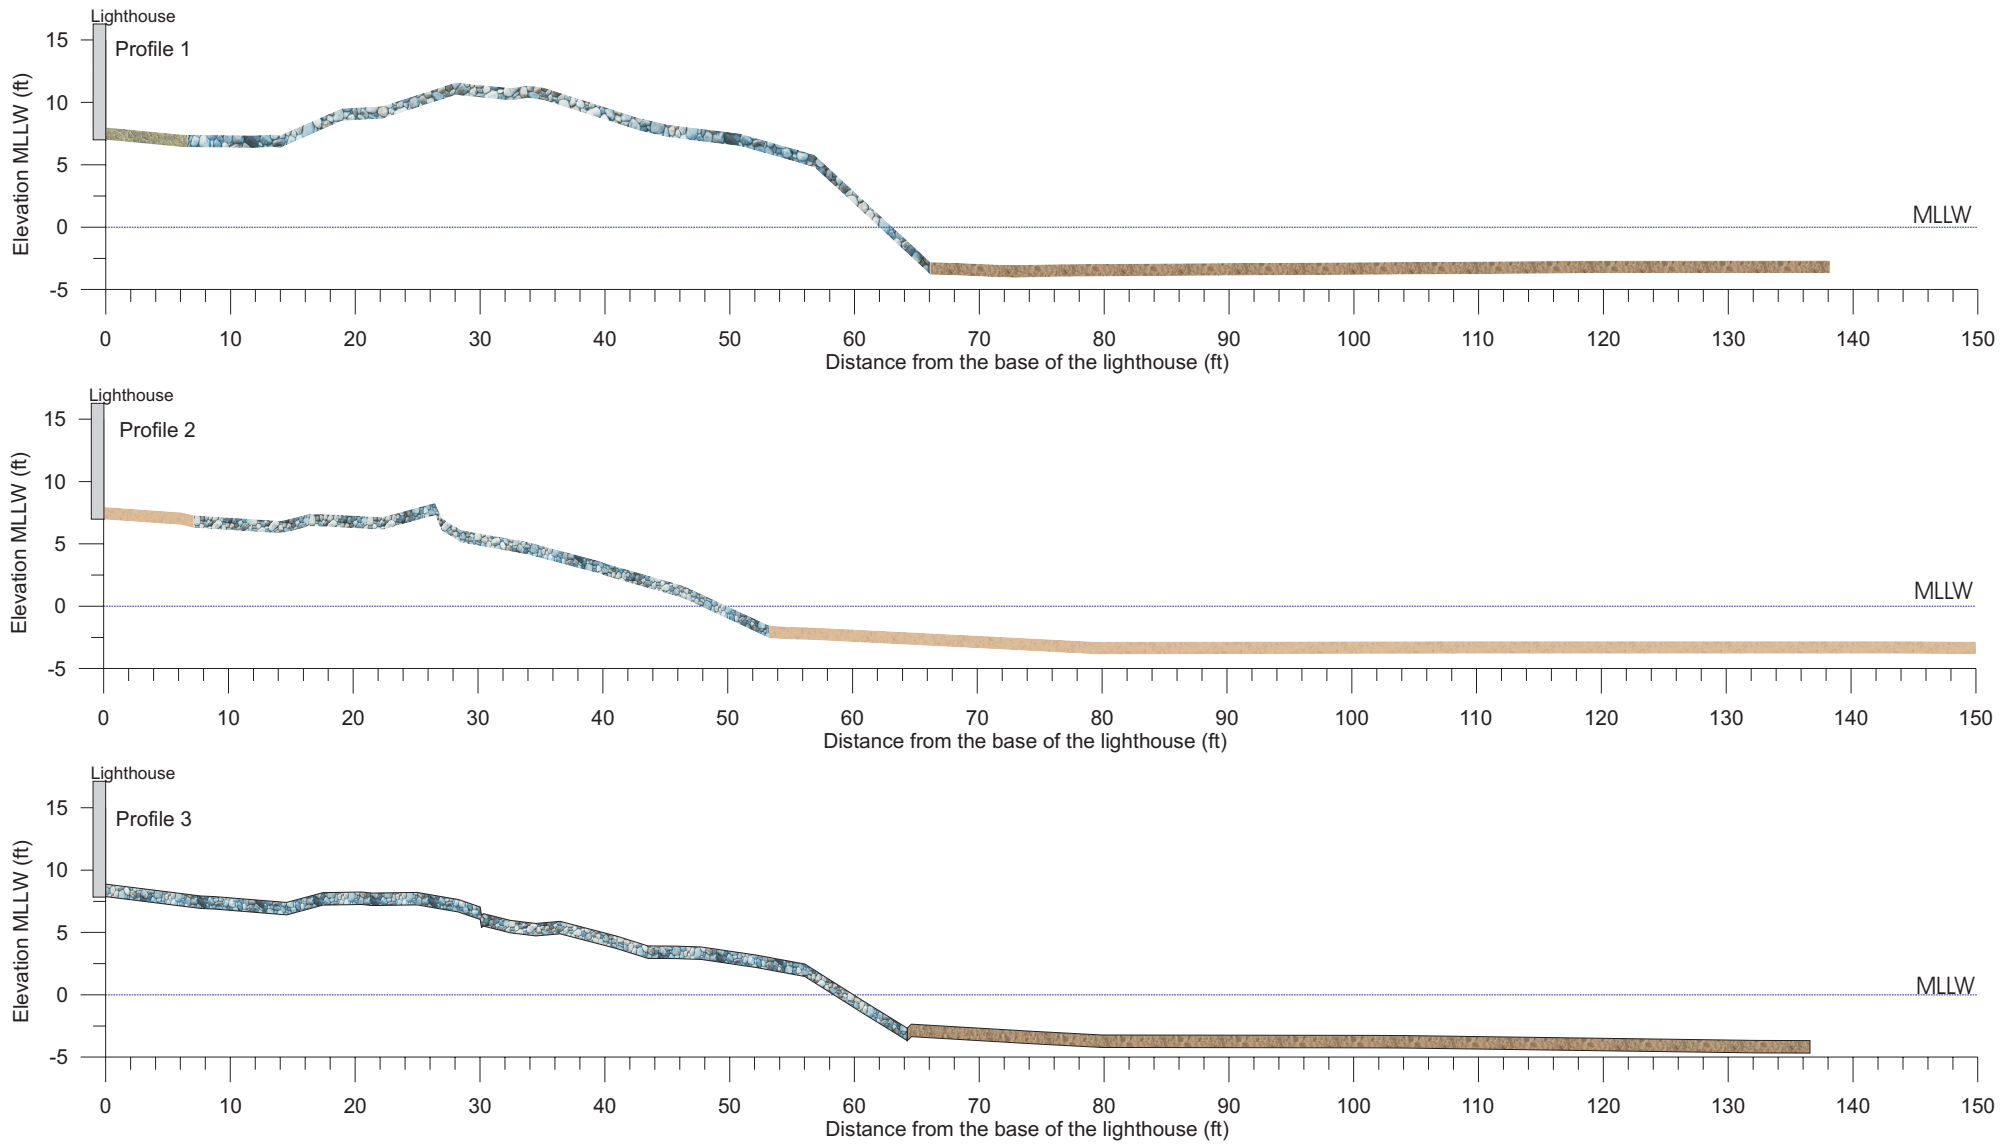
Figure 10. Cross-sections 1 through 3 of the island using the survey data taken in the summer of 2007. The extent of the rock is shown on the profile. Cross-section location is shown on Figure 9.

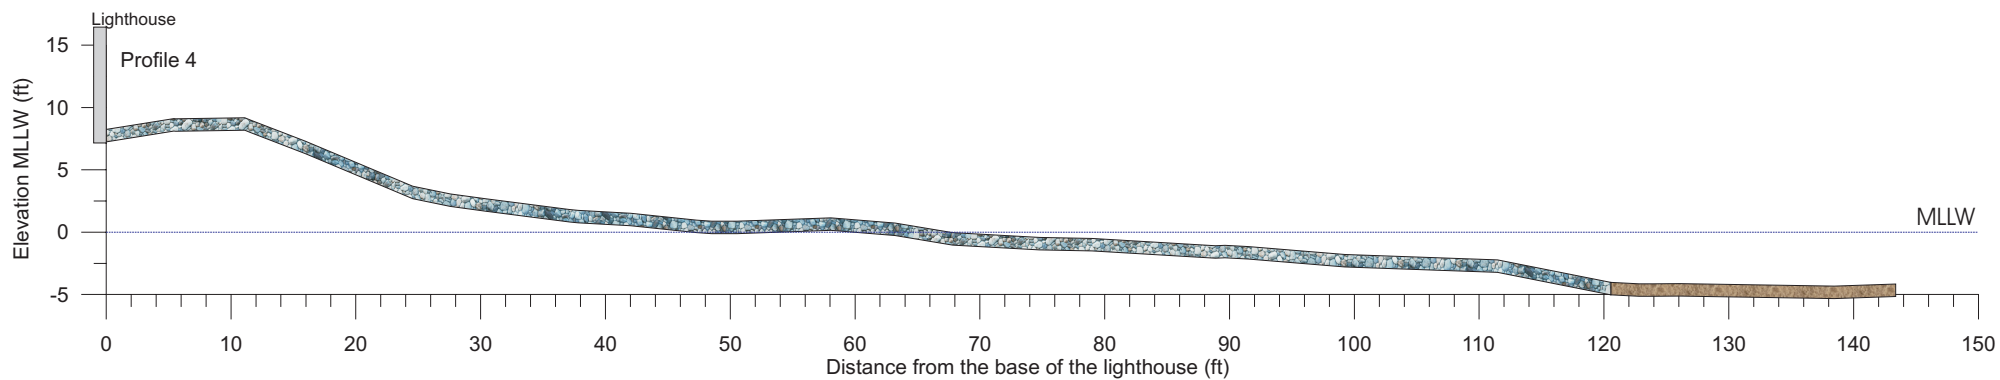
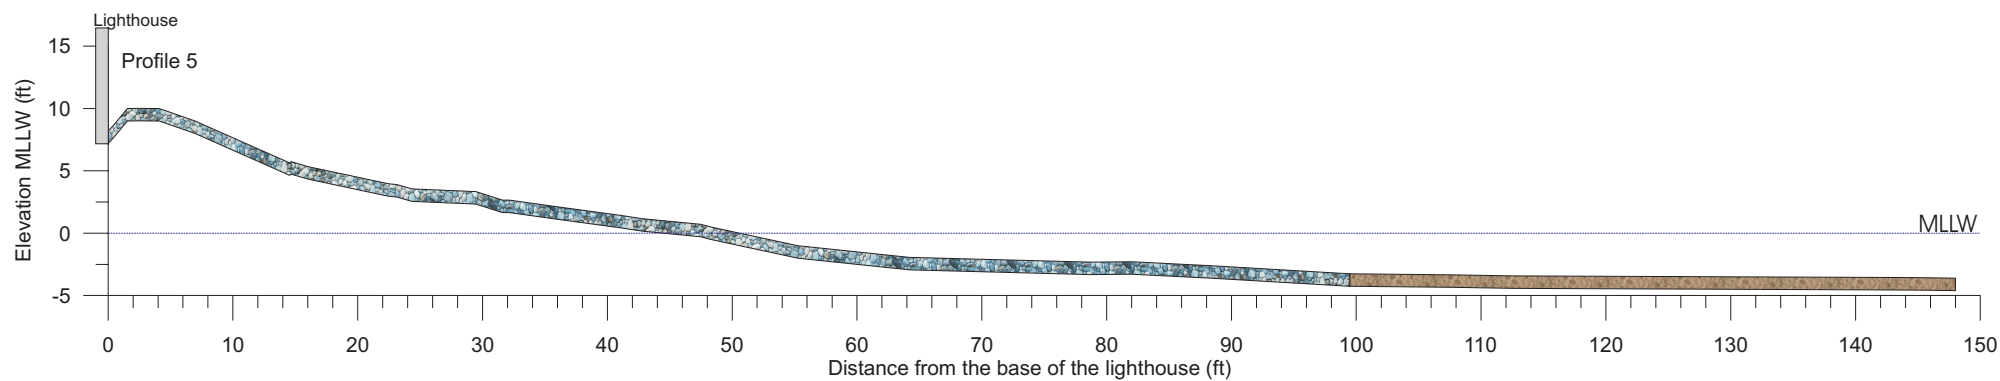
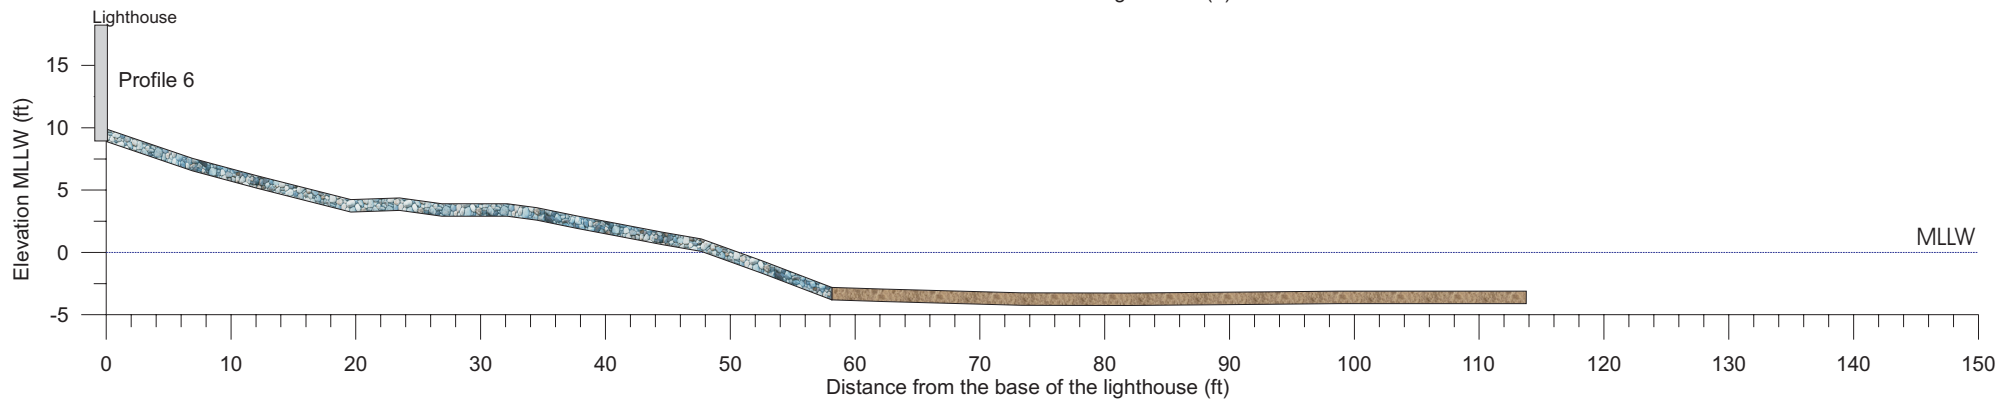
Figure 11. Cross-sections 4 through 6 of the island using the survey data taken in the summer of 2007. The extent of the rock is shown on the profile. Cross-section location is shown on Figure 9.

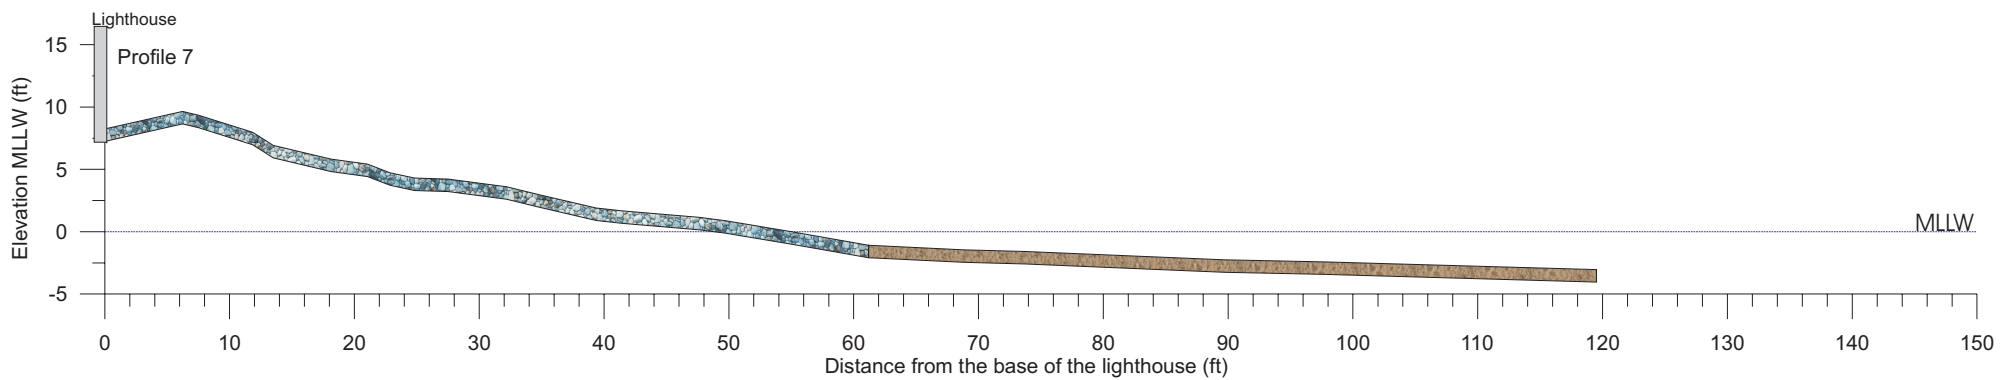
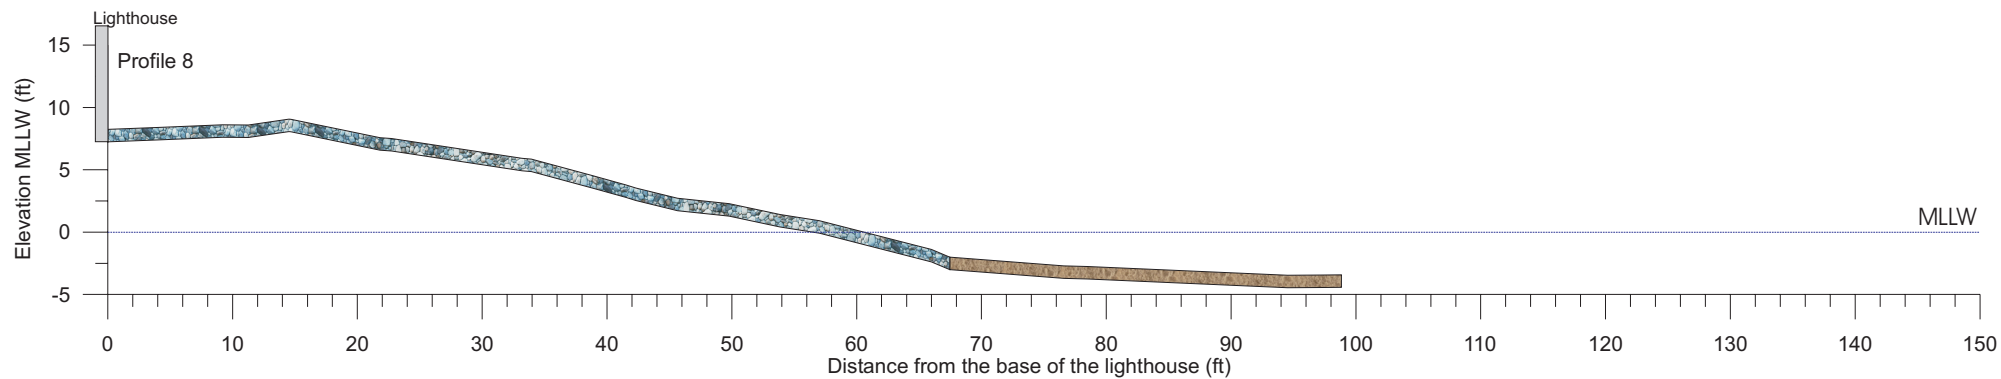
Figure 12. Cross-sections 7 and 8 of the island using the survey data taken in the summer of 2007. The extent of the rock is shown on the profile. Cross-section location is shown on Figure 9.

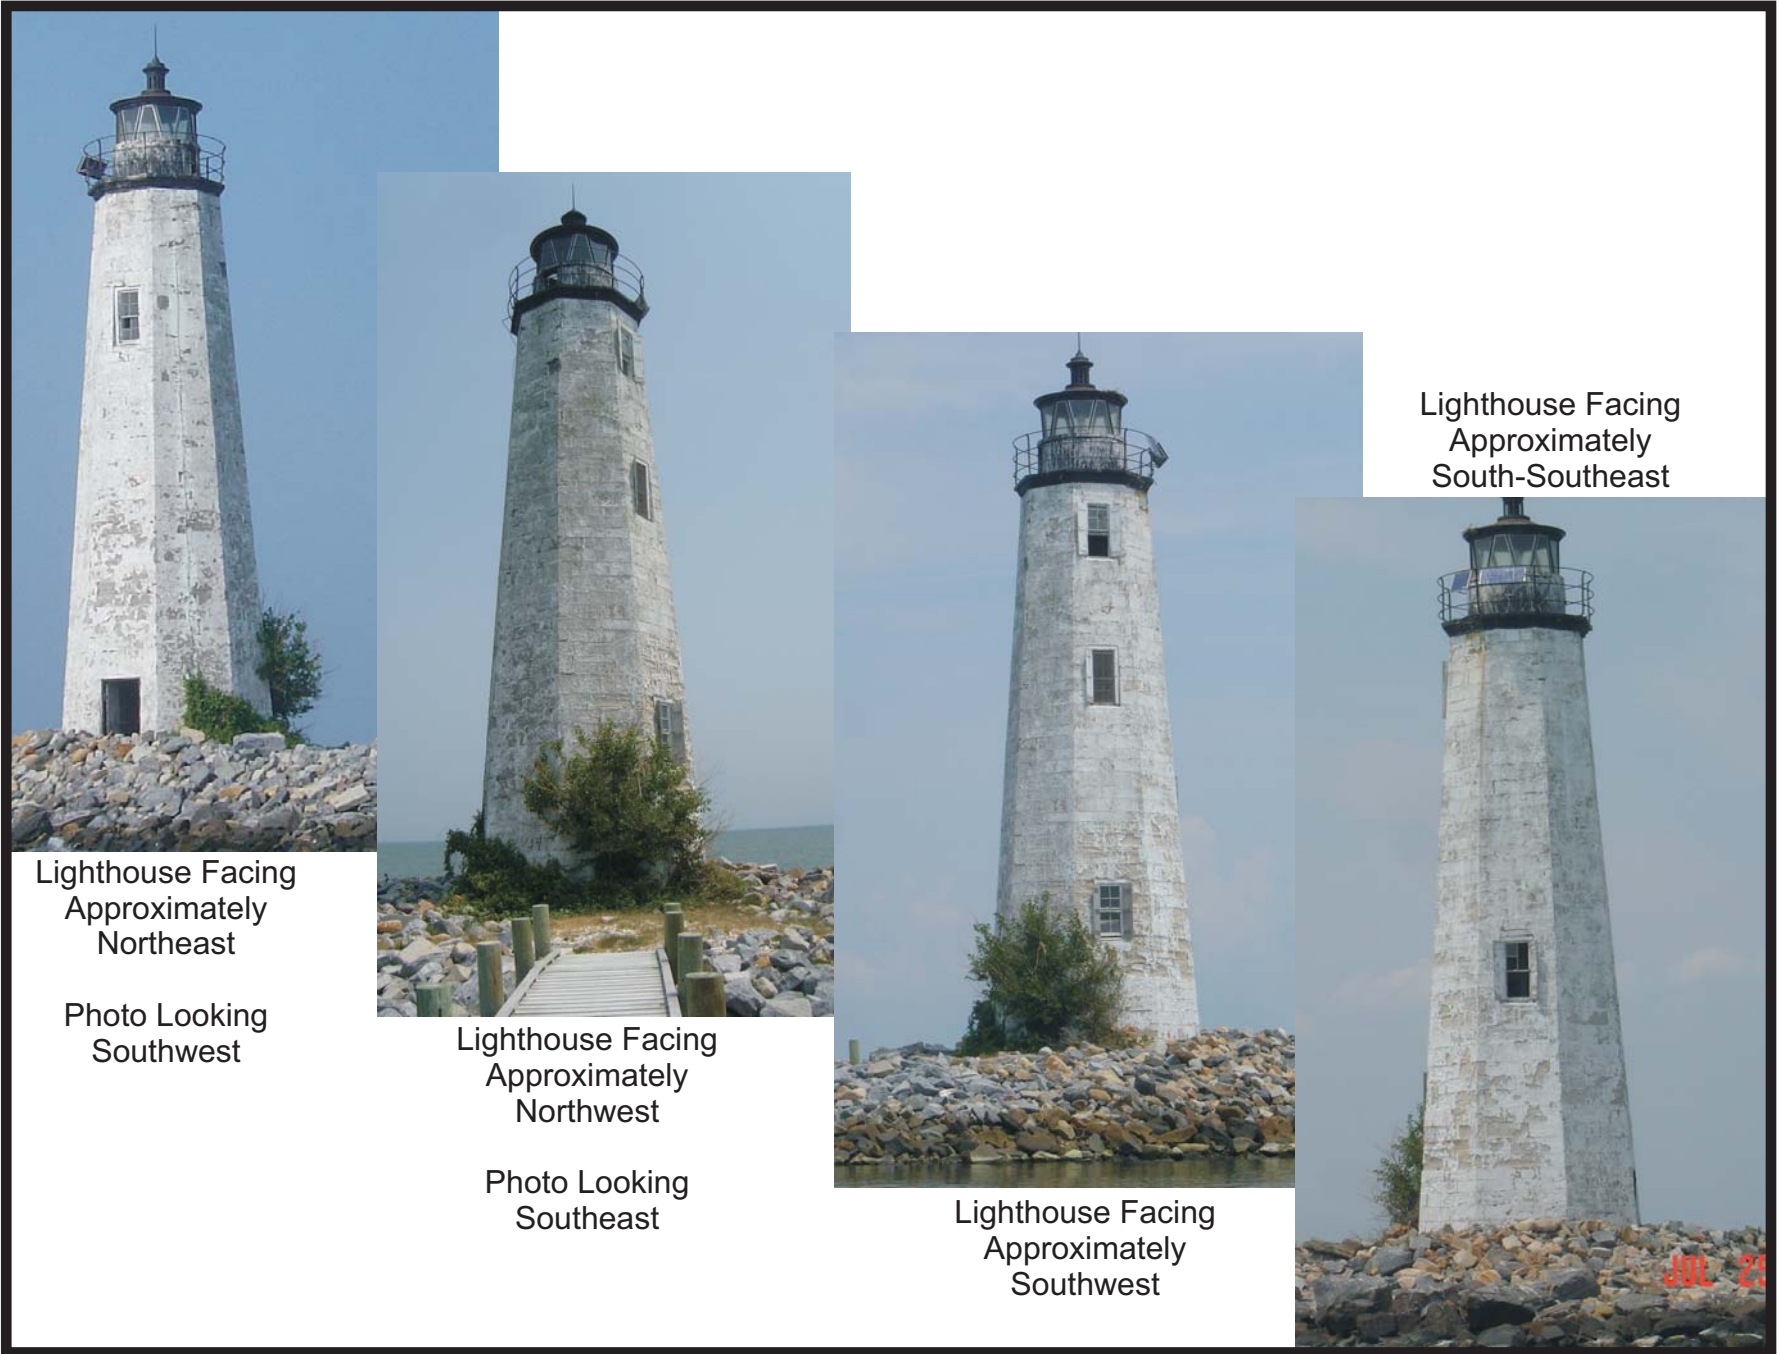
The lighthouse, itself, is being impacted by the elements. Being exposed to the elements due to peeling paint and broken windows and doors, the sandstone structure is eroding. Figure 13 shows that all sides of the lighthouse are in need of repair. The door to the structure is open (Figure 14) allowing the elements to cause interior deterioration (Figure 15). Figure 16 depicts the state of the outside of the lighthouse. Peeling paint threatens the integrity of the sandstone structure. The sandstone is being worn away and mortar between the joints is being eroded.

Figure 13. Photos of the lighthouse from all sides. The photo in the upper left is dated 26 June 2007. The others were taken on 25 July 2007.

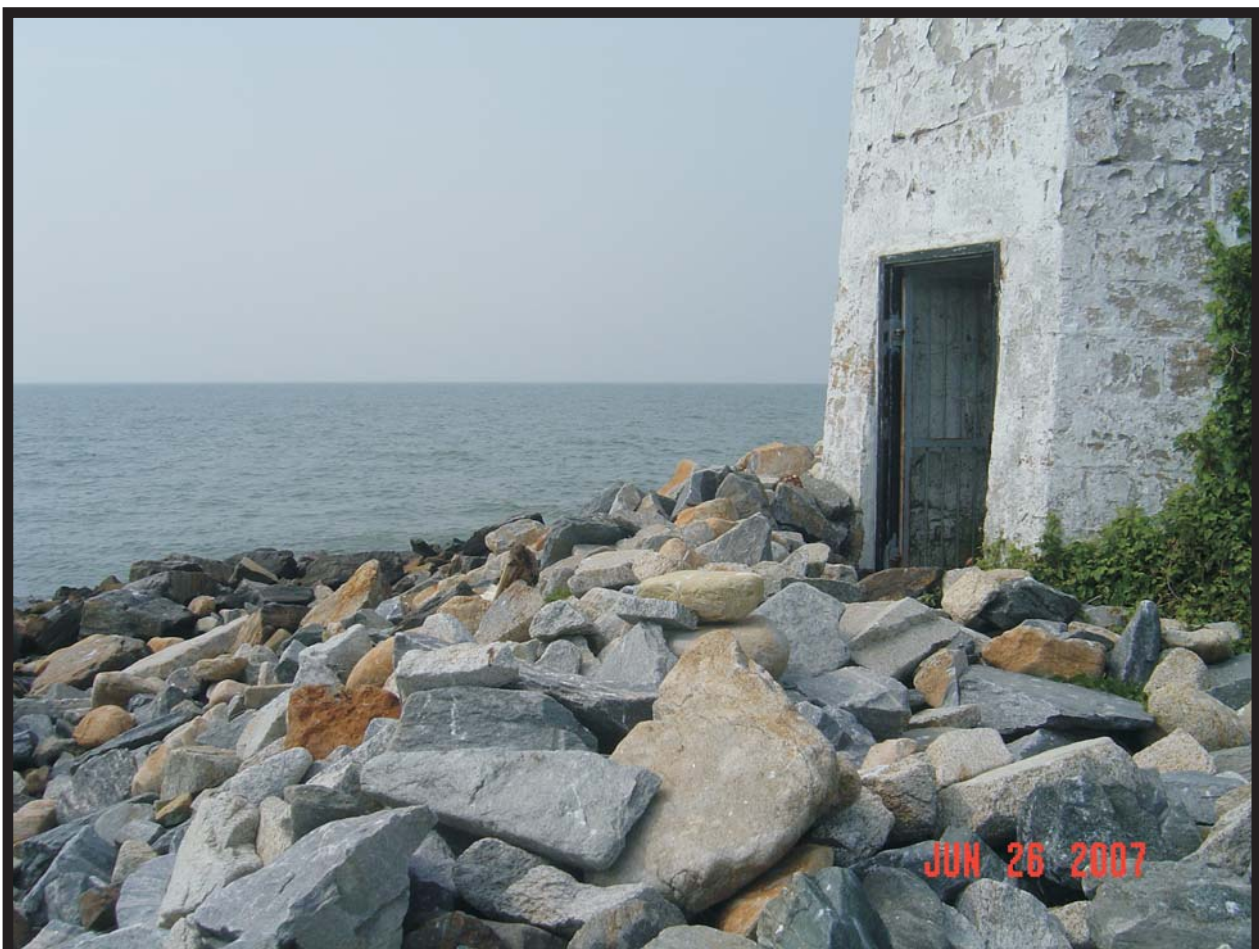
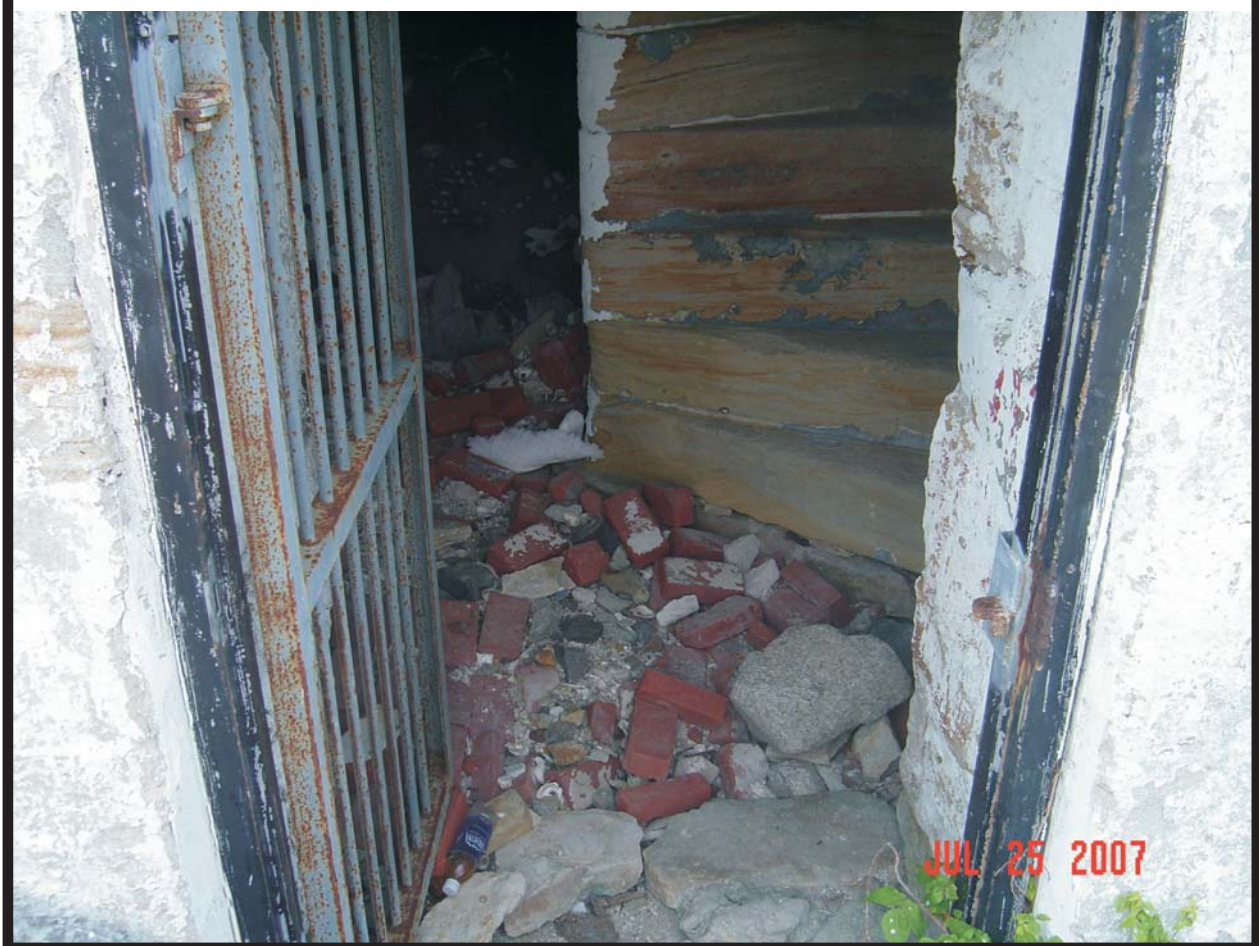
Figure 14. The door to the lighthouse is open exposing the interior to the elements and wildlife.

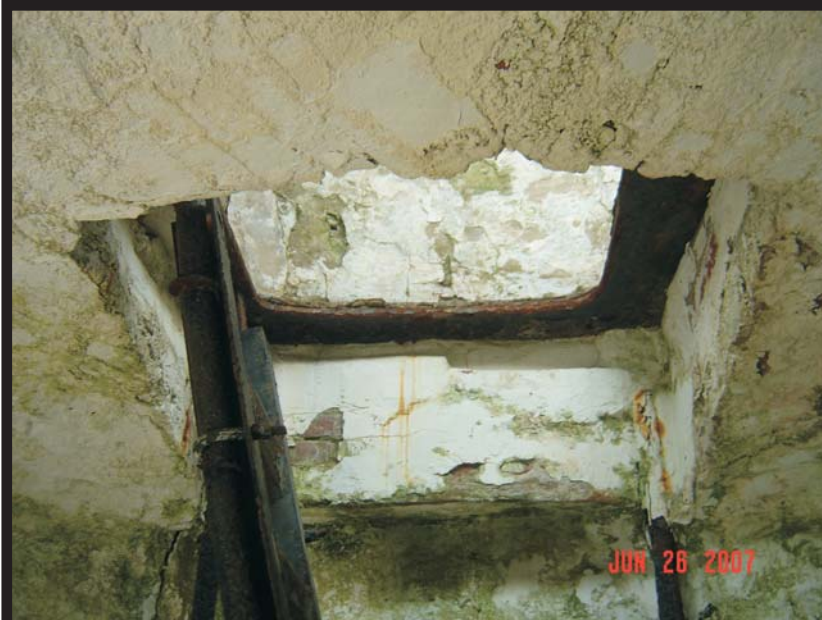
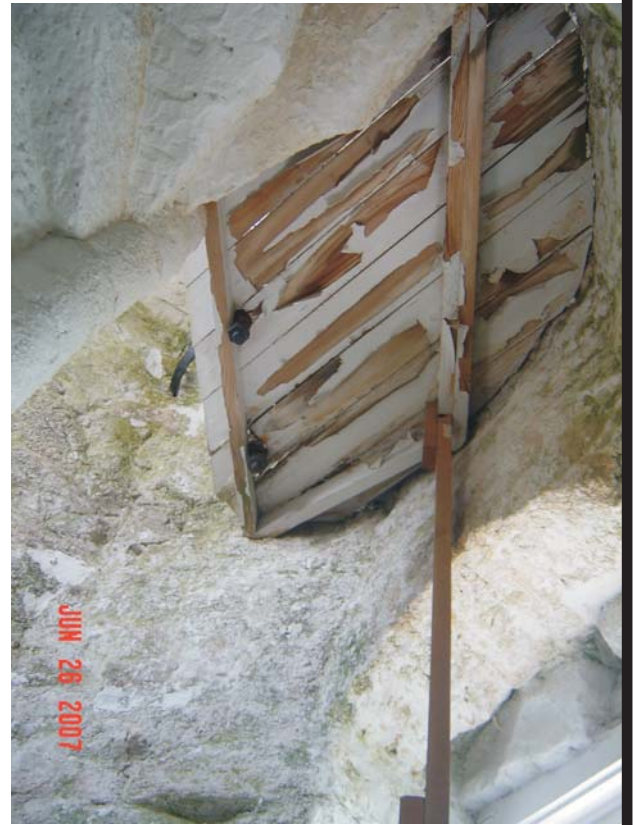
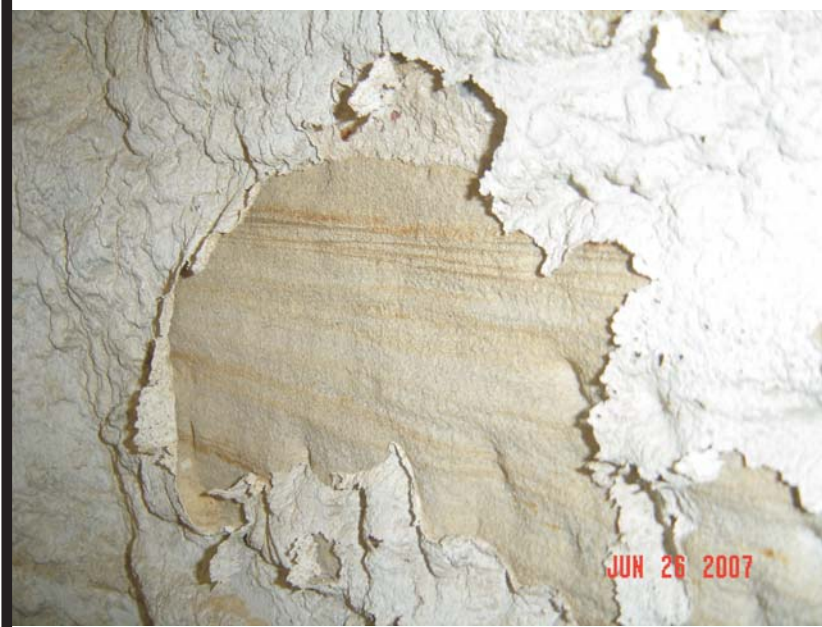
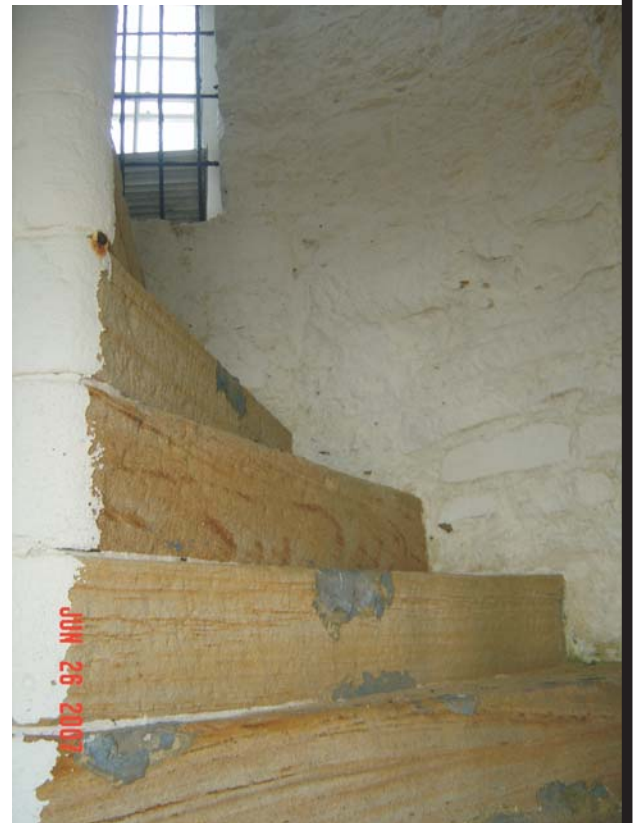
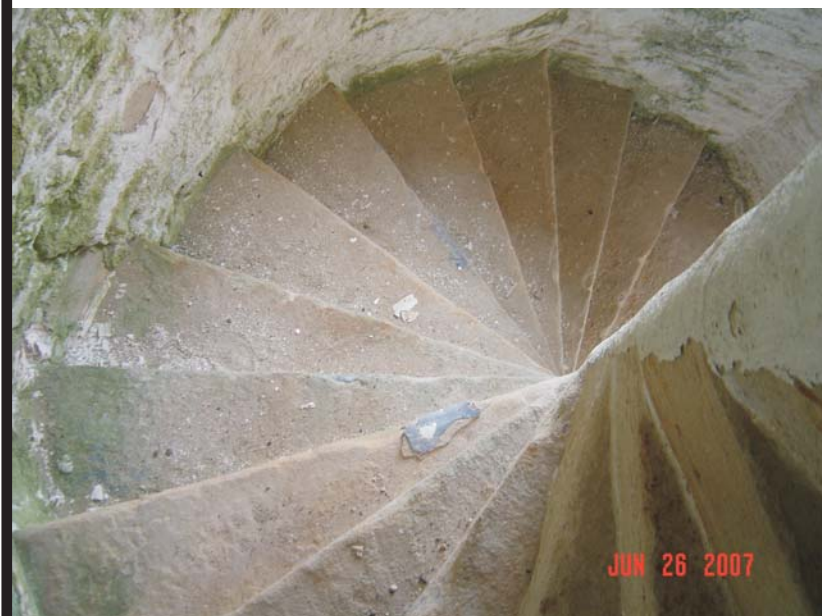
Figure 15. Photos depicting the present state of the interior of the lighthouse. The sandstone steps are exposed to the elements and eroding. The upper level platform is only being held up by a 2x4.

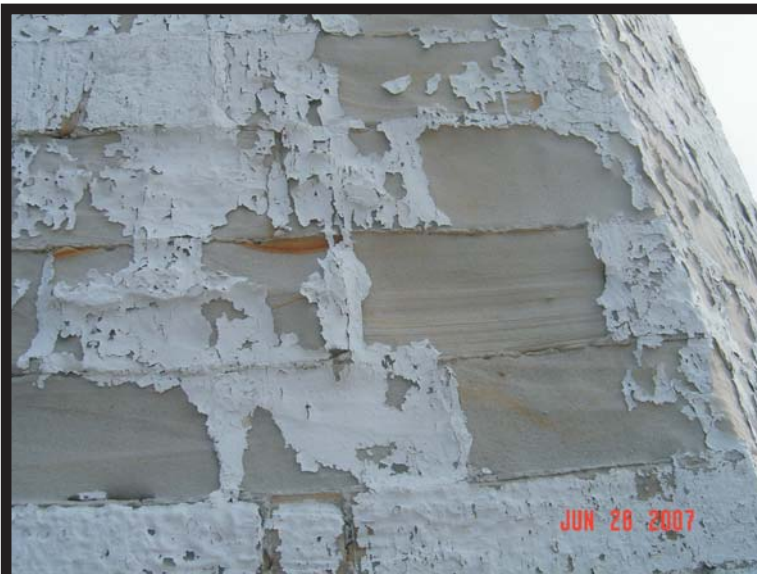
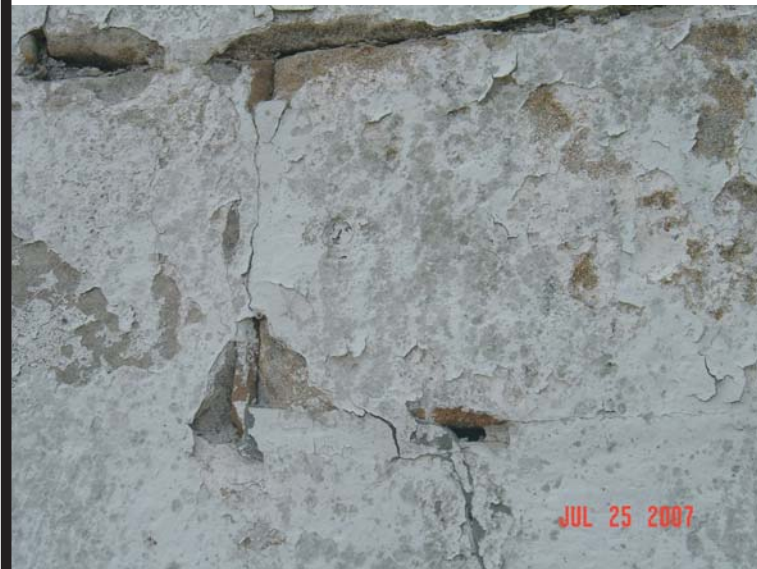
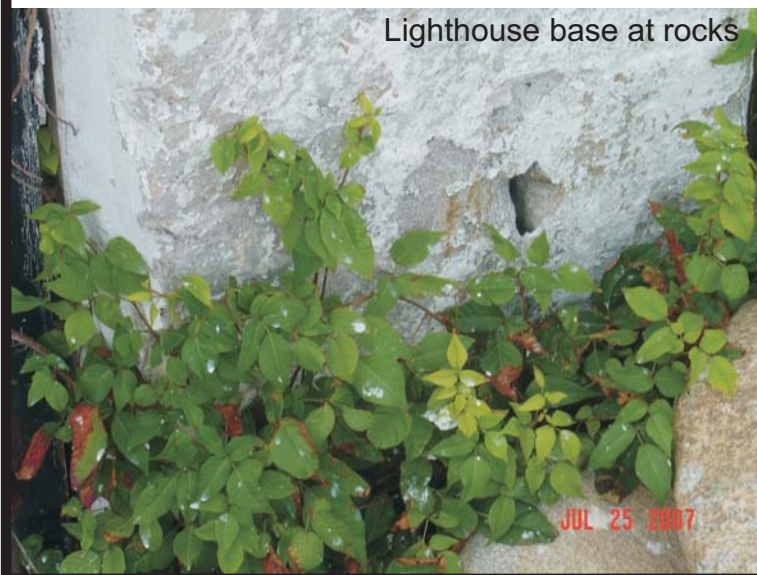
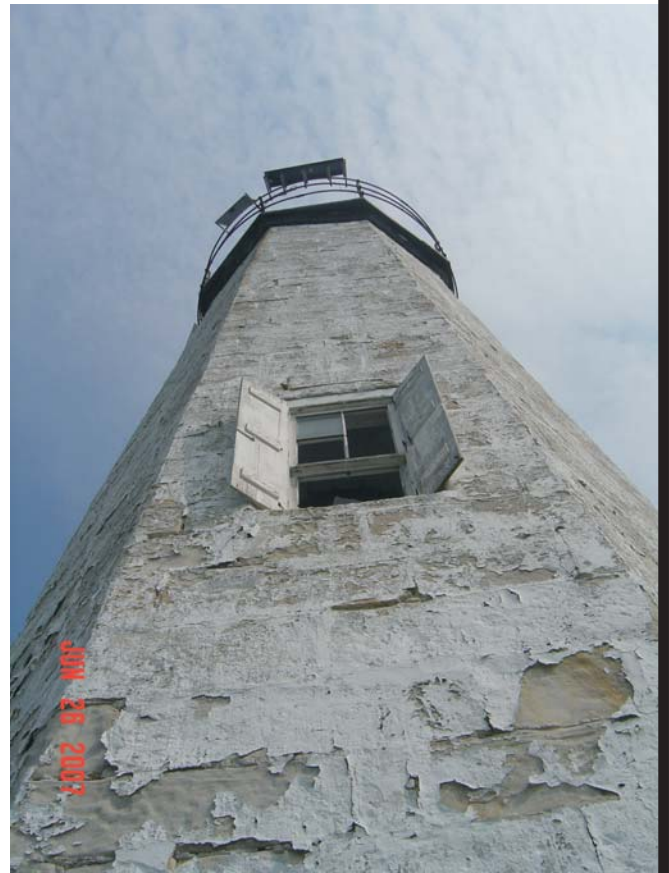
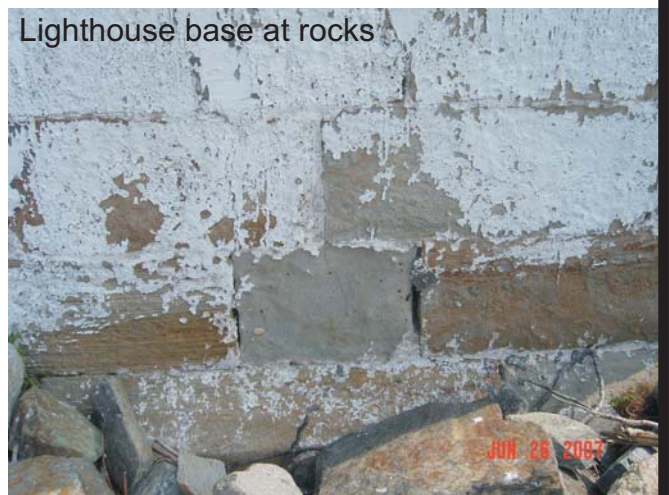
Figure 16. Damage to the structure is occurring due to the elements. Peeling and chipping paint, vegetation, and broken windows is exposing the soft sandstone structure and damaging the mortar joints.

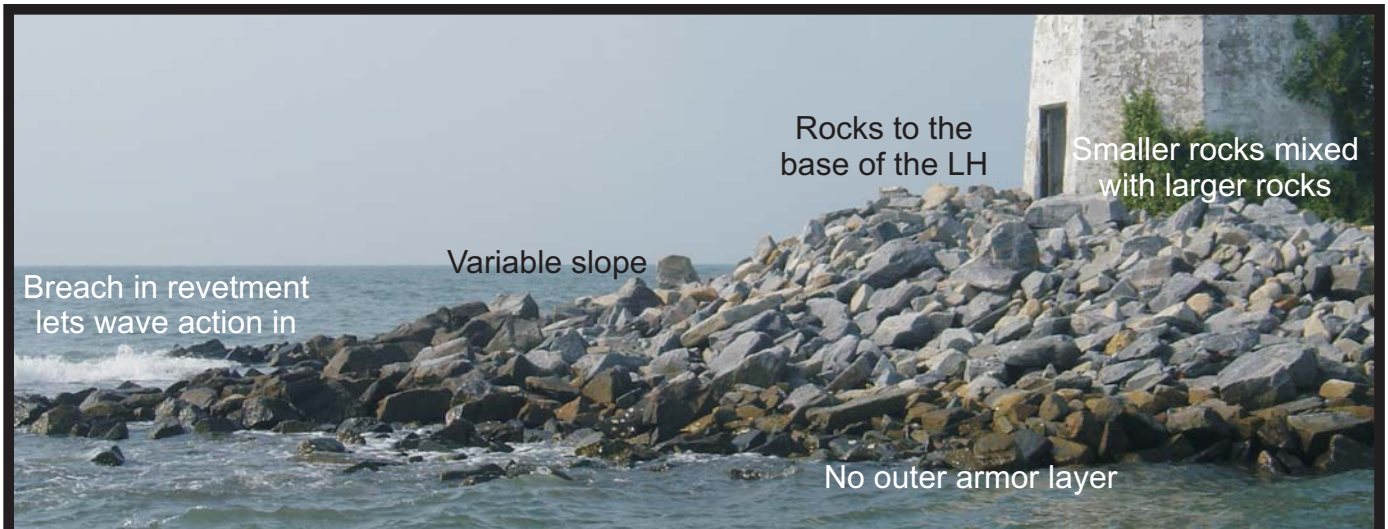
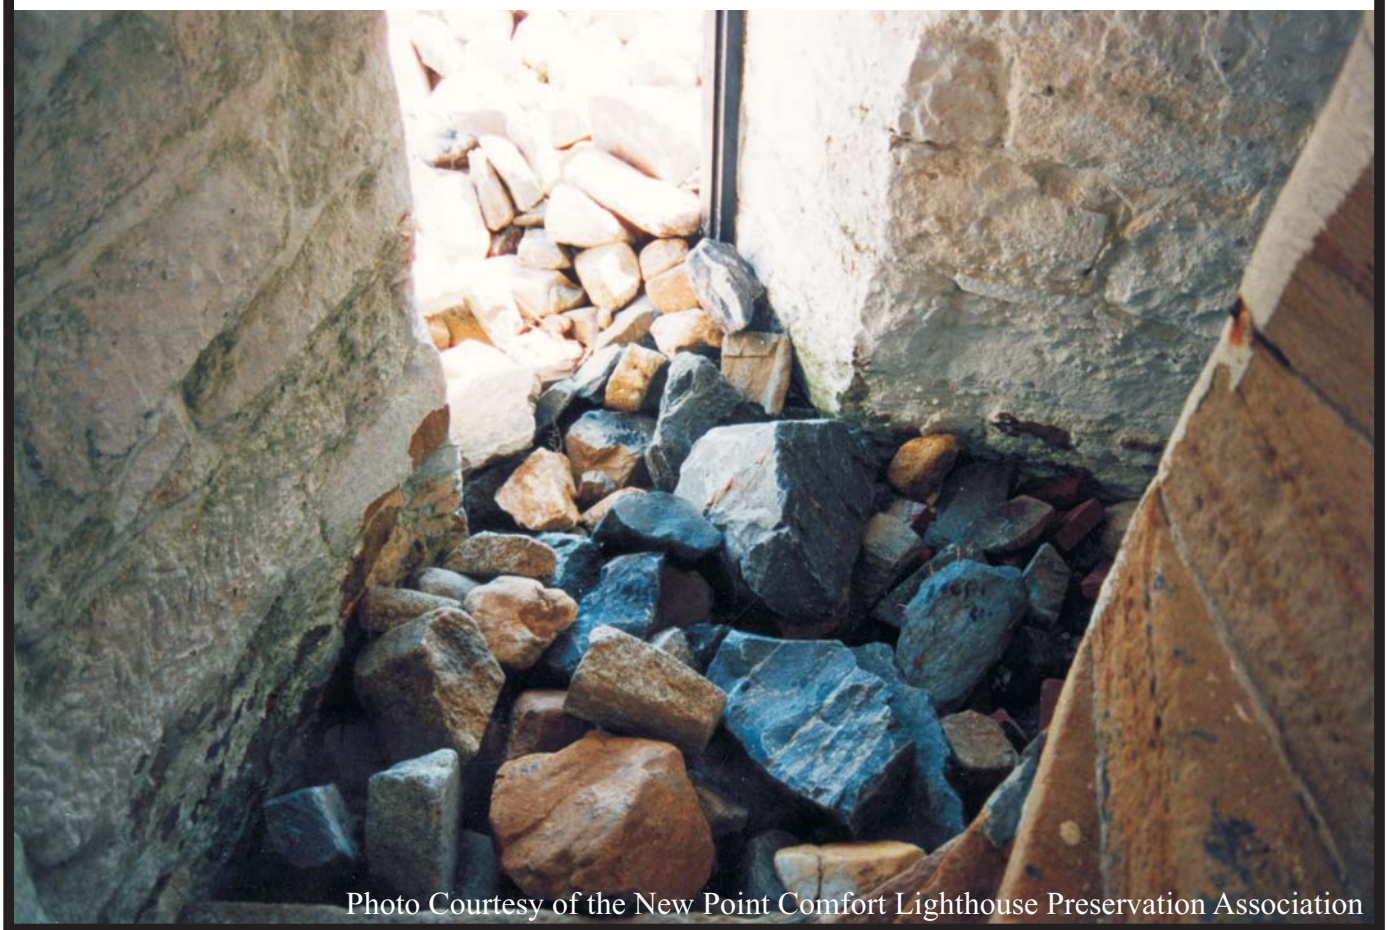
Previous research has identified the causes of instability of the island on which New Point Comfort Lighthouse sits as well as provided plans for its stabilization. In general, McKay (2003) rated the present rock revetment around the lighthouse as "poor to grave" and susceptible to a large storm event (Figure 21). He predicted that a large storm event would push the undersized rocks at the crest of the revetment into the walls of the lighthouse. This occurred during Hurricane Isabel which impacted the region on September 18, 2003 (Figure 21) as a minimal category 1 storm. As part of his report, McKay (2003) developed several alternative plans but also made a recommended core course of action (Figure 22). His plan consists of a 50 ft level, open surface around the base of the lighthouse, a proper rock revetment 50 ft wide and a crest elevation of +10.5 ft with at least two grades of rock, geotextile fabric, and an embedded toe to guard against undermining, a parapet wall cast into the crest of the revetment, and a new pier. McKay (2003) noted that this core plan, which was estimated to cost just over \$1 million, would stand alone as primary protection for the lighthouse but will also be compatible with future phases, should they occur.

Figure 21. Photo illustrating the present rock revetment's deficiency's and a photo showing how many of the smaller rocks on the island were pushed into the lighthouse during Hurricane Isabel (18 Sep 2003).

The plan that resulted from our research efforts are similar to those proposed by McKay (2003). Several variations resulted from a new wave climate information (Hurricane Isabel) and modeling. Figure 24 shows the revetment that will surround the island, and its dimensions are shown in Figure 25. The revetment is proposed to follow the outline of the lighthouse itself being an octagon rather than round. This is mostly for aesthetic reasons and visual interest. The footpath or open level surface around the entire perimeter of the lighthouse is 20 ft wide, reduced in width from McKay's (2003) plan, but sand fill is required. The revetment will be built on a 2:1 slope and is 46 ft wide, extending 66 ft out from the lighthouse. The crest elevation is +12.5 ft MLLW. The rock size for the armor layer needs to have a  $D_{50}$  of 3,700 lbs. The rocks from the existing revetment can be reused in the bedding and armor layers of the proposed revetment.

This plan results from new understanding of wave climate due to recent storm activity. A storm surge of over 8 ft MLLW was documented during what's been called a 100-yr event (Hurricane Isabel). However, Isabel was only a minimal category 1 hurricane and since it occurred, three additional storm events caused surges of around 6 ft MLLW. In addition, sea level rise is continuing in the lower portion of the Bay. In order to maintain long-term protection, it was deemed necessary to raise the elevation of the revetment. The final design may modify this plan and will include a new access pier.
