## **New Point Comfort Lighthouse Mathews, Virginia Site Assessment Plan**

New Point  
Comfort  
Lighthouse  
Mathews, Virginia

Site Assessment Plan

**February 2008**

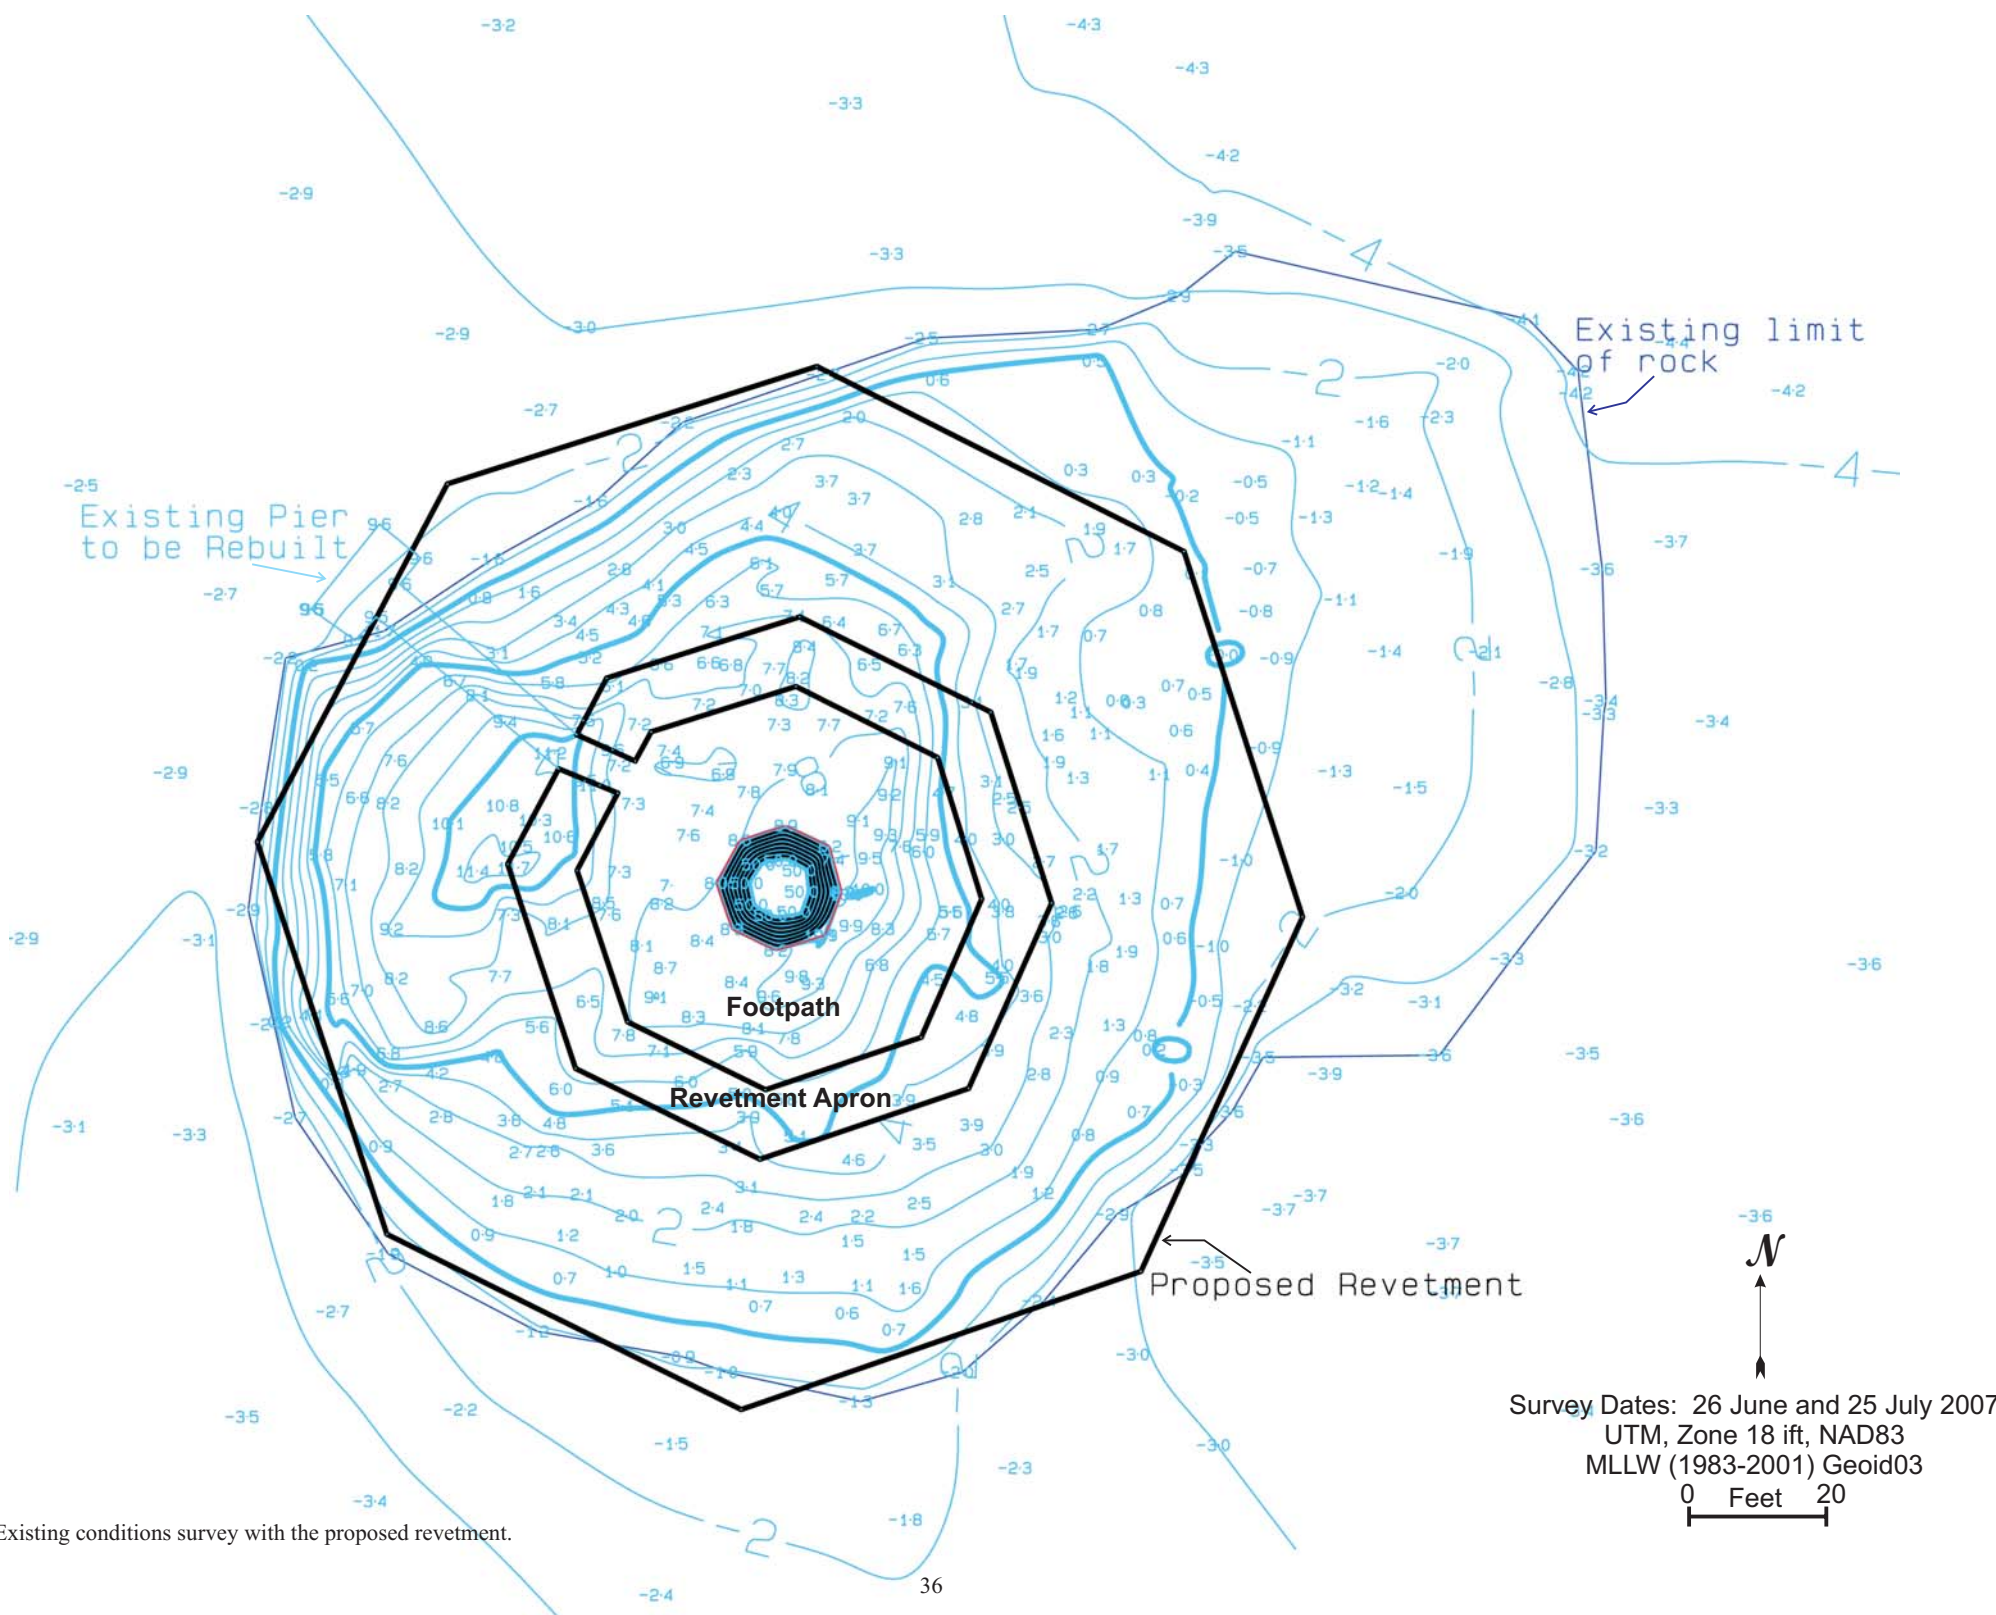
Figure 24. Existing conditions survey with the proposed revetment.

The plan that resulted from our research efforts are similar to those proposed by McKay (2003). Several variations resulted from a new wave climate information (Hurricane Isabel) and modeling. Figure 24 shows the revetment that will surround the island, and its dimensions are shown in Figure 25. The revetment is proposed to follow the outline of the lighthouse itself being an octagon rather than round. This is mostly for aesthetic reasons and visual interest. The footpath or open level surface around the entire perimeter of the lighthouse is 20 ft wide, reduced in width from McKay's (2003) plan, but sand fill is required. The revetment will be built on a 2:1 slope and is 46 ft wide, extending 66 ft out from the lighthouse. The crest elevation is +12.5 ft MLLW. The rock size for the armor layer needs to have a  $D_{50}$  of 3,700 lbs. The rocks from the existing revetment can be reused in the bedding and armor layers of the proposed revetment.

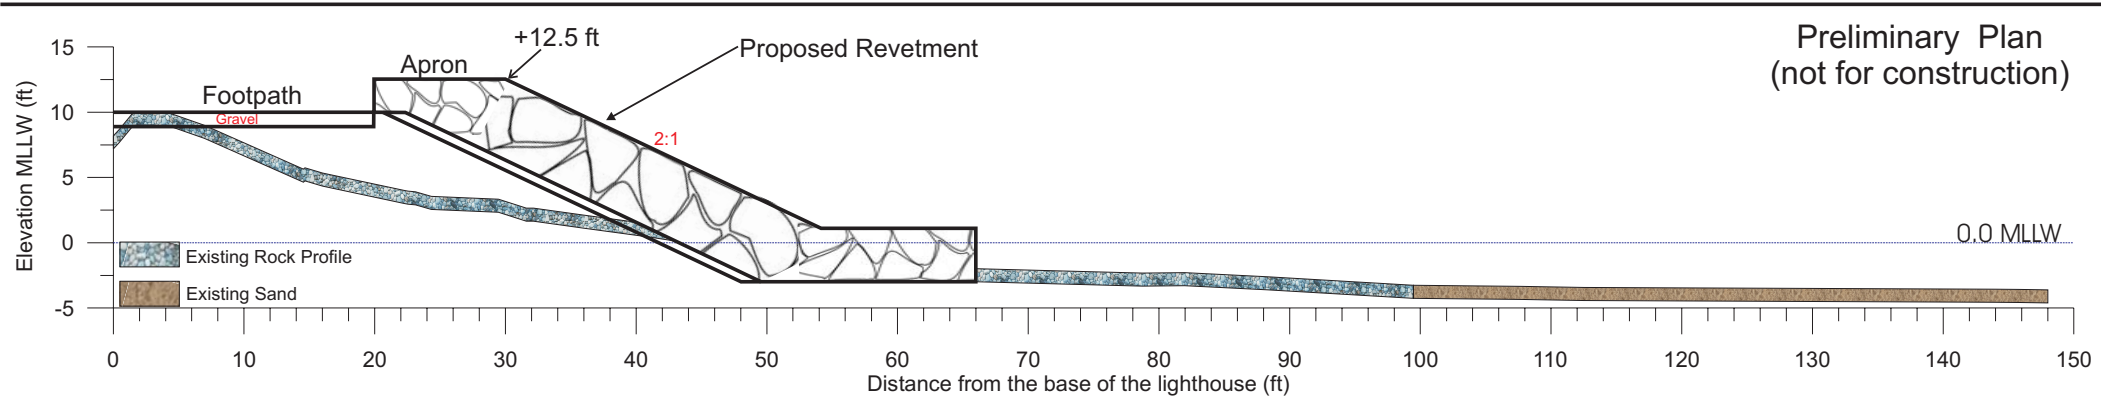
Figure 25. Typical cross-section with existing conditions and proposed revetment.
