## The Durability of Gabions Used for Marine Structures in Virginia

**THE DURABILITY OF GABIONS  
USED FOR MARINE  
STRUCTURES IN VIRGINIA**

**June 1988**

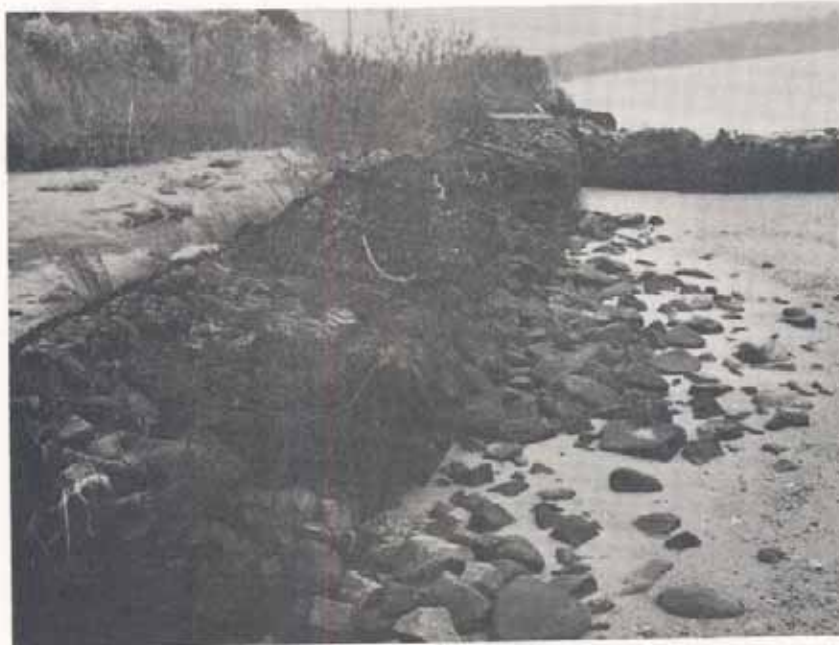
The west shore revetment has one groin associated with it (Figure A2). The 96-foot long revetment is built of size "C" baskets. The overall structural condition is failure of the gabions. There are massive holes along the front face and on top of the structure and there is loss of rock fill. Mr. Abernathy attributes much of this damage to floating stumps and logs coming down the James River and striking the structure. The single gabion groin is in similar condition.

Figure ALA. West Shore Site, looking southward along the structure.

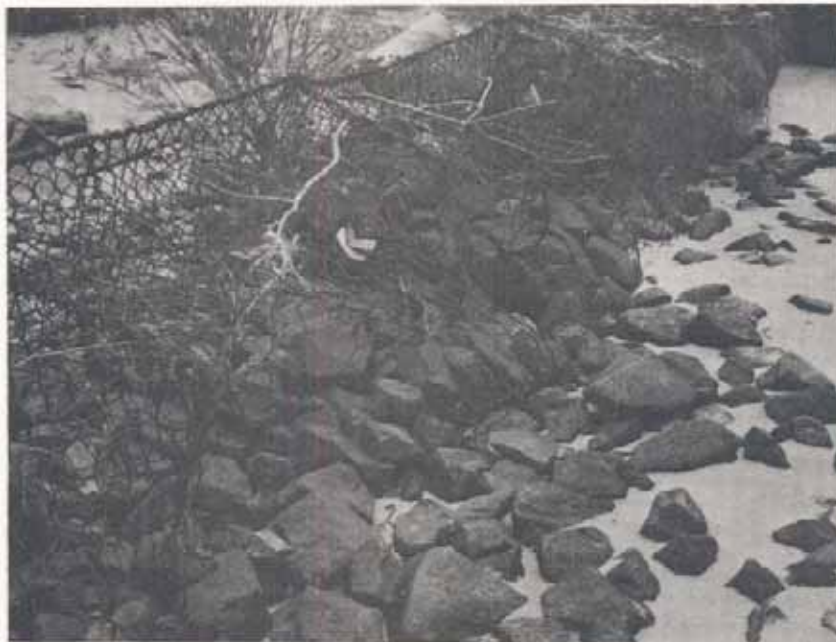
Figure A2B. West Shore Site, close-up of the structure. Note failure of wire and loss of rock.

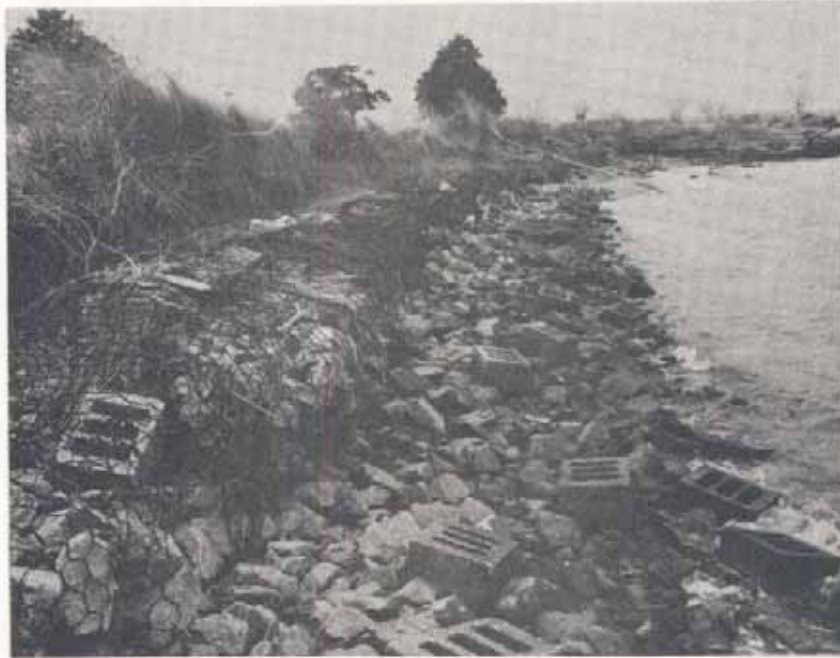
The revetment in front of Mr. Abernathy's house is composed of size "C" gabions sitting on top and back of two size "F" gabions (Figure A3). They were filled with a combination of rock and large cinderblocks. The condition of the structure is massive failure along the front face of upper size "C" baskets and across the tops of the fronting size "F" baskets. Mr. Abernathy stated that an old wooden barge had broken loose during a storm on 4 November 1985 and caused the bulk of the damage.

Figure A3A. Mr. Abernathy's House, looking northward along the structure.

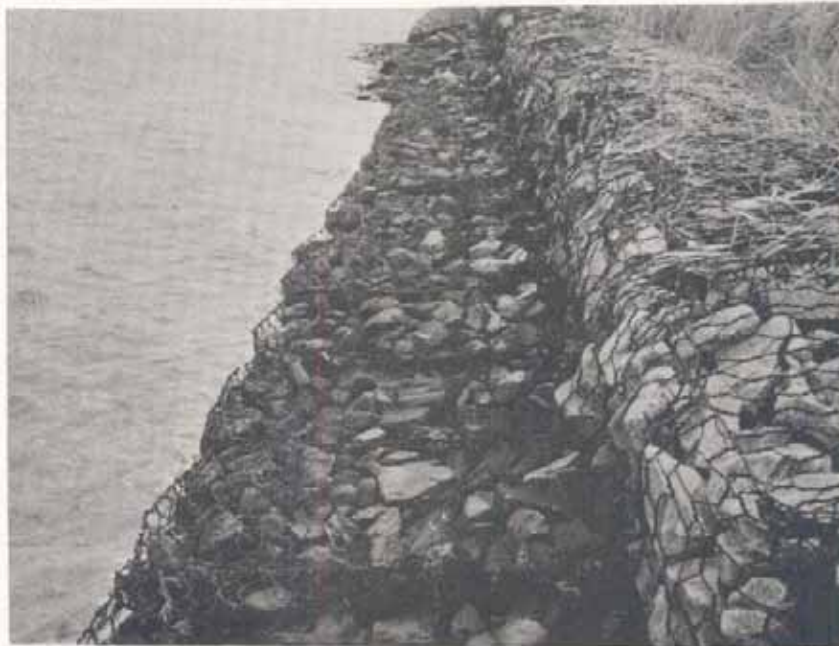
Figure A3B. Mr. Abernathy's House, closeup of the structure. Note failure of wire along top of lower gabions.

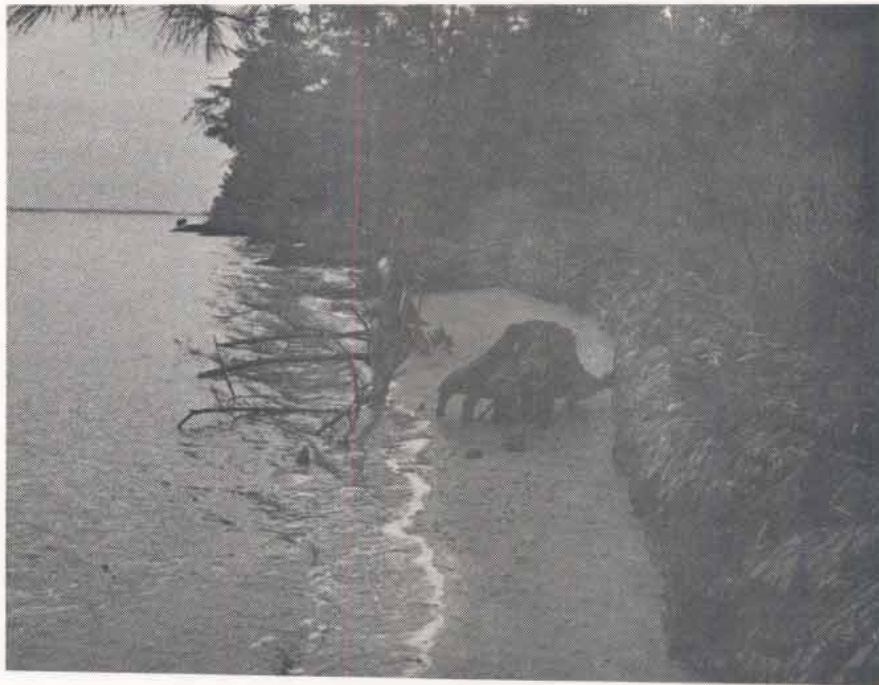
The approximately 800-foot long gabion revetment at the Heron Rook has eight groins associated with it (Figure A4). Both type structure are built of size "C" baskets and are filled with rock. The revetment is generally intact. However, it has rotated seaward in many places. There are only two basket failures on the northern half of the revetment. These occur at the juncture of groins and revetment. The southern half has 11 baskets with large holes and loss of rock. Most of these failures also occur adjacent to the groins. The groins have also failed at the junction as well as at their ends. The south half of the Heron Rook revetment may be more exposed to floating debris than the north half which is partially protected by marsh headland just upriver. This may account for the higher number of basket failures in the downstream section.

Figure A4A. Heron Rook Site, looking southward along the structure.

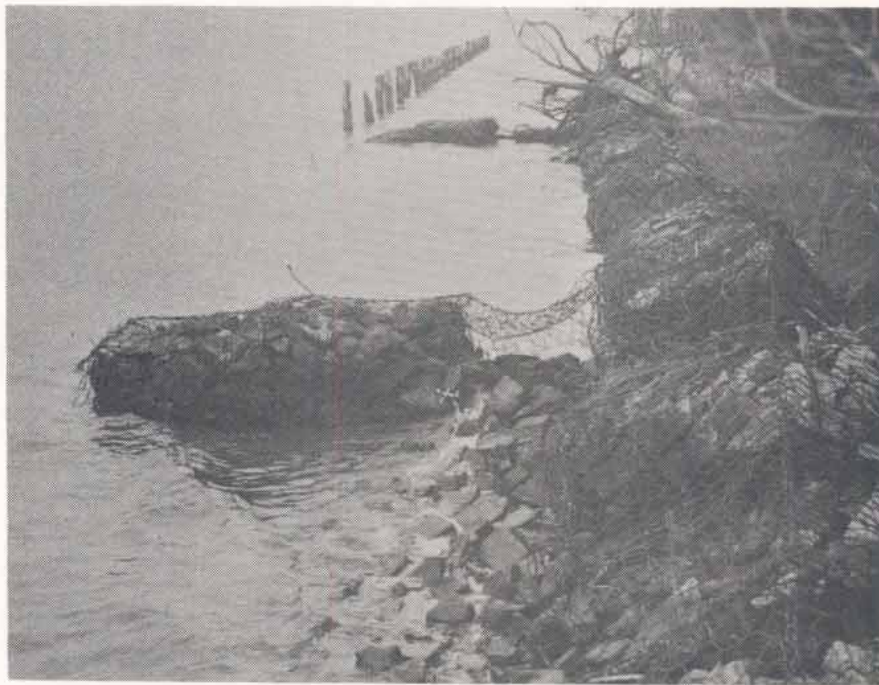
Figure A4B. Heron Rook Site, closeup of the structure. Note failure at juncture of revetment and groins.

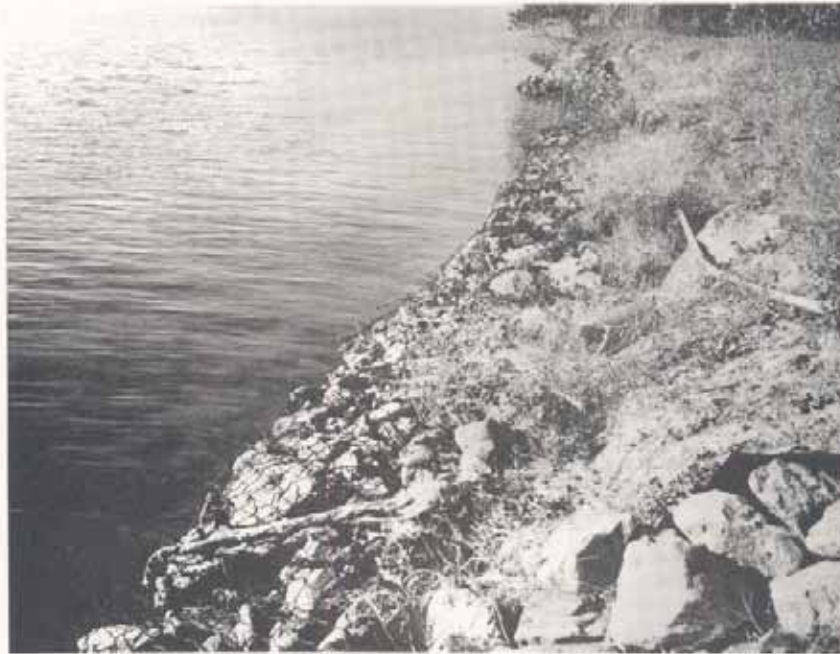
The gabion revetment along the property of L.R. Evans is composed of three layers of size "F" baskets stacked slightly stair-stepped and filled with rock (Figure A6). Overall the structure is in good shape. The PVC coating is split intermittently and the wire rusted. This occurs mostly where the wire twists and bends. The lower half of the structure is intertidal with no beach. Numerous small oysters have attached to the basket and rocks below MSL.

Figure A6A. L.R. Evans Site, looking northward along the structure.

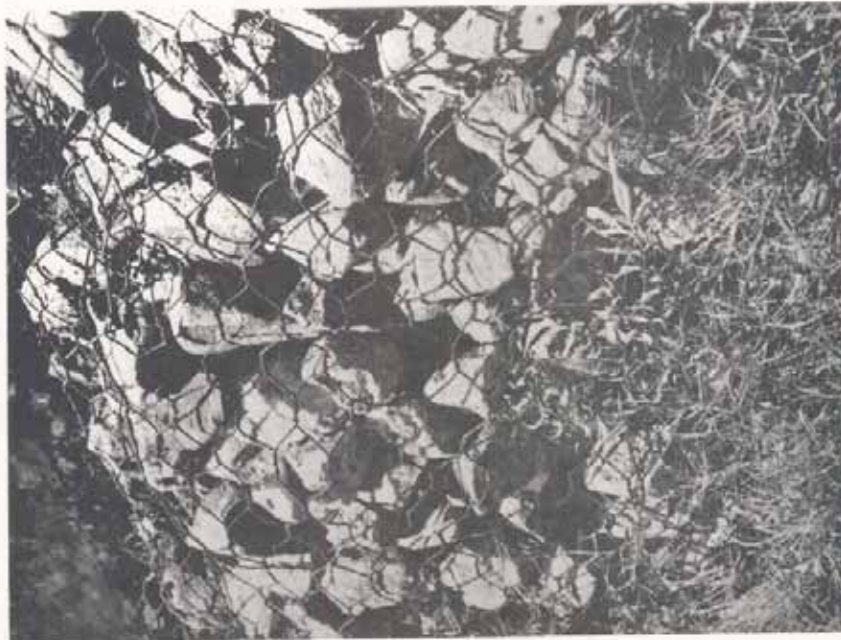
Figure A6B. L.R. Evans Site, closeup of structure, intact.

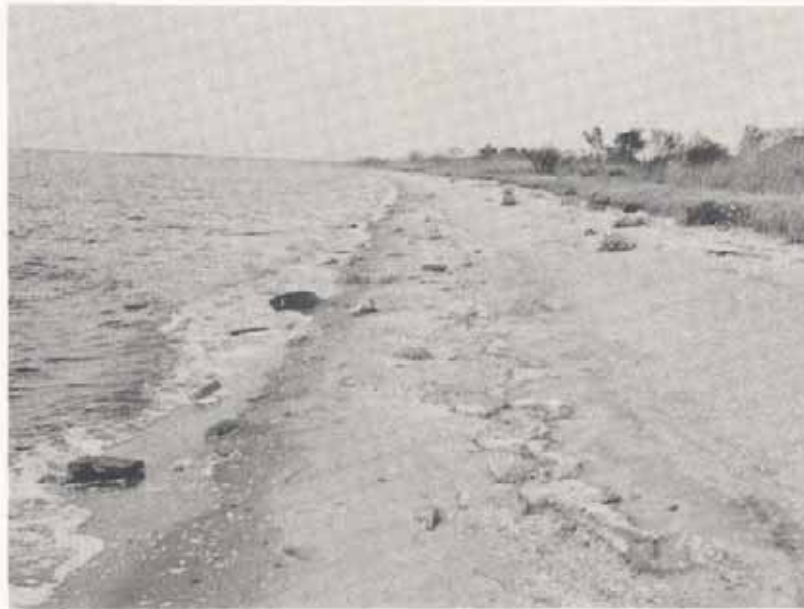
The sill at Saxis, built in 1978, is composed of size "C", rock filled baskets with alternating 12-foot sand bags. It is 220 feet long and was placed initially at ~ -0.5 foot MLW. The sand bags have deteriorated. The baskets were inspected in 1983 and were partially buried and very much intact. Today the entire sill is covered with sand and is assumed to still be in good shape (Figure A8).

Figure A8. Saxis Site, looking northward along the shore. Sill structure is buried just above water's edge.

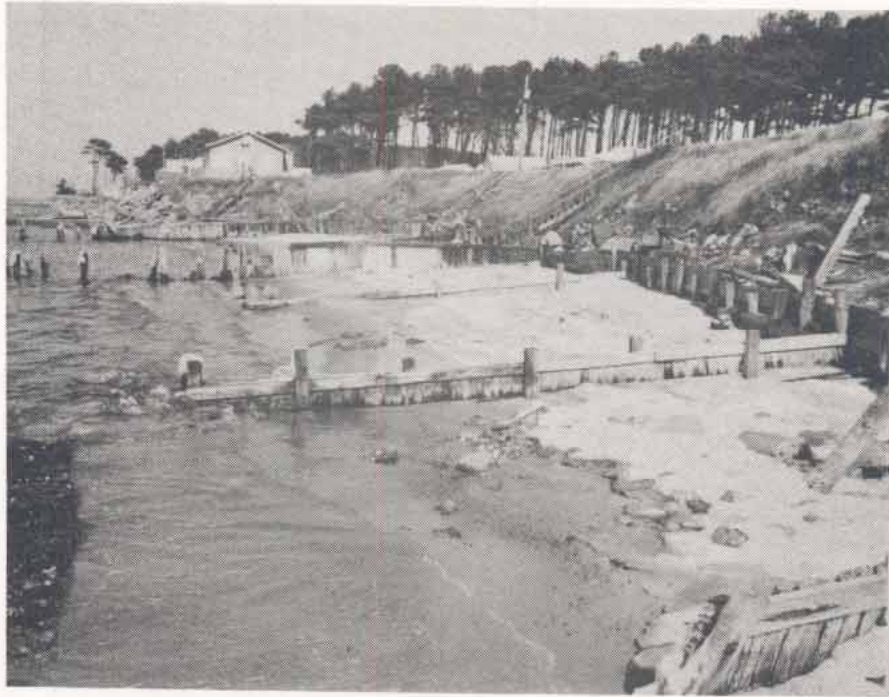
The gabion sill at Silver Beach is constructed of size "C" baskets filled with rock. It is 150 feet long and was initially one half of a continuous sill (Figure A10). The other half was made of sand bags which have since deflated with only remnants of cloth remaining. Four to 5 basket cells have failed and are completely void of rock. The PVC wire on the remaining baskets is scarred and rusted. Sand on the beach side covers the bottom half of the structure. Numerous large pieces of broken concrete are strewn across the beach and nearshore. Most likely

Figure AIOA. Silver Beach Site, looking northward along the shore. Gabion sill is seen on left of photo.

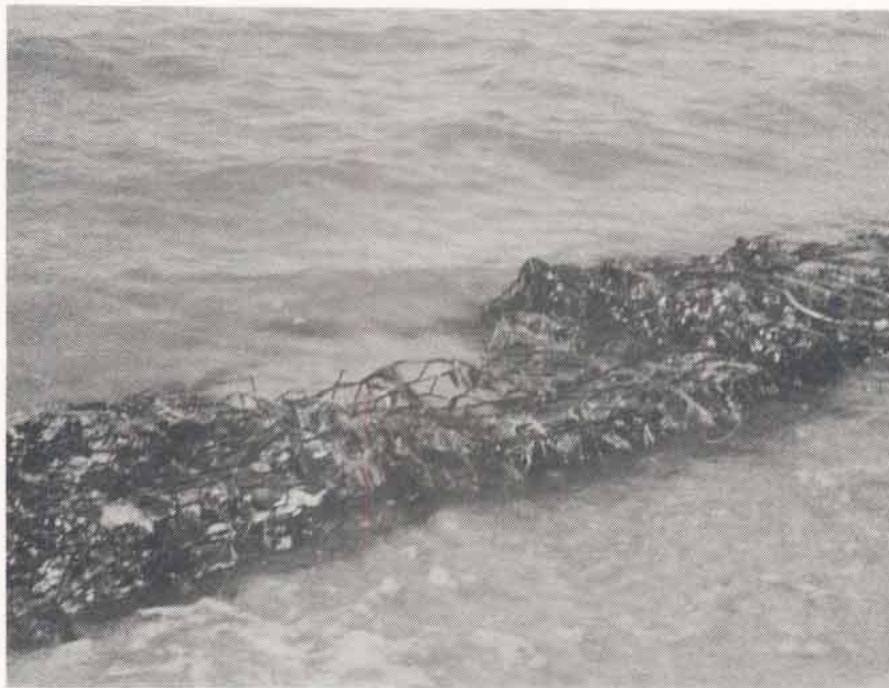
this loose debris occasionally strikes the exposed portion of the gabion sill and abrades the PVC.

Figure AIOB. Silver Beach Site, closeup of the structure. Note the failure of wire in middle of sill.

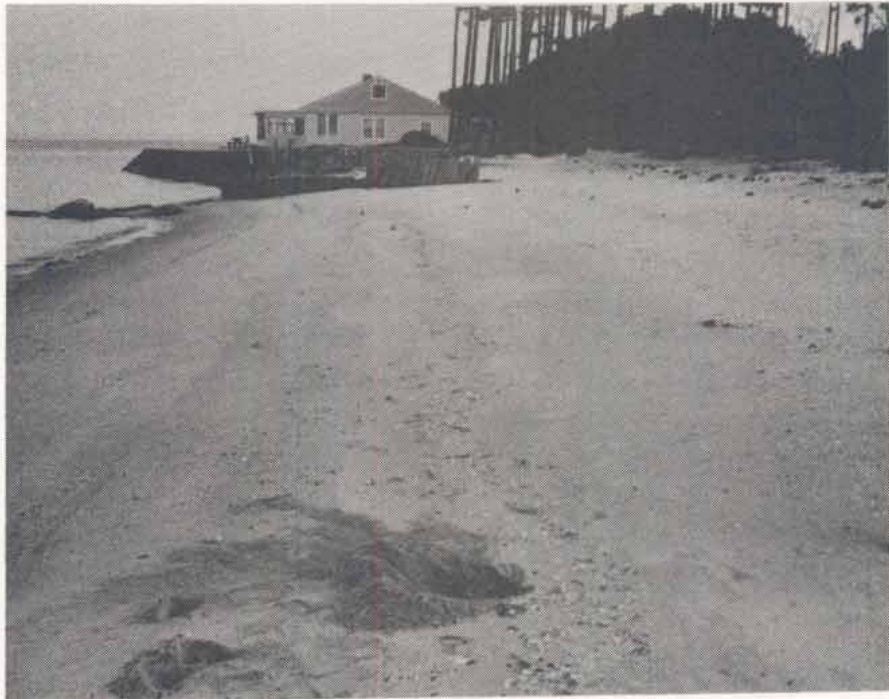
The gabion sill at the D. Smith site was placed at about MLW, is 180 feet long and is composed of size "C" baskets. Soon after installation in 1978, sand began to fill behind the sill. Today, it is completely buried and presumed intact (Figure A12).

Figure A12. D. Smith Site, looking south along the shore. Sill structure is buried and runs parallel to the shore. The hole in the beach designates location of structure.

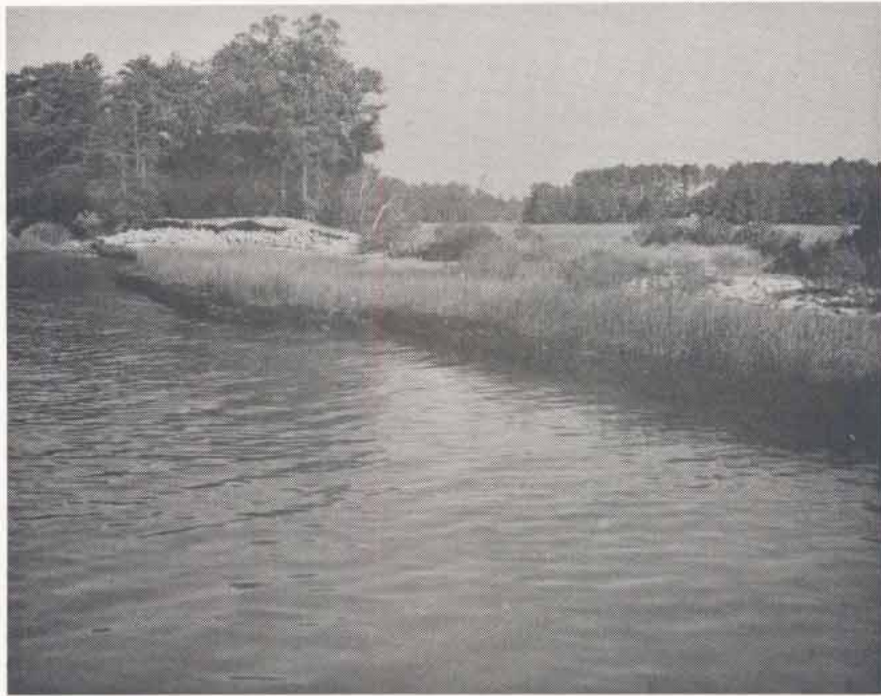
This site was not part of the aforementioned Demonstration Project but was installed in the same year (1978). The structure was filled loosely with broken concrete (Figure A14). This may be the only site in the report that did not use Maccafferri gabions. Much of the sill has failed along the tops of the baskets. The structural failure appears attributable to poor construction. Loose packing of broken concrete which has shifted under wave action scarred and abraded the PVC inducing rust and causing subsequent breakage of the wire.

Figure A14A. D. Vann Site, looking northward along the structure.

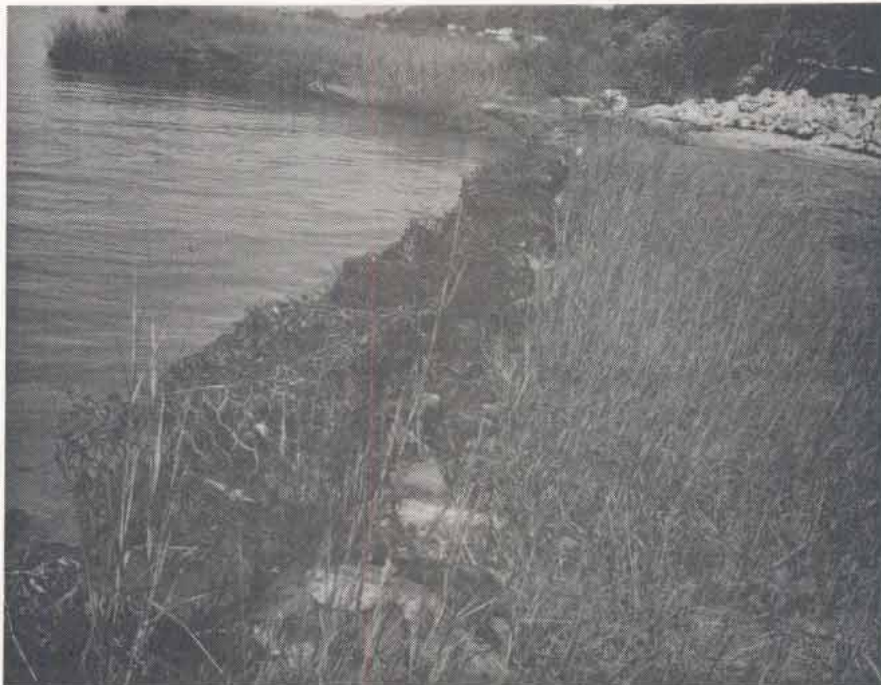
Figure A14B. D. Vann Site, closeup of north end of the structure.  
Basket wire deteriorated with massive failures.

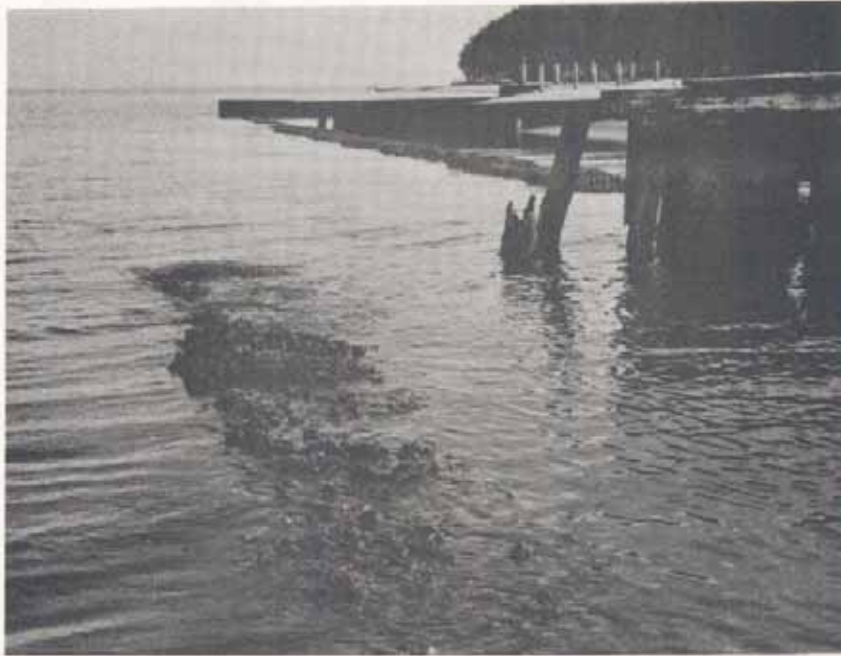
There are three gabion sill installations at the Herndon site. The northern-most is at -3.0 feet MLW (1), the middle sill at -0.5 foot MLW (2) and the southern sill at -0.5 foot MLW (3) (Figure A15). Sills 1 and 2 are intact with abundant growths of oysters, sponges, and such. Sill 3 was placed adjacent to the existing bulkhead where it acted partially as a spur. The basket at the juncture of the bulkhead has failed with the loss of the stone fill.

Figure AlSA. Herndon Site, looking south along sill installations 1 and 2.

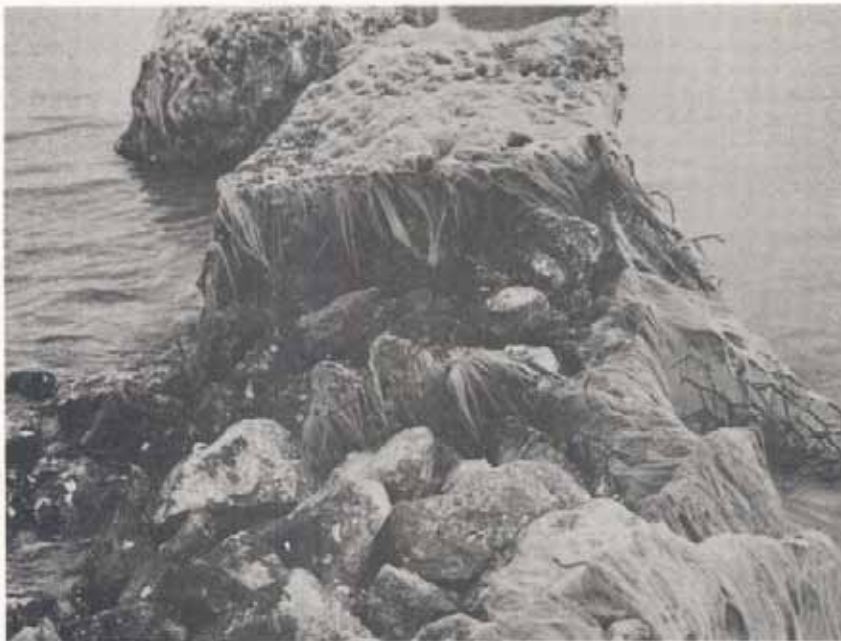
Figure AlSB. Herndon Site, closeup of sill installation 3 adjacent to the bulkhead. Note failure at junction point.

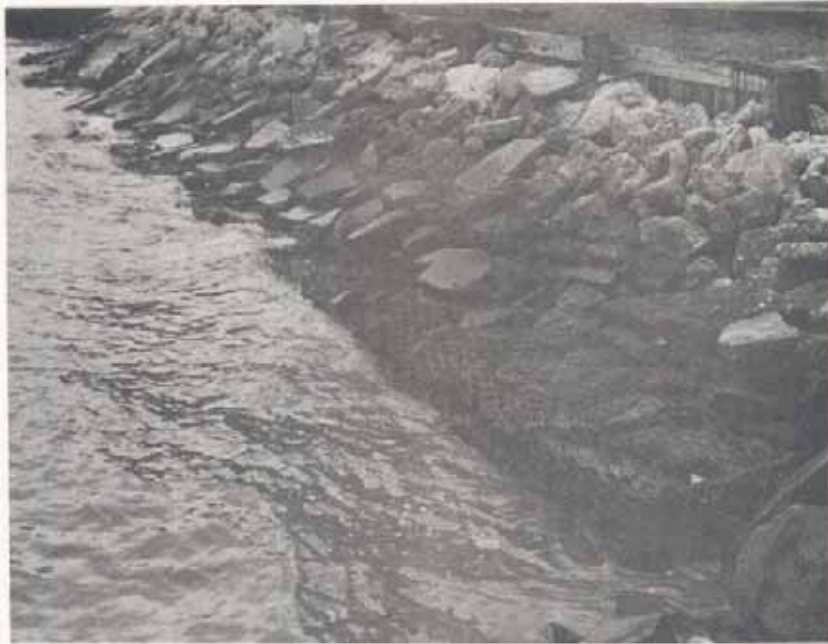
The sill at the Mizelle site apparently was constructed as a scour apron in front of a wooden bulkhead. The size "F" baskets are filled with broken concrete. After emplacement of the sill, additional broken concrete was stacked behind it and against the bulkhead (Figure A17). Subsequent wave action has moved the loose pieces of broken concrete across the top of the sill. This has caused abrasion of the PVC wire and in some places basket failure.

Figure AI7A. Mizelle Site, looking south along the structure.

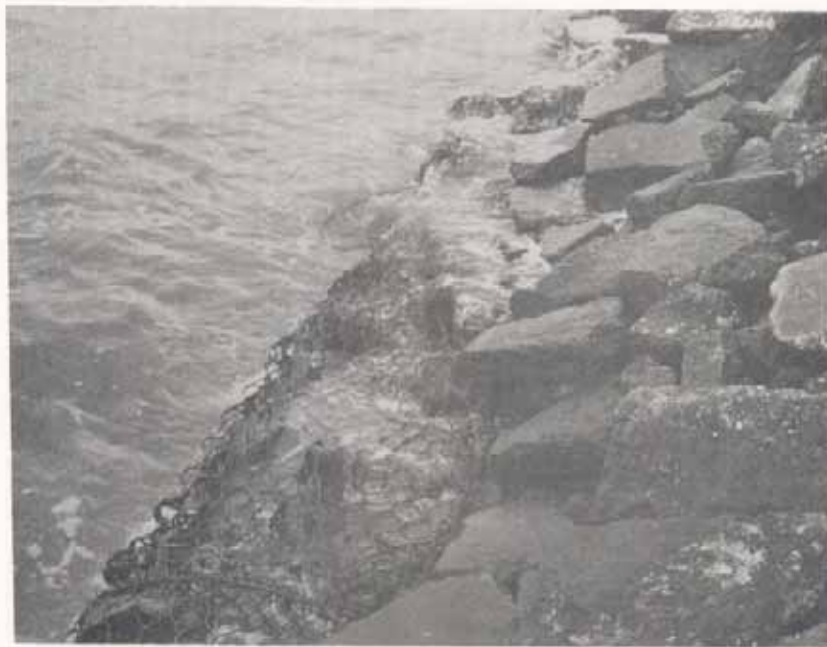
Figure AI7B. Mizelle Site, closeup of the structure. Note failure and broken concrete along top of baskets.

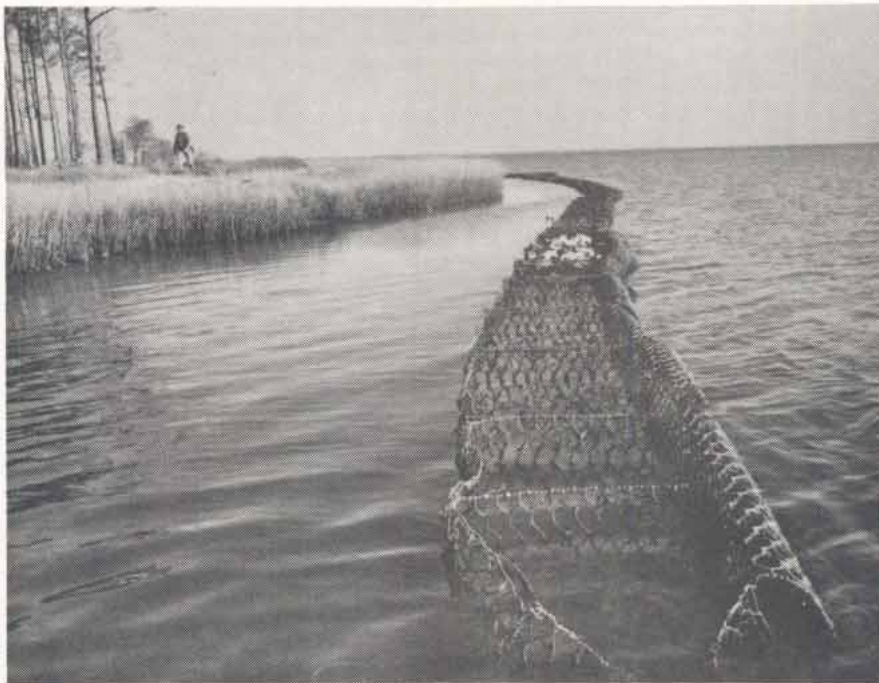
The gabion sill at the Funston site initially was installed in the spring of 1987. Apparently it still is under construction (Figure A19). The structure is 360 feet long. Some of the size "D" baskets have been set in place but not filled with rock. The packing is poor and the tying is loose. Since it is a recent structure, the PVC wire is still in good shape. However, given the poor construction technique and long fetch exposure, the potential for premature basket failure is high.

Figure AI9A. Funston Sitet looking east along the structure. Note unfilled basket, job still incomplete.

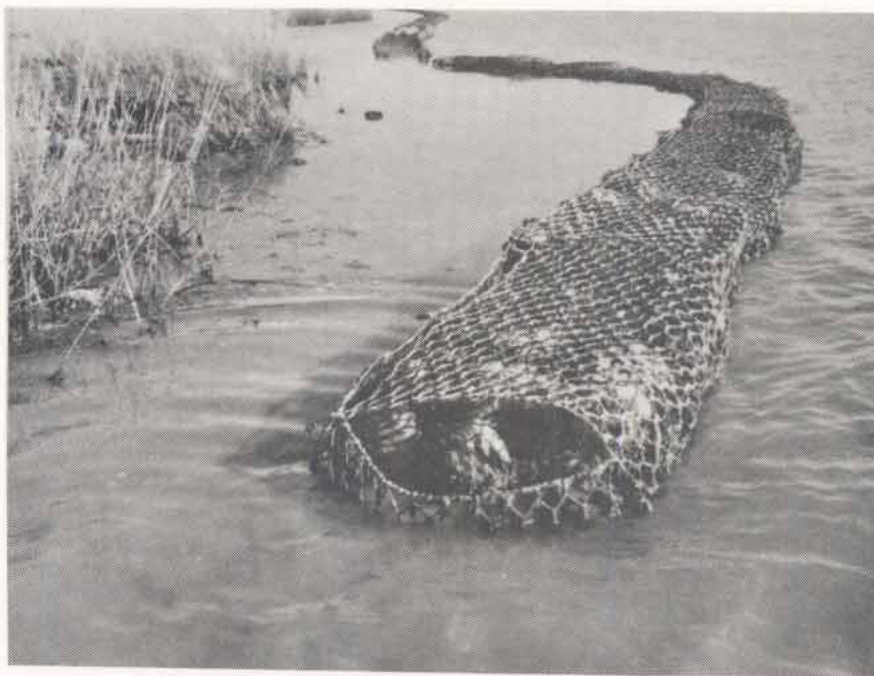
Figure AI9B. Funston Site, closeup of the structure. Note loosely tied basket top.

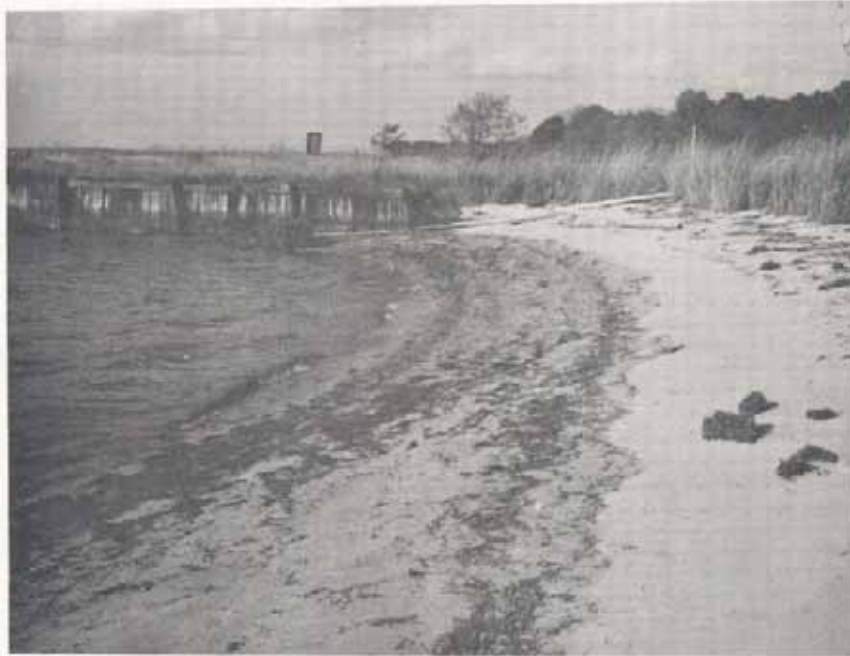
Today the PVC coating is in good shape with minor slits and rust color at the twists which is exposed above MHW (Figure A21). The wire has several breaks across the top. The tire casings which were used as fill could not produce the proper filling volume to keep the basket tight.

Figure A21A. VIMS Spur Site, looking north at the structure next to wooden groin.

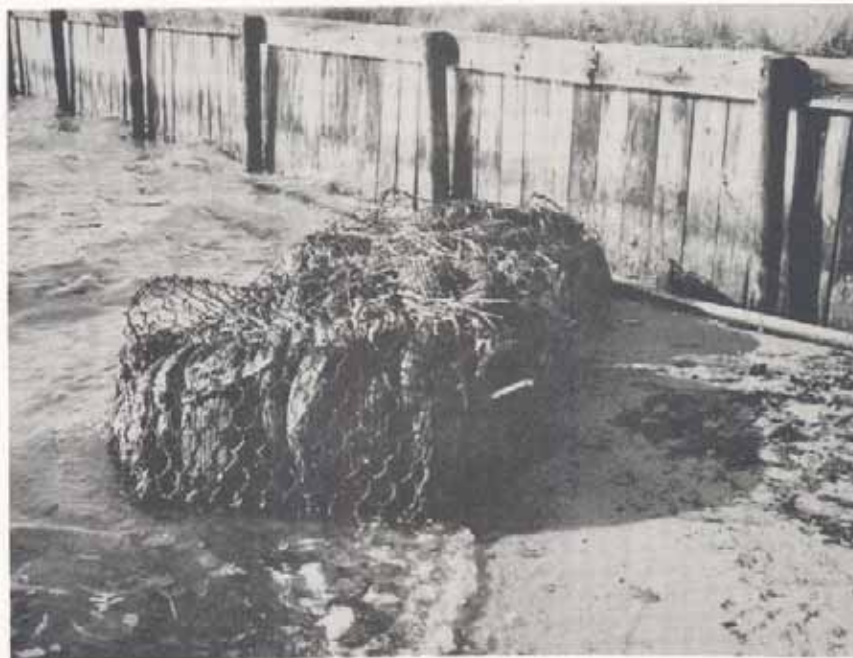
Figure A21B. VIMS Spur Site, closeup of the structure. Note tire bundles used as fill.

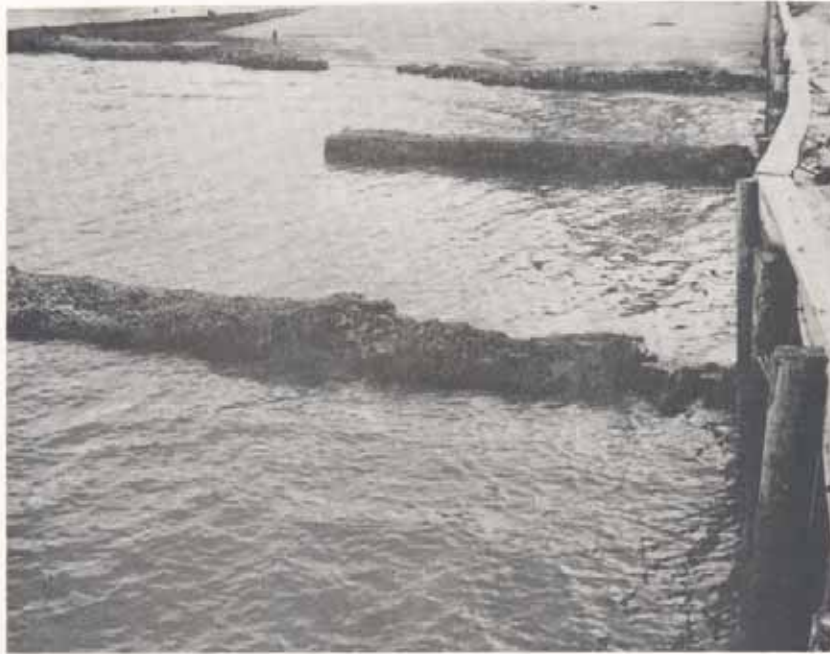
The spurs were constructed of size "C" baskets and placed at about -0.5 ft MLW. They have since suffered major failure of the baskets at the juncture of the spur and groin. This pattern of failure supports the theory of concentrated wave energy possibly in combination with floating debris at those points. This appears to be true especially if the spur is exposed above MLW.

Figure A22A. Herndon Spur Site, looking west at spur and sill structures.

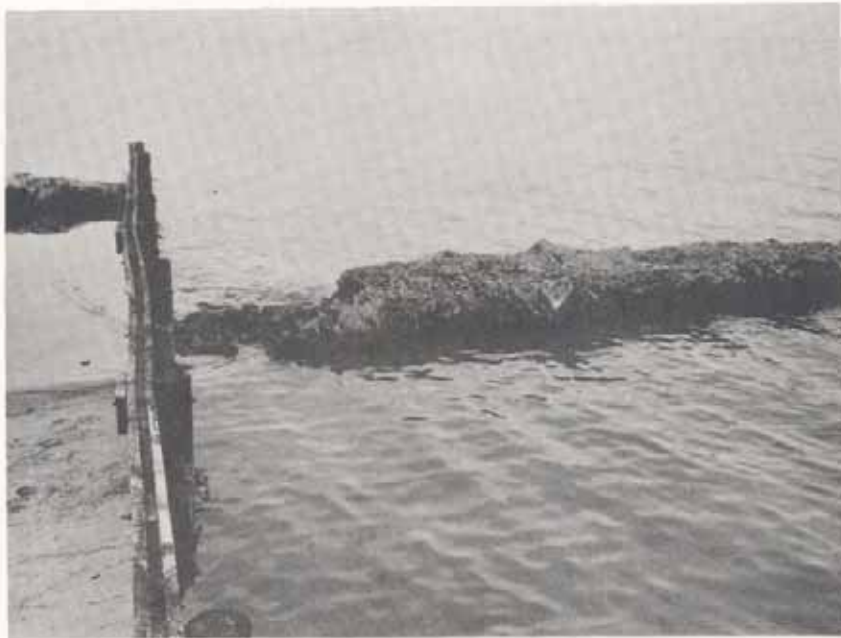
Figure A22B. Herndon Spur Site, closeup of spur. Note failure at junction point at groin.
