## Piankatank River Shoreline Situation Report

# Piankatank River Shoreline Situation Report

*Special Report in Applied Marine Science and Ocean Engineering*  
*SRAMSOE No. 361*

*April, 2000*

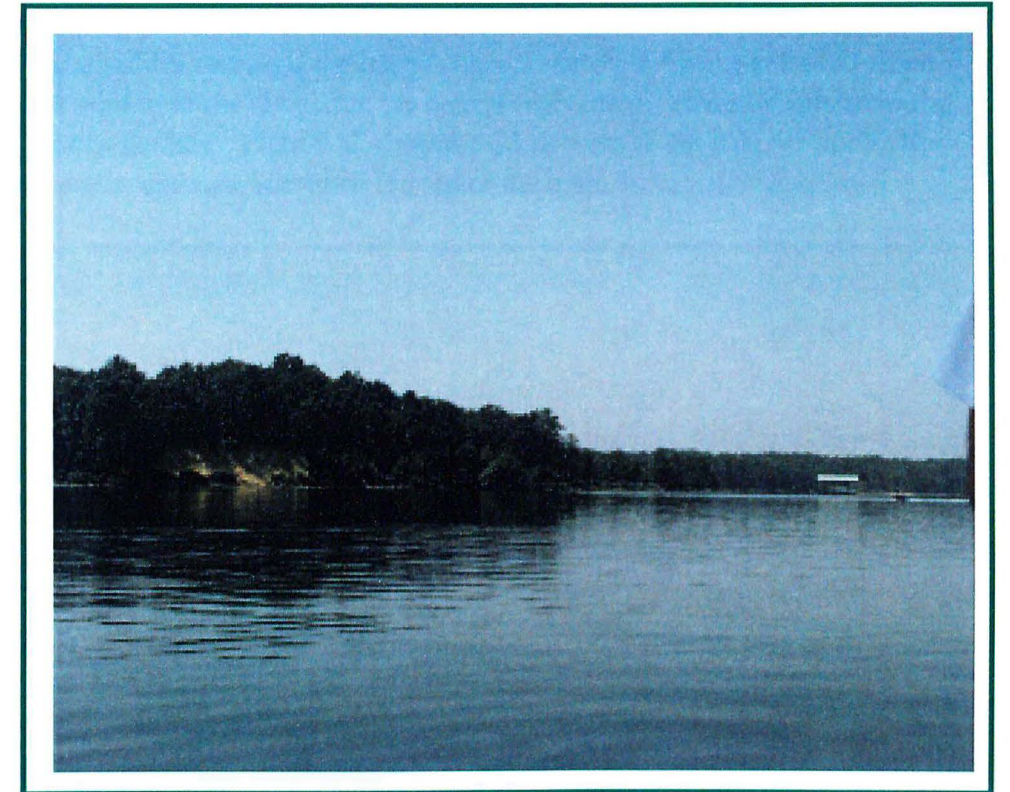
Eroding bluffs at Holland Point

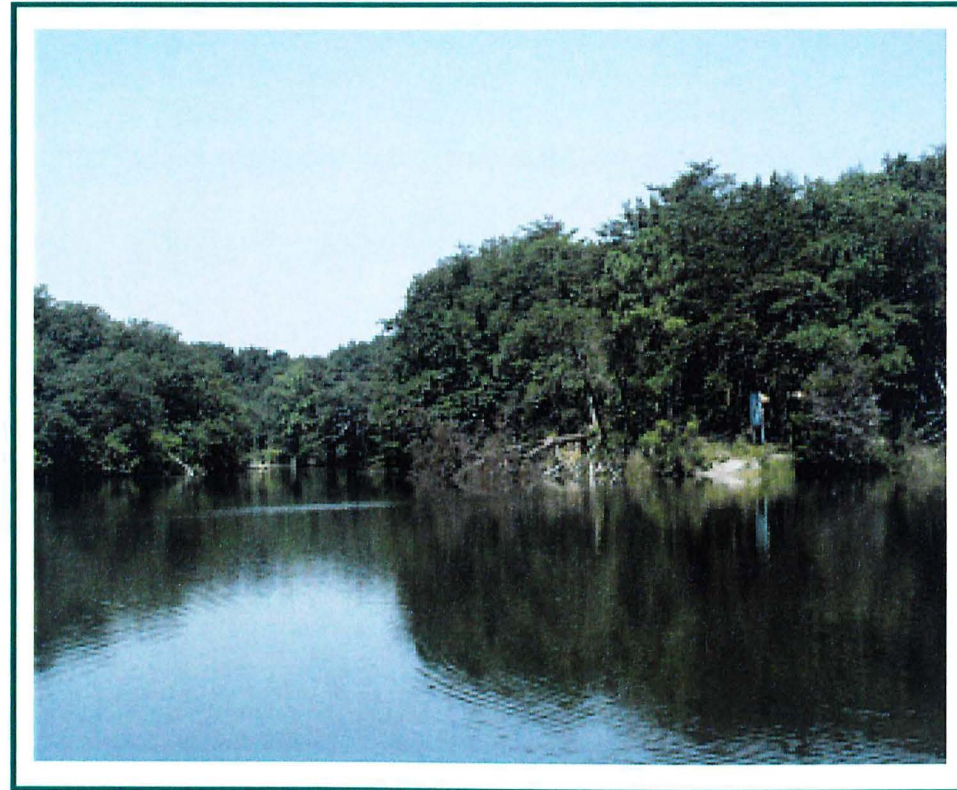
Eroding banks in Wilton Creek

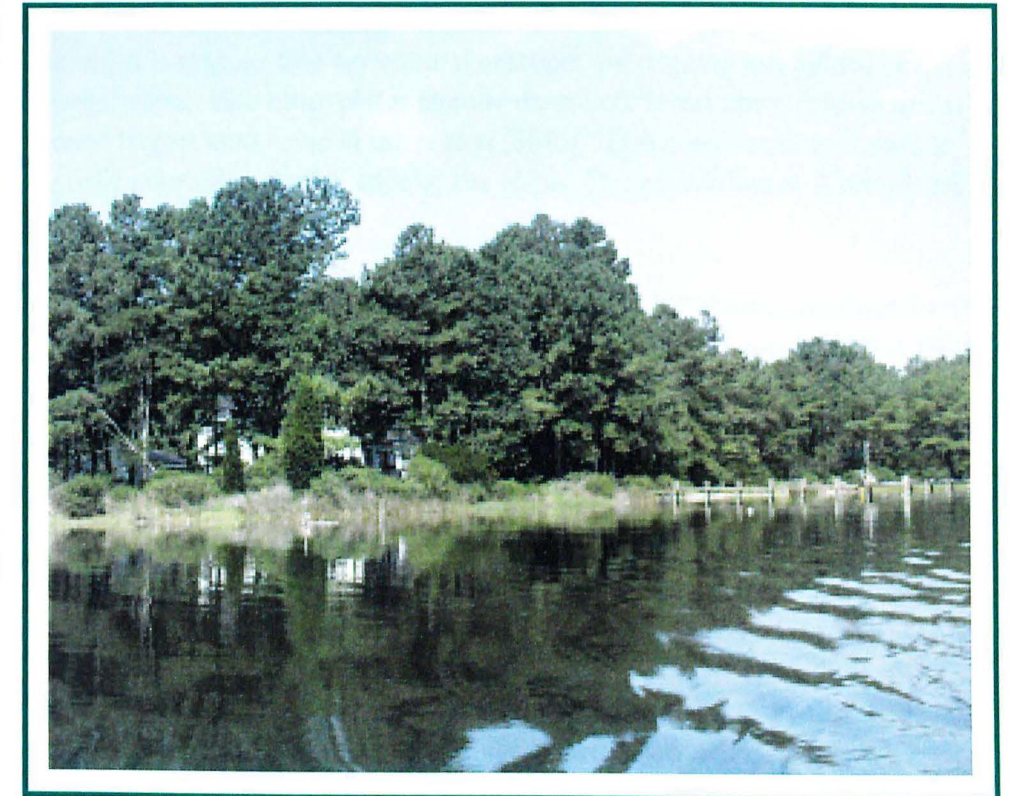
Fringe marsh along Cobbs Creek in Mathews County

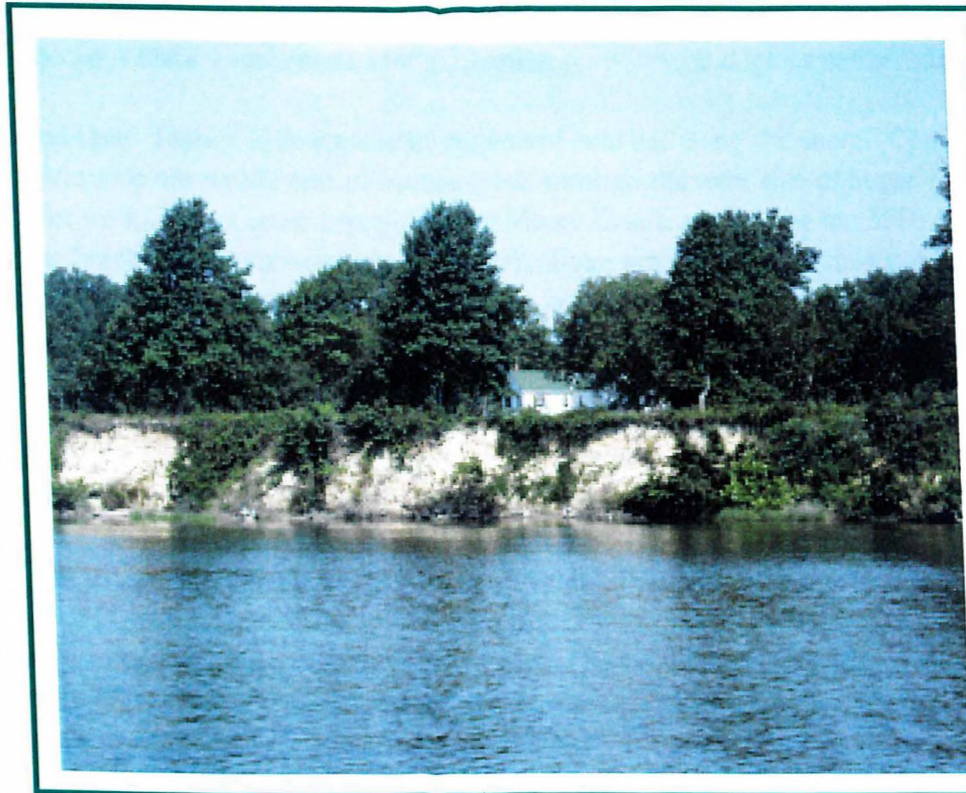
Eroding banks outside Cores Creek in Middlesex County
