Oyster Bag Sill Construction and Monitoring at Two Sites in Chesapeake Bay

Donna A. Milligan
Virginia Institute of Marine Science

October 2018

Shoreline Studies Program

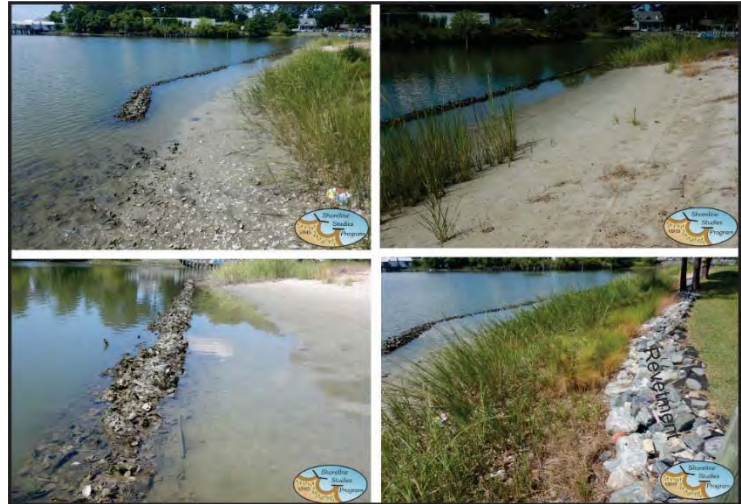
Figure 4-6. Present condition of Site 1 oyster bag sill (6 September 2018).

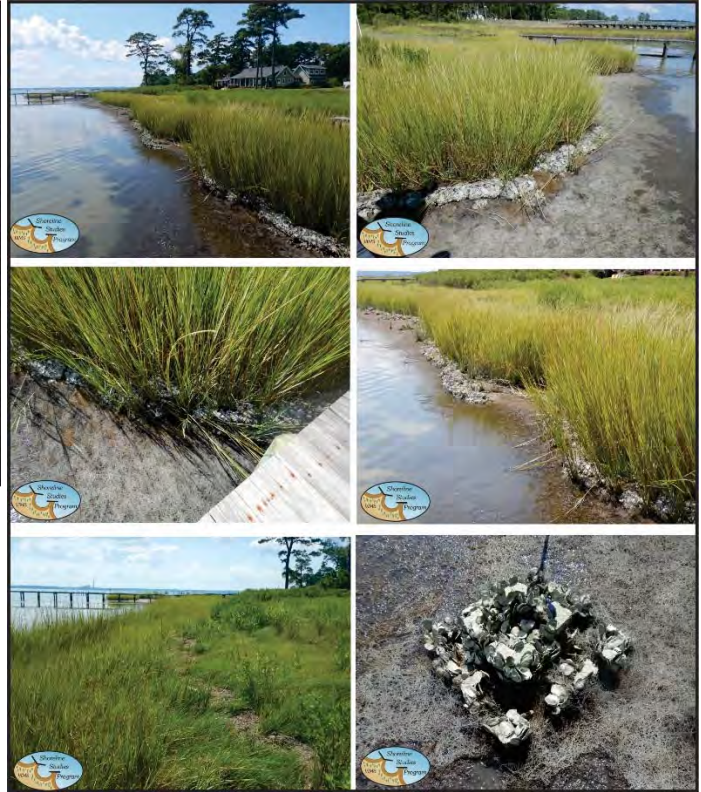
Figure 4-12. Site 2 sill in September 2018.

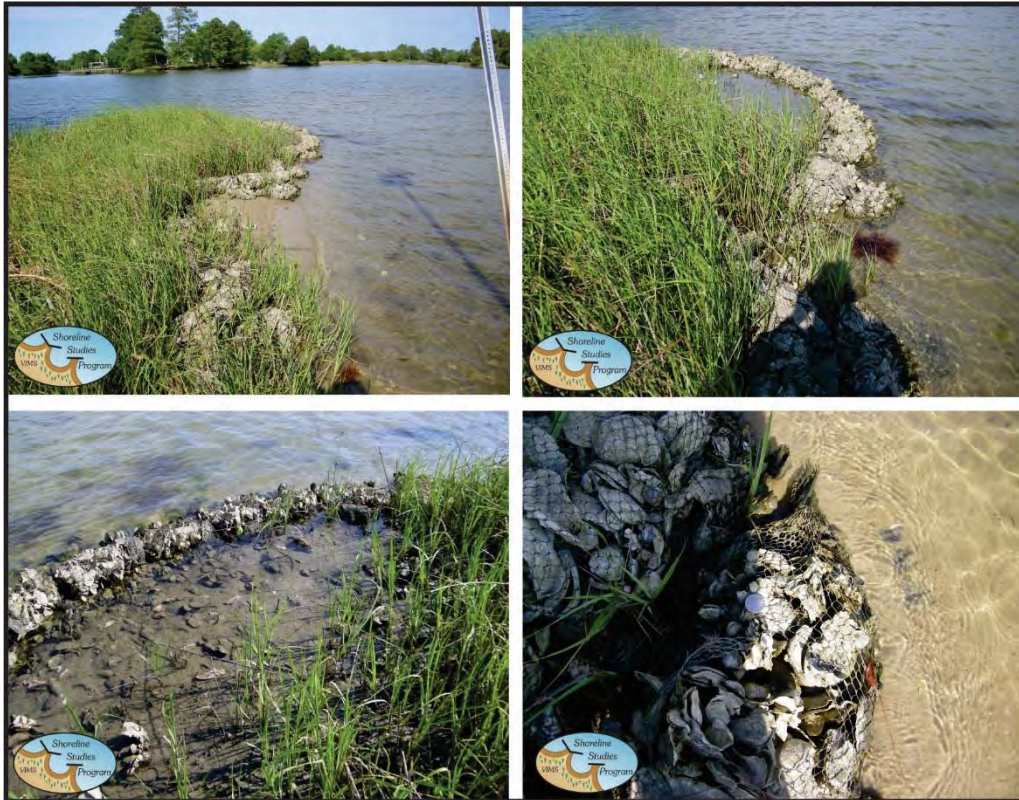
After three years, the marsh was growing in front of the bags in one section of the sill. After four years, the area behind the bags has filled in with marsh, creating a nice marsh fringe at the site that has grown in front of the bags in some areas of the project (Figure 4-15).

Figure 4-14. Oyster bag sill at Site 3, St. Johns Point on 10 May 2017 approximately 3 years after placement.

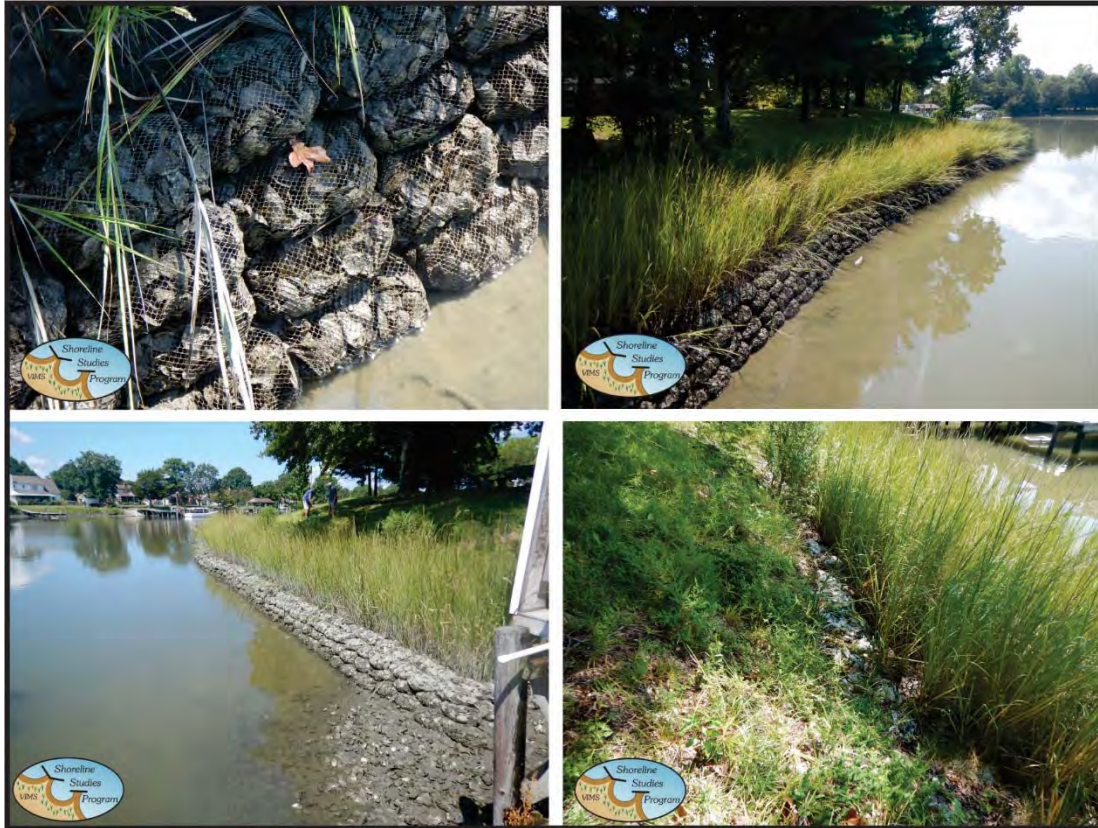
Even though the project is just a year old, the marsh has filled in behind the structure and the

upland bank has been stabilized. Though no significant storms have affected the site, the established marsh should help protect the shoreline over time.

Figure 4-19. Site 4 oyster bag sill in September 2018.

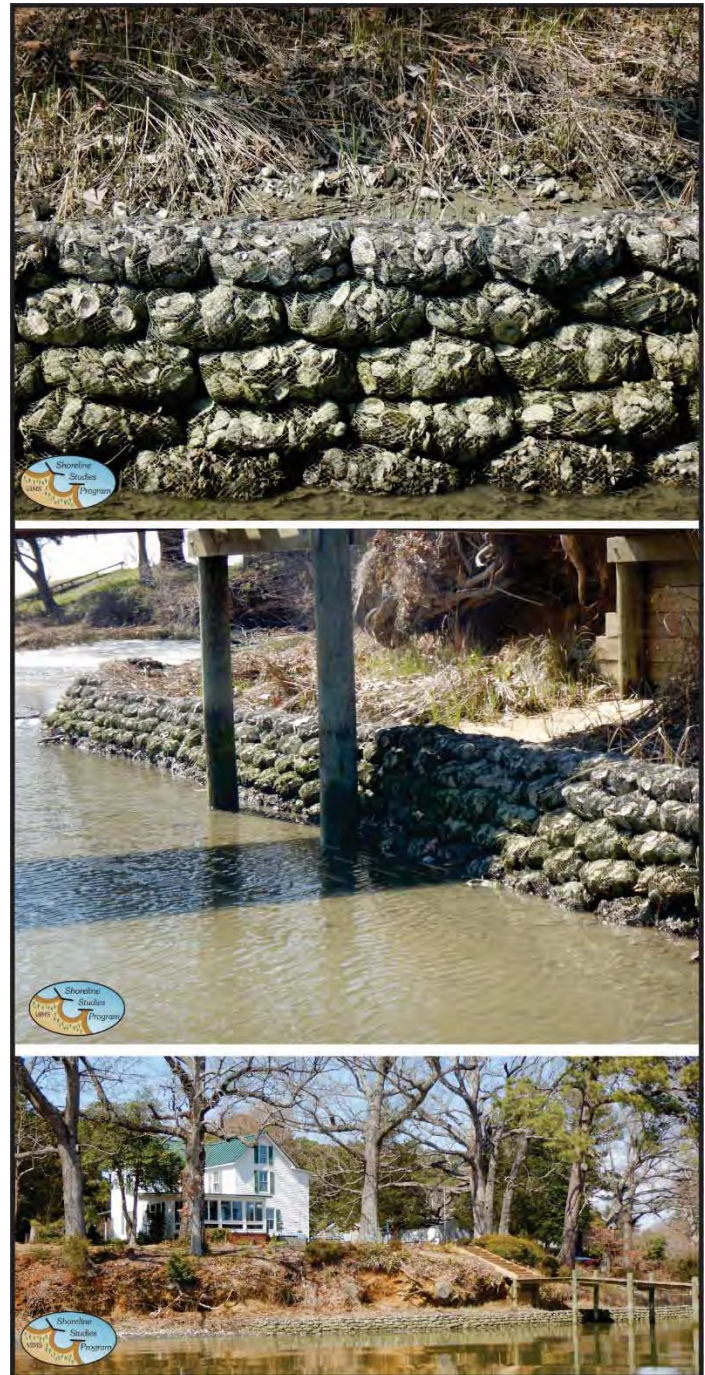
This oyster bag sill has been very successful in terms of both shore protection and habitat creation. After two years, the oyster bags are still intact, and many oysters are growing on the bags. Sediment has been deposited behind the structure, and the marsh edge is no longer scarped behind the

Figure 4-24. Site 5 on March 28, 2018. After nearly two years, the bags are still intact and have stayed as placed. Marsh has filled in behind the structure. Oysters have been recruited along the sill.

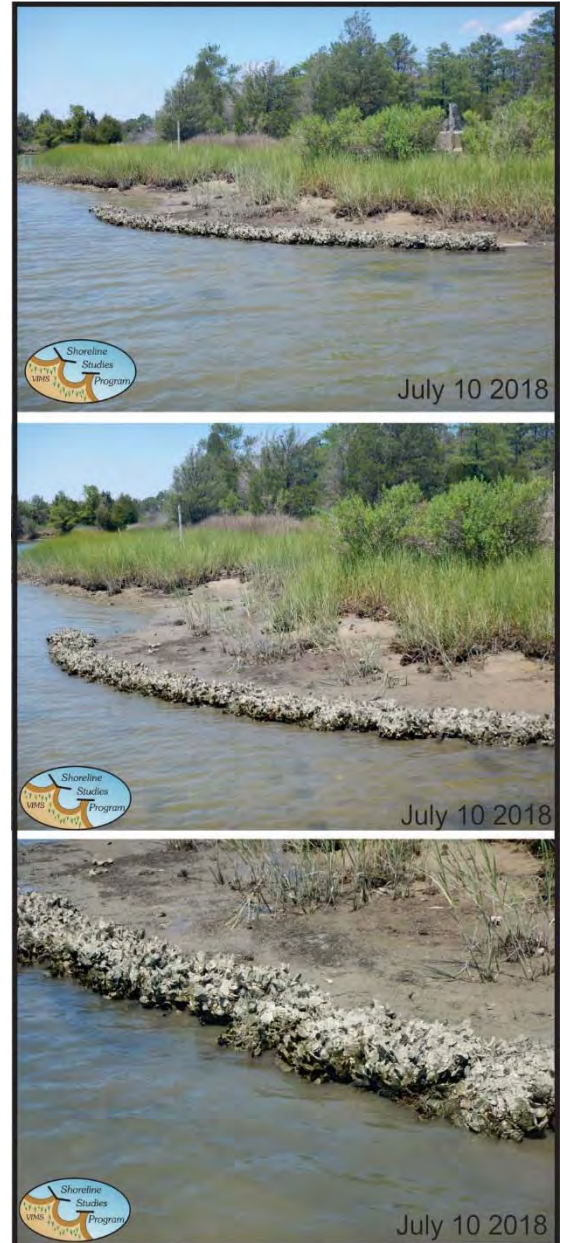
structure as it is along the marsh adjacent to the project (Figure 4-27). In addition, marsh grass runners are extending toward the sill on the newly deposited sediment.

Figure 4-27. Site 6 oyster bag sill two years after installation. The sill has provided shore protection and created habitat. A great many oysters are growing on the bags. In addition, sediment has come in behind the sill, the marsh is no longer scaped, and marsh grass runners are extending toward the sill.

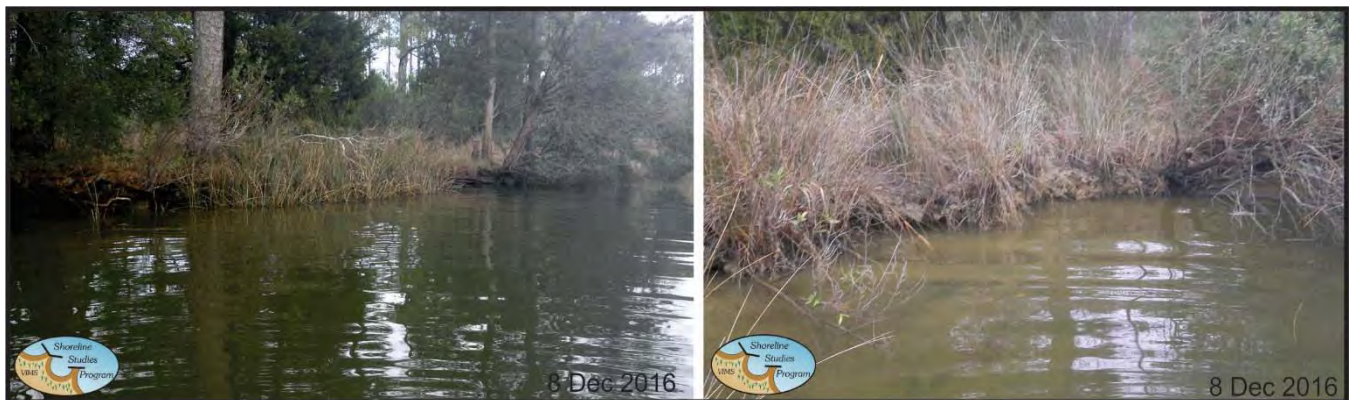
Prior to installation of the project, the upland and marsh shoreline were exposed and eroding (Figure 5-2). The oyster bag sills were placed in front of both the upland and the marsh shorelines.

Figure 5-2. Heritage Park shoreline prior to the installation of the oyster bag sill. Both marsh and upland sections of the shoreline were eroding.

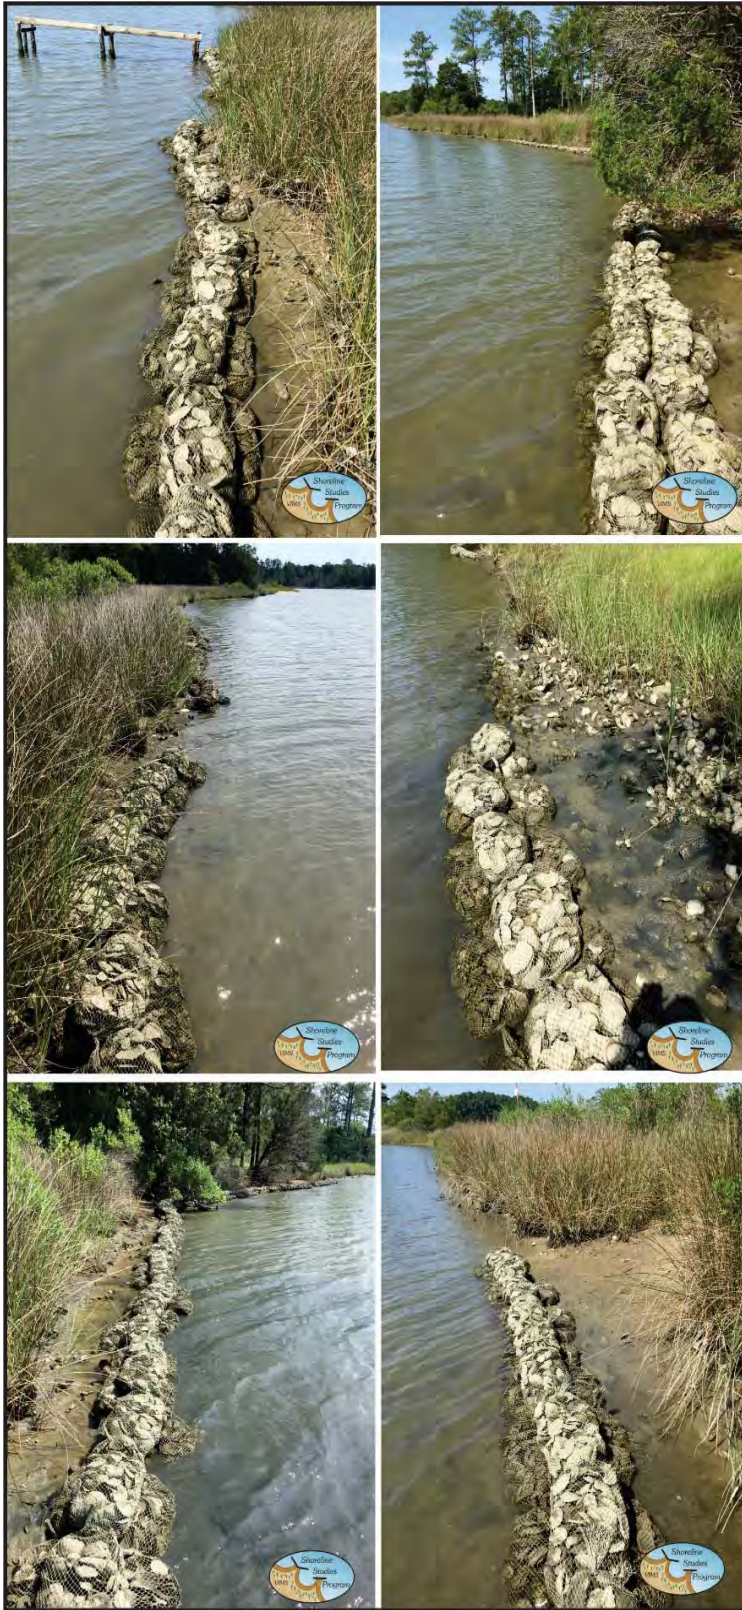
Overall, the sill has remained intact over the 1.5 years that it has been installed (Figure 5-4). The bags have remained in place with no apparent sinking or movement landward. Visual inspection determined that some fine-grained sediment is accumulating behind some sections of the structure (Appendix C) though it was not measured.

Figure 5-4. Heritage Park three months after construction (June 29, 2017).

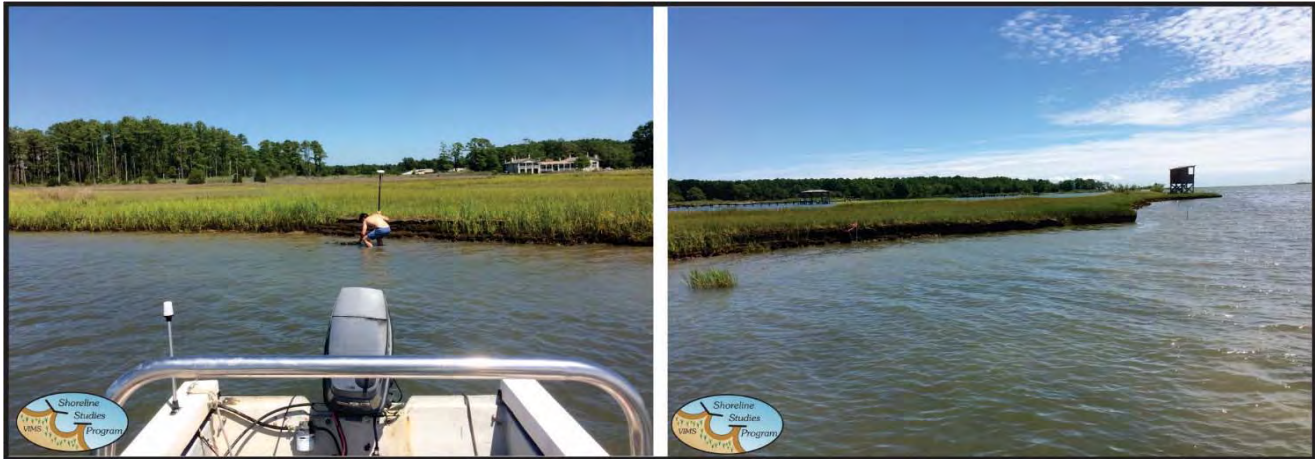
Figure 5-5. Existing shoreline along the marsh at CSRA, August 6, 2017.

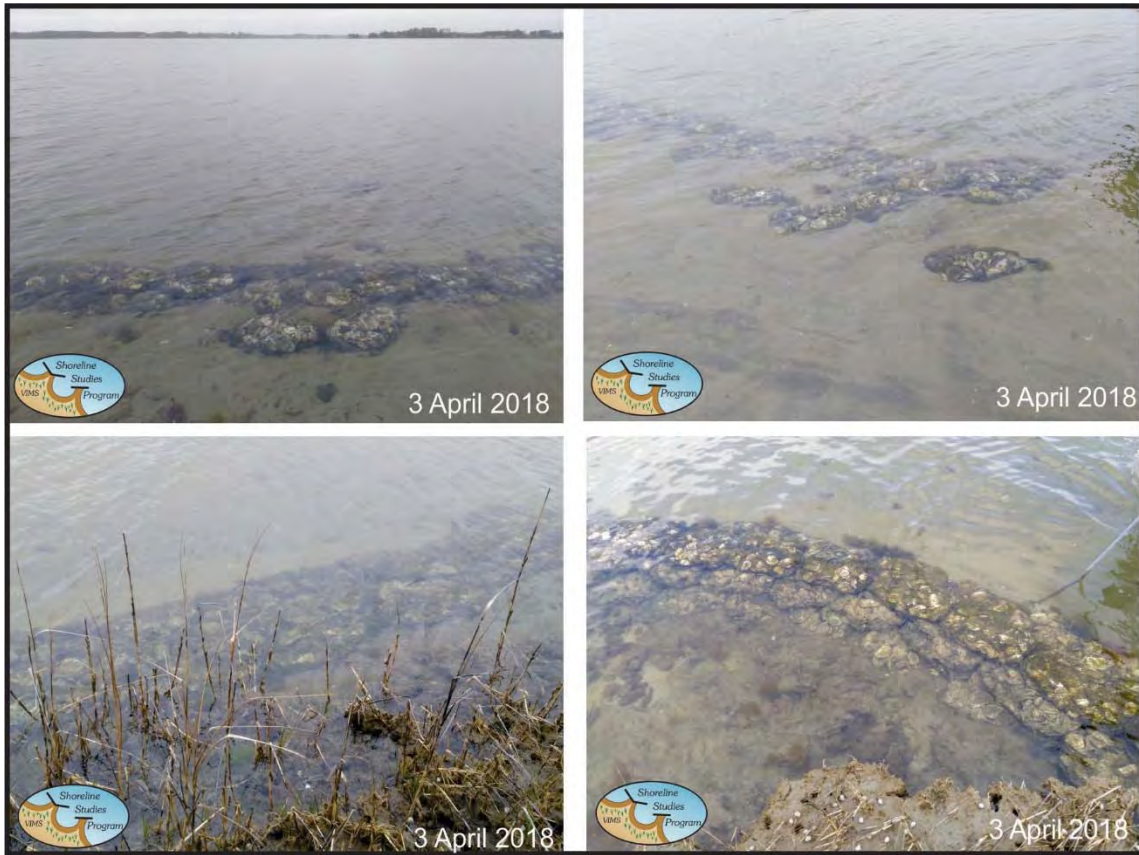
Overall, the 6-bag sill has fared very well. It has remained intact over the past year. The 3-bag sill has had mixed results. The sections of sill that are farther north, and therefore are more protected, remained intact as did those that were placed close to the marsh. However, the top bag on the 3-bag sills that were placed farther from the marsh because of the slope of the intertidal area tended to roll ([Figure 5-9](#)). This was even more noticeable in July 2018 ([Figure 5-10](#)). This section of shoreline has a higher average fetch than the existing oyster bag sills that were described in Section 4 which may account for the difference in sill structure. No definitive data has determined whether or not the change in structure will affect the role the bags play in shore protection.

Figure 5-9. The three bag sill (top) that was placed on the southwest-facing shoreline has not been as stable. The top bag of some sections were rolled toward the shoreline. The six bag sill (bottom) on the point and the southeast-facing shoreline has remained intact.

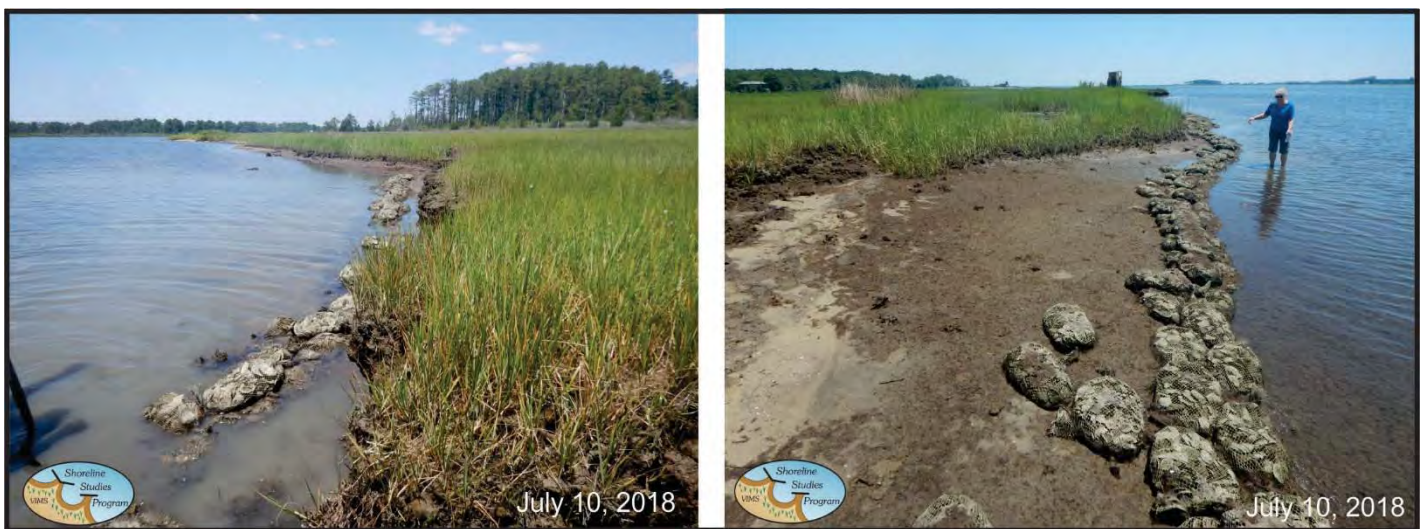
Figure 5-10. The 3-bag sill tended to remain intact when placed close to the eroding marsh scarp (left). However, when the bags are placed at low water farther from the shore because of the gentle slope of the intertidal area, they tended to roll.

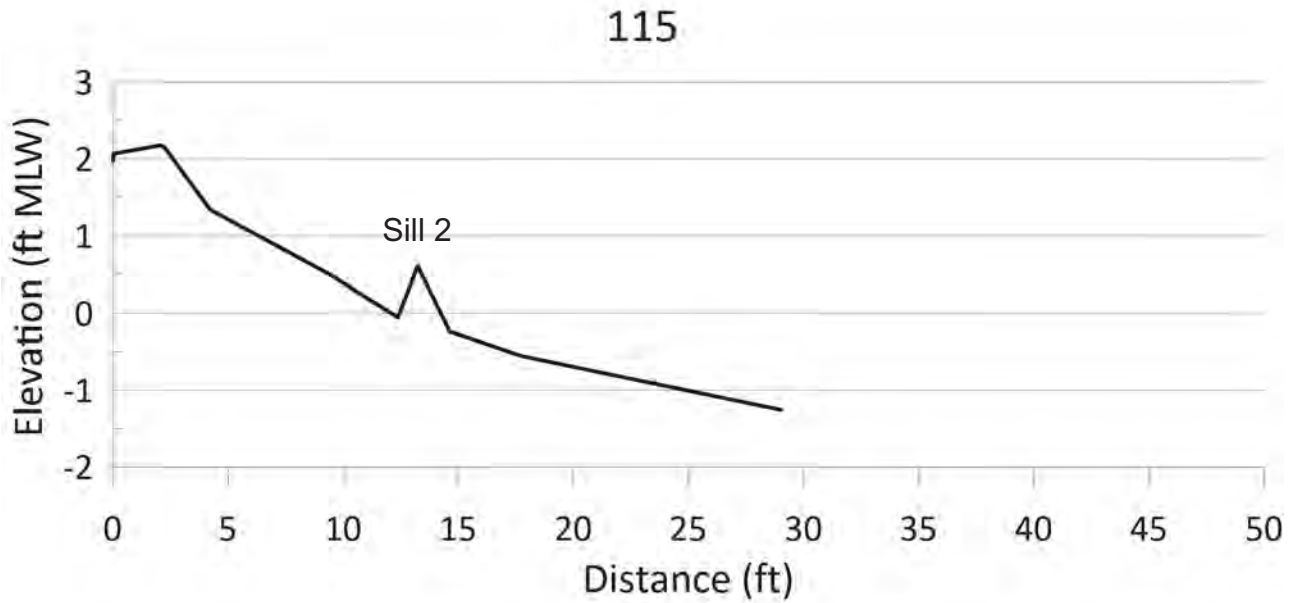
Cross-sectional profile 115 of Sill 2 fronting the upland. Survey taken 26 Jan 2018, ten months after installation. The bags were placed at about mean low water (0) and are about 0.5 ft high.

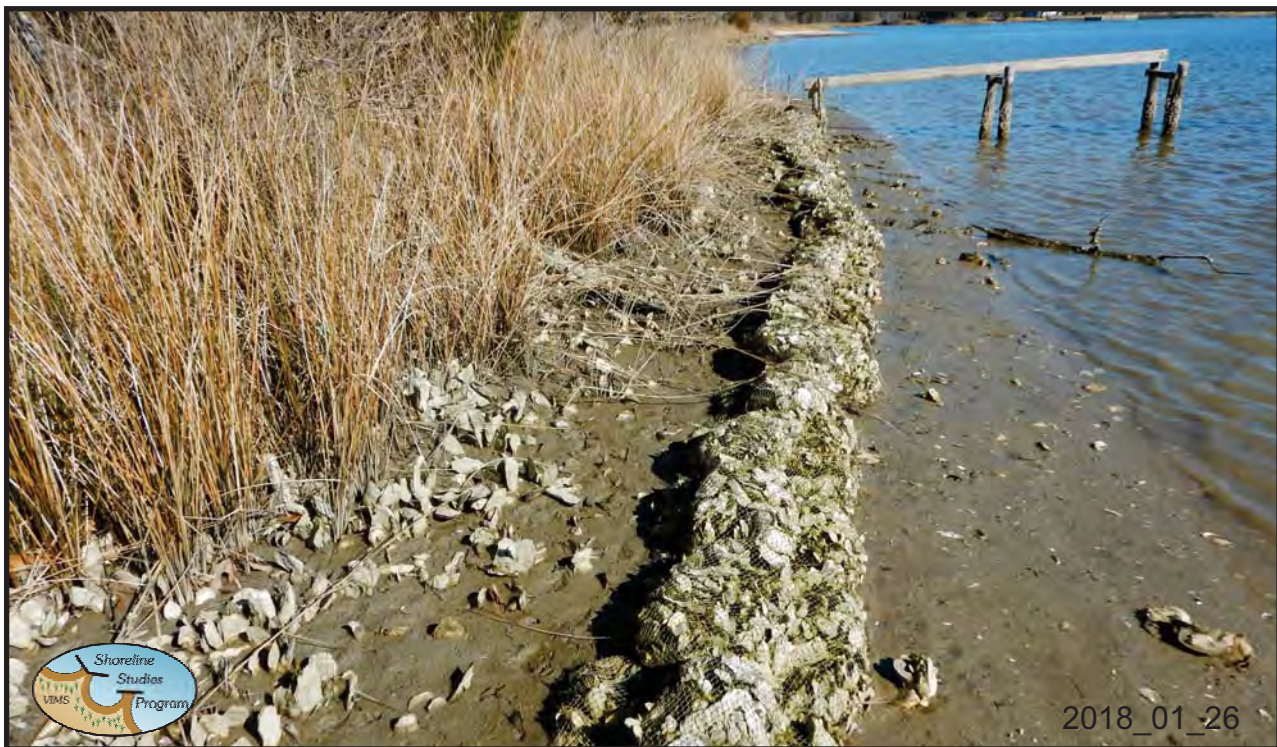
Sill 2. Some fine-grained sediment has been deposited behind the sill structure.

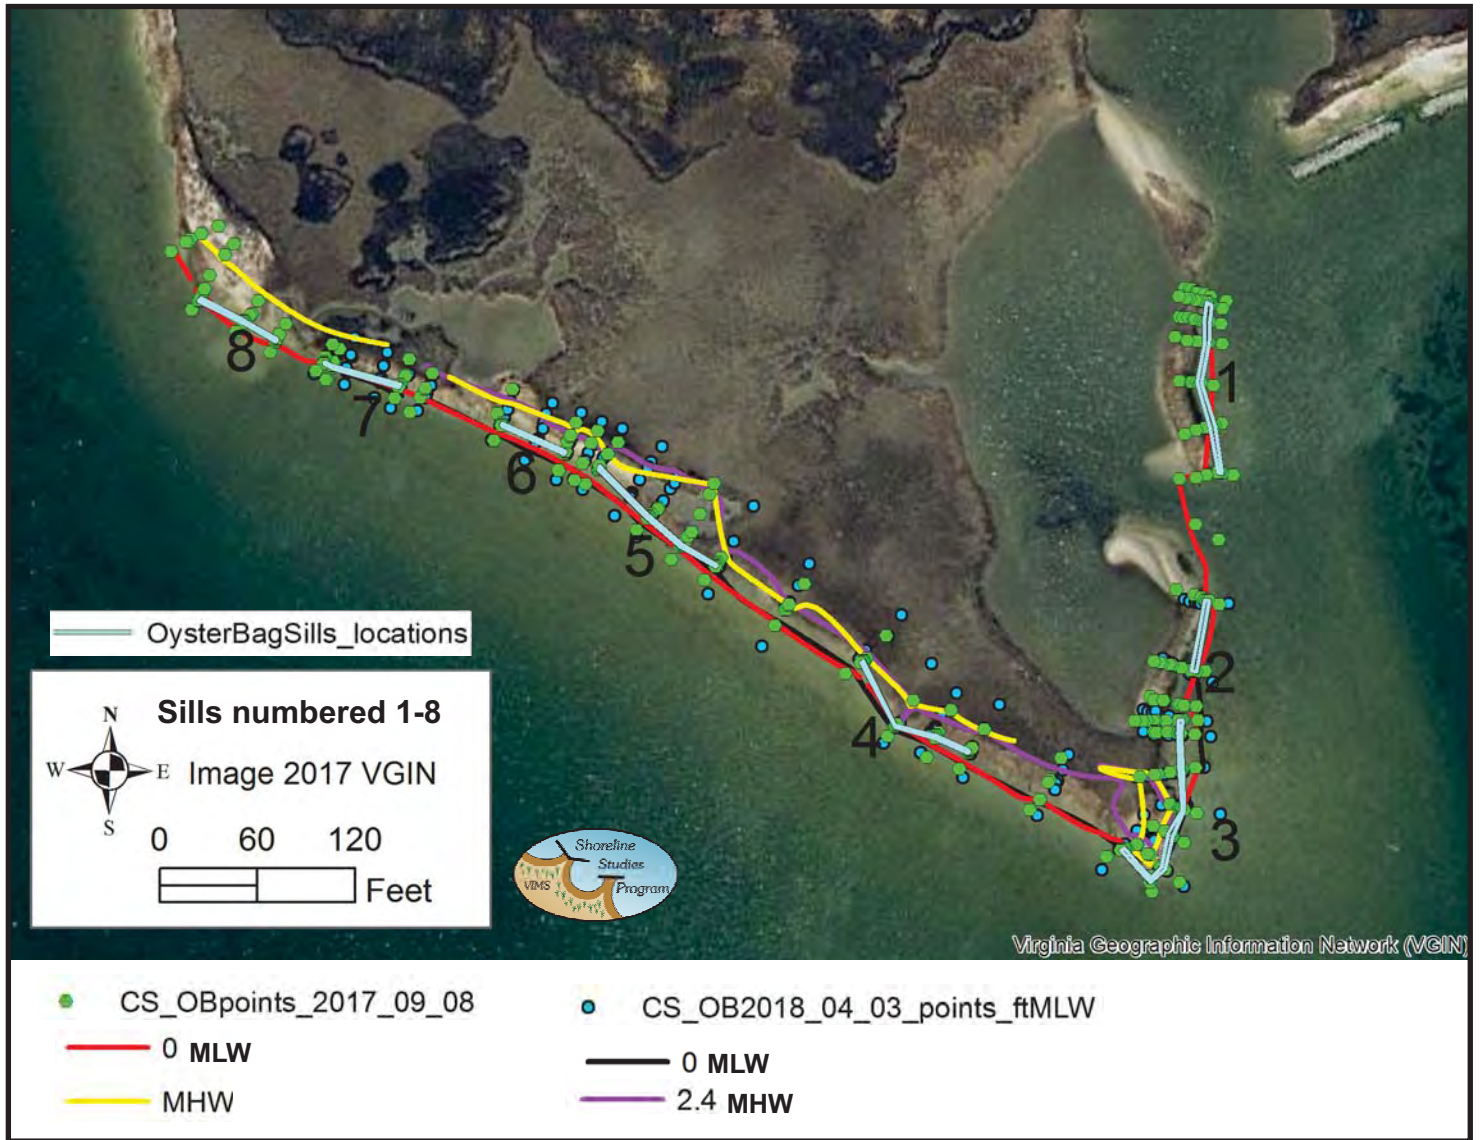
Little change occurred between the post-sill survey in September 2017 and April 2018. Mean low water and mean high water

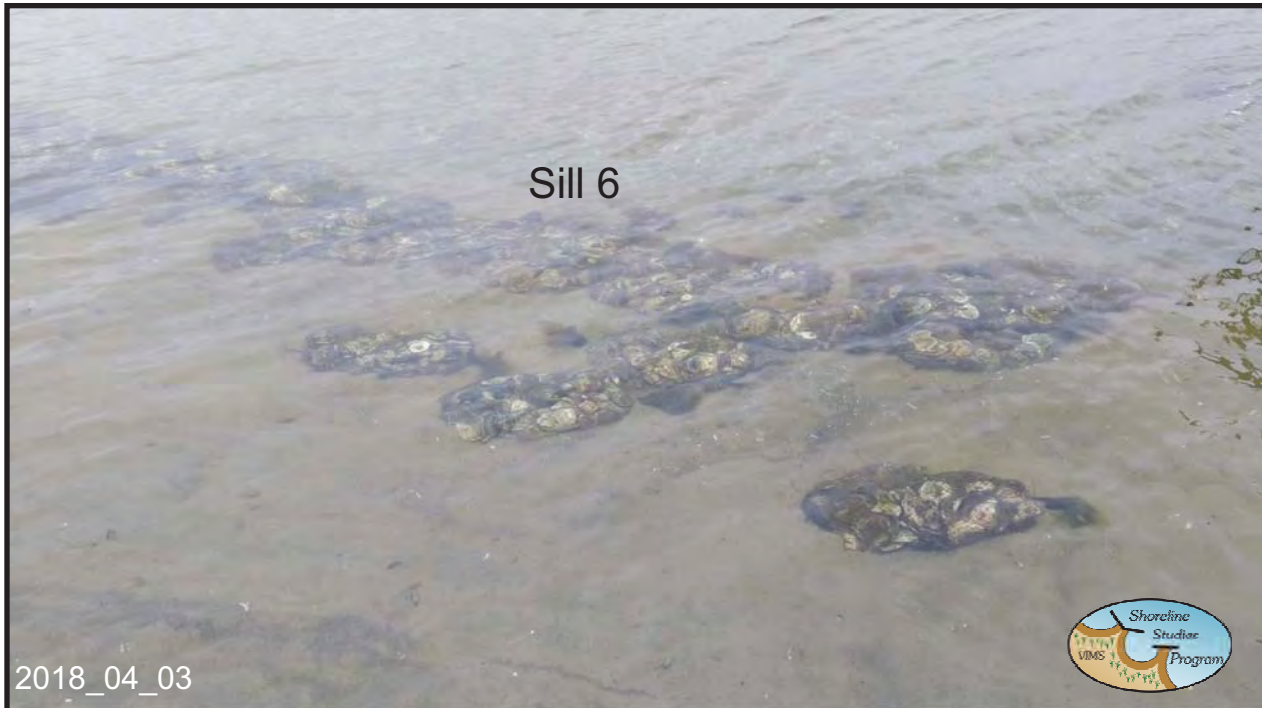
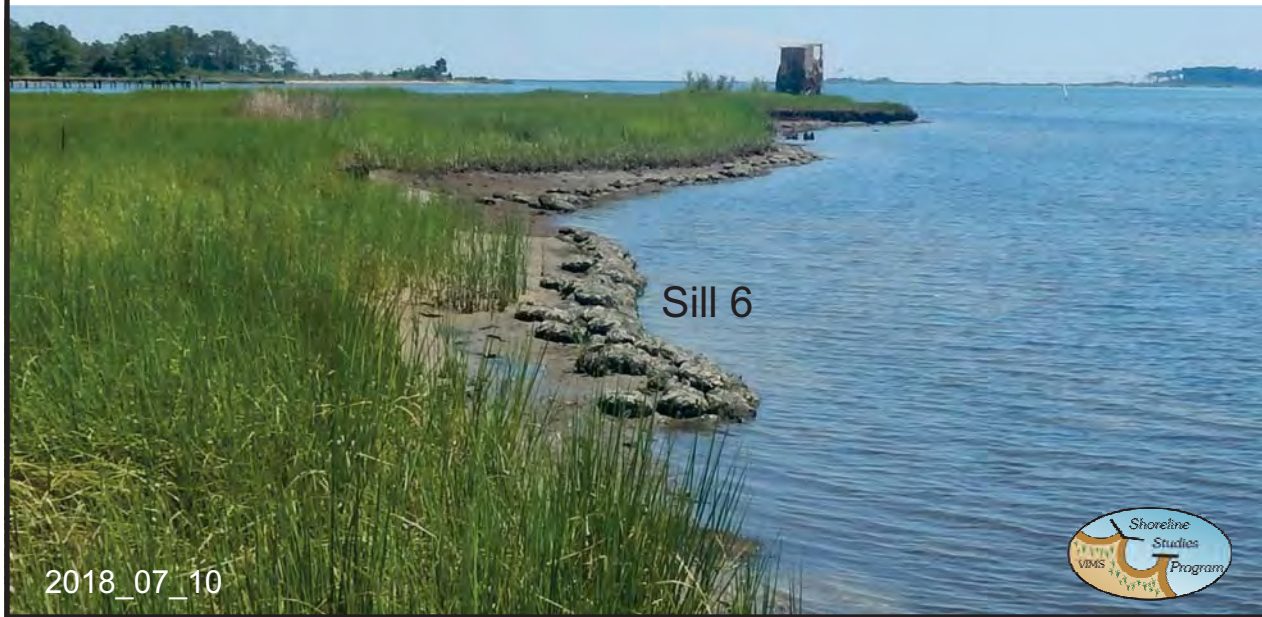
The bags in sill 6 did not maintain their structure. The bags were farther offshore and rolled in toward the marsh.

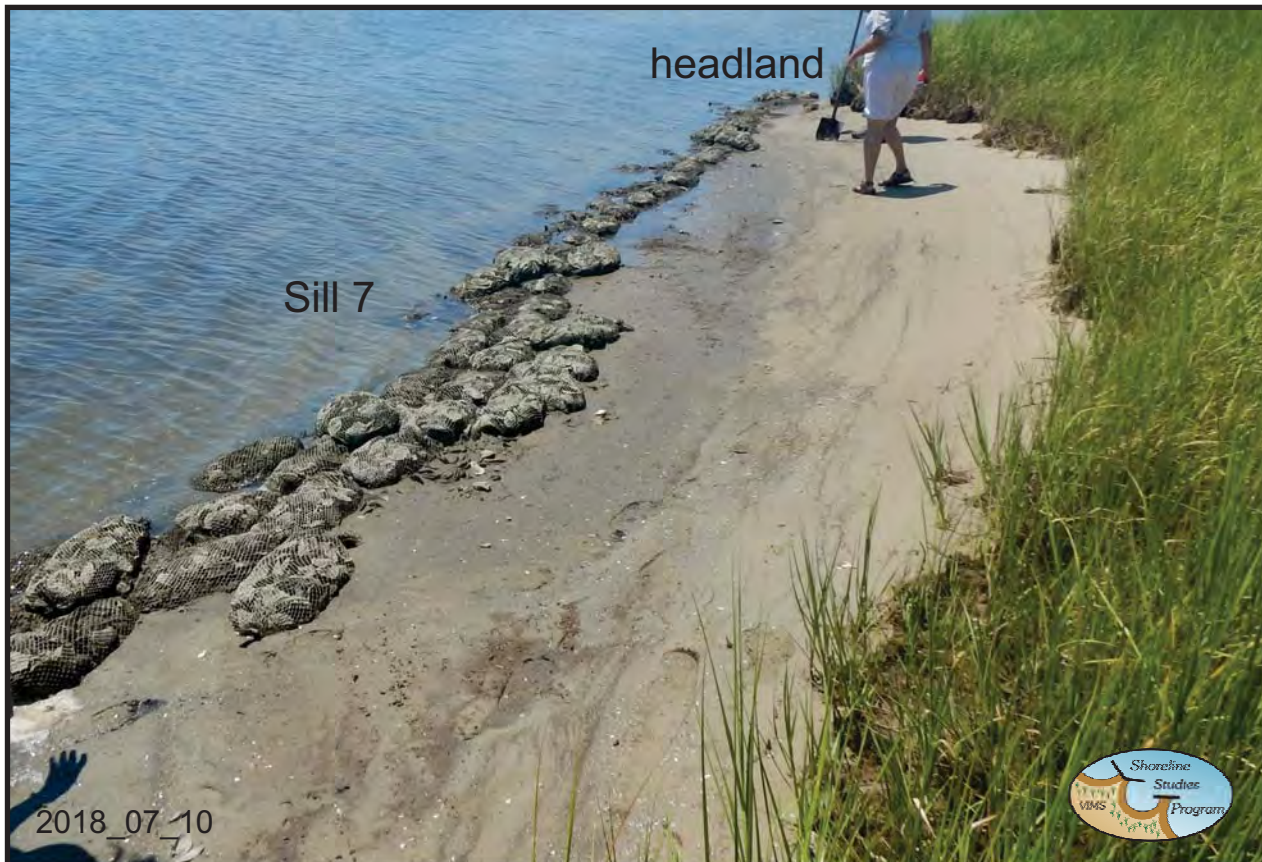
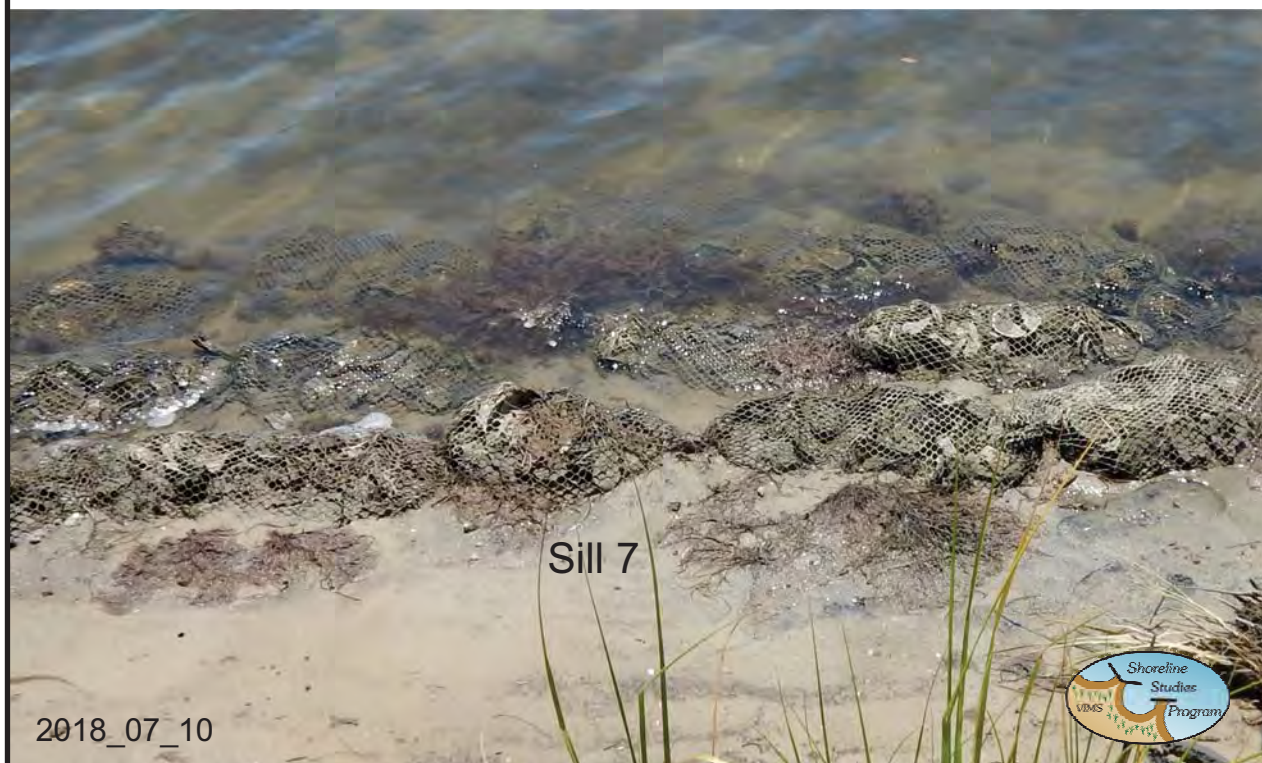
Sill 7 also had bags that rolled toward the marsh. Next to the headland, where the sill is closer to the marsh, sediment has been deposited landward of the bags.

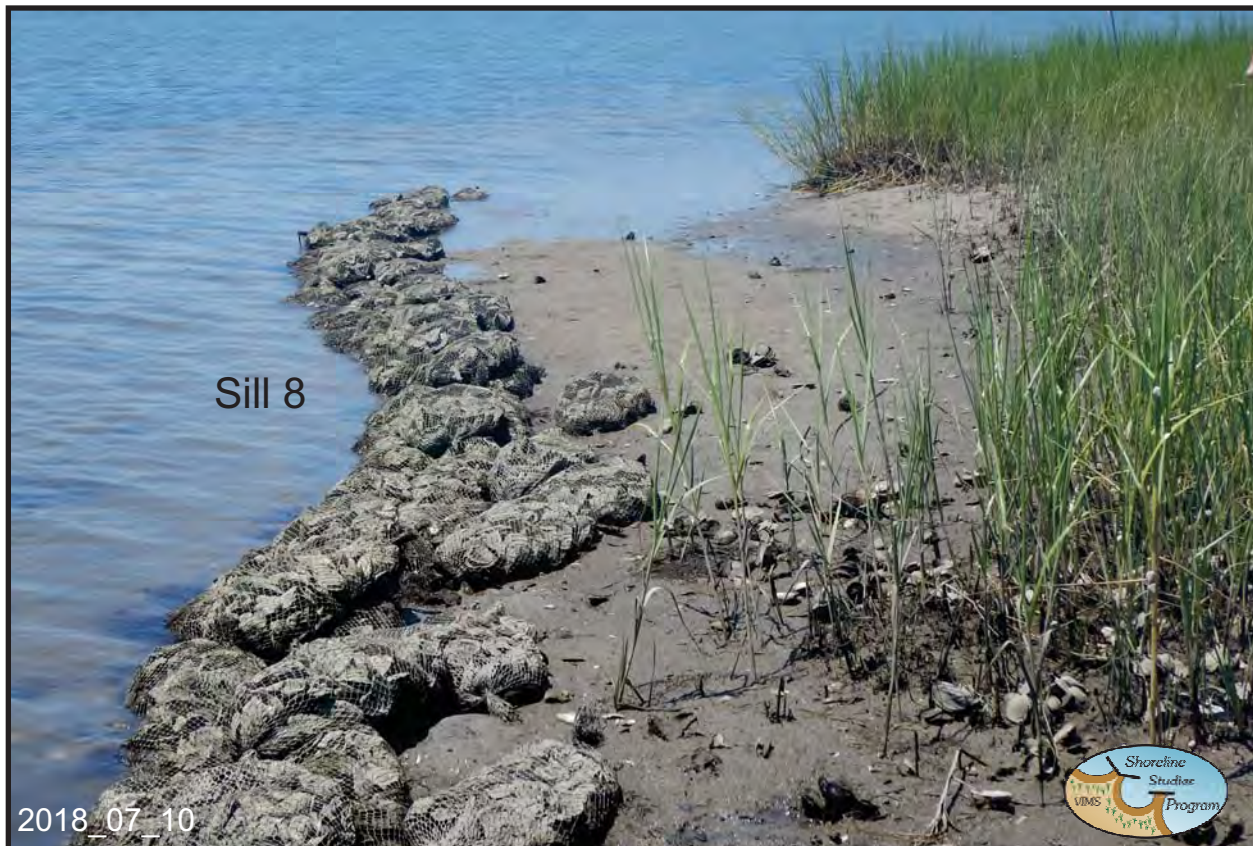
At Sill 8, sediment has been deposited behind the oyster bag sill allowing marsh grasses to grow riverward.
