A CASE STUDY OF ENGINEERING ETHICS: LESSON LEARNED FROM BUILDING COLLAPSE DISASTER TOWARD MALAYSIAN ENGINEERS

ABSTRACT

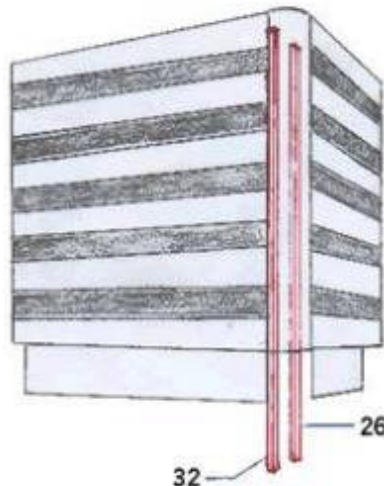
Again, the engineers checked the blue prints and original design plan of the building. After calculation process, the root cause behind the collapse was finally discovered. Throughout this investigation, it was found that the dead load of the building was not accounted in the original design plan and it means that the building itself had been stressed to the allowable limit from the first day and the collapse cannot be avoided [4].

As a conclusion, the source of collapse was determined to be the fault of the engineers responsible for the structural integrity of the building as they overlooked the importance of dead load in the construction stage which caused the under-designed columns and foundation of the building's supporting elements to crack easily during the addition of the huge live loads. The tragedy of the Hotel New World building is a type of progressive collapse. Progressive collapse occurs when a structural failure in an area continuously spread to other area through connective structure causing an enormous destruction of a building. In this case, it is due to over stressed column that caused micro-cracks in the building and subsequently downfall.

The two major columns that were affecting the overall collapse of the Hotel New World are shown in Figure 2. Column 26 experienced micro-cracks initially due to the over stressed condition. The weakening of the support structure in column 26 caused the other load propagate to another column which was the column 32. As a consequence, column 32 also unable to support the additional weight hence experienced the micro-cracks. Thus, other columns in the other corners are eventually having the same problem due to the large live load and dead load which led the whole building to collapse [6]. Fig. 3 shows the before and after the Hotel New World collapsed.

Fig. 2: Two columns that collapsed in the beginning [2].

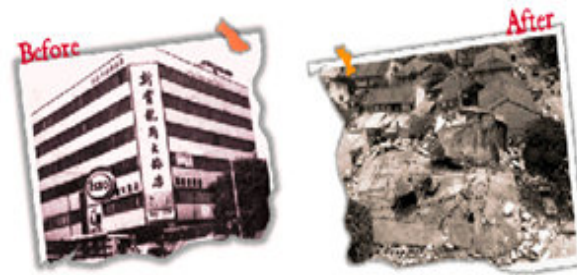
Fig. 3: Before and after the building collapsed.
