An Engineering Ethics Case Study Review: Petrobras P-36 Accident

O. A. A. Ghani^a, M. Z. Kamruzaman^b, M. F. Sulaima^c, M.N. Othman^d
Faculty of Electrical Engineering, Universiti Teknikal Malaysia Melaka, Malaysia

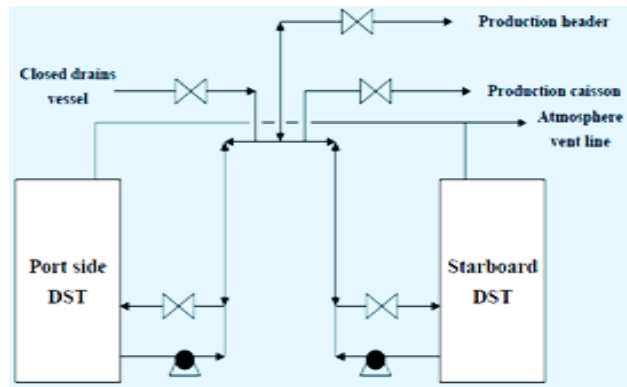
The Fig. 5 and 6 show that the system is in a multi-functional failure, as well as deficiencies in the initial setup which was introduced as a guide [4-5].Due to the delay in the drain pump port emergency drain tank inevitable and clarified the fluid flow takes approximately 1 hour. This fluid can flow through the valve leak emergency drain tank closed inner right side, which, having no secondary protection in place to prevent leakage. After the tank set off water pipes burst and the sea was breaking, flooding has caused seawater pump travel distance becomes shorter. The valve components (still in set design failure) fail in the open position, after the flood of uncontrolled inner pole began to flow freely. Despite the failure to make a choice set is not necessarily yes presumed guilty , also place control without any advance preparation system for controlling the flow of sea water when the pump is running and has are short circuited from the flood. In addition, the failure of watertight dampers in the ventilation system works add to the effects of more severe flooding.

Fig. 5 Condition of component failure
