# A CASE STUDY OF ENGINEERING ETHICS: LESSON LEARNED FROM BUILDING COLLAPSE DISASTER TOWARD MALAYSIAN ENGINEERS

*This paper presents the case study on the Hotel New World tragedy. The building collapsed on 15th March 1986 and an investigation was conducted to determine the main cause of this tragedy. There were several speculations made on the cause of the collapse such as internal explosion, bad concrete mixture and swampy land affecting the building's foundations. However, after thorough investigations, these speculations were proved to be inappropriate and the main cause was found to be due to the engineer's miscalculation during the designing stage which leads to this catastrophic failure of the building. Rescue operation was initiated immediately after the collapse to rescue the victims and the aftermath of this tragedy had led to multiple reclamations. These reclamations include the endorsement of Building Control Act 1989 along Building Control (Accredited Checkers) Regulations 1989 as a stricter quality control measure. The analysis shows that this case may be due to unwanted mistakes or negligence of the engineers in carrying out their duties. Several actions were taken a

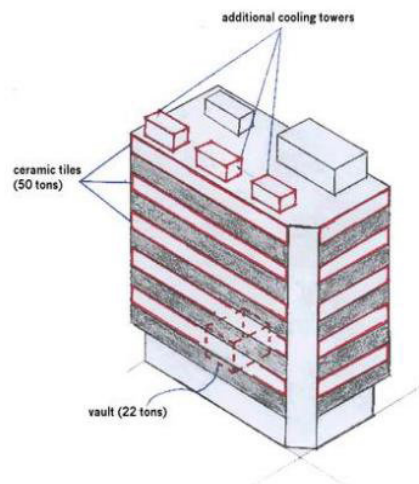
Fig. 1 shows that heavy equipment, which were not stated in the original design plan, were found in the debris. Those equipment are the extra loads added by the owner during the building's 15 years of lifespan.

Fig. 1: Additional loads to the building [2].

- i. In 1975, there was a vault with 22 tons placed in the bank on the ground floor.
- ii. In 1978, two additional cooling towers were added by the owner on the roof of the building.
- iii. In 1982, exterior layer on each floor were fixed with a heavy duty ceramic that carries a total of 50 tons due to architectural reasons.
- iv. In 1986, an extra cooling tower was added on the roof by the owner again.

Nevertheless, all these additional loads was already accounted under the live load category in the design plan. The engineer's calculations proved that the extra amount of weight does not contribute much to the collapse [4].

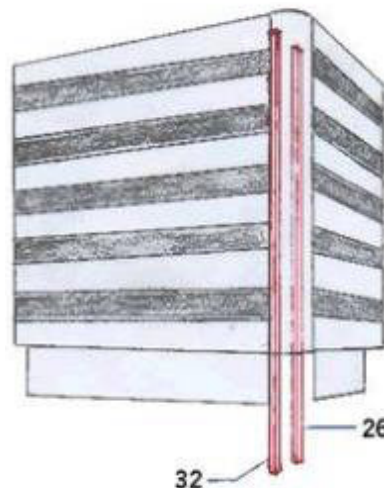
Again, the engineers checked the blue prints and original design plan of the building. After calculation process, the root cause behind the collapse was finally discovered. Throughout this investigation, it was found that the dead load of the building was not accounted in the original design plan and it means that the building itself had been stressed to the allowable limit from the first day and the collapse cannot be avoided [4].

The two major columns that were affecting the overall collapse of the Hotel New World are shown in Figure 2. Column 26 experienced micro-cracks initially due to the over stressed condition. The weakening of the support structure in column 26 caused the other load propagate to another column which was the column 32. As a consequence, column 32 also unable to support the additional weight hence experienced the micro-cracks. Thus, other columns in the other corners are eventually having the same problem due to the large live load and dead load which led the whole building to collapse [6]. Fig. 3 shows the before and after the Hotel New World collapsed.

Fig. 2: Two columns that collapsed in the beginning [2].

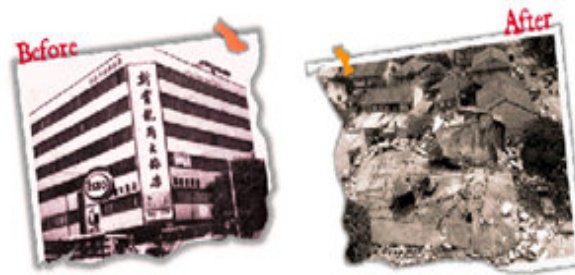
Fig. 3: Before and after the building collapsed.
