Geomorphological Accidents caused by the Tokachioki Earthquake

Kasuke NISHIMURA, Shuryo SEGAWA, Hiroshi MIZUNO,
Hosei HOTTA, Osamu MIURA, Toshikazu TAMURA
and Takekazu AKAGIRI

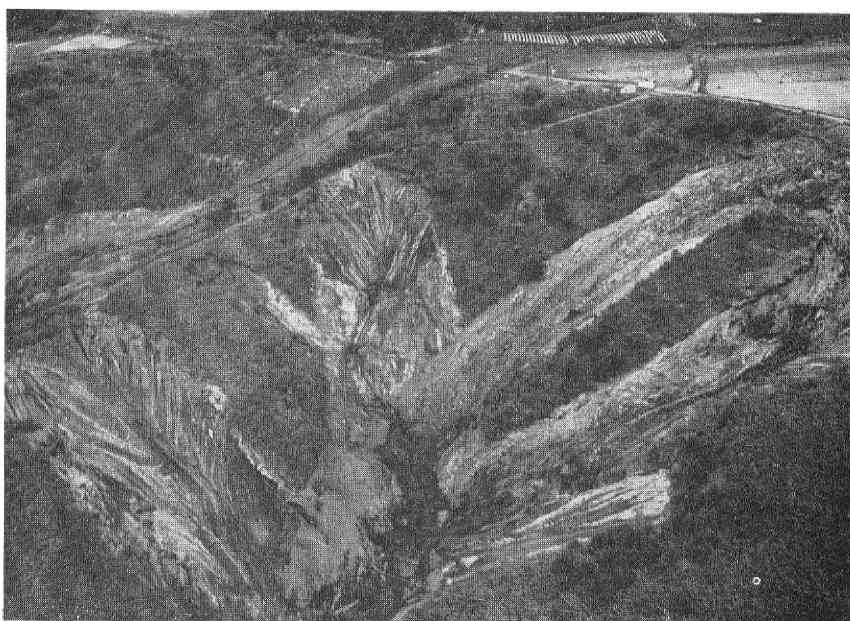
Most of slope failures are concentrated in the valleys of small tributaries of the Asamizu river (west of Hachinohe) where there had been the heaviest rainfall amounting to 210 mm (observed at Gonohe) in preceding three days (Figs. 2 and 3). Each failed zone on the slope between the undulating upland surface and the narrow valley floor is composed of erosion area, runway through which detritus passed and deposition area (Figs. 4 and 5). The form of erosion area is apparently classified into Scauper and Plane types (Fig. 5, Photos. 1, 2).

Photo. 1 Erosion areas and runways of six failed zones at Temmatai.
Two erosion areas, the left and the right sides, are of Plane type and the central four erosion areas are of Scauper type.

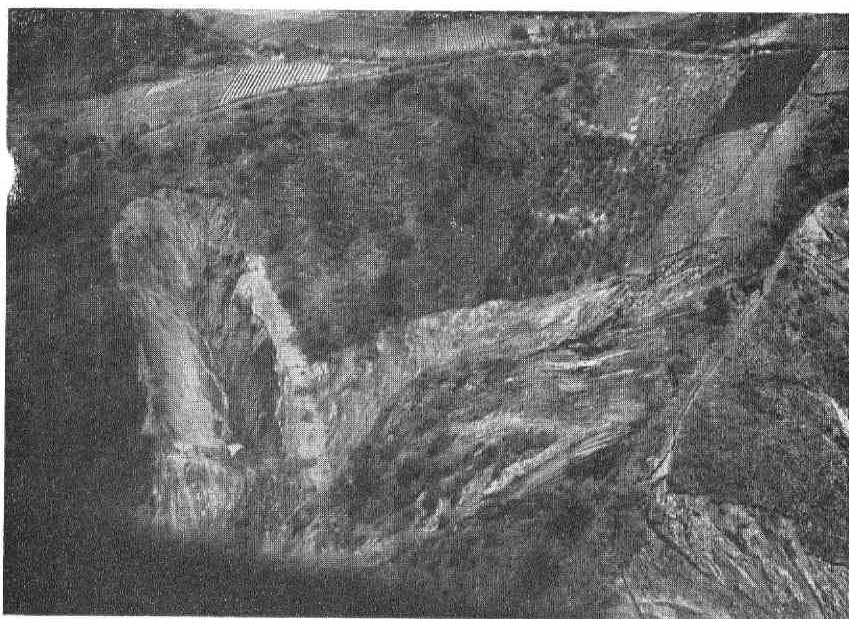
The erosion area of scauper type is situated in small shallow depression excavated in upper convex slope. The lower end of the erosion area looks like a Karboden and is at the boundary between upper convex slope and middle straight slope (Photo. 3).

Photo. 2 Scauper-type erosion areas formed on one side of the shallow depressions in the upper convex slope.

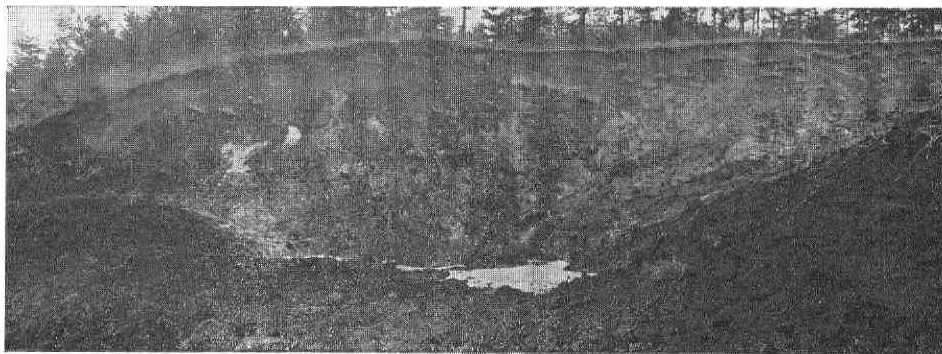
↑
 Photo. 3 The erosion area and the Karboden-like terracette at the lower end of it at Daibutsu (Loc. 1 in Fig. 3). See Figs. 5 and 6 also.

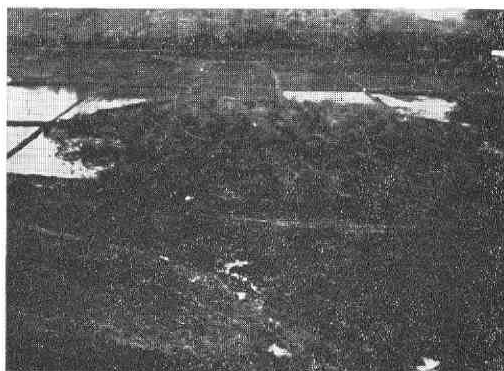
Deposition area spreads widely on lower concave slope and valley floor like a palm leaf or a tongue where the valley is wide enough (Photo. 4) and elongated downstream where it is narrow. Deposited materials on the area about 1 m in depth are consisted of smashed materials of black surface soil and dark brown subsoil with

←Photo. 4 The deposition area of the failed zone at Eifukuji (Loc. 2 in Fig. 3). See Fig. 5 also.

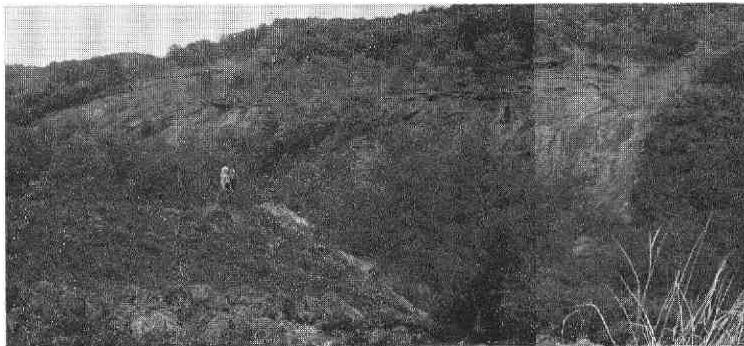
There are some compound types of scauper and plane types in erosion area (Fig. 5b). The slope failures observed at Nyûguchi-zawa (Photo 5), to the north of the area shown in Fig. 3, are varieties of plane-type failures fit for the local topographic setting which has small river terraces in front of upper convex slopes. The case seen in the campus of Kitazato College, Towada city, is a scauper-type failure lacking runway because of the gentle (5°) and low (10 m) valley wall (Photo. 6). Collapsed materials of these cases are stratigraphically same as the region to the west of Hachinohe.

↑
 Photo. 5 Failed zones at Nyuguchizawa.

Erosion areas of varial Plane type, straight (relatively steep) runways and deposition areas are seen. There are many large blocks with standing trees on runways and deposition areas.

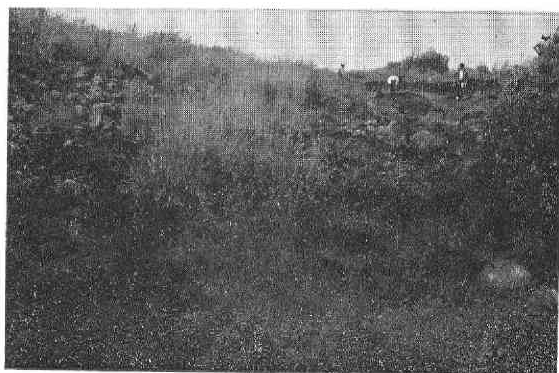
←Photo. 6 The failed zone in the campus of the Kitazato College. Erosion area adjoins to deposition area to this side and runway is lacking.

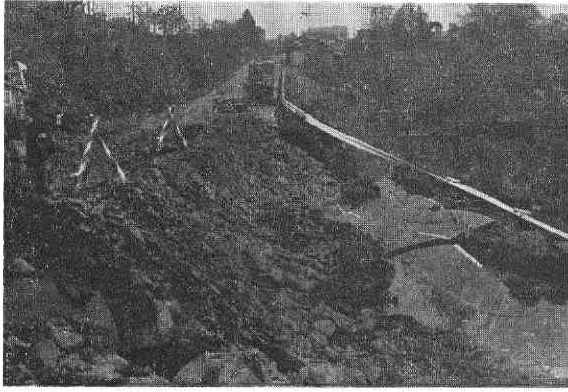
The destruction of railroads and highways at more than two hundred places in Aomori prefecture were caused by the collapses of artificial embankments such as railroad basements or highway roadbeds across the dissected valleys. They were generally filled with dark-brown loamy volcanic ash (Photo. 7).

The heavy rainfall just before the earthquake had prepared the collapses of embankments, that is, the heavy rainfall above 160 mm in three days made the embankments fragile, and the earthquake itself was no more than the motivation of collapses.

Photo. 7 Roadbed destruction of National Highway Rt. 104 near Kita-takaiwa

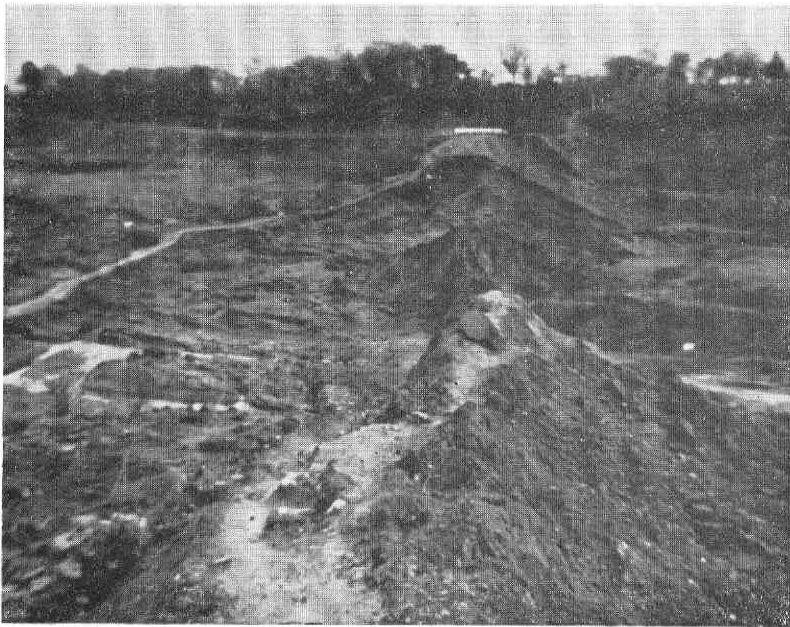
At Hayakake-numa the earthquake caused several cracks parallel to the length of the dam and broke it at two places. Total width of the breaks reached about 150 m (Photo. 8). Consequently a flood happened and it flowed with full strength eastward to the Tanabu river, and it washed away the roadbed of the Ohata line railroad (Photos. 9, 10). Then the flood flowed down southward along the Tanabu river, when the flood-flow was weakened and controlled by micro-landforms, and formed a temporary lake at the upper side of Akasaka bridge east of Mutsu city.

Causes of breaks of the dams in Shimokita district are as follows: 1) dams were made of earth and constructed over 20 years before, 2) capacity of reservoirs were large and every reservoir was filled fully with the rain water of the preceding heavy rainfall, 3) the shock of the earthquake was too strong.

Photo. 8 Dam destruction of Hayakake-numa Reservoir

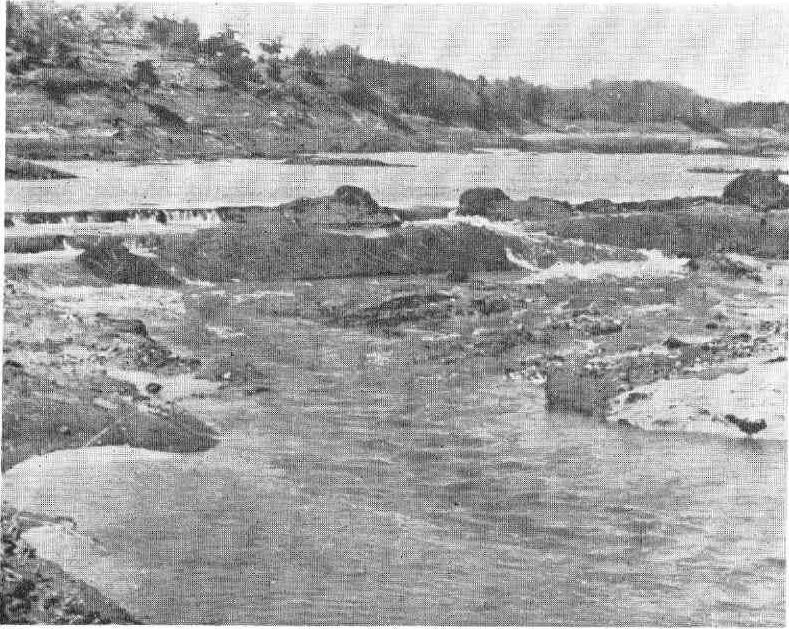
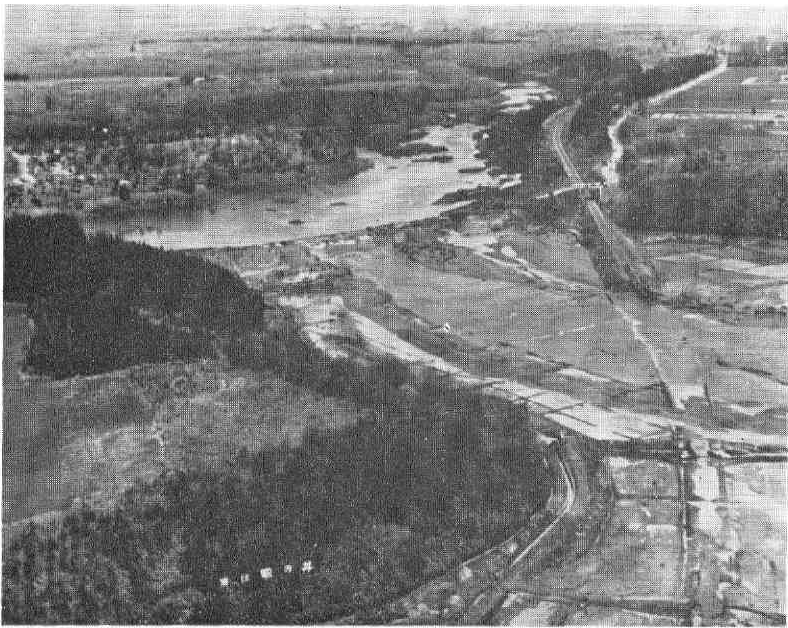
Photo. 9, 10 Hayakake-numa immediately after the destruction

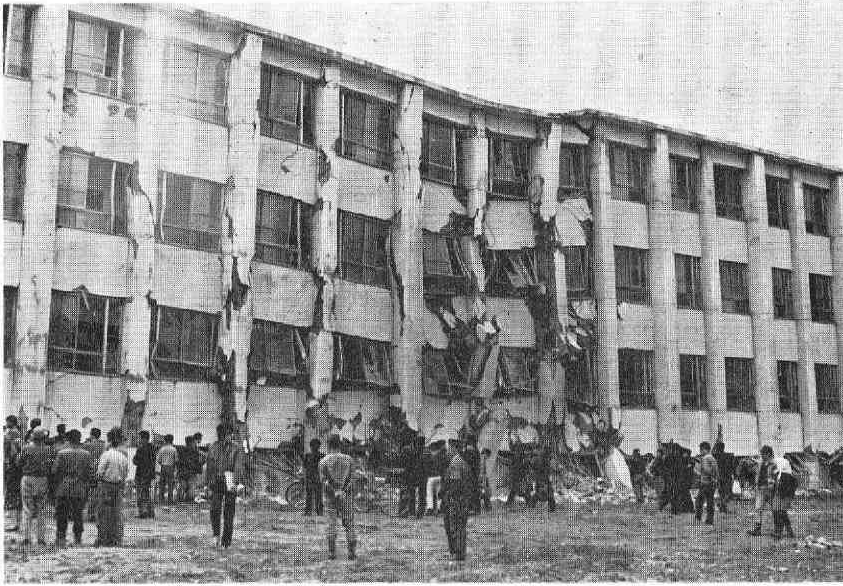
These accidents are almost always found in the land reclaimed from the sea. The collapse of the Hakodate college on the coastal terrace surface is the only exception, which is perhaps due to the architectural faults (Photo. 11)

Photo. 11 Hakodate College severely destroyed

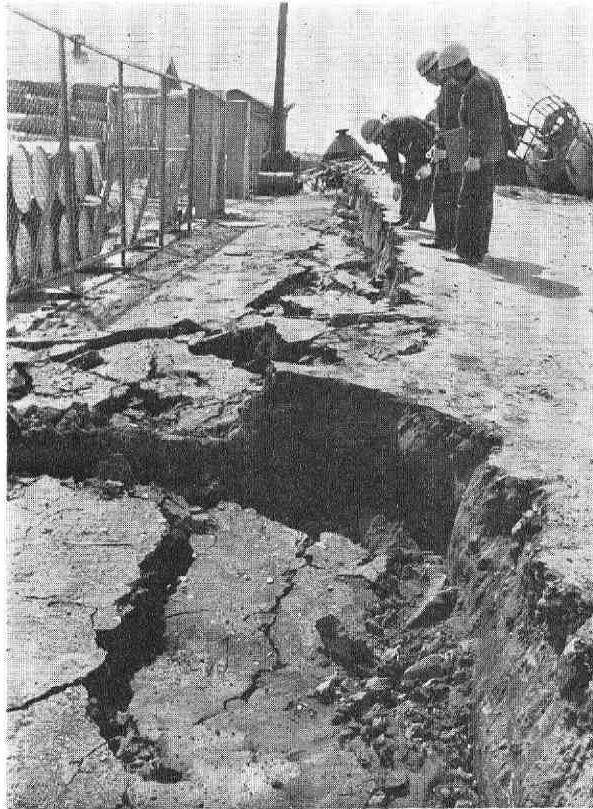
Landform dislocations caused by the Tokachi-oki earthquake in Hakodate city are classified into cracks, horizontal and vertical dislocations mainly in the reclaimed lands (Photo. 12, 13).

Photo. 12 Fissured yard, Mitsubishi Petroleum Co., Hakodate City

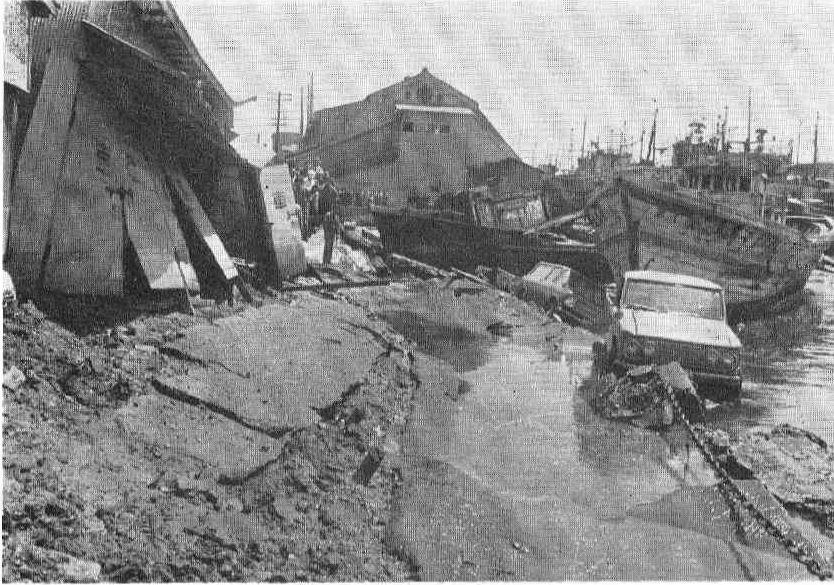
Photo. 13 Subsided Wharf in Hakodate City

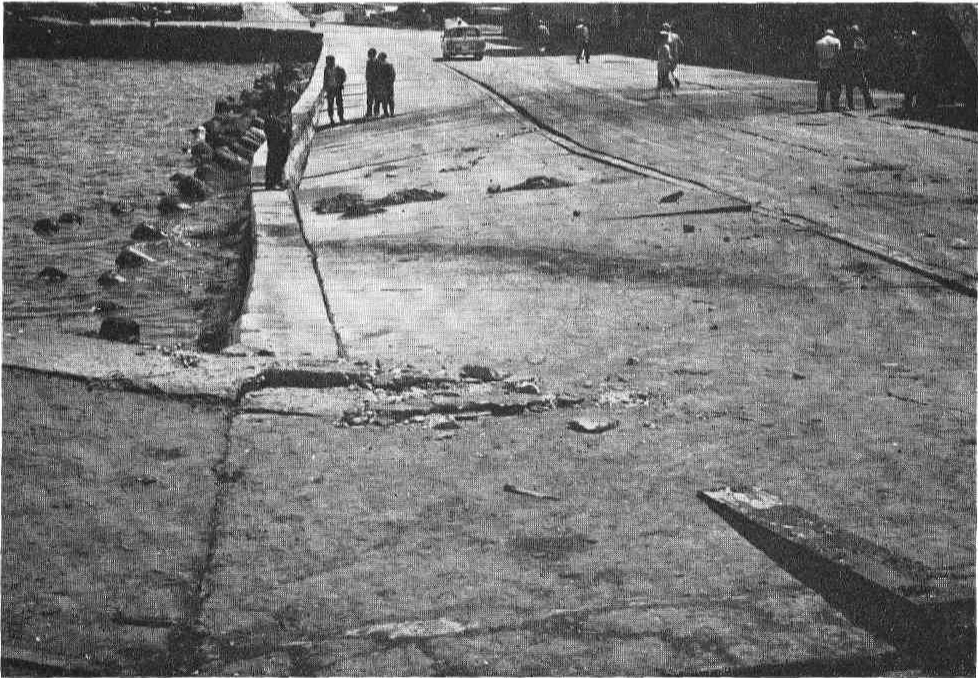
In the coastal area the land had been graded for the purpose of constructing factories, wharves and sheds. Unconsolidated lands which once had been back-marshes among beach-ridges were depressed unequally and jetted out water, and then many factories, wharves and sheds were damaged there (Photo. 14).

Photo. 14 Subsided Wharf in Aomori City

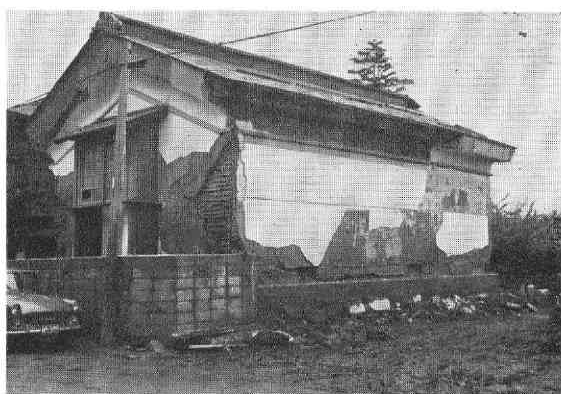
Photo. 15 A godown in Noheji Town

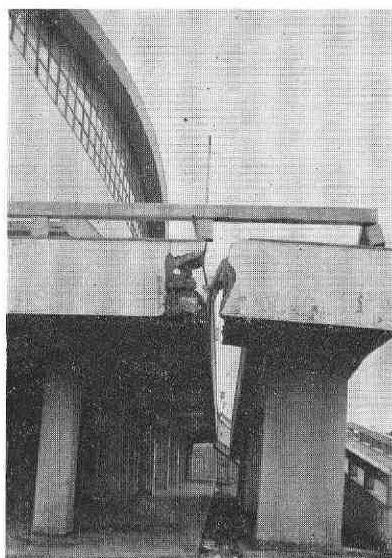
below the upland called Hachinohe terrace were damaged, for example, the municipal gymnasium (Photo. 16).

Photo. 16 Hachinohe Municipal Gymnasium

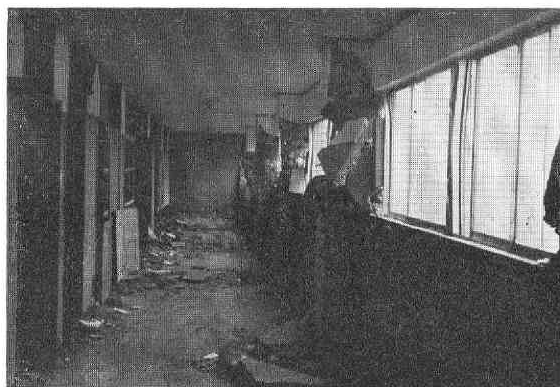
The three-storied steel-concrete building of Hachinohe Technical College on another terrace 50–53 m above sea level suffered severe destruction by the earthquake (Photo. 17). The subsurface geology of the ground of the building is almost the same as the Hachinohe terrace. Before the College was built, there had been a few open, shallow valleys cutting the terrace surface as on the Hachinohe terrace (Fig. 15). In the college campus there occurred cracks on paved road, and depressions and mud-jetting on the ground. Especially, in the first floor of the college building many parts of wall cracked, many pillars and windows broke. It is dangerous to build steel-concrete building on the very position of the above mentioned valleys buried with thick volcanic ashes which absorb water easily.

Photo. 17 Hachinohe Technical College
