Electron Diffraction Study on Nickel Surfaces Tarnished in the Course of Heat-Treatment in Hydrogen

Shiro OGAWA and Denjiro WATANABE

The Research Institute for Iron, Steel and Other Metals

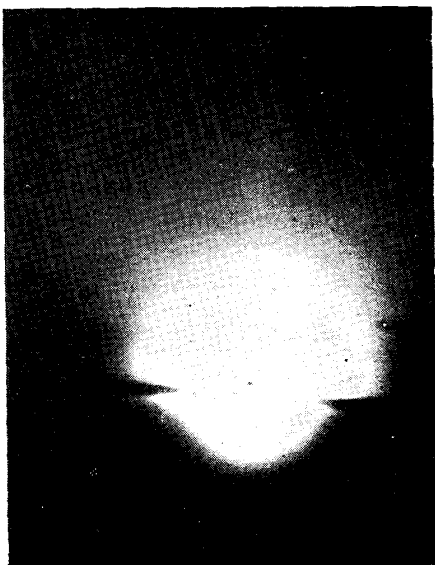
Fig. 1. A 1999
Heat-treated at 900°C
for 1 hr.
Milk-white appearance

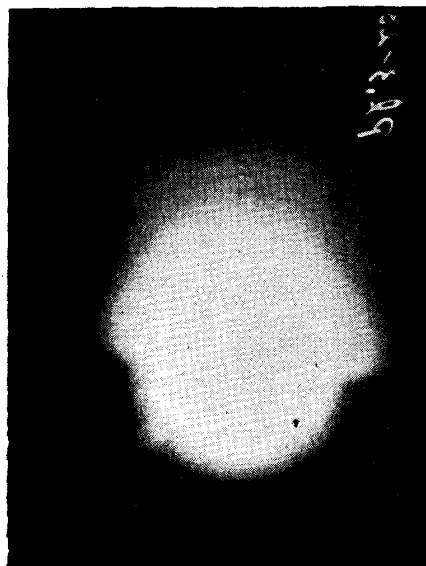
Fig. 2. No. 1
Heat-treated at 900°C
for 1 hr.
A little milk-white appearance

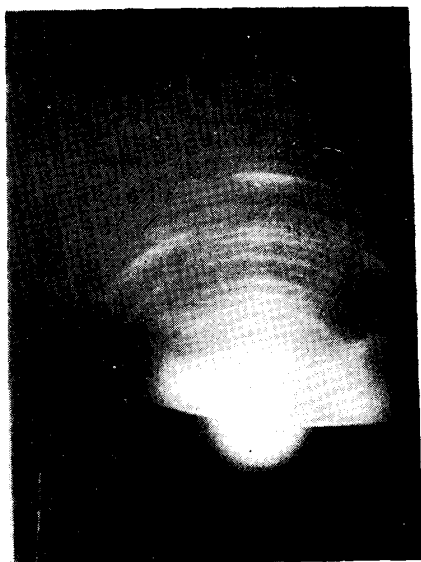
Fig. 3. No. A
Heat-treated at 900°C
for 1 hr.
Lustrous.

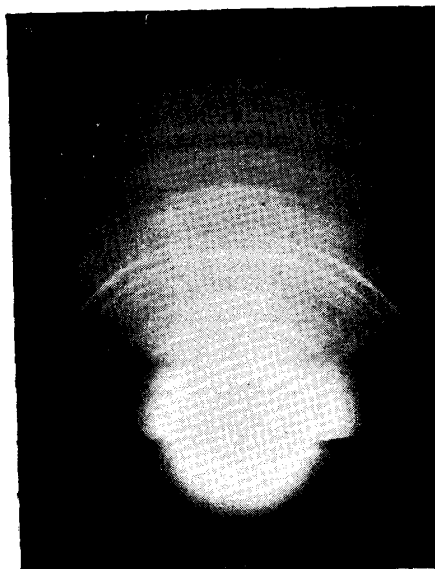
Fig. 4. A 2017
Heat-treated at 900°C
for 1 hr.
Lustrous.
