Journal of University of Babylon, Engineering Sciences, Vol. (26), No. (5): 2018.

Geometrical Design Errors in Duhok Intersections by Driver Behavior

Abstract

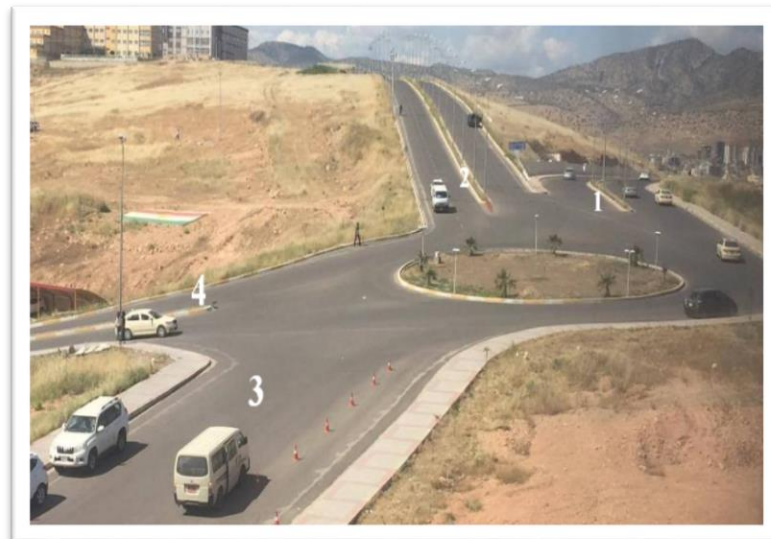
Approach 2 from the college of medicine has a very steep slope, Figures (4) and (5). The slope towards the roundabout reaches 14%. Making it very difficult to break at the roundabout entrance. If driver enter the roundabout at a speed of 30 km/hr he needs about 40m to stop if break at the roundabout entrance. According to the AASHTO green book (AASHTO, 2011) “grades in excess of 3 percent should be avoided on the intersecting roads and where conditions make special designs too expensive, grades should not exceed about 6 percent. To reduce the speed on this approach a rubber hump was put at the entrance of this approach to the roundabout.

Figure (4) Photo of the roundabout taken from the department of psychology

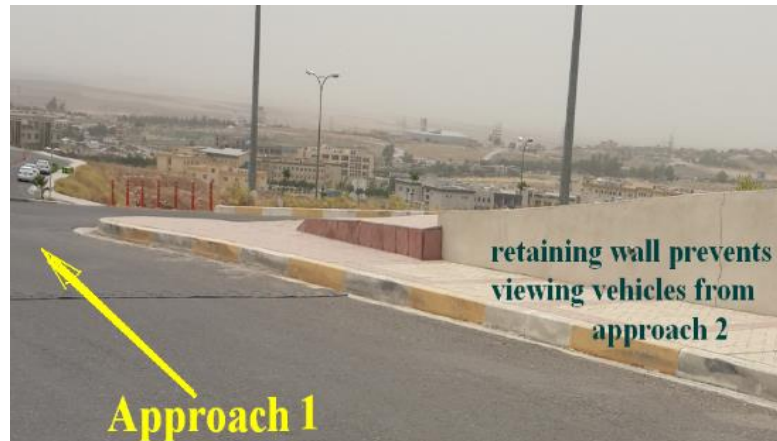
because of the high slope of approach 2 and the existing of a retaining wall, Figure (5), separating approach 1 and 2, no enough stooping sight distance is exist between vehicles approaching the roundabout from directions 1 and 2. The available stopping sight distance is about 16m, Figure (6), whereas the required stopping sight distance for a vehicle approaching from 1 at a speed of 30km/hr is 28m.

Figure (5) Retaining wall shorten the stopping site distance for vehicles at approach1

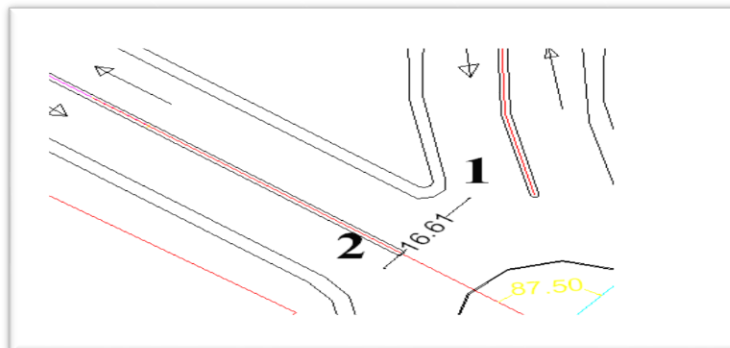
Figure (6) the available stopping sight distance for vehicle at approach 1

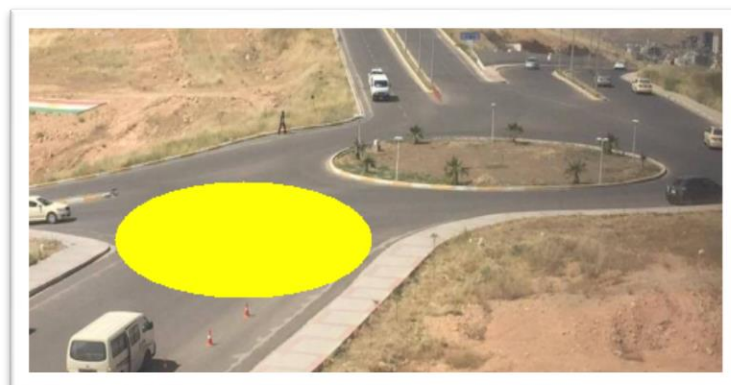
3- The lack of proper divisional islands and the small size of the central island provide a large wander space, Figure (7). This will encourage drivers to make wrong side movements.

Figure (7) Large wander space on the roundabout

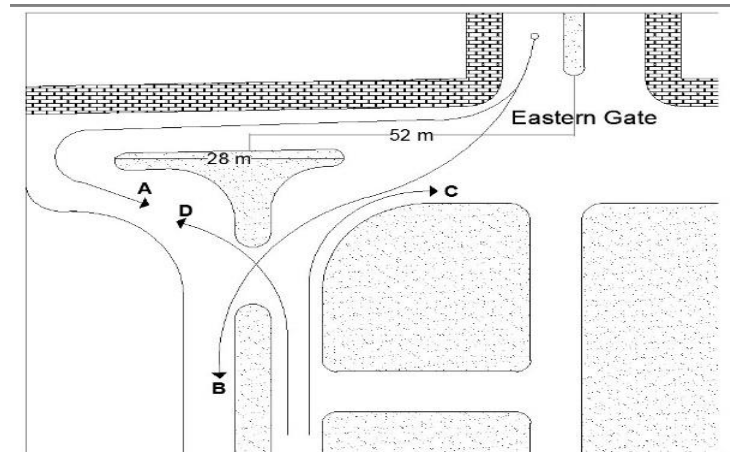
Figure (8) the intersection on the eastern gate

- 1- A large eccentric alignment between the university main gate and the main road. The (52) m eccentricity makes the traffic flow more difficult, create some congestion on the morning peak hour, and encourage wrong side driving.
- 2- Drivers exiting the university main gate toward the main road have to move around (28) m divisional island, direction (A), Figure (8) before entering the main road. This encourage wrong side driving in (B) direction.
- 3- Drivers heading for the university cultural center from the main road should rotate around the (28) m divisional island in a sharp curve. This will encourage wrong side driving in direction (D)

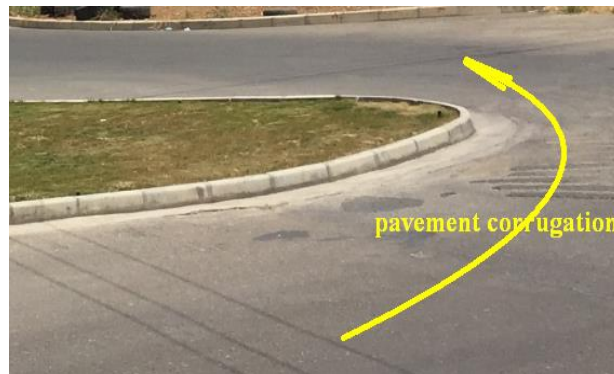
On driving on path (A), vehicles faces a sever pavement corrugation, Figure (9), encouraging driving on wrong path.

Figure (9) Pavement corrugation around the divisional island

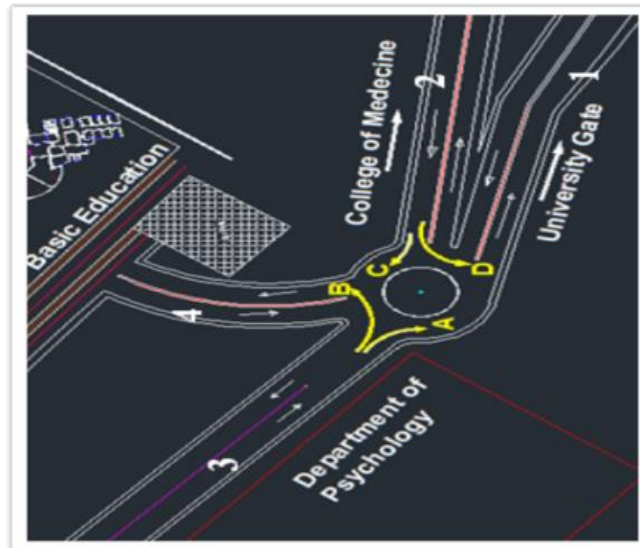
As previously mentioned the geometry of the roundabout encourage wrong side movement. The large circulatory roadway and the lack of proper divisional islands increase wander space. Giving the driver a thought that it is a large open pavement area and not a roundabout. Figure (10) shows the observed wrong side movements: B, and D.

Figure (10) Observed wrong side movements, B and D

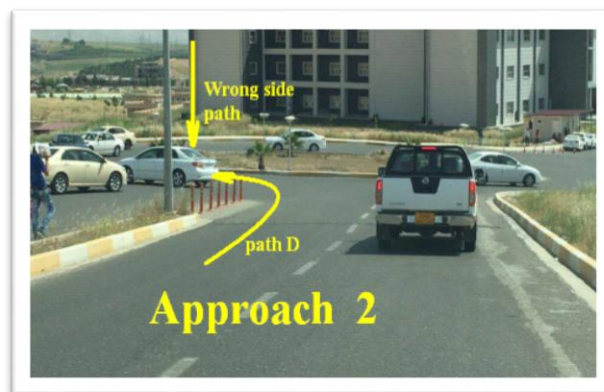
Wrong side driving on path D, Figure (12), is hazardous as there is not enough stopping sight distance for vehicles entering the roundabout from approach 2 to see the wrong side moving vehicle.

Figure (12) Wrong side movement from approach 2

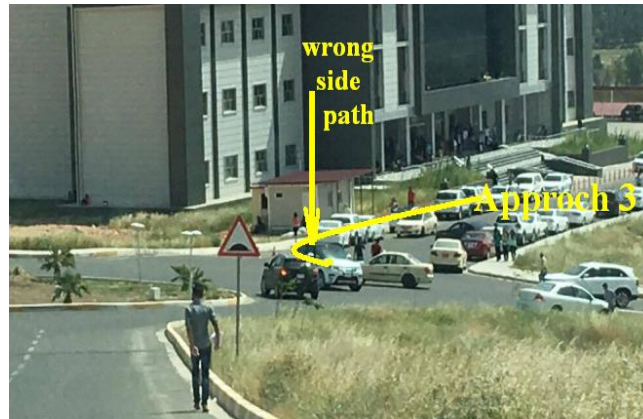
The majority of wrong side driving took place on path B, approach 3, Figure (12). About 32% of vehicles entering the roundabout from approach 3 make wrong side turn. This can be explained by examining the roundabout geometry. The absence of a divisional island on approach 3 and the large wander area, shown in Figure (6), encourage this behavior.

Figure (13) Wrong side movement from approach3

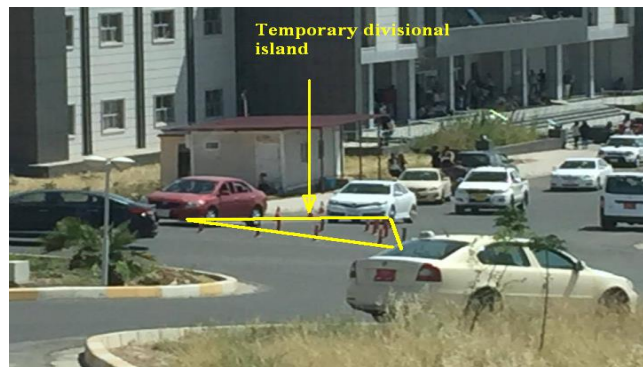
Figure (14) Temporary divisional island at entrance of approach 3

As a solution a temporary divisional island was established, Figure (14). This island should discourage driving in the wrong path B. on erecting this island, a count was made on vehicles emerging from approach 3 and the data is listed in table (2)

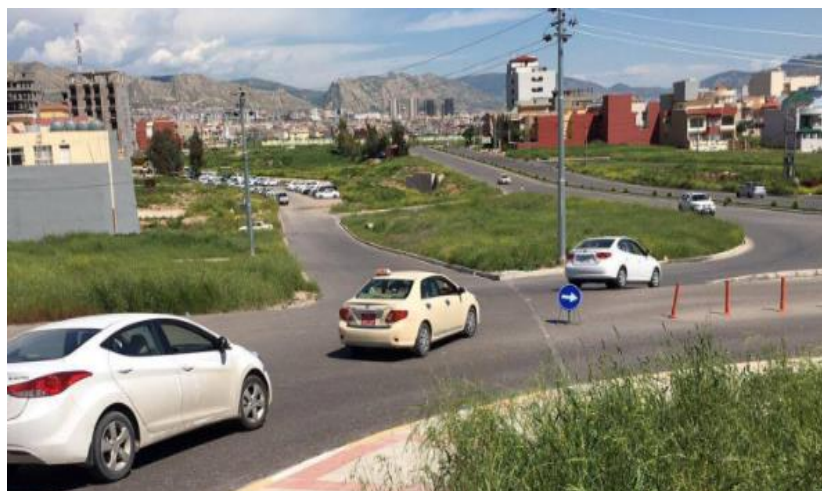
Figure (18) the direction guide sign

As a control measure, a direction sign, Figure (18), was fixed to guide drivers for the right direction A.

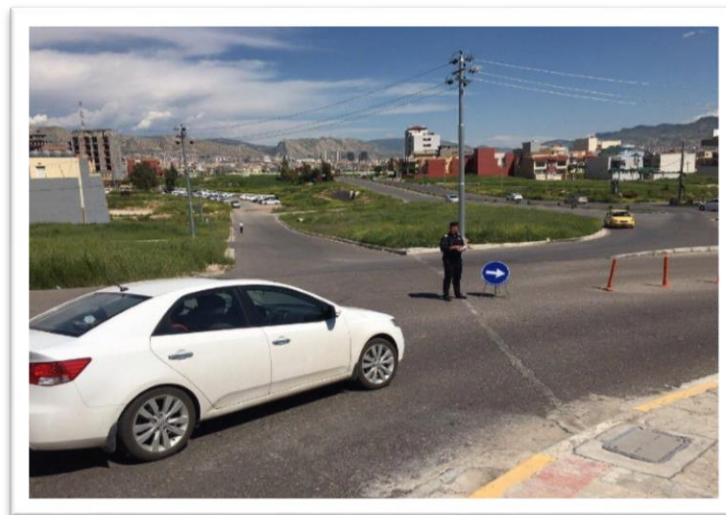
Figure (21) a standing policeman beside the direction sign

A new count was made to see the effect of having a watching traffic policeman, Figure (21), beside the direction sign. Data is listed in table (5)
