Field Experimental Study on Corrosion Mechanism of Well Lai 14-9

Abstract

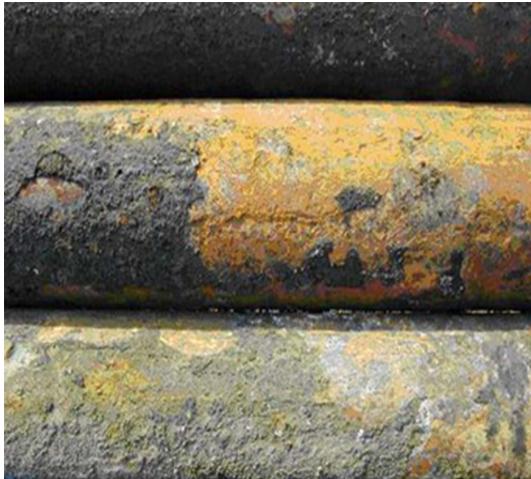
Figure 1
External Corrosion of Casing

The conformation of casing corrosion is shown from Figure 1 to Figure 3. Casing corrosion has the following characteristics: (a) The corrosion fouling in outer layer of the casing wall is easy to fall off, its color is black and the thickness is 2-3 mm, and the inner layer of the casing wall is made up of rust material with different sizes, which indicates acute local corrosion (Figure 1); (b) There is even corrosion fouling covering the inner wall of the casing, its color is tawny and the thickness is 1-2 mm and

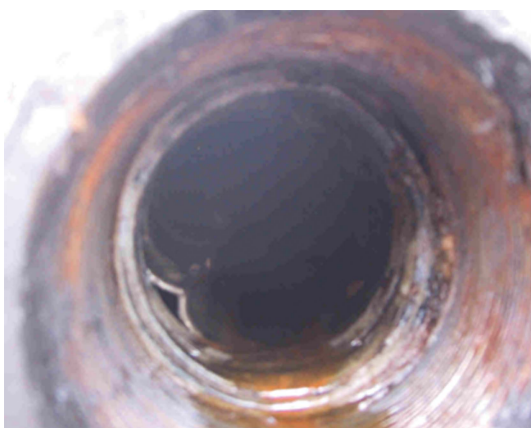
Figure 2
Internal Corrosion of Casing

it is not likely to fall off, the inner wall is characterized by local potholes corrosion (Figure 2); (c) Some of the exterior surface of the casing is eroded by superficial water or even punched (Figure 3) and it can occur in just 8 months since its putting into production, which directly affected the normal operation of the oilfield and its safety.

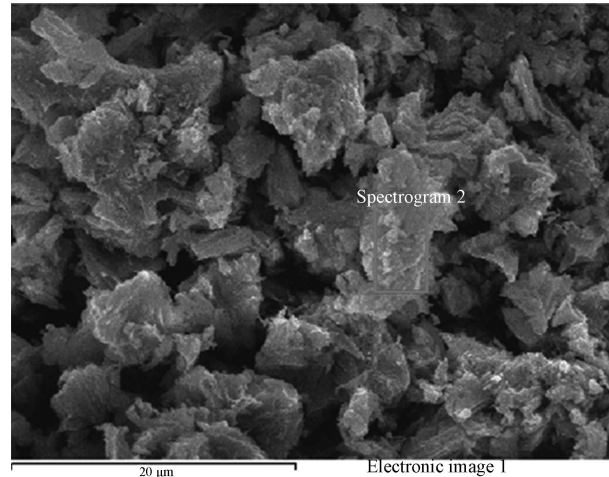
Figure 4
SEM Picture of Corrosion Fouling of 10 m Depth

It can be seen from Figure 4 that corrosion fouling is likely to fall off. SEM observation indicates that the product of corrosion mainly contains 3 elements: O, Fe and Cl. The reason for the casing corrosion of 10 m depth is thought to be the electrochemical erosion initiated by Cl^- , and its mechanism is shown as follows:

After this reaction, reaction (3) will resume and Fe(OH)_3 is generated, resulting in deep potholes in some special parts. As time goes on, casing strength decreases sharply and finally even punched.

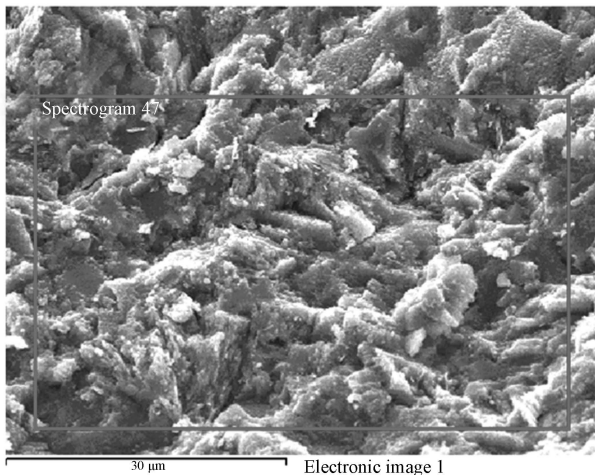
Figure 5
SEM Picture of Corrosion Fouling of 100 m Depth

The results show that the main element in the corrosion fouling is O and C, Fe and Cl followed. XRD analysis spectrum is adopted, and it can be analyzed that the corrosion products are mainly FeCO_3 , $\text{Fe}_2(\text{OH})_3$, $\text{Fe}_2\text{O}_3 \cdot n\text{H}_2\text{O}$, which is shown in Figure 6. So we can safely come to the conclusion that the main reason for the casing corrosion of 100 m depth is oxygen corrosion and carbon dioxide corrosion, and the existing of Cl increases the corrosion.

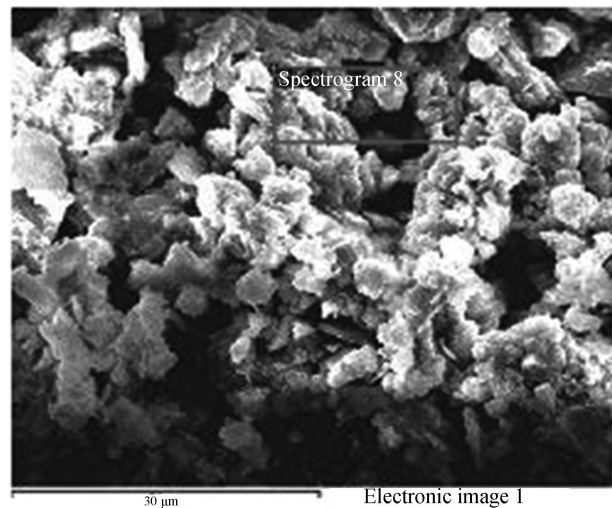
Figure 7
SEM Picture of Corrosion Fouling of 500 m Depth

The results show that the main element in the corrosion fouling is C and O, Fe and Ca follow. XRD analysis spectrum is adapted, and it can be analyzed that the corrosion product of 500 m depth are mainly Fe₉S₈, CaCO₃ and FeCO₃, which is shown in Figure 8.

So we can safely come to the conclusion that the main cause of the casing corrosion of 500 m depth is SRB, the reasons are as follows: (a) The temperature of 100 m to 1,000 m depth is about 30 to 40 Celsius degree, which falls in the limits that fits the build-up and reproduce of SRB; (b) The S elements of the Energy spectrum analysis are not from crude oil; (c) The Fe₉S₈ found in XRD analysis spectrum is one of the classic products of SRB corrosion.

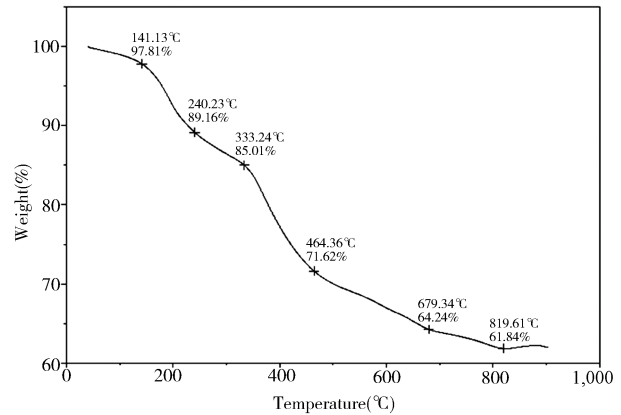
Figure 9
TGA Analysis of the Corrosion Fouling Picture of 500 m Depth

After analyzing of TGA analysis results, it can be easily seen that there are two temperature weightless intervals: 141.3 - 240.23 °C and 333.24 - 464.36 °C. They respectively correspond to the hydrate decomposition and the decomposition of FeCO₃. Besides, there are some twists and turns in the curve which indicates various compounds in the sample.

From above analysis, the main reasons for casing corrosion come to CO₂ corrosion and SRB corrosion.
