# URBAN FLOODING AND SLOPE STABILITY IN AUSTIN, TEXAS

## AUSTIN GEOLOGICAL SOCIETY FIELD-TRIP GUIDEBOOK

VICTOR R. BAKER, E. L. GARNER, L. JAN TURK, AND KEITH YOUNG

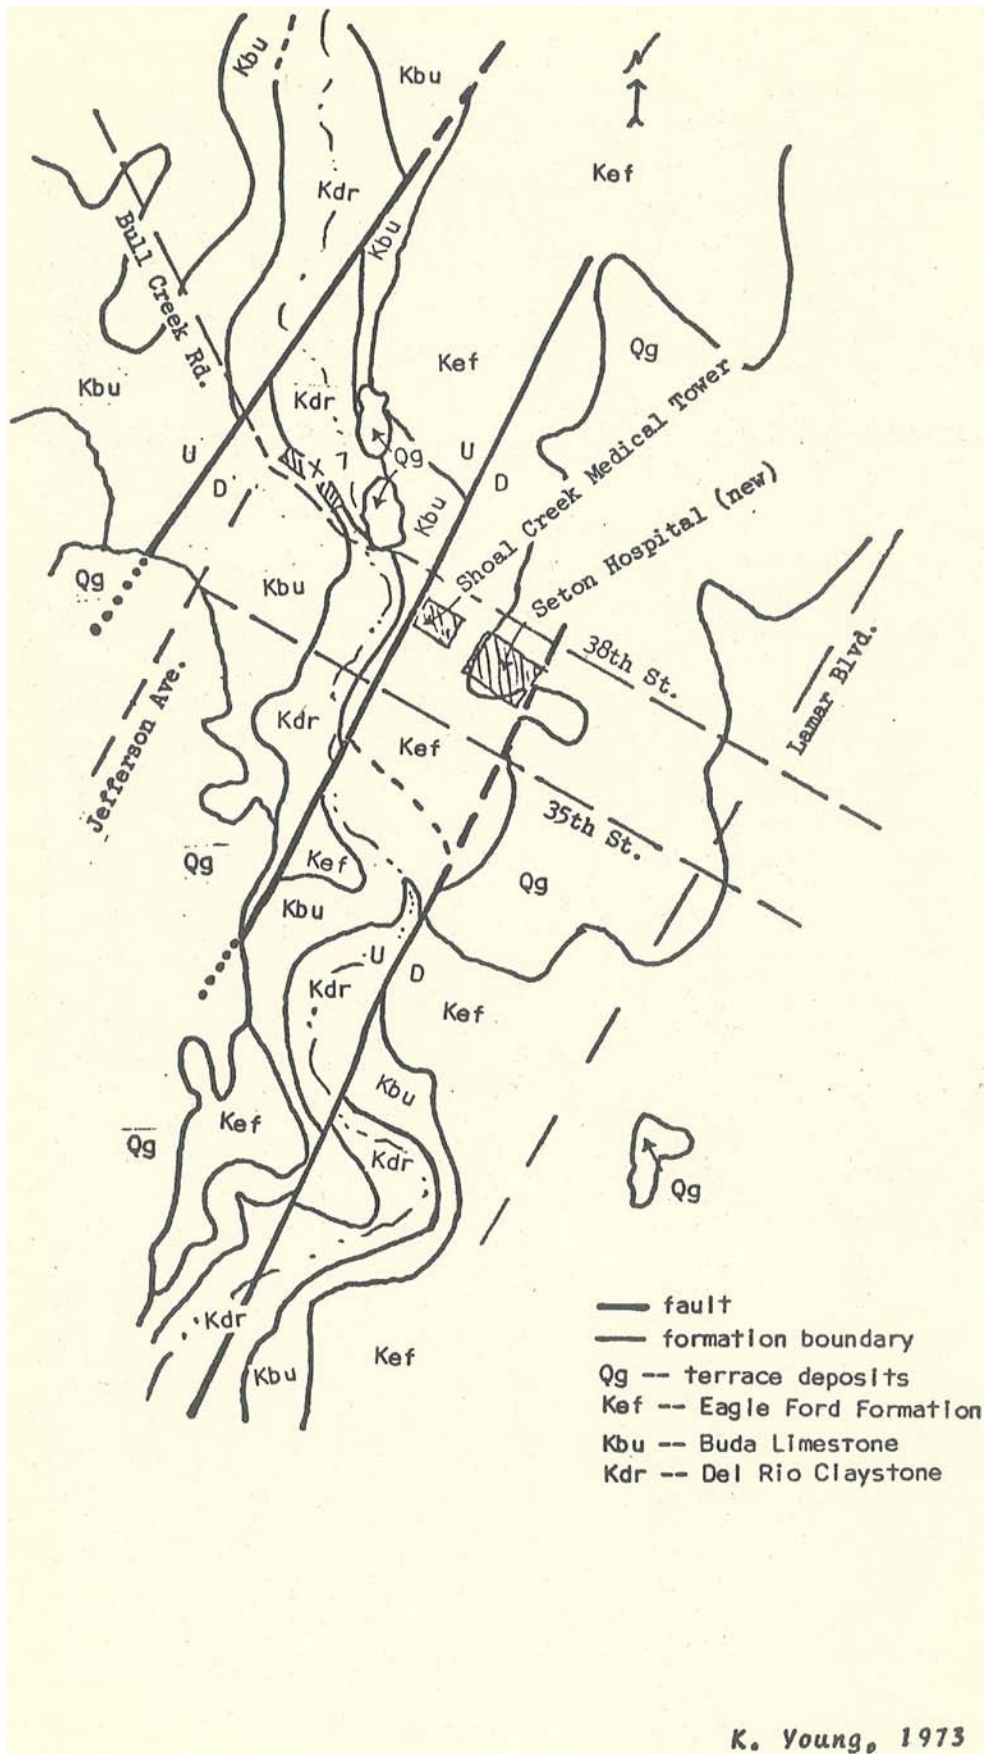
Figure 2 AREA OF SHOAL CREEK MEDICAL PARK

The Jefferson Building and the adjacent building are near the top of the Del Rio. Buda Limestone was exposed in the top of the excavations and it is about 70 feet to the Georgetown Limestone. The Shoal Creek Hospital is on Eagle Ford fill, which in turn rests on the Del Rio Formation. There is also about 70 feet of Del Rio between this site and the underlying Georgetown Limestone. There is a fault between the site of Stop 7 and the hospital (fig. 2).

Another fault is just east of the east bank of Shoal Creek, but west of the Shoal Creek Medical Tower. Consequently, the Shoal Creek Medical Tower and the new Seton Hospital are on the Eagle Ford Formation. It is only about 15 feet to the Buda Limestone, so the building sites were excavated to the limestone.

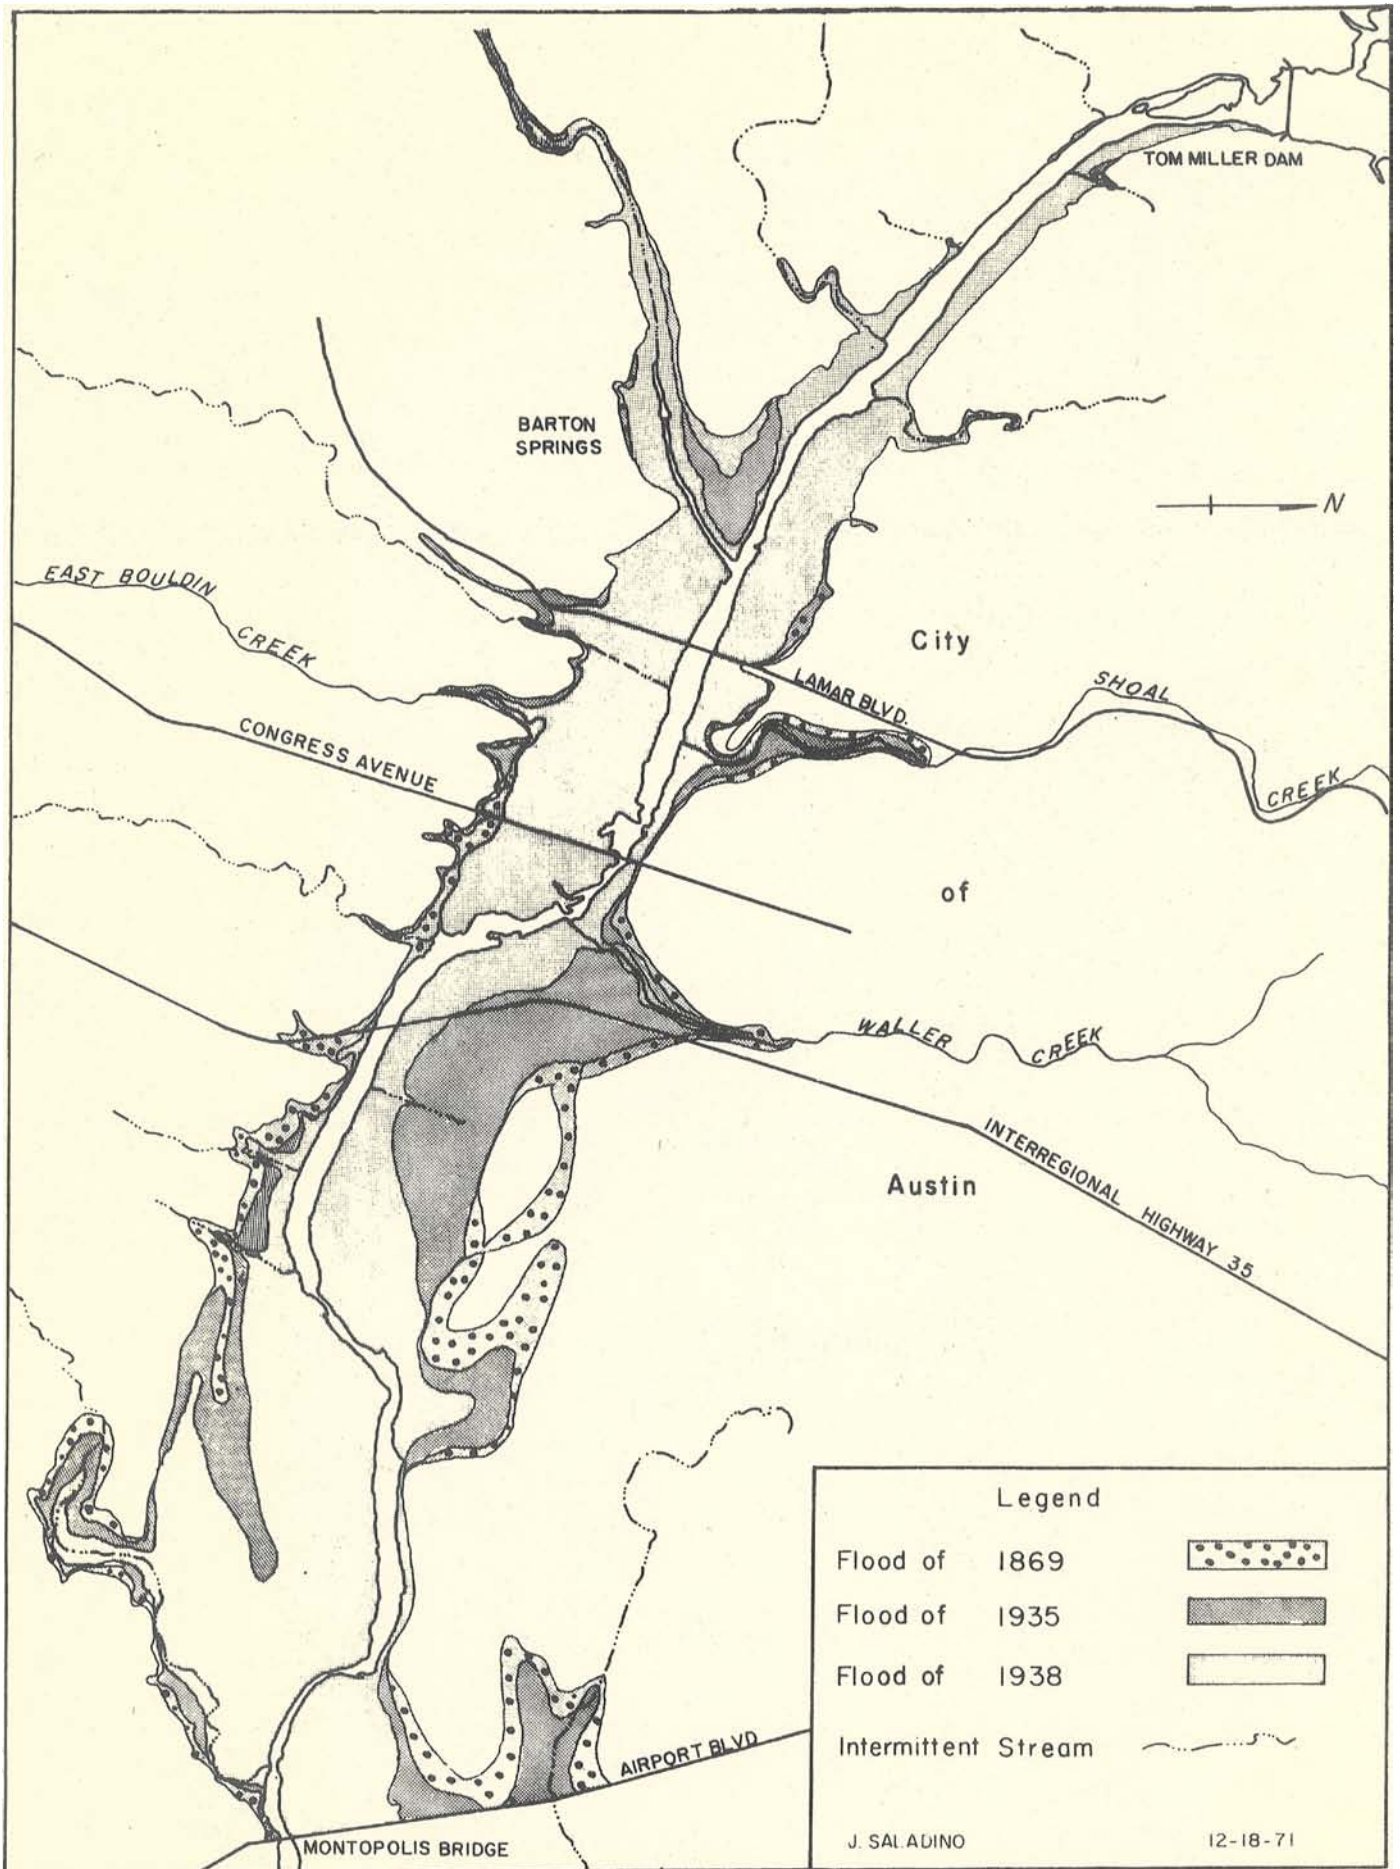
FIGURE 5.-Flood levels of Colorado River at Austin, Texas

This site has been flooded by the Colorado River about six times in the last century. Although defined by engineers as part of the 100-year flood plain, this site has been under water on an average of about once every 20 years. Figure 5 shows the extent of the 1869, 1935, and 1938 floods.

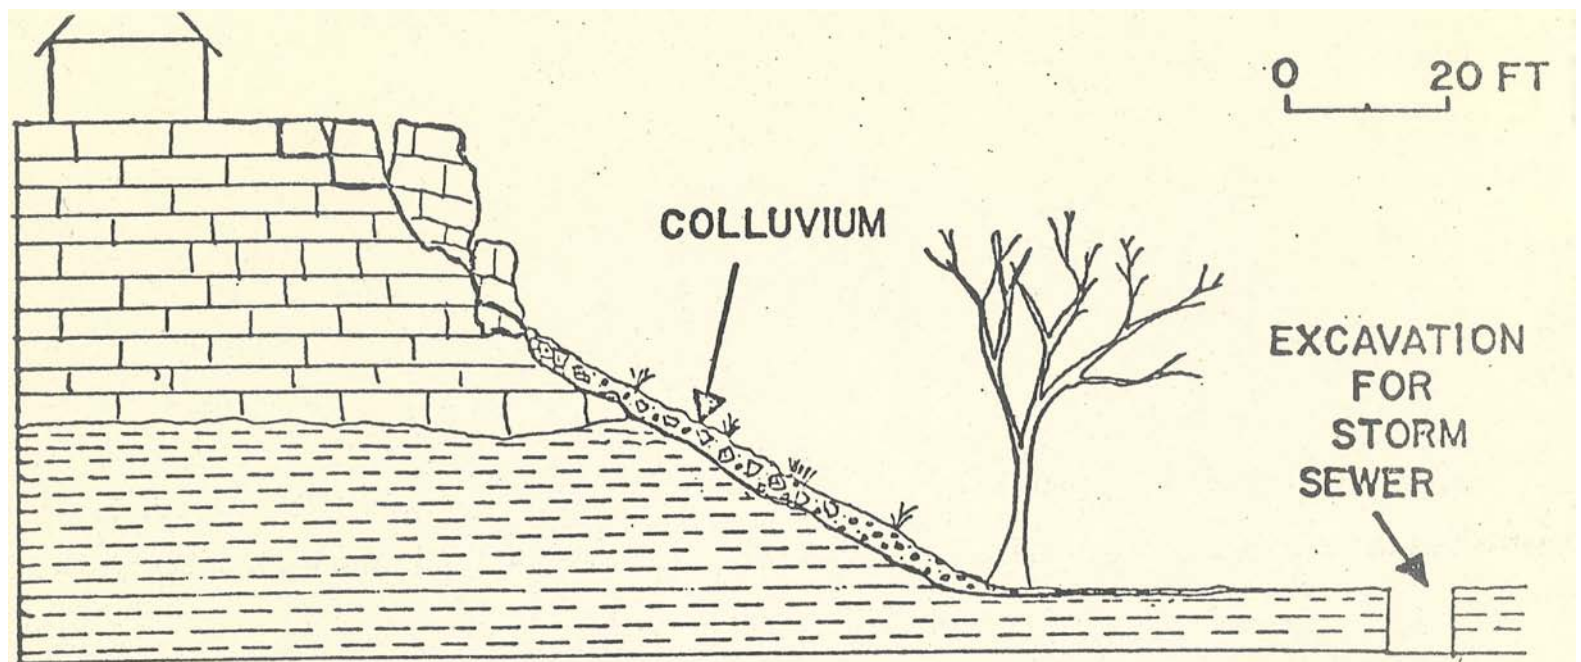
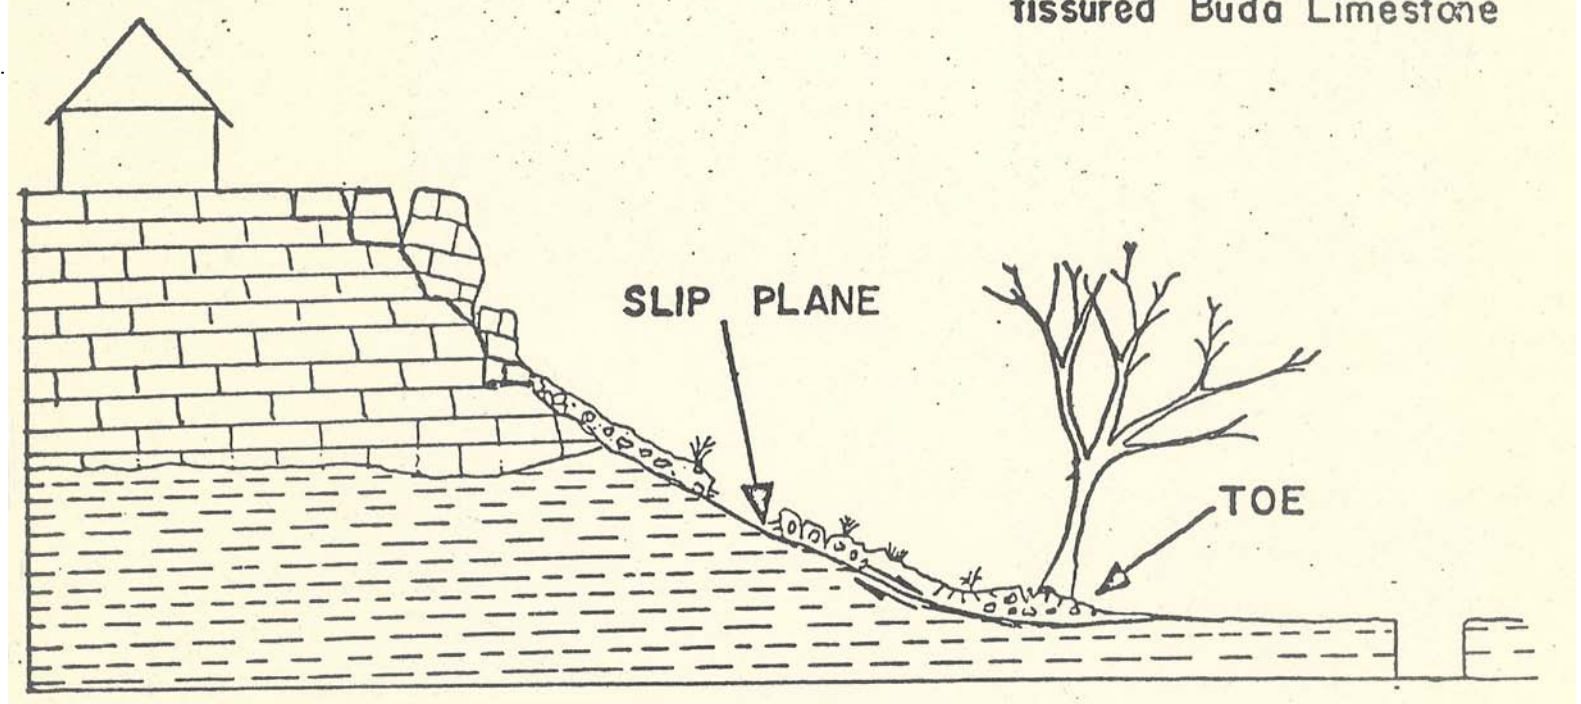
Figure 7 SHEET SLIDE IN DEL RIO SLOPE MANTLED WITH COLLUVIUM BARTON SPRINGS ROAD

Figure 7 shows a larger such landslide that occurred during the construction of a storm sewer in a small drainage just north of Barton Springs Rd. The colluvium, consisting of angular limestone rubble in a plastic clayey matrix, overlies a nearly impervious surface of Del Rio Clay. Runoff enters cracks and fissures of the calving Buda Limestone and flows along the permeability boundary formed at the clay-colluvium contact. This results in a great reduction of cohesion, which will lead to landslides if triggered by the removal of support at the base of the slope.

orange line indicates seepage path of water entering fissured Buda Limestone

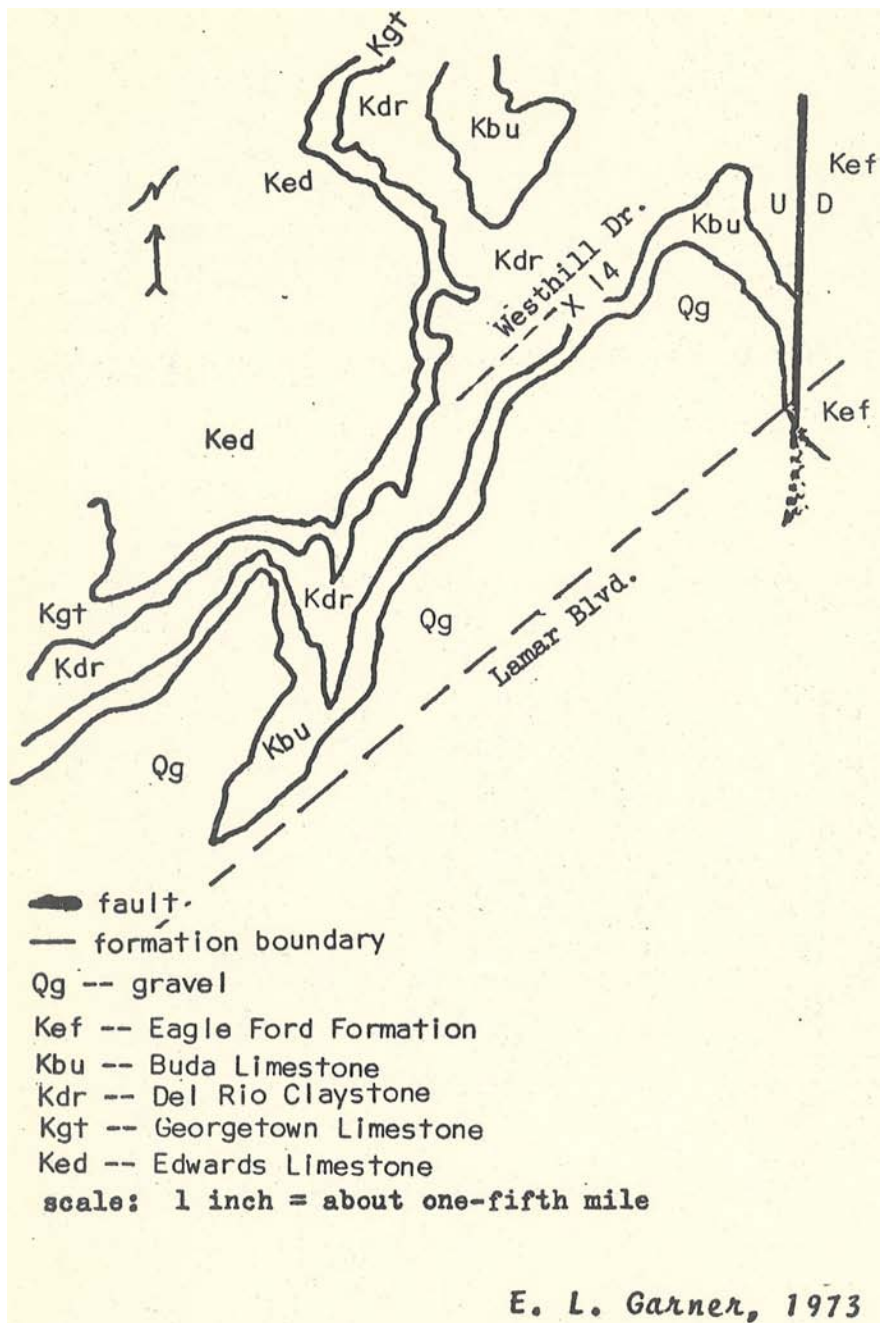
**Figure 8**  
**WESTHILL DRIVE AREA**

The next slide to the north is not as active, but displays a very steep head scarp. Construction of the dwelling above this scarp began in January 1973. Footings were laid within 1 foot of the head scarp, and part of the head scarp has been covered with concrete to retard erosion.

Driveways and walkways on the east side of Westhill Dr. show cracking and settling caused by the slow creep of the Del Rio. Tension cracks and pressure ridges occur on Westhill Dr. itself, along the steep section of road that passes below the Del Rio-Buda contact.

Rates of movement in these near-surface creep zones are affected by moisture and temperature changes. Below an upper zone of seasonal creep, movement probably results from plastic deformation of the clay along a shattered shear zone rather than along distinct shear surfaces as in the landslides. Problems could probably be minimized by placing 12-24 inches of well-graded subbase beneath rigid pavement.

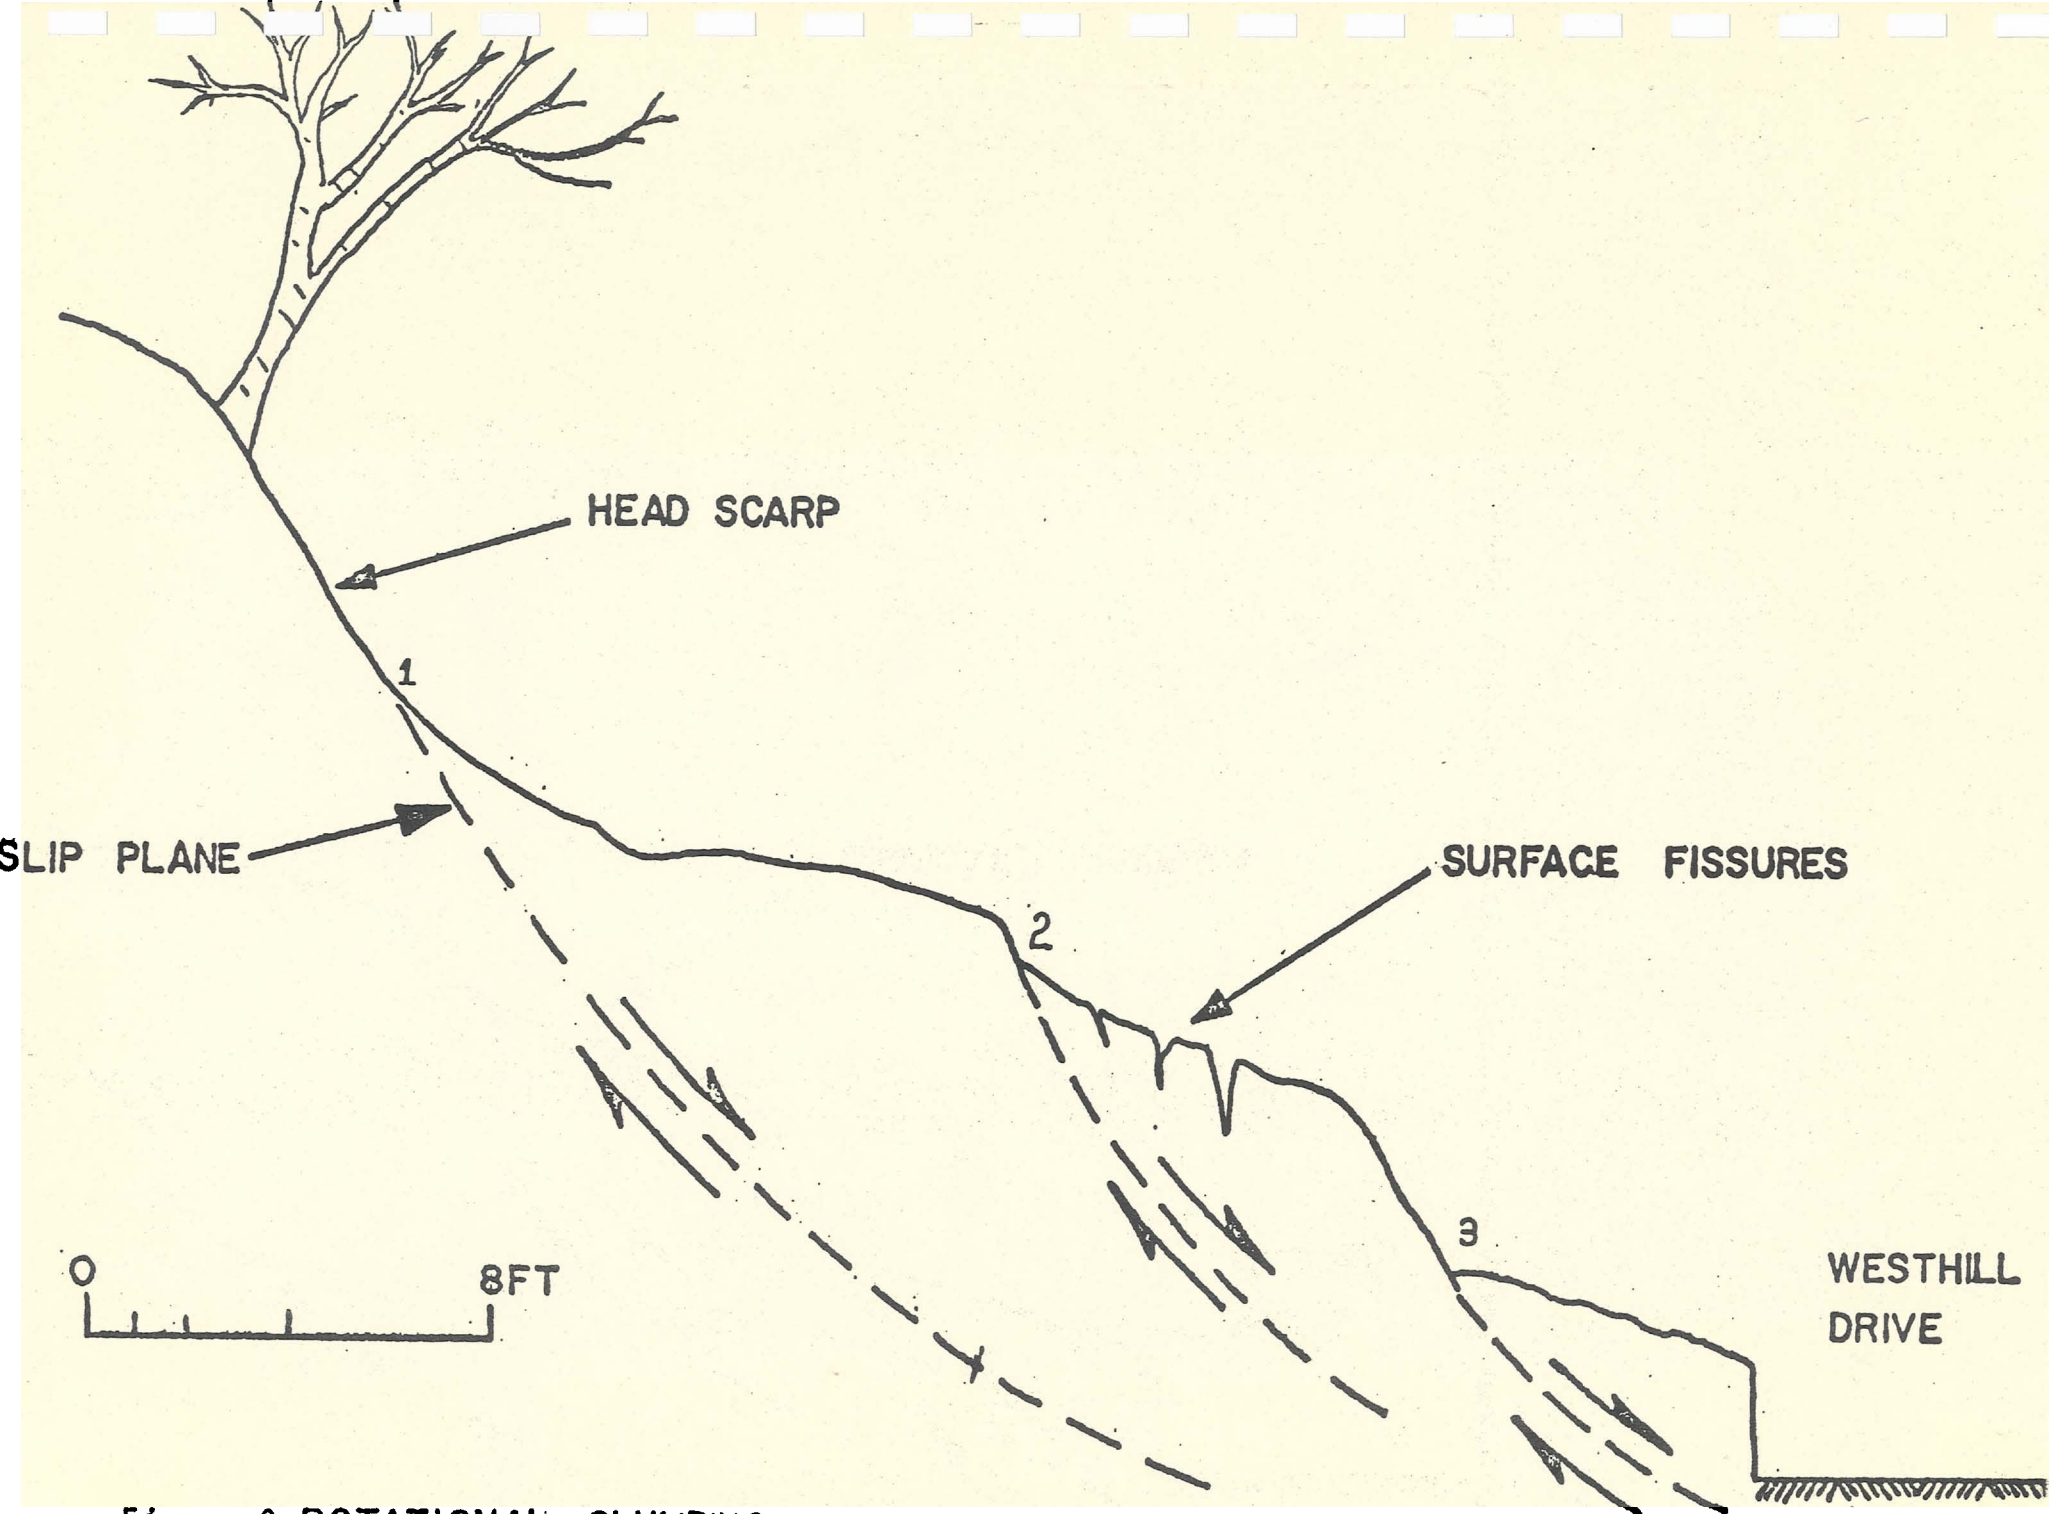
Figure 9 ROTATIONAL SLUMPING IN DEL RIO CLAY  
WESTHILL DRIVE

This stop illustrates many of the construction problems associated with the Del Rio Clay. Two large slumps occur on the east side of the street. The southern slump (fig. 9) exhibits very active slip planes. Plane 2 has moved approximately 1 foot since September 1972. Fresh slickensided surfaces can be observed at the minor scarps on the surface of this slump. The present movement of the slump mass across Westhill Dr. has taken place since April 1972, when the toe of the slide was graded to the curb by the city of Austin.

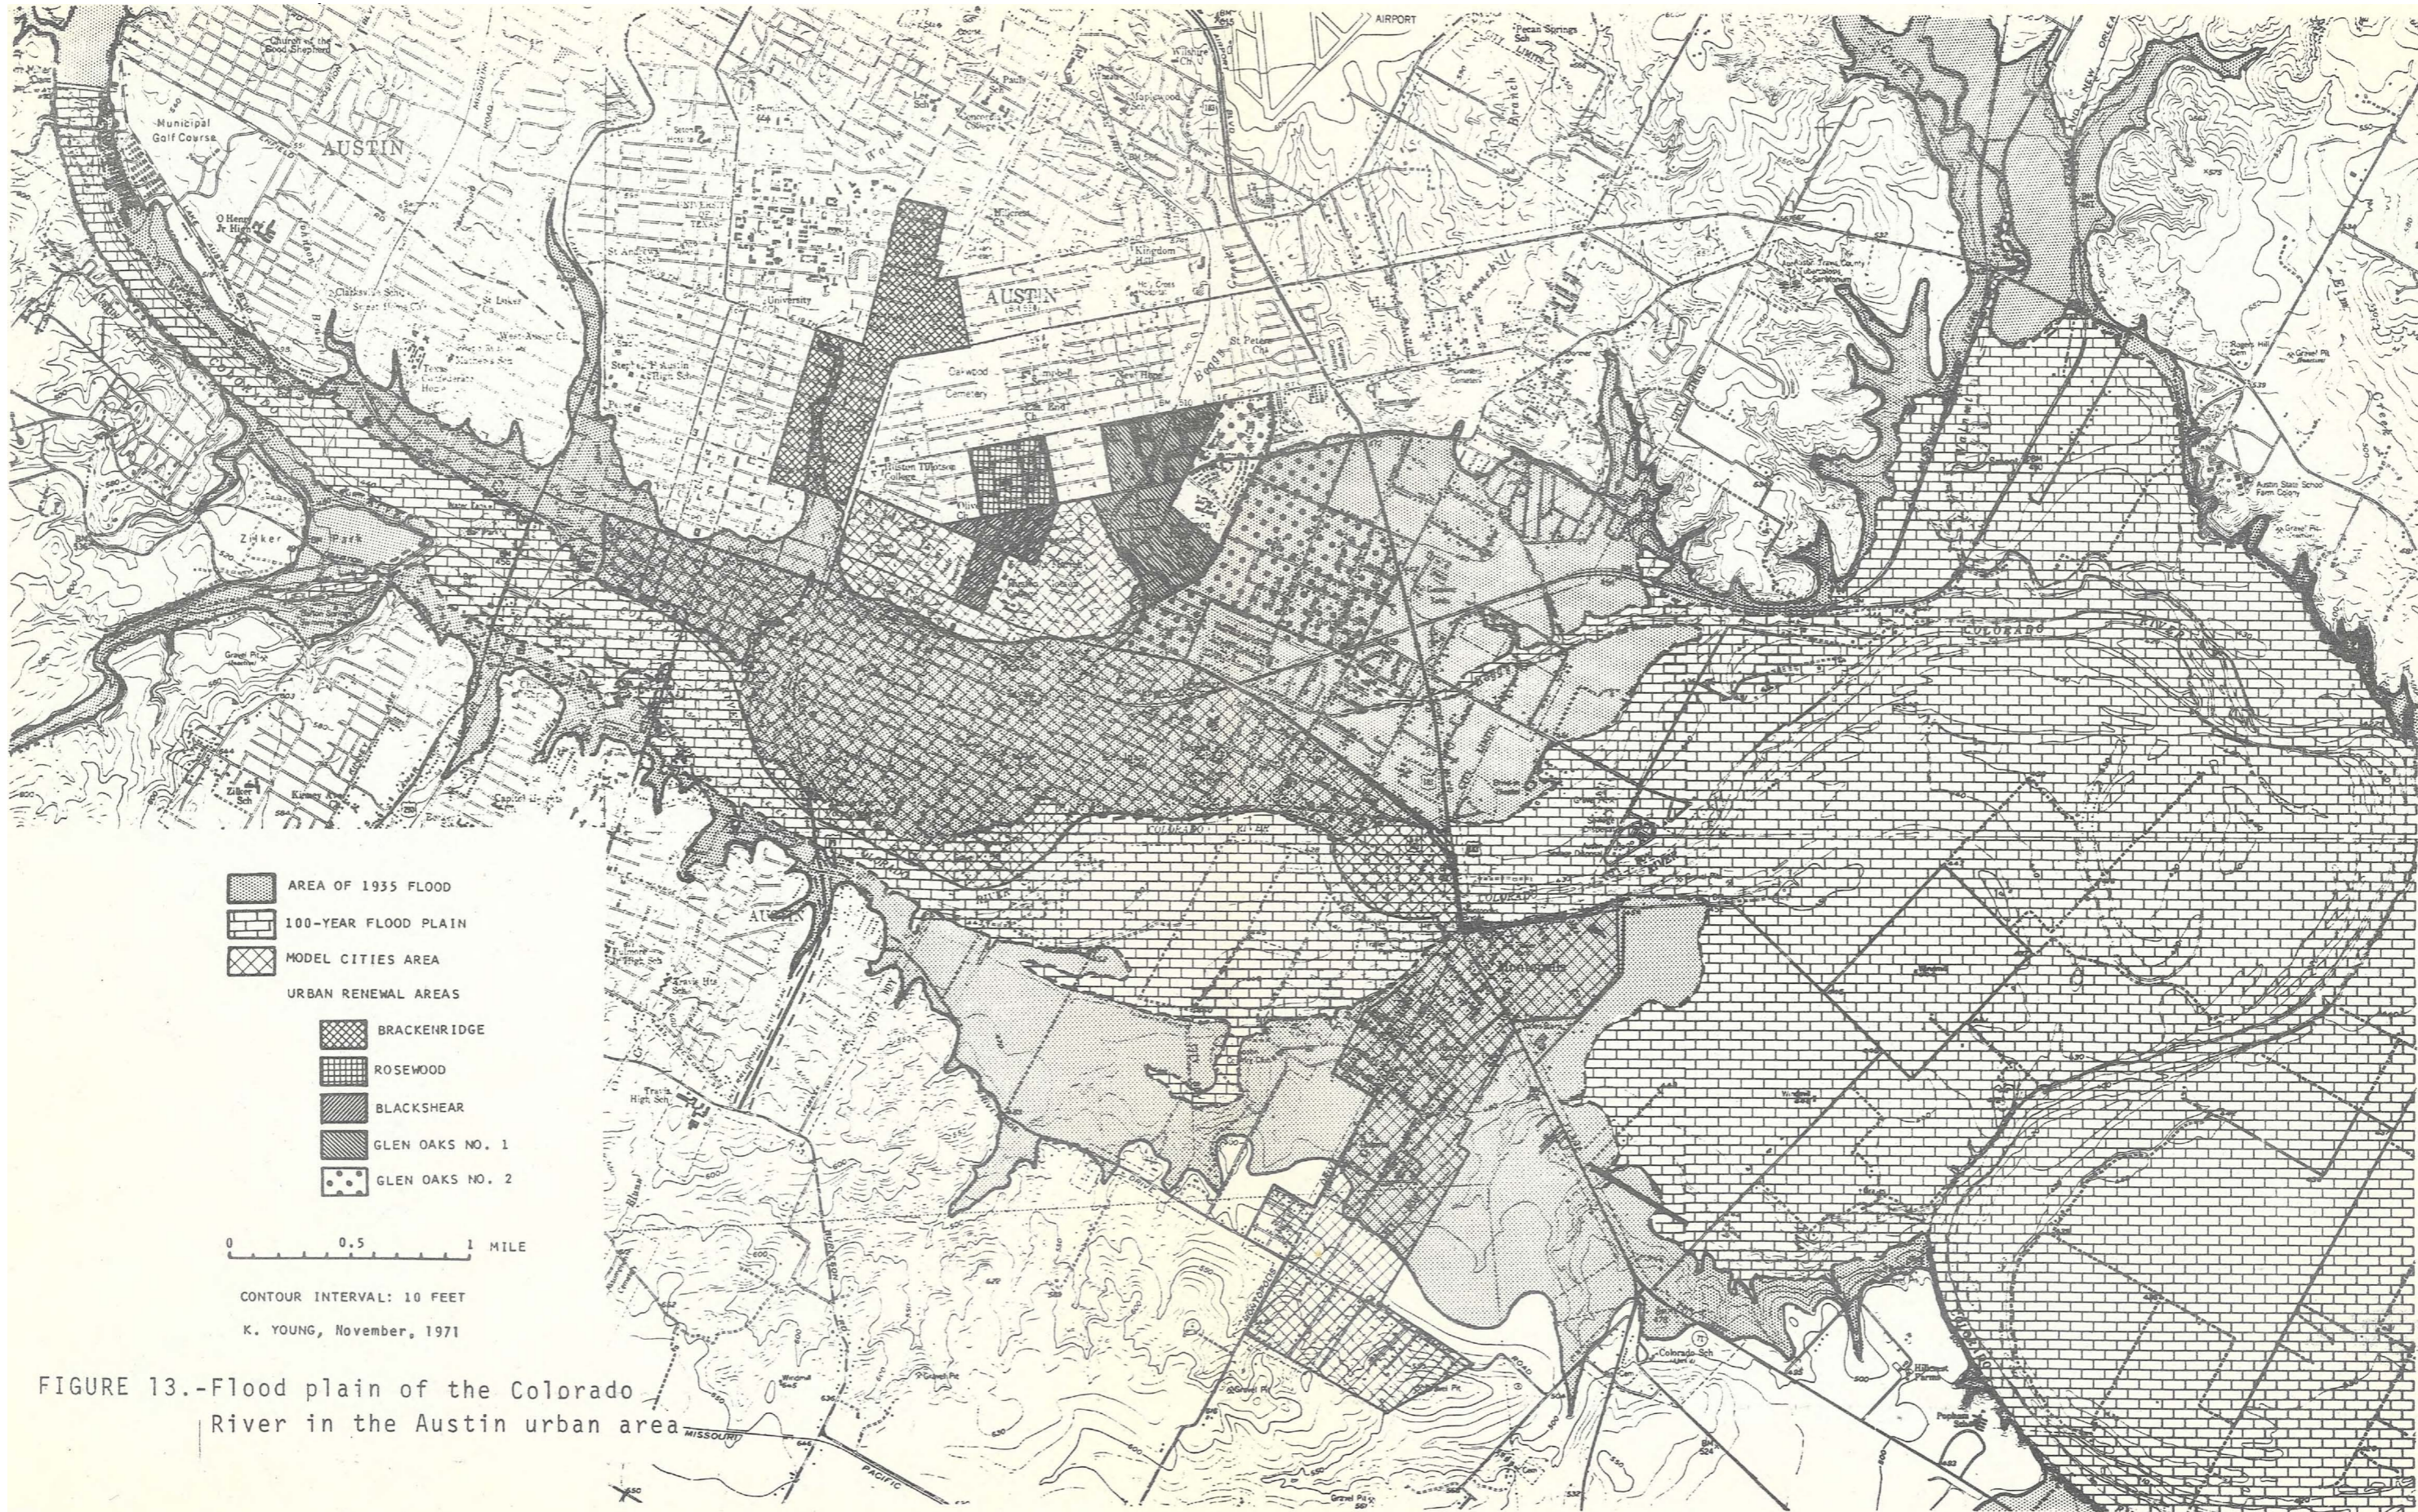
FIGURE 13.-Flood plain of the Colorado River in the Austin urban area

<u>Mileage</u>	<u>Interval</u>	
22.1	0.4	Four-way stop at Woodland and Parker Ln.
22.5	.4	Turn left into Stop-&-Go before reaching Riverside Dr.
		<u>STOP 15:</u>
		The flood plain of the Colorado River to the northeast, now so densely populated with apartment houses, was under water in 1869 and 1935; and most of it was under water in 1938 (fig. 13).

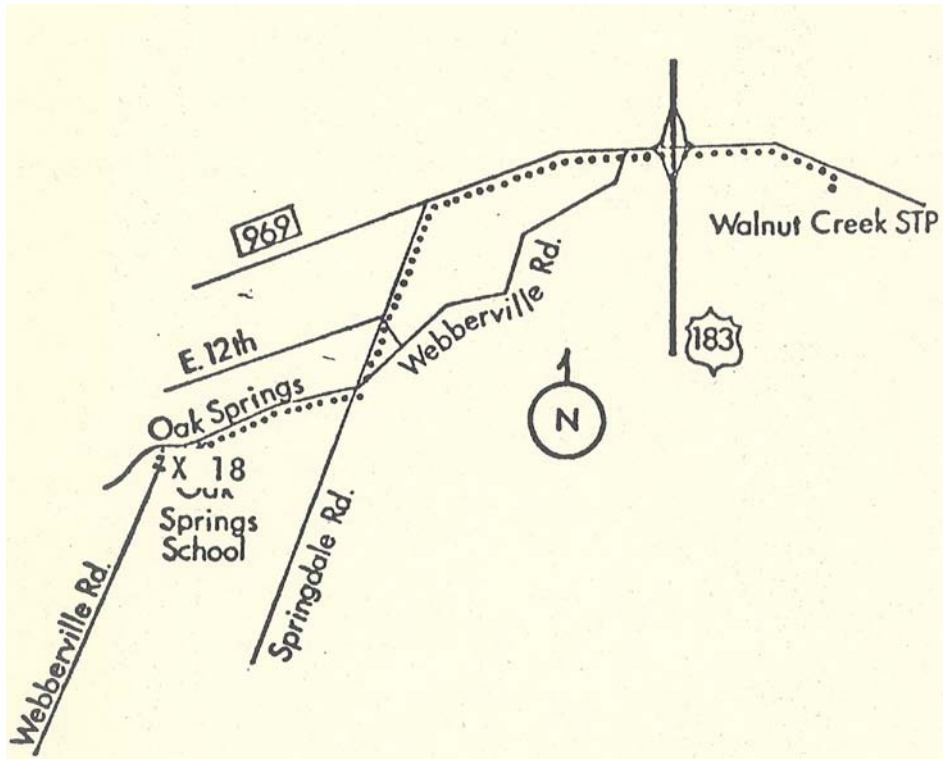
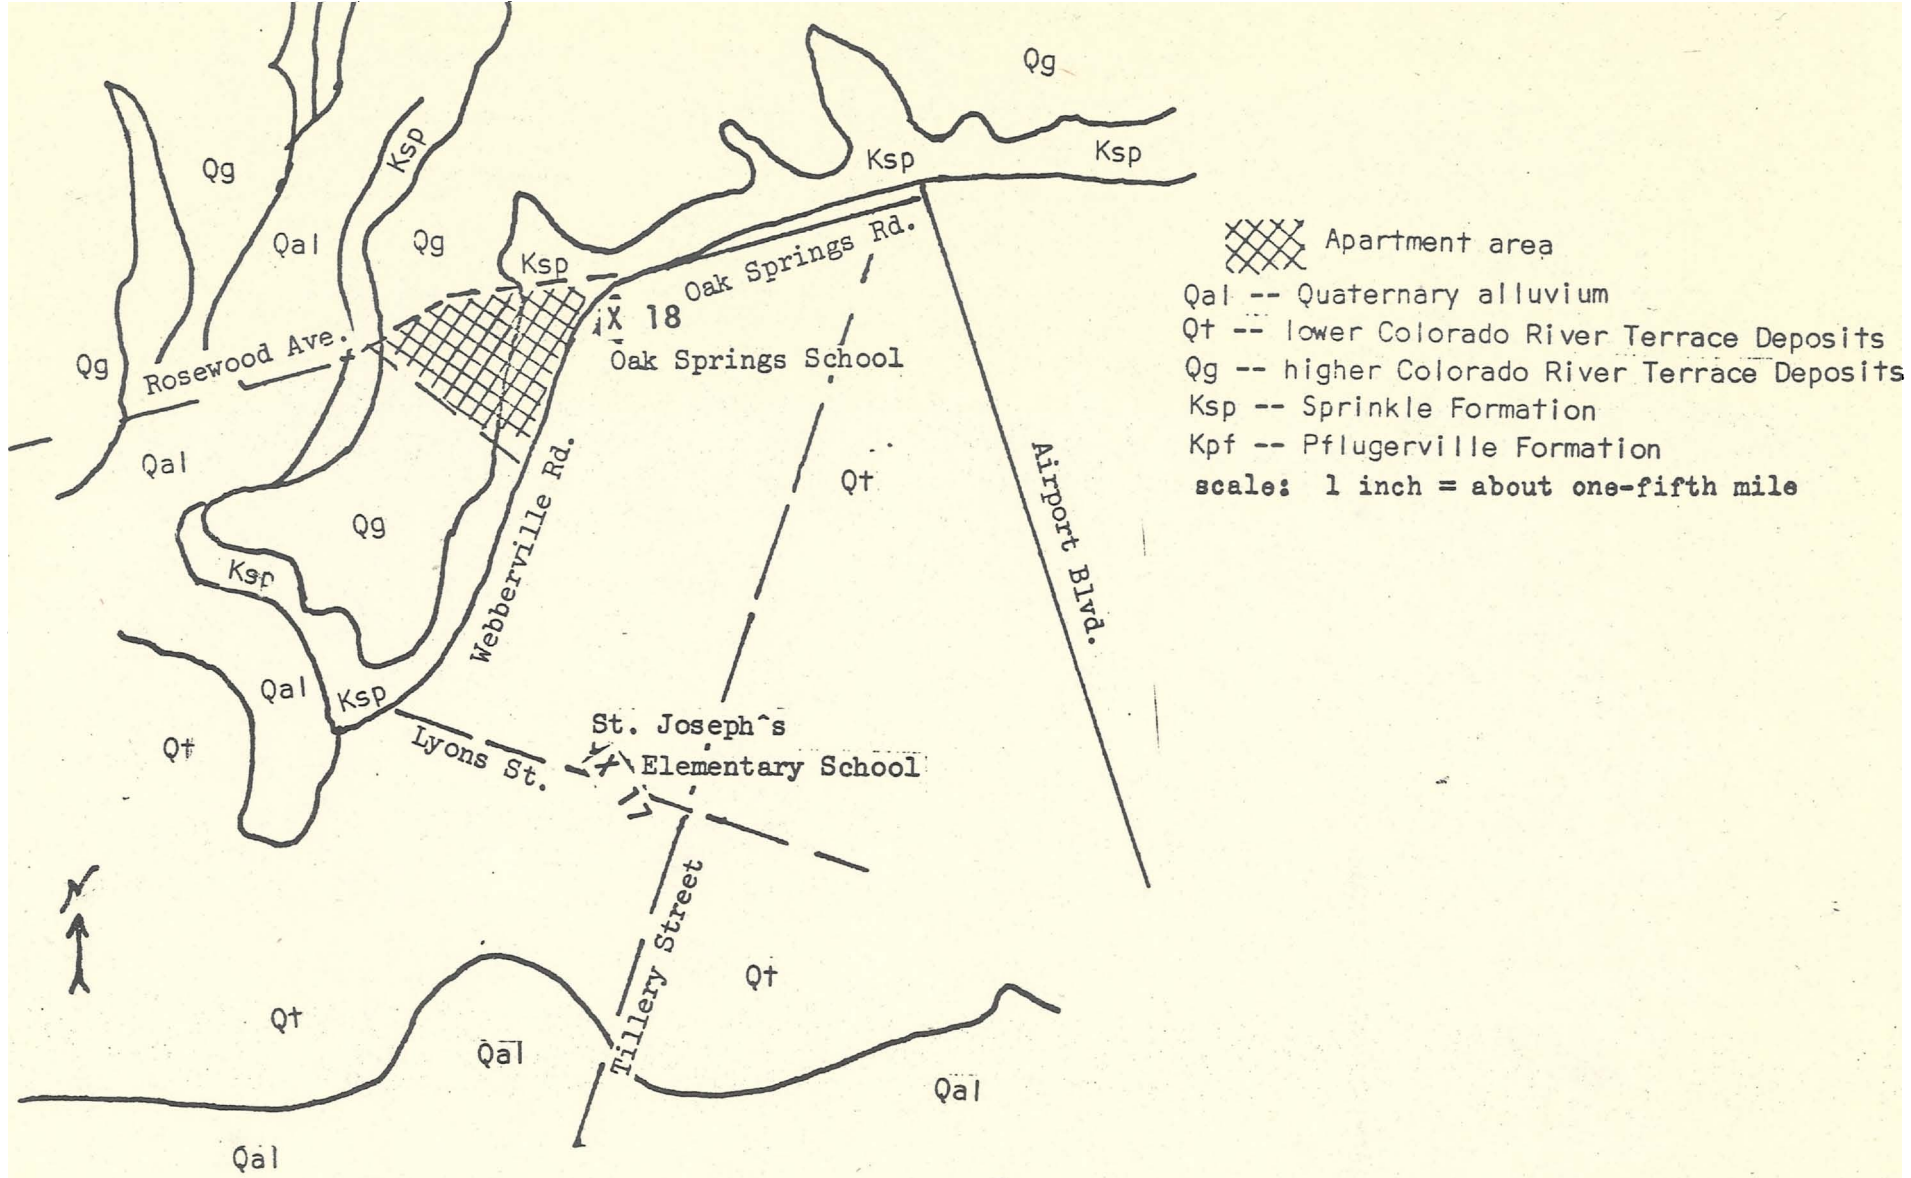
Figure 16  
OAK SPRINGS SCHOOL AREA

27.0	.3	Turn right on Webberville Rd.
27.6	.6	<u>STOP 18:</u> Oak Springs Elementary School. Pull into the parking lot (figs. 15 and 16).  Across the street are the buildings of the East Washington Urban-Housing Project. The higher buildings are on gravels of a Colorado River terrace, and the lower buildings are on Sprinkle (lower Taylor) Claystone. The apartment buildings on gravel suffer little damage. Many of the buildings on unstable Sprinkle Claystone have been repaired and even partly rebuilt. This is an excellent example of using "standard" construction plans without regard for the geology.
