Contaminant Release from Storm Water Culvert Rehabilitation Technologies: Understanding Implications to the Environment and Long-Term Material Integrity

October 31, 2019

Andrew J. Whelton, Kyungyeon Ra,
Seyedeh Mahboobeh Teimouri Sendesi, Md Nuruddin, Xianzhen Li,
John A. Howarter, Jeffrey P. Youngblood, Chad T. Jafvert,
Nadezhda N. Zyaykina

FHWA TPF-5(339) • DOI: [10.5703/1288284317089](https://doi.org/10.5703/1288284317089)

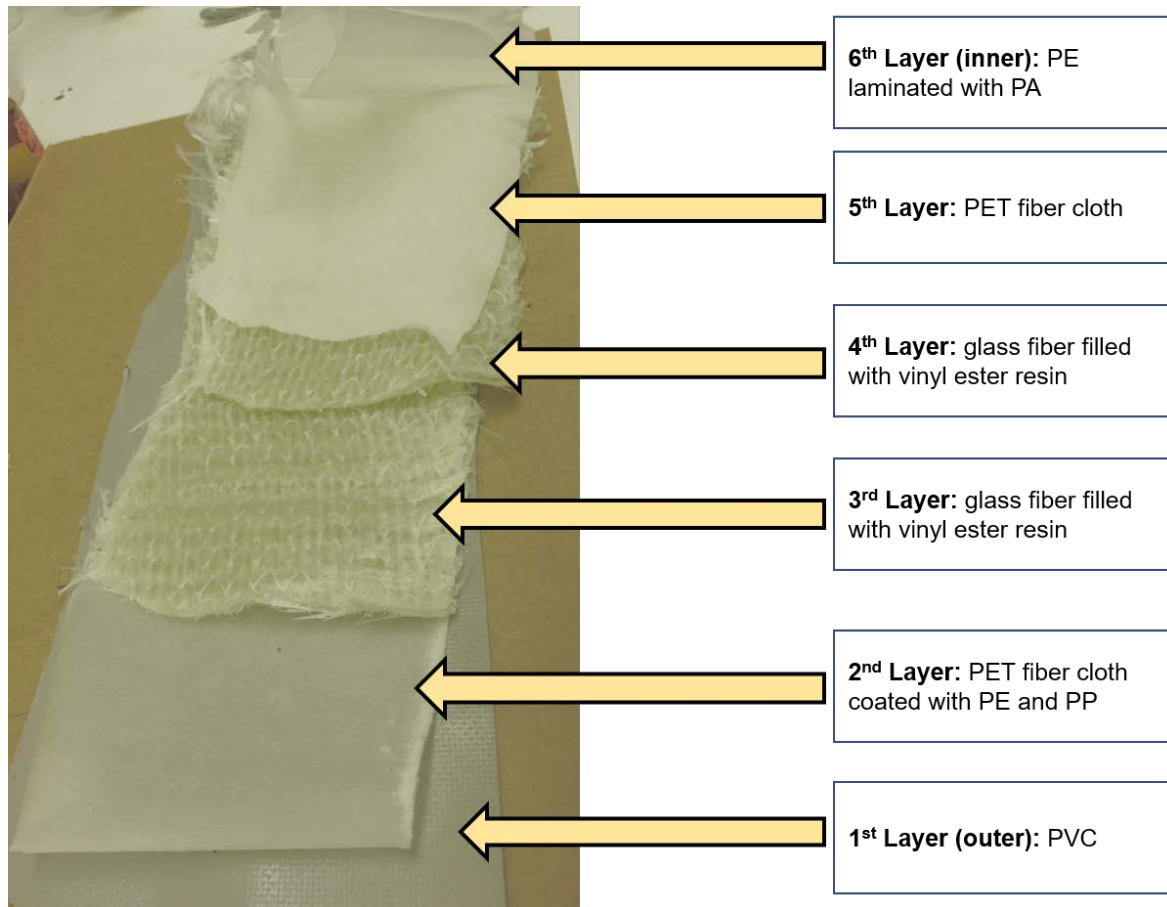
Figure 3. The uncured resin tube in New York contained six components. PA: polyamide, PE: polyethylene, PET: polyethylene terephthalate, PP: polypropylene, PVC: polyvinyl chloride.

was in greatest abundance at the PVC layer 1 but was also present at a much lower loading towards the center of the uncured resin tube. DBP is a common plasticizer, HAP, and suspected endocrine disruptor. Layer 6, the layer closest to the UV light train, generally had the lowest contaminant loading. It is unclear if chemicals penetrated through the PVC layer as this was not the intent of the testing. It is well-known that PVC can be permeated by organic contaminants like those used in CIPP resins, but this would depend on temperature, concentration, thickness of the PVC, among other factors. When the uncured resin tube was inserted and underwent curing, some of the outer layer extended out of the host pipe and was exposed to the air.

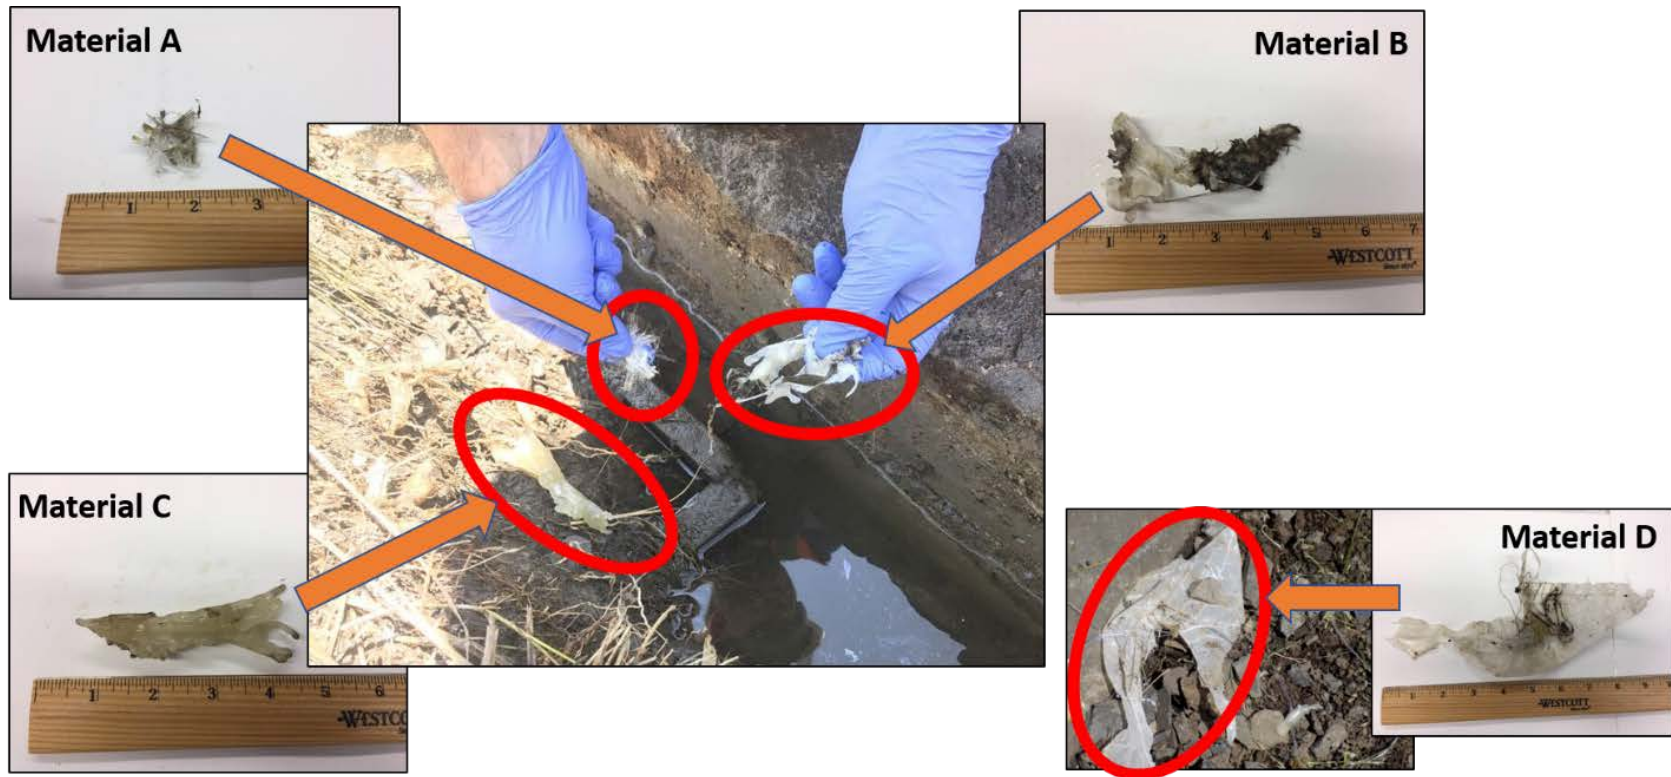
Figure 4. Materials found at NY site 2 CIPP installation were identified using optical microscopy, FTIR, and TGA. Fiber glass reinforced vinyl ester resin (material A); partially cured vinyl ester resin (materials B and C); PE laminated with PP (material D). Materials A-C were found on the culvert inlet standing water, Material D was found at the culvert outlet on top of rip rap.

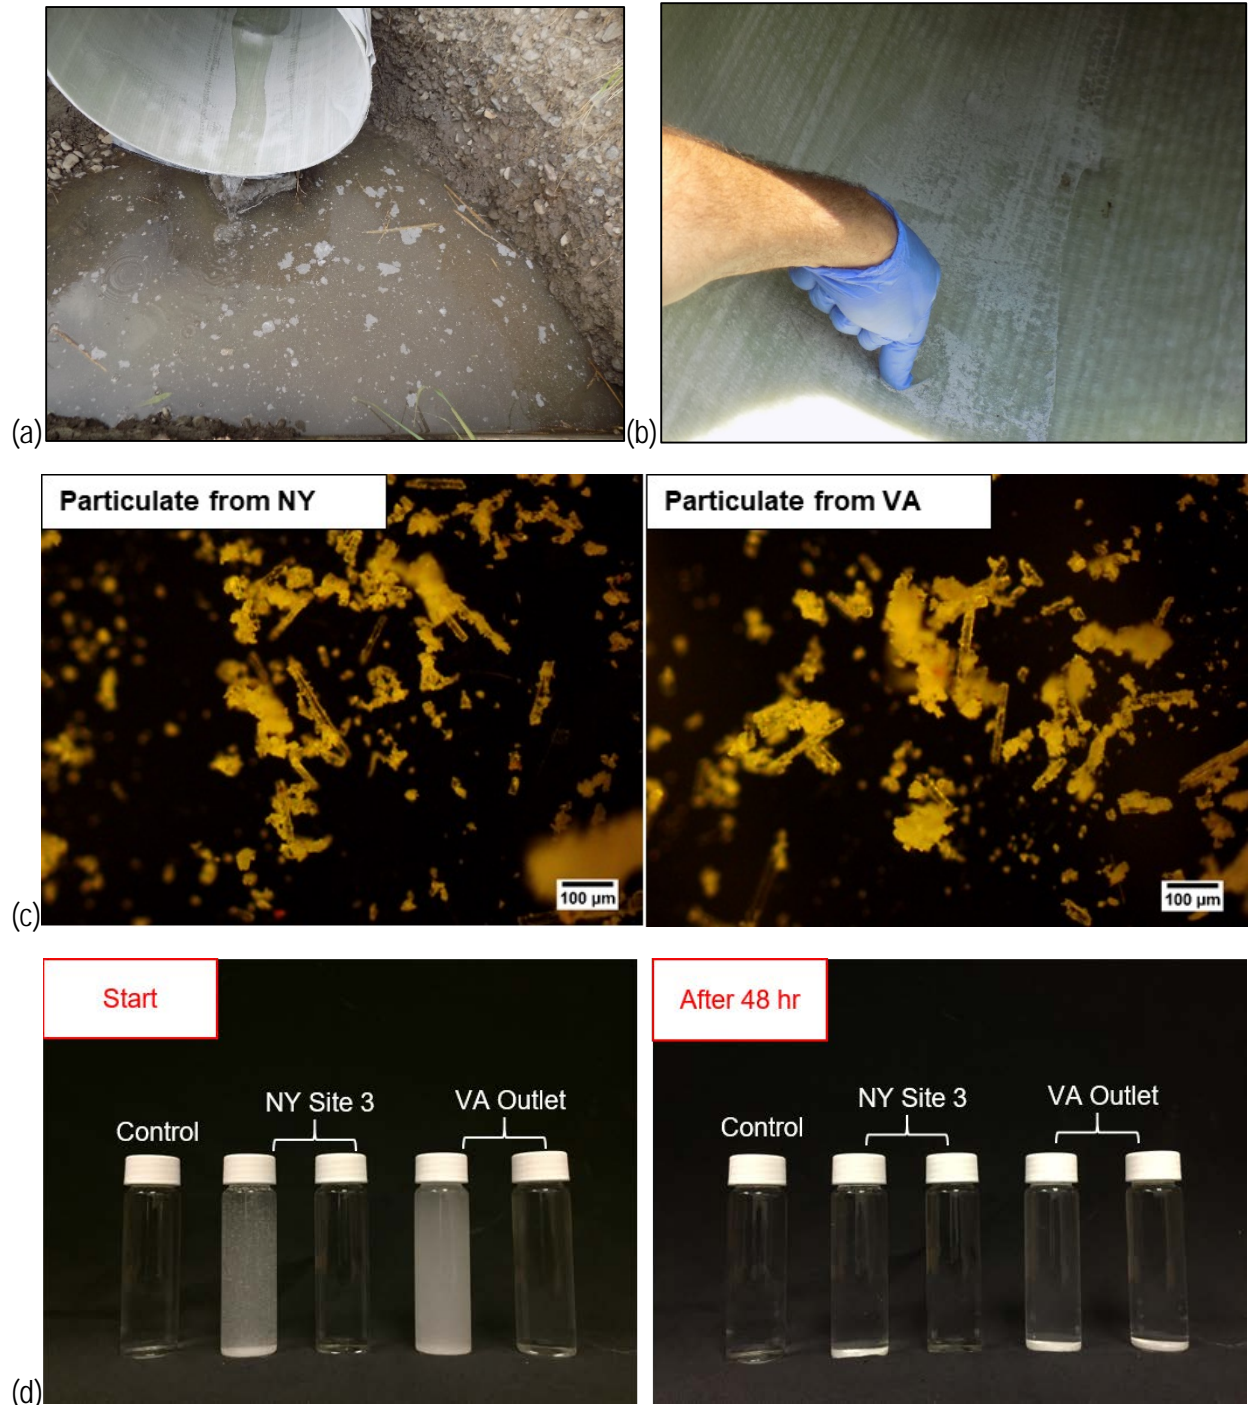
Other chemicals with state water quality standards were also present in the particulate, but only styrene in water was examined. In laboratory experiments, some of this particulate settled in the water column while other materials remained suspended. In the field, particulates were observed to be suspended, flowed downstream, and adhered to nearby vegetation. This cutting material was identified as a source for chemical pollution, and had been observed at other field sites for the present study and in images from prior studies by others. Though, the present study is the first known characterization of the cutting particulate leaching potential.

Figure 5. (a) Visual observation of cutting material left in water at the culvert outlet, (b) Visual observation of cutting materials staying on the CIPP inner surface, (c) Optical microscopy images of cutting particulates from NY and VA CIPPs, (d) Particulate behavior in water.

installation monitoring shows there can be potential for chemical discharge and leaching into the environment at CIPP manufacturing sites, so environmental monitoring is necessary. Waste from CIPP cutting processes can also pose an environmental hazard. Further, partially cured resin, particulate, organic vapors, and water vapor were found being discharged into air at steam CIPP exhaust in a parallel study. The fate of these materials in the environment (i.e., whether they deposit on land or waterways) has not yet been studied. Some deposition is likely based on their observed properties. It is recommended these materials are captured and not permitted to be discharged to the environment.
