Conductor cable externalization in an atrial hemodynamic sensor lead in a patient presenting with inappropriate shocks

Sing-Chien Yap, MD, PhD,* Mark G. Hoogendijk, MD, PhD,* Suzanne D.A. Valk, MD,† Sweder W. Van de Poll, MD, PhD,† Peter van der Kemp,† Tamas Szili-Torok, MD, PhD*

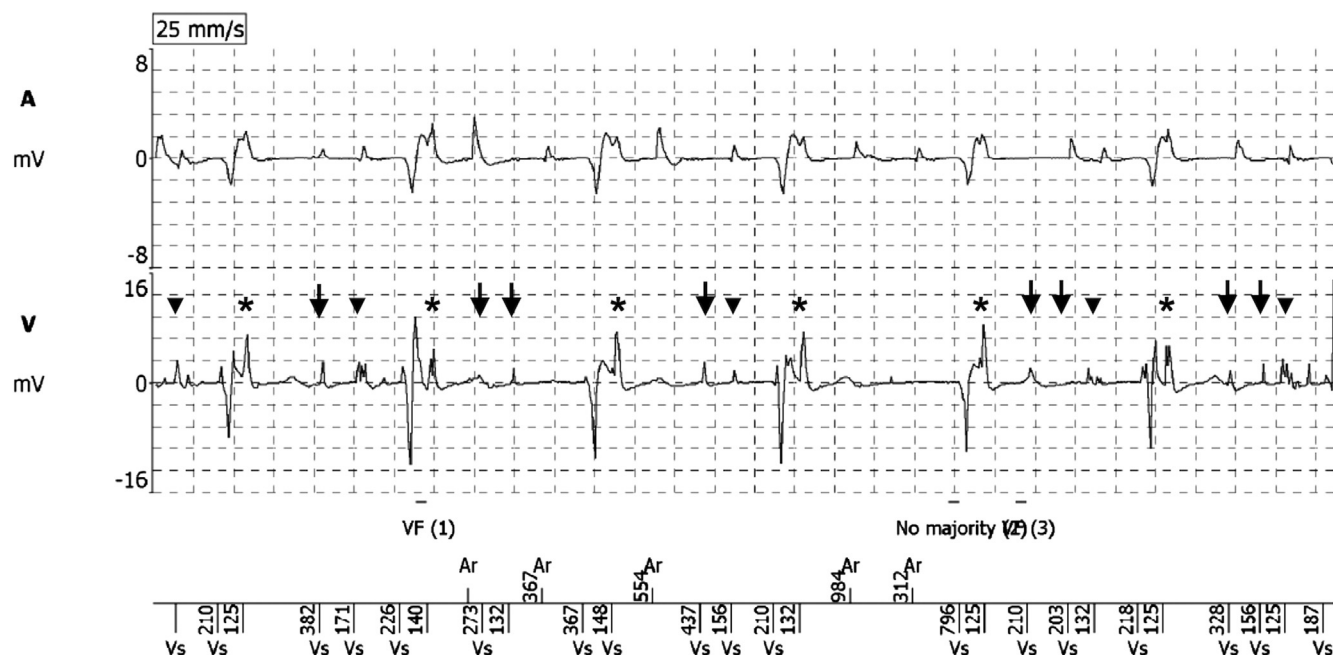
All her electrical parameters were in the normal range until she presented with an ICD storm in May 2019. She experienced 5 inappropriate ICD shocks before arrival at the emergency room. Upon arrival at the emergency room she lost consciousness after an inappropriate ICD shock initiated ventricular fibrillation (VF) and additional ICD shocks failed to terminate VF. Finally, external defibrillation terminated VF. The patient experienced 19 ICD shocks in total. Her post-shock electrocardiogram demonstrated RV pacing only, hence loss of biventricular pacing. When the device was interrogated, both the atrial and ventricular channel showed discrete nonphysiologic noise (Figure 1). Discrete noise on the atrial channel was usually blanked out and not detected. Discrete noise on the ventricular channel was either perisystolic (just after ventricular electric activation or just before atrial electric activation) or at random. After the ICD storm, the measured impedances of the atrial lead, RV pacing lead, left ventricle (LV) pacing lead, and RV coil were 240 Ω, 2913 Ω, >3000 Ω, and >3000 Ω, respectively. The LV pacing configuration was LV tip to RV coil. The lead trends demonstrated a progressive decrease in RV sensing amplitude and a sudden increase in both the LV lead impedance and high voltage impedance in the period preceding the ICD storm

Figure 1 Electrogram just before the first inappropriate implantable cardioverter-defibrillator shock. Both the atrial (A) and right ventricular (V) channel showed discrete nonphysiologic noise. Discrete noise on the atrial channel was usually blanked out. Discrete noise on the ventricular channel was either perisystolic (just after ventricular electric activation [asterisks]) or just before atrial electric activation [arrowheads] or at random (arrows). Note that the noise is low in amplitude.

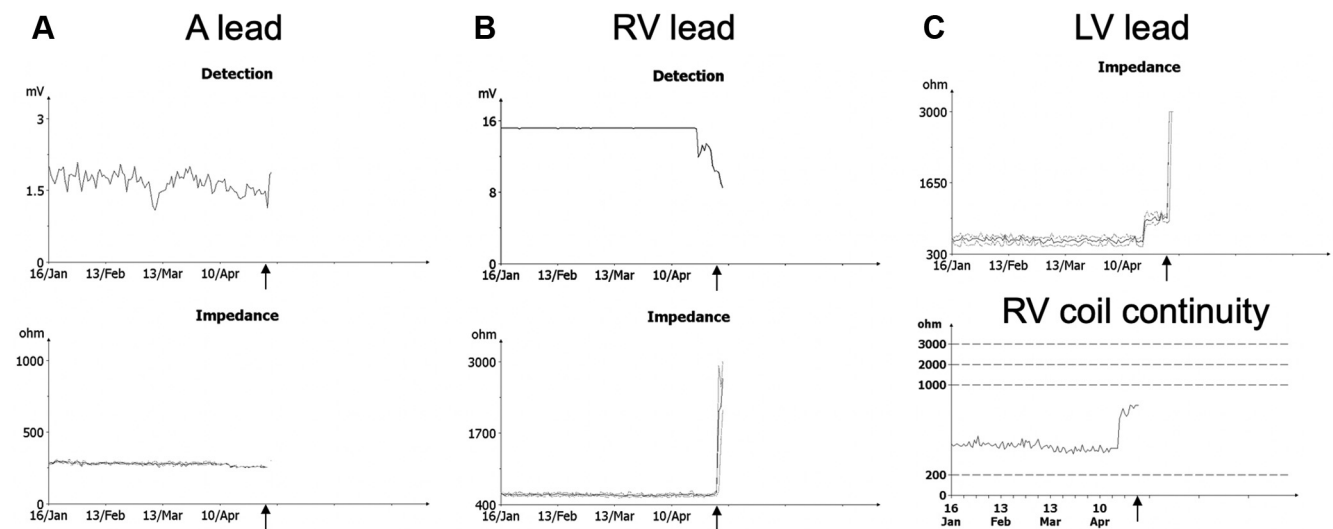
(Figure 2). Furthermore, there was a slight decrease in the atrial lead impedance preceding the abovementioned changes. On fluoroscopy, a fracture and protruding coil conductor cable was seen just proximal to the RV coil. Furthermore, externalization of conductors of the atrial lead was noted (Figure 3A). All leads demonstrated excessive slack.

Figure 2 Lead trends. **A:** Upper panel: atrial lead sensing amplitude; lower panel: atrial lead impedance trend. **B:** Upper panel: right ventricle (RV) lead sensing amplitude; lower panel: RV lead impedance trend. **C:** Upper panel: left ventricle (LV) lead impedance; lower panel: RV coil continuity. The period preceding the implantable cardioverter-defibrillator storm (arrow) was characterized by a progressive decrease in RV sense amplitude (suggesting insulation failure), a sudden increase in LV lead impedance (configured as LV tip to RV coil), and high voltage impedance. Note that the impedance of the atrial lead showed a slight decrease since mid-April.

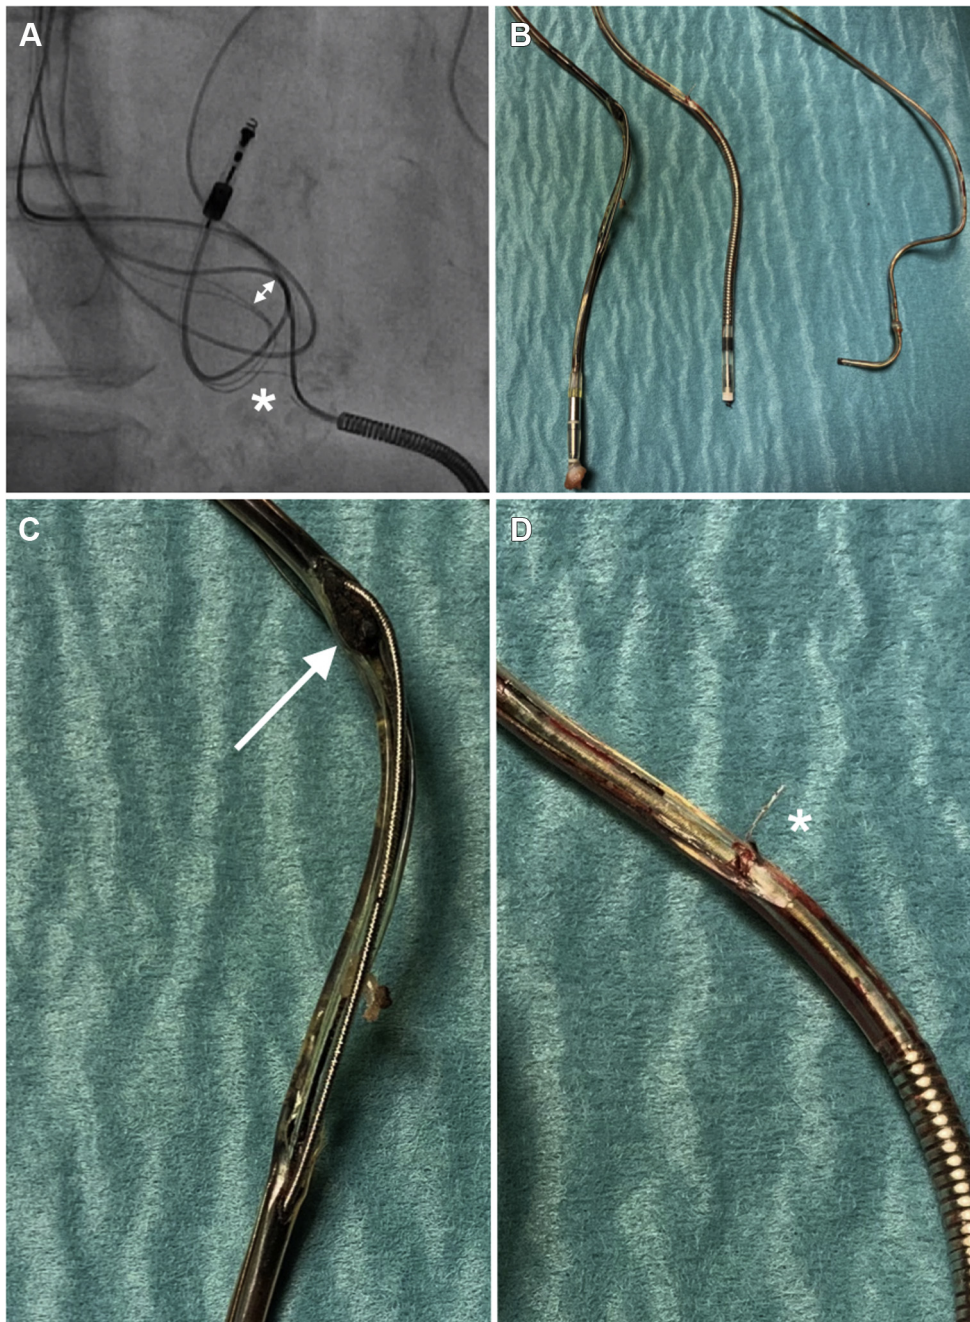
extraction tools (Figure 3B). Inspection of the extracted SonRtip atrial lead showed externalization of the pace coil over a distance of approximately 4.5 cm (Figure 3C). There was accumulation of biologic debris at the proximal site of the insulation breach. Inspection of the extracted Protego S lead demonstrated a conductor cable protruding through a breach in the silicone jacket insulation 1.5 cm proximal to the shock coil (Figure 3D). The insulation breach of the Protego S lead had smooth edges. As the patient had developed

Figure 3 Failed SonRtip (MicroPort, Shanghai, China) atrial lead and Protego (Biotronik, Berlin, Germany) defibrillator lead before and after extraction. **A:** Pre-extraction fluoroscopy demonstrating conductor cable externalization of the SonRtip lead (*double arrowheads*) and fracture and protrusion of the shock coil conductor (*asterisk*). **B:** Overview of the 3 extracted leads with, from left to right, SonRtip lead, Protego S lead, and QuickFlex (St. Jude Medical, St. Paul, MN) 1258T left ventricular lead. **C:** Detailed view of the SonRtip lead. Old, dark blood was seen in the lead body distant from the insulation breach. Note that the tip conductor coil is protruding out of the silicone body with accumulation of biologic debris and altered blood underneath the coil (*arrow*). There is a large insulation breach over a distance of approximately 4.5 cm. Additional cables remain within their lumens. **D:** Detailed view of the Protego S lead. Discrete breach in the silicone insulation proximal to the shock coil with protrusion of part of the shock coil conductor cable (*asterisk*).

to LV tip to RV coil). Interestingly, the insulation defect of the SonRtip lead was not associated with a significant change in electrical parameters before the ICD storm. During routine follow-up there was only mild attenuation of the atrial signal and mild augmentation of the ventricular far-field signal causing inappropriate mode switch episodes. The breach in the insulation jacket of the SonRtip atrial lead was large, with ragged edges. The build-up of biological debris underneath the pace coil (arrow, [Figure 3C](#)) clearly suggests a pre-existing insulation breach that was not caused by the extraction procedure. The mechanism of CCE is most likely IOA.

suspected to be IOA. Excessive slack of the atrial lead may have contributed to this phenomenon, but the multilumen design may also contribute to IOA. Data regarding the long-term longevity of these multilumen atrial leads are limited, because these leads have been in use for <9 years. According to the May 2018 product performance report of MicroPort there were only 5 cases (0.07%) of insulation breach (location not specified) in 6968 worldwide implants.¹⁰ CCE was not reported in the product performance report; however, underreporting of CCE is possible, as this defect is not always accompanied by electrical abnormalities and is only detected with fluoroscopic imaging.
