Monitoring Historic Concrete and Associated Cementitious Repair- A Case Study of Boathouse 4, Portsmouth Historic Dockyard, UK

A.H. Alwaal and S. Barnett

School of Civil Engineering and Surveying, University of Portsmouth, Portsmouth, UK

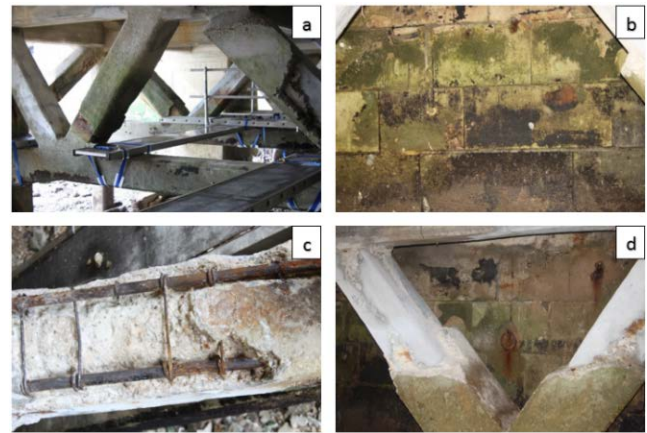
Fig. 2. Deteriorated concrete in the undercroft (Coats *et al.*, 2015)

According to a condition assessment survey report conducted by Concrete Repairs Limited (CRL), deterioration and distress were found on the concrete elements forming the building mainly as a result of either chloride-induced corrosion or carbonation induced corrosion aggravated by chlorides. There was a variation in the condition of the reinforcement exposed within the undercroft wherein some locations, the steel was found to be clean and uncorroded while in other locations, complete loss of section was observed. Conventional concrete patch repairs and cathodic protection were undertaken on the elements forming the undercroft as well in other parts of the building, totalling more than 1000 patch repairs (Pierce., 2013).

Figure 2 presents several pictures of damaged concrete in the undercroft of BH4. Based on the visual observations shown in Fig. 2, the concrete damage process could be described as follows:

- General view looking across the undercroft. Note the faint green staining to the elements indicating the typical level of the tides (shown in Fig. 2(a))
- Green vegetation growth possibly indicating historic water penetration into the structure (shown in Fig. 2(b)).

- Exploratory breaking out into an area of spalling. Note the condition of the reinforcement with some loss (shown in Fig. 2(c))
- Sub-efflorescence, rusts staining and repair (shown in Fig. 2(d))

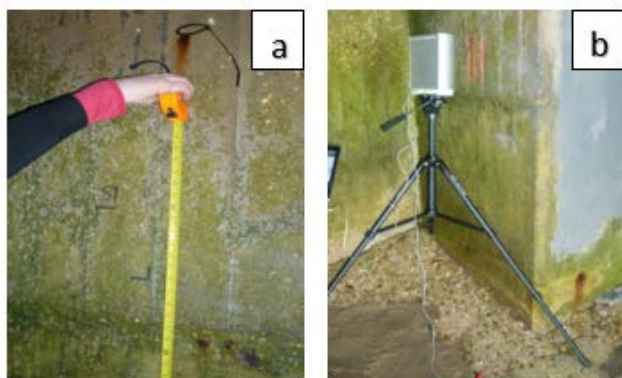
Fig. 4. Patch 1: (a) Shows the dimensions, (b) Shows the scanner set up

Patch 1 identifies the presence of algae growth on concrete. The patch is located on a wall, slightly above the high tide level. The scanned area is 160 mm h x 100 mm w (shown in Fig. 4 (a) (b)).

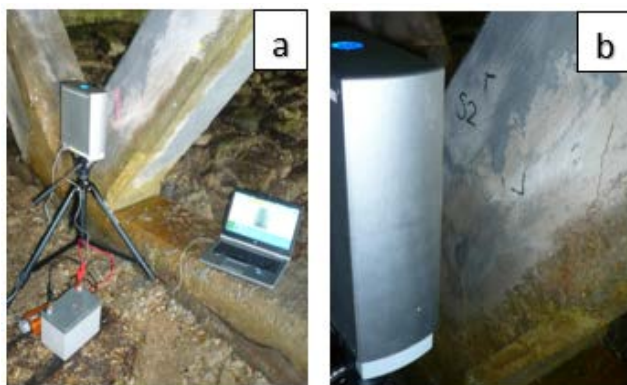
Fig. 5. Patch 2 truss element: (a) shows the scanner, external battery and laptop for data acquisition, (b) Shows an up-close view of the scanned area

Patch 2 is located on a diagonal truss element, slightly below the high tide level. The scanned area is 130 mm h x 90 mm w (shown in Fig. 5 (a) (b)). The white area on the top left-hand side of the scan identifies brushstrokes where a patch repair has been applied to the truss, so the patch includes both original concrete and repair materials.

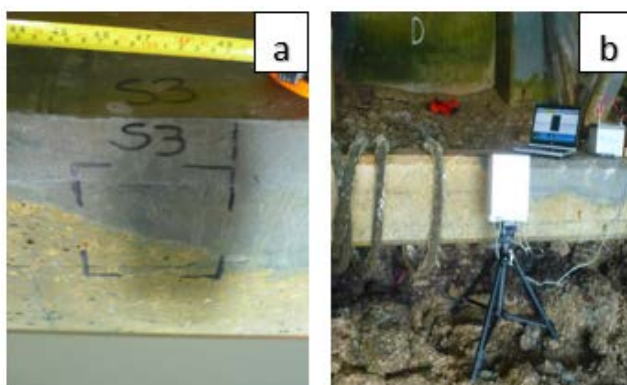
Fig. 6. Patch 3: (a) shows the dimensions, (b) Shows the scanner set up

Patch 3 is located on a horizontal beam, closer to the low tide level than the other sites. The scanned area is 135 mm h x 95 mm w (shown in Fig. 6 (a) (b)). Each patch was scanned three times over the space of three years. Data from two sets of scans taken 9 months apart are presented here.

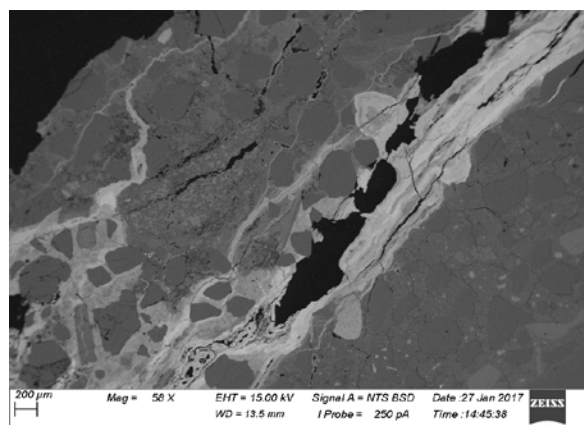
Fig. 7. Backscattered electron image (BSE)

Figure 7 shows Backscattered electron image (BSE) of concrete with some rust from corroded steel which has gradually been washed out of the concrete (white areas on the image). Mapping of elements of this region given in Fig. 8 shows the presence of S (sulphur), Na (sodium) and Cl (chlorine) which is an indication of the presence of sodium sulphate (Na_2SO_4) and sodium chloride (Na Cl).

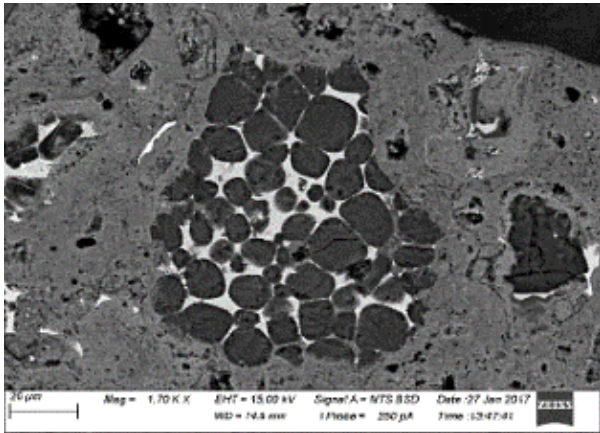
Fig. 9. Backscattered electron image (BSE)

Figure 9 shows Backscattered electron image (BSE) of concrete with a cluster of particles similar in appearance to belite nest (Pintér & Gosselin, 2015) However, element maps show no Ca in the darker particles which are rich in Si only. Fig. 10 illustrates the mapping of elements in this region.

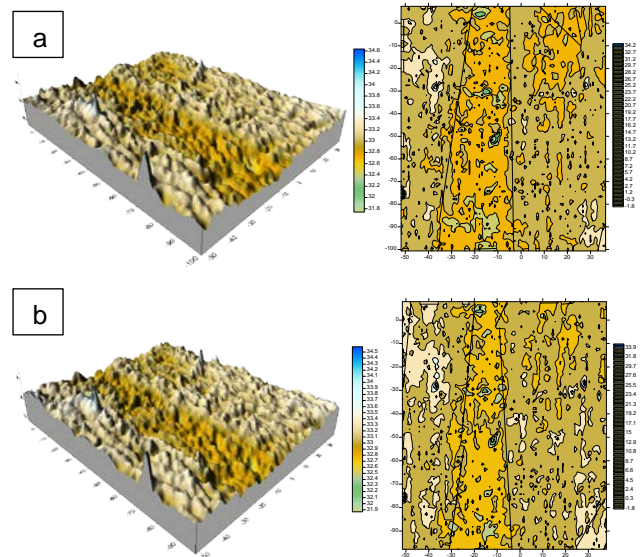
Figure 11 illustrates the surface topography of patch 1: (a) reference (first) scan, (b) compared (second) scan 9 months later. The global values are very similar. However, there are some localized feature changes.

Fig. 11. Generated 3D and contour maps of patch 1 using Surfer software: (a) Reference scan (first scan), (b) Compared (second scan) 9 months later

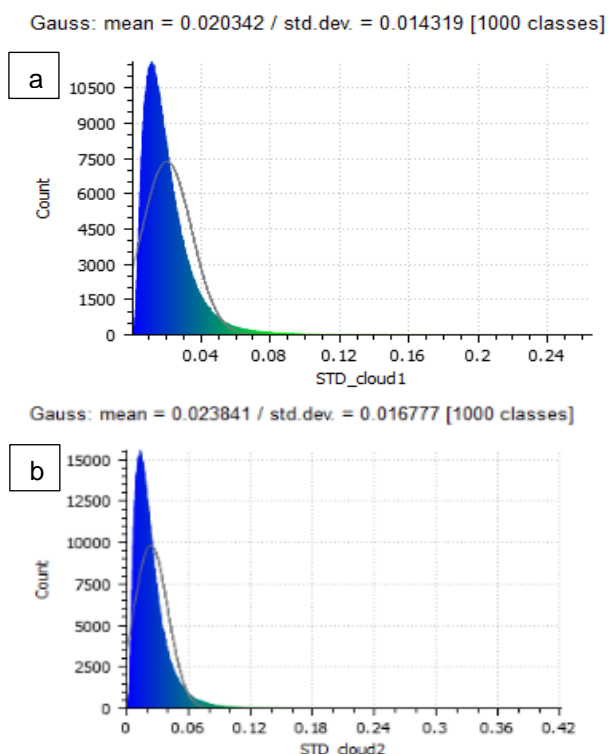
Fig. 12. Histogram plot of STD cloud 1&2

Figure 12 illustrates a histogram plot of (a) cloud 1 (reference), (b) cloud 2 (compared). The statics illustrate no significant changes as the roughness has not considerably changed with standard deviations being 0.014 mm and 0.017 mm for the first and second scans.

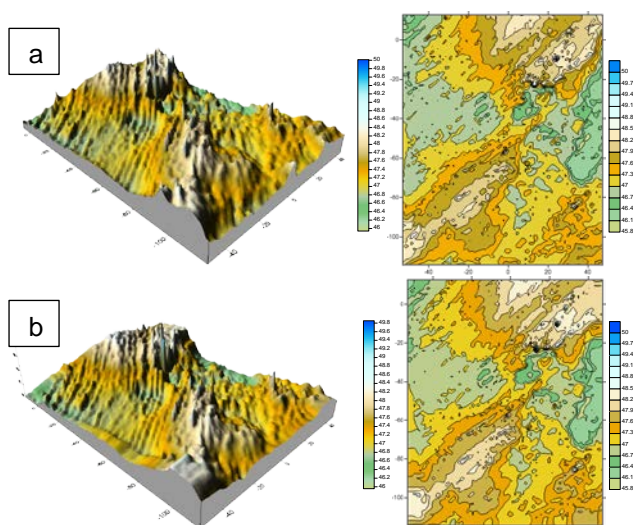
Figure 13. illustrates the surface topography of patch 2, (a) reference (first) scan, (b) compared (second) scan 9 months later. The maps clearly show almost every points are the same in relation to every other point. No changes could be detected.

Fig. 13. Generated 3D and contour maps using Surfer software: (a) Reference scan (first scan), (b) Compared (second scan) 9 months later

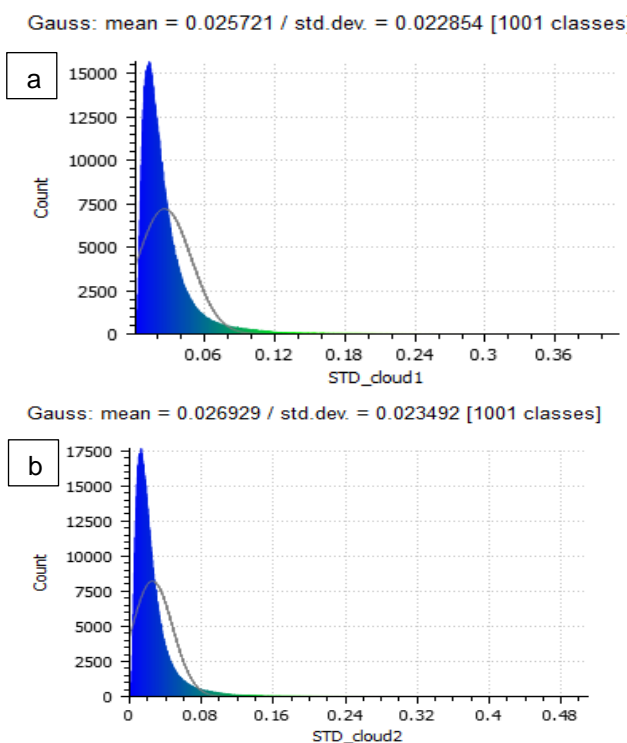
Fig. 14. Histogram plot of STD cloud 1&2

The results below indicate the surface roughness is consistent over time where the standard deviation is 0.023 mm in both scans as shown in Fig. 14 (a) (b).

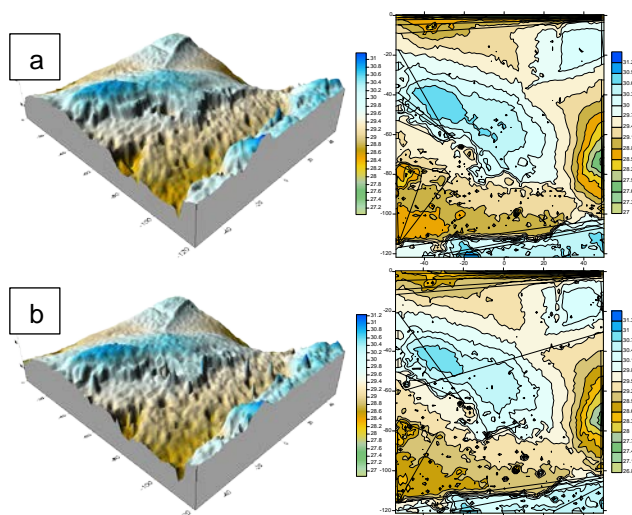
Figure 15 illustrates the surface topography of patch 3, (a) reference (first) scan, (b) compared (second) scan 9 months later. Changes in surface form have occurred at some particular locations. This patch is

closer to the seawater, so changes in the surface are expected to occur more rapidly than other patches. It reflects the exposure of the surface concerned. Moreover, visual evidence identifies a change in colouring to the repair material over time (as shown in Fig. 16).

Fig. 15. Generated 3D and contour maps using Surfer software. (a) Reference scan (first scan), (b) Compared (second scan) 9 months later.

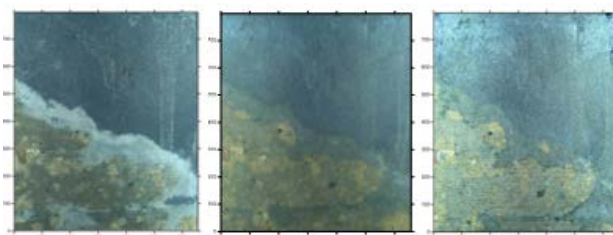
Fig. 16. Repair colour changes over time

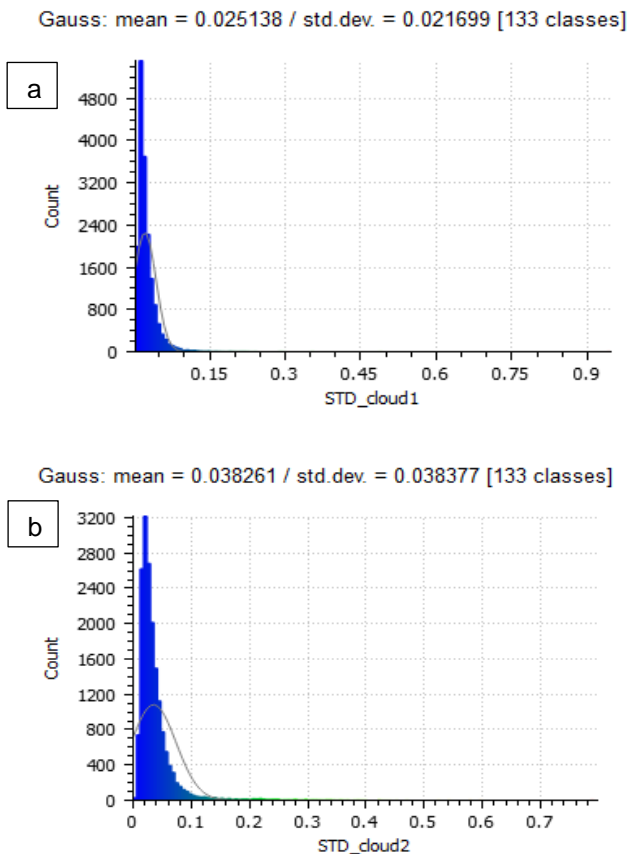
Fig. 17. Histogram plot of STD cloud 1&2

The roughness has increased over time between the two clouds where the standard deviation in cloud 1 is 0.022 mm compared to cloud 2 which is measured at 0.038 mm (as shown in Fig. 17 (a) (b)).
