**Structural Evaluation and Testing of Damaged  
Reinforced Concrete Bent Caps**

**Thesis**

The University of Texas at Austin

May 2019

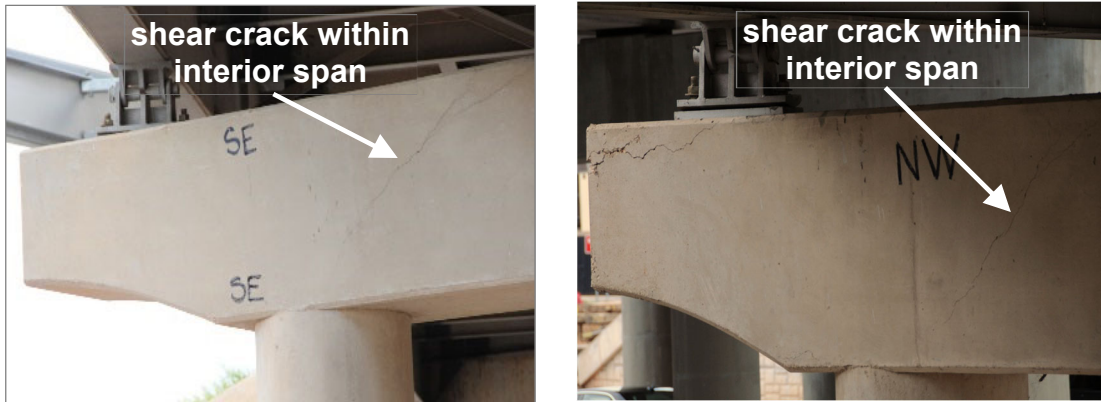
Figure 2.4. Interior span shear cracks

In nearly all of the bent caps comprising the two bridges, large-width diagonal cracks were observed within the interior spans of the bent caps, immediately adjacent to the exterior columns. Figure 2.4 presents examples of the wide shear cracks that had developed while the bridges were in service. The largest diagonal cracks observed in the bent caps generally comprised the cap regions located between the exterior column and the adjacent interior GL.

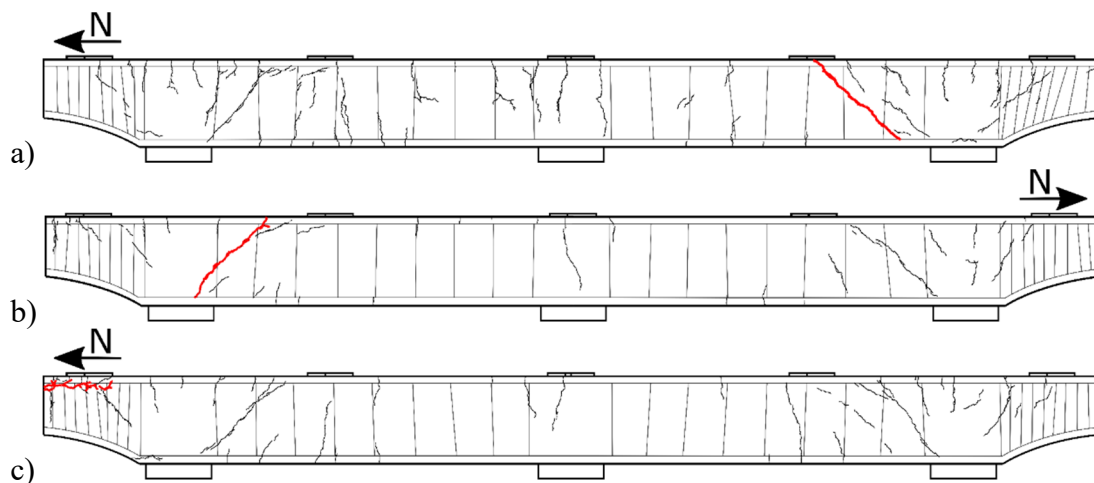
Figure 2.11. Largest crack width locations (represented in red); a) west face of BC1, b) east face of BC2, c) west face of BC2

The eight primary cracks were found to have maximum measured crack widths that ranged from 0.022 to 0.039 in. (0.55 to 1.00 mm) and an average crack width on the order of 0.016 in. (0.41 mm). However, it should be noted that the majority of all the documented cracks (i.e., considering both shear and flexural cracks) had width measurements on the order of approximately 0.003 to 0.012 in. (0.10 to 0.30 mm).

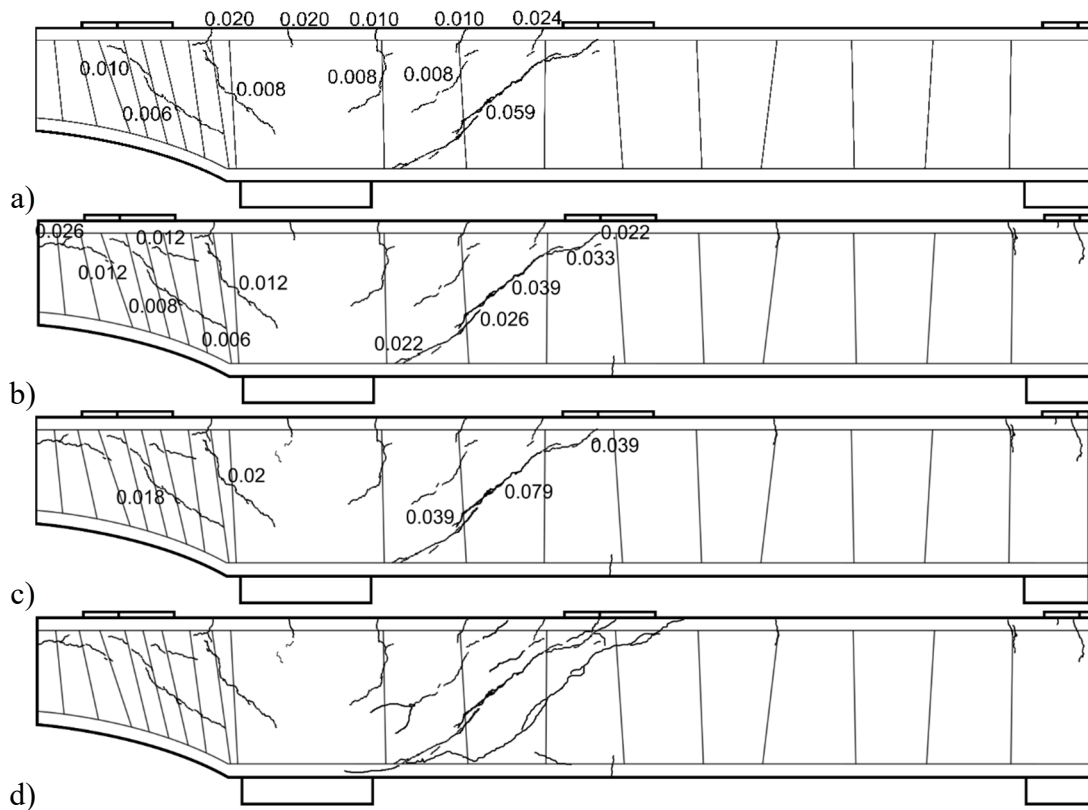
Figure 3.7. BC1-1 cracking data, and measured reinforcement placement, a) Field inspection, b) Constant dead load case, c) 180 kip load case (i.e., at approximately 90 % of the ultimate capacity), d) Crack pattern after test

The failure of test BC1-1 was controlled by a tension-controlled shear failure. Shear cracking damage was observed on the interior span throughout the duration of the test, specifically within the concrete comprising the main strut (i.e., stemming from the location of the column stub to GL2). The development of new, but small-width, shear cracks were formed at the overhang. The failure occurred after the shear cracks of the interior span widened excessively. Concrete crushing was also observed within the concrete comprising the main interior span strut. Note that, after reaching ultimate shear, the resistance of the cap rapidly decreased and no sign of ductile behavior was observed. At 90 % of ultimate load, the major shear crack was x 1.3 the width of that measured during the field inspection. The shear cracks can be visualized in Figure 3.9c, 3.9d, 3.9e, and 3.9f.

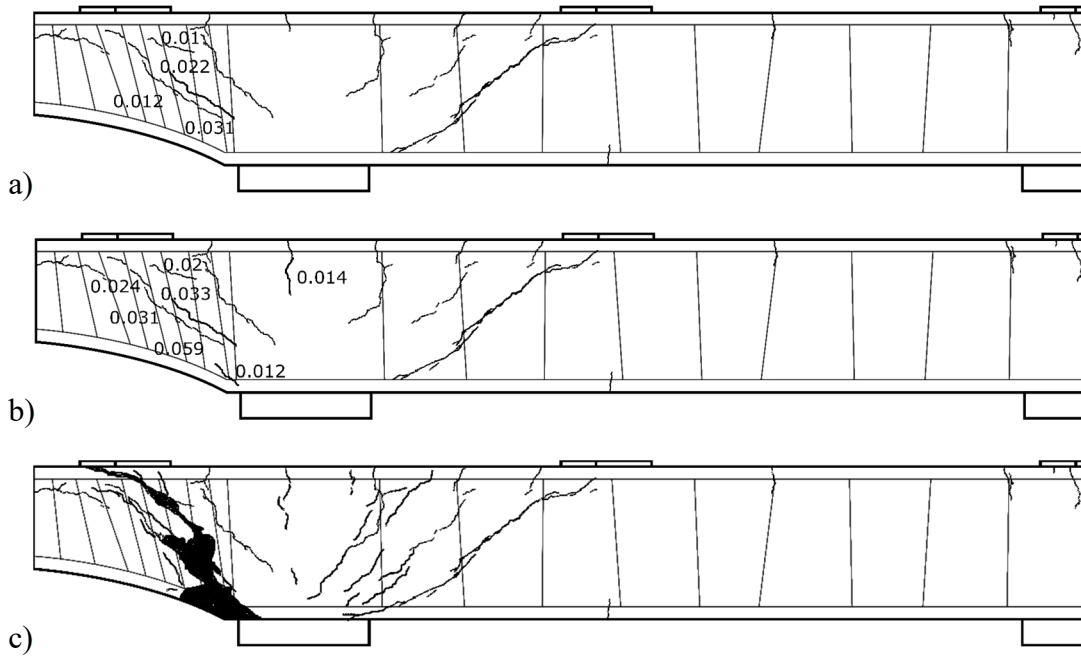
Figure 3.15. BC1-3 crack widths and pattern, and actual reinforcement, a) 250 kip load case, b) 300 kip load case, c) Crack pattern after test

The ultimate shear force resisted by the bent cap overhang span was estimated to be 317 kip, which corresponded to a maximum applied girder line load of 319 kip (note, the slight offset is due to the self-weight of the overhang). The bending moment developed at the face of the column, immediately prior to failure, was equal to 682 kip-ft. The measured shear capacity of the interior span was comparable to that estimated by way of current AASHTO provisions, which was estimated to be 331 kip.

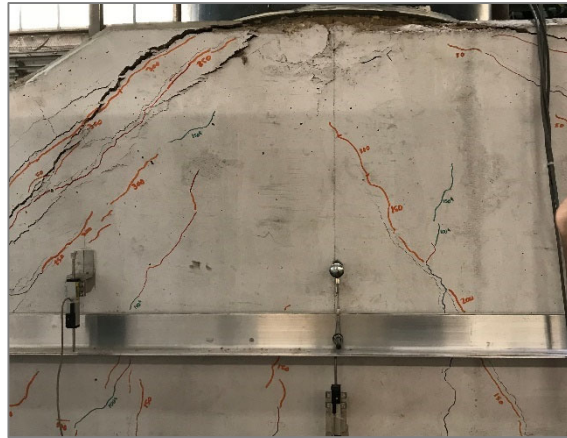
b) Shear cracks and observed concrete crushing after test completion (east face)

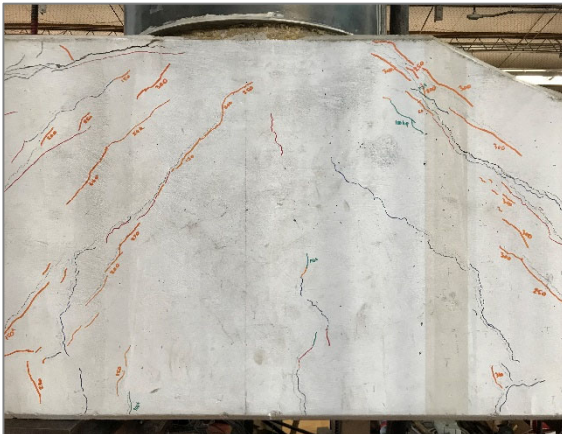
c) Crack pattern at column stub at the 300 kip load case (west face)

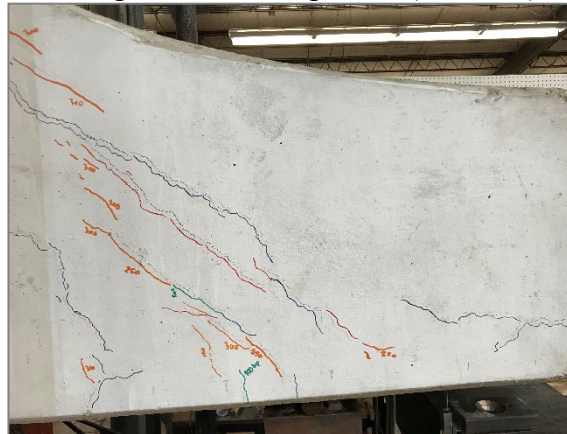
d) Crack pattern at overhang at the 300 kip load case (west face)

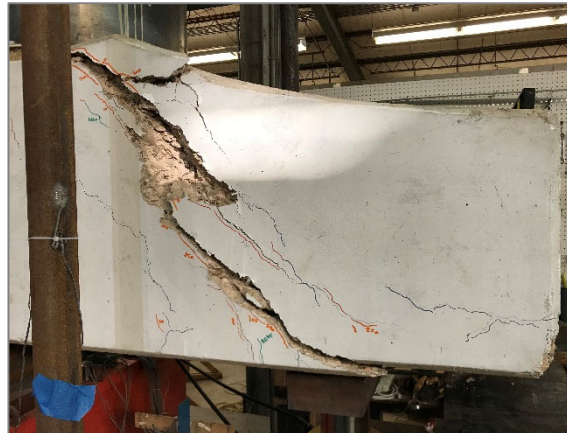
f) Shear cracks and concrete crushing at overhang after test completion (west face)

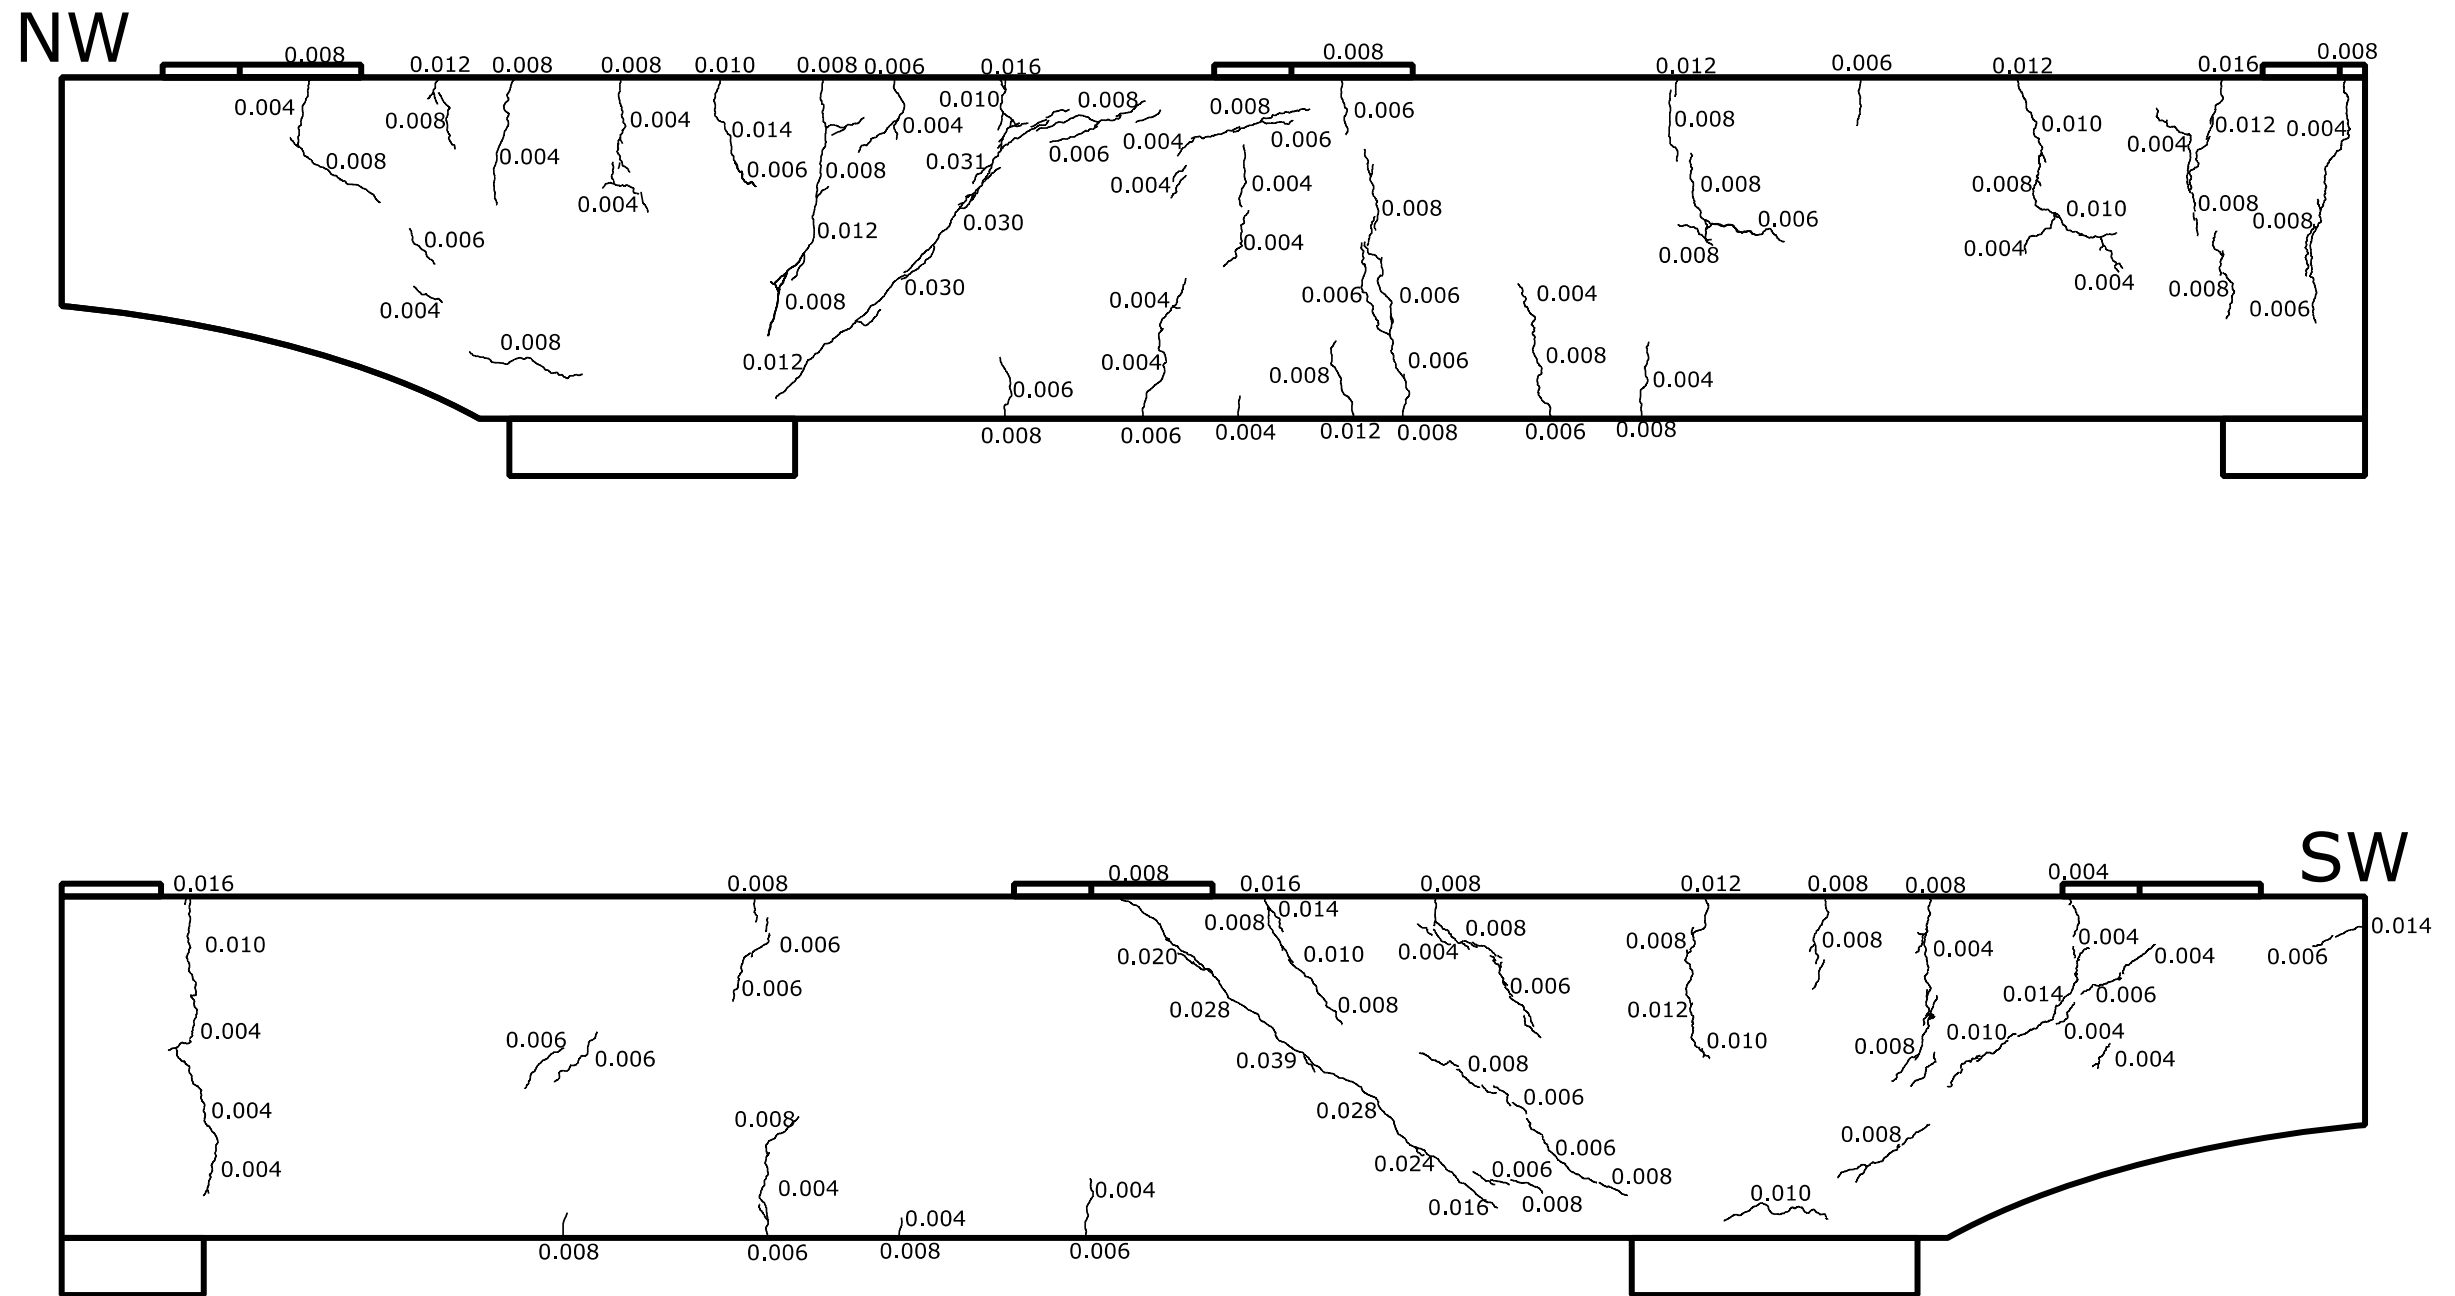
Figure A.8. West face of BC1: cracking measured from laboratory inspection; crack widths reported using units of inches

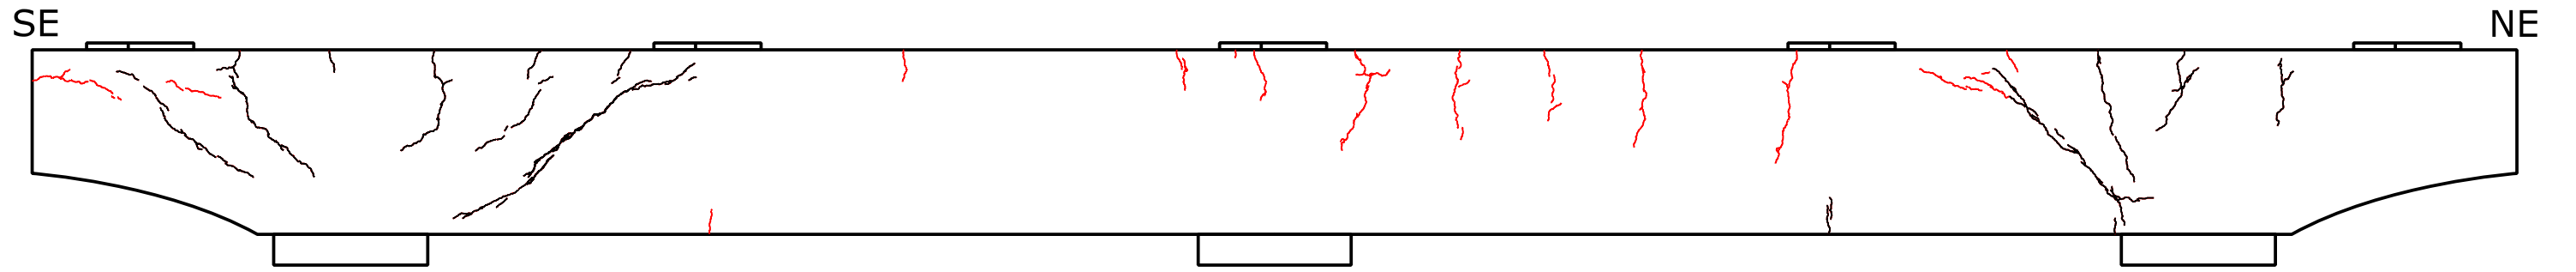
Figure A.9. East face of BC1 additional crack pattern found in FSEL (represented in red)

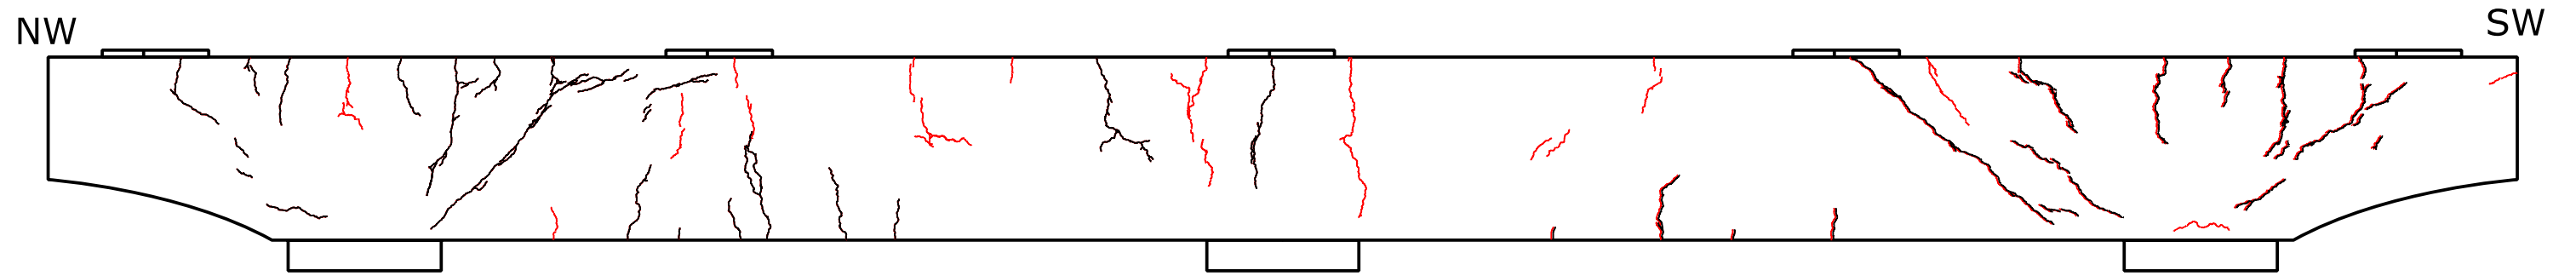
Figure A.10. West face of BC1 additional crack pattern found in FSEL (represented in red)

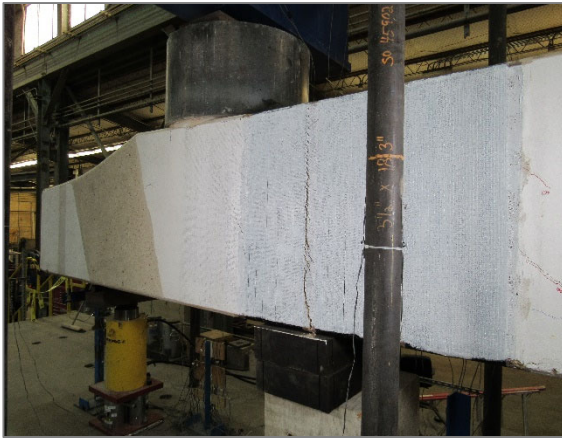
a) Formation of major flexural and shear cracks (west face)

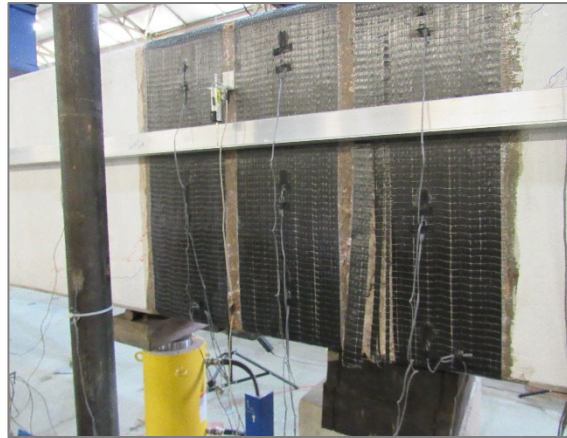
b) Delamination and rupture of CFRP at location of major flexural crack (east face)

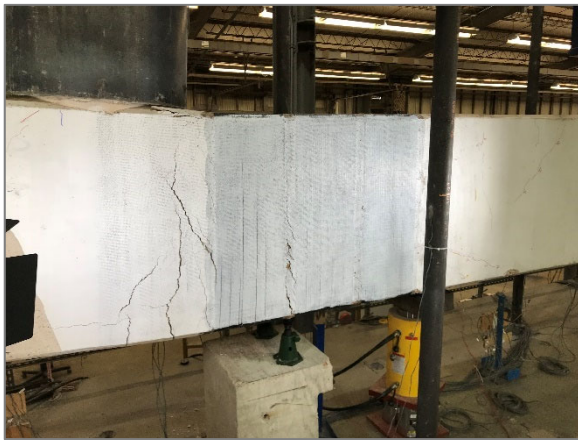
a) Major shear and flexural cracks after test completion (west face)

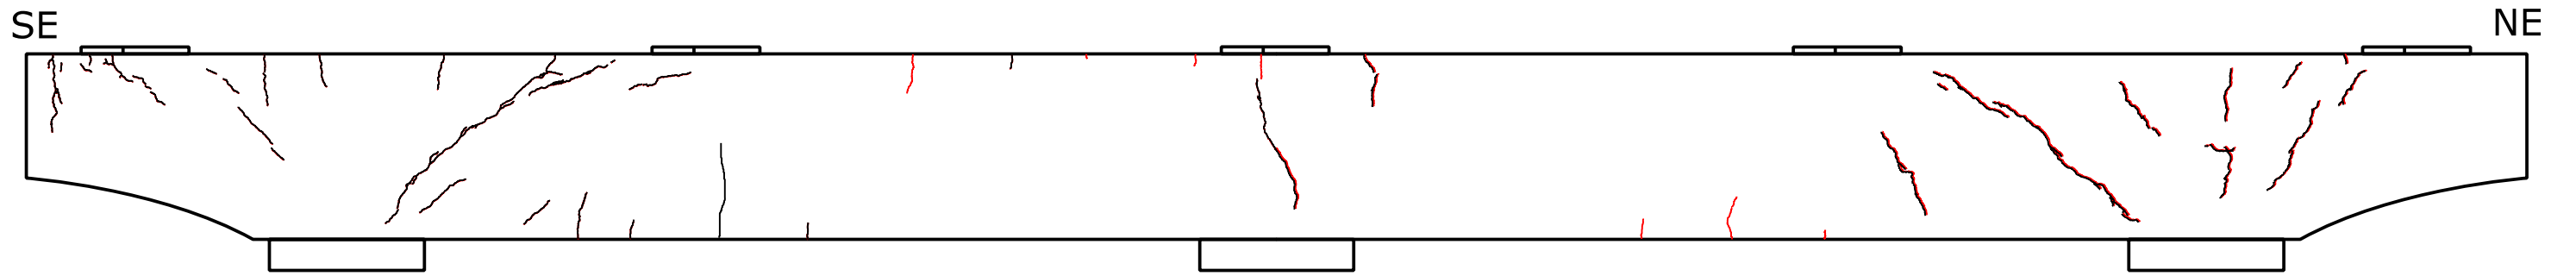
Figure B.10. East face of BC2 additional crack pattern found in FSEL (represented in red)

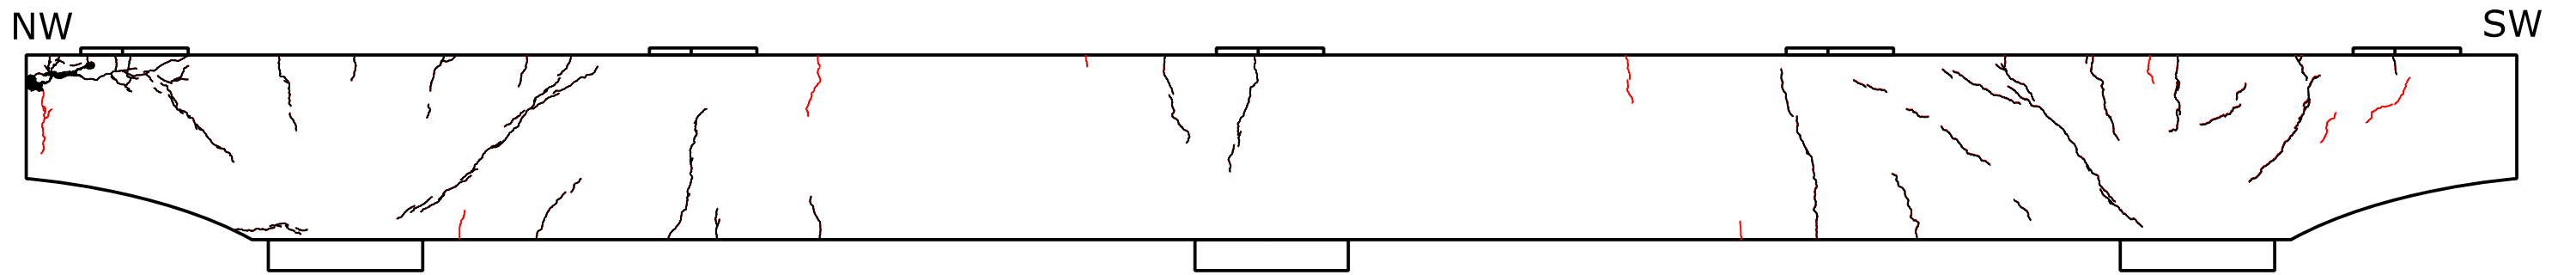
Figure B.11. West face of BC2 additional crack pattern found in FSEL (represented in red)

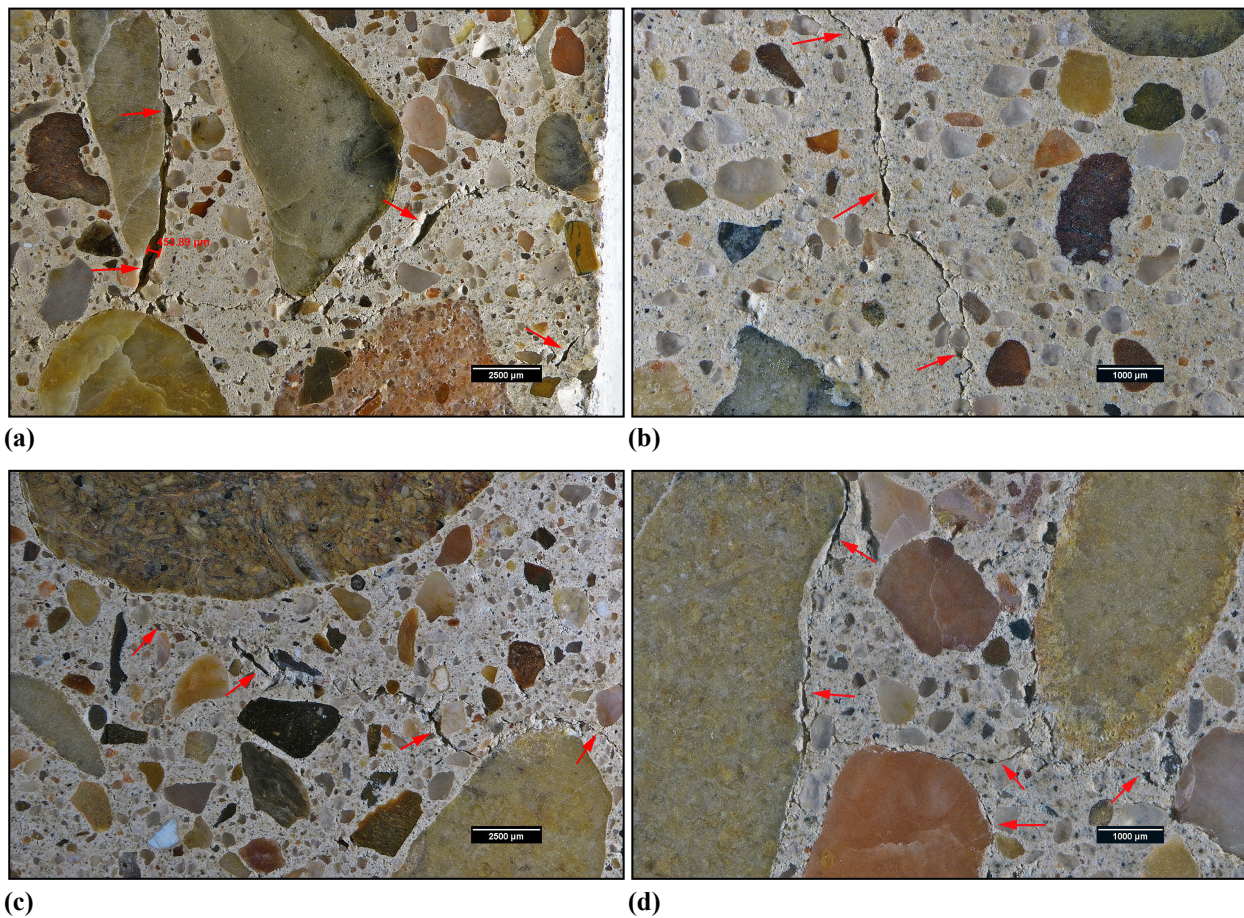
**Figure 6.** (a) Reflected light photomicrograph of the polished surface of Core 12T1 showing hairline cracks (red arrows) at the outer end of the core. (b) Reflected light photomicrograph of the polished surface of Core 12T1 showing microcracks (red arrows) about 25 mm (1 in.) from the outer surface. (c) Reflected light photomicrograph of the polished surface of Core 1T2 showing hairline cracks (red arrows) about 25 mm (1 in.) from the outer surface. (d) Reflected light photomicrograph of the polished surface of Core 1T2 showing microcracks (red arrows) about 19 mm ( $\frac{3}{4}$  in.) from the outer surface.

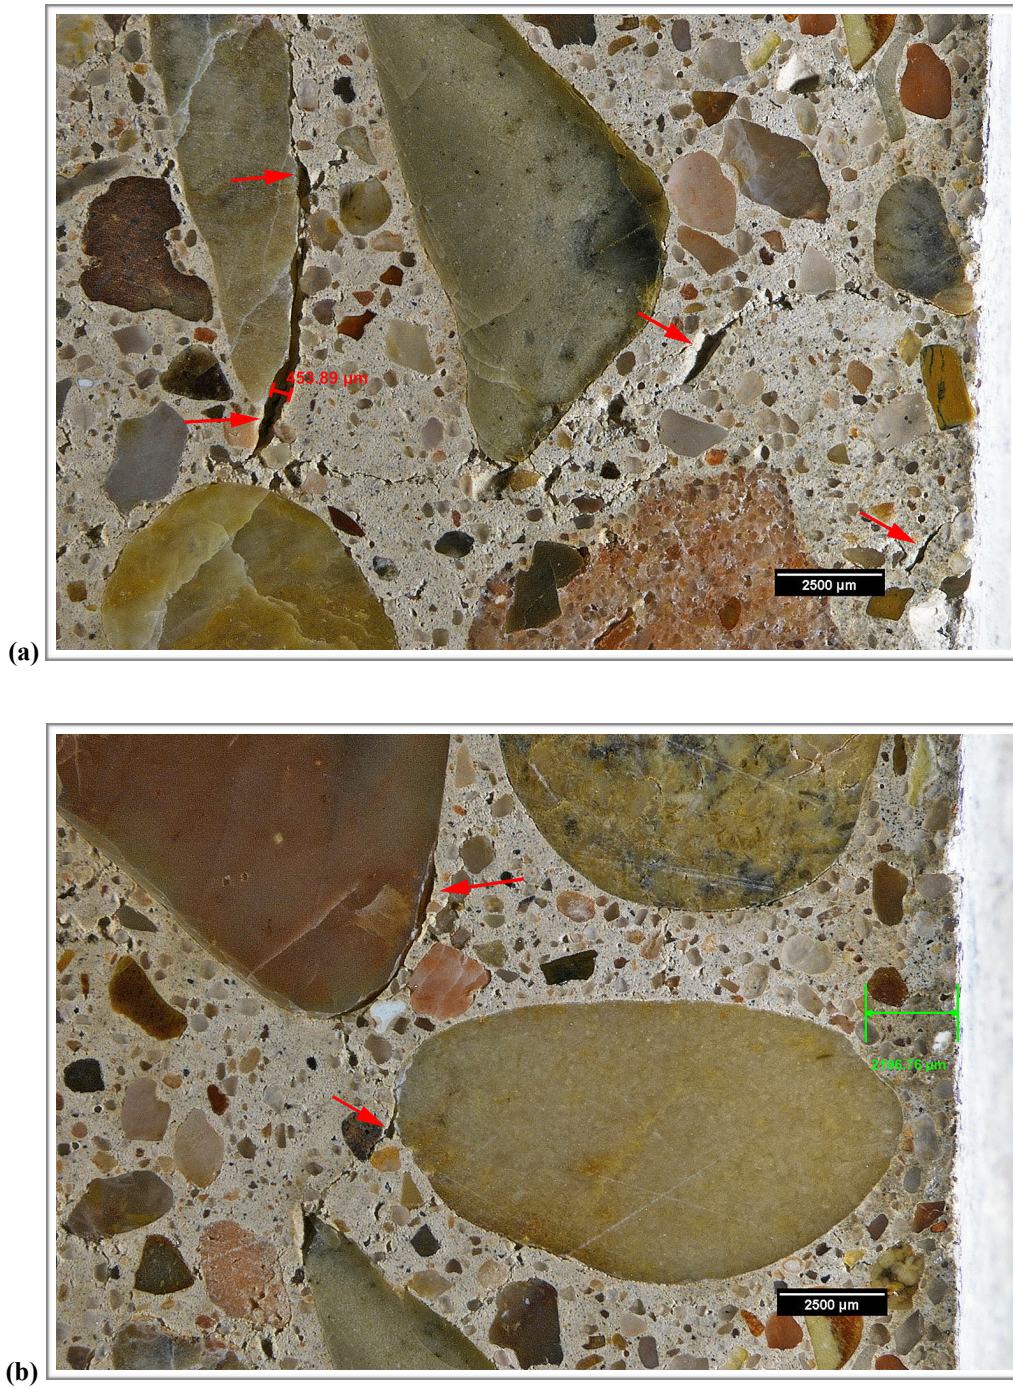
Figure A4. Reflected light photomicrographs of the polished surface showing hairline cracks (red arrows) near the outer surface of the core. The green bar in (b) measures the thickness of the zone of darker paste.

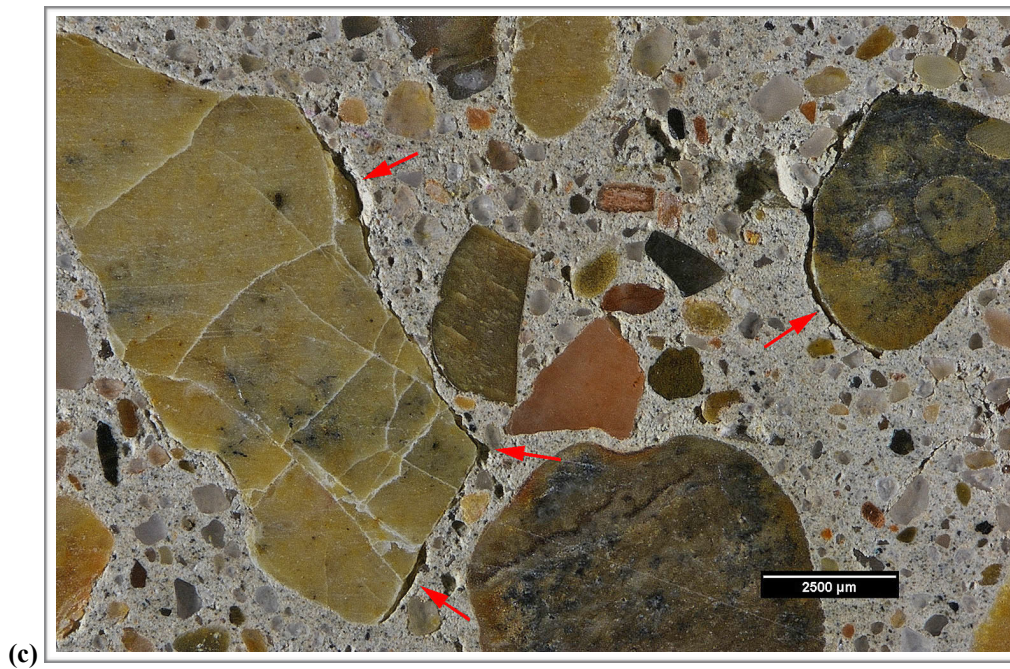
Figure A4 (cont'd). (c) Reflected light photomicrograph of the polished surface showing hairline cracks (red arrows) about 55 mm (2 1/8 in.) from the outer surface of the core.

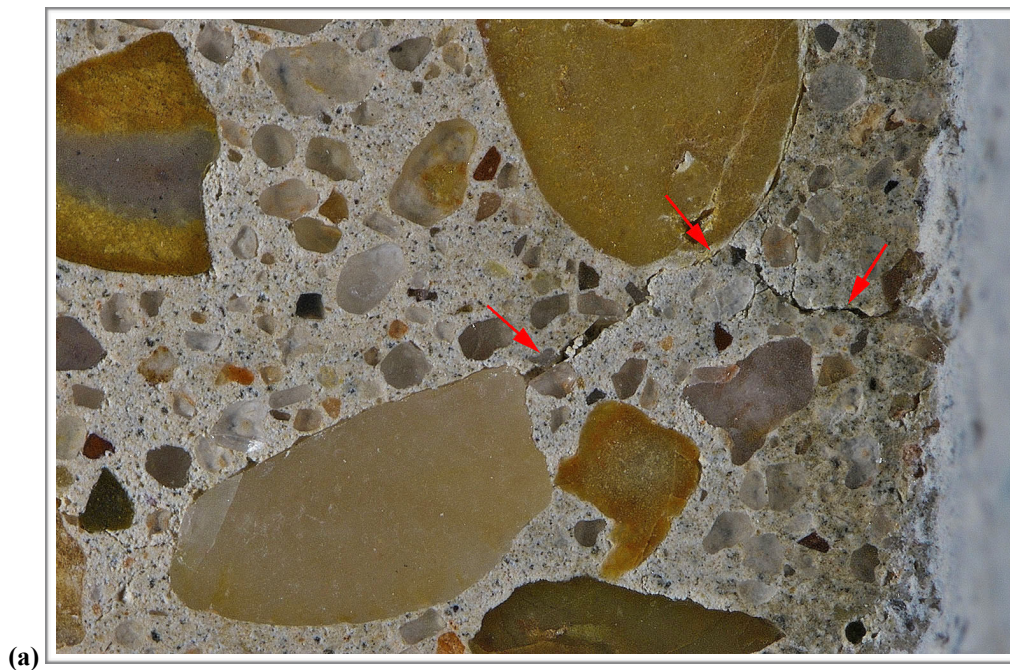
Figure A5. Reflected light photomicrograph of the polished surface showing microcracks (red arrows) near the outer surface of the core.

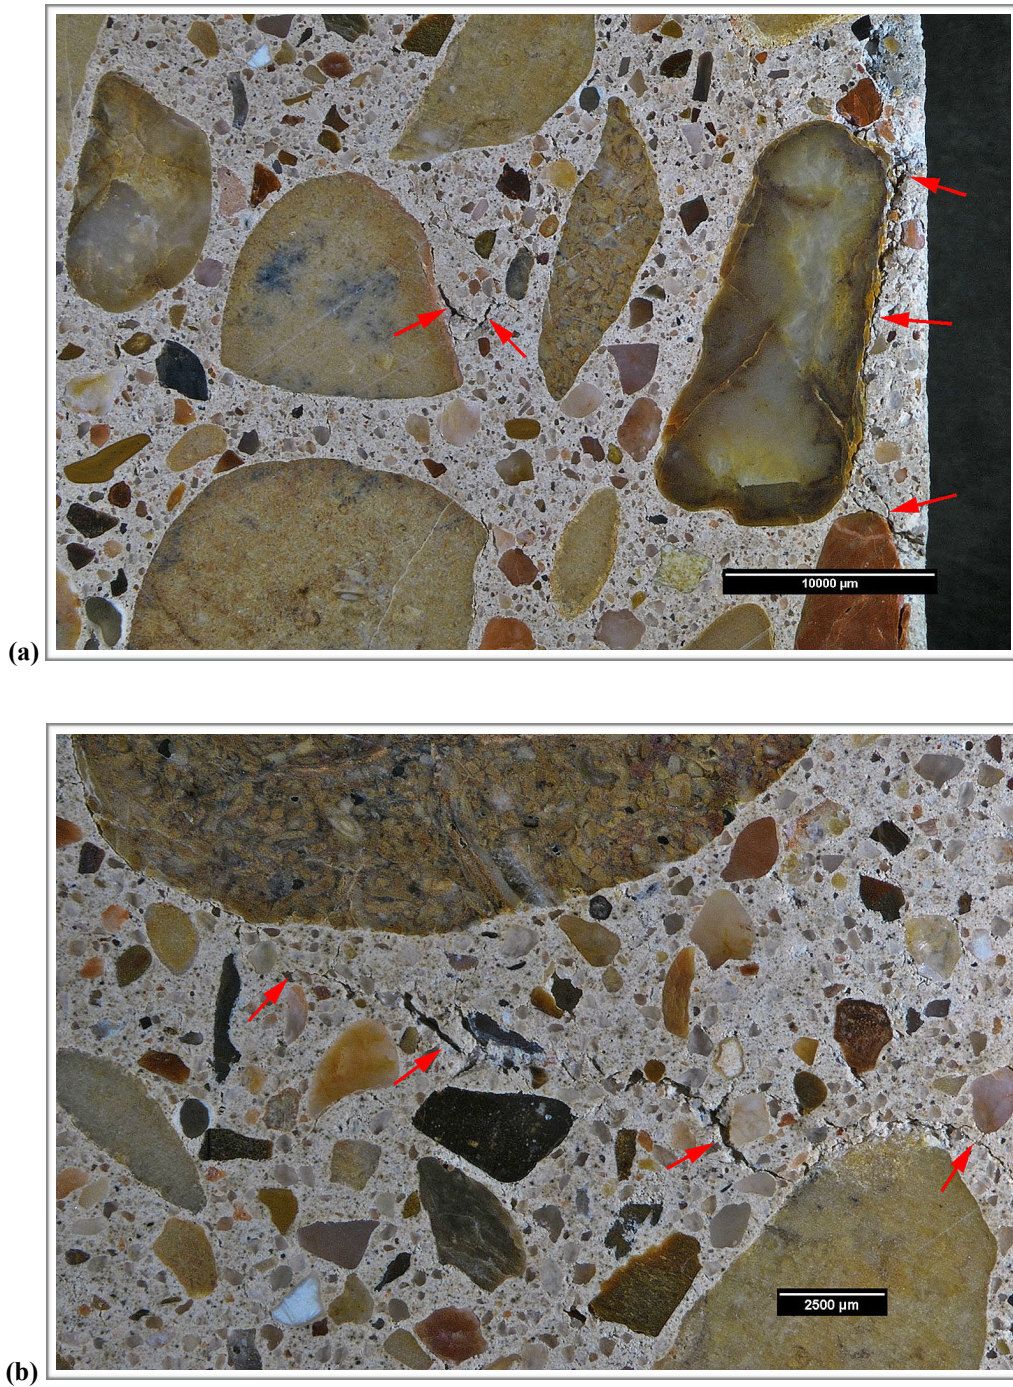
Figure B4. Reflected light photomicrographs of the polished surface showing hairline cracks (red arrows) near the outer surface of the core.

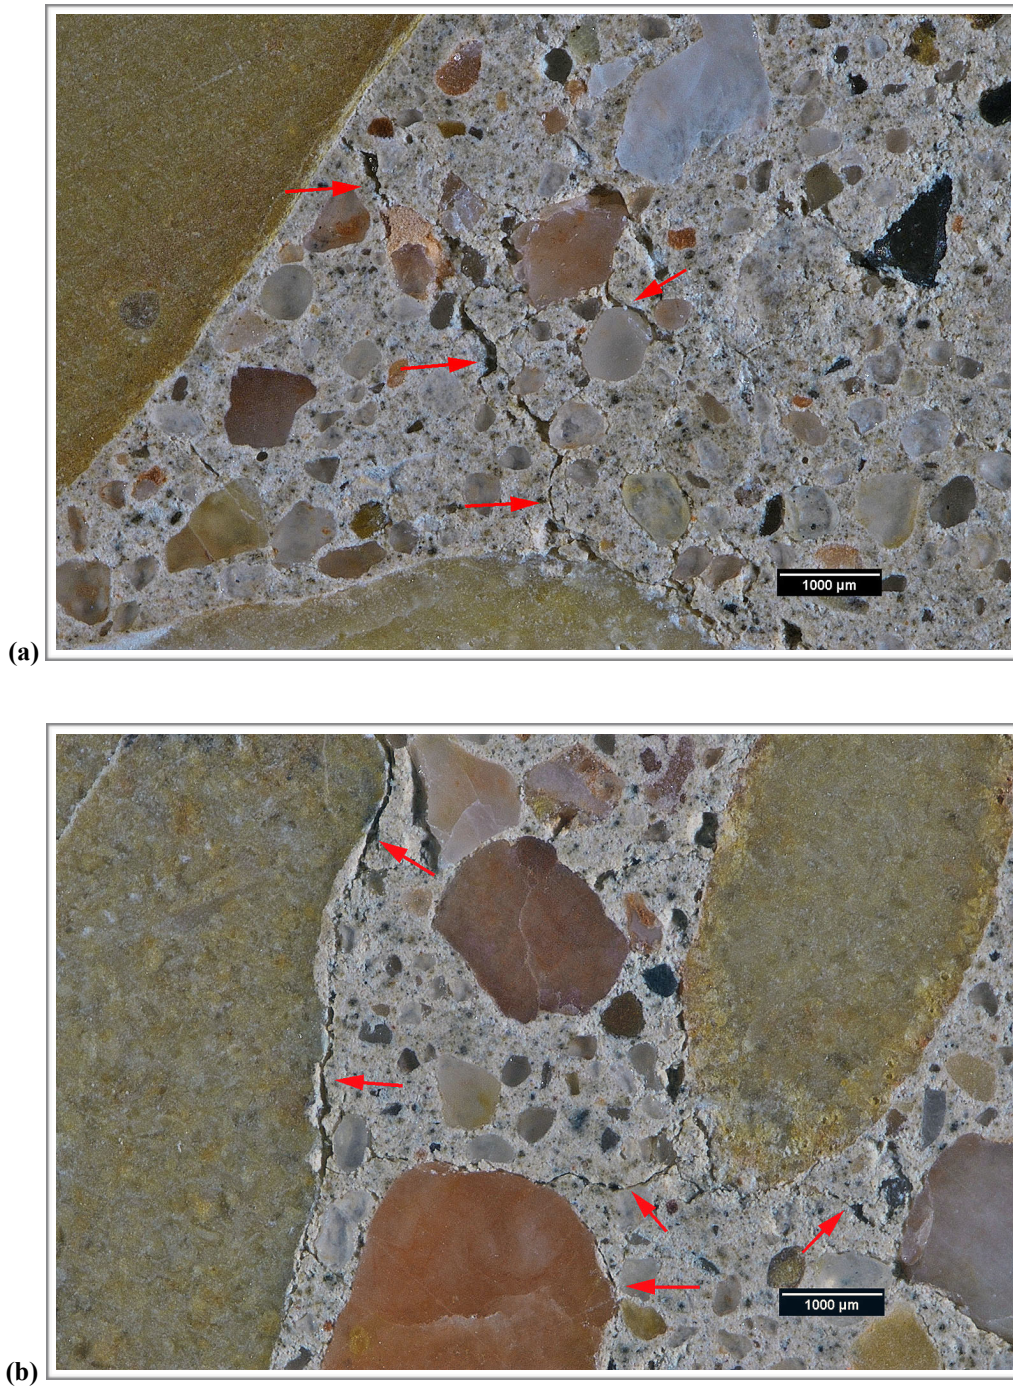
Figure B5. Reflected light photomicrograph of the polished surface showing microcracks (red arrows) cutting through the paste about (a) 12.5 mm ( $\frac{1}{2}$  in.) and (b) 19 mm ( $\frac{3}{4}$  in.) from the outer surface of the core.
