## Laboratory Simulation of Rolling Contact Fatigue Cracks in Wind Turbine Bearings Using Hydrogen Infused 100Cr6 Bearing Steel

Janakiraman, Shravan; West, Ole; Klit, Peder; Jensen, Niels Steinfeldt

*Publication date:*  
2014

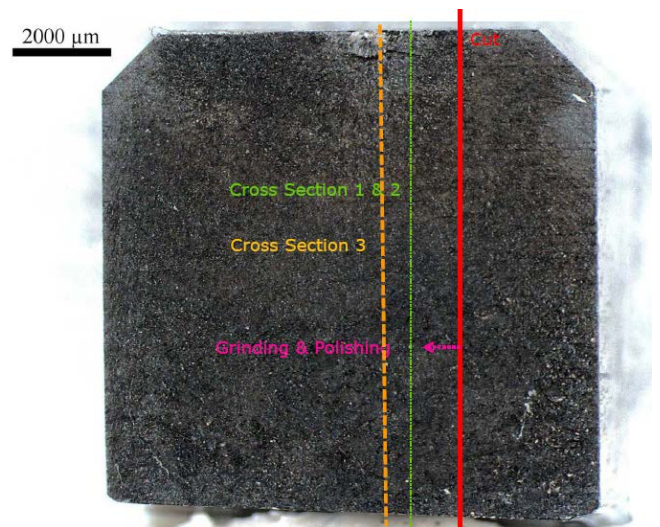
**Figure 2 :** Stereomicroscope image of the fracture surface of ring B1

A cut is made along the red line in (Fig. 2) and the sample is mounted. The specimen is then ground and polished, with material removed in the axial direction, until faces close to the crack are reached. White Etching Areas are usually observed in these axial cross sections. However, there may be some cross sections where the white areas might not be found as the total number of WEA can be small. Thus, the probability of finding a White Etching Area close to a crack

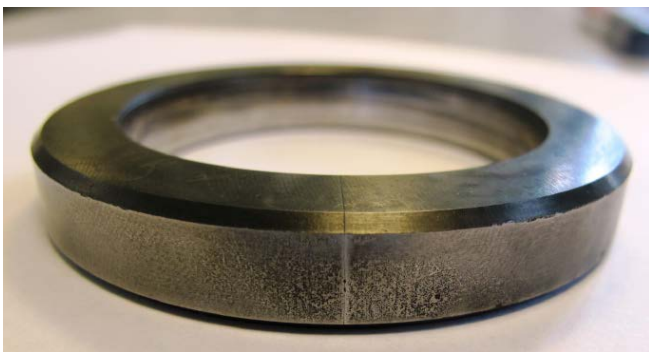
**Figure 3 :** Axial crack on ring B1.

(**Fig. 3**) and (**Fig. 4**) show the fracture surfaces of the ring B1 that fractured after 11 million cycles. A cross

material is similar to the material of the test ring specimens used for testing. These cracks look similar to the axial crack on the surface of the ring B1 (**Fig. 3**). The failed bearing inner ring from service are sectioned, polished, etched and viewed under a microscope. Their failure characteristics are then compared to the failure characteristics in the laboratory simulated RCF rings.

(**Fig. 3**) and (**Fig. 8**) also show pitting on the surface of the test specimen. Pitting could occur due to the presence of small solid contaminants in the lubricant, or due to a subsurface cracks growing to the surface.

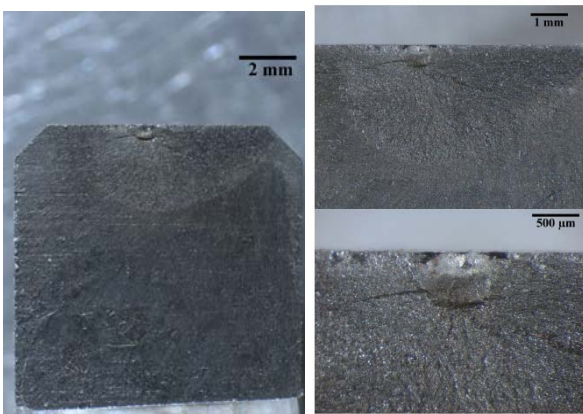
**Figure 4:** Stereomicroscope images of the fracture surface of ring B1

(**Fig. 4**) and (**Fig. 5**) shows a resemblance to the fractured sample in the ball bearing fatigue test conducted by Clark [2]. The fracture surface shows a difference in texture between the top and bottom of the specimen. The rough, rounded portion close to rolling surface appears to have fractured by fatigue while the smooth lower portion appears to have fractured in a brittle manner.

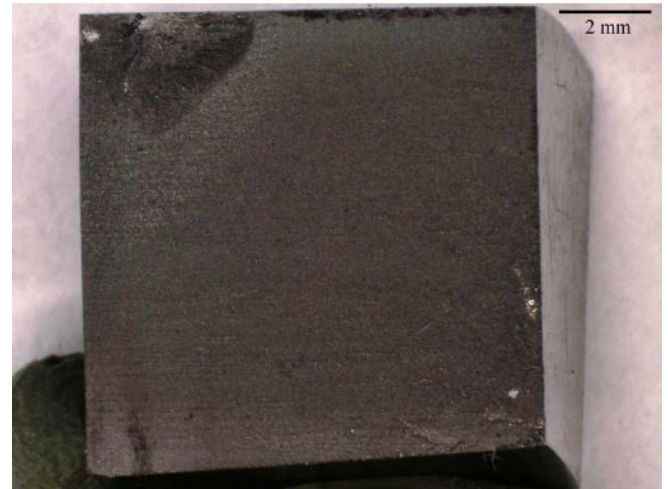
**Figure 5:** Stereomicroscope image of the fracture surface of the ring A2

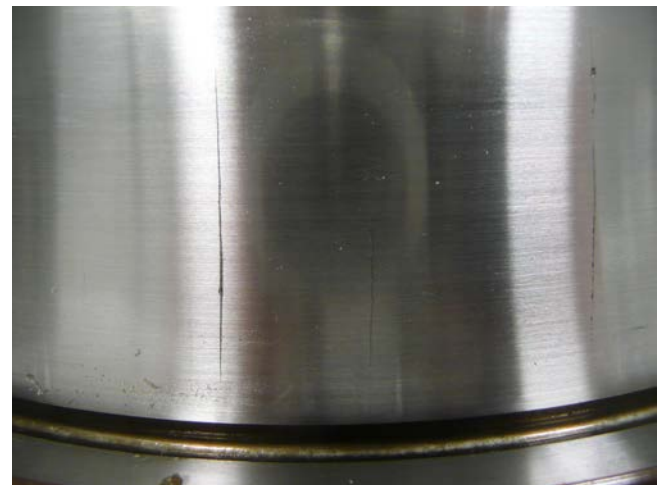
**Figure 6:** Axial crack on the inner ring of a bearing from service

(**Fig. 6**) shows multiple axial cracks on the inner ring of a tapered roller bearing from service. The bearing was positioned on the shaft at the intermediate stage inside the gearbox of a wind turbine. The gearbox belonged to a 2.3 MW turbine. The material is a through-hardened martensitic bearing steel. This

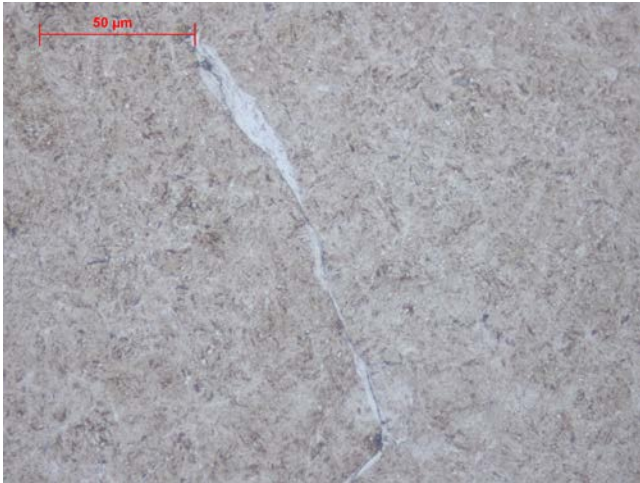
**Figure 7:** RLM image of a nital etched axial cross section (cut parallel to the over-rolling direction) showing a White Etching Area (WEA) around a crack in the inner ring of the bearing.

(**Fig. 7**) shows a characteristic WEA around a crack in an axial cross section of the bearing inner ring surface. It has been suggested by Kino et al., [6] that hydrogen plays a role in the formation of these WEA. Uyama [6] studied these WEA using a Transmission Electron Microscope (TEM) and observed that the white structure consisted of an ultra fine grained structure. He further suggested that the localized microstructural changes are caused by the hydrogen and hence supposed that the basic role of hydrogen is to localize plasticity.

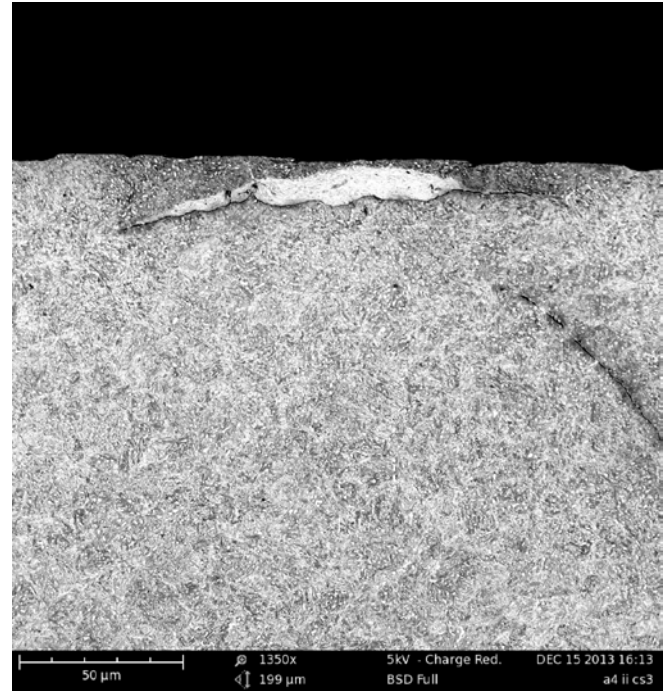
(**Fig. 8**) shows a WEA found in an axial cross section near a crack formed subsurface. This crack is less than 20 microns from the rolling surface. This is believed to be because raised levels of hydrogen closer to the rolling surface, weaken the material and make it more susceptible to crack initiation. Evans [5] showed that decreasing the levels of hydrogen artificially infused in the surface of the ring causes these cracks to be formed much further away below the rolling surface.

**Figure 8:** WEA found near a crack on the failed lab specimen B2

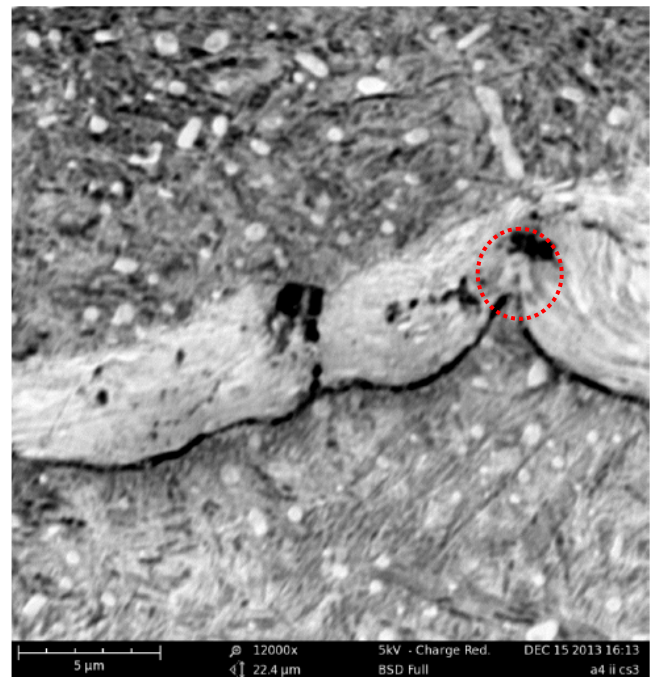
(**Fig. 8**) shows a highly magnified SEM image of the WEA. The light triangular shaped region within the red dotted circle is suspected to be a deformity like an inclusion or a void formed at the location of a former inclusion, just like Evans [5] had predicted, although

not yet confirmed by performing EDAX studies. The shape of the crack also seems to resemble the butterfly cracks described by Evans in the same paper.

**Figure 9:** SEM image of the WEA around the crack
