Site Assessment Report

**Douglas Shoal Remediation Project
Great Barrier Reef Marine Park Authority**

8 November 2019

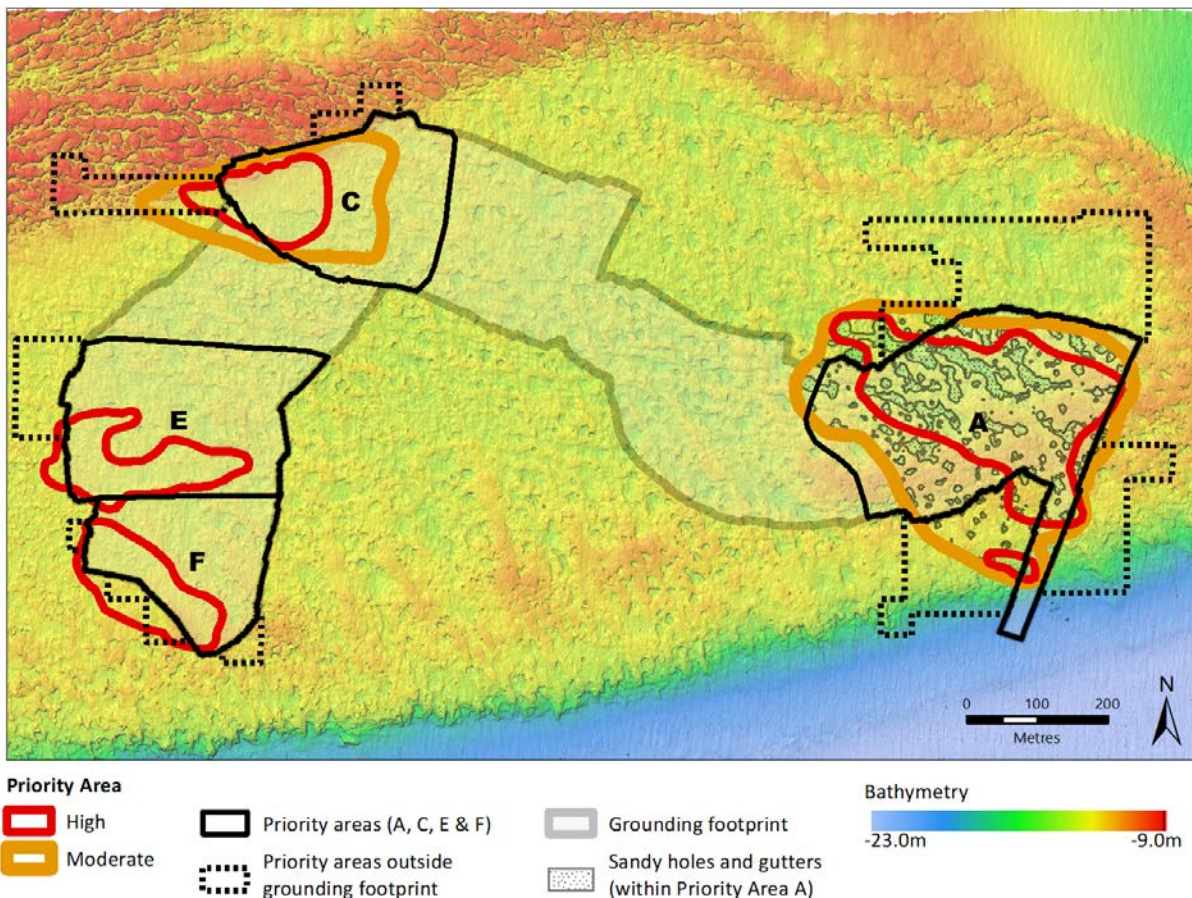
- Remediation priority for contamination in part of Priority Area A:
 - Moderate priority assigned where analysis shows concentrations of TBT, copper or zinc in sediment are predominantly above default guideline values for ecosystem protection, with contaminant levels in sediment likely to remain above the guideline values for about ten years
 - High priority assigned where, in addition to the above, analysis shows that disturbance of the sediment is likely to release water with concentrations of TBT, copper or zinc above default guideline values for the protection of a high ecological or conservation value system.
- Remediation priority for persistence of rubble in part of priority areas C, E and F:
 - High priority assigned where analysis shows most substrate is rubble
 - Moderate priority assigned where analysis shows rubble is a significant part of the substrate.

Figure 1-7 Delineation of high and moderate priority areas

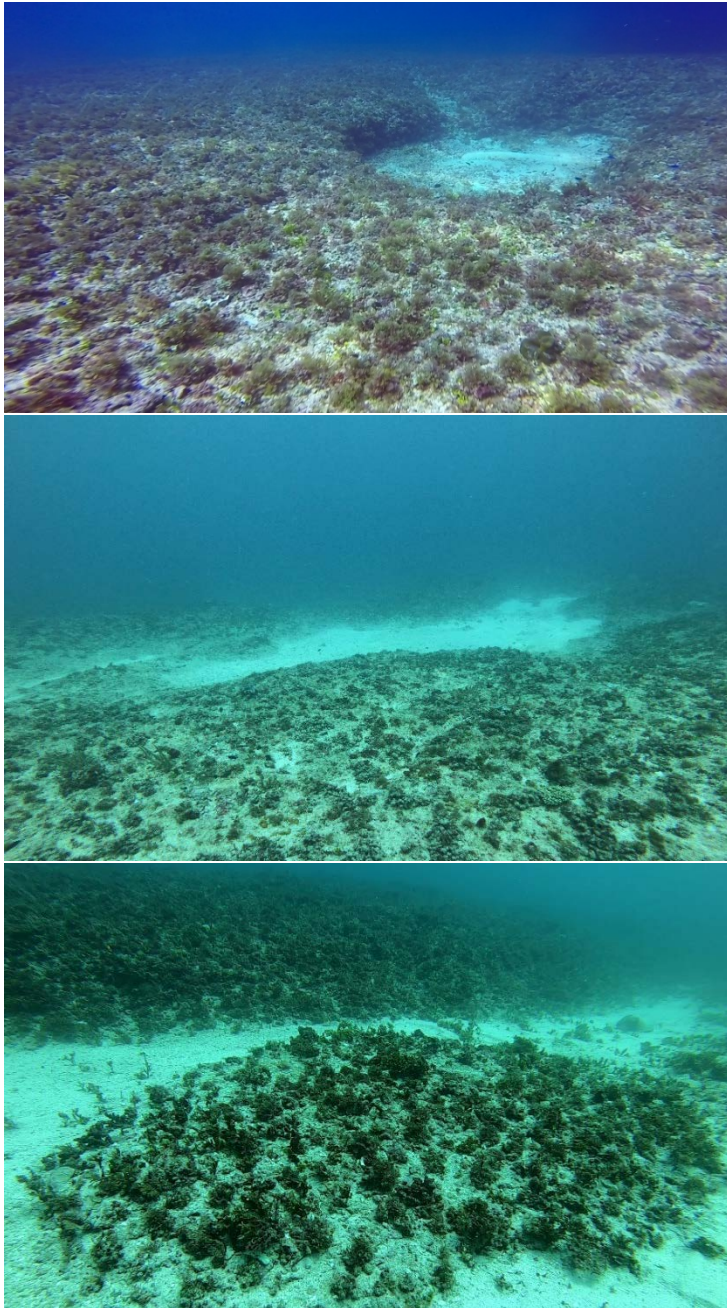
Figure 5-24 Deep and shallow holes, channels or gutters in the grounding footprint of Priority Area A

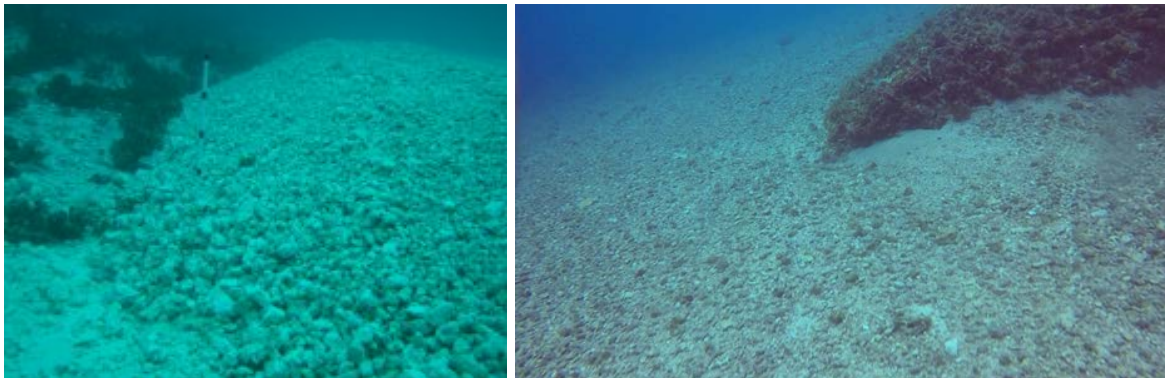
Figure 6-1 Rubble banks observed during the initial assessment in April 2010 (left) and March 2019 (right) (note locations are not the same)

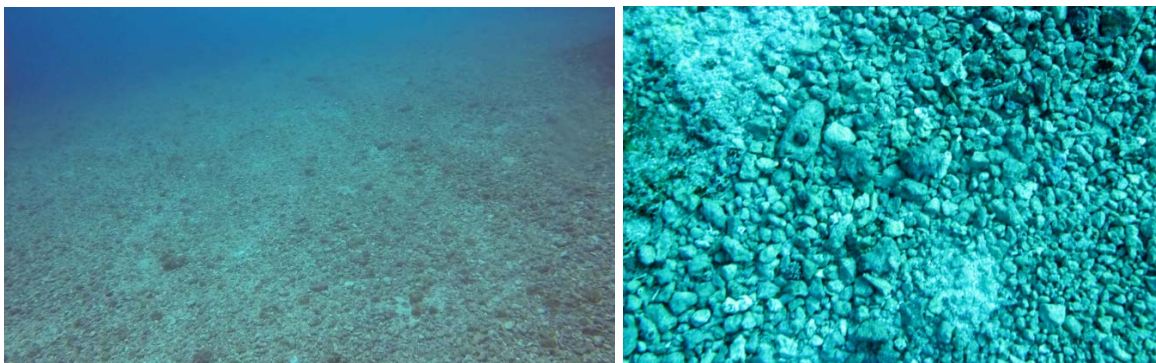
Figure 6-2 Rubble across the grounding footprint in 2019 from Priority Area C (T14)

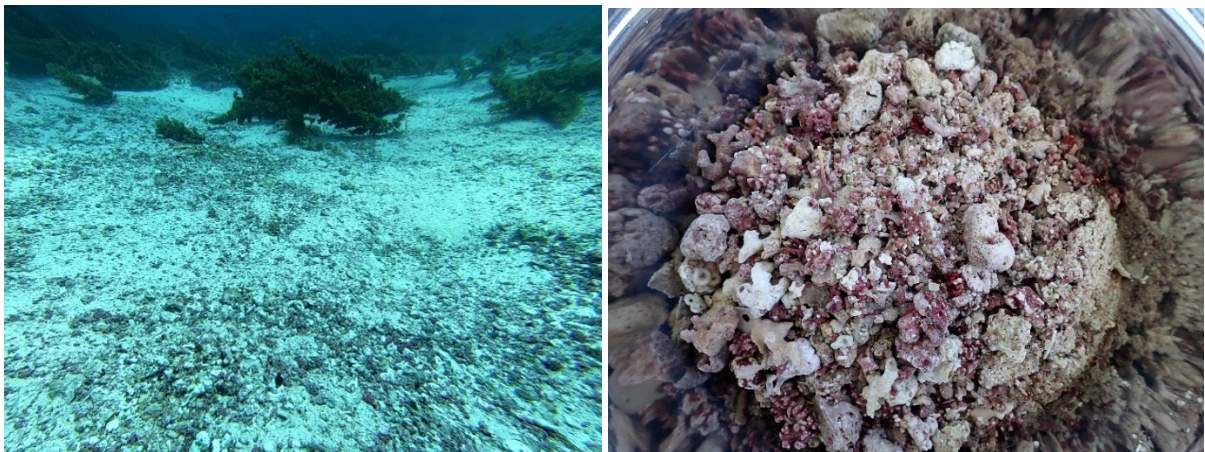
Figure 6-4 Expanses of sand and dead coral fragments and collected sediment from Reference Area 2 (Site R2-11)

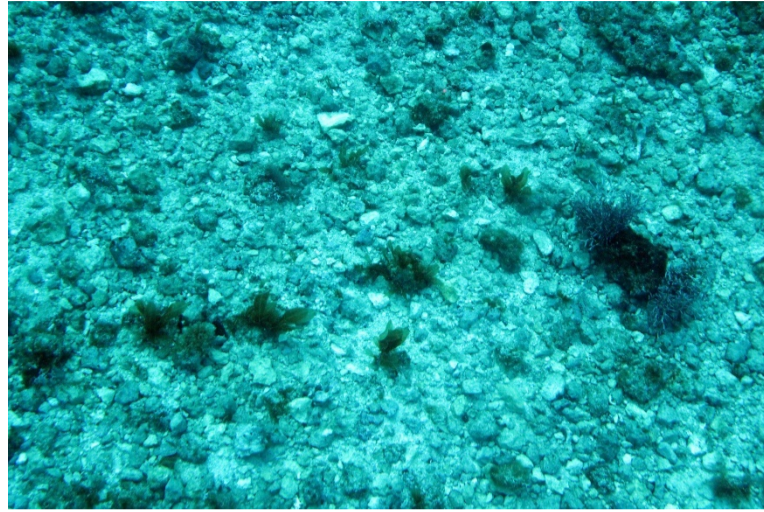
Loose rubble and juvenile *Sargassum* spp.

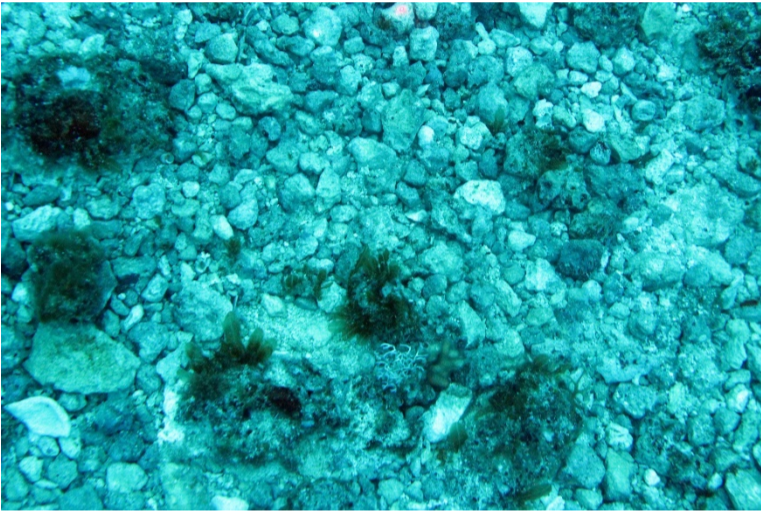
Loose rubble and macroalgae.

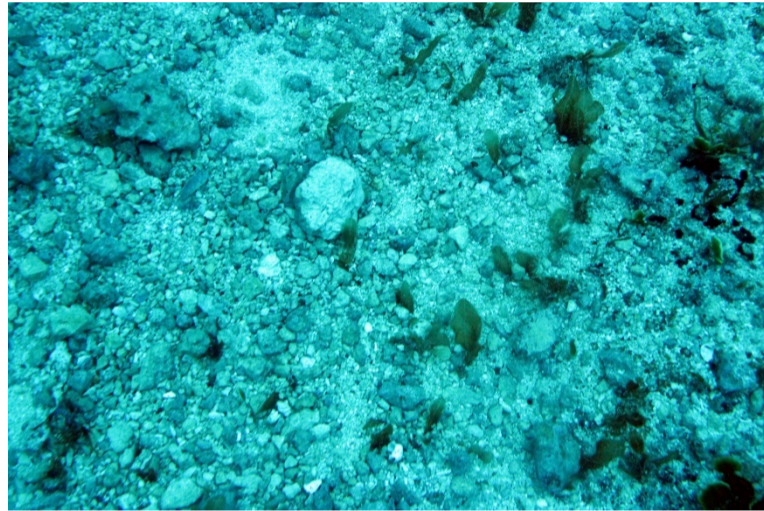
Loose rubble and juvenile *Sargassum* spp.

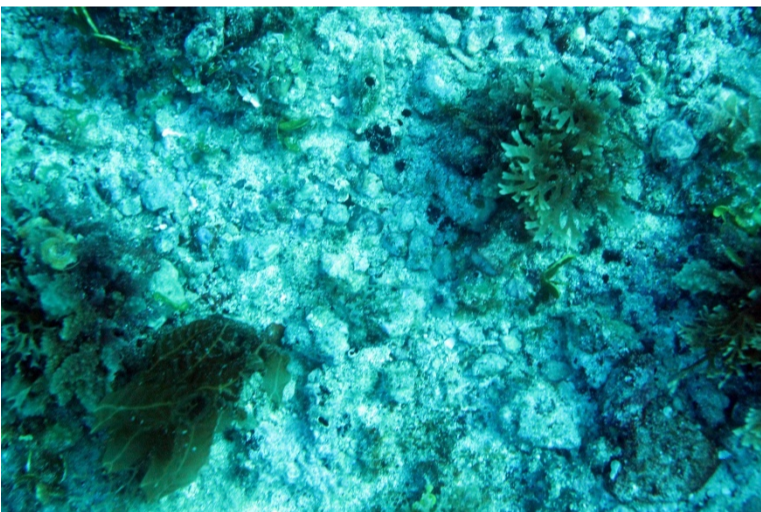
Consolidated rubble covered in turf algae.

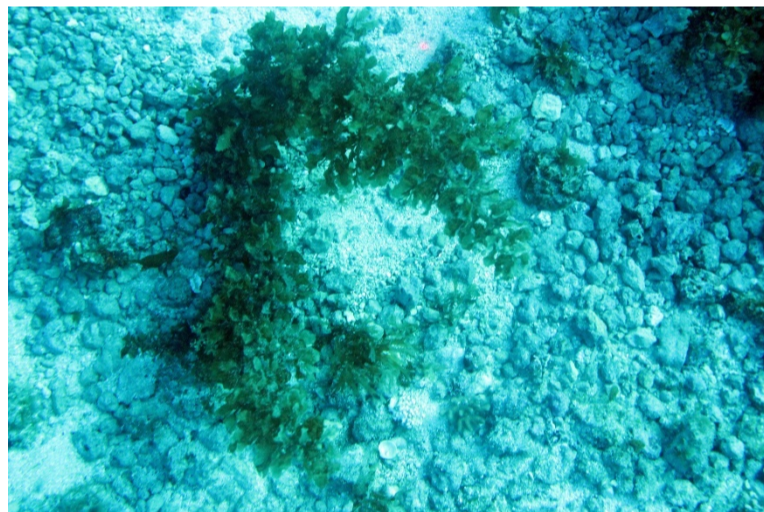
Loose rubble and mature *Sargassum* spp.

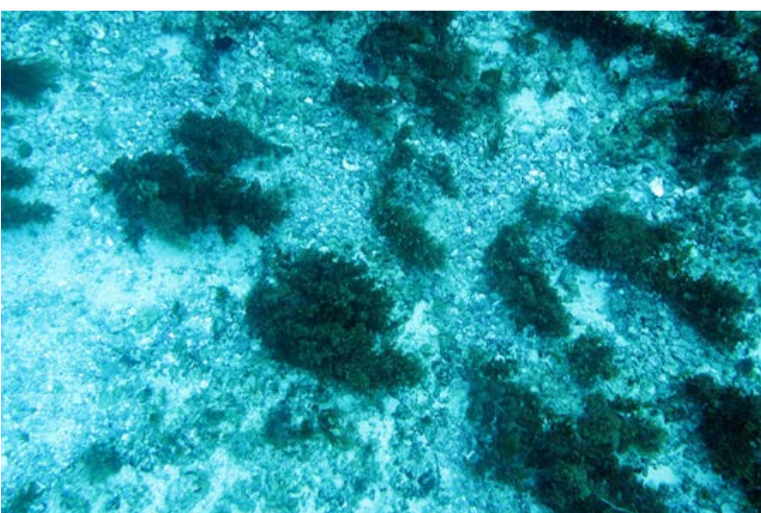
Loose rubble and mature and juvenile *Sargassum* spp.

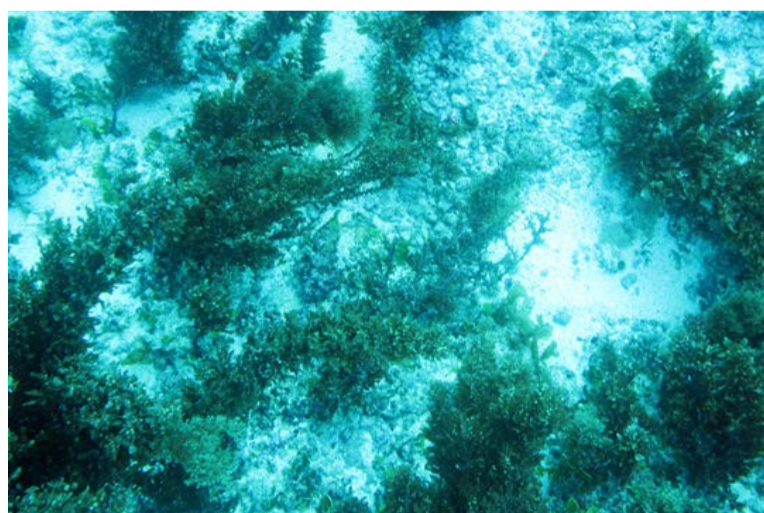
Loose rubble and adult *Sargassum* spp.

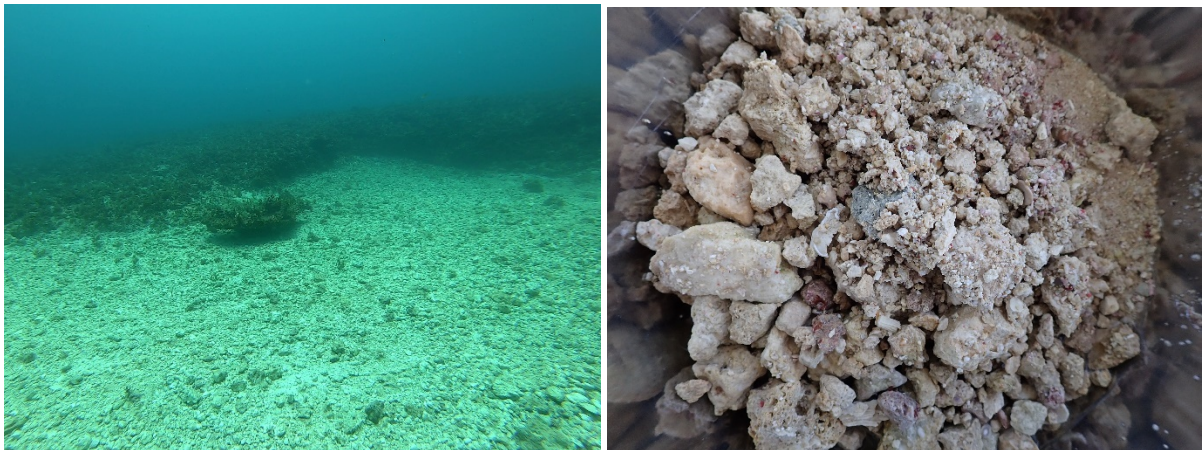
Figure 6-16 Rubble areas in situ and collected from Priority Area A (site A4-11)

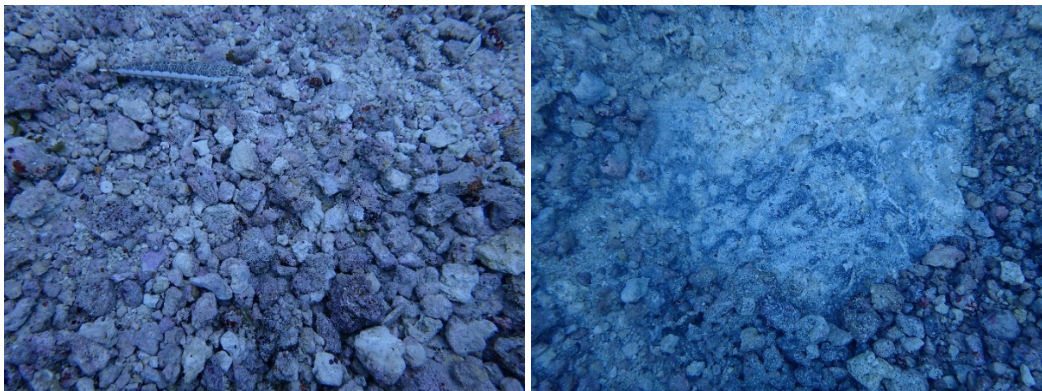
Figure 6-27 Flattened reef structure in Priority Area F grounding footprint with rubble layer and after removal

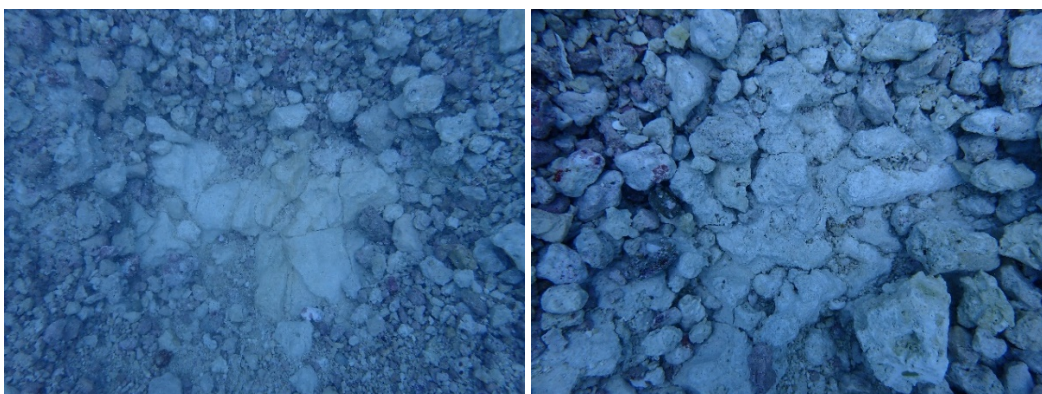
Figure 6-28 Areas where compaction was found in Priority Area F
