### Cultural site evaluation of Coloma, Montana, 2000

A CULTURAL SITE EVALUATION OF  
COLOMA, MONTANA  
2000

Prepared for Bureau of Land Management  
By Paige Hoskinson

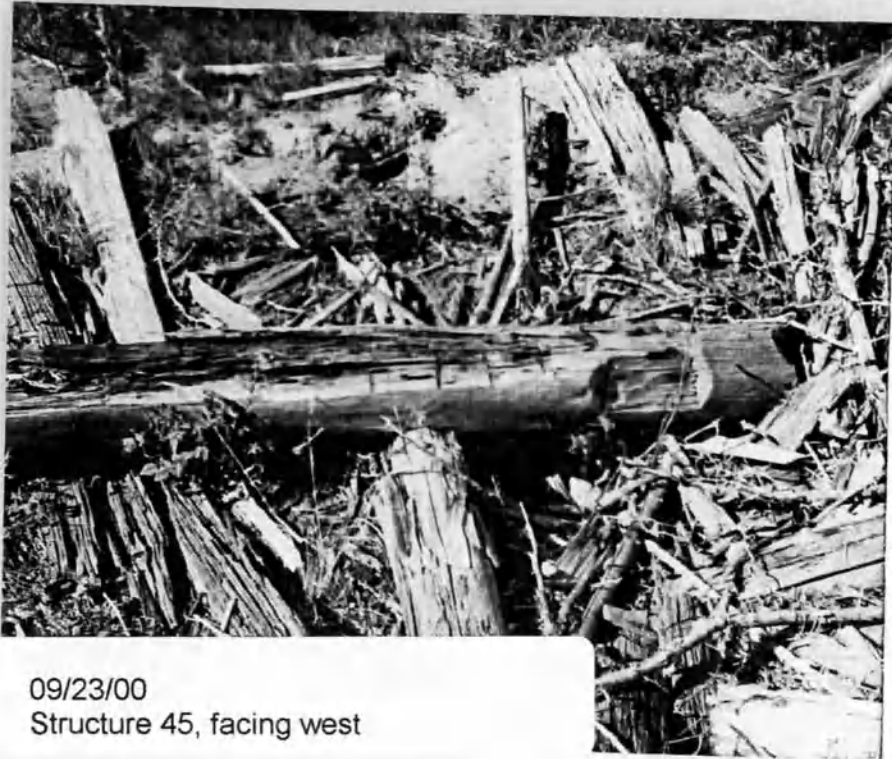
09/23/00  
Structure 45, facing west

*The location of Structure 45 had been disturbed. The shallow earth foundation measures approximately 15'x15' No material type or architectural style remains. No associated dump was located.*
