## Hydrology of the Colorado Tailings Area, Butte, MT

Ted Duaiame, John Sonderegger and Marek Zaluski  
Montana Bureau of Mines and Geology  
Montana Tech  
Butte, MT 59701

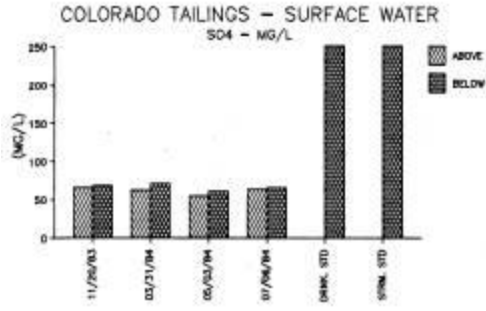
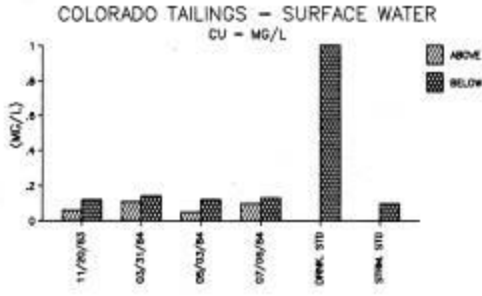
FIGURE 7

In most cases, concentration levels of metals were greater below the tailings than above (figs. 7. 8. 9); the exception being a single occurrence for iron where the opposite was true. For the same sampling periods, flow rates varied from a 10% loss to a 35% increase, as shown in figure 10.

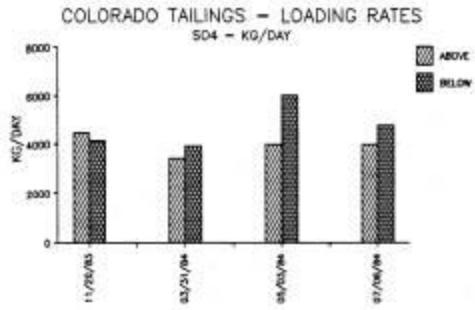
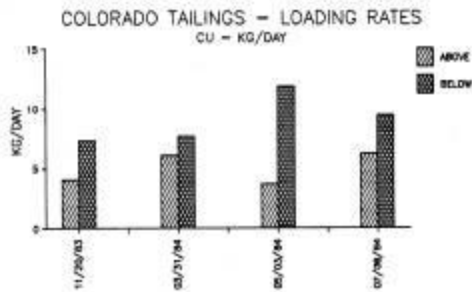
FIGURE 12

Knowing concentration levels and flow, loading rates, in kilograms per day (kg/d), were calculated showing changes once again from above the tailings to below them (figs. 11, 12, 13). This showed the same trend as did concentration (mg/L) only with sulfate being the one exception where loading above was greater than below on one occasion. The average loading rate increases varied from 15% for iron to greater than 70% for copper and zinc, with the greatest increases occurring during the May period, which was also the time of highest flow (spring runoff).

In order to mitigate the tailings impact on surface and ground water quality, the reclamation plan must reduce the amount of water, which passes both through and over the tailings area.
