Assess for Less:
A Solution-Oriented, Ground-Based Geomorphic Analysis
of an Urban Watershed in the Piedmont of North Carolina.
October 14, 2008

The Bolin Creek Watershed Geomorphic Analysis and Potential Site Identification for Stormwater Structures and Retrofits

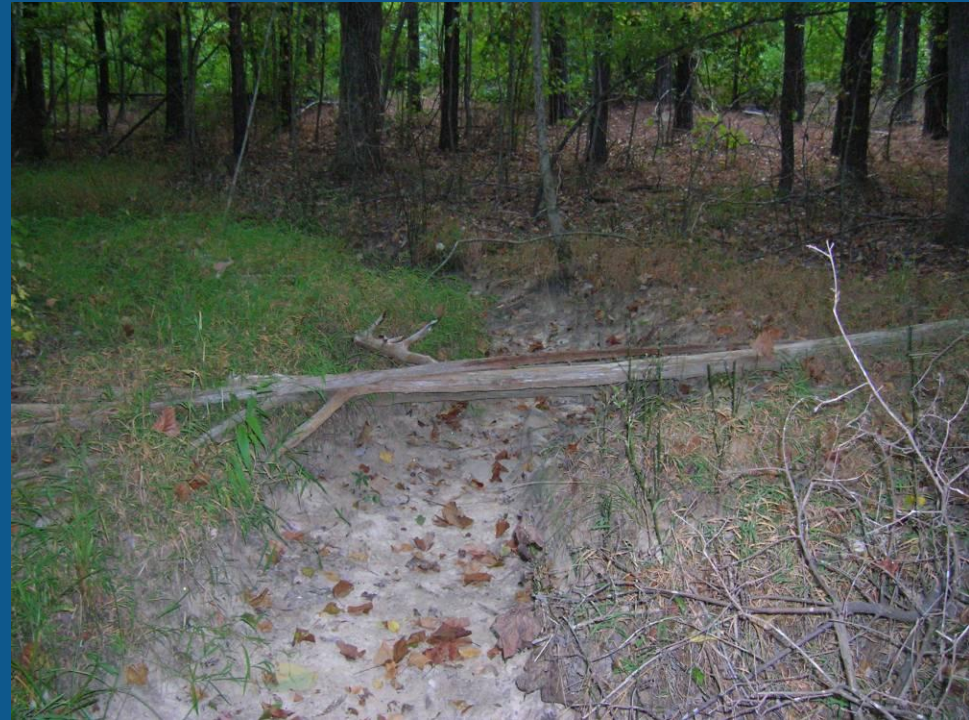
Site 3

- Stabilization of headcut on Intermittent Channel.
- Above headcut:
 - Intermittent stream is relatively stable, low bank height ratio

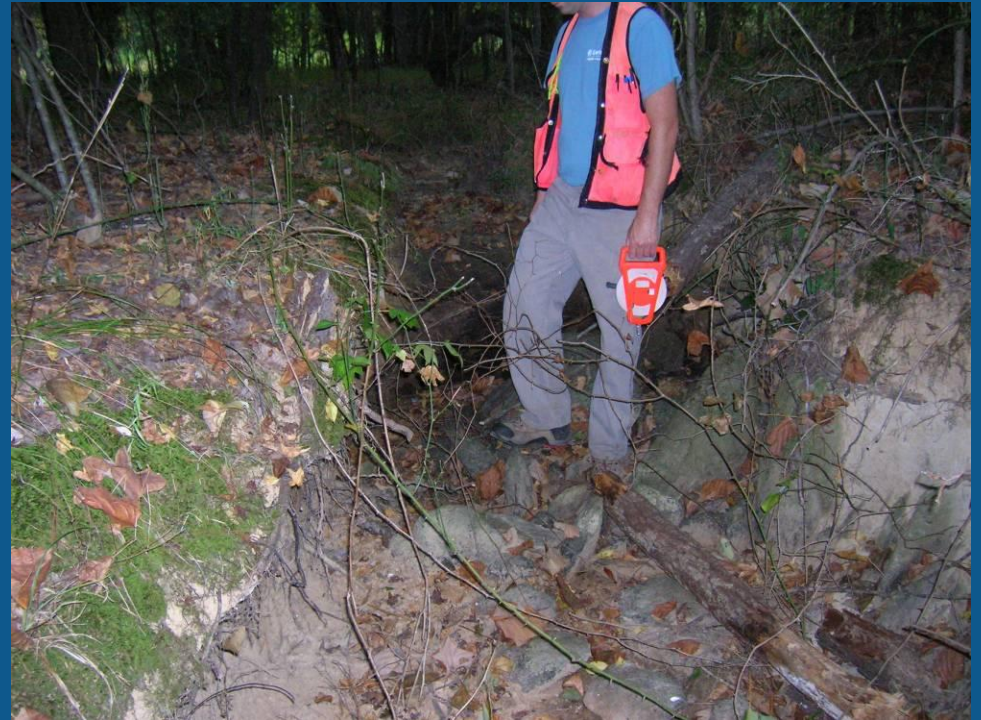
Site 3

- Below headcut:

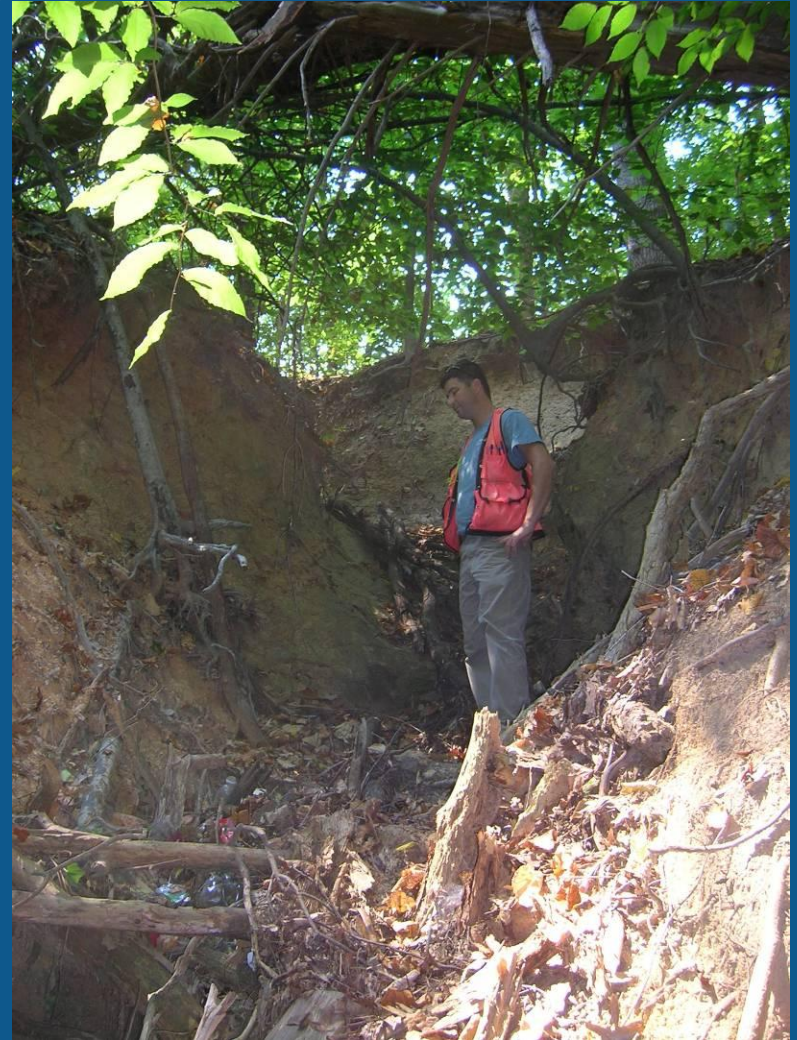
Site 21

- Restoration of stormwater outfall and gulley
- Gulley created by stormwater being discharged from outfall directly above a steep hillside.
- Example of the many sources of instability in the watershed caused by stormwater infrastructure.

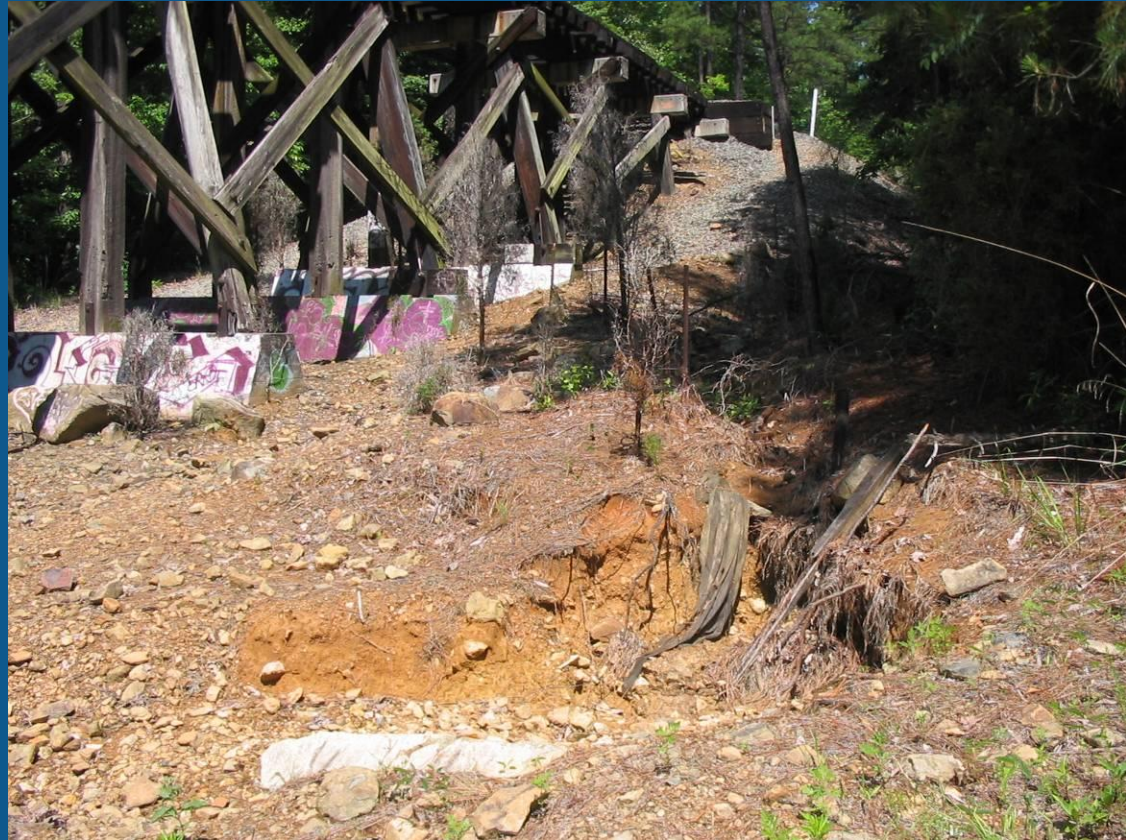
Site 18

- Restoration of erosive gully beneath railroad trestle and water quality treatment of runoff from subdivision.
- Hillside erosion occurring because no stormwater control from railroad.
- Small channel also receives stormwater flow from roads and rooftops of large subdivision uphill.
