# Understanding Architectural Iron Conservation: Corrosion Studies at Fort Sumter National Monument

### UNDERSTANDING ARCHITECTURAL IRON CONSERVATION: CORROSION STUDIES AT FORT SUMTER NATIONAL MONUMENT

A Thesis Presented to the Graduate Schools of Clemson University and College of Charleston

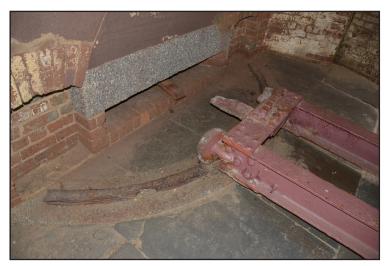
*Figure 4.17 Traverse Rails inside Right Face casemate at Fort Sumter (photo by author)*

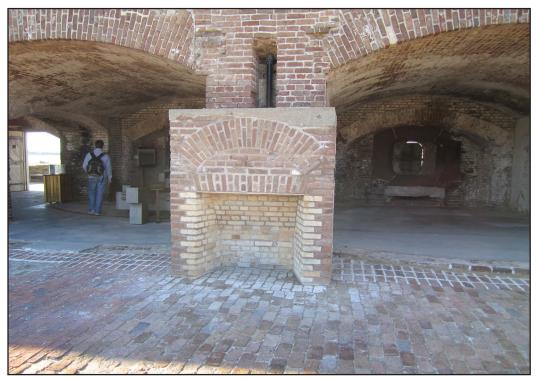
Figure 4.25 Left Flank Fireplace after December 2012 conservation work. (photo by author)

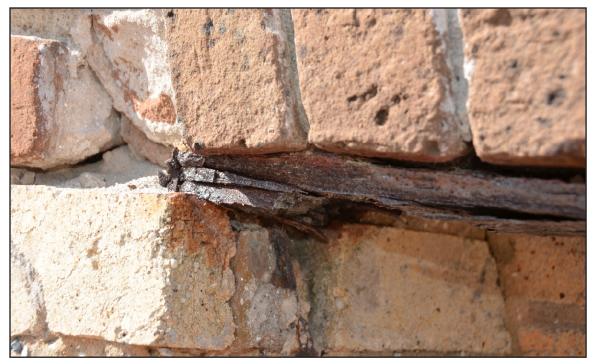
The survey of the historic Civil War era metal showed that both fireplace lintels and the tie-rod were significantly affected by either the surrounding material or atmosphere. There was general corrosion over the exposed surface of the iron that appears to be in a relatively stable state. At the interface of the metal and mortar supporting the lintels, the corrosion had reached such an advanced state that there was little metallic iron remaining in the juncture. In fact, during the course of this study, the lintel along the Left Flank failed and collapsed. The differential exposure between shallowly embedded metal and the exposed portion is likely causing a higher concentration of chloride levels at the metal interface and the high humidity levels at the fort are causing the lintel to have a near constant electrolytic film. Additionally, the corrosion process is likely exacerbated as

*Figure 6.9 Detail of the Left Flank fireplace lintel showing remaining metal core and remaining corrosion after failure of lintel. (photo by author)*

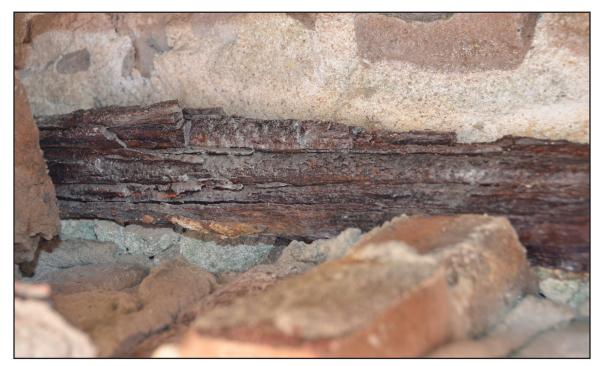
*Figure 6.10 Interior detail of the Left Flank fireplace tie-rod showing remaining metal core and remaining corrosion. (photo by author)*

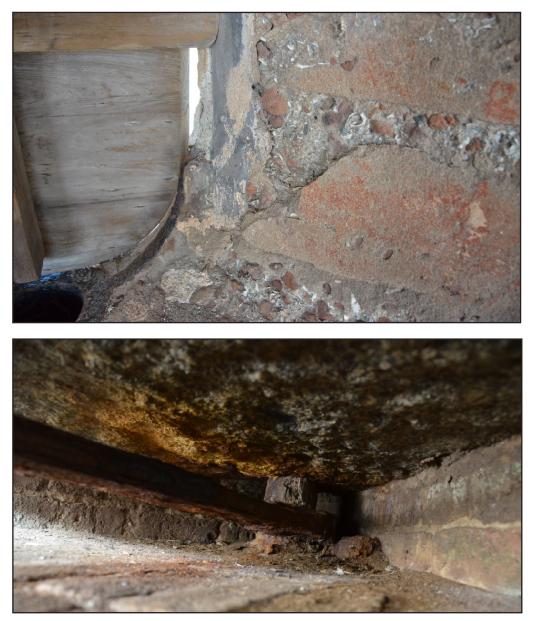
(top) Figure 6.13 Brick rubble cement around pintle in Left Flank embrasure. (photo by author)

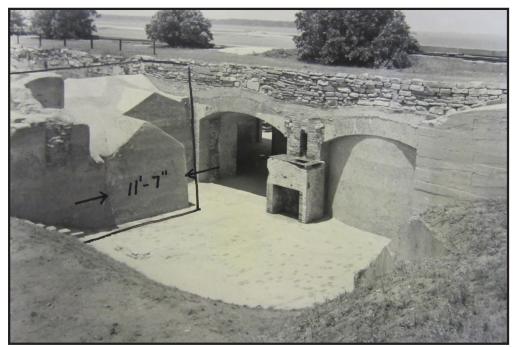
Figure 7.2 Left Flank fireplace in signficantly better condition than the ruins found along the Gorge Wall (courtesy of Fort Sumter National Monument)

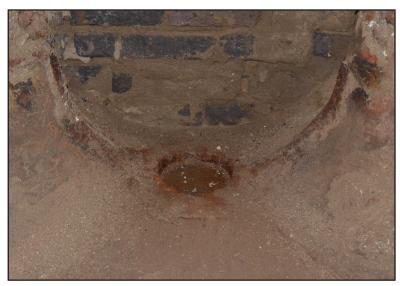
*Figure 8.4: Filled cavity in pintle in casemate C-4. (photo by author)*
