RESTORATION AND CONVERSION TO RE-USE OF HISTORIC BUILDINGS INCORPORATING INCREASED ENERGY EFFICIENCY A Case Study – the Haybarn Complex, Hilandar Monastery, Mount Athos

Original scientific paper
DOI: 10.2298/TSCI160208131I

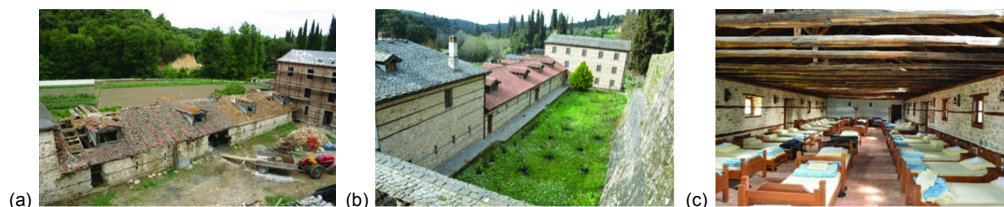
The Haybarn Complex is situated near the access road to Hilandar Monastery. It was once used to shelter monastery animals and their food (hay). These buildings were built in the first part of the 19th century, outside the monastery walls but close to them. The Haybarn Complex had not been used for decades, therefore the buildings were partially demolished.

**Figure 1. The Haybarn Complex: Mulekeepers' House, Stable, Haybarn (left to right);
(a) former appearance, (b) façade after the restoration, (c) interior of Stable after the restoration
(photos taken by authors)**

The Haybarn used to be a tall building used to store hay (case 1). Its perimeter walls were extremely tall and made of broken and roughly dressed stone. The façade stone was also visible, fig. 1(a). The function and original visual appearance of this building cannot be categorized in accordance with current regulations. If this building had been used to accommodate people, including the application of hygiene measures only (tab. 3, case 1), it would not have met the requirements of the current Regulations on Energy Efficiency of Buildings.

After the restoration that was performed in 2006, (case 2), the façade walls remained unchanged – both exterior and interior walls had visible stone, figs. 1(b) and (c). The floor was restored and improved by adding thermal insulation. This restoration is very significant because the unique roof structure of this building – king post truss, was kept as it had been before the restoration. The roof structure is a part of the interior in the sleeping rooms for visitors, fig. 1(c). New layers of roof with thermal insulation were installed over the existing roof structure. Small windows arrangement remained on the façade. Roof dormers were put in the same place as they used to be. This is how the form and authentic appearance of the building itself was preserved. The windows were replaced with new, 9 cm thick, wood-framed, double-

During the restoration of the Mulekeepers' House in 2006, the visual appearance of its façades remained the same (case 2) – the face of exterior walls were made of stone, as well as interior ground floor walls. Since the upstairs façade stone walls had been plastered before the restoration, the room walls were thermally insulated from the inside during the reconstruction (tab. 2, case 2). As for the ground floor, its floor was restored and insulated. In accordance with the Restoration Plan, the joists as structural components between the storeys remained, along with the wood flooring, as a final coat. However, new fillings were applied. Thermal insulating sheathing boards were installed above the first floor, towards the attic area. Roofing stone plates, as roof covering, was installed in accordance with all modern principles of ventilated roofing. This modern technological design of ventilated roofing and stone as a final roof covering was applied for the first time in conservation and restoration practice, during the restoration of Hilandar Monastery buildings [16]. The windows were replaced with new, wood-framed, 9 cm thick, double-glazed windows with krypton gas (4 + 12Kr + 4 mm). The front door was replaced with a new one, made of solid wood.

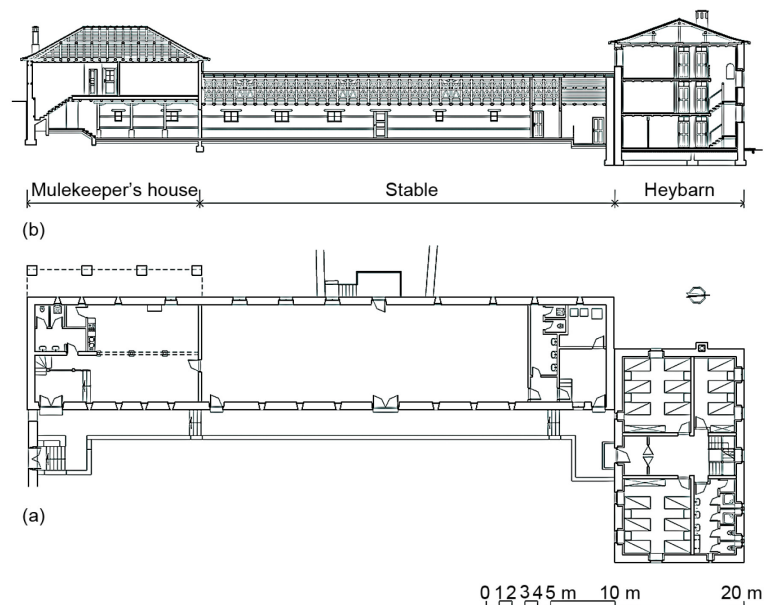
Figure 2. The Haybarn Complex (the appearance after the restoration); (a) ground floor plan, (b) cross-section
