29 The research within this paper is based on components postmortem analysis carried out in the
 30 TES-PS10 pilot plant facility built by Abengoa to test the PTC TES systems prior to the design
 31 of commercial projects with this technology [32,33]. The postmortem tests were performed after
 32 more than 30000 hours of operation under representative commercial operation conditions.
 33 Storage fluid analysis is not within the scope of this study, which is focused on the corrosion
 34 performance of storage tanks and pumping systems. Results provide understanding of corrosion
 35 performance of materials typically used for this application and lessons learnt to take into account
 36 for TES systems design to be integrated in PTC facilities at commercial scale.

2 **2. Materials and methods**3 **2.1. TES-PS10 pilot plant**

3 **2.2. Components to be evaluated**

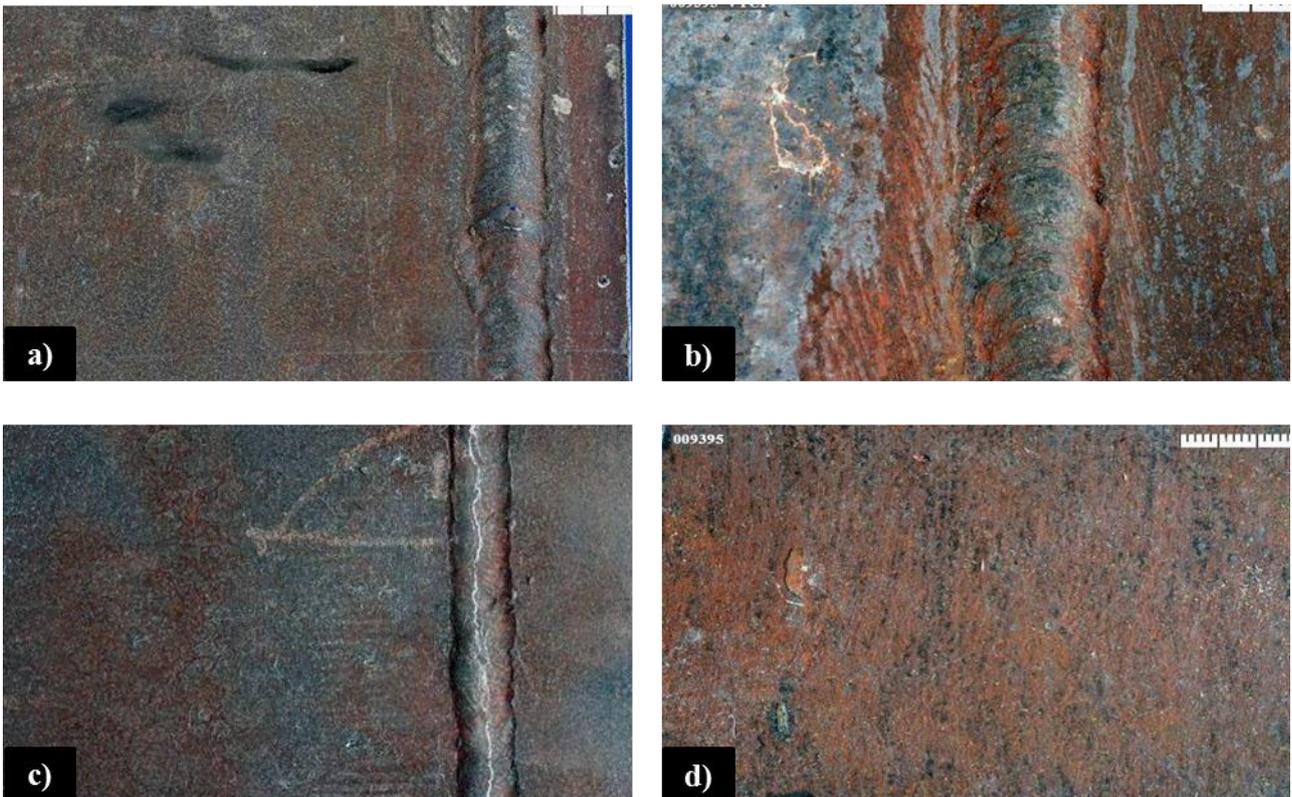
7 Generalized corrosion was observed on the UHT plate surface generating an irregular reddish-
8 brown oxide layer (Figure 4a). The plate showed areas in which the oxide layer was detached as
9 well as small areas with somewhat larger corrosion product generation. These areas were
10 examined more in detail in the SEM/EDS analysis. On the other hand, the LHT plate showed
11 abundant nitrate salt deposits which were partially cleaned using distilled water for a detailed
12 examination of the metal surface. Then, a generalized corrosion could be observed with the
13 formation of a reddish-brown oxide layer, slightly less thick than the one observed on the UHT
14 sample. Corrosion products were also partially detached in some areas (Figure 4b). The UCT
15 plate, Figure 4b, showed a generalized corrosion on its surface with a formation of an apparently
16 compact reddish-brown oxide layer. Finally, the LCT shell section showed a general and fairly

17 uniform corrosion with a reddish-brown oxide layer formation.

19 **Figure 4. Storage tanks shell sections visual inspection. (a) upper hot tank (UHT) shell**
20 **plate section; (b) lower hot tank (LHT) shell plate section; (c) upper cold tank (UCT) shell**
21 **plate section; (d) lower cold tank (LCT) shell plate section**

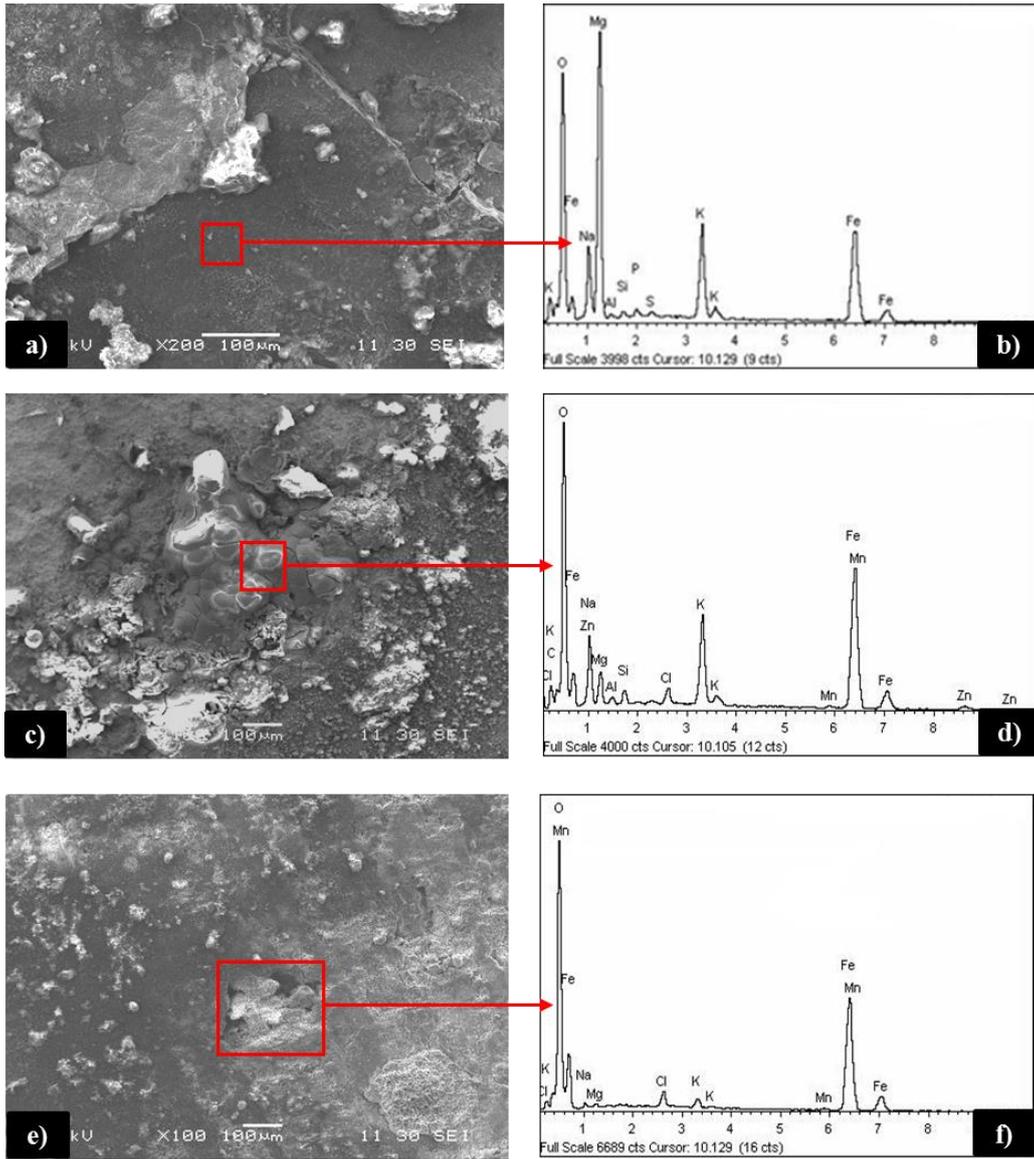
1 Figures 5 includes several micrographs of the corrosion products generated on the surface of the
2 UHT plate. The oxide layer had a certain exfoliating and/or laminating nature in some areas
3 (Figure 5a). EDS spectra associated to this layer indicated that it was basically comprised of iron
4 (Fe) and oxygen (O), as iron oxide, together with significant quantities of sodium (Na), potassium
5 (K) and magnesium (Mg) coming from nitrates salts (Figure 5b). Magnesium is typically in the
6 form of magnesium oxide due to the decomposition of magnesium nitrate which is one of the
7 impurities of sodium and potassium nitrates [34]. SEM micrographs clearly showed the
8 generation of more reddish and voluminous corrosion products in specific areas (Figure 5c). EDS
9 spectra over these corrosion nodules showed chloride not previously detected in addition to iron
10 oxide and nitrate salt residue (Figure 5d). The surface analysis of the LHT plate showed a

11 relatively compact and firmly attached oxide layer, with no evidence of exfoliation unlike what
12 was detected in UHT plates (Figure 5e). Small reddish corrosion spots were also detected in some
13 areas of LHT plates corresponding to micro-areas of localized corrosion. Associated EDS
14 spectrum also showed chloride as one of the elements present in the chemical composition of the
15 corrosion nodule (Figure 5f). On the other hand, Figure 6 displayed different views of the oxide
16 layer generated over UCT and LCT tanks shell sections being the corrosion morphology
17 practically identical for both plates. Micrographs highlighted some areas where corrosion
18 products were detached without exfoliation phenomena (Figure 6a). Sections extracted from cold
19 tank also evidenced micro-areas of localized corrosion (Figure 6b and Figure 6c). Finally, UCT
20 and LCT shell EDS spectra were like ones obtained for hot tank.

Figure 5. UHT and LHT SEM micrographs and EDS spectra. (a) upper hot tank (UHT) section micrograph; (b) upper hot tank (UHT) section EDS spectrum; (c) upper hot tank (UHT) corrosion spot micrograph; (d) upper hot tank (UHT) corrosion spot EDS spectrum; (e) lower hot tank (LHT) section micrograph, (f) lower hot tank (LHT) corrosion spot EDS spectrum

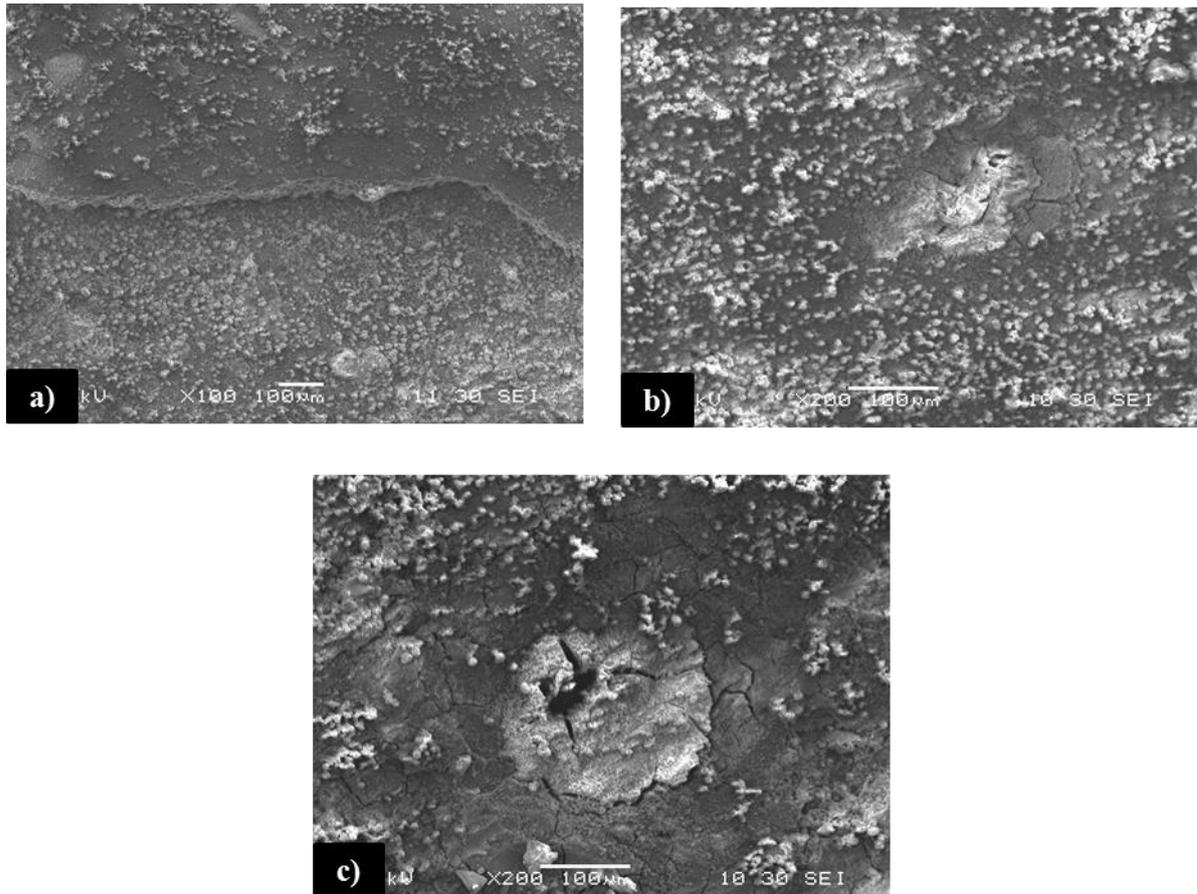
1
2 **Figure 6. UCT and LCT SEM micrographs and EDS spectra. (a) upper cold tank (UCT)**
3 **section micrograph; (b) upper cold tank (UCT) corrosion spot micrograph; (c) lower cold**
4 **tank (LCT) corrosion spot micrograph**

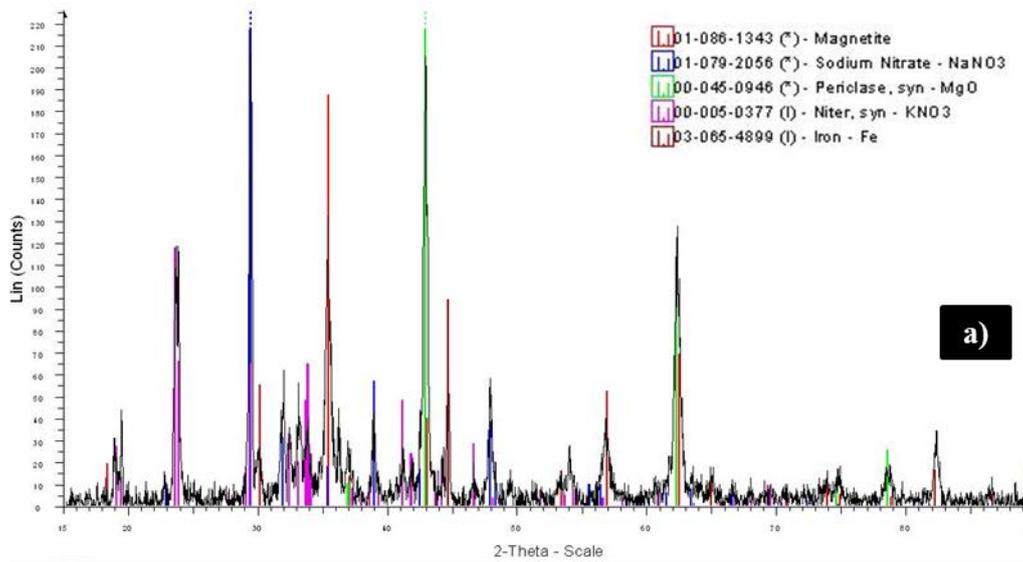
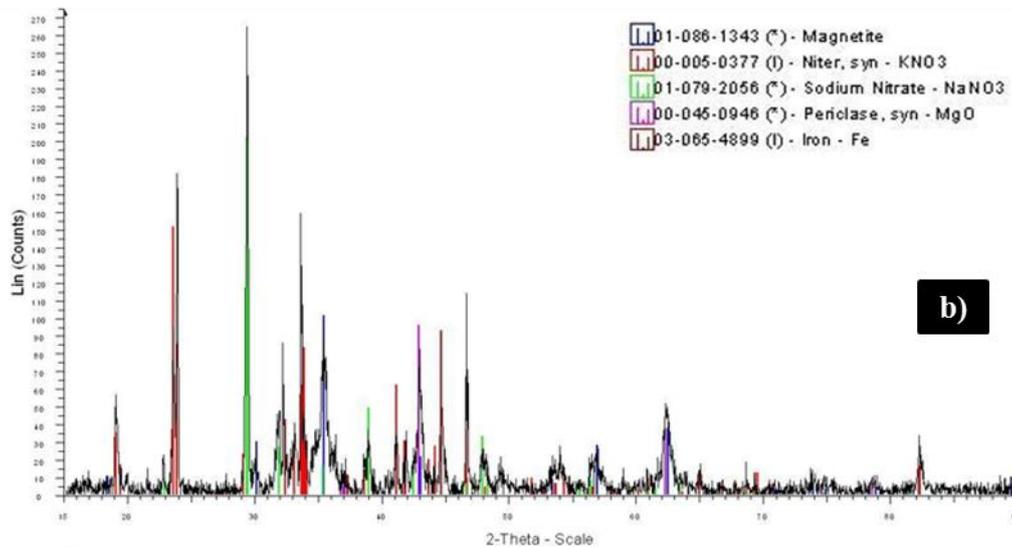
5
6 XRD analysis was carried out over the surface of tank plates. Periclase (MgO) was detected in
7 the XRD spectra which is aligned with EDS analysis showed in Figure 5. As explained before,
8 MgO is produced due to the decomposition of magnesium nitrate and is typically found in the
9 surface of metal components exposed to solar salts [34]. Iron oxide in the form of magnetite
10 (Fe_3O_4) was also detected in XRD spectra. This observation was also found by the authors in
11 previous studies which evaluate the corrosion performance of carbon steel coupons immersed in
12 the storage tanks of the pilot plant under discussion in this manuscript [31]. In addition to MgO
13 and Fe_3O_4 , other species such as NaNO_3 , KNO_3 , and iron was detected in the spectra. This
14 chemistry was similar corrosion products generated in the molten salts pump sections under
15 evaluation. Figure 7 shows XRD spectra for UHT (Figure 7a) and UCT (Figure 7b) as examples

Figure 7. XRD spectra. (a) Upper hot tank (UHT); (b) Upper cold tank (UCT)

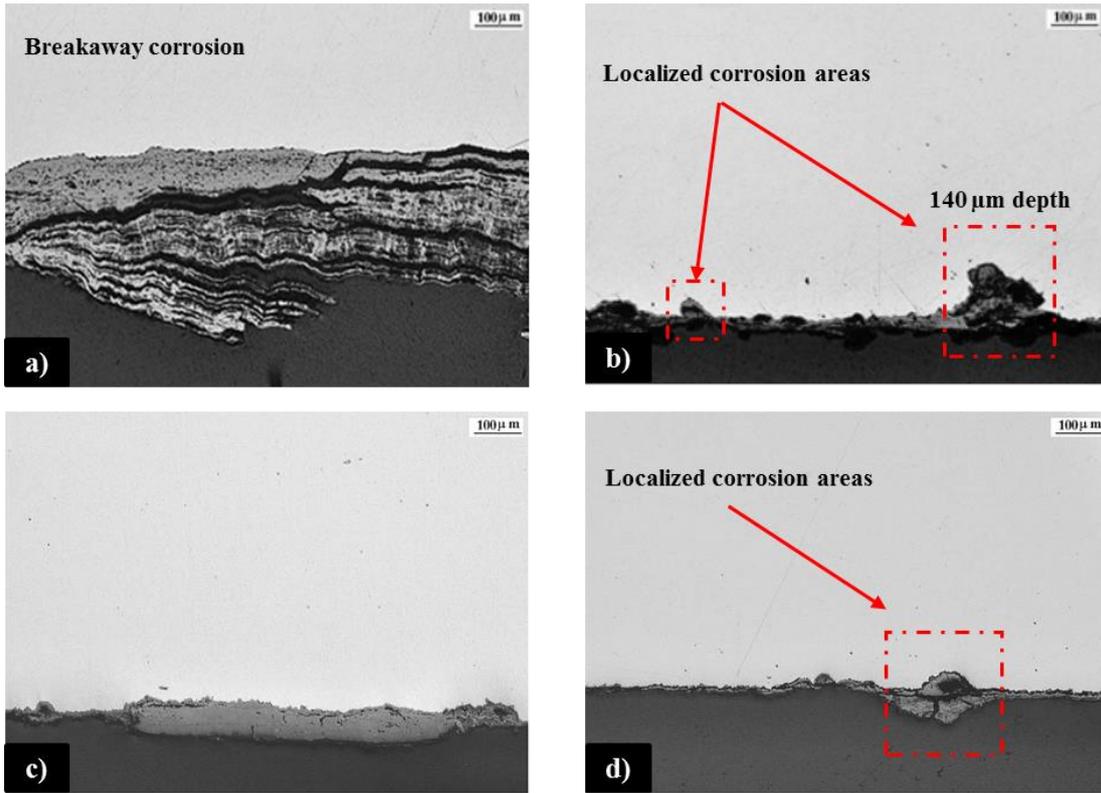
5 Optical micrograph in Figure 8a showed the oxide scale delamination observed in certain areas
 6 on the UHT plate. The small localized corrosion areas (more reddish) detected in the SEM study
 7 are shown in Figure 8b. This latter figure shows the maximum penetration depth observed in the
 8 different embedded sections of the UHT plate. The corrosion progression through base metal was
 9 about 140 microns. Optical micrographs in Figure 8 also show the different morphology
 10 characteristics of the oxide layer on the LHT plate. LHT also shows small localized corrosion
 11 areas, which barely penetrated the material (Figure 8d). Oxide layer delamination was not
 12 observed on this sample. The corrosion morphology and extension on the UCT and LCT samples
 13 was practically identical to those observed on the LHT plate section. A partially detached and
 14 cracked oxide layer with constant thickness was observed in addition to micro-areas of localized

1 Corrosion phenomena detected in UHT is typically called as breakaway corrosion being
 2 characterized by non-protective oxide scales. This type of corrosion may occur on carbon steels,
 3 generally at temperatures above 400 °C, although in certain conditions, such as with the presence
 4 of CO₂, chlorides or water vapor on the medium, this phenomenon may happen at lower
 5 temperatures. Thus, in the presence of CO₂, the temperature from which this breakaway corrosion
 6 may be provoked is in the range of 350 °C [35]. Steel parts under this phenomenon are exposed
 7 to higher corrosion rates due to the non-protective performance of corrosion products generated
 8 over the base metal. Conditions under which the preheating of the hot tank was carried out would
 9 be the origin of the non-protective oxides generation in areas intermittently exposed to nitrates
 10 salts. The main goal of tanks preheating was to adequate the metal temperature of the vessel

11 avoiding both, metal thermal shocks during filling and molten salts freezing. Tanks preheating
 12 system was an 850 kW power preheated air blower with propane burner. In addition to metal
 13 temperature increasing prior to salts filling, preheating equipment was also used as a back-up
 14 heating system during the first weeks of operation due to the elevate heat losses higher than
 15 expected and inclement weather during the start-up. Preheating system specification did not limit
 16 the amount of CO₂ introduced inside the tanks so that carbon steel under intermittent exposure
 17 was exposed to the combination of chlorides (coming from molten salts), CO₂ (coming from
 18 preheating system), and water vapor (due to salts hygroscopicity). Taking into account the
 19 corrosion morphology experienced by UHT plates, it is seen that this mixture (CO₂+Cl+H₂O) was
 20 especially aggressive in the hot tank due to higher temperature in this vessel.

Figure 8. Hot storage tanks shell sections micrograph. (a) Oxide scale delamination in upper hot tank (UHT) shell plate section; (b) Localized corrosion in upper hot tank (UHT) shell plate section; (c) Oxide scale in lower hot tank (LHT) shell plate section; (d) Localized corrosion in lower hot tank (LHT) shell plate section

- 13
- 14 • UHT sample showed areas on the internal surface characterized by the growth of an
15 exfoliating/delaminating non-protective oxide scale caused by breakaway corrosion
16 phenomenon. The reason why this attack occurred in the hot storage tank plates exposed
17 to intermittent exposure was due to the combination of CO₂, water vapor and chlorides at
18 high temperature. This mixture was in contact with carbon steel during the preheating of
19 the vessel and later in the first weeks of operation when the preheating equipment was
20 used as a back-up heating system. Because of this result, the design of commercial
21 preheating systems must assure that a minimum amount of CO₂ is introduced during the
22 preheating process to avoid the breakaway corrosion phenomenon.

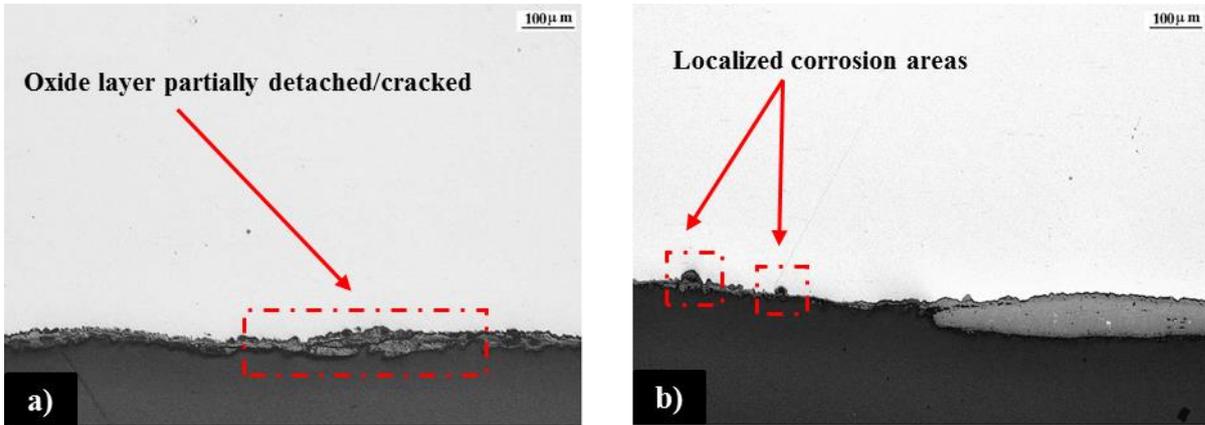
15 corrosion (Figure 9a and Figure 9b).

21 On the other hand, localized phenomena were developed by carbon steels under all tested
 22 conditions, hot and cold tank in addition to continuous and intermittent molten salts exposure as
 23 previously stated during the evaluation of the metal surface by SEM. This corrosion attack was
 24 not previously detected by the authors in other studies developed with corrosion racks submerged
 25 in TES-PS10 storage tanks nor laboratory tests analyzing the corrosion performance of high
 26 chloride content nitrates salts [29,31]. Within this study, EDS spectra detected the presence of
 27 chloride within the corrosion products being able to take an important role in combination with
 28 storage tanks corrosion atmosphere leading the corrosion mechanism produced in these specific
 29 areas. The main reason for this different corrosion performance in the tanks would be linked to
 30 the exposure time. while the pilot plant was in operation for 30000 hours, corrosion coupons

31 submerged inside the tank were exposed between 1680 and 8712 hours. The higher exposure time
 32 in the tank plates produced the accumulation of chlorides in the localized corrosion areas creating
 33 an accelerated corrosion process in these points. Chlorides concentration increasing was
 34 confirmed by a semi-quantitative EDS analysis of the salt adhered to the plate (Table 3).

Figure 9. Cold storage tanks shell sections micrograph. (a) Partially detached oxide layer in upper cold tank (UCT) shell plate section; (b) Localized corrosion in upper cold tank (UCT) shell plate section

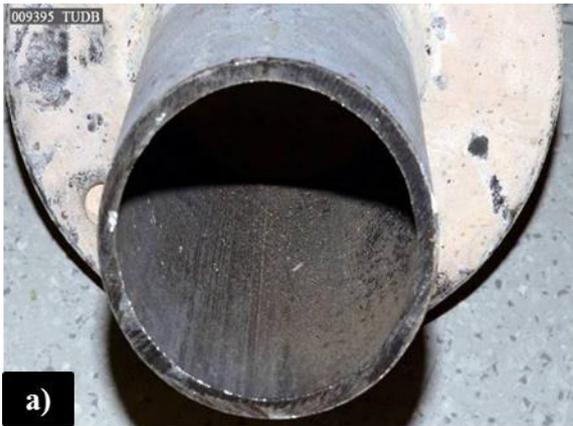
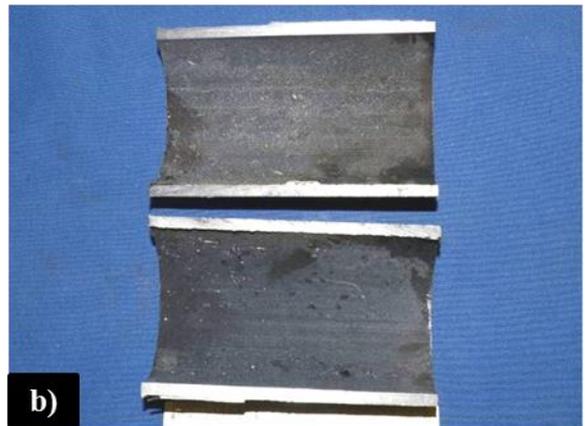
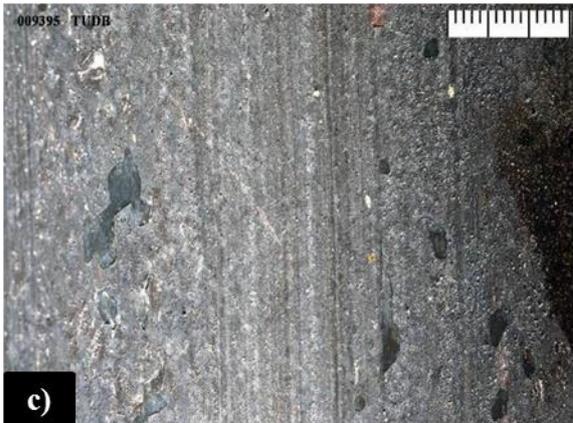
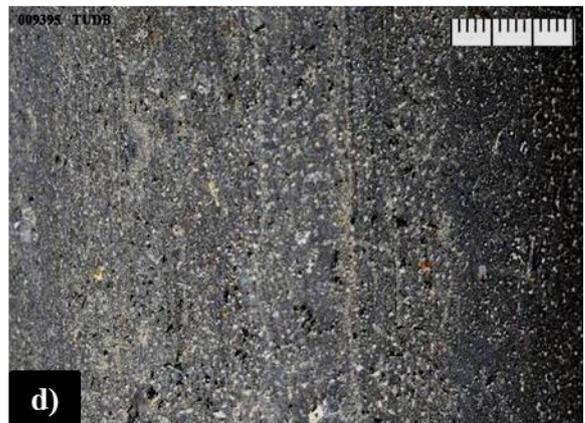
10 Figure 10a shows a photograph of the discharge pump pipe section (DP) after removal from the
11 installation. The external and internal side of this component was continuously exposed to solar
12 salts at an operating temperature in the range of 390 °C. Salt residues were observed on the
13 external surface as well as small areas of reddish-brown corrosion products. A longitudinal dry
14 cut was made in the pipe section in order to examine the internal surface (Figure 10b). A uniform
15 generalized corrosion was observed with a compact and firmly attached blackish oxide layer. In
16 this sense, few small areas showed oxide layer detachment (Figure 10c). The pipe surface next to
17 the flange weld showed small corrosion particles or aggregates, probably due to the corrosion of
18 particles or contaminants generated during the welding of the pipe to the flange. Localized
19 corrosion on this component was not detected (Figure 10d). On the other hand, Figures 11 shows

Figure 10. Discharge pump (DP) sections visual inspection. (a) DP overall detail; (b) Dry cut over DP section; (c) DP internal section detail; (d) DP internal section detail in an area close to nozzle joint

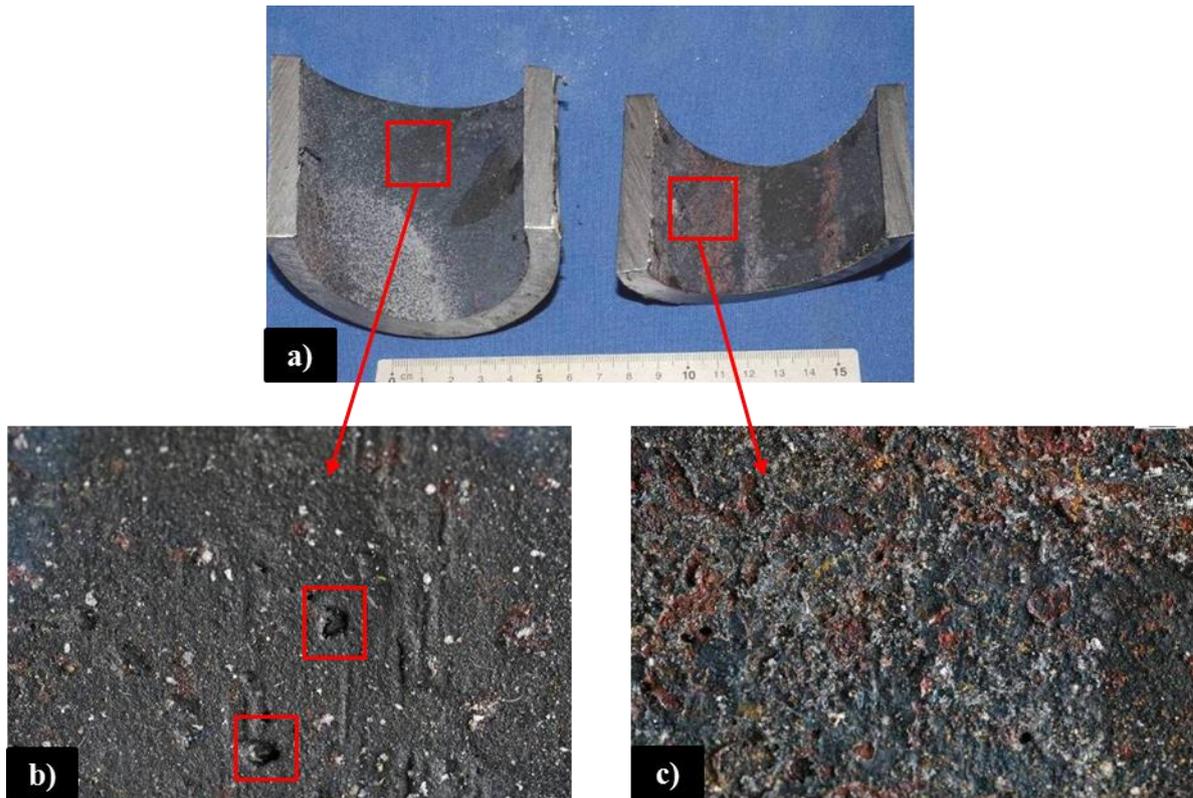
20 different details of the discharge elbow (DE) section. The external surface kept most of the
21 original paint, although there was evidence of salt residue and areas with slight generalized
22 corrosion. The DE section was also cut for a detailed analysis of the internal surface (Figure 11a).
23 In general, a compact adherent blackish oxide layer was present in most of the internal surface.
24 However, some reddish corrosion spots on top of the initial blackish oxide layer could be observed
25 (Figure 11). Several pores or cavities are detected on the internal surface (red rectangles in Figure
26 11b).

2 **Figure 11. Discharge elbow (DE) sections visual inspection. (a) Dry cut over DE section;**
 3 **(b) DE internal section highlighting cavities; (c) DE internal section highlighting reddish**
 4 **corrosion spots**

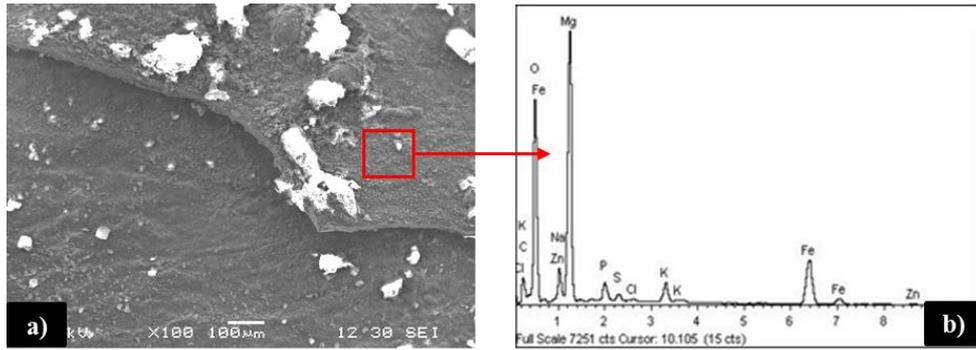
7 The internal surface of the pipe was examined by SEM-EDS for a detailed analysis of the
 8 corrosion products generated in the metal surface characterizing chemical elements involved in
 9 the oxides layers. The electron micrograph in Figure 12a shows a detail of the internal surface of
 10 the DP section. The oxide layer was partially detached in some areas. The EDS analysis of this
 11 layer indicated that it was basically comprised of Fe and O, as iron oxide, together with significant
 12 quantities of Na, K and Mg as constituents of the nitrate salts (Figure 12b). The DP external
 13 surface showed a similar morphology to that found on the internal surface. In this case, the
 14 original coating layer was cracked in several areas (Figure 13a). Beneath this cracked layer, the
 15 pipe surface looked rusted. The EDS analysis conducted on the painted surface detected a
 16 significant amount of the salt residue. The presence of calcium (Ca), copper (Cu), and aluminum

Figure 12. Discharge pump (DP) internal surface micrograph and EDS spectrum. (a) DP internal surface SEM; (b) DP internal section EDS spectrum

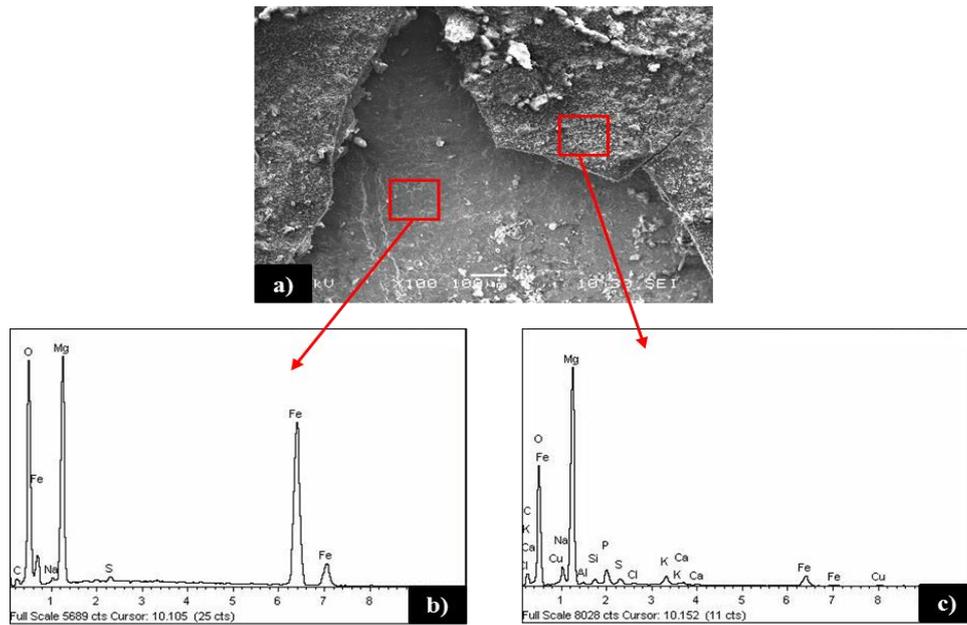
17 (Al) on the coating would be associated to the paint itself (Figure 13c). The appearance of the
 18 internal surface of DE sample in a pore-free area is shown in Figure 14a. The electron micrograph
 19 showed a thin and compact oxide layer over the base metal. The micrograph in Figure 14c showed
 20 the aspect of the micropores observed on the internal surface of the component in Figure 11b.
 21 Finally, EDS spectra were in agreement with previous profiles analyzed within this study in
 22 previous components (Figure 14b and Figure 14d).

Figure 13. Discharge pump (DP) external surface micrograph and EDS spectra. (a) DP external surface SEM; (b) DP external surface EDS spectrum (below coating); and (c) DP external surface EDS spectrum (coating)

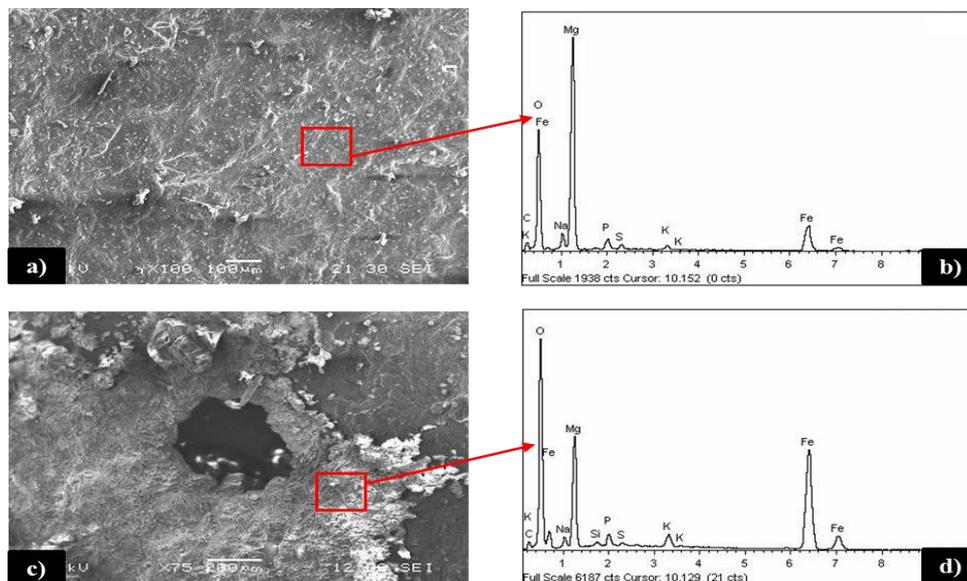
1 **Figure 14. Discharge elbow (DE) internal surface micrograph and EDS spectra. (a) DE**
2 **free-cavities area SEM; (b) DE free-cavities area EDS spectrum; (c) DE cavity SEM; (d)**
3 **DE cavity EDS spectrum**

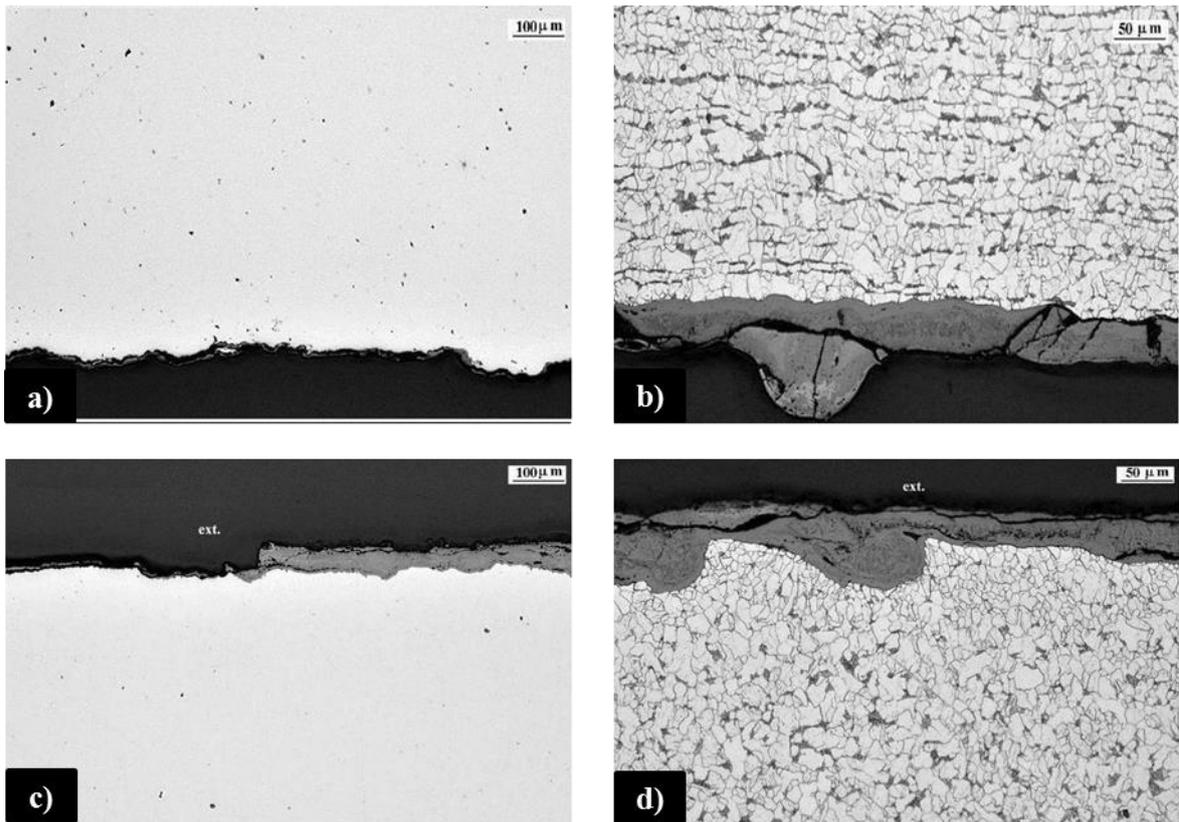
6 Metallographic specimens were prepared from transversal sections extracted from the DP sample
7 under evaluation to be analyzed by using optical microscopy. The internal surface of DP section
8 had an almost uniform and firmly attached oxide layer (Figure 15a). The external surface showed
9 a similar corrosion to that observed on the internal one. In this way, corrosion products were
10 similar in thickness and shape in zones where coating was practically removed (Figure 15c). DP
11 sample showed a ferrite-perlite microstructure which is typical of in carbon steels (Figure 15b
12 and Figure 15d). Transversal sections were also cut from DE sample for microstructural analysis.
13 Then, Figure 16a shows the internal surface detecting a very well adhered and thin oxide layer.
14 Micro-pores discussed in previous sections are shown in Figure 16b and Figure 16c being mostly
15 located on the internal surface of the elbow. The size of these cavities was variable, being able to

19
20 **Figure 15. Discharge pump (DP) sections evaluation. (a) DP internal surface; (b) DP**
21 **internal surface microstructure with metallographic etching; (c) DP external surface; (d)**
22 **DP external surface microstructure with metallographic etching**

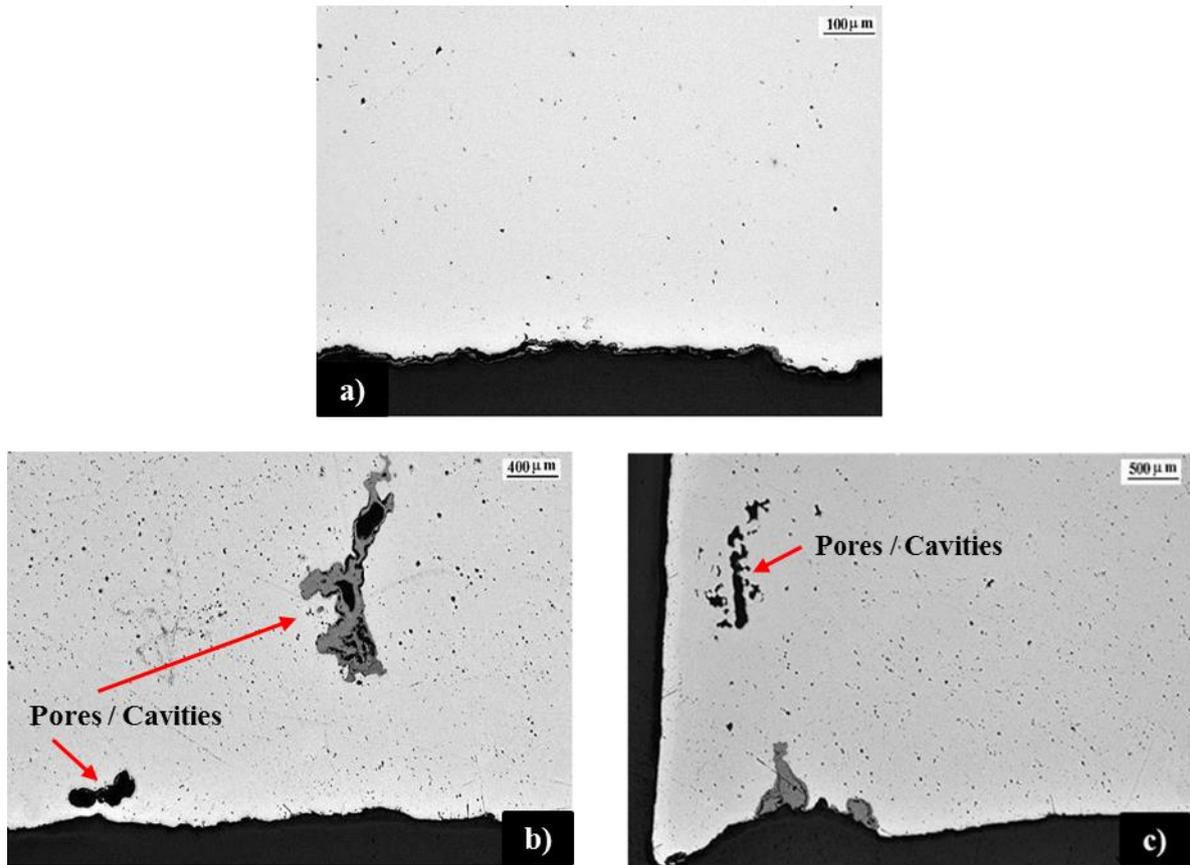
16 reach up to 1 mm in size. Accordingly, the metallurgical quality of the cast steel was not the most
17 suitable because of many pores were observed in the original material.

1
2 **Figure 16. Discharge elbow (DE) section evaluation. (a) DE internal surface; (b) and (c)**
3 **DE internal surface highlighting cavities**

- Metallurgical quality of the cast steel was deficient detecting many pores/cavities in the original material. The possible coalescence of these cavities could lead to an unexpected failure of the component for long-term expositions. An exhaustive quality control over sections manufactured by casting processes must be carried out to avoid in service failures.
