**A PERFORMANCE EVALUATION OF HOT MIX
ASPHALT THIN LIFT
TREATMENTS**

A thesis submitted to the faculty of
The University of Utah
in partial fulfillment of the requirements for the degree of

The University of Utah

May 2017

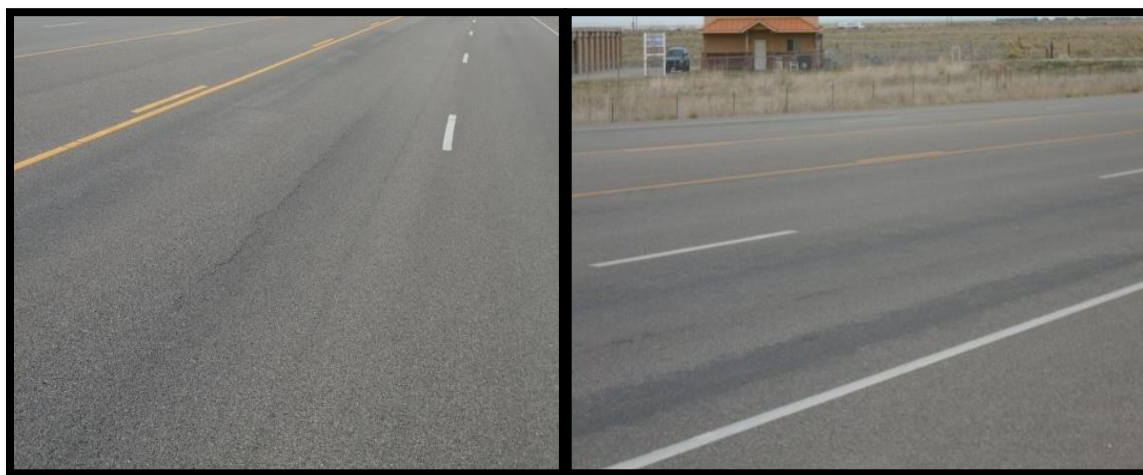
Figure 2. SR36: WP crack, possibly reflected, and typical bleeding seen in the wheel paths throughout the section (March 2015).

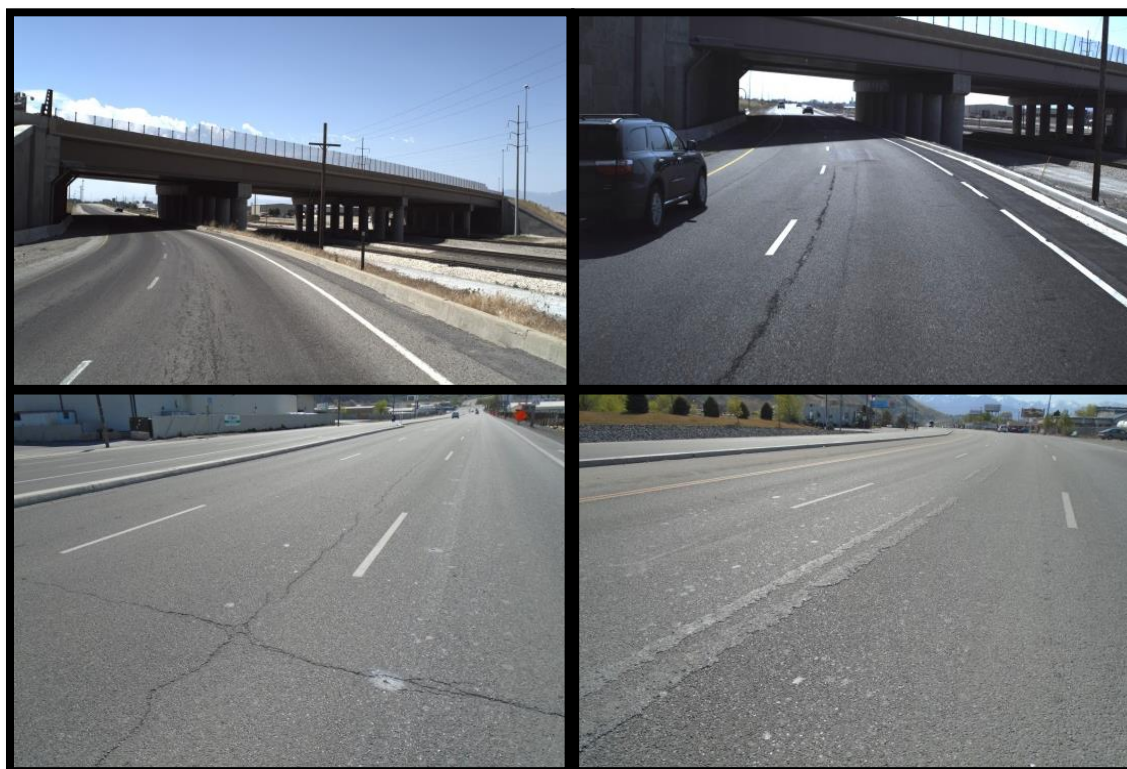
Figure 3. SR89: Top left, 2012 pretreatment fatigue damage. Top right, same location 2014. Bottom left, posttreatment transverse, and longitudinal cracking with spalling. Bottom right, medium severity bleeding (April 2015).

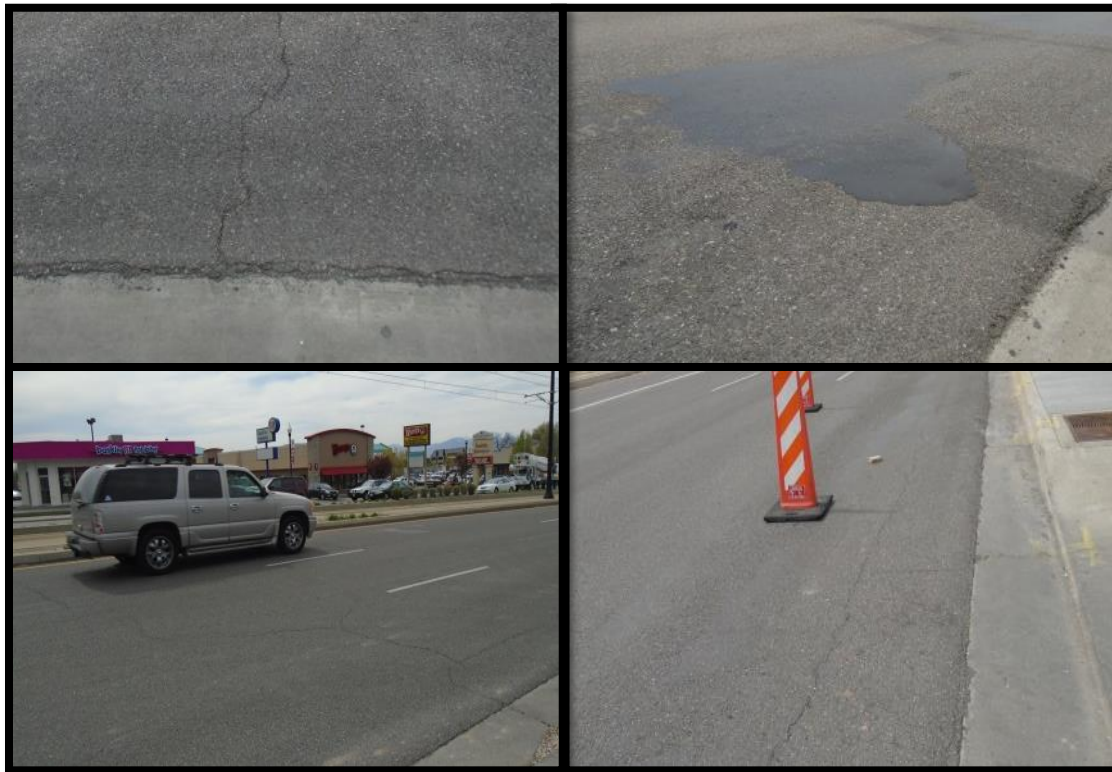
Figure 4. SR186 (1): Top left: transverse crack with raveling. Top right: medium severity bleeding. Bottom left: block cracking. Bottom right: WP cracking (April 2015).

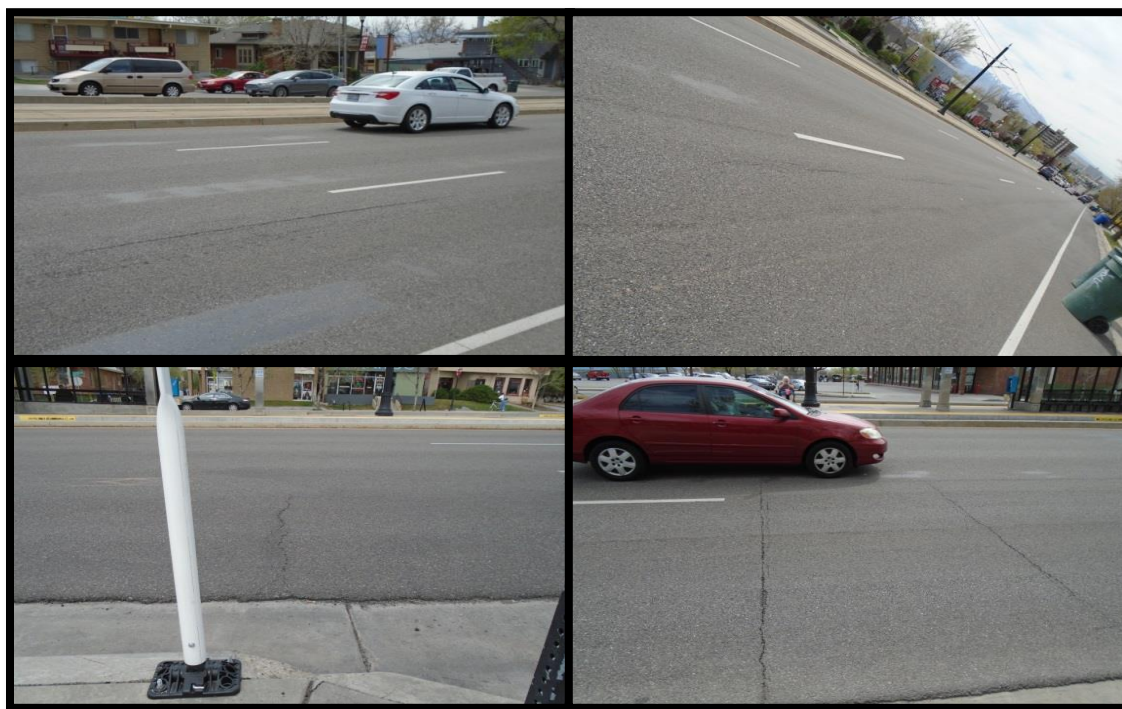
Figure 5. SR186 (2): Starting from top left to right and top to bottom: WP cracking with bleeding, additional WP cracking, transverse cracking, and block cracking (April 2015).

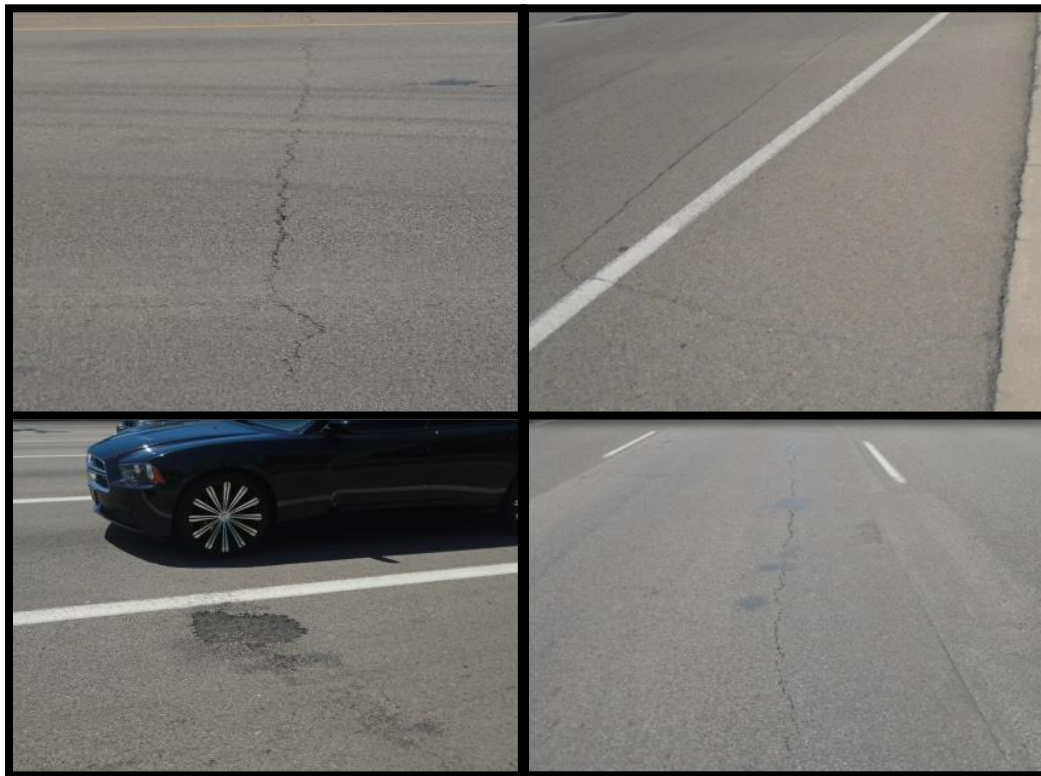
Figure 6. SR269: Top left clockwise: transverse crack, block crack, WP crack, and medium severity pothole (April 2015).

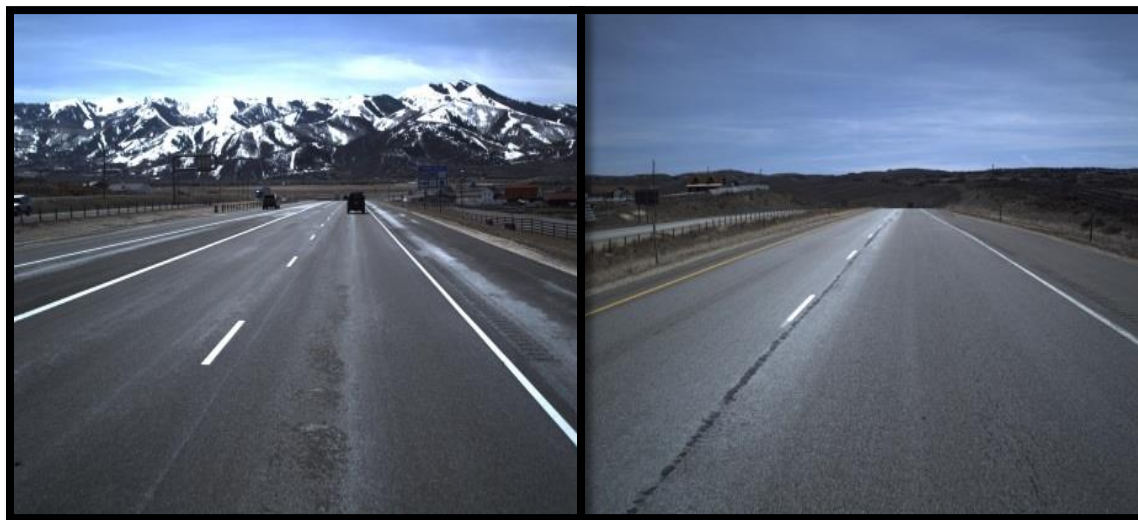
Figure 7. SR80 (1): Minor raveling and bleeding, Roadview Explorer (April 2014).

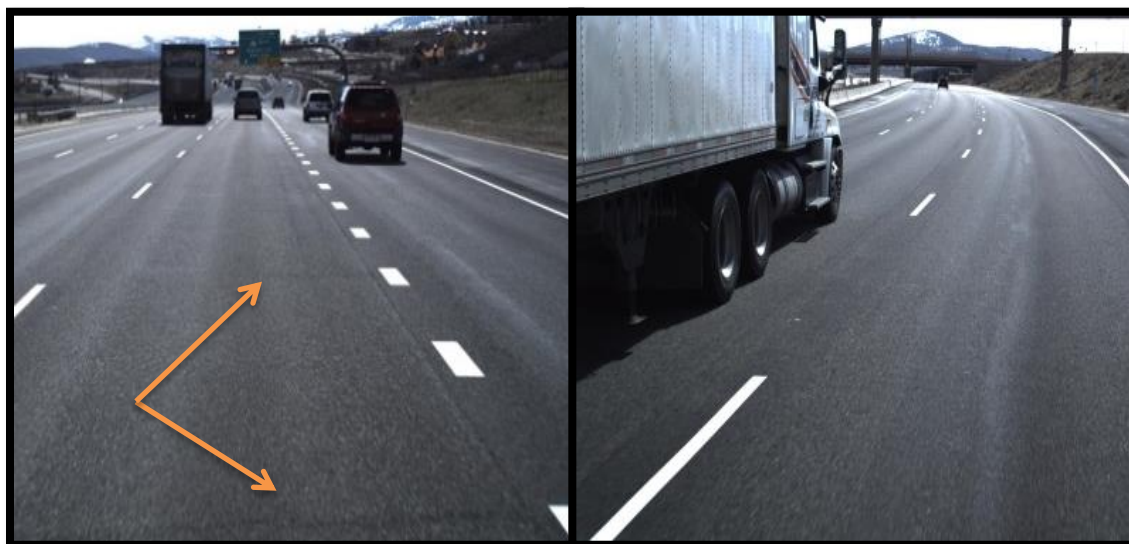
Figure 8. SR80 (2): Two minor transverse crack formations depicted on the left with minor bleeding in the center of the outside lane on the right (April 2014).

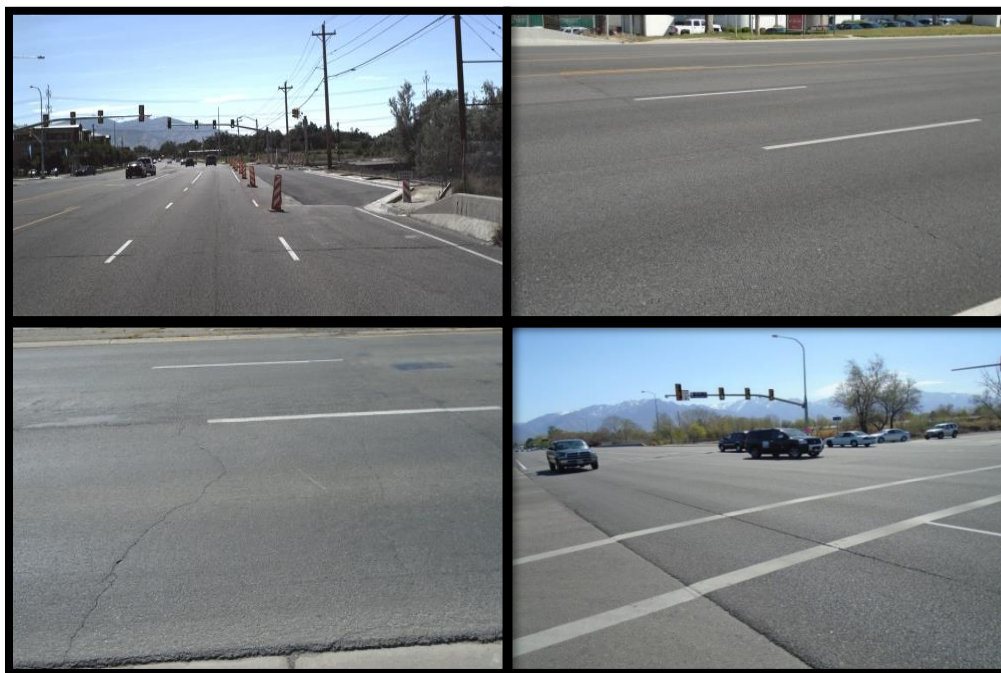
Figure 9. SR171: Top left: transverse crack posttreatment (2012). Top right: same location (2015). Bottom left: block and transverse cracking. Bottom right: LWP cracking (April 2015)

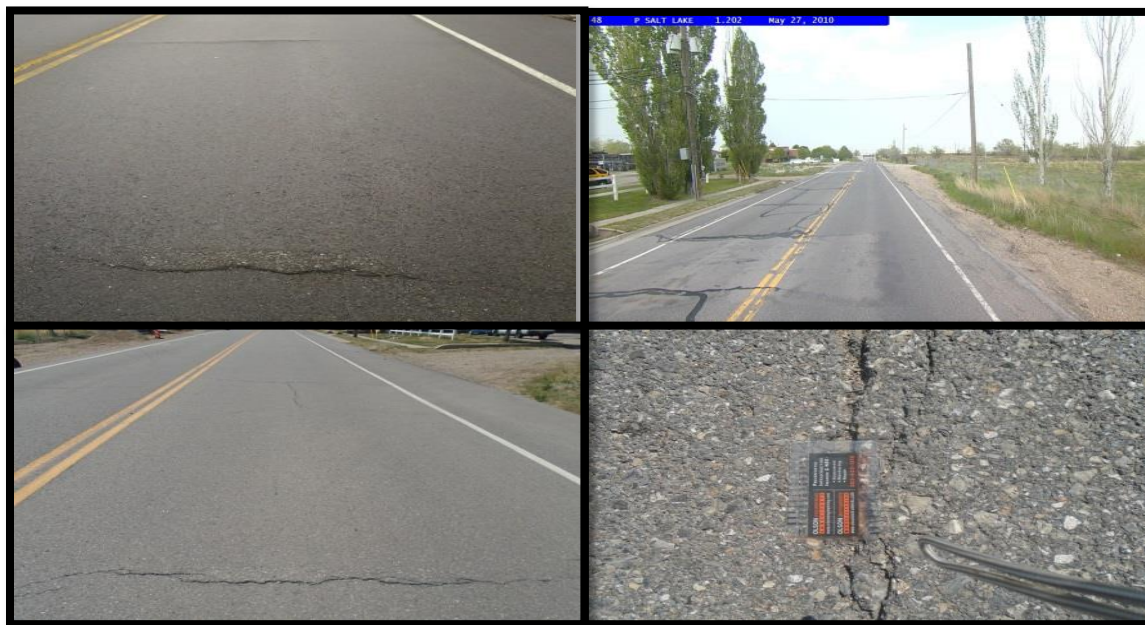
Figure 10. SR48: Transverse cracks, upper left proceeding clockwise: posttreatment (2014), pretreatment (2012), posttreatment (2015), 0.5 inch wide.

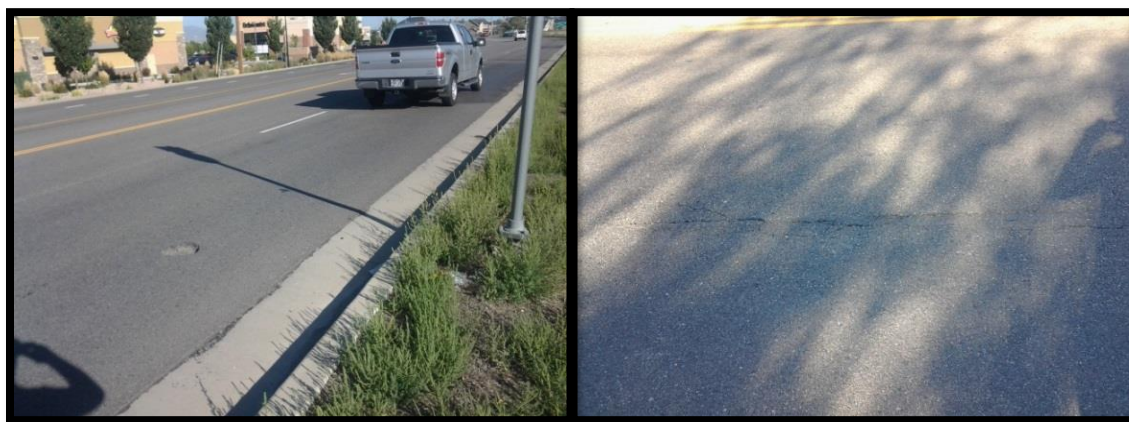
Figure 11. SR154: One of three potholes in the wheel path (left) and (right) LNWP joint crack (September 2014).

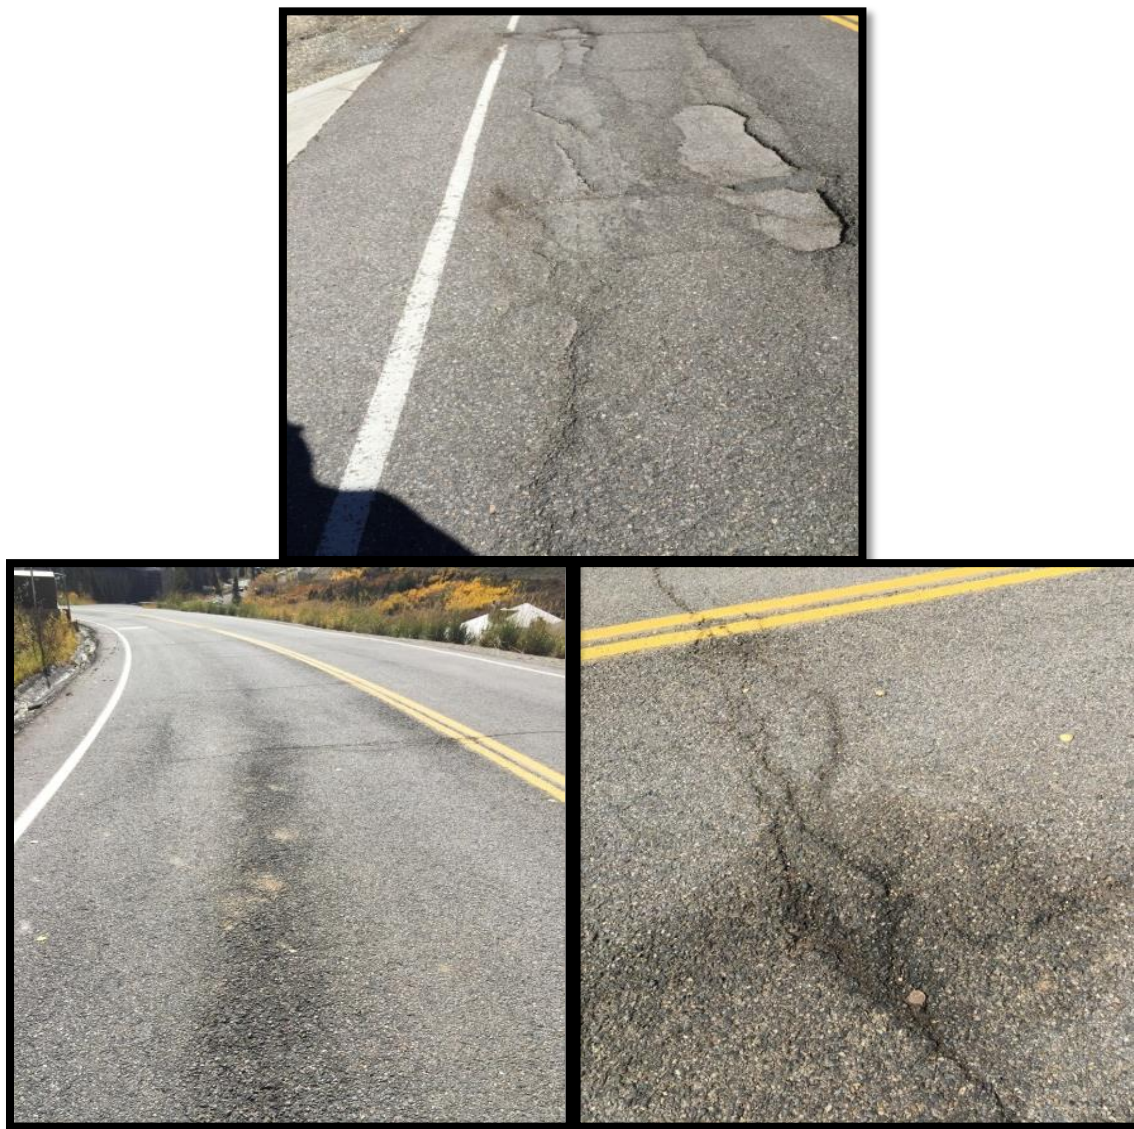
Figure 12. SR210: Delamination (top), raveling, and transverse cracking with raveling (April 2015).

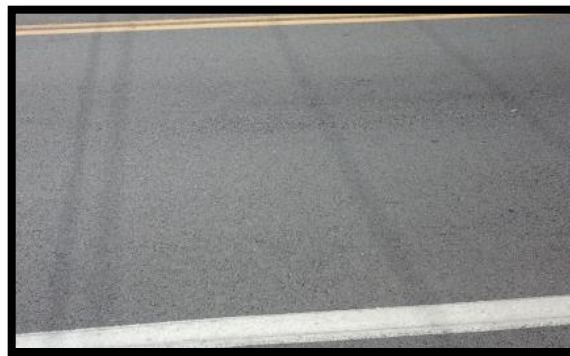
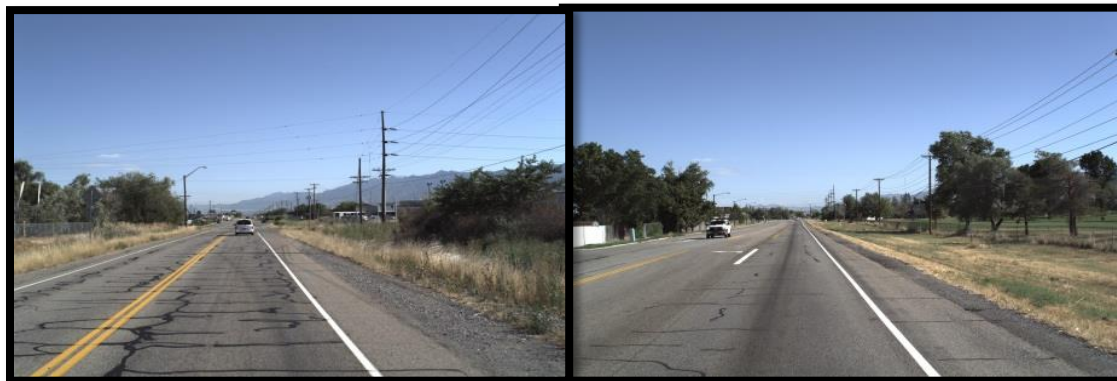
Figure 13. SR68: Raveling in the wheel path (top). Pretreatment conditions showing many tar sealed cracks (bottom).

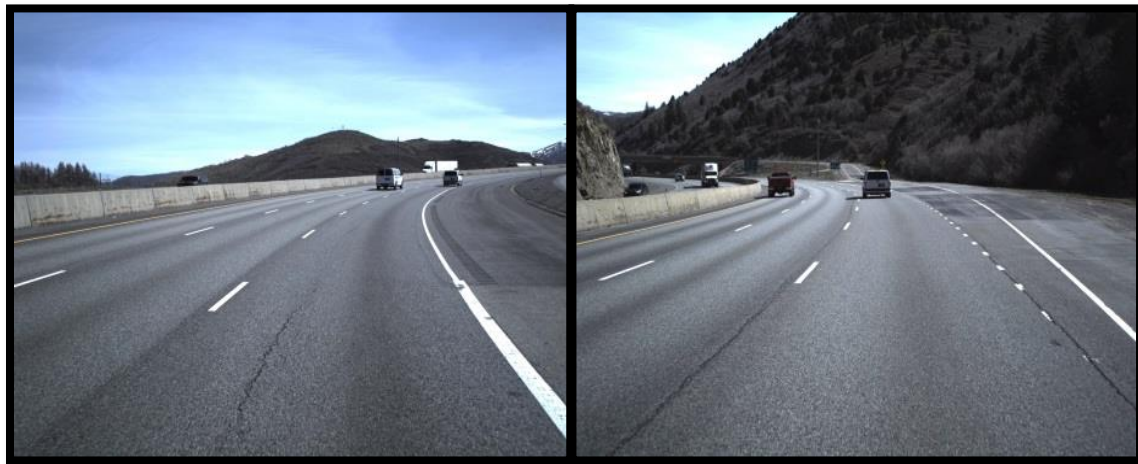
Figure 14. SR80 (3): Low severity WP cracking (left) and LNWP joint crack (right) (April 8, 2014).

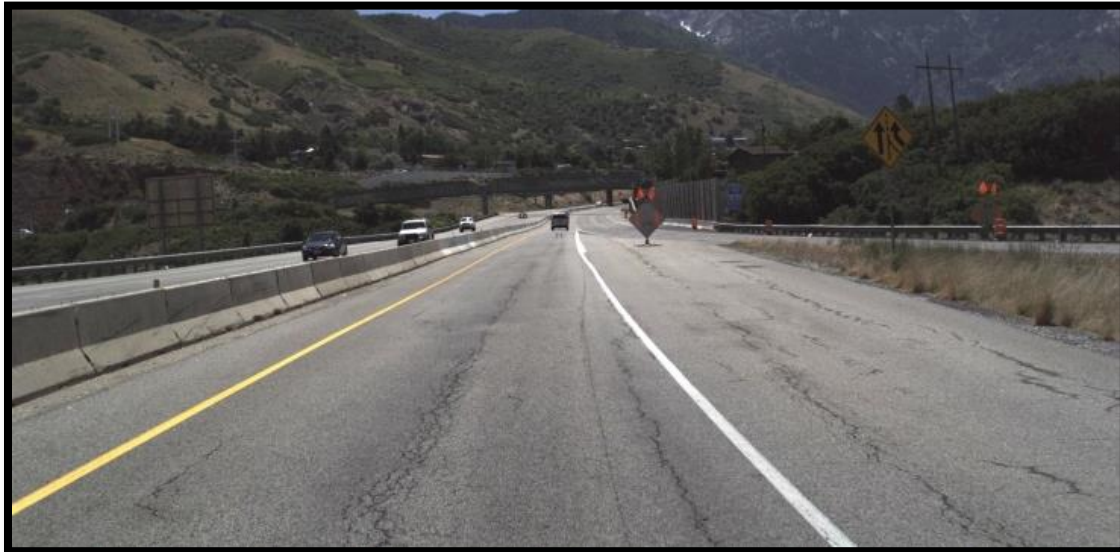
Figure 15. SR215: Medium severity fatigue cracking, found in pretreatment condition, Roadview Explorer (June 17, 2012).
